Asset #03655(Routine)

SH 13-SEC 10 over I 40-SEC 41 LOG 182.51

Location: 1.41 MI N JCT US 70

Team Lead: Bryan Saunders, Inspection Date: 07/31/2023

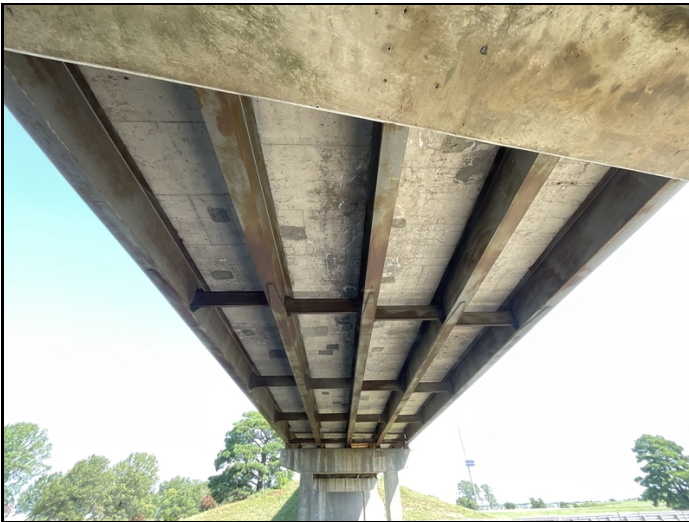
span 2 soffit

Soffit span 2 has cracking with efflorescence

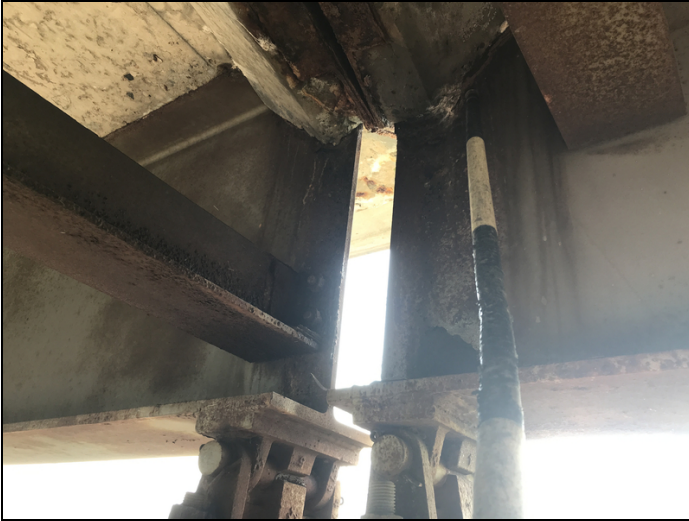
Span 1, beam 5, pitting to 3/16 inch deep on upper web.

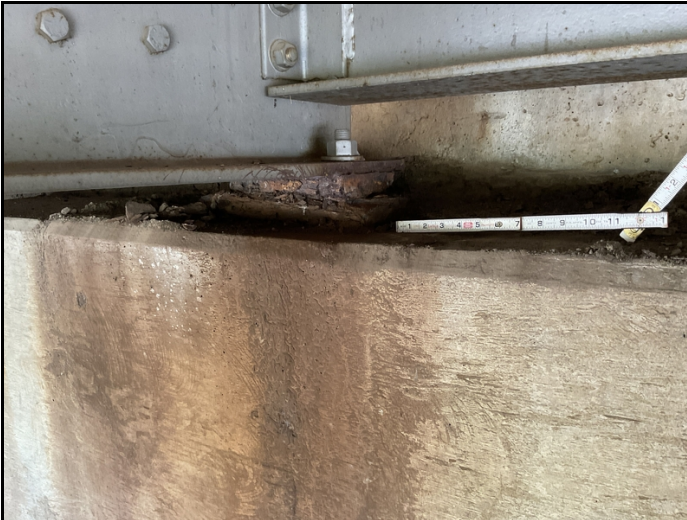
Bent 5 beam 2 bearing

At bents 1 and 5 the bearings have heavy laminating rust to bearings and masonry plates.

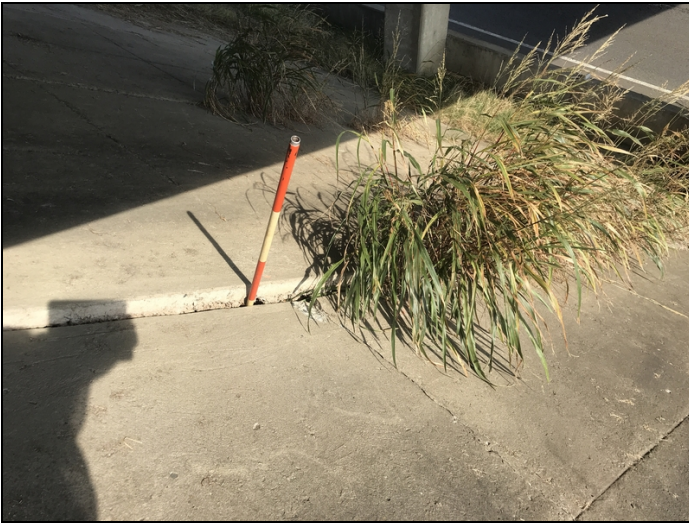
South end slope paving

Slope paving undermined on the south end

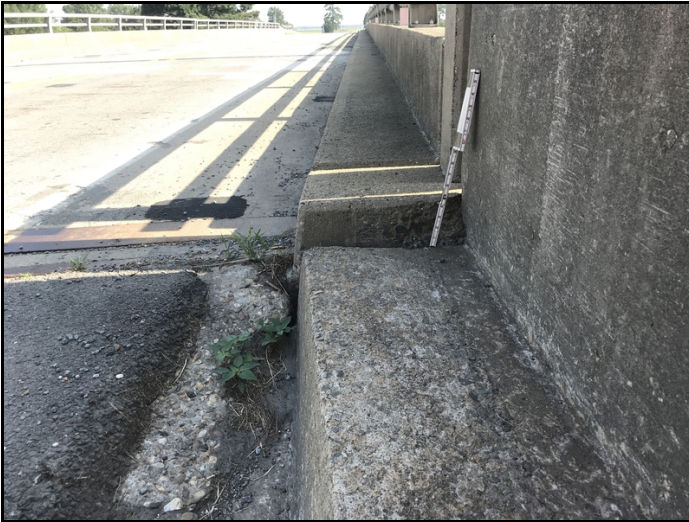
South approach has settled over 4". The north approach has also settled approx. 2.5".

North approach has settled over 4"

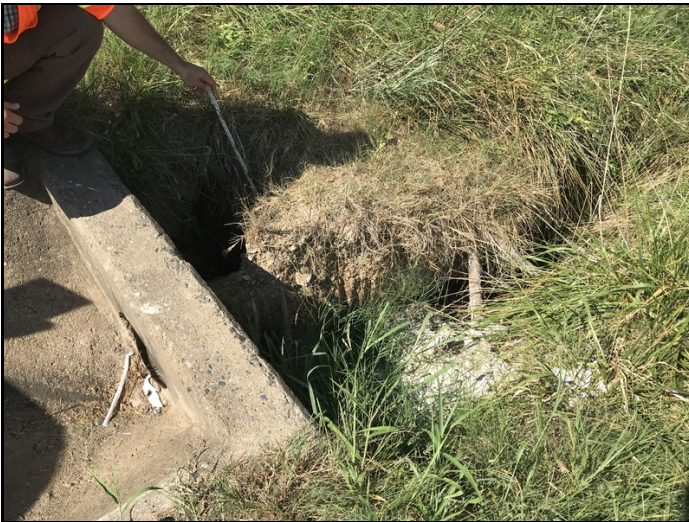
Northwest end of bridge has 5' hole at approach slab drain.
Southwest end of bridge has 3' hole at approach slab drain.

Northwest end of bridge has 5' hole at approach slab drain.
