Asset #A3424(Routine)

I-30 WB Log 97.06 over Ouachita Rvr& Riverview

Team Lead: Shane Byrd, Inspection Date: 06/20/2022

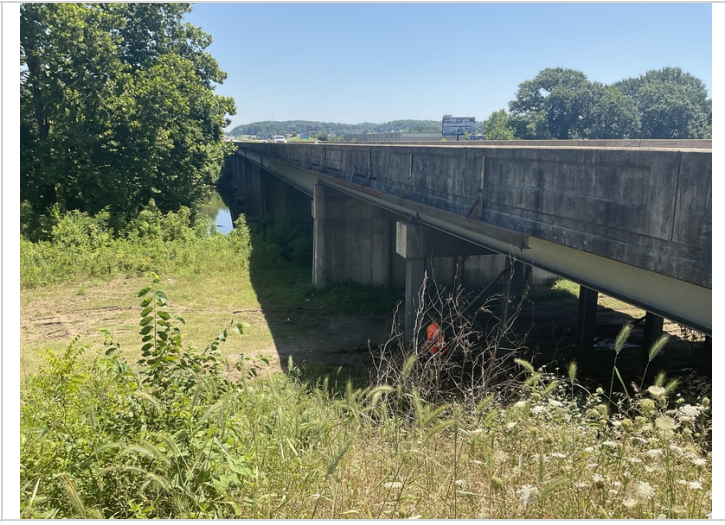
Elevation.

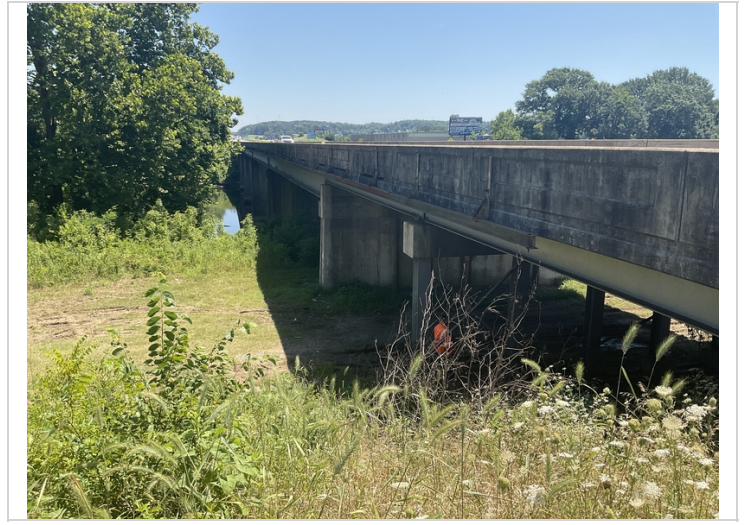
Elevation.

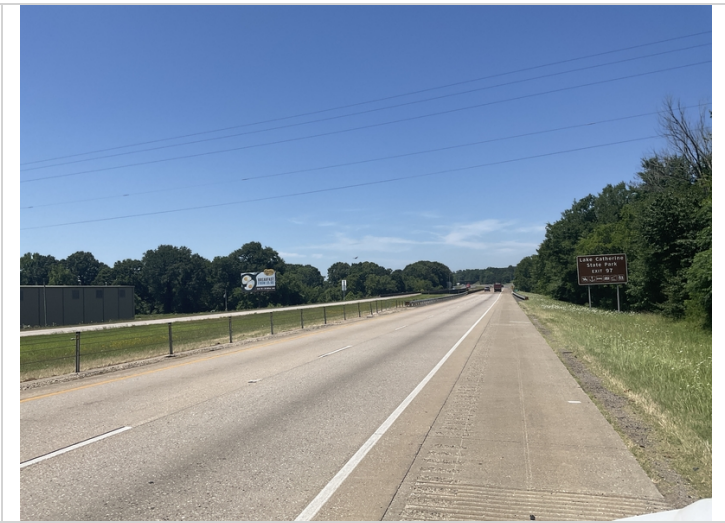
Approach westbound.

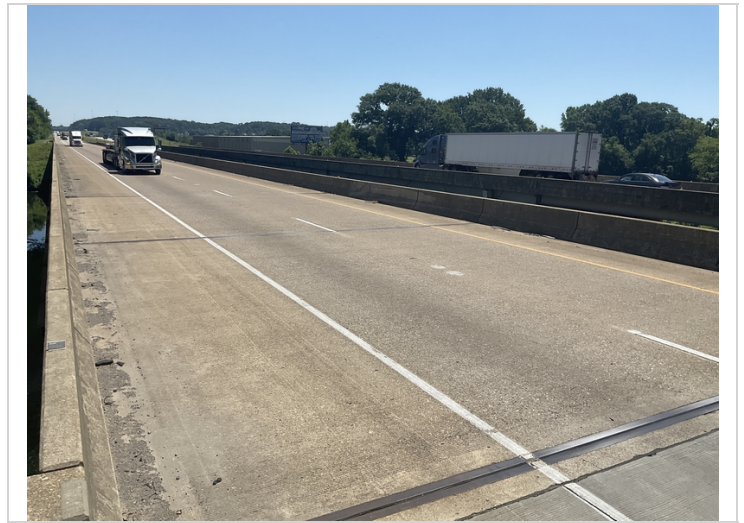
Deck overview.

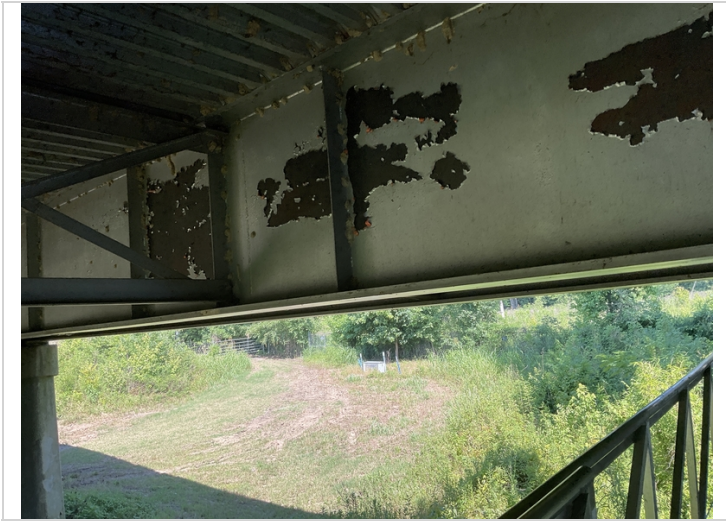
(515-107) Paint system has scattered locations of peeling paint and freckled rust on bottom flanges and scattered locations of freckled rust in the webs.

Span 3 girder 2 peeling paint. Common all spans.

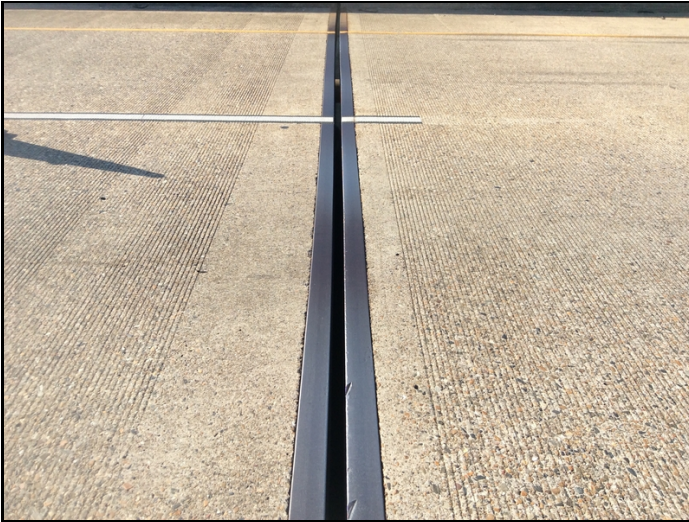
Joint seal have fallen out at pier 1,2,4 & 5

Pier 4, joint seal has fallen out.

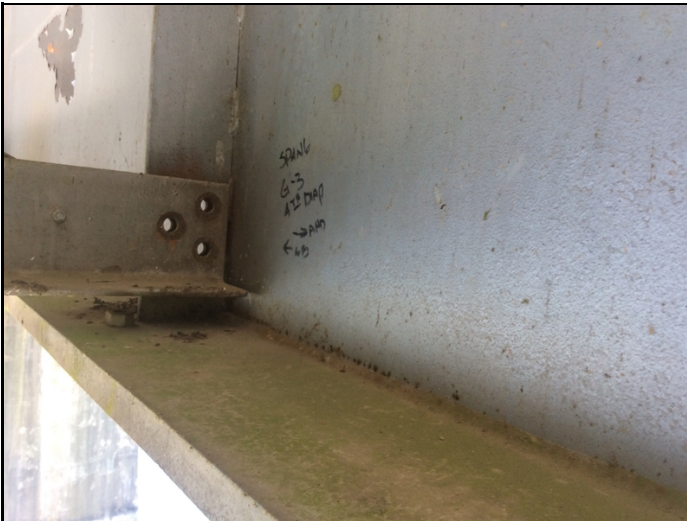
Missing or loose diaphragm bolts at span 2 beam 3 at the 1st diaphragm, Span 5 girders 2 and 3 at the 4th diaphragm and span 6 girder 3 at the 4th diaphragm.

Span 6 girder 3 4th diaphragm has missing bolts

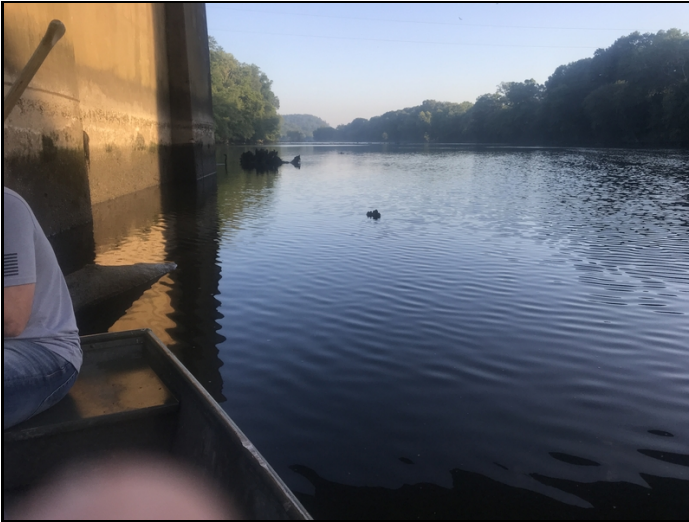
Pier 3 trees lodged against bent. Common at pier 2,4 & 5

Pier 3 tree lodge against bent.

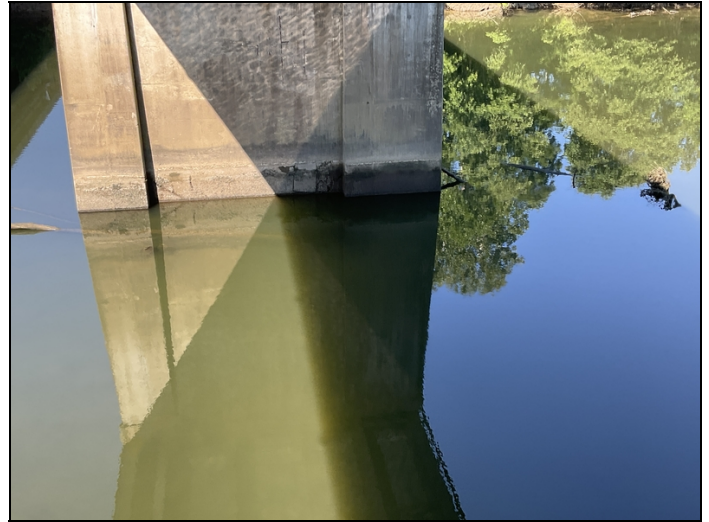
Pier 3 logs against bent.

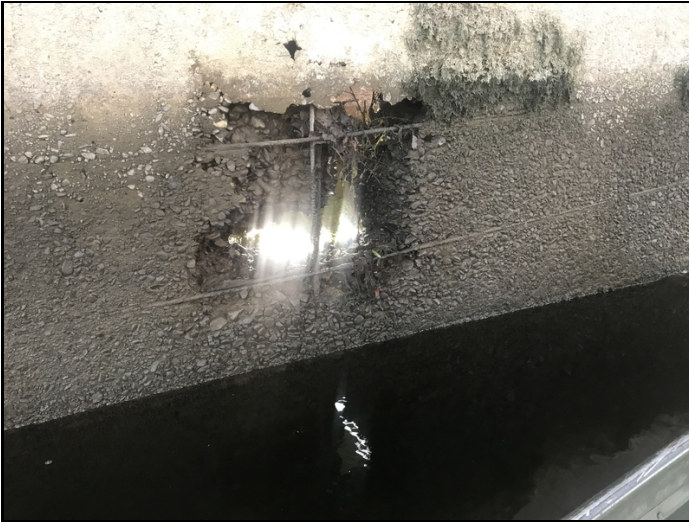
Piers 2 thru 5 have areas of severe abrasion.

Pier wall 5 has severe abrasion with exposed rebar.

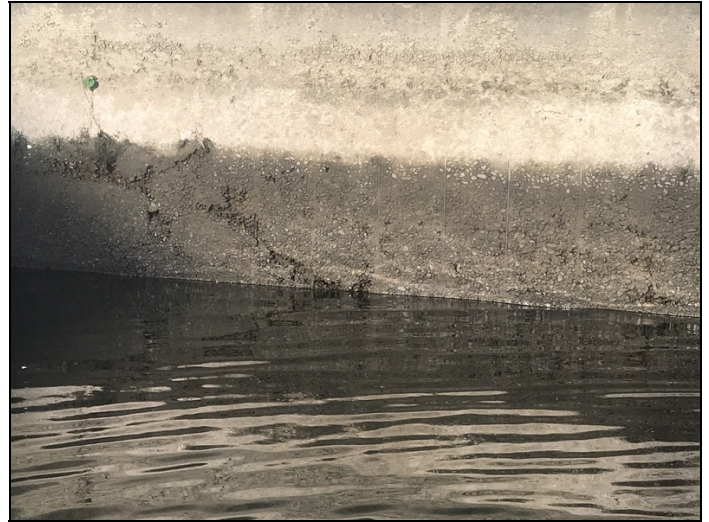
Pier 2 ahead abrasion with exposed rebar to pier wall.

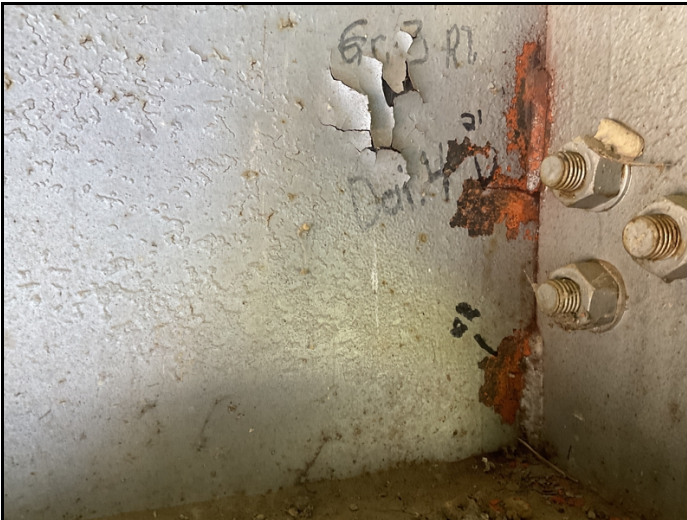
(107) Span 5 Girder 3 diaphragm 3,Span 6 Girder 3 diaphragm 3, Span 7 girder 3 diaphragm 3, Span 7 Girder 3 diaphragm 4.
Cracks in the web that have propagated from diaphragm welds. See Photos.

Span 5 Girder 3 diaphragm 3, Span 6 Girder 3 diaphragm 3, Span 7 girder 3 diaphragm 3, Span 7 Girder 3 diaphragm 4. Cracks in the web that have propagated from diaphragm welds. See Photos.

Span 7 girder 3 diaphragm 4 right side back of diaphragm cracks in the web.
