Bridge 00899 Inspection Report

Asset #00899(Routine, Underwater type 2)

US 67 S-6 LM 3.73 over CADDO RIVER

Team Lead: Rickie Bratton Inspection Date: 08/21/2024

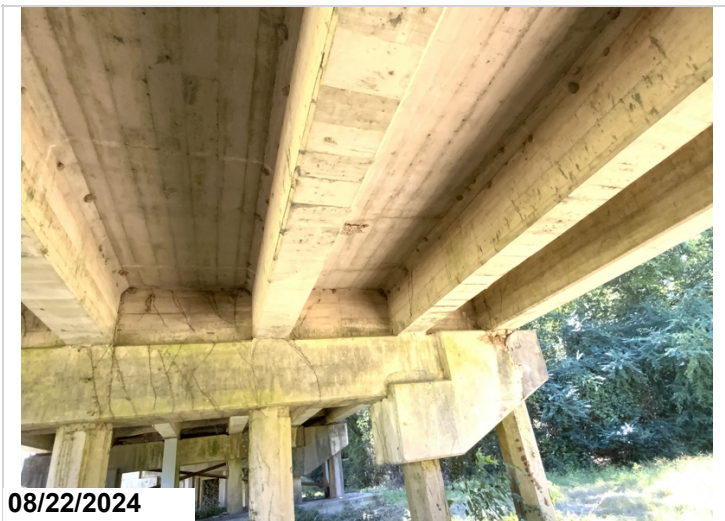
Bent 6 cap ahead left side 1' exposed rebar CS3

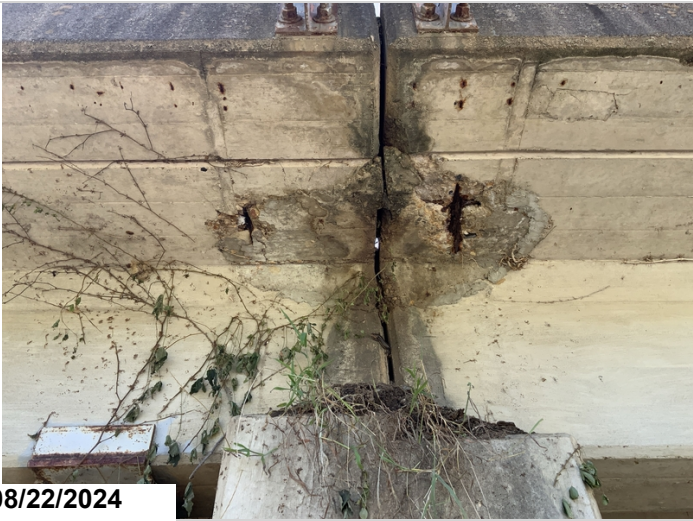
Bent 15 right side overhangs of spans 14 and 15 have exposed rebar. 2' CS3

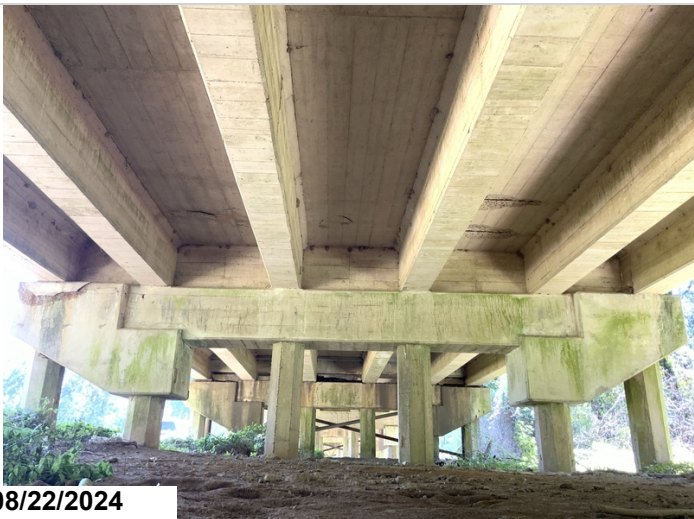
Span 18 bay 2 exposed rebar 6' CS3

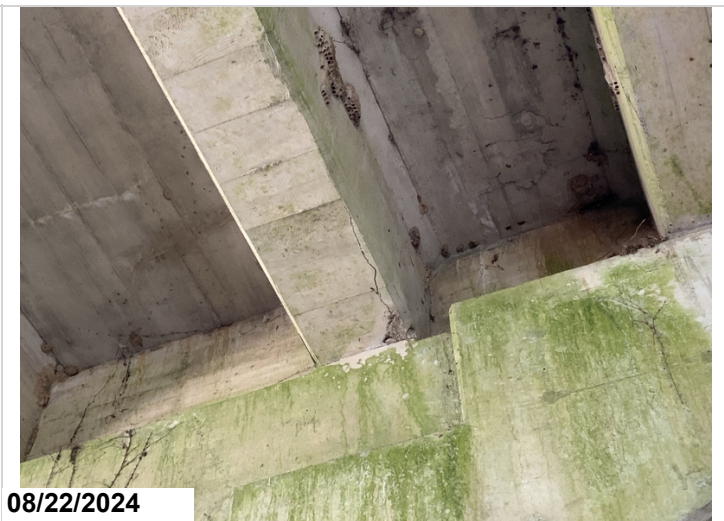
Span 23 bent 23 girder 2, delam 1' CS2

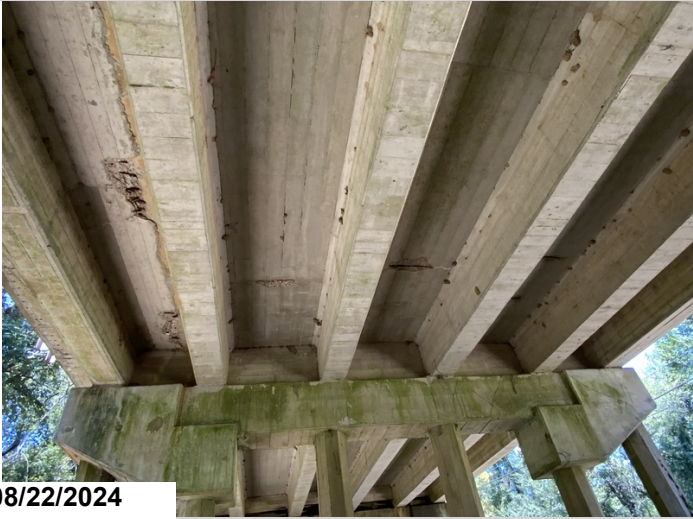
Span 24 bays 1-4 have exposed rebar, 21' CS3

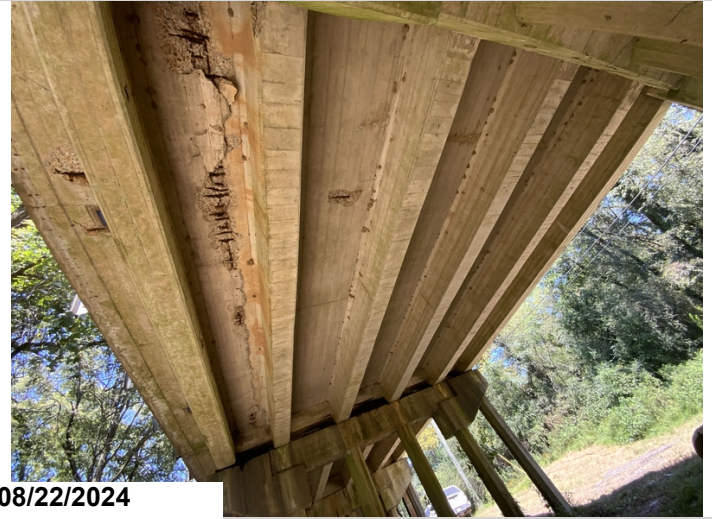
Span 25 bay 1 and left over hang exposed rebar 13' CS3.

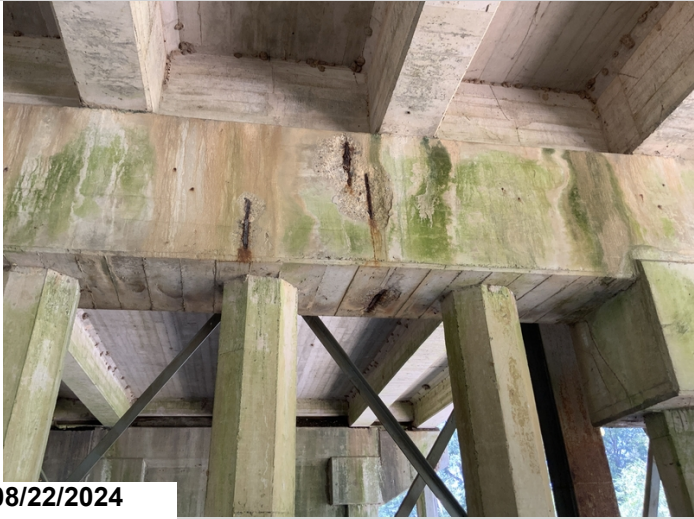
Bent 27 cap back above pile 3 has 3' exposed rebar CS3.

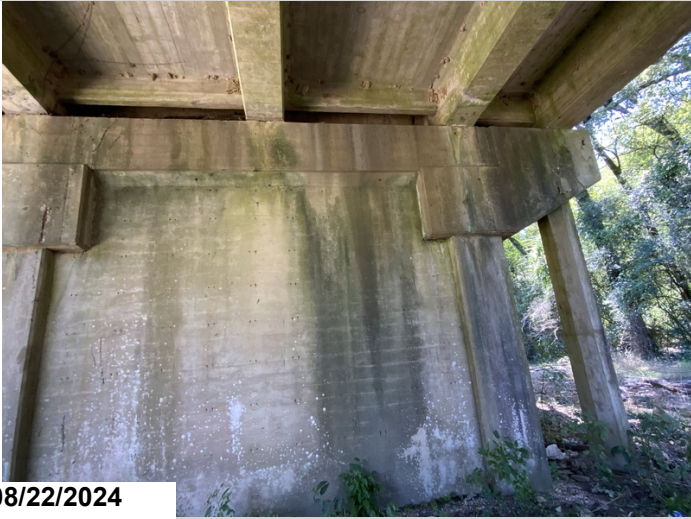
Bent 28 cap ahead right side exposed rebar 1' CS2

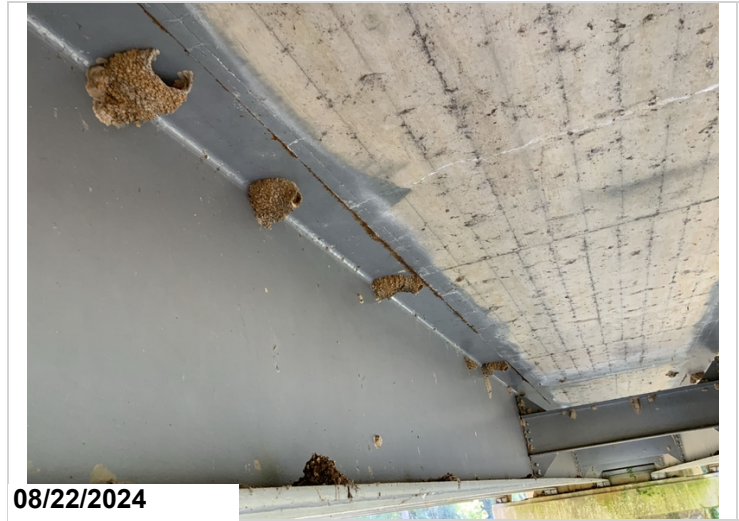
Typical paint system near top flange.

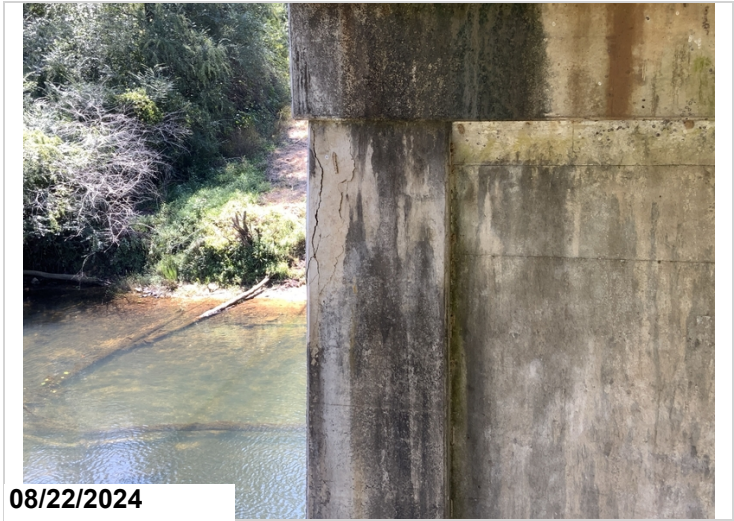
(205) Bent 30 Pier column #2 has large spall on back face of the column. (1080-205) Bent 30 ahead face column 2 : large delaminating near cap CS3 (1090-205) Bent 30 column 2 back: large spall with exposed rebar. CS3 Bt. 30, column 2, spall with exposed rebar							
210	Reinforced Concrete Pier Wall	LF	125	88	30	7	0
1080	Delamination/Spall/Patched Area	LF	5	0	5	0	0
1090	Exposed Rebar	LF	7	0	0	7	0
1190	Abrasion/Wear (PSC/RC)	LF	25	0	25	0	0
(1090-210) Bent 29 back pier wall 7' exposed rebar CS3							
215	Reinforced Concrete Abutment	LF	63	19	31	13	0
1080	Delamination/Spall/Patched Area	LF	12	0	0	12	0
1090	Exposed Rebar	LF	1	0	0	1	0
1130	Cracking (RC and Other)	LF	31	0	31	0	0

Bent 30 ahead face column 2 : large delaminating near cap
CS3

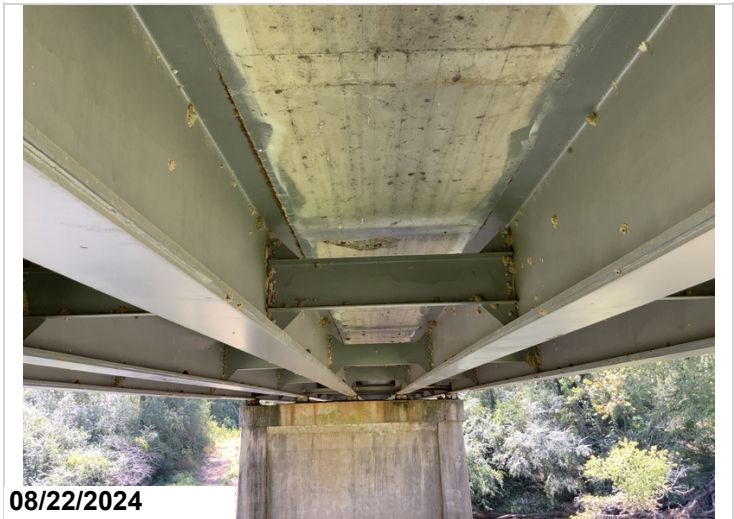
Span 30 girder 5 left at first diaphragm ahead of bent 30:
missing nut.

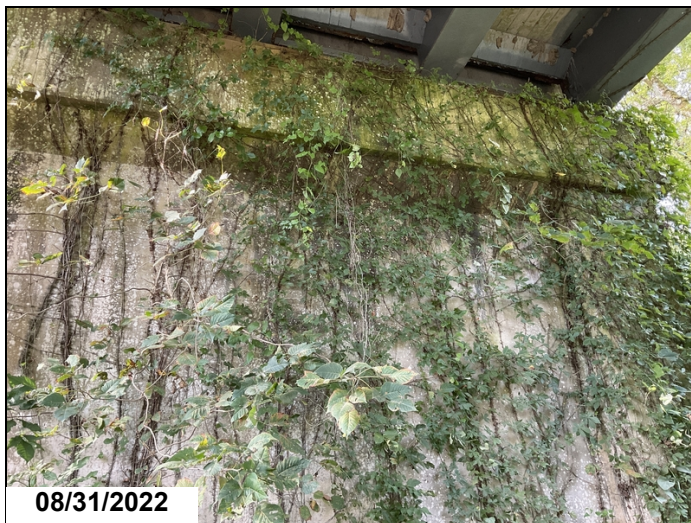
Bt. 29, pier covered with poison ivy.
