Bridge #02872(Routine)
SH 77-02- LM 6.76 over LITTLE RIVER
Location: 0.05 MI S JCT OF SH 158

Team Lead: Tim Myrick **Inspection Date:** November 24, 2020

IDENTIFICATION	
(1) State Names	Arkansas
(8) Structure Number	02872
(5) Inventory Route	77
(2) Highway Agency District	10
(3) County Code	93-Mississippi County, Arkansa

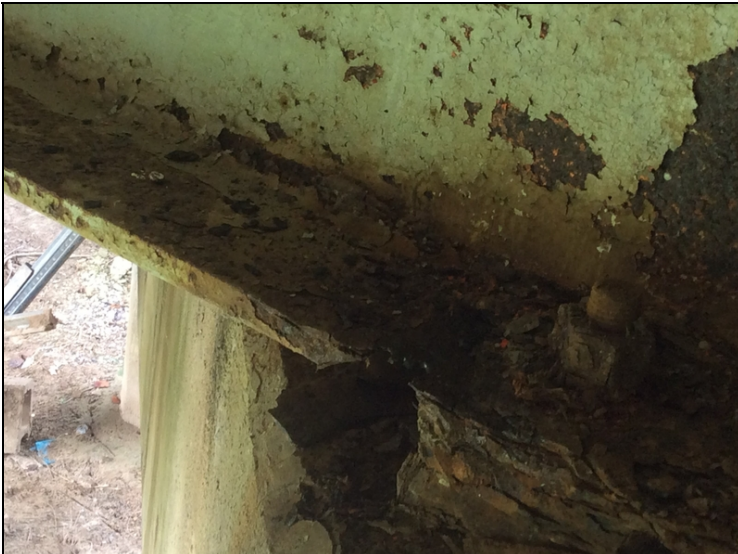
02872 10-01-2015 Span 2 Girder 2 over bent 2
bottom flange.

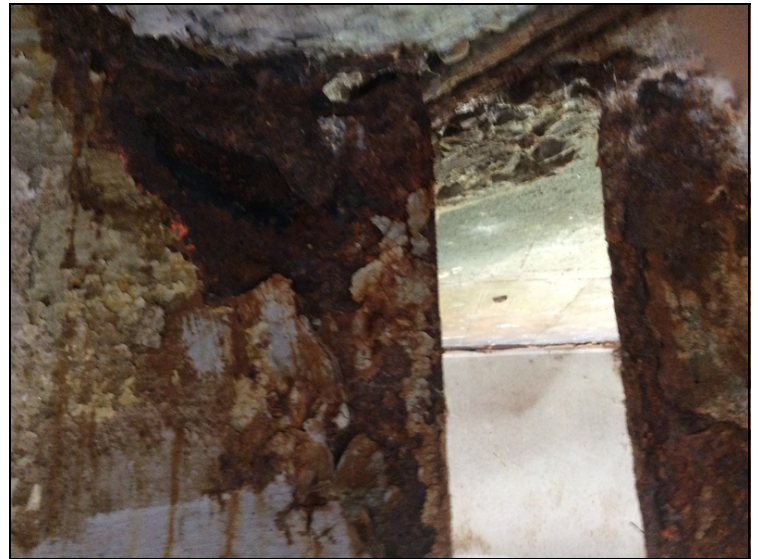
02872 10-01-2015 Span 2 Girder 2 over Bent 3.

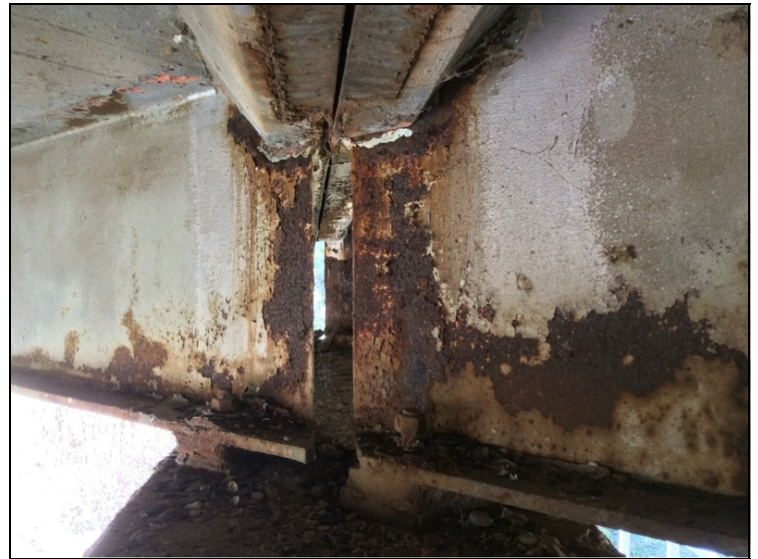
02872 10-01-2015 Span 3 & 4 Girder 4 over Bent
4.

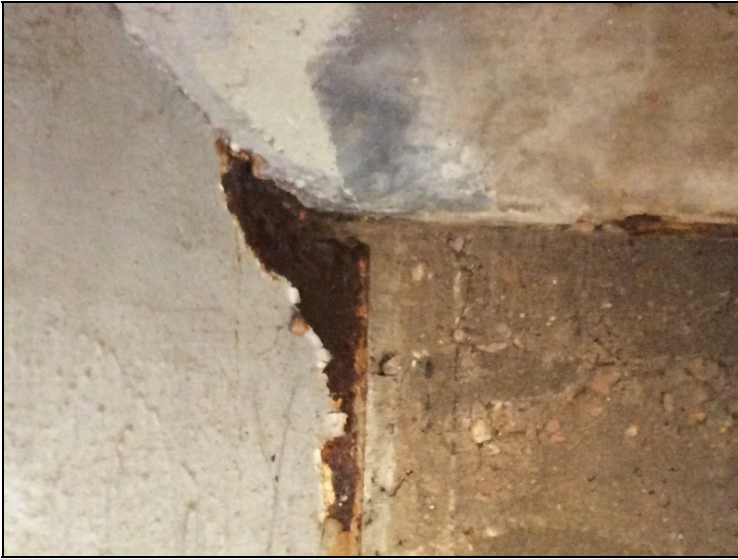
02872 10-01-2015 Span 5 Girder 3 over Bent 6.

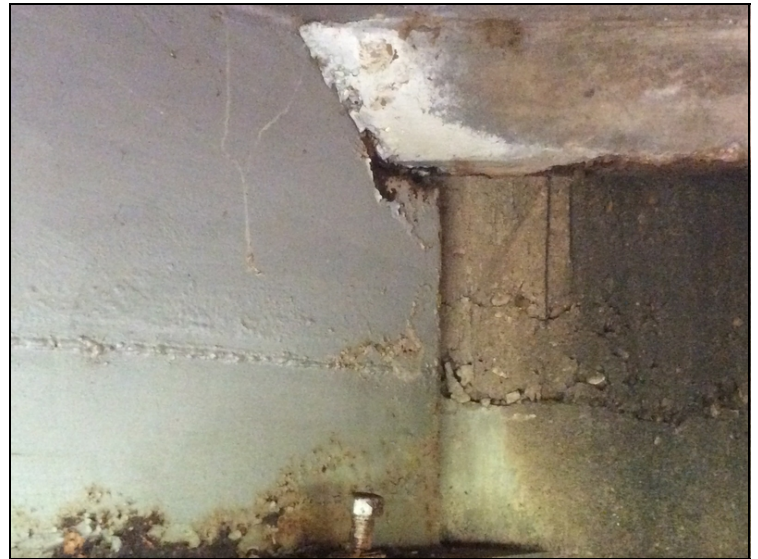
02872 10-01-2015 Span 1 Girder 3 over Bent 1.

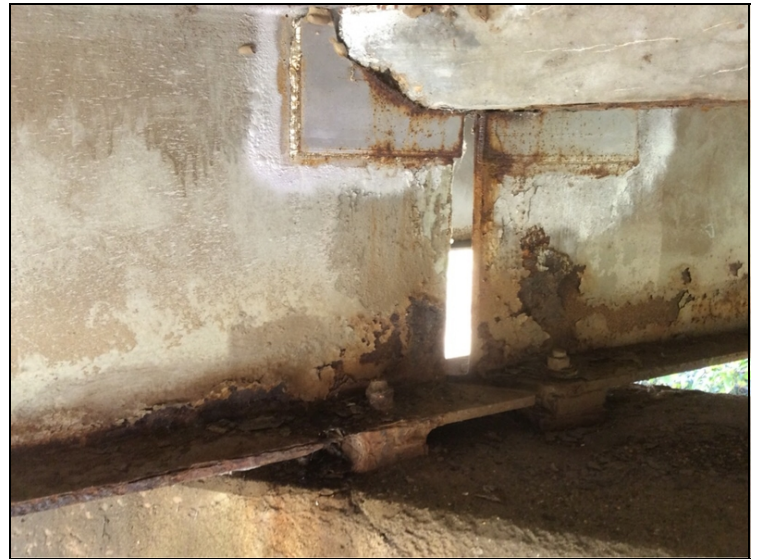
02872 10-01-2015 Span 1 Girder 3 over Bent 2.

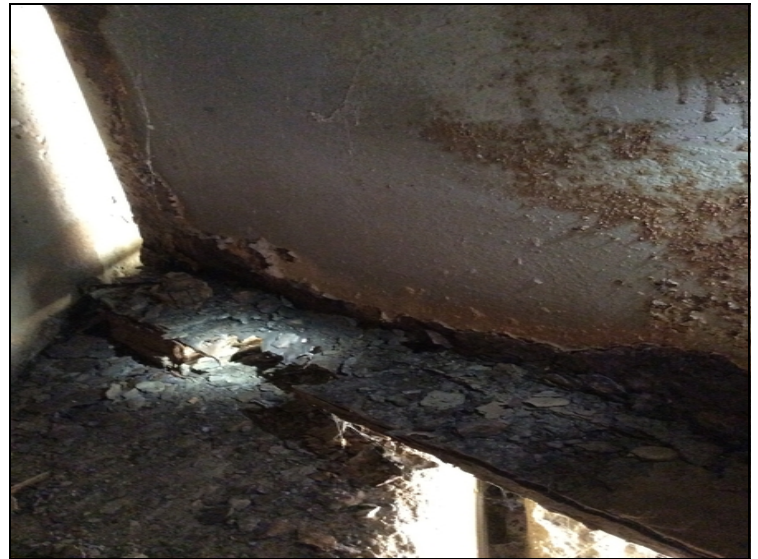
02872 10-01-2015 Span 3 Girder 2 over Bent 4.

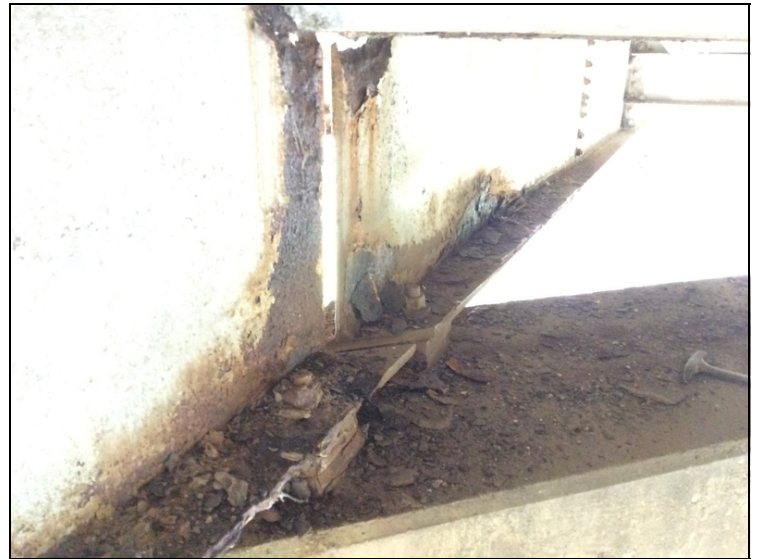
02872 10-01-2015 Span 3 Girder 3 over Bent 4
Bottom Flange.

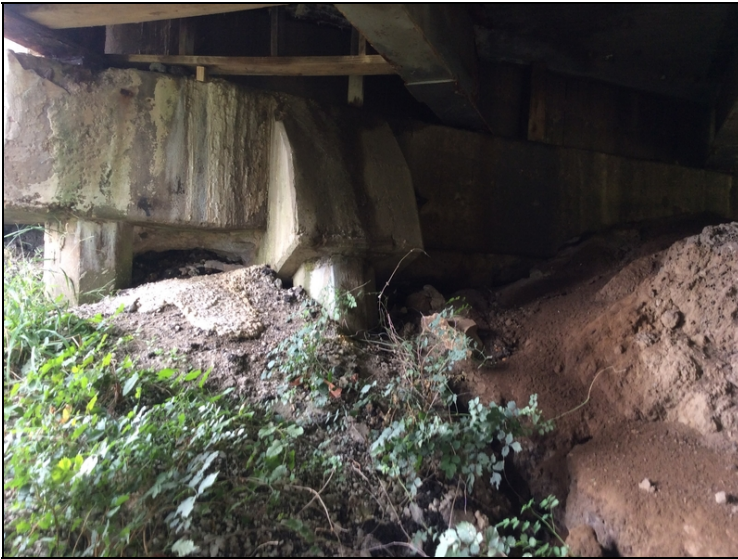
02872 10-01-2015 Bent 6 Left end

Bent 6 abutment erosion heavy slope erosion from roadway runoff has undermined left side of bent 6 abutment, 2' deep and 2' back under, exposing piling.

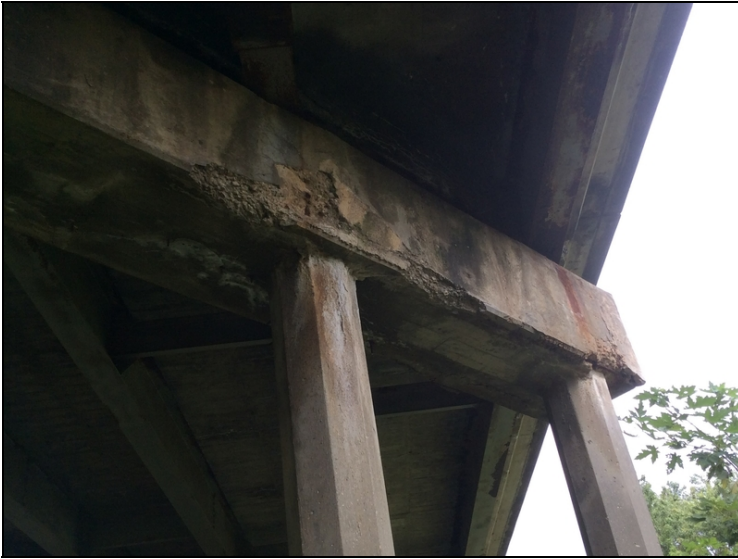
Bent 2 cap left end of has a 2' x 6" spall with exposed rebar, 1' of exposed rebar on bottom near pile 2, a 2' x 4" spall with exposed rebar at pile 4, 2' of deterioration near girder 5.
Bent 3 cap has heavy deterioration and cracking with 10' total of exposed rebar due to lack of steel coverage. Span 3 side of cap has 15' of spall with some exposed rebar, right end of cap over pile 5 has 3' of cracking.
Bent 4 top of cap left end between girders 1 & 2 is spalled up to 2" deep.
Bent 4 left end of cap has 3' spalled with exposed rebar (with section loss) over pile 1.
Bent 5 cap has 6' of cracking & impending spalls.
Bent 6 abutment left end has a 2' x 4" deep spall with exposed rebar (with section loss to rebar) under bearing 1 with 1" of loss of bearing.

02872 10-01-2015 Bent 3 Cap Span 3 Side.

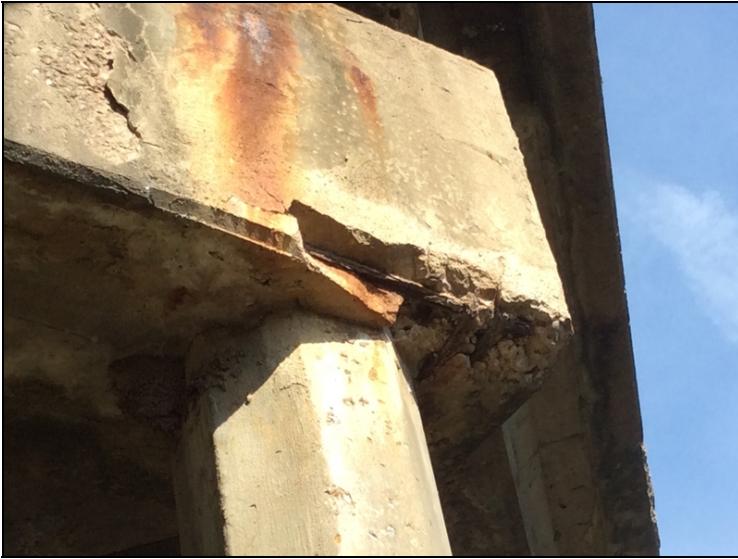
02872 10-01-2015 Bent 2 Cap Left end

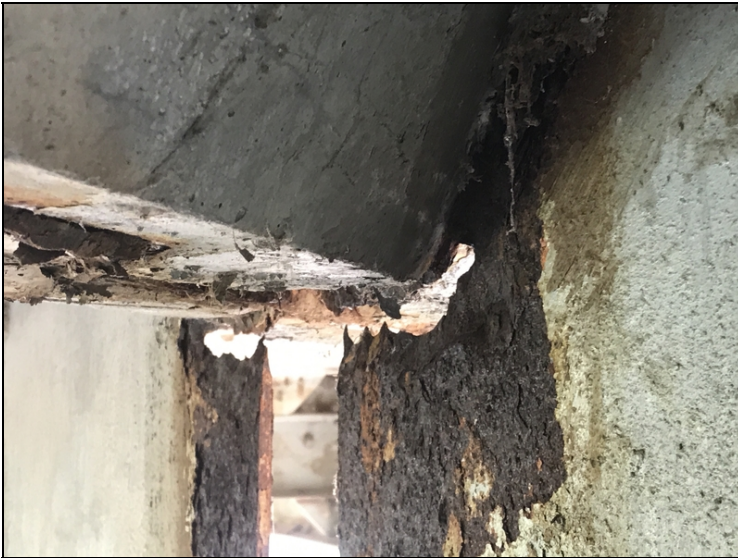
Span 4 girder 4 at bent 4

Span 4 bent 4 girder 4 has a 7"x 1" hole in web at haunch, and heavy section loss at bearing.

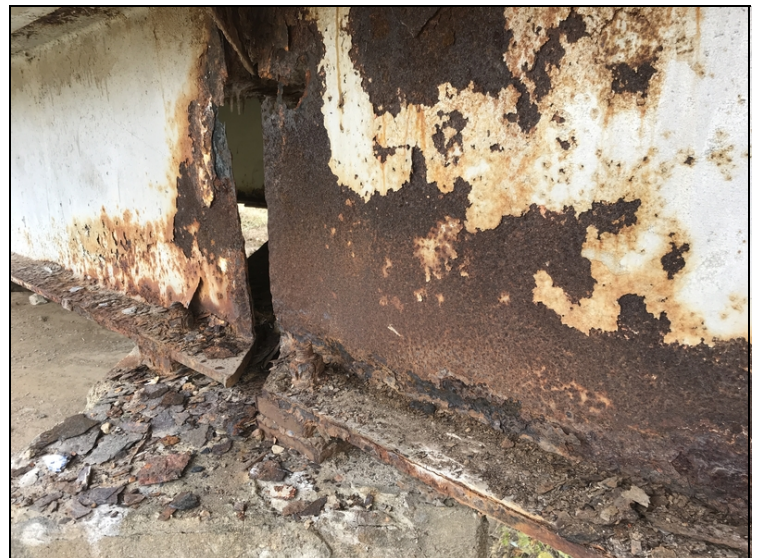
B2 right g5

Span 2 bent 2 girder 5 has 9" x 1" hole in web at haunch, 3/8" section loss bottom flange 5" x 3' area and crushing.
Span 2 bent 3 girder 1 has a 18" crack with holes in web crushing over cap.
Span 5 bent 6 girder 4 has a 1" diameter hole everywhere in web at Haunch and end of web, and the left flange (near bearing) has a 4" x 8 1/2" hole and the right flange has heavy section loss with a 1" hole, plus web has 3 1/2" x 1" hole.
