Asset #A2885(Routine)

SH 135-01- LM 2.67 over TYRONZA RIVER

Location: 2.43 M N JCT US 63 &SH135

Team Lead: Richard Jones, Inspection Date: 07/26/2023

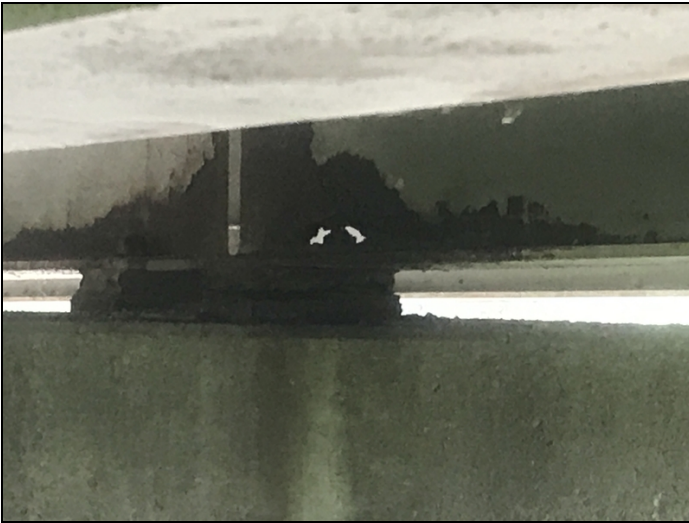
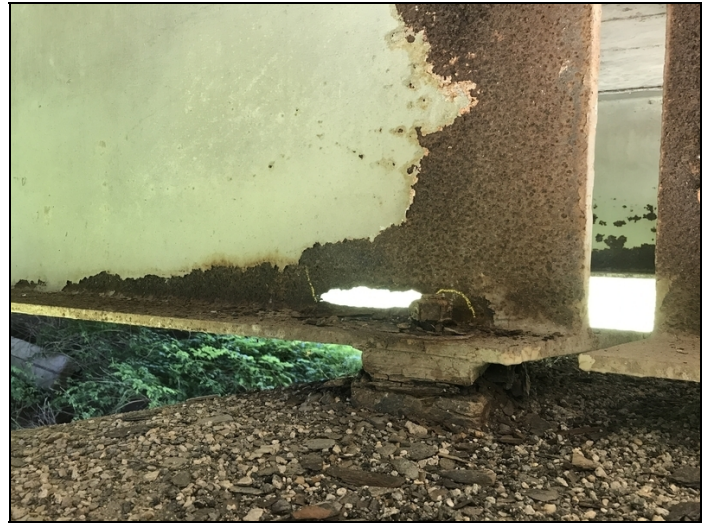
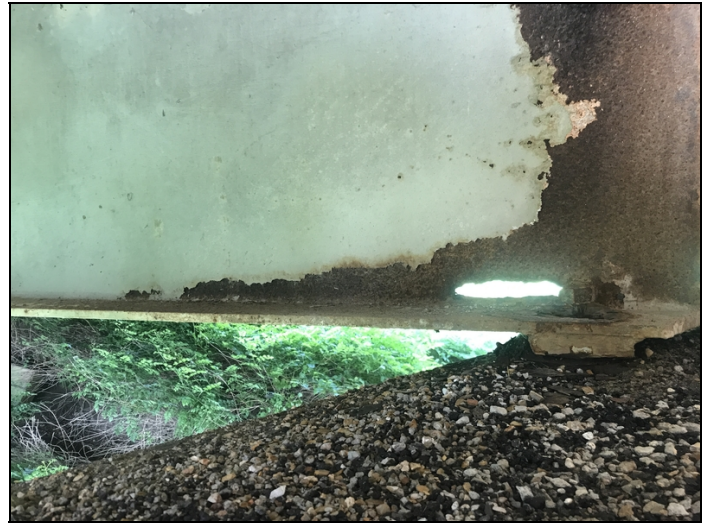
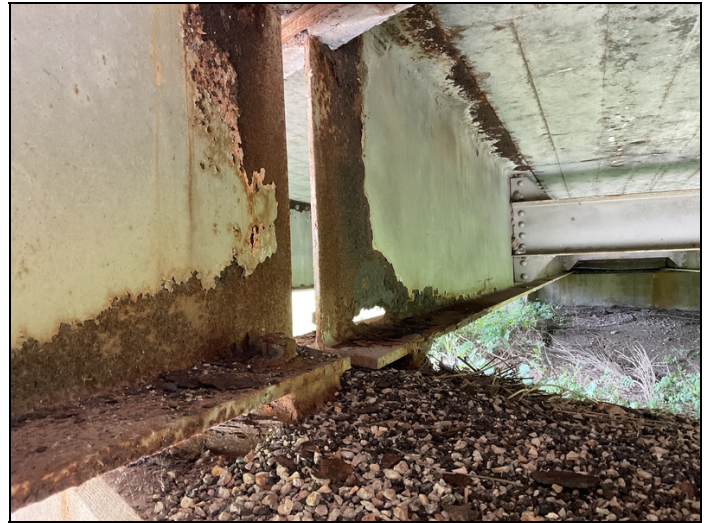
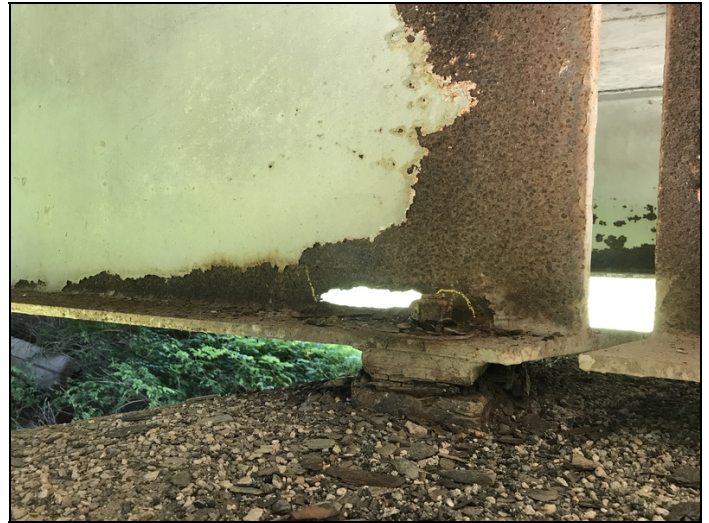
Span 1 Bent 2 girder 4 2019

Span 1 bent 2 girder 4
9" x 2" hole @ bottom of web 6" from end. Knife edge
bottom flange.

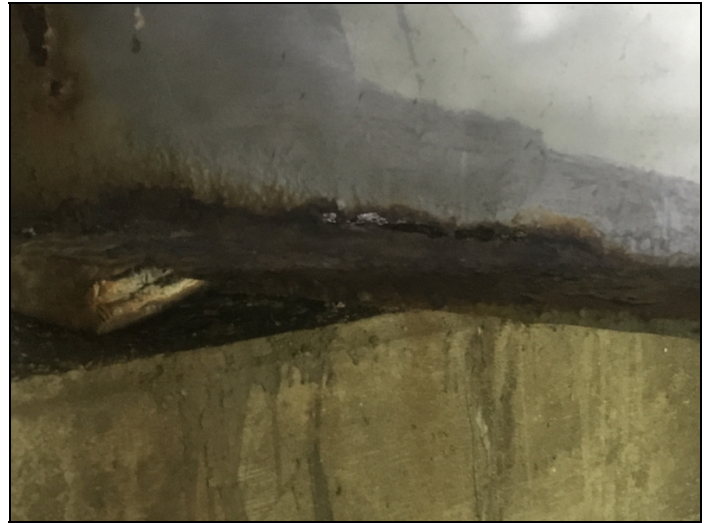
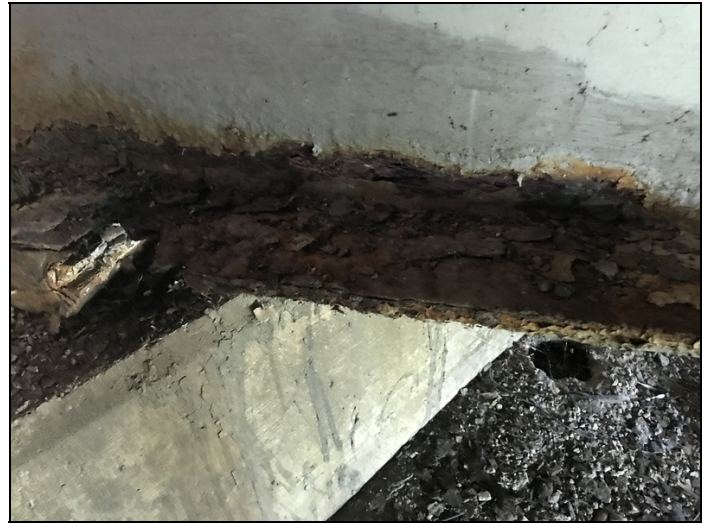
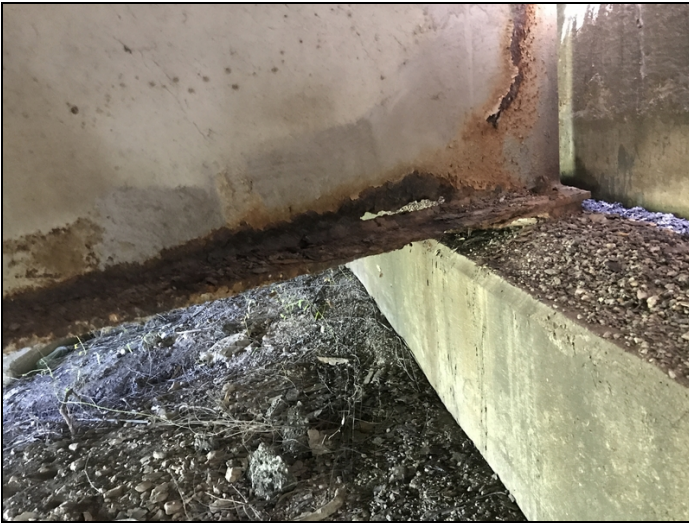
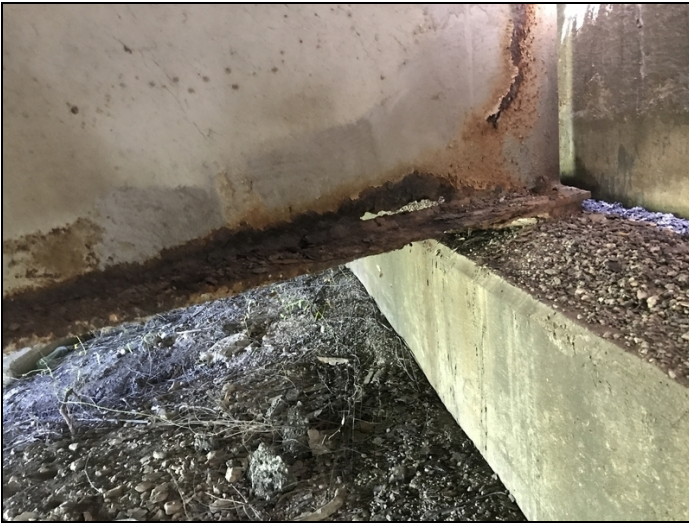
Span 7 bent 8 girder 3 2019

Span 7 bent 8 girder 3 Lt
18" x up to 1" hole in bottom of web 9" from end of girder,
and a 6" x 3" hole in Lt bottom flange.

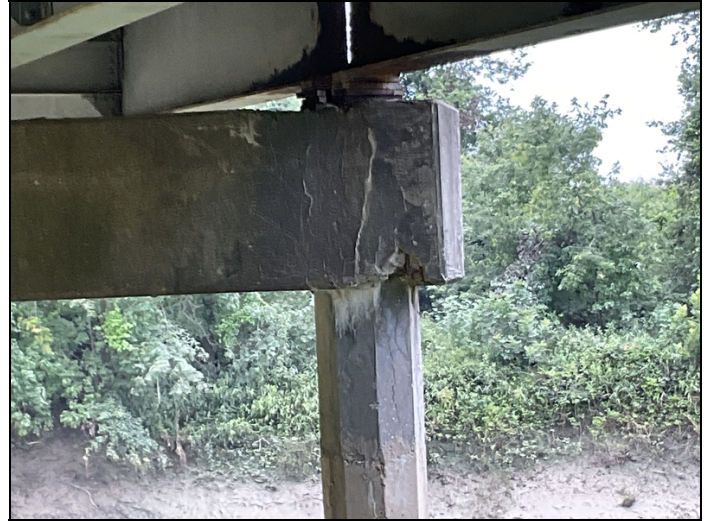
Bent 6 Lt

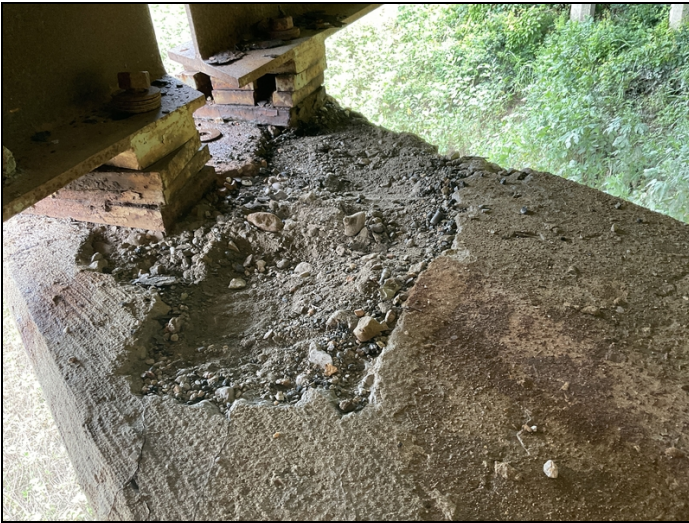
Bent 6 cap near bearing 1

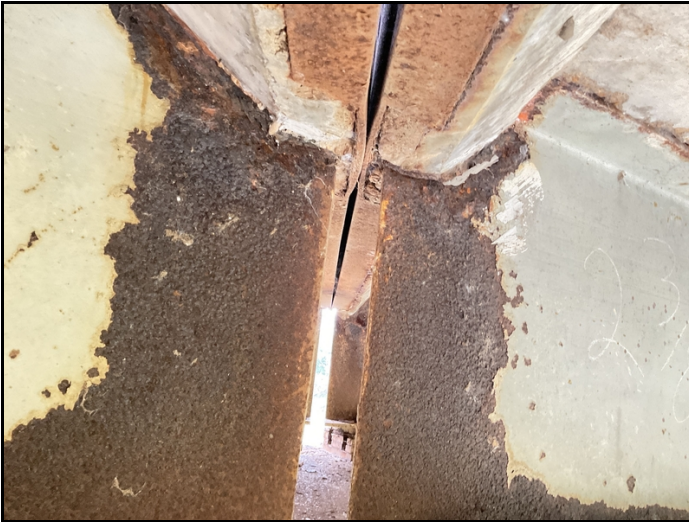
Span 4 bent 4 girder 2

Girder ends have section loss, especially at web below haunch. See photos and element notes for specific locations.

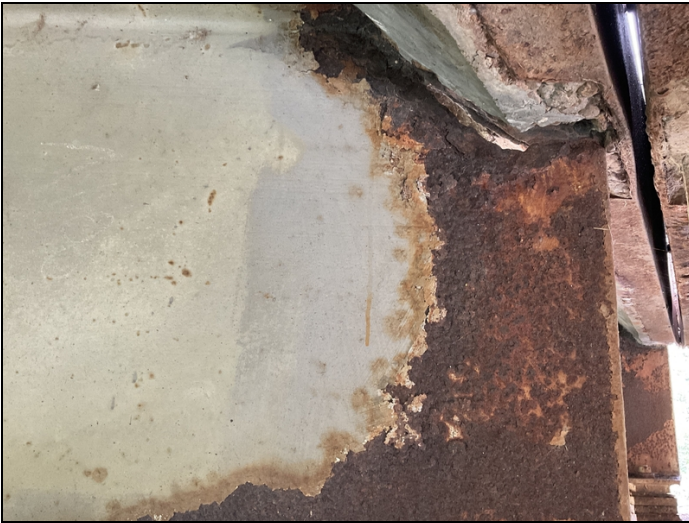
Span 6 bent 6 girder 4
6" x 1" hole @ haunch

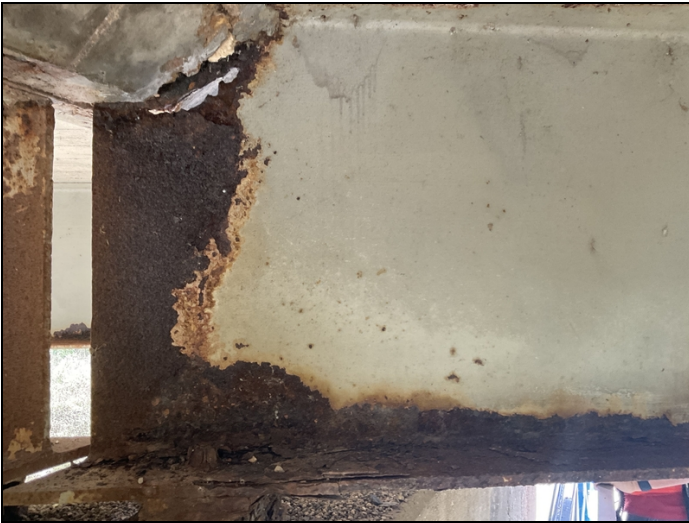
Span 2 bent 3 girder 4
6" x 1" hole @ haunch

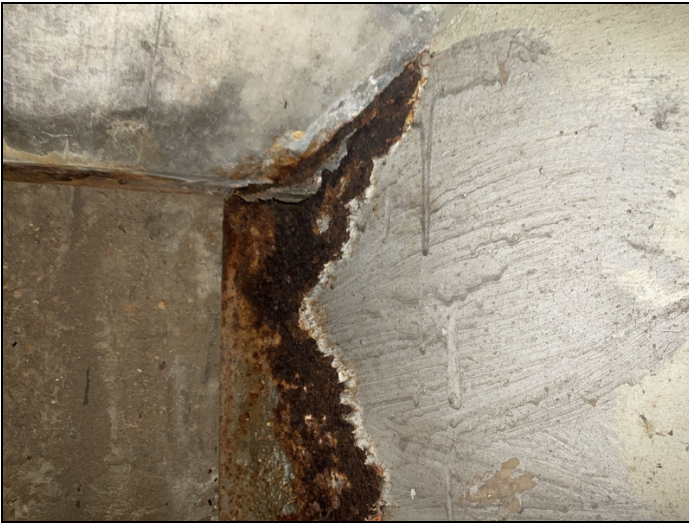
Span 7 bent 8 girder 4
10" x 1" hole @ haunch

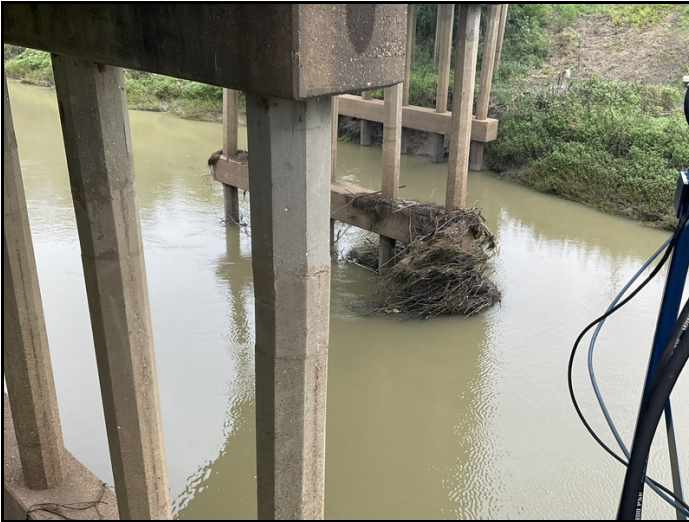
Bent 4 drift

Bents 3 and 4 have small drift buildup lodged on piles.
