Route:50 Section:01 Log:13.54

Arnold Road ID:68x50x1xA, Arnold Log mile:13.543

District 01, 123 - St. Francis County

INSPECTIONS *			
(90) Inspection Date	03/25/2024		
(91) Frequency	12		
(92) Critical Feature Inspection	Done	Freq. (Mon)	Date
A: Fracture Critical Detail	No		
B: Underwater Inspection	No		
C: Other Special Inspection	No		
* The inspection date and frequency information in this box contains the current NBI date and frequency information. Please refer to the report header for the date this inspection was conducted.

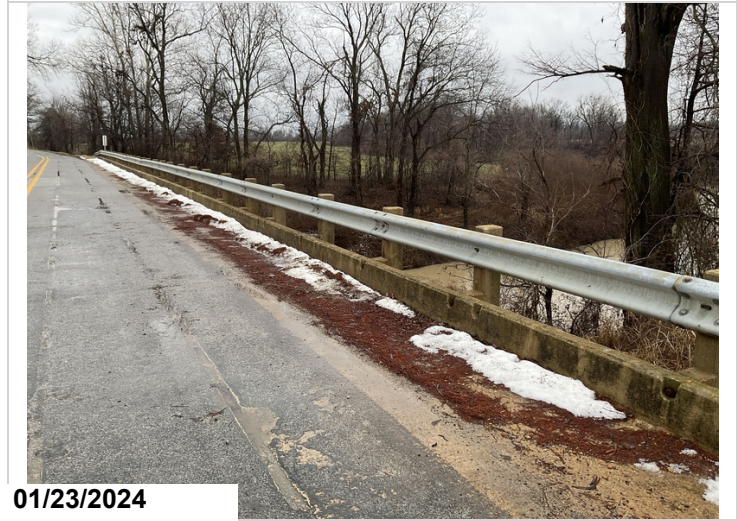
Bridge rail right side

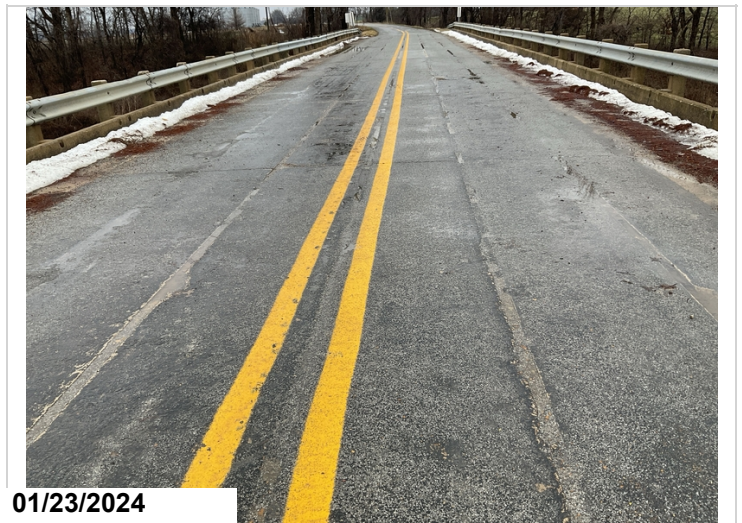
Typical deck

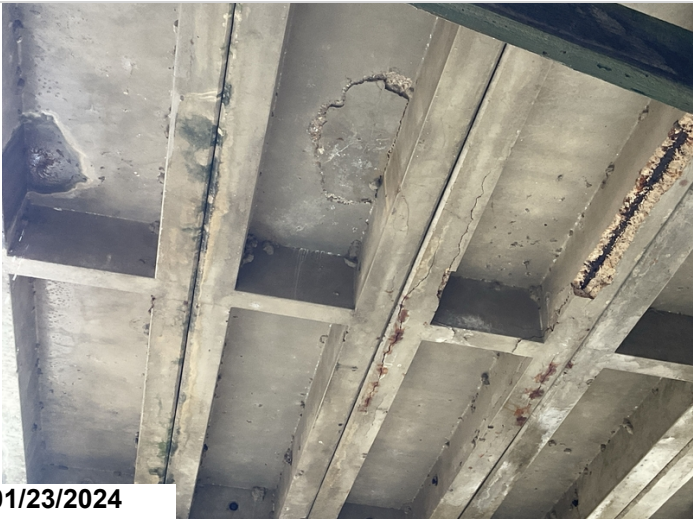
Span #3 girder #2 has two foot delaminated area in soffit near mid span.

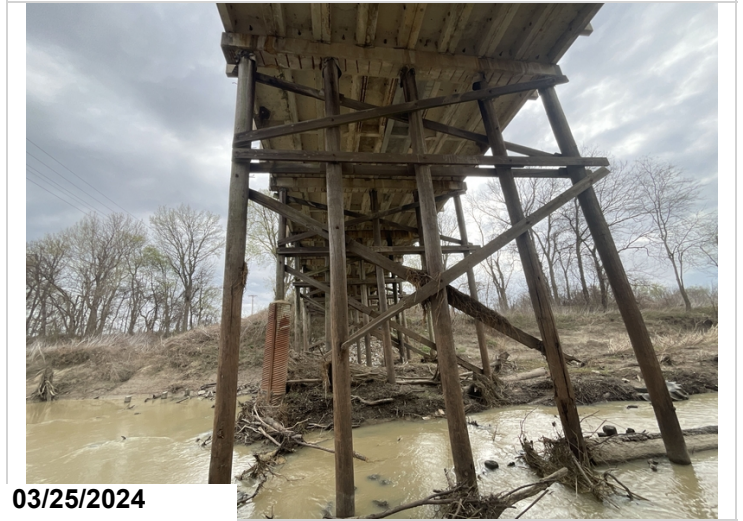
Bent 5 back face

Bent #5 pile #4 is core decayed with large section loss and mushrooming.

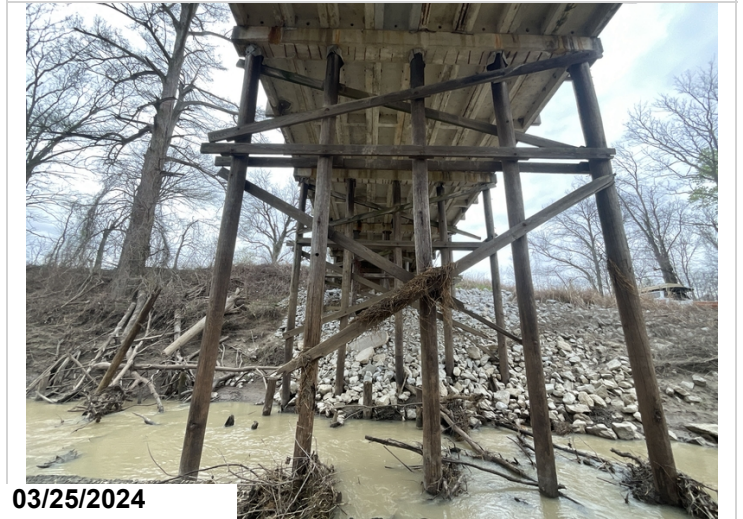
Bent 5 ahead face

Bent #6 pile #4 has outer shell decay with moderate section loss.

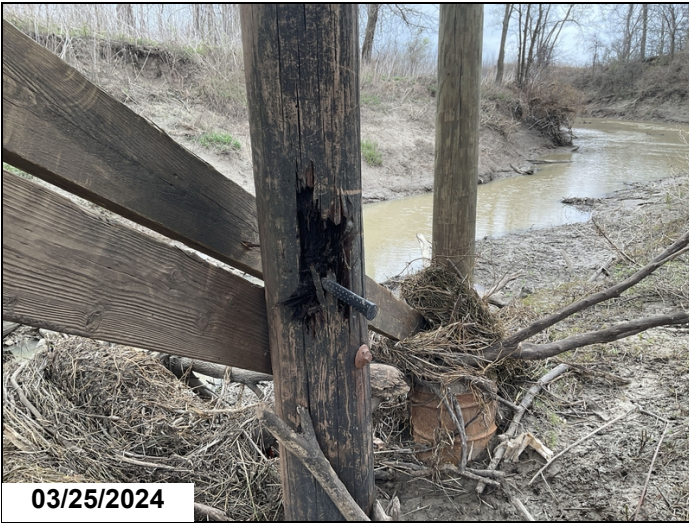
Bent #7 pile #4 sounds very hollow with hole in left face.

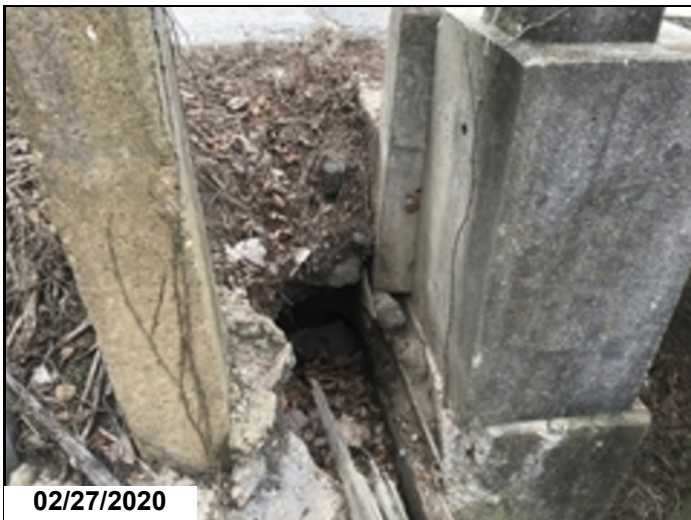
Abutment 2 left side, runoff has eroded shoulder at bridge end exposing bridge end and causing a 2' deep void under left shoulder.

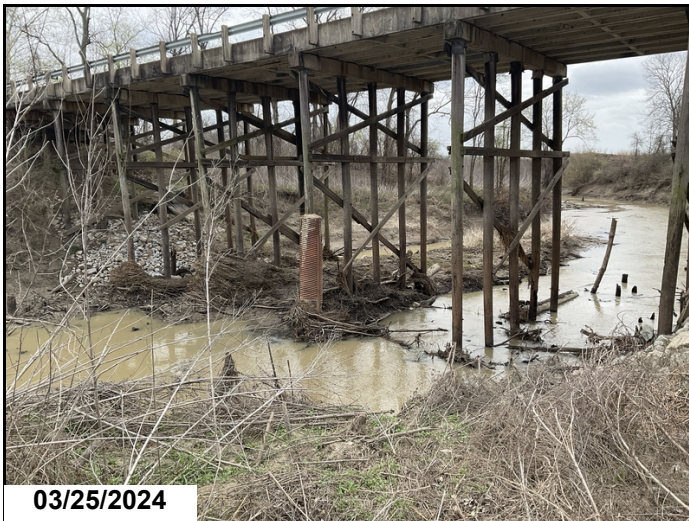
Large accumulation of debris and silt build up in channel under bridge and downstream of bridge.

Silt and debris in channel

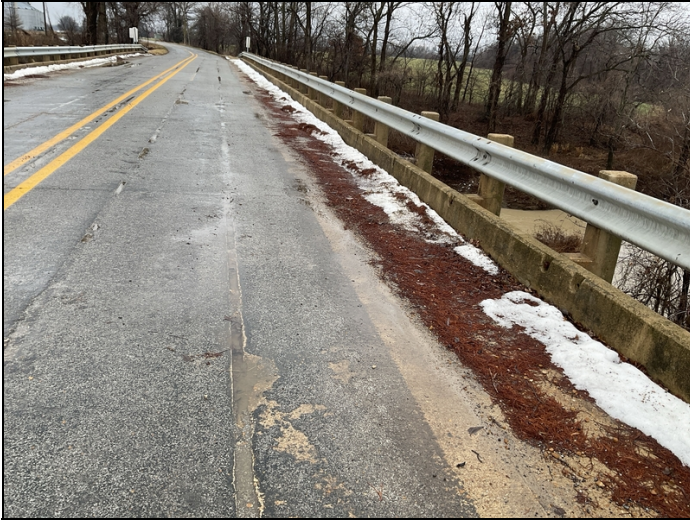
Gutters have dirt and debris in them.

Dirt and debris in gutters

A-55 - Deck Washing Needed (Yes)
