# Bridge #01391(Fracture Critical, Routine)

## Us-70/Sec-19/L5.19 over St. Francis River

### Location: 5.19 Miles East Of Sh 1

Team Lead: Drew Melton Inspection Date: May 10, 2021

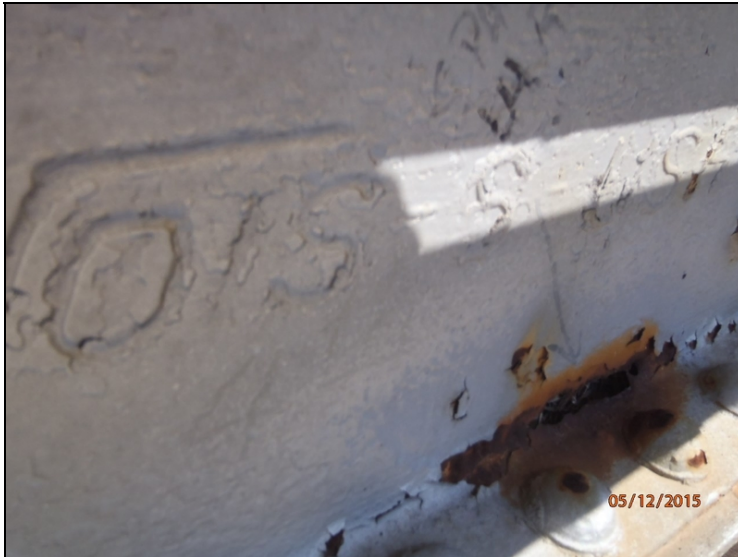
Span #5 right side of bridge at vertical location L4  
lower outside web of bottom chord has area with a  
hole in web.

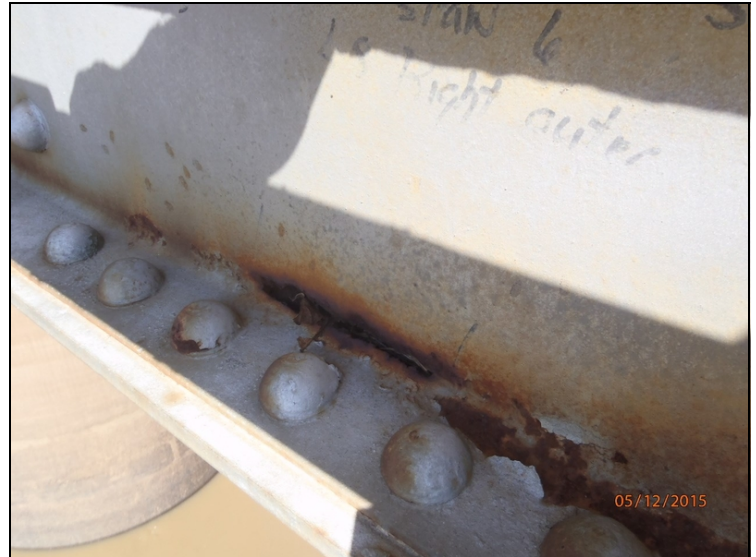
Span #6 right side of bridge at vertical location L8  
lower outside web of bottom chord has area of hole  
in web.

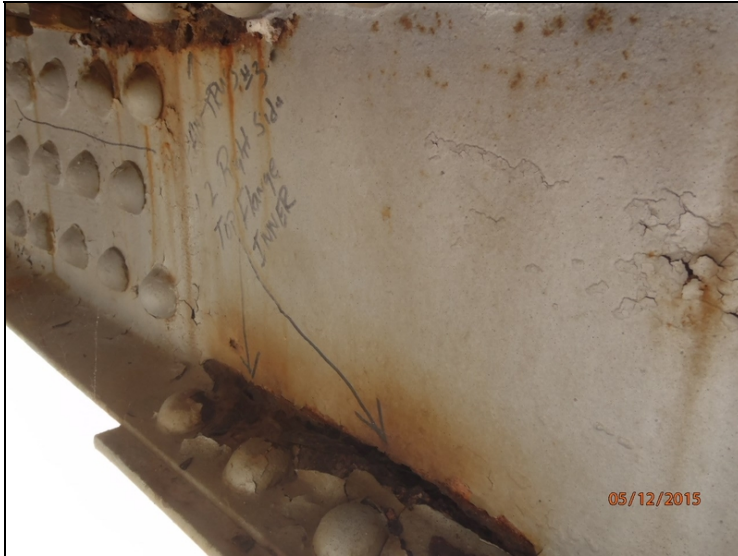
Span #5 right side of bridge at vertical location L2 lower inside web of bottom chord has area of hole in web.

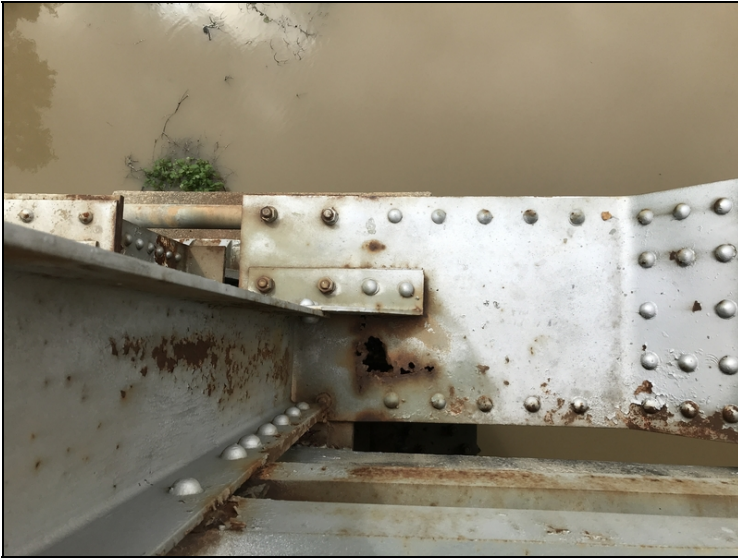
Span #6 right side cover plate at bent #7 L12 connection.

Span #3 cover plate on lower chord right side of bridge at L8 connection has hole rusted through.							
Span #4 cover plate on lower chord right side of bridge at L0,L8 connections have holes rusted through.							
Span #7 left side inner flange dented behind rail on diagonal between L3 U4.							
Span #7 left side of bridge at L2 connection bottom chord is corroded for 2' with 50% section loss.							
Span #7 right side lower chord cover plate at end of truss L8 connection has two inch crack at floor beam connection.							
152	Steel Floor Beam	LF	1040	4	597	381	58
1000	Corrosion	LF	709	0	297	358	54
515	Steel Protective Coating	SF	8291	0	1222	5240	1829
3440	Effectiveness (Steel Protective Coatings)	SF	5847	0	0	4385	1462

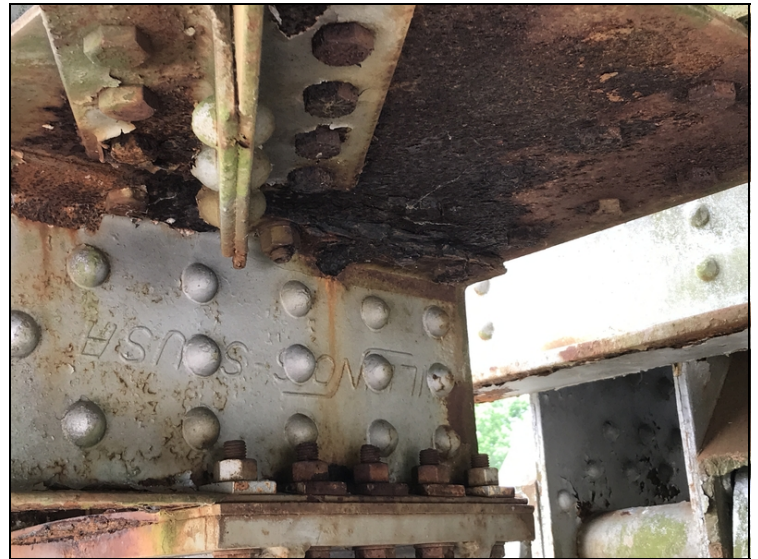
Span #6 left side end of truss at bent #7 lower cord and connection plate to floor beam and x brace has section loss up to 70% at connection of top flange of lower cord and connection plate.

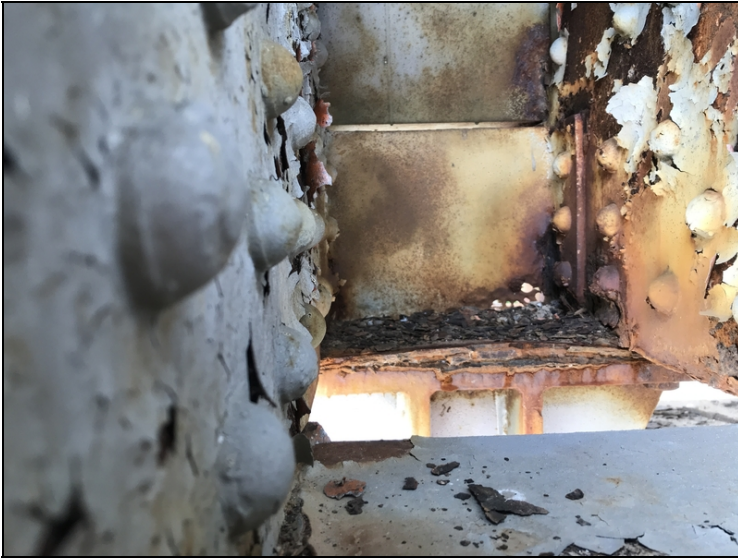
Span #5 at bent #5 right side lower cord inside at end above bearing has a transverse connection plate with section loss and holes.

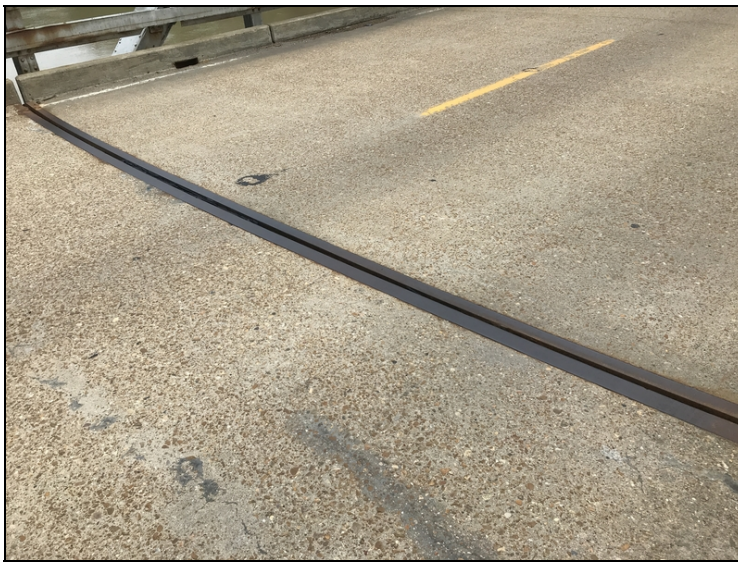
Bent #5 joint

ELEM	DESCRIPTION	UNITS	TOTAL	CS1	CS2	CS3	CS4
Bent #7 joint seal has fallen out.							
305	Assembly Joint without Seal	LF	160	34	74	50	2
2370	Metal Deterioration or Damage	LF	51	0	26	25	0

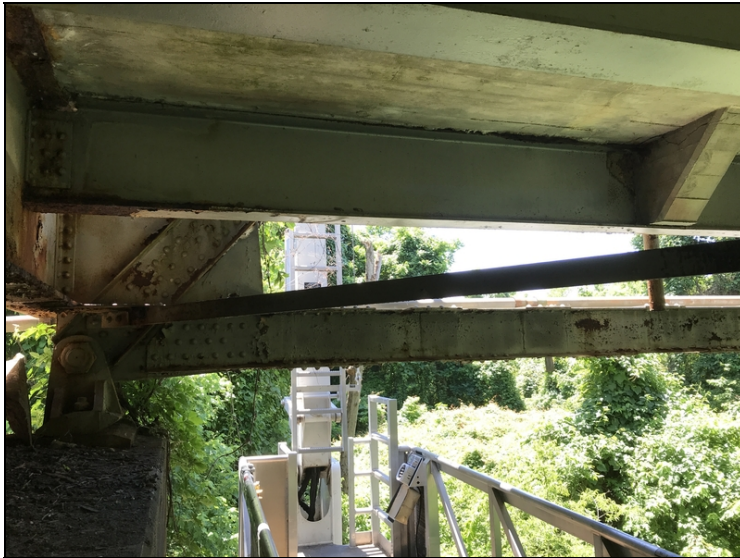
Span #7 stringer #5 at bent #7 is lifted up one inch breaking concrete stiffener.							
Span #7 stringer #1 at bent #8 web at top flange has a two inch hole on end.							
120	Steel Truss	LF	710	3	520	153	34
1000	Corrosion	LF	476	0	337	129	10
7000	Damage	LF	4	0	4	0	0
515	Steel Protective Coating	SF	92709	0	11588	50295	30826
3440	Effectiveness (Steel Protective Coatings)	SF	46586	0	0	31057	15529
3420	Peeling/Bubbling/Cracking	SF	15529	0	7764	7765	0

Span #7 stringer #5 at bent #7 is lifted up one inch breaking concrete stiffener.

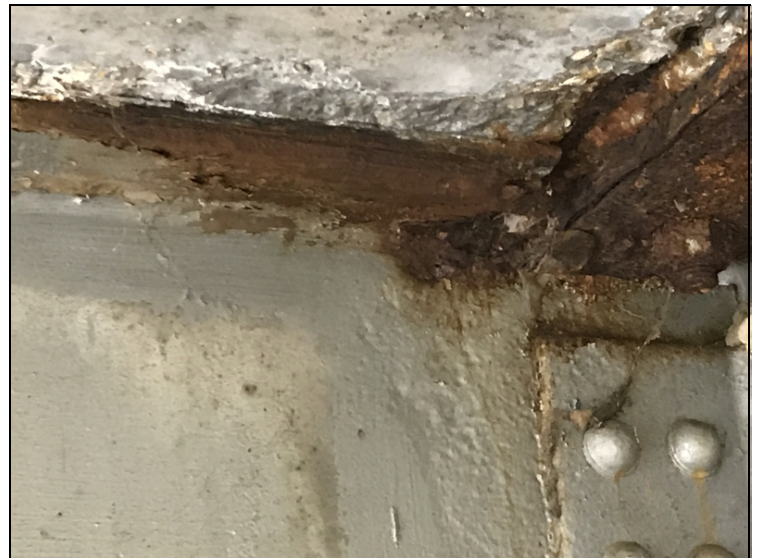
Span #7 stringer #1 at bent #8 web at top flange has a two inch hole on end.

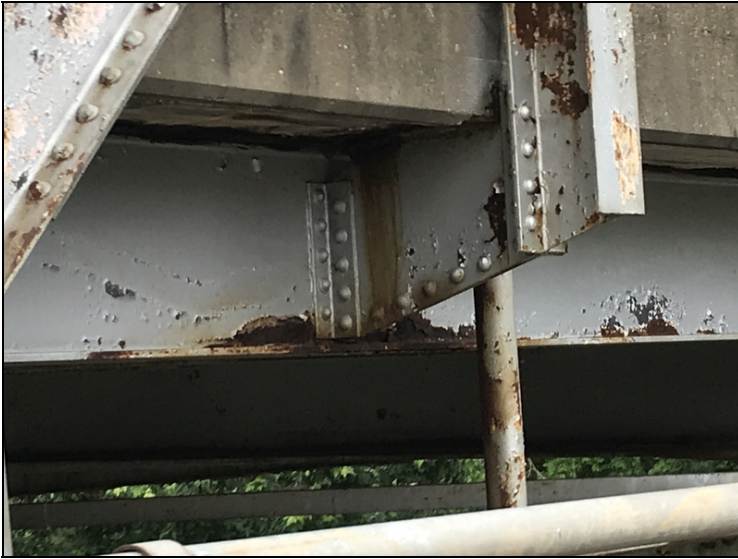
Typical outside stringers near drains.

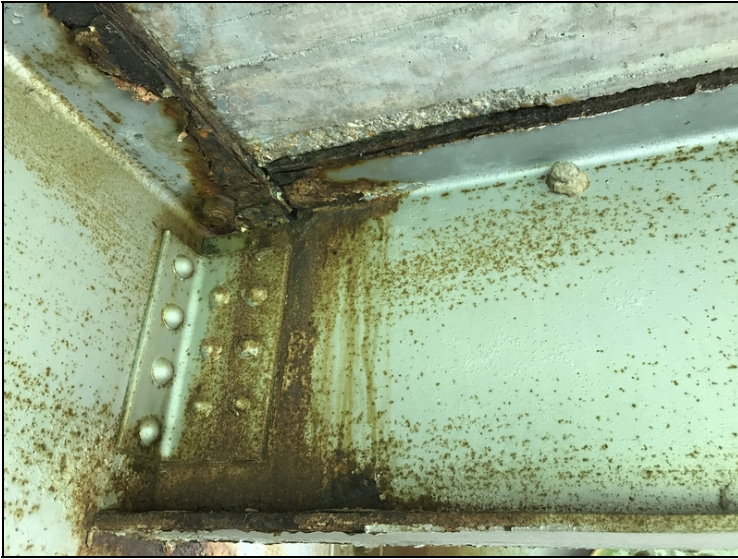
Typical stringer #1,5 at bents.

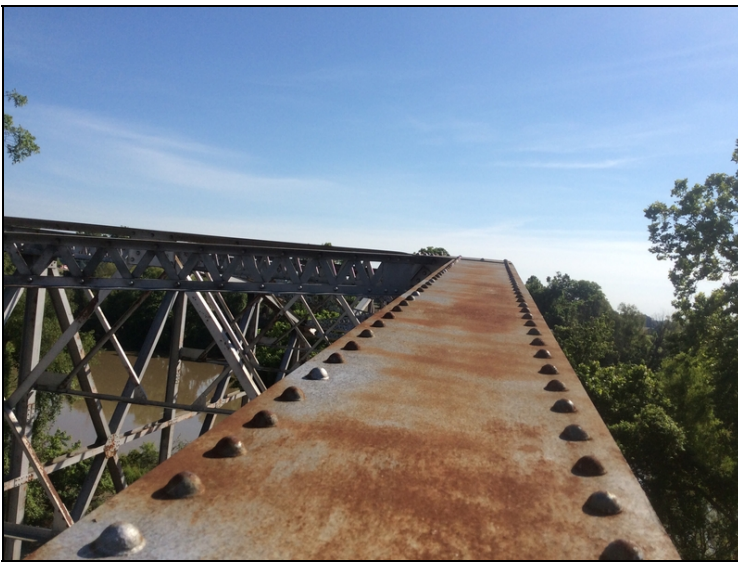
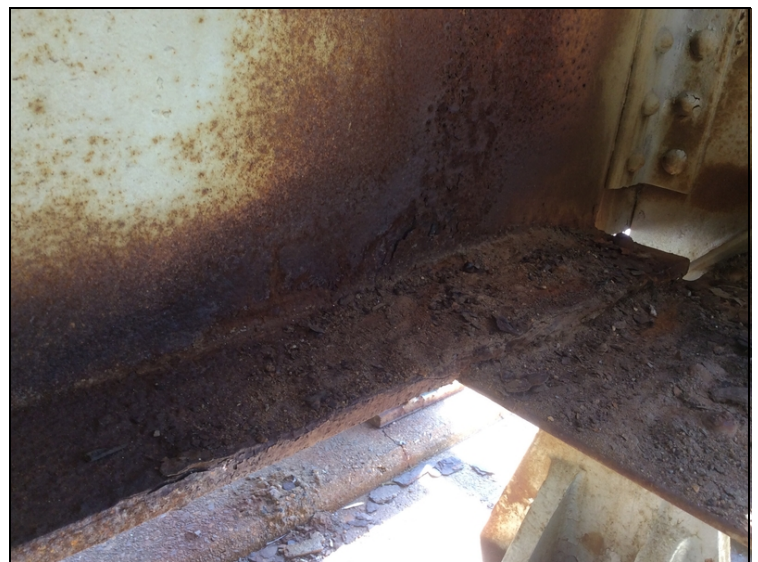
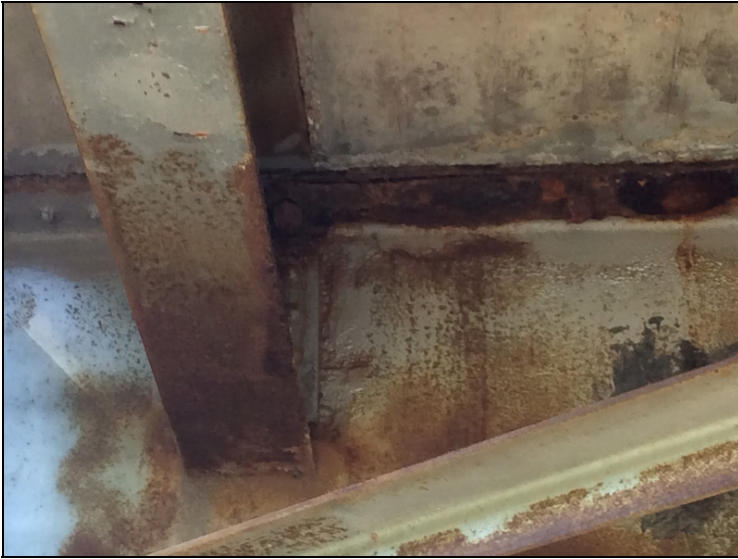
Typical steel on bridge

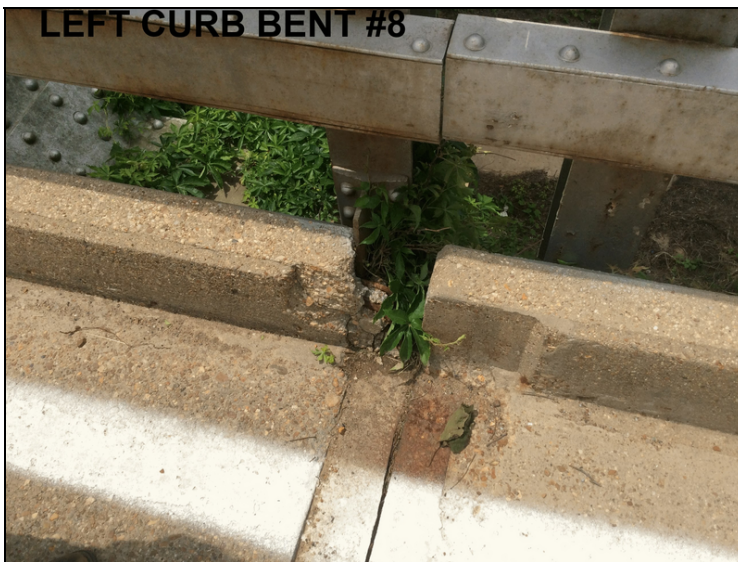
Bent #8 left curb

(12)							
<p>Curbs at bent #3 right and bent #8 left have 1' spall with exposed rebar no section loss.</p> <p>Curbs spans #1,2,8,9 both sides have areas of exposed rebar due to poor concrete coverage approximately 40 square feet.</p> <p>Spans #1,2,8,9 deck has transverse open cracks spaced 2' apart with half being sealed with epoxy.</p> <p>Spans #1,2,8,9 deck has light to moderate scaling exposing coarse aggregate with some loose aggregate.</p> <p>Span #1,2,8,9 soffit-under surface has transverse cracks spaced 3' apart with half having light to moderate efflorescence and rust staining.</p> <p>Soffit-under surface in spans #1,2,8,9 have approximately 20 square feet of 1' to 2' spalls with exposed rebar with 10% section loss.</p> <p>Deck span #1 has 40 square feet of sound patches and 7 square feet of unsound patches.</p> <p>Deck span #1 has 7 square feet of shallow spalls one foot and under in size no rebar exposed.</p> <p>Deck span #1 has 2' of heavy scaling in left gutter at abutment #1 and 3' in right gutter at bent #2.</p> <p>Deck span #2 has 220 square feet of sound patches and 40 square feet of unsound patches.</p> <p>Deck span #2 has 8 square feet of shallow spalls one foot and smaller no rebar exposed.</p> <p>Deck span #2 has 3 square feet of heavy scaling in right gutter at bent #2.</p> <p>Deck span #2 right lane has 2' shallow spall and 2 one foot shallow spalls with no exposed rebar.</p> <p>Deck span #8 has 28 square feet of concrete repair that is sound.</p> <p>Deck span #8 has 2 small spalls.</p> <p>Deck span #9 has 35 square feet of concrete repair that is sound.</p> <p>Deck span #9 at bent #9 right side of joint spalled for 5' x 1' no exposed rebar.</p> <p>Deck span #9 right gutters have heavy scaling 2' x 15'.</p> <p>Asphalt overlay at abutment #2 has multiple spalls and repaired areas that are failing.</p> <p>Soffit-under surface at bent #2 span #1,2 between girders #3,4 each have forms left in place.</p> <p>Soffit-under surface span #2 at bent #3 between girders #1,2 and 4,5 each have a form left in place.</p> <p>Soffit-under surface span #1 between girders #2 and 3 has 1 1/2' x 2 1/2' spall with exposed rebar moderate section loss approx. 15' from bent #2 and 4' of shallow spalling beside top flange of girder.</p> <p>Soffit-under surface span #1 between girders #3 and 4 has 1' spall with exposed rebar moderate section loss.</p> <p>Soffit-under surface span #1 between girders #4 and 5 has 3' long transverse crack with exposed rebar moderate section loss mid span, and 2' of shallow spalling beside top flange of girder.</p> <p>Soffit-undersurface span #1 between girders #5 and 6 has 1' spall with exposed rebar moderate section loss.</p> <p>Soffit-under surface span #9 between girders #1,2 has 1' spall with exposed rebar moderate section loss.</p> <p>Soffit-under surface span #9 between girders #4,5 has 2 two foot spall with exposed rebar moderate section loss.</p>

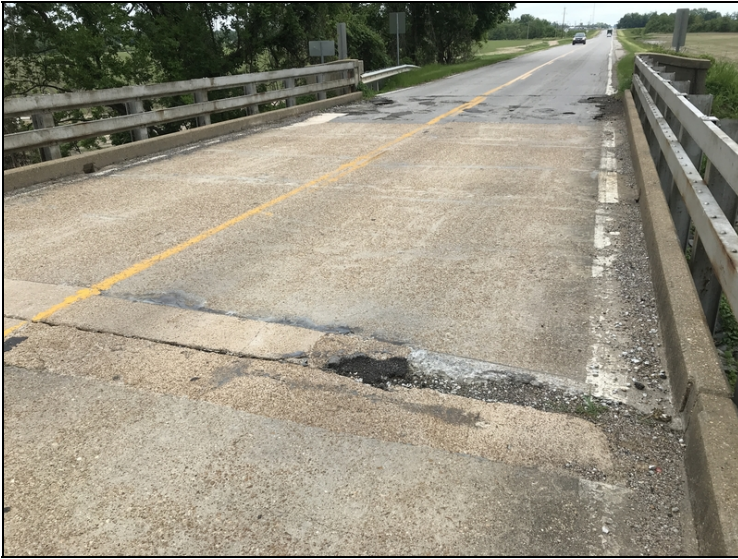
Span #9

(12-510)							
Abutment #2 span #9 asphalt area on end of deck has multiple spalls and patched areas.							
107	Steel Open Girder/Beam	LF	1212	12	1075	100	25

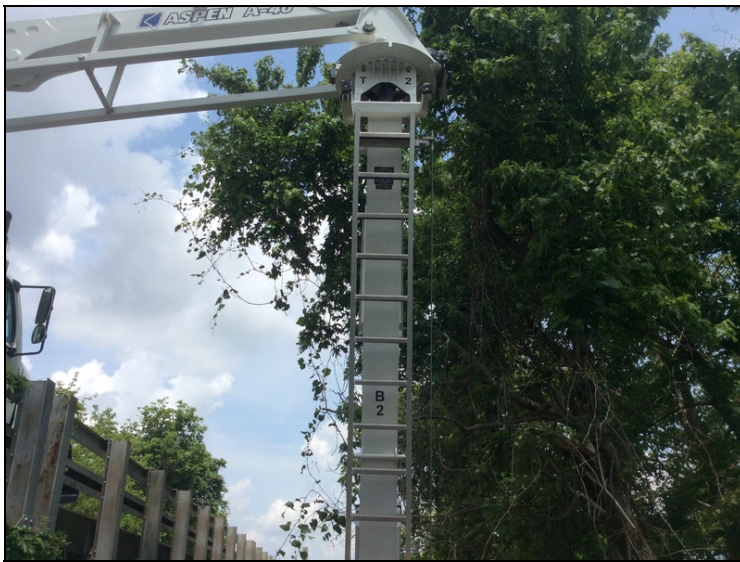
Vegetation hindering snoopers operation.

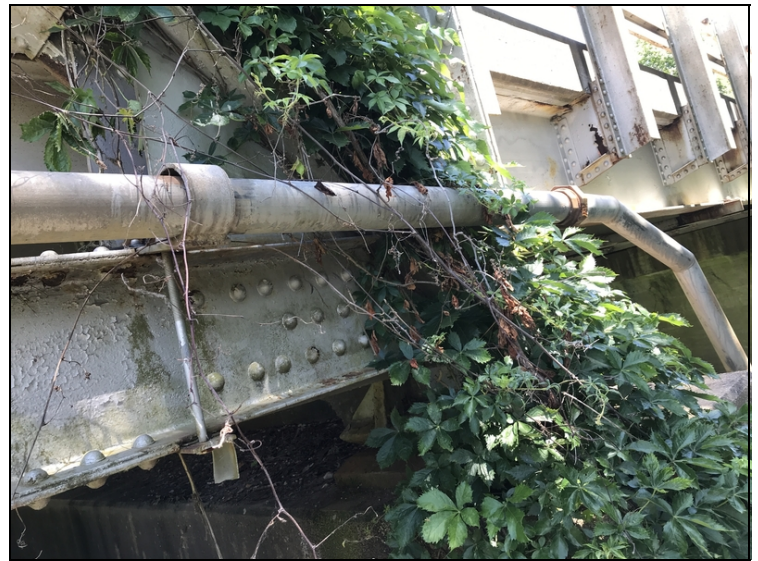
Bent #8 both sides have vines growing up bent onto truss and roadway.

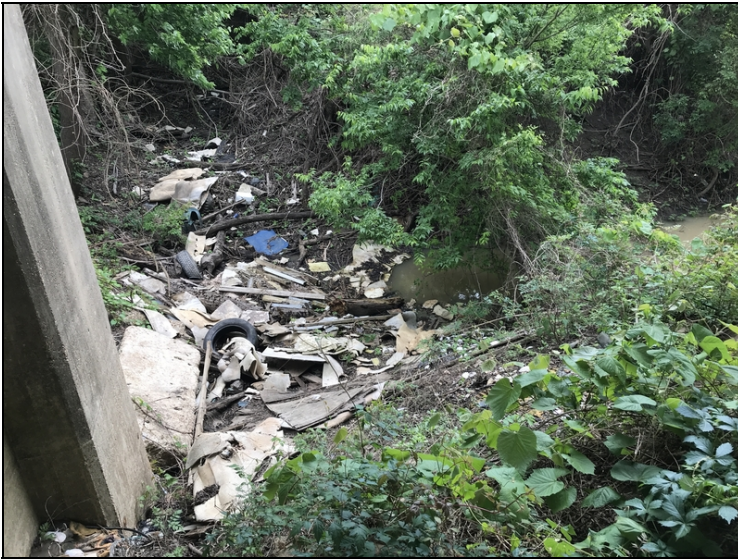
Erosion area right side span #7 bent #8

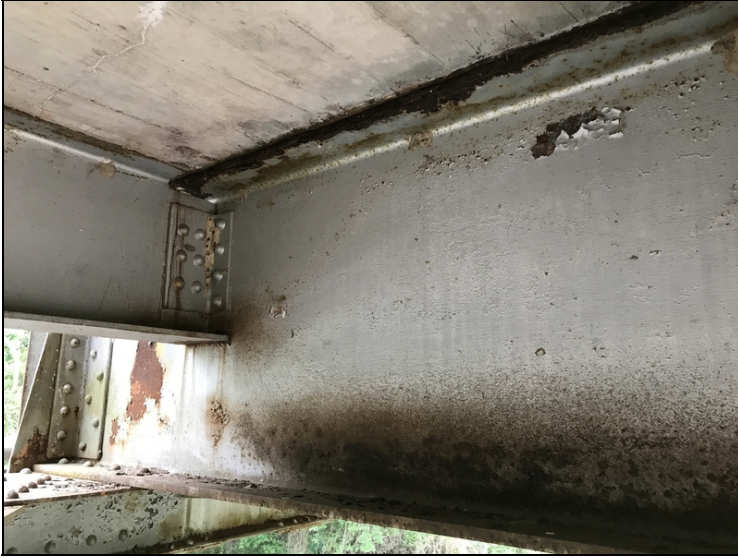
Typical ends of floor beams on all truss spans except those at bents.

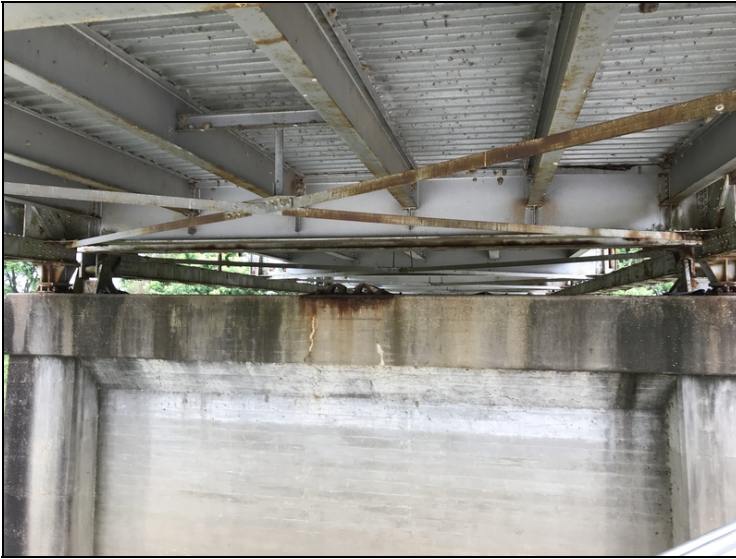
Span #6 bent #7 floor beam.

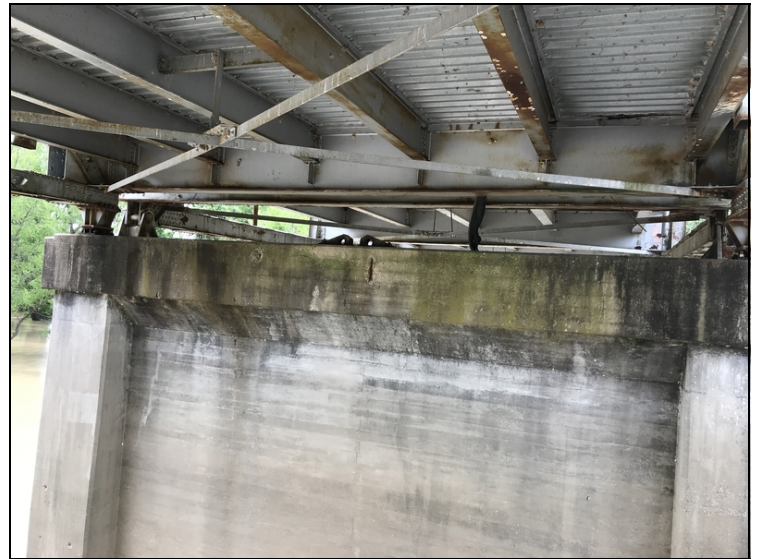
Span #5 bent #5 floor beam #1

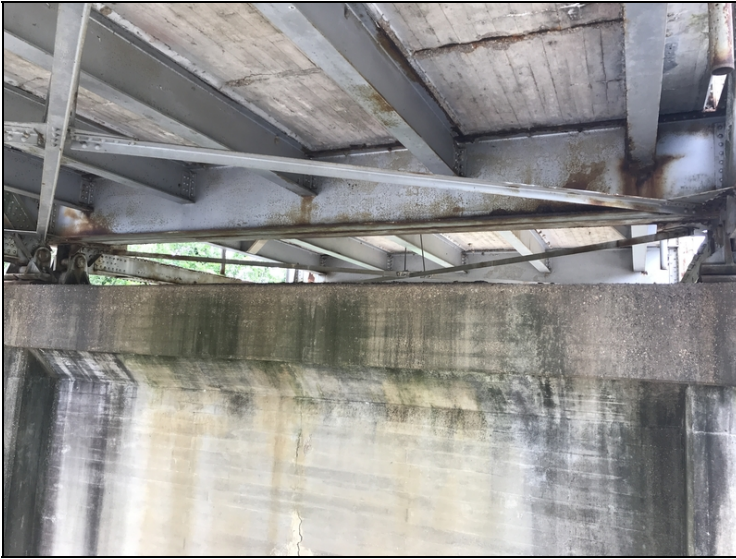
Span #4 bent #4 floor beam #1

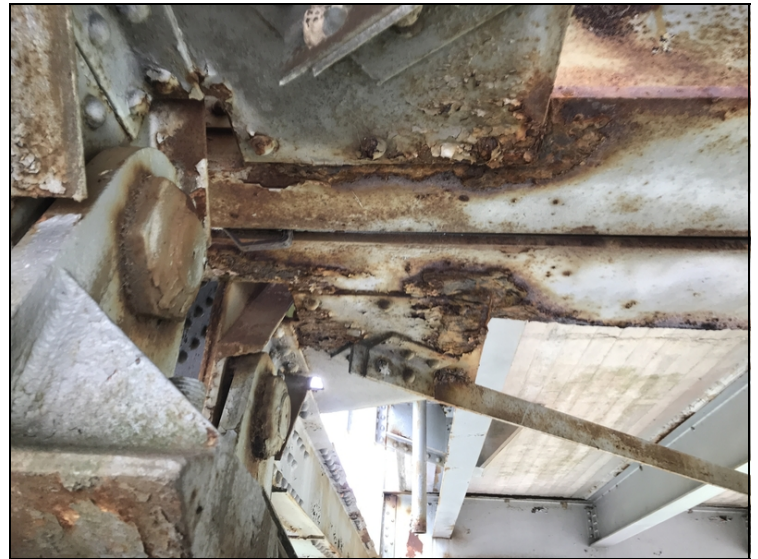
Typical bottoms of floor beam #1,9 spans #3,4,7 on ends at connections.

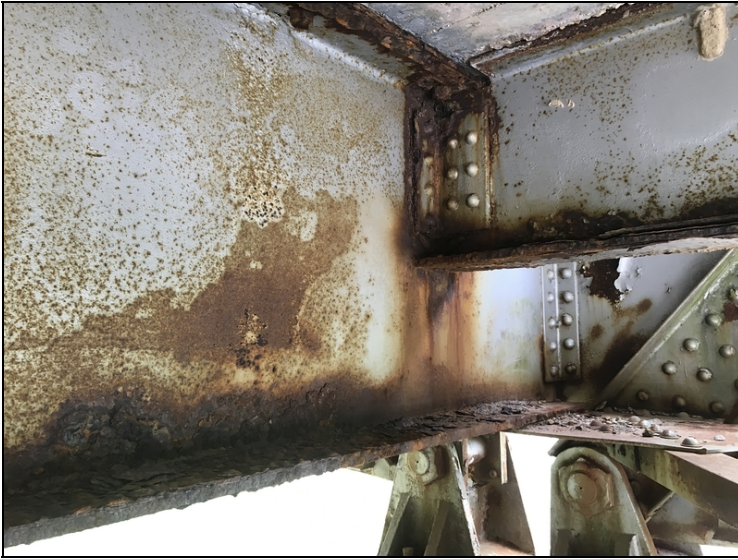
Span #4 at bent #4 connection area of floor beam  
#1 and stringer #1 left side of bridge.

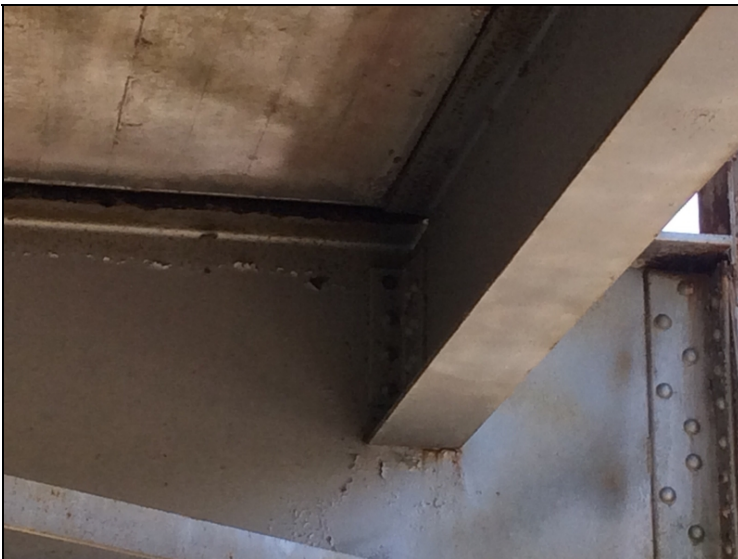
Span #7 floor beam #1 stringer #3 right ahead side top rivet sheared off.

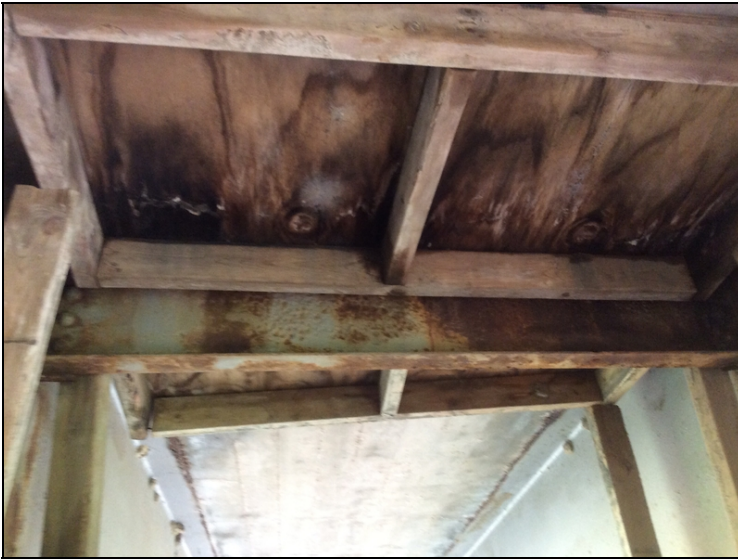
Bent #2 span #1,2 between girders #3,4 has forms left in place.

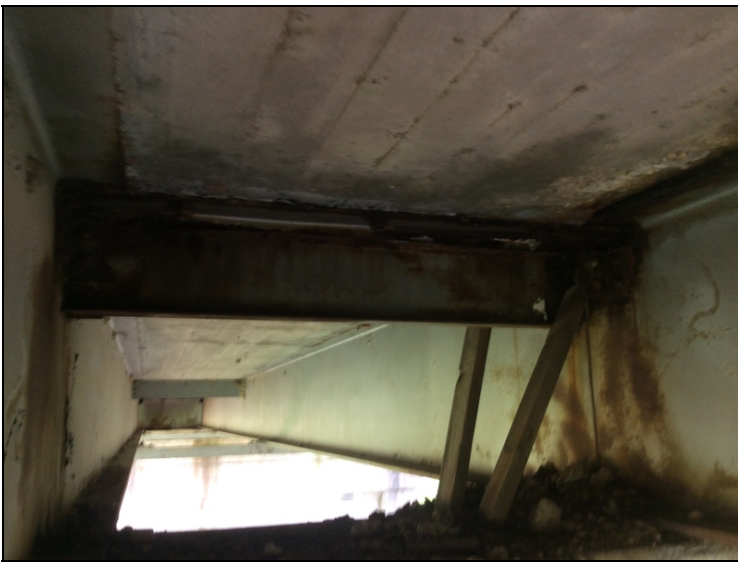
Approach spans steel diaphragms between girders all have large amounts of section loss and some are rusted away.

Typical approach spans diaphragms Spans  
#1,2,8,9

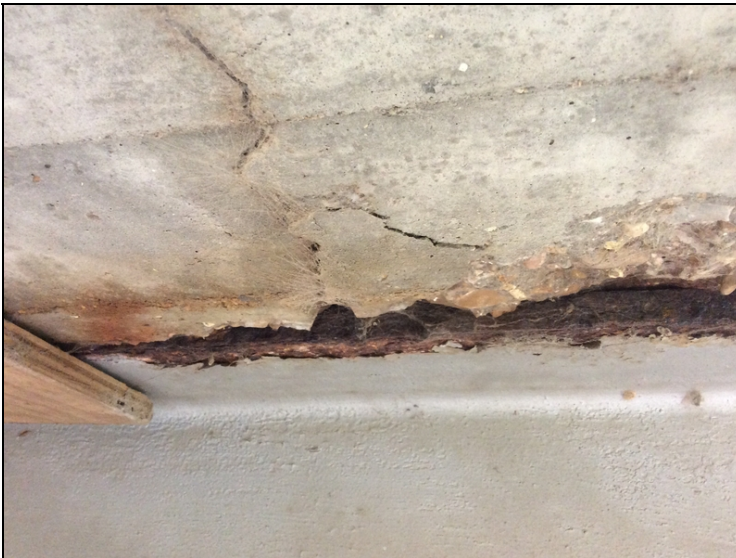
Top flanges of girders in approach spans last three feet of girder ends have corrosion with up to 30% section loss.

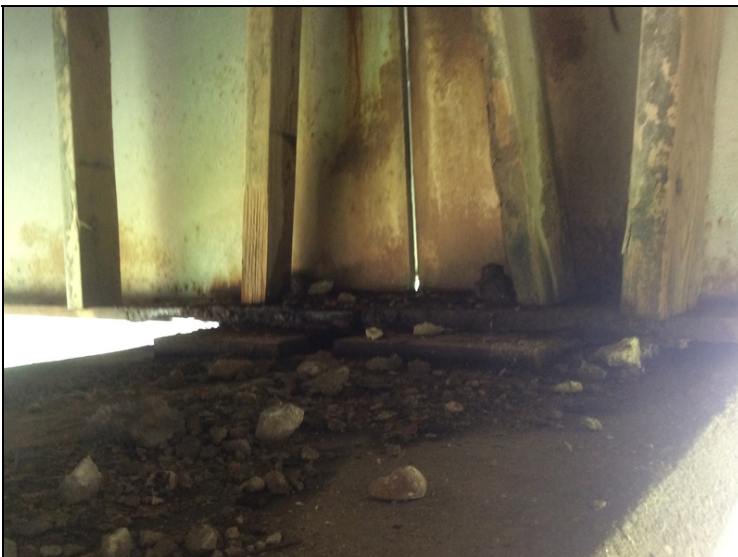
Bent #2 span #1,2 girder #4 lower flange for first foot has 50% to 75% section loss on bottom of flange.

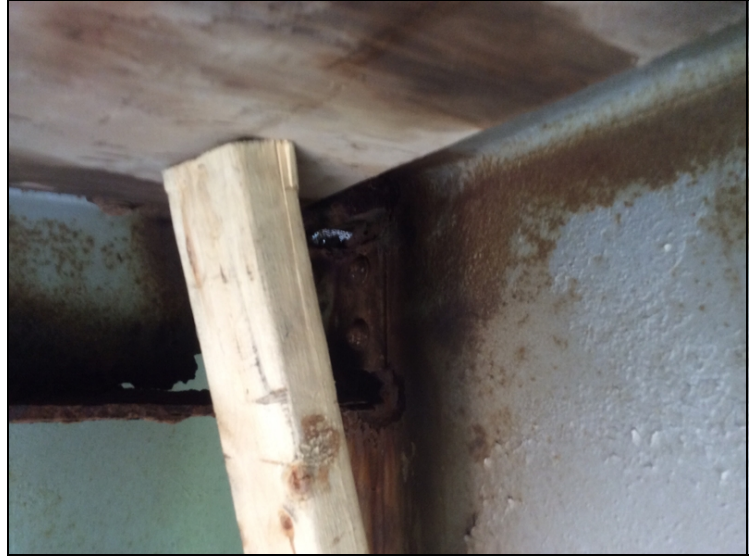
Span #2 girder #2 at bent #3 has a six inch long hole in web at top above diaphragm.

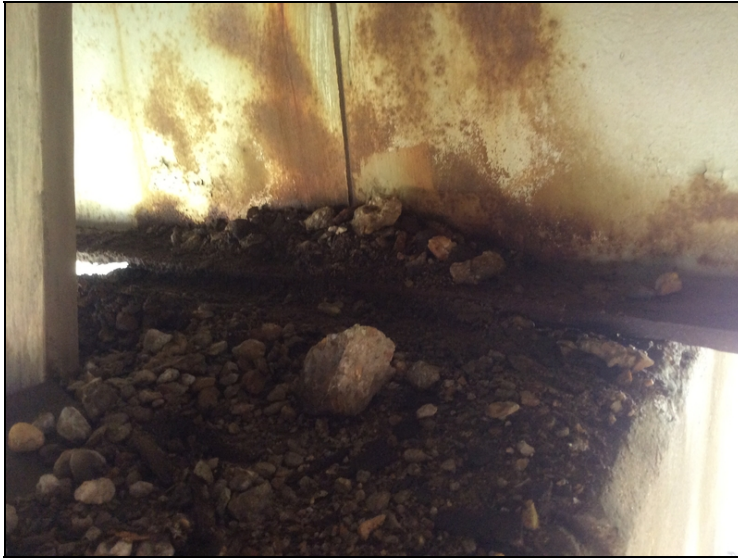
Bent #2 girder #3 span #1,2 lower flange for first foot has section loss up to 70%.

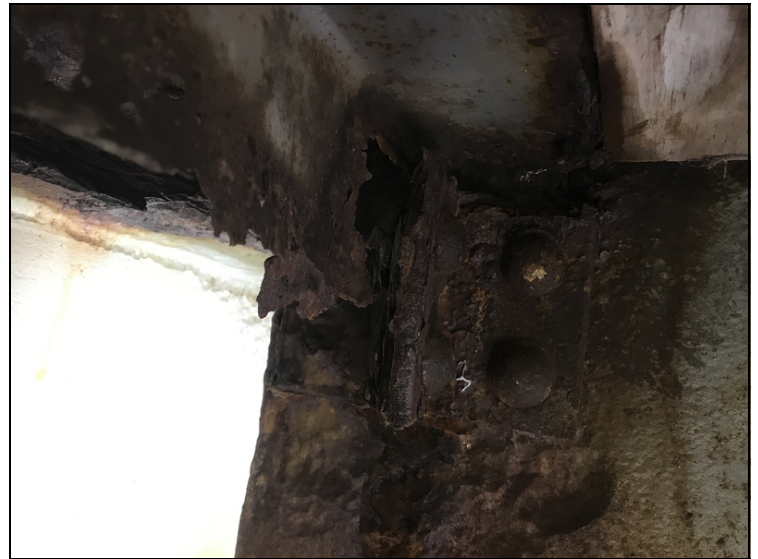
Span #2 girder #5 bent #2 has 1" hole in web above diaphragm connection and a pin hole below diaphragm connection.

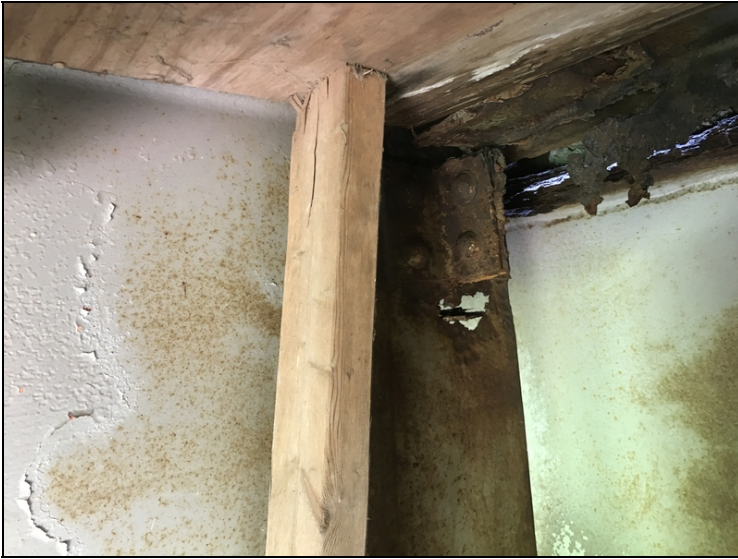
Span #2 girder #4 bent #3 has 3" long x 1 1/2" tall hole in flange below diaphragm connection.

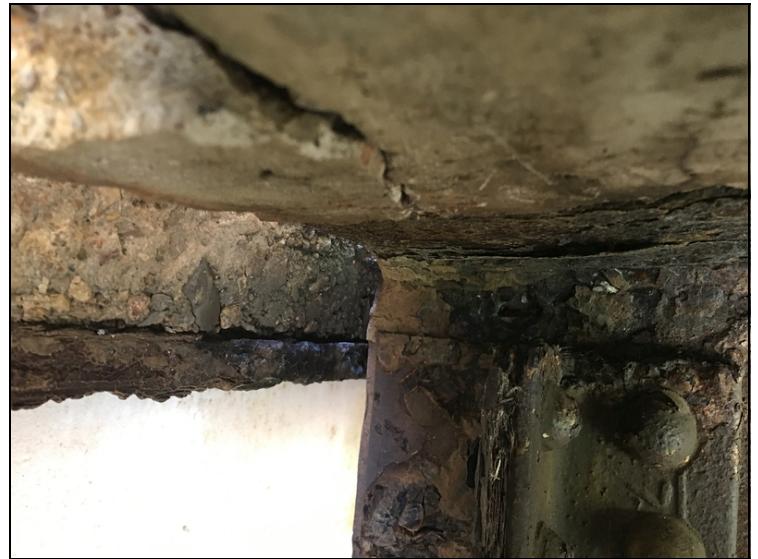
Span #2 girder #3 bent #3 has half inch hole above diaphragm connection and 60% section loss below diaphragm connection.

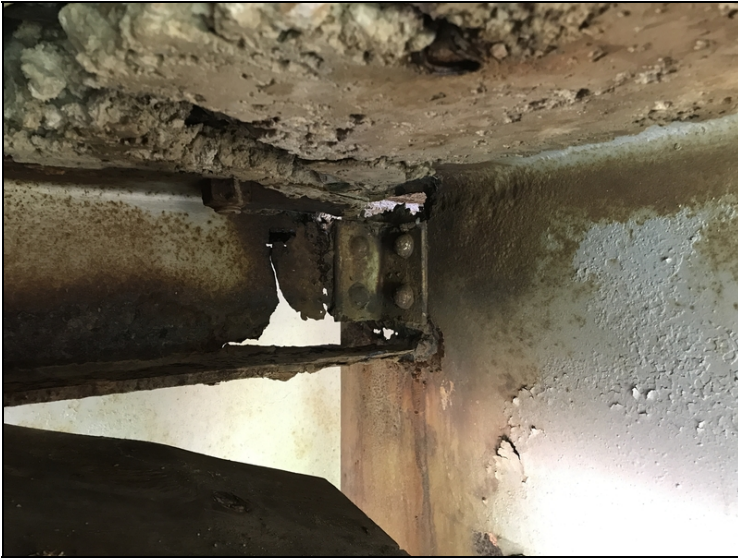
Span #2 girder #2 bent #3, girder has 6" long x 1 1/2" hole in web at top flange at end of girder and a 2" long x 1" tall hole in web below diaphragm connection.

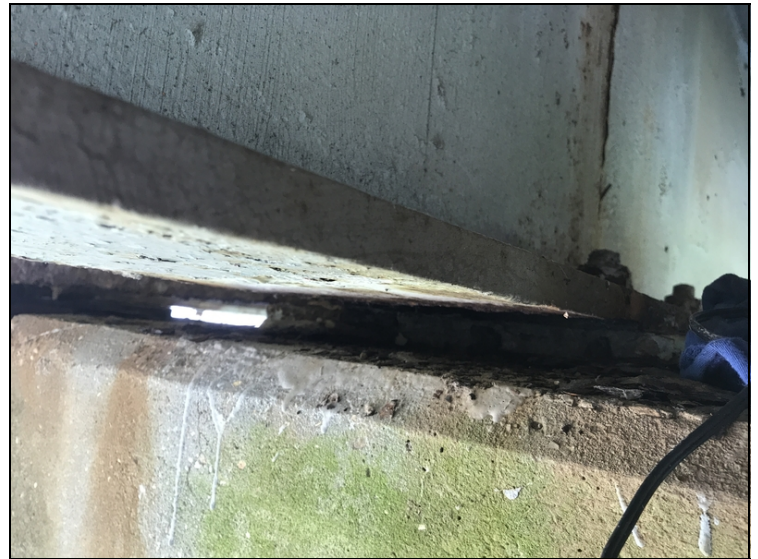
Span #2 girder #5 at bent #2, 1' from end of girder has a 4" long area across bottom flange original thickness .850" remaining .575".

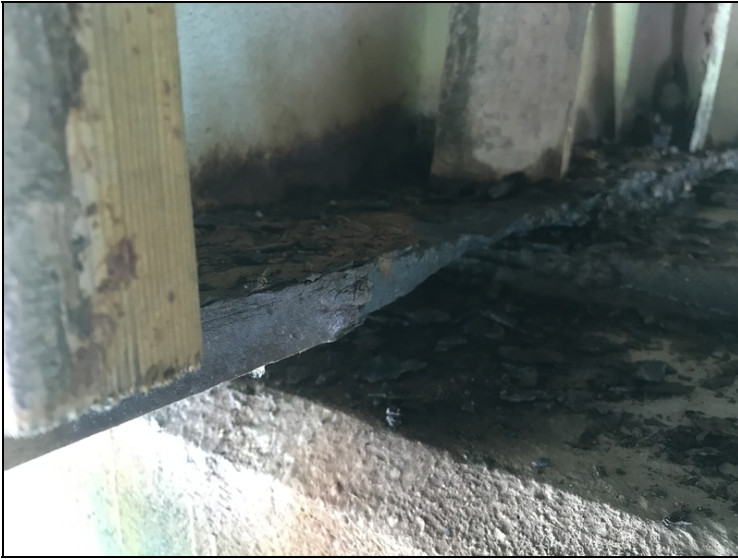
Span #2 girder #3 at bent #3, 1' from end of girder has 6" long area across bottom flange original thickness .850" remaining .260".

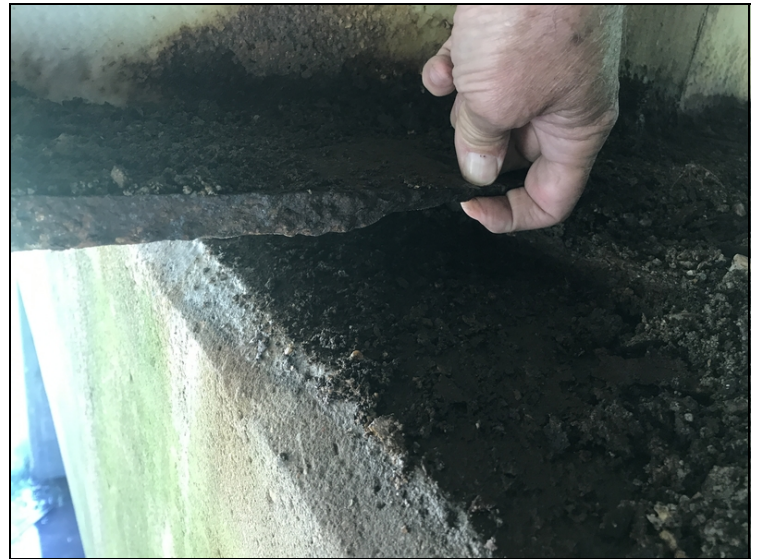
Span #2 girder #3 at bent #2 1' from end of girder has 5" long area across bottom flange original thickness .850" remaining .250".

Span #2 girder #3 bent #2, last 1' bottom flange original thickness .850" remaining .250", 75% section loss.  
Span #2 girder #3 bent #2 bottom flange has 3/4" hole rusted through ahead of bearing.  
Span #2 girder #2 bottom flange into lower web for first foot of girder has up to 85% section loss.  
Span #8 bent #9 girder #2,3,4 last one foot of lower flange has corrosion with laminations and section loss up to 100%.  
Span #9 bent #10 girder #1 first foot lower flange has corrosion with laminations and section loss up to 100%.  
Span #9 bent #10 girder #6 has corrosion with laminations last foot of lower flange with section loss up to 100% and web at bottom flange on end has eight inch area of holes in web near top flange and has 3" x 6" area of 100% section loss in web at lower flange at end of girder.

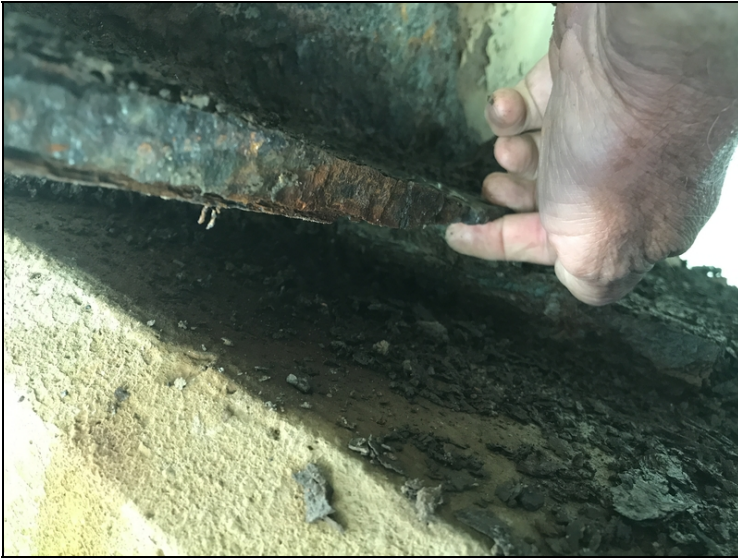
Span #2 girder #2 at bent #2 1' from end of girder has 5" long area across bottom flange original thickness .850" remaining .183", next 2' has .750" remaining

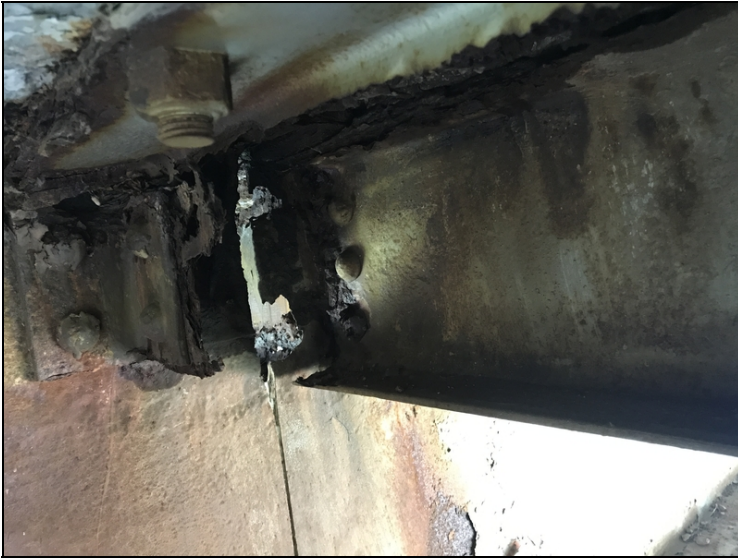
Span #2 bent #2 girder #2 has an 1 1/2" x 6" area of 100% section loss on the end at top.

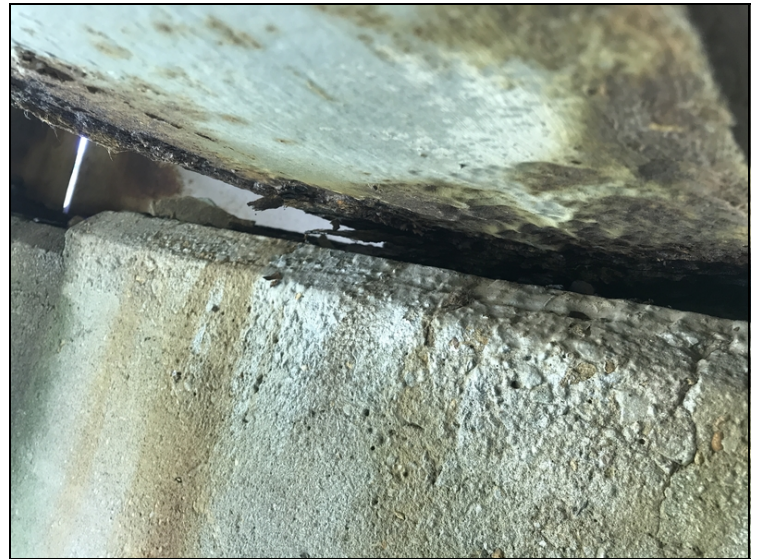
Span #1 girder #2 at bent #2 1' from end of girder has 5" long area across bottom flange original thickness .850" remaining .520".

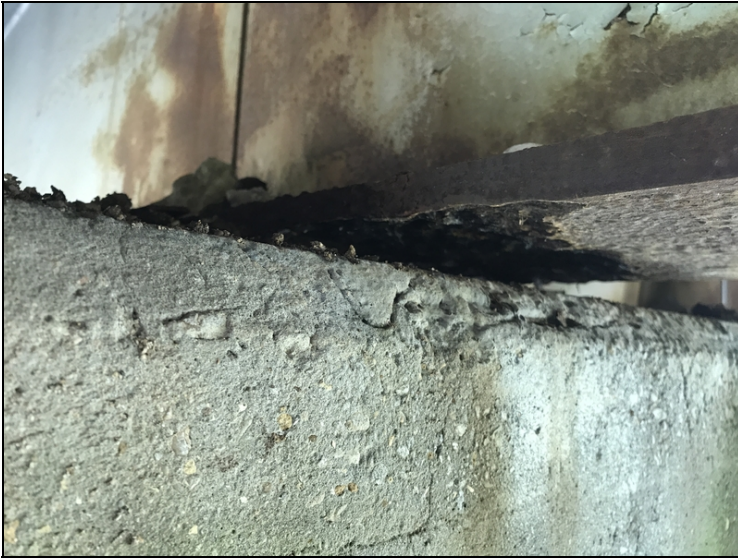
Span #1 girder #3 at bent #2 1' from end of girder has 5" long area across bottom flange original thickness .850" remaining .272".

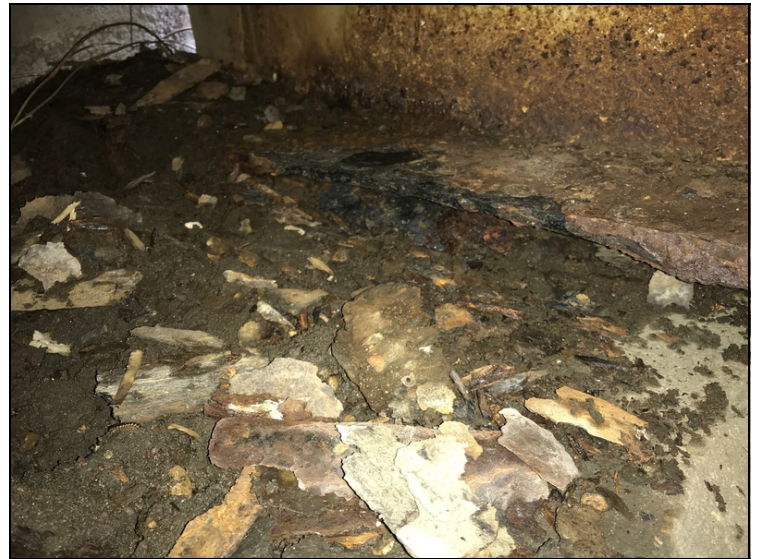
Span #1 girder #2 bent #1 first 1' bottom flange  
original thickness .850" remaining .309"

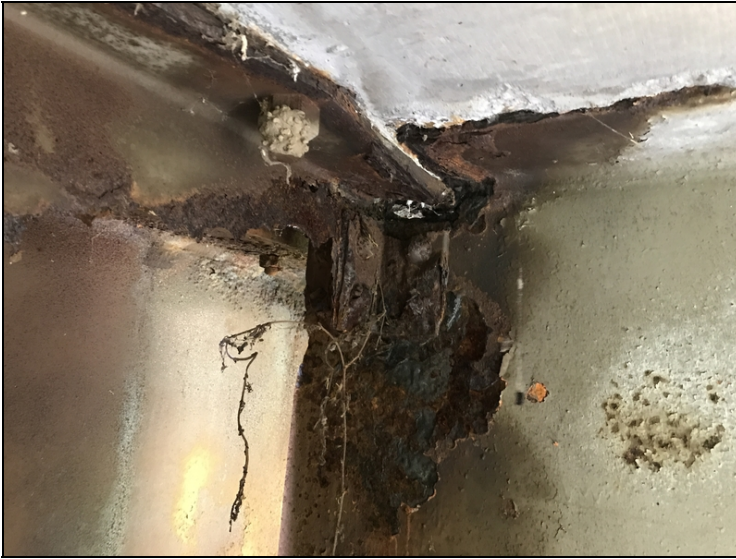
Span #8 bent #8 girder #5 has a three inch hole in web above diaphragm.

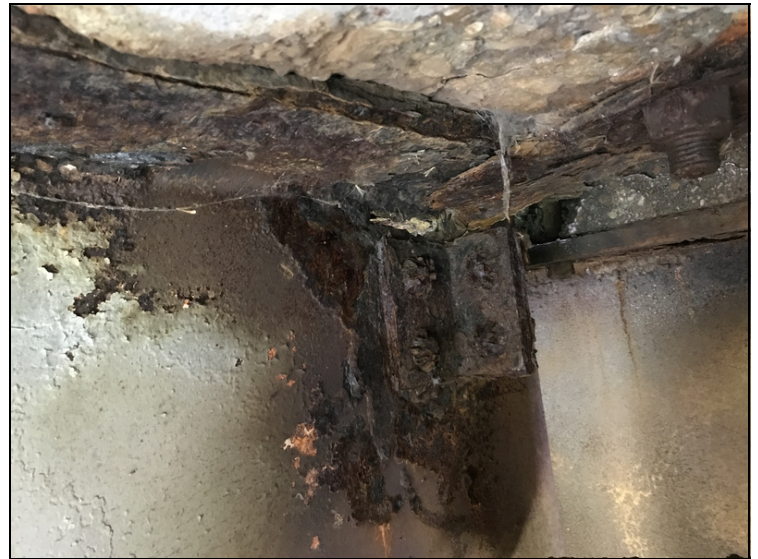
Span #8 girder #3 at bent #8 has a three inch hole in web above diaphragm.

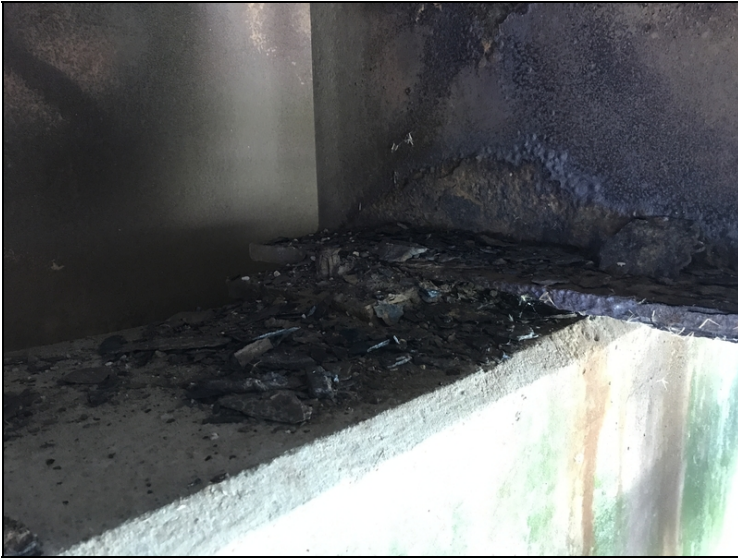
Span #8 girder #3 at bent #8 lower flange first two feet has areas of section loss up to a knife edge.

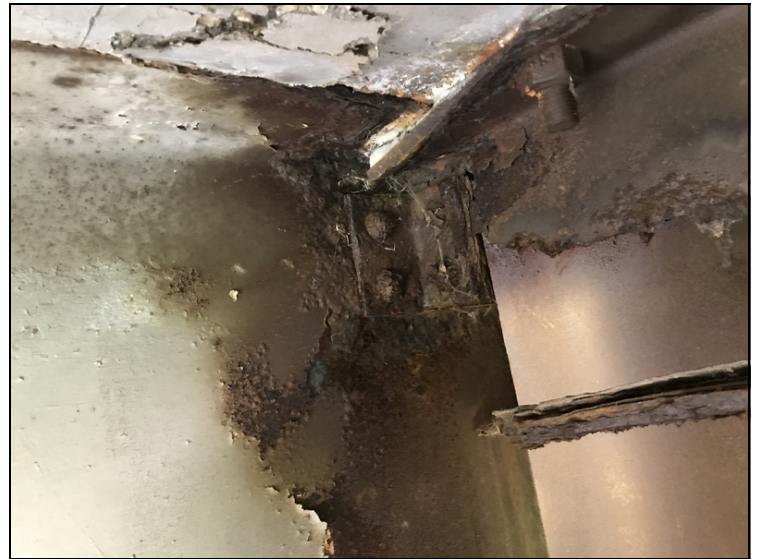
Span #8 girder #2 at bent #8 has a two inch hole in web above diaphragm.

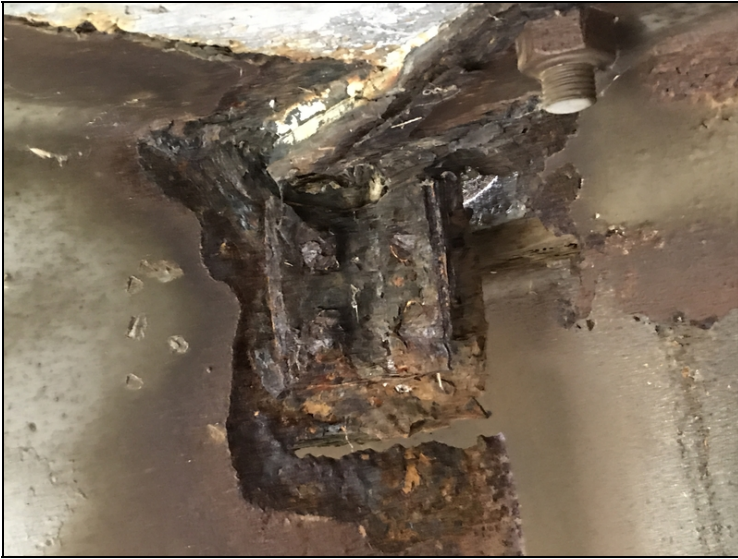
Span #8 girder #4 at bent #8 has a two inch long hole in web above diaphragm and a six inch hole below diaphragm.
