# Bridge #01391(Fracture Critical, Routine)

## Us-70/Sec-19/L5.19 over St. Francis River

### Location: 5.19 Miles East Of Sh 1

Team Lead: Drew Melton Inspection Date: May 10, 2021

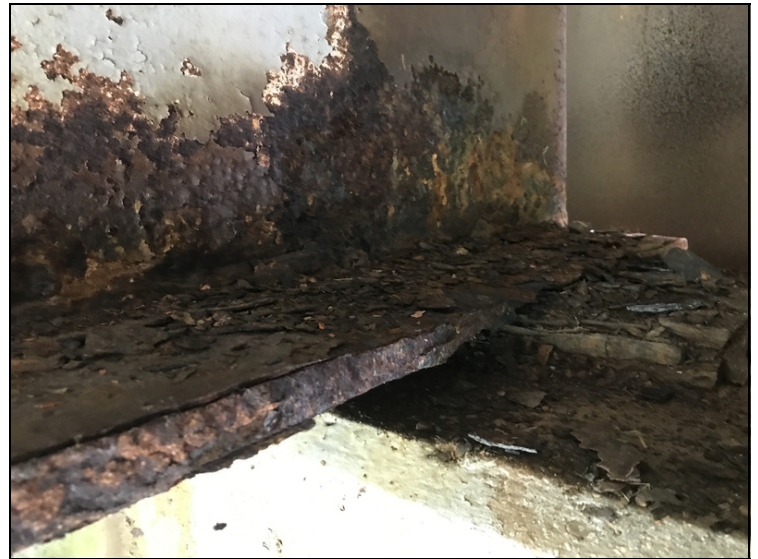
Span #8 girder #4 at bent #8 lower flange first two feet has areas of section loss up to a knife edge.

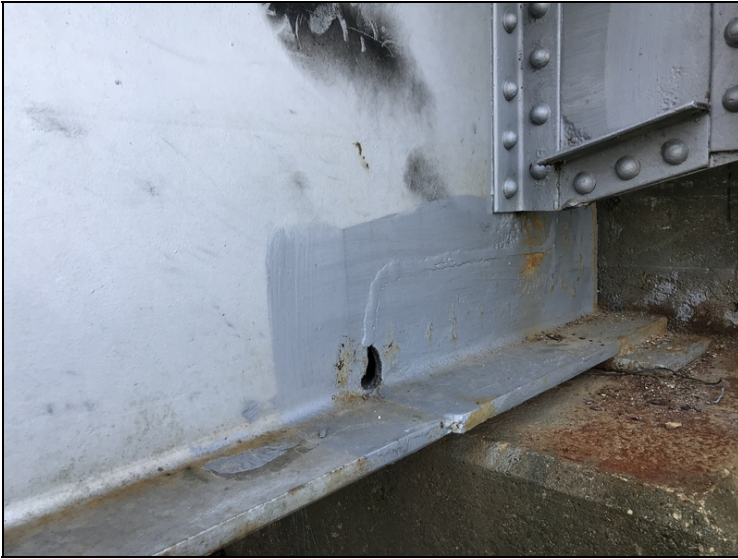
Span #1 girder #1 bent #1 has a t-splice first two feet by seven inches tall.

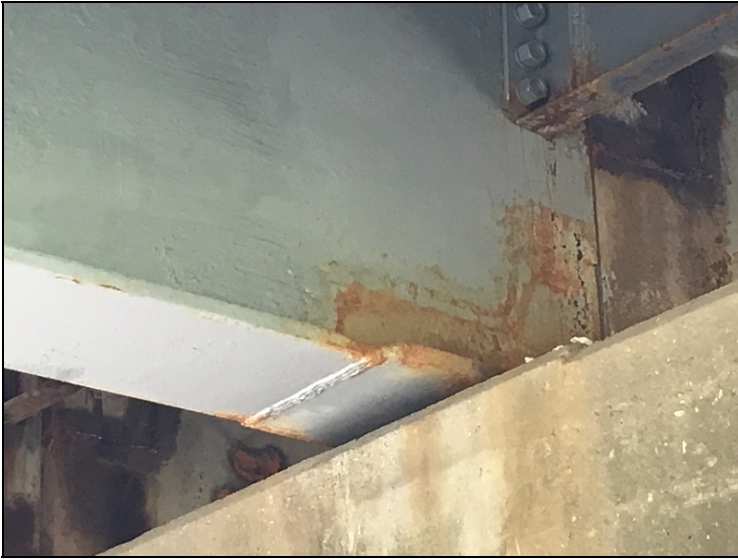
Span #2 girder #3 bent #2 has a L shape t-splice one foot long.

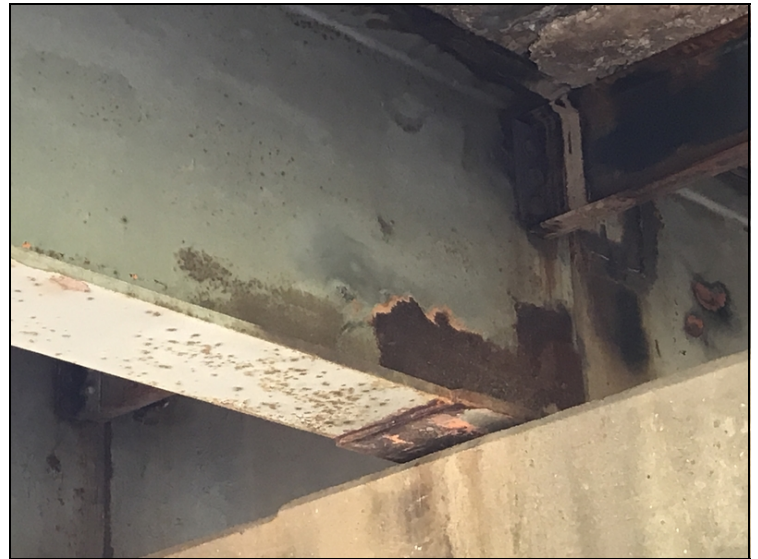
Span #2 girder #4 bent #2 has a L shape t-splice one foot long.

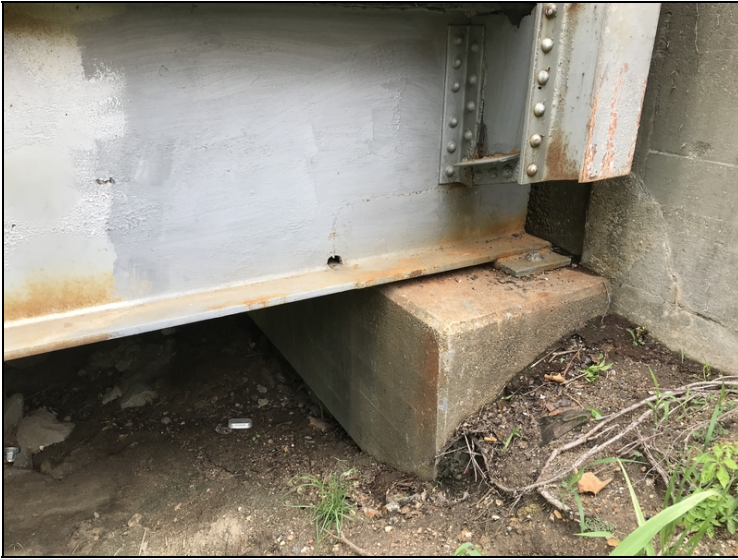
Span #9 girder #6 abutment #2 has been t-spliced  
two foot long eight inches tall.

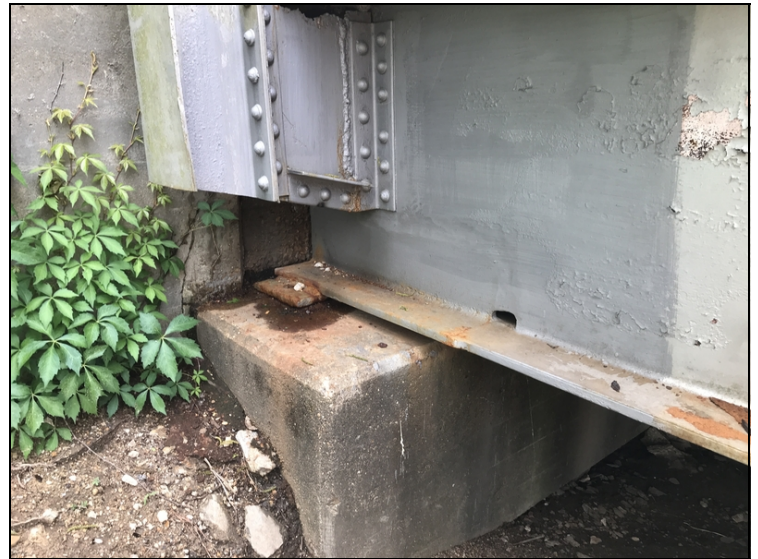
Span #9 girder #1 abutment #2 has been t-spliced  
two foot long eight inches tall.

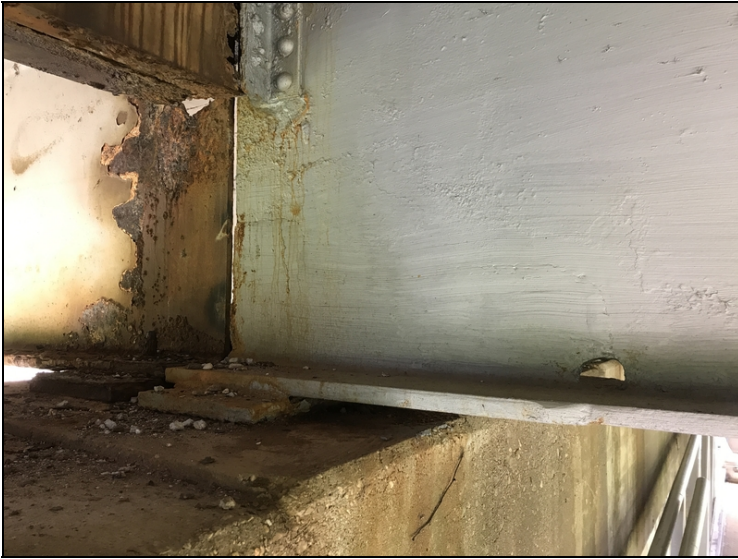
Span #8 bent #9 girder #2 has a t-splice that is two foot long by eight inches tall.

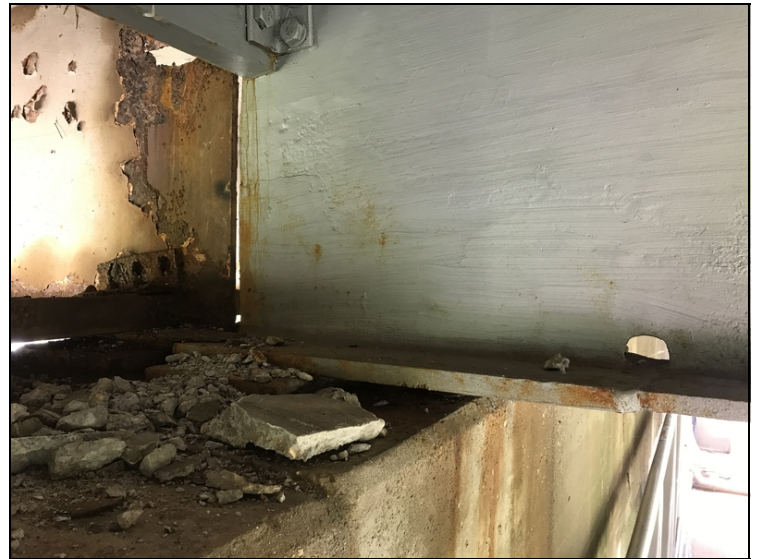
Span #8 bent #9 girder #3 has a t-splice that is two feet long by ten inches tall.

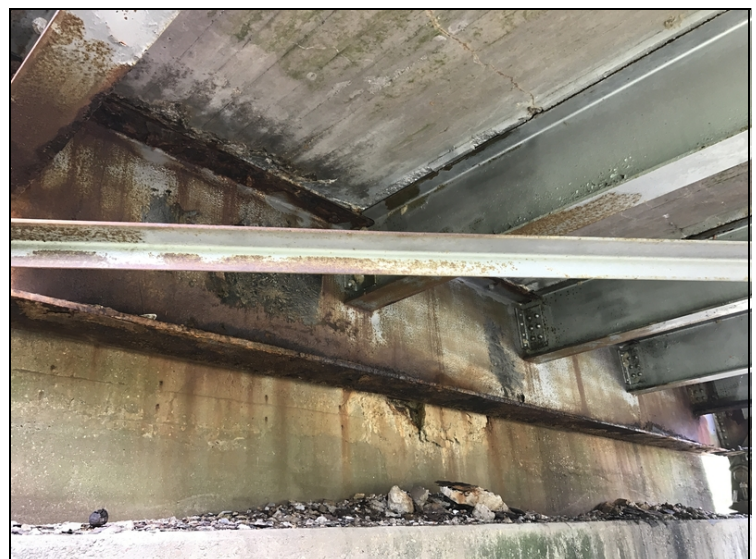
Span #3 floor beam #1.

Span #3 at bent #3 floor beam #1 has heavy corrosion full length top and bottom flanges with areas of section loss up to 60%.

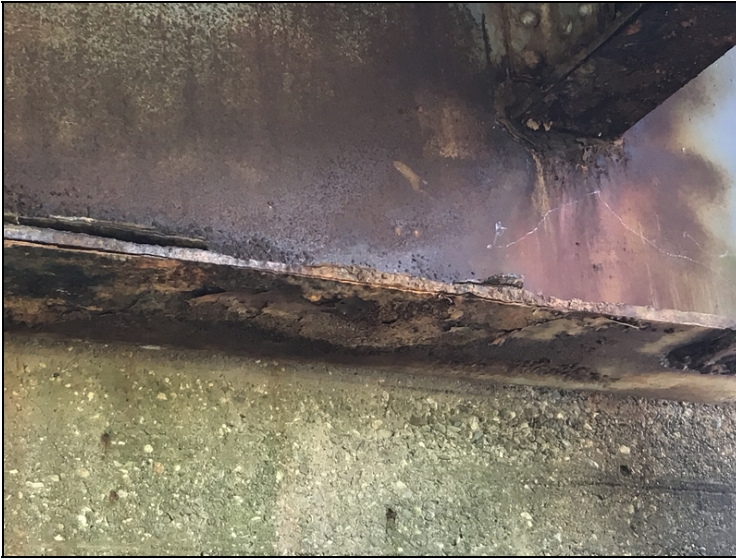
Span #3 at bent #3 floor beam #1 has heavy corrosion full length top and bottom flanges with areas of section loss up to 60%.

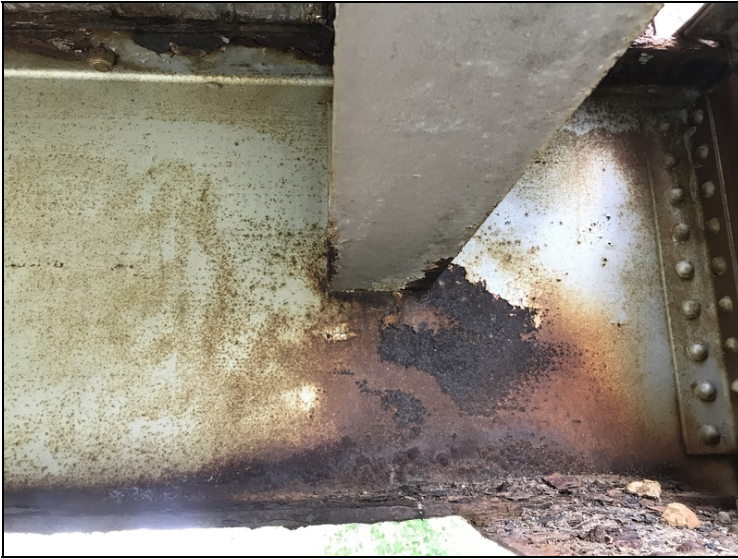
Span #3 at bent #4 floor beam #9 bottom flange right side of bridge at x bracing connection has section loss up to 50%.

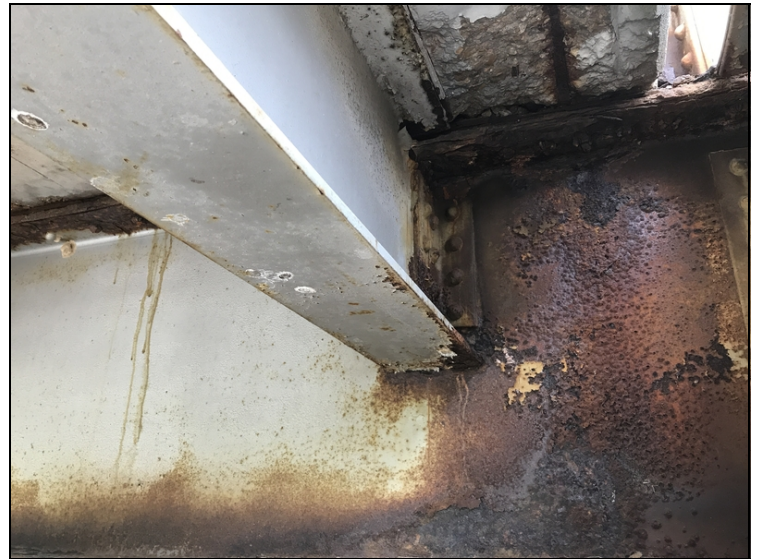
Span #4 at bent #5 floor beam #9 right side first two feet top flange has areas of section loss up to 70% leading into web with section loss up to 20%.

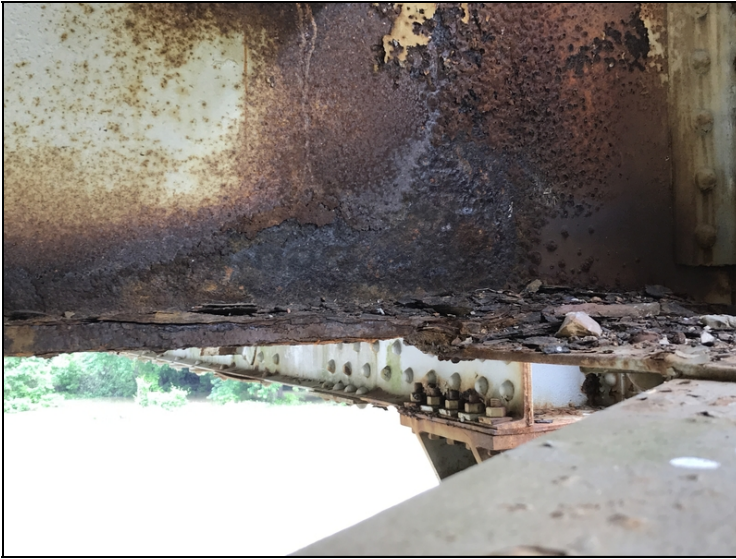
Span #4 at bent #5 floor beam #9 right side at connection to lower chord last 2' has up to 90% section loss on lower flange and 20% section loss in web.

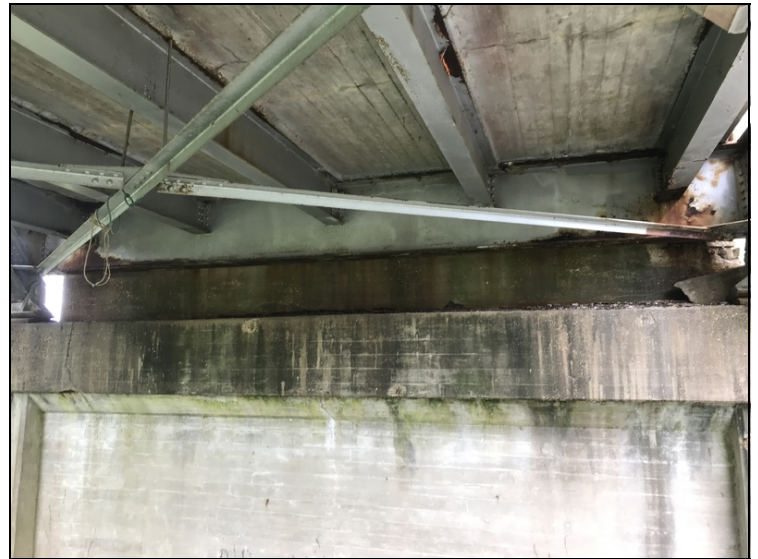
Span #7 bent #8 floor beam #9

Span #7 floor beam #9 on ends for four feet top flange has corrosion laminations and section loss up to 50%.

Span #7 floor beam #9 left end for three feet lower flange into web has corrosion with laminations and section loss up to 90%.

Span #7 floor beam #9 right end for three feet lower flange into web has corrosion with laminations and section loss up to 50%.

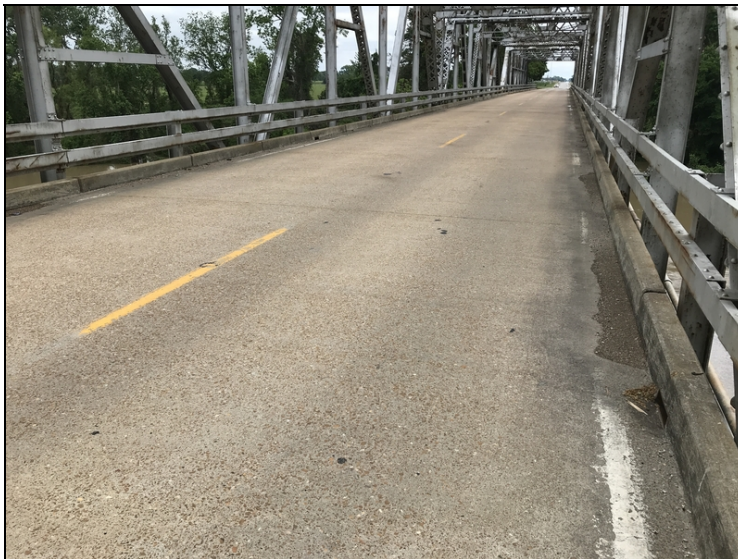
Span #5,6

Spans #1,2,8,9 deck has transverse open cracks spaced 2' apart with half being sealed with epoxy.  
Spans #1,2,8,9 deck has light to moderate scaling exposing coarse aggregate with some loose aggregate.  
Deck spans #3,4,7 has transverse open cracks spaced 2' apart with half being sealed with epoxy.  
Deck spans #3,4,7 has light scaling exposing coarse aggregate little loose aggregate.  
Deck each truss span #3,4,7 has crack through to deck 6' from bents.  
Deck spans #5,6 has transverse cracks spaced 3' apart half being sealed with epoxy.

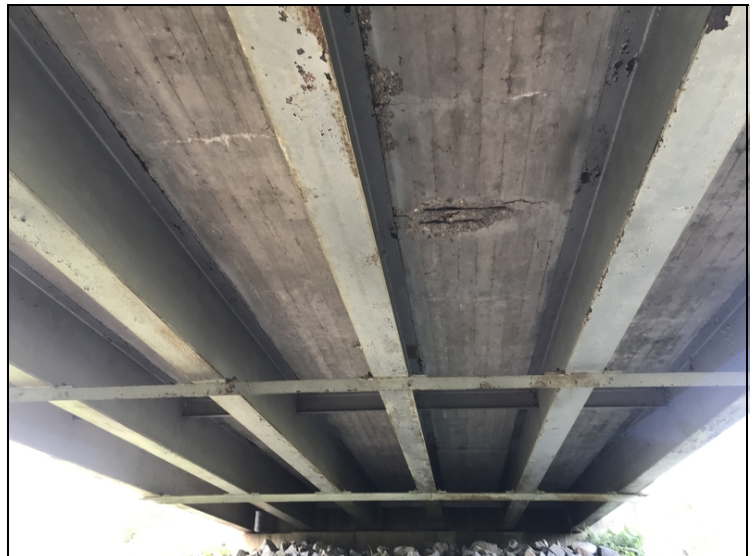
Span #1 soffit-under surface

Soffit-under surface span #1 between girders #2 and 3 has 1 ½' x 2 ½' spall with exposed rebar moderate section loss approx. 15' from bent #2 and 4' of shallow spalling beside top flange of girder.  
Soffit-under surface span #1 between girders #3 and 4 has 1' spall with exposed rebar moderate section loss.  
Soffit-under surface span #1 between girders #4 and 5 has 3' long transverse crack with exposed rebar moderate section loss mid span, and 2' of shallow spalling beside top flange of girder.  
Soffit-undersurface span #1 between girders #5 and 6 has 1' spall with exposed rebar moderate section loss.  
Soffit-under surface in spans #3,4,7 have transverse cracks spaced 2' apart with 1/3 having light efflorescence with rust staining.  
Soffit-under surface in spans #3,4,7 have approximately 20 square feet of 1' to 2' spalls with exposed rebar with 10% section loss.  
Soffit-under surface span #9 between girders #1,2 has 1' spall with exposed rebar moderate section loss.

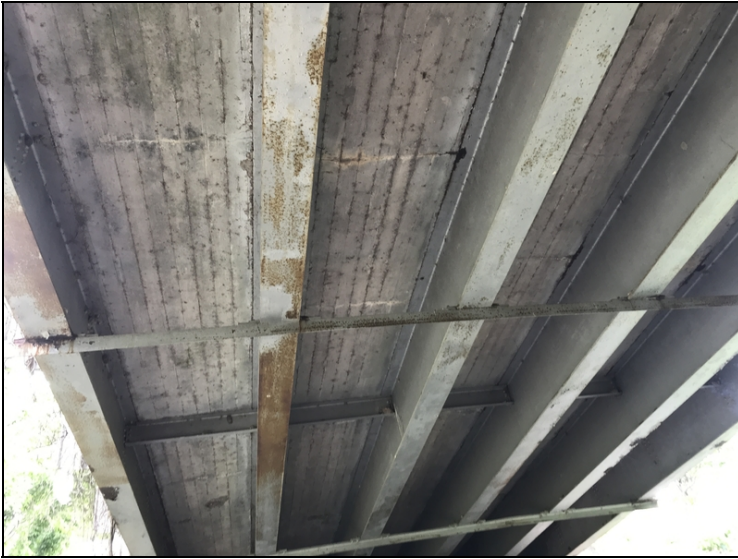
Span #9 soffit-under surface

Soffit-under surface span #9 between girders #4,5 has 2 two foot spall with exposed rebar moderate section loss.

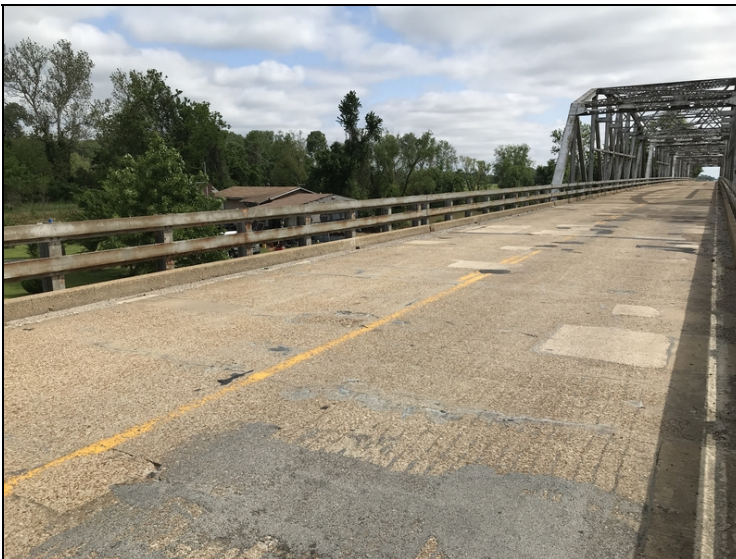
Left bridge rail

Bridge rails have surface rust full length with 10% bare steel rest of paint has limited effectiveness.  
Bridge rails have areas of pact rust with section loss up to 20% in connection points and a few areas with 100% section loss.  
Span #5 at bent #5 left side and span #6 at bent #7 left side both have collision damage.

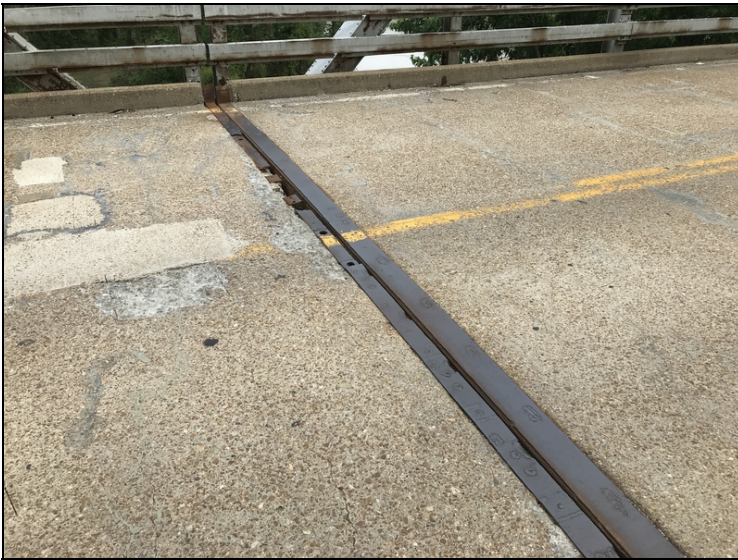
Bent #4 joint has two foot area of all joint steel missing in left lane causing a large hole at joint.

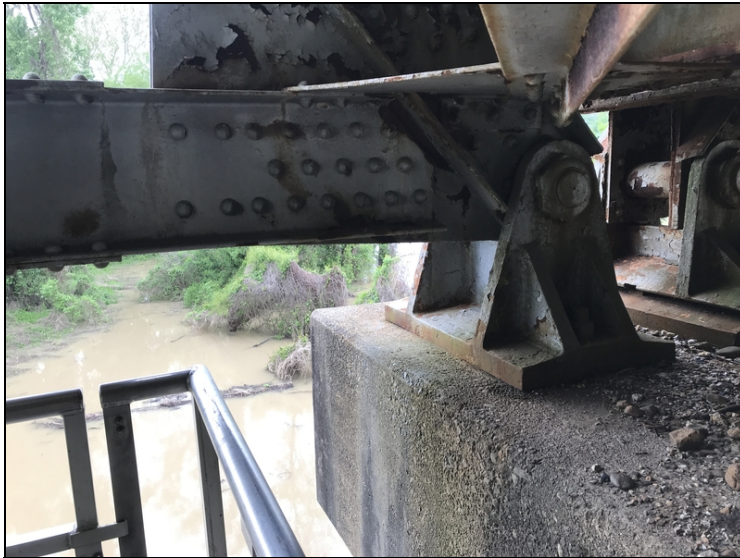
Typical fixed bearing truss.

Paint on movable bearings truss spans 3,4,5,6,7 have 70% bare steel with 30% limited effectiveness.  
Truss spans 3,4,5,6,7 bearings are corroded with laminations with section loss up to 10% unless other wise noted.  
Paint on fixed bearings truss spans 3,4,5,6,7 50% bare steel 50% is limited effectiveness.

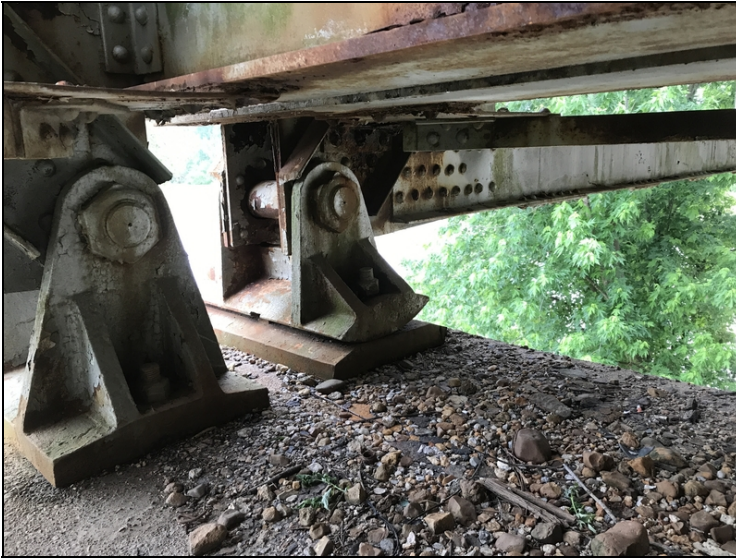
Typical movable bearing truss.

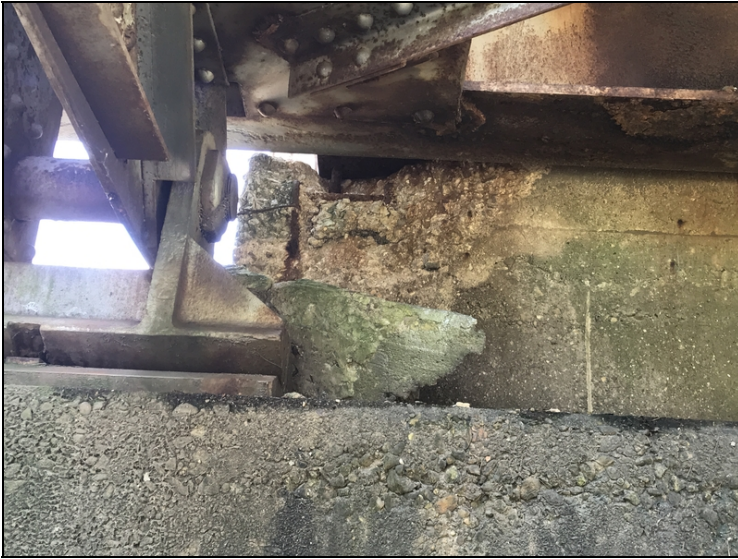
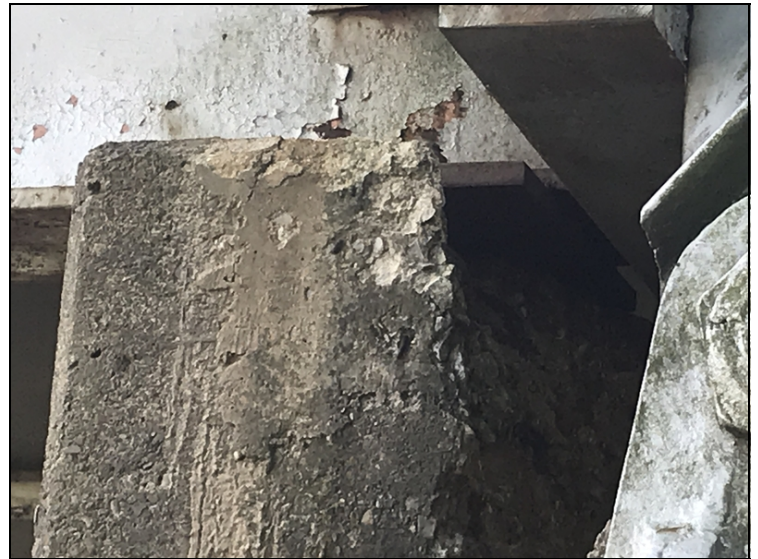
Bent #3 cap is spalled on right end with exposed rebar span #2 side reducing bearing area under girder to 50%.  
Bent #8 front face has a two foot spall at top right side under bearing of girder #6 with exposed rebar with 5% section loss and 50% loss of bearing support.

Bent #3 span # 2 cap spalled reduced bearing area to 50%.

Span #2 bent #3 cap ahead face under girder #6.

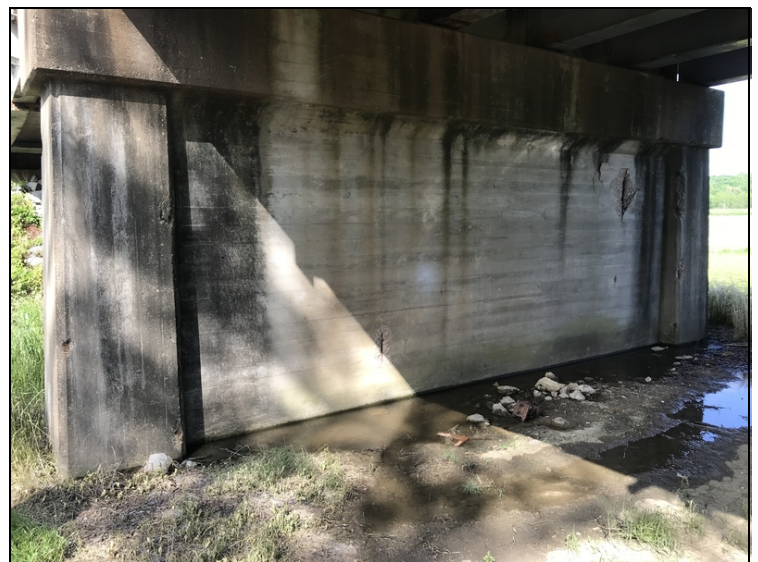
Bent #2 ahead face

Pier walls and columns have several areas of cracks, delaminations, and spalls with exposed rebar.
