## Bridge 03767 Inspection Report

Route:78 Section:01 Log:5.1

Arnold Road ID:68x78x1xA, Arnold Log mile:5.12

Team Lead: Anthony Caudel, Inspection Date: 02/26/2024

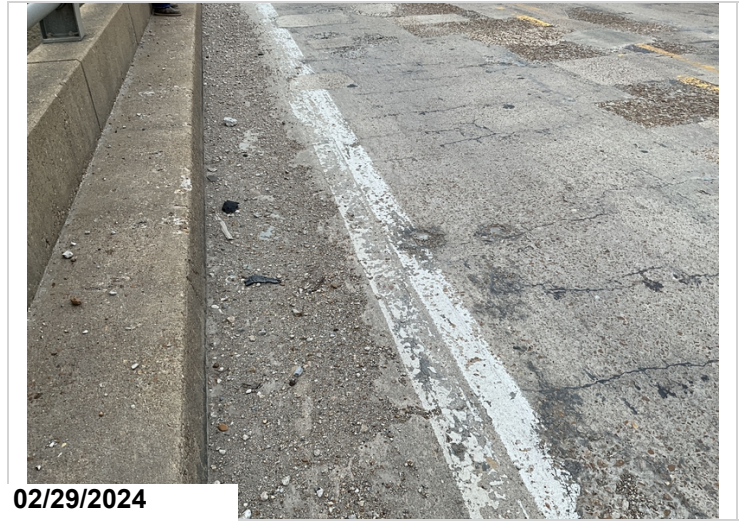
Deck washing need in all spans.

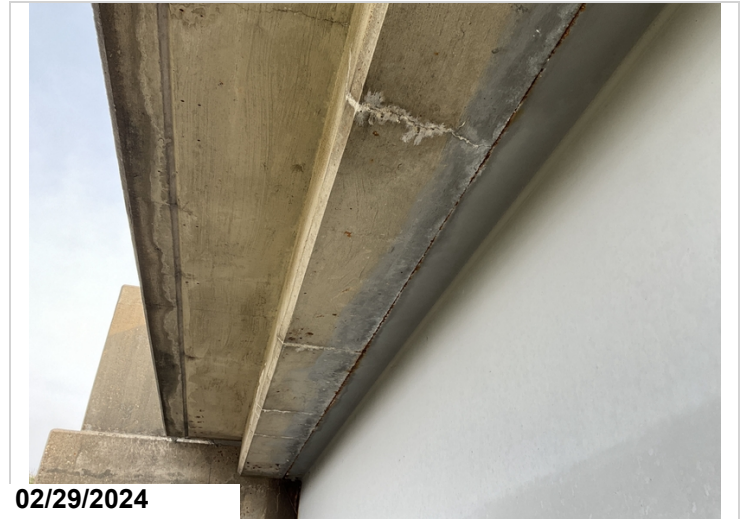
Span 1, right soffit area has heavy leaching to deck. CS3

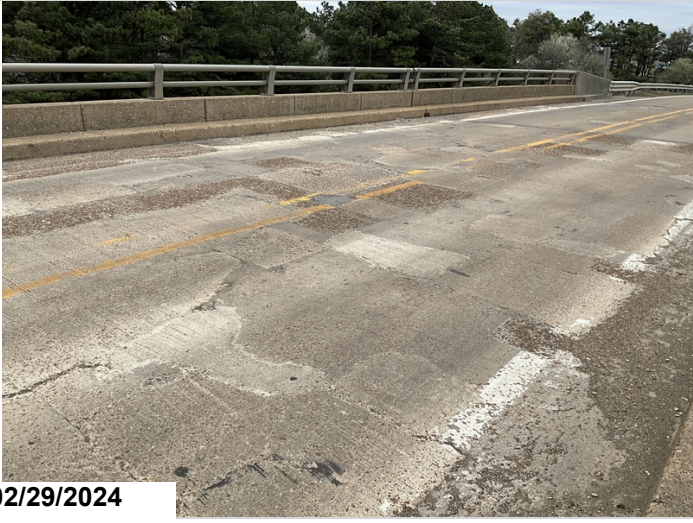
Typical photo of span 3. CS3 Abrasion

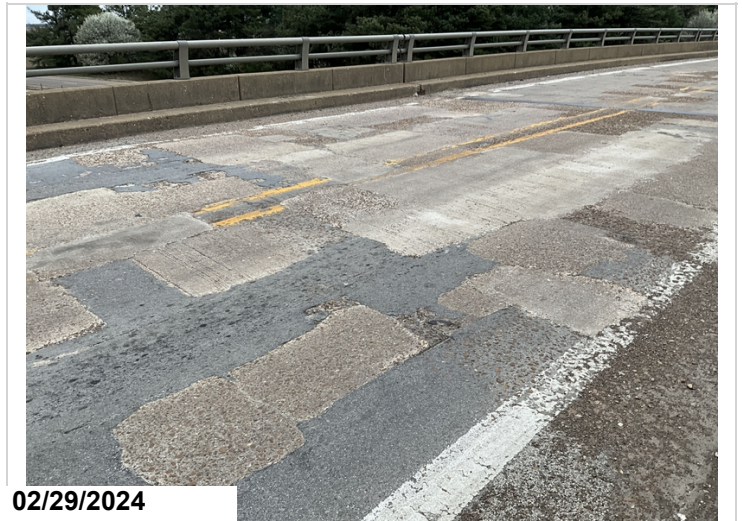
Span 1, typical photo of deck patches sound and unsound patches.

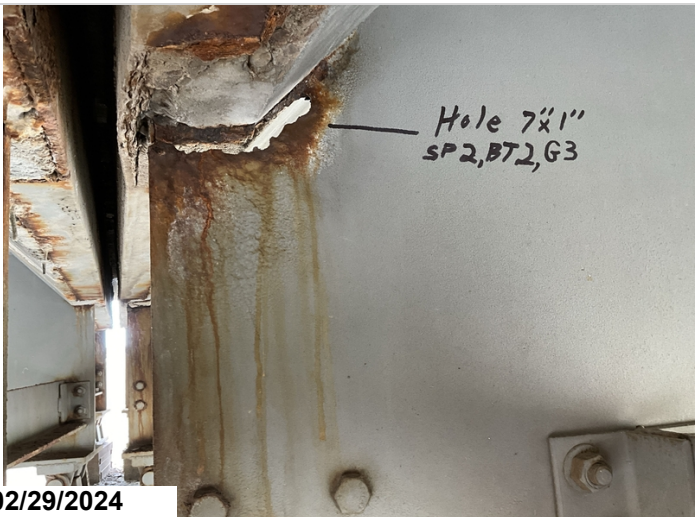
Span 2, bent 3, girder 3, haunch area has a 7"x1" hole. CS3

All beam ends, and bearings need to be sandblasted and painted after holes in girders are repaired.

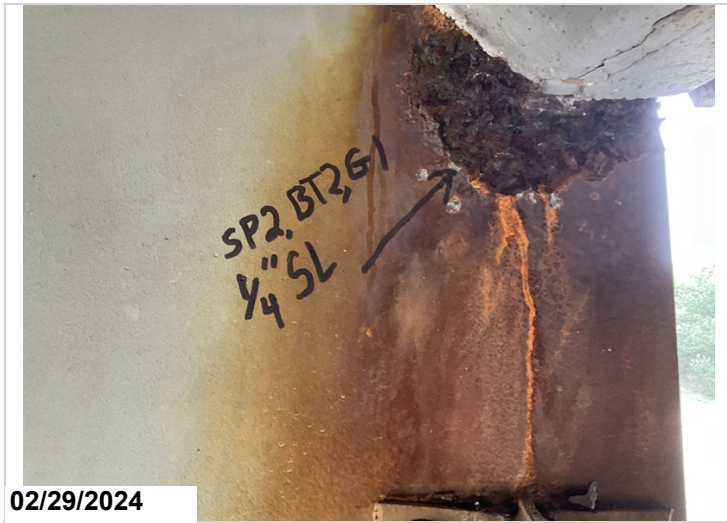
Span 2, bent 3, girder 1, in the haunch area has up to 1/4" section loss. CS3

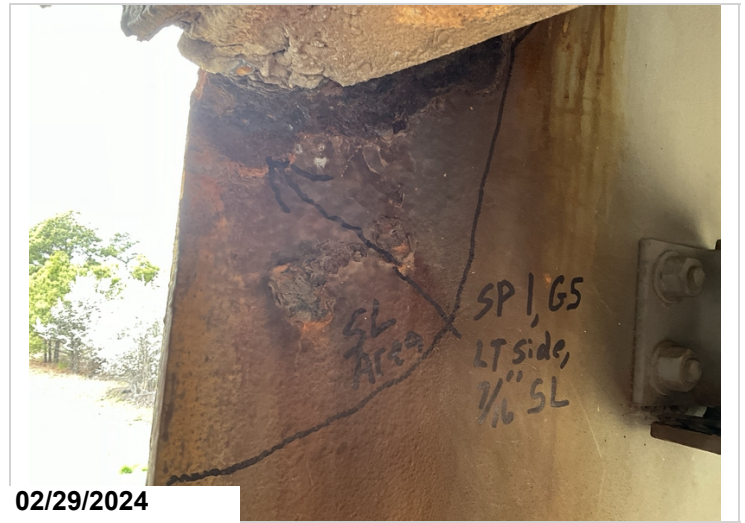
Span 1, bent 2, girder 5 in the haunch area has up to 7/16" section loss. CS3

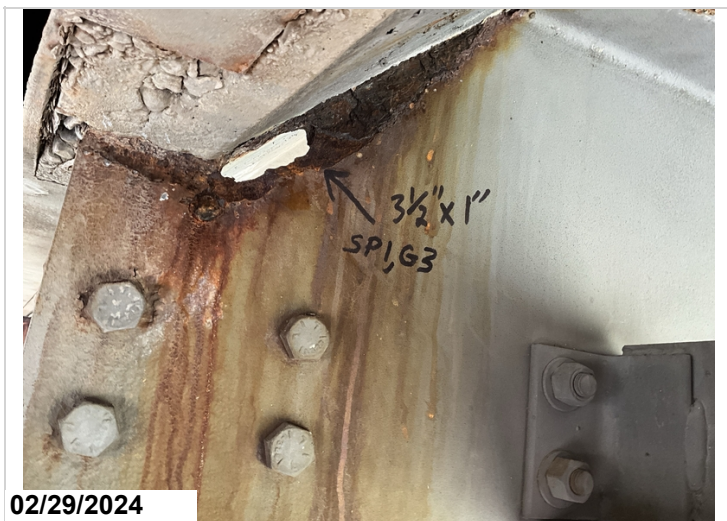
Span 1, bent 2, girder 3 in haunch area has a 3 1/2"x1 1/2" hole. CS3

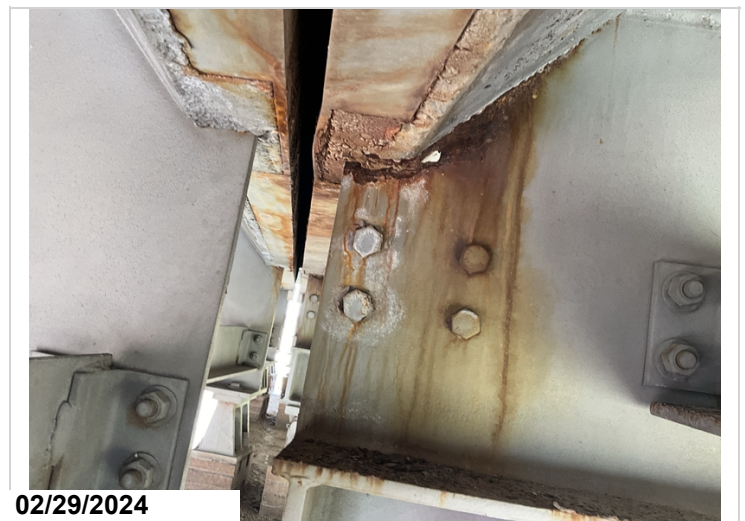
Span 1, bent 2, girder 2 has a hole in the haunch area 1"x5". CS3

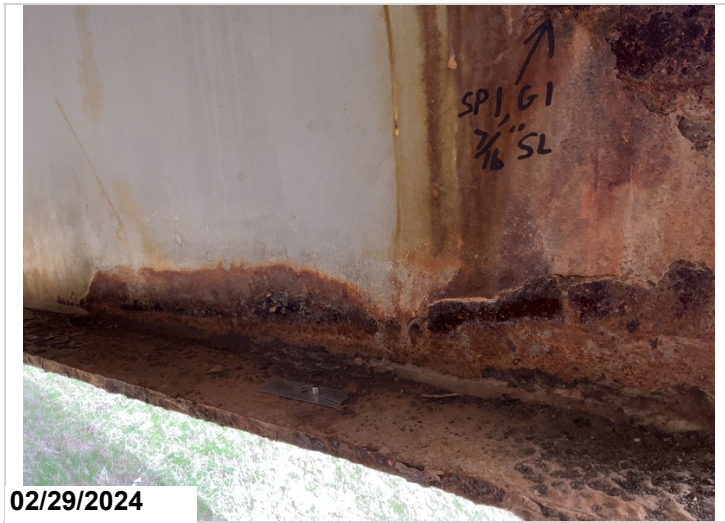
Span 1, girder 1, bent 2, bottom flange has up to 3/8 section loss. CS3

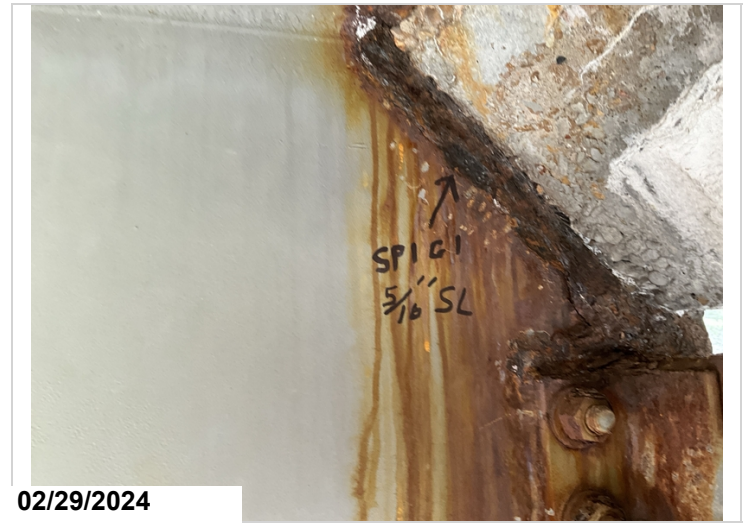
Span 1, girder 1, bent 2, in the haunch area has up to 5/16" section loss. 16"x 2"x 5/16", CS3

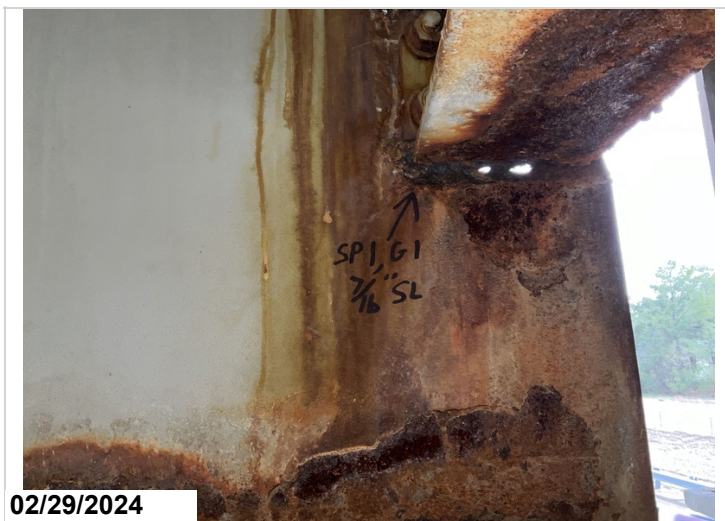
Span 1, bent 2, girder 1 under diaphragm connection at bent 2, has 2 small hole in web. Dime size and quarter size holes. CS3  
8x12 area around diaphragm, this is the section loss area.

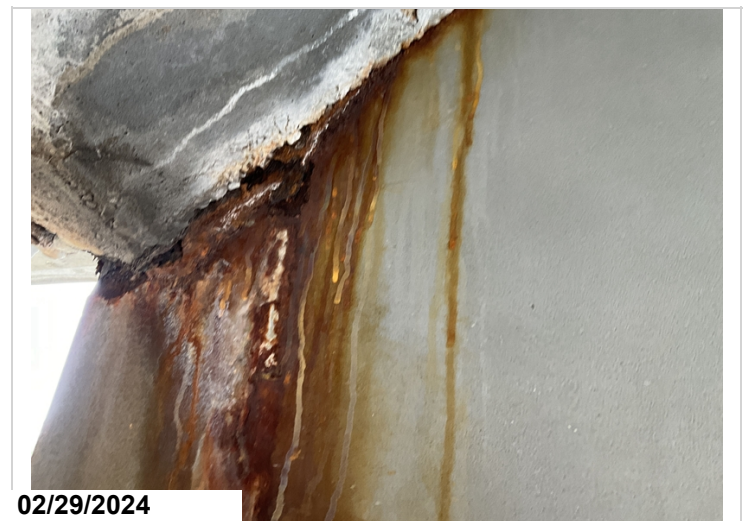
Span 3, bent 3, girder 1, in the haunch area has up to 3/16" section loss. CS3

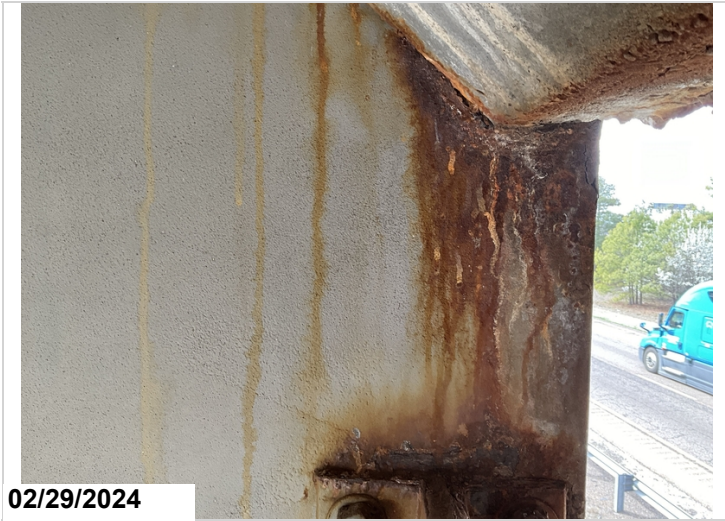
Span 3, bent 3, girder 5 in the haunch area has up to 1/8" section loss. CS3

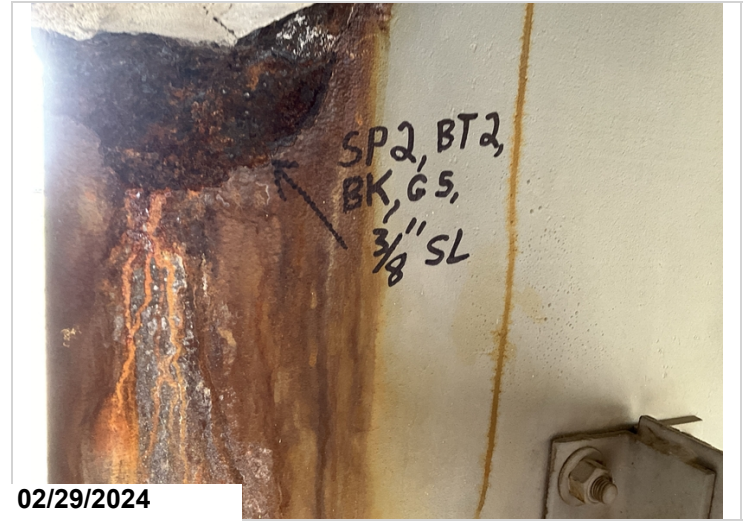
Span 2, bent 3, girder 5, in haunch area has up to 3/8" section loss. CS3

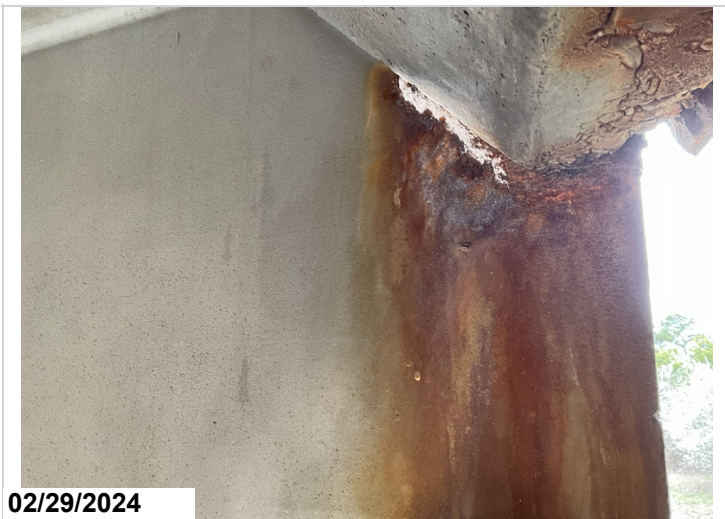
Span 2, bent 2, girder 5, in haunch area has up to 1/8" section loss. CS3

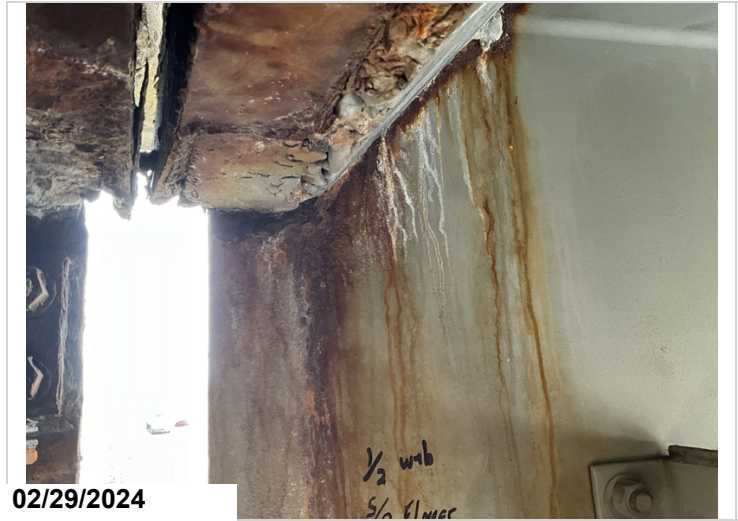
Span 2, bent 2, girder 1 in haunch area has up to 1/8" section loss. CS3

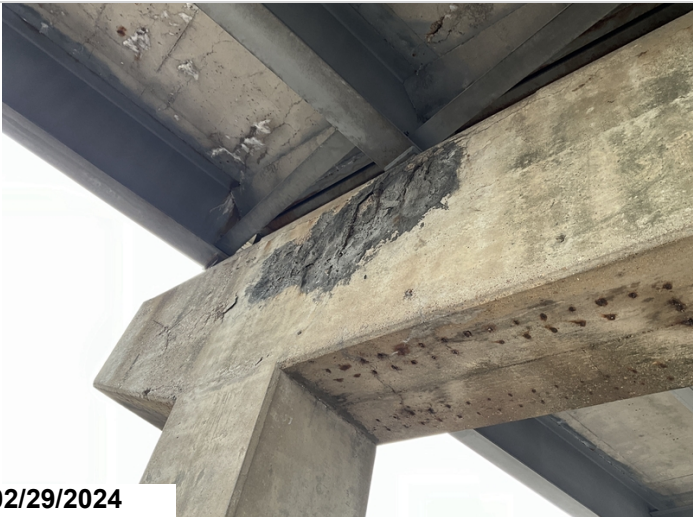
Bent 4 cap, backside, above column 1 has large spalled area with exposed reinforcing steel with section loss. CS3

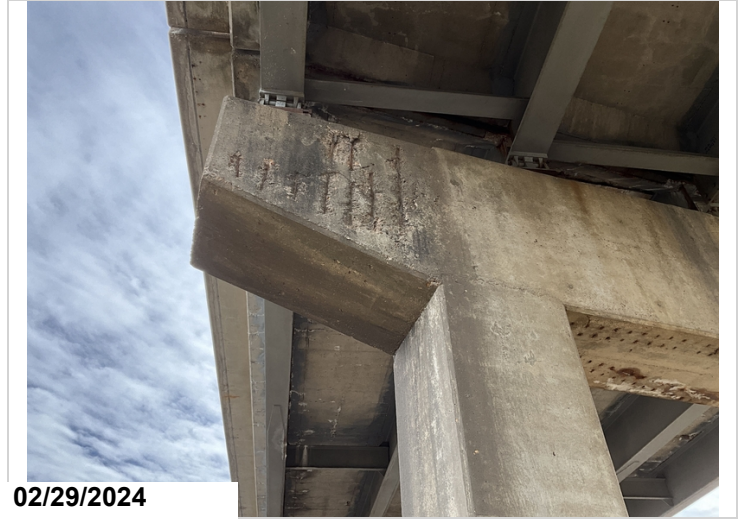
Bent 3 back has large area with exposed reinforcing steel with section loss. CS3

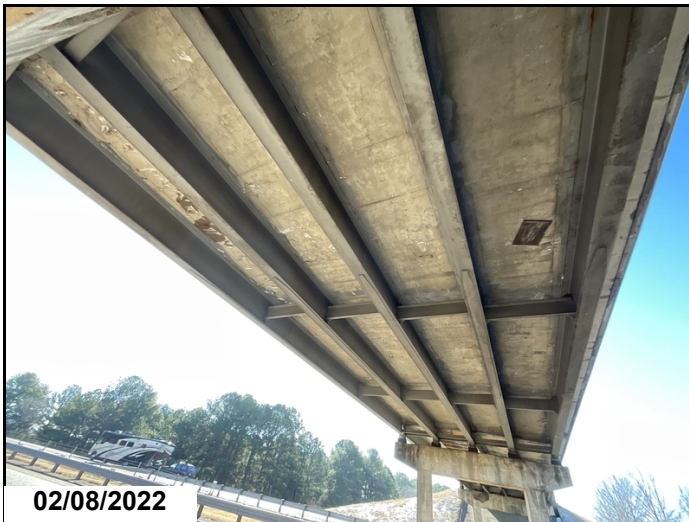
Span #2 soffit-under surface has 10 square feet of delaminations and one form board left in place over right travel lane.  
Span #3 soffit-under surface has 5 square feet of delaminations over left travel lane and median.

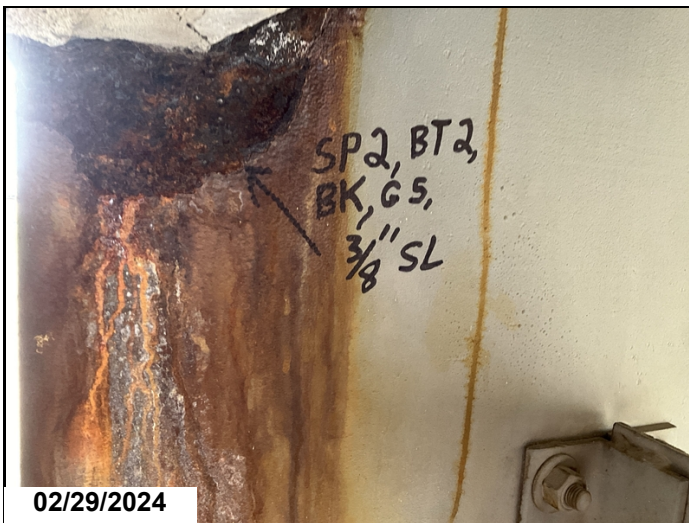
Span 2, bent 3, girder 5, in haunch area has up to 3/8" section loss. CS3

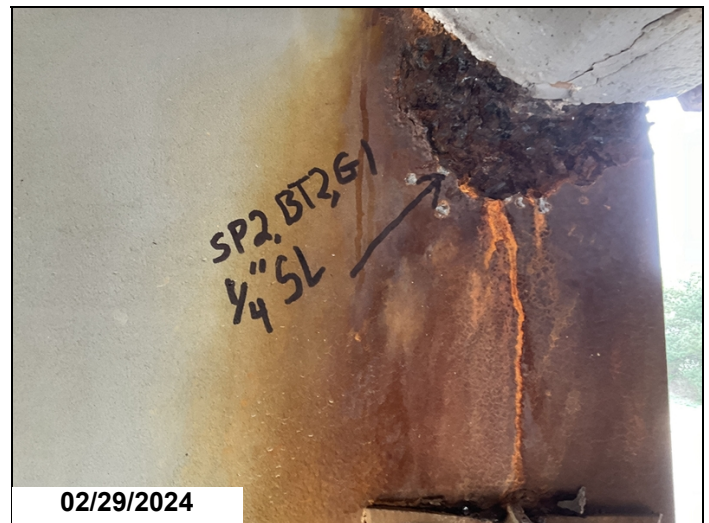
Span 2, bent 3, girder 1, in the haunch area has up to 1/4" section loss. CS3

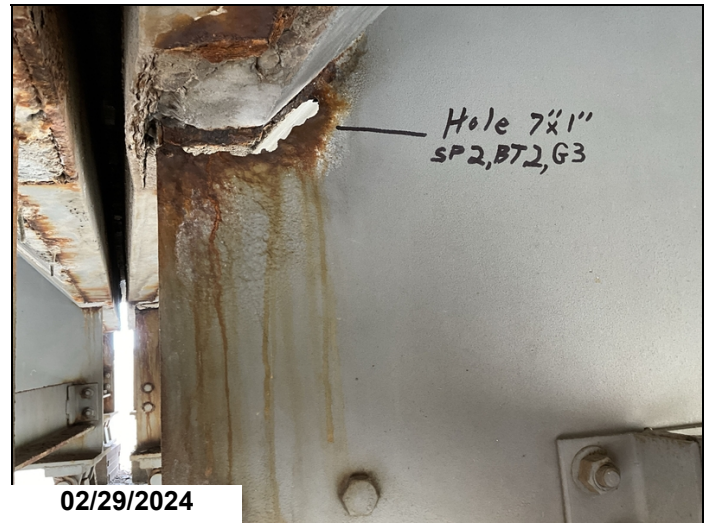
Span 2, bent 3, girder 3, haunch area has a 7"x1" hole. CS3

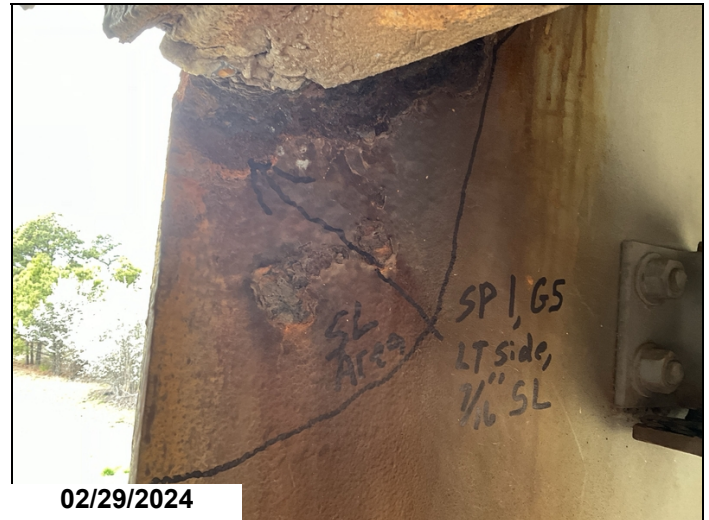
Span 1, bent 2, girder 5 in the haunch area has up to 7/16" section loss. CS3

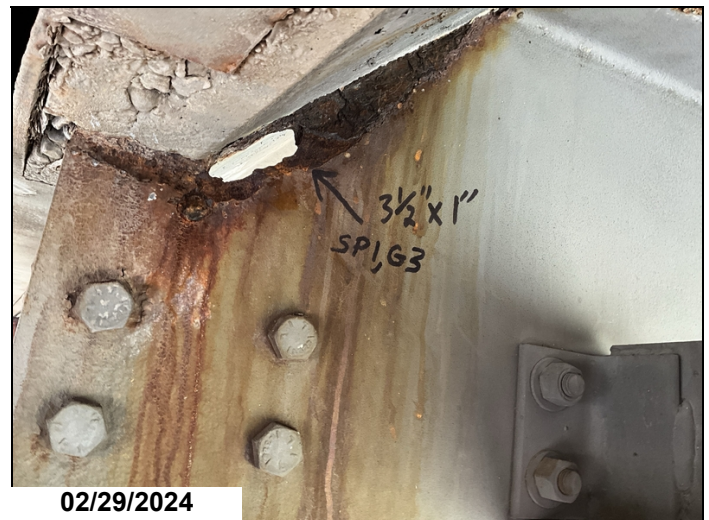
Span 1, bent 2, girder 3 in haunch area has a 3½"x1" hole. CS3

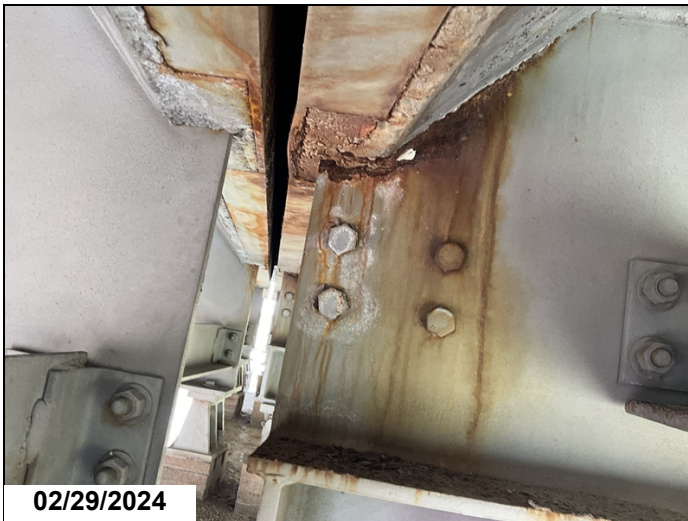
Span 1, bent 2, girder 2 has a hole in the haunch area  
1"x5". CS3

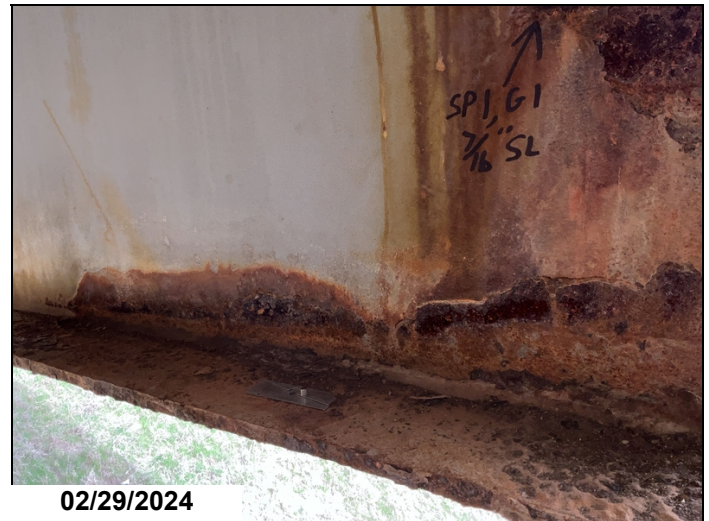
Span 1, girder 1, bent 2, bottom flange has up to 3/8  
section loss. CS3

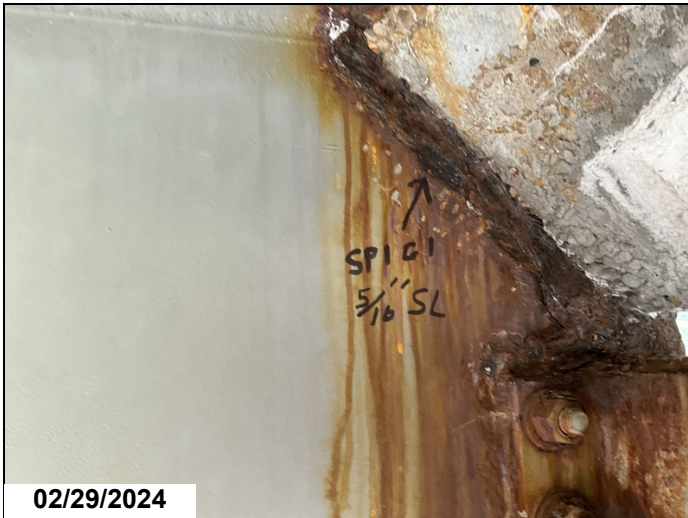
Span 1, girder 1, bent 2, in the haunch area has up to  
5/16" section loss. 16"x 2"x 5/16", CS3

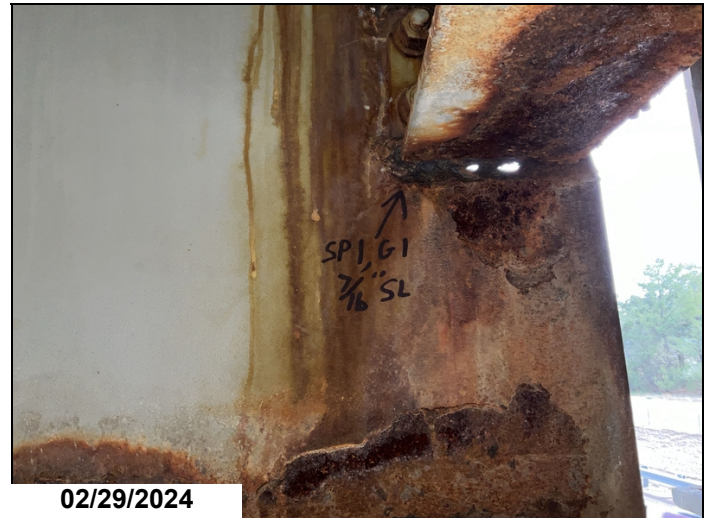
Span 1, bent 2, girder 1 under diaphragm connection at  
bent 2, has 2 small hole in web. Dime size and quarter  
size holes. CS3  
8x12 area around diaphragm, this is the section loss  
area.

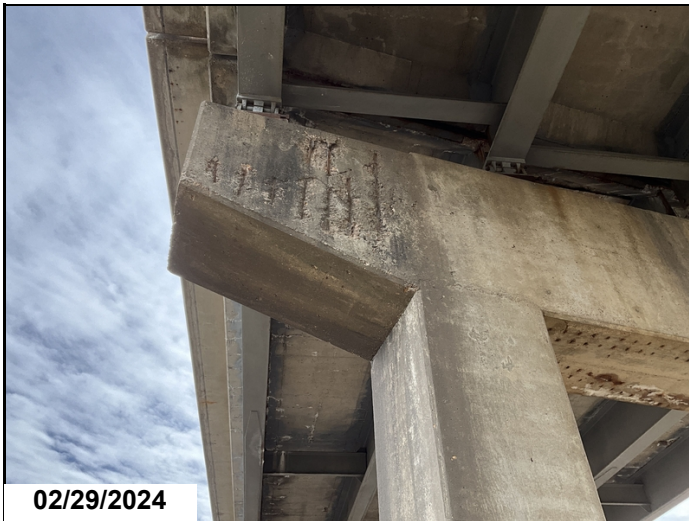
Span 2 bent 3 back has large area with exposed reinforcing steel with section loss.

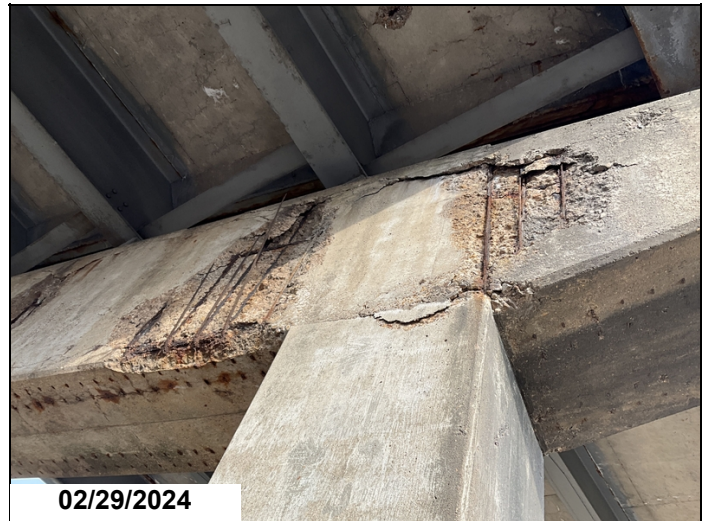
Bent 2 ahead has large area of exposed reinforcing steel with heavy section loss to rebar. CS3

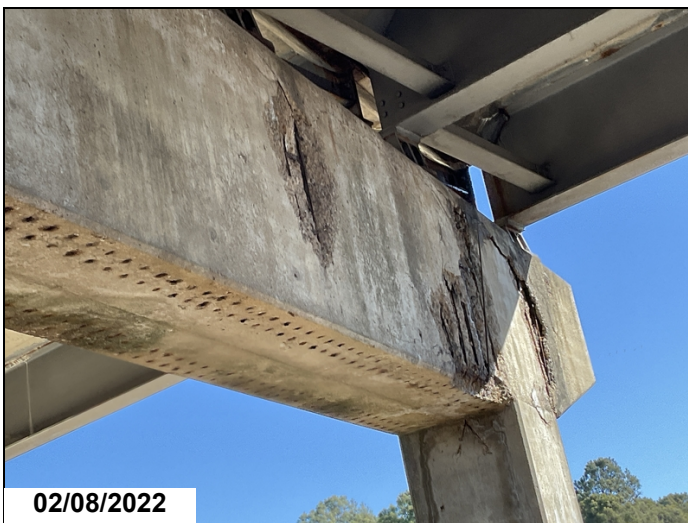
Bent #2 ahead face cap

Bent #2 cap has 14' area on front face with delaminations and spalls and cracks with exposed rebar with moderate section loss, one piece of rebar has 100% section loss.

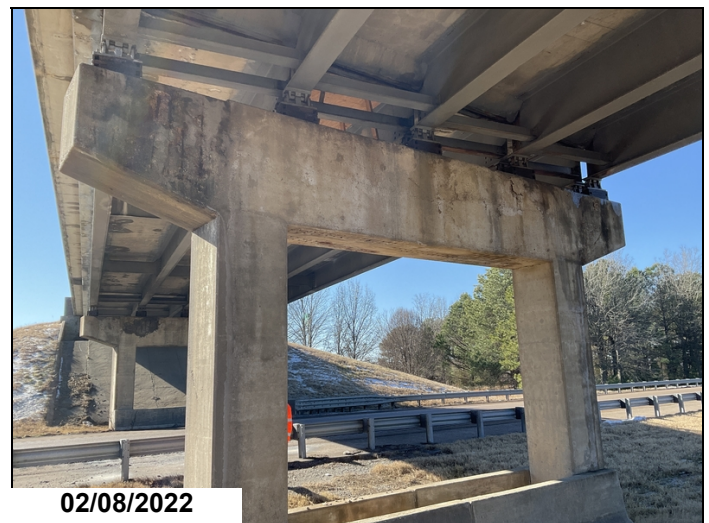
Bent #3 cap ahead face

Bent 3 cap ahead face has 1' x 2' spall with exposed rebar with moderate section loss and has horizontal crack between columns 4" from bottom and 4' of cracking under girder 4.

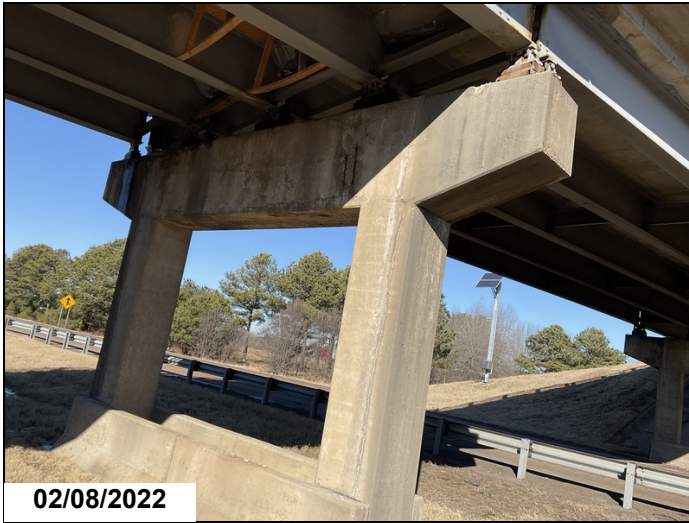
Bent #3 cap back face

Bent #3 cap has 6' area on back face left side and a 4' area on front face left side with delaminations and spalls with exposed rebar with moderate section loss, and 4' of horizontal cracking 4" from bottom near column 2.

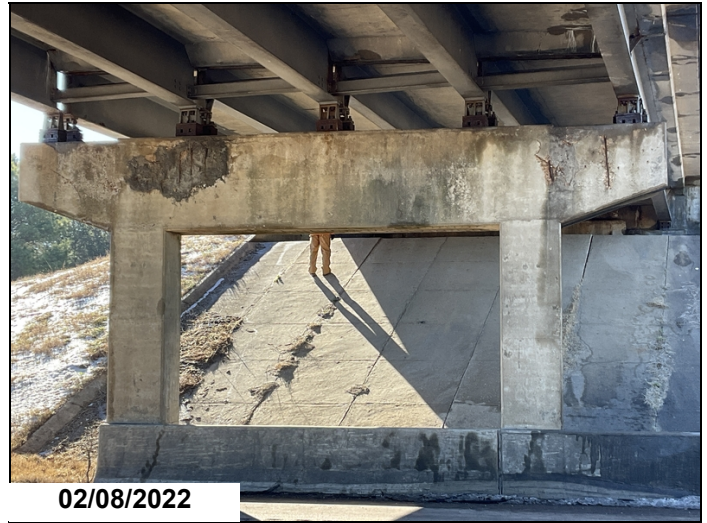
Bent #4 cap back face

Bent #4 cap has 6' area on back face with spalls with exposed rebar with moderate section loss some has had grout smeared over it but rebar is still visible.

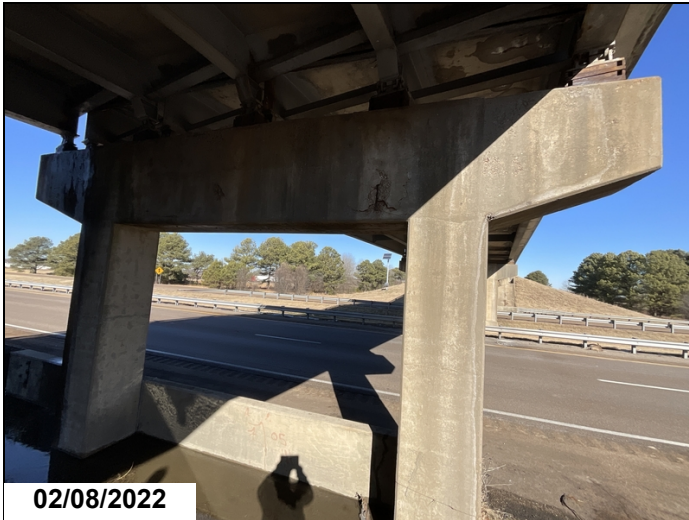
Bent #4 cap ahead face

Bent #4 cap front face has 2 one foot spalls with exposed rebar with moderate section loss, two 1' delaminations and 4' of horizontal cracking.

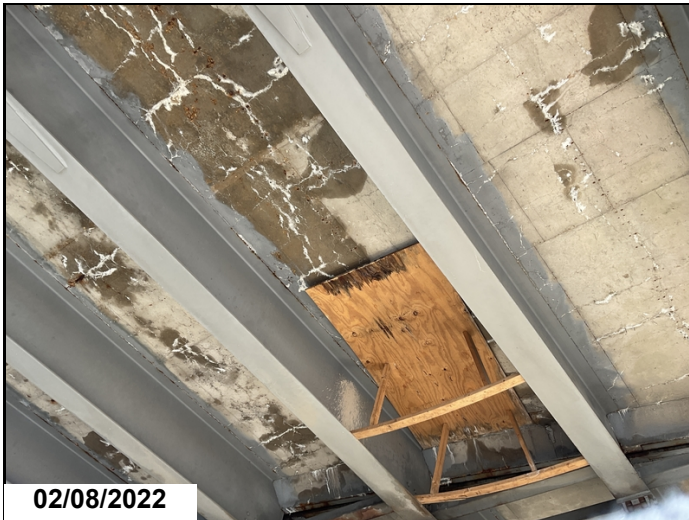
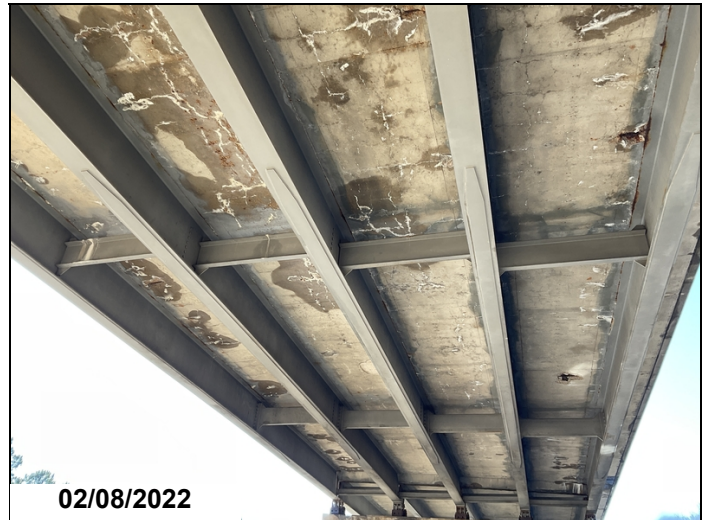
Span #3 soffit-under surface has 15 square feet of spalls with rebar exposed with moderate section loss.  
Span #3 soffit-under surface at bent #3 has a form left in place.

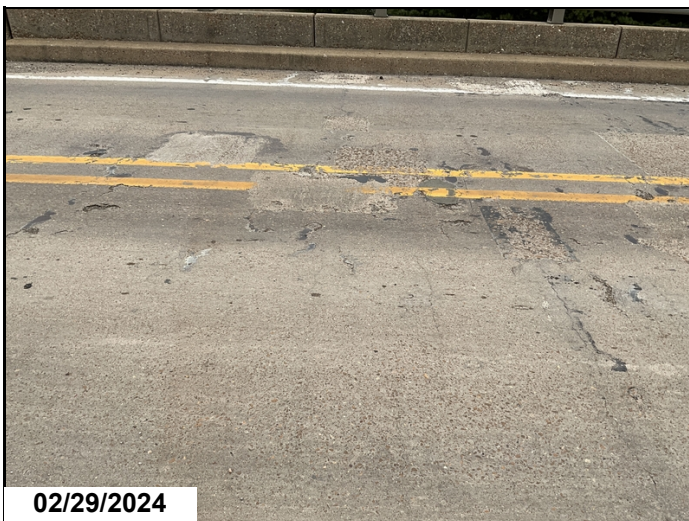
Span 4 has scattered areas of spalls/delam. CS3

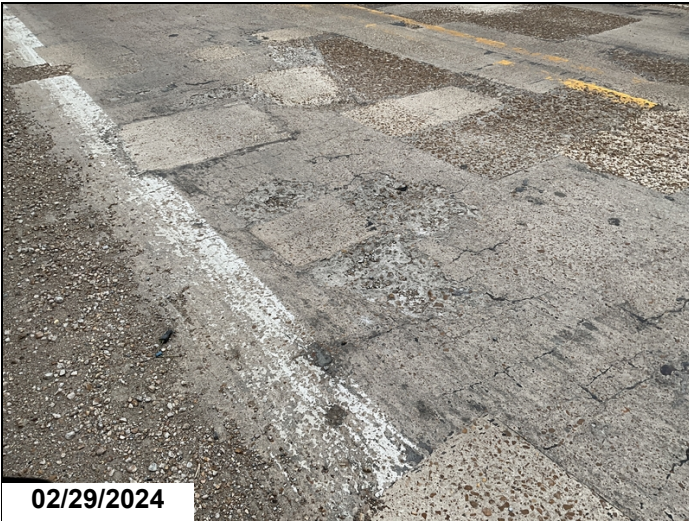
Span 2, left lane has large spalled areas. CS3

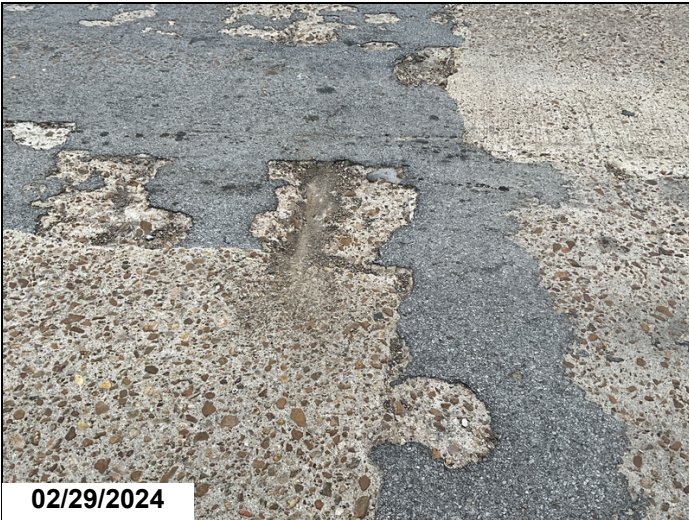
Span 1, left lane has spalling with exposed reinforcing steel with section loss. CS3

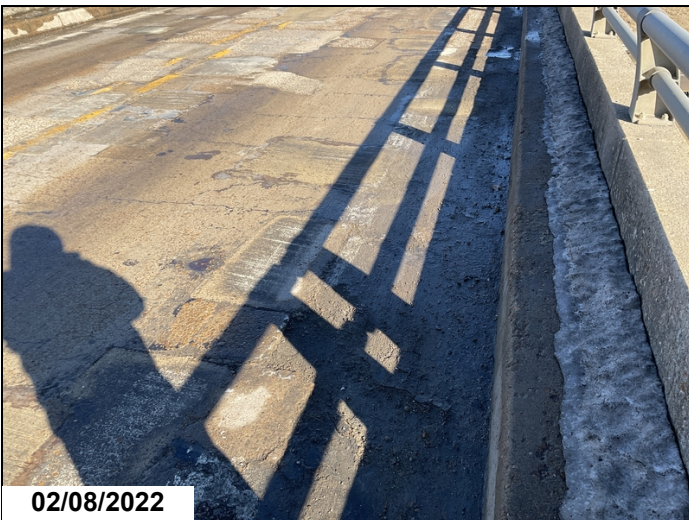
Span #3 has 8 square feet of small spalls with no rebar exposed.

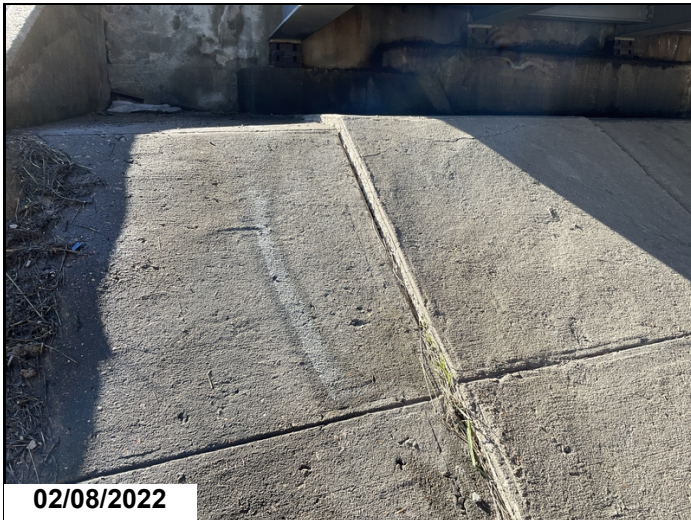
Bent 5, left slope pavement has settled 2".

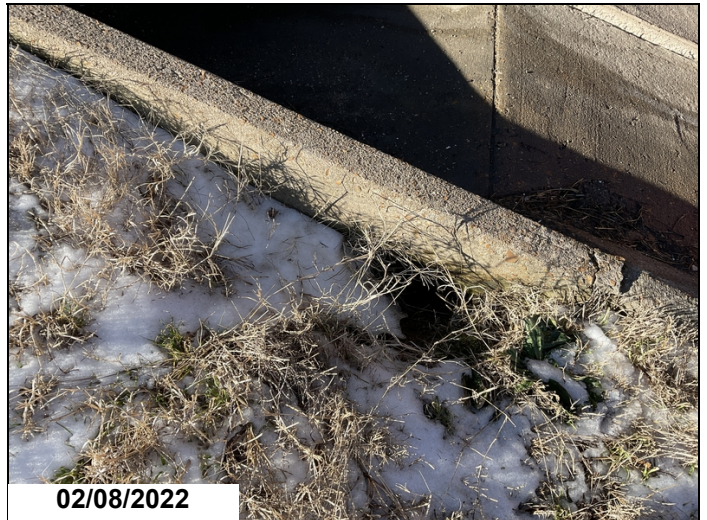
Bent 5 slope near top both sides have holes going under concrete slope.

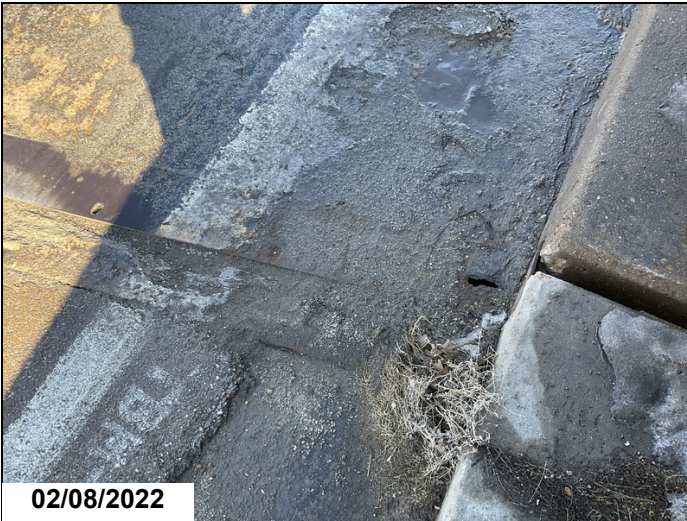
Bent #5 left shoulder top plate has a 4" area with 100% section loss.

Assembly joints are in poor condition and need to be replaced.

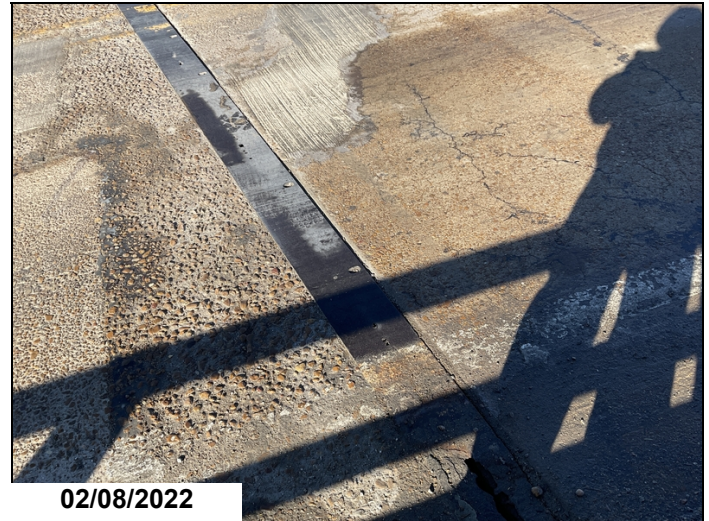
Bent #3 left shoulder top plate has a 6" long area and several small areas across joint with 100% section loss two feet total.

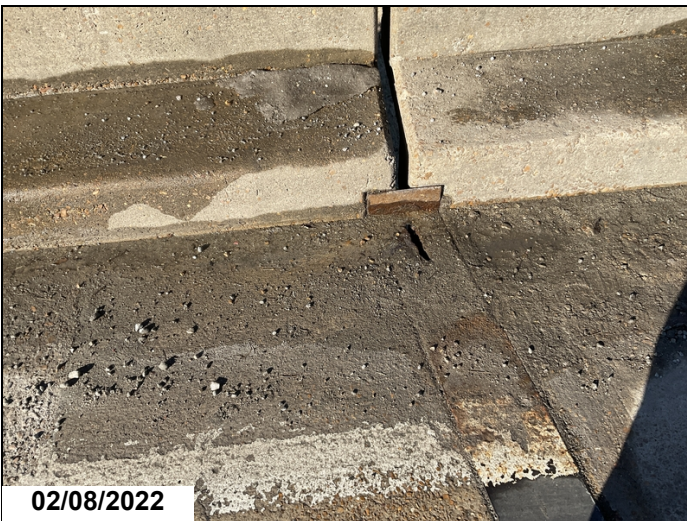
Bent #2 right shoulder top plate has a 6" area with 100% section loss.

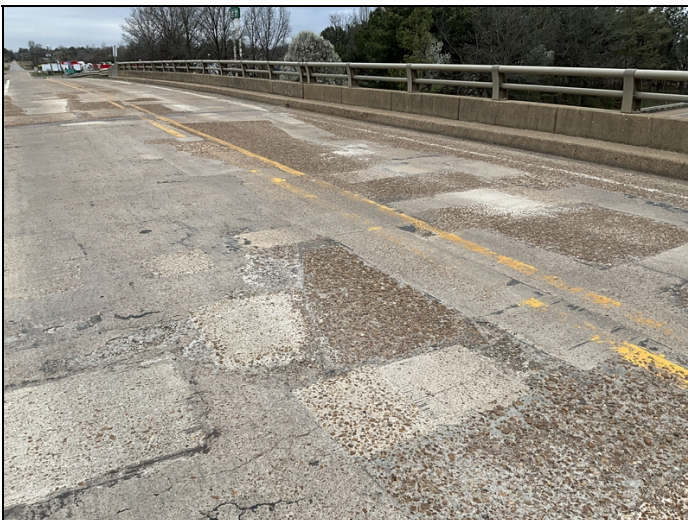
Typical photo of span 2

This deck is in poor condition and needs to be sealed. This structure needs a new deck.

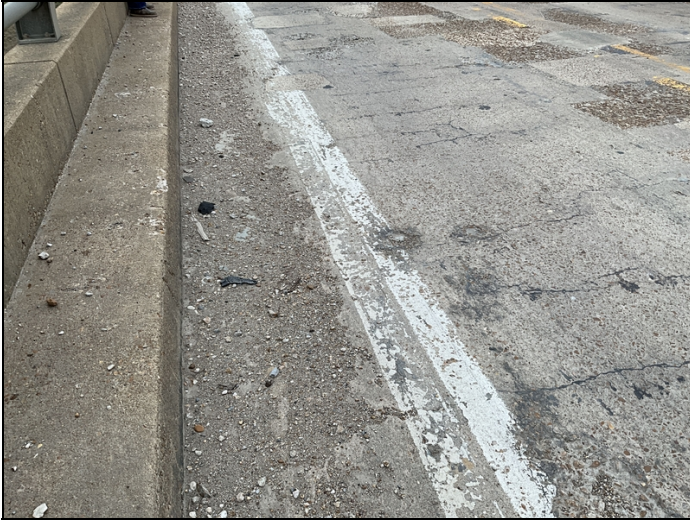
The gutter lines in all spans have dirt and debris.

Deck washing need in all spans.

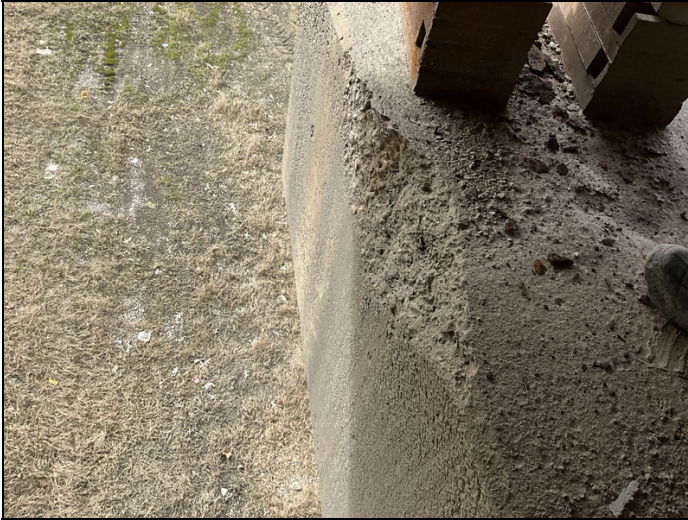
Bent 3 ahead, right side has large spall near bearing area.CS3
