## Bridge 07069 Inspection Report

**Asset #07069**(Routine)

**Us-49/Sec-8/L-6.96 over I-40/Sec-43/L-215.74**

**Team Lead: Myron Futrell Inspection Date: 10/17/2023**

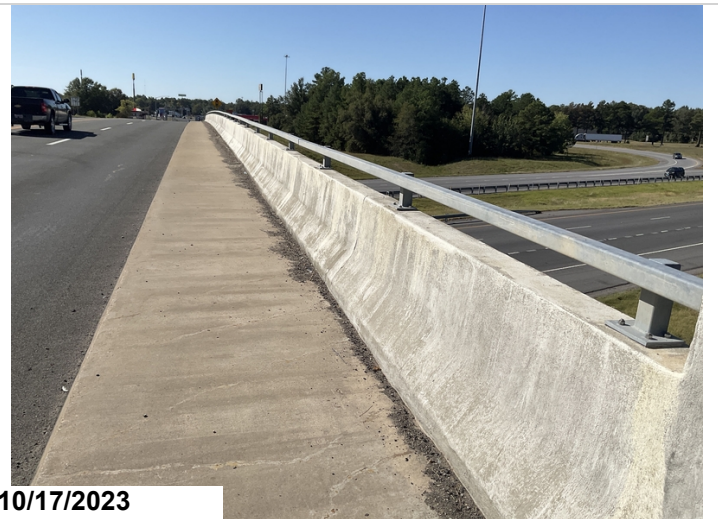
Typical vertical crack in concrete bridge rail

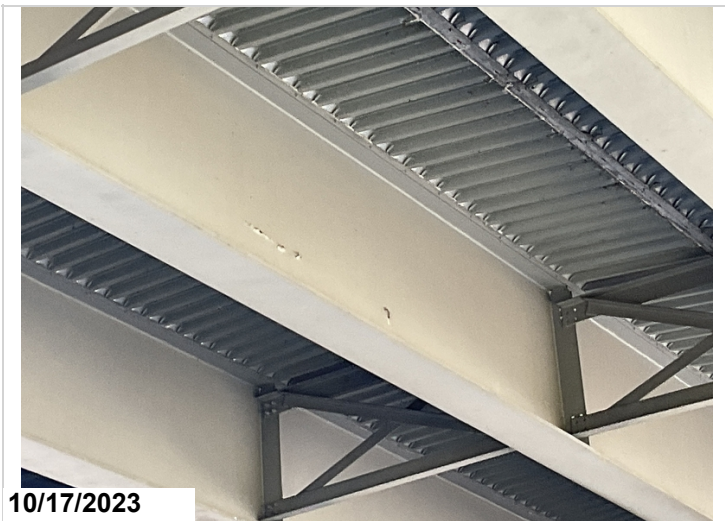
Span #2 girder #5 left side has one foot of paint beginning to peel.

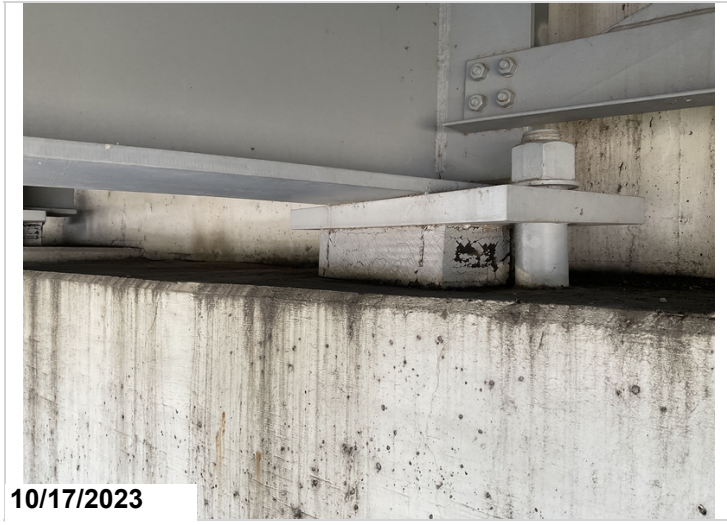
Typical abutment bearing

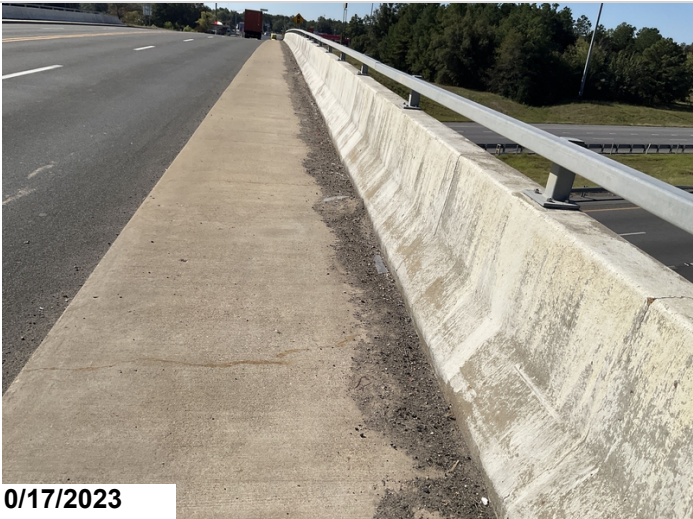
Dirt and debris in sidewalks

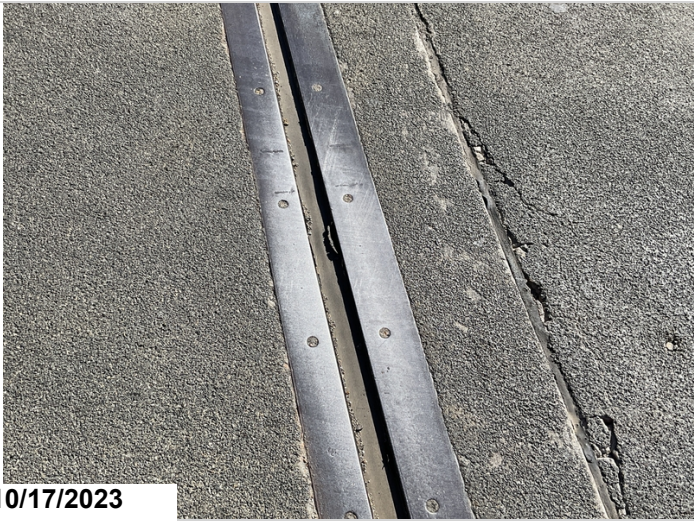
(301) Joints have a small amount of debris in them. Abutment #2 joint seal has several areas of lost adhesion allowing leakage through joint. (2310-301) A#2 joint seal has three feet of lost adhesion allowing leakage through joint.							
310	Elastomeric Bearing	EA	24	24	0	0	0
321	Reinforced Concrete Approach Slab	SF	3363	3363	0	0	0
521	Concrete Protective Coating	SF	3363	3343	0	20	0
3540	Effectiveness (Concrete Protective Coatings)	SF	20	0	0	20	0

Abutment #2 joint seal right outside lane has one foot of lost adhesion

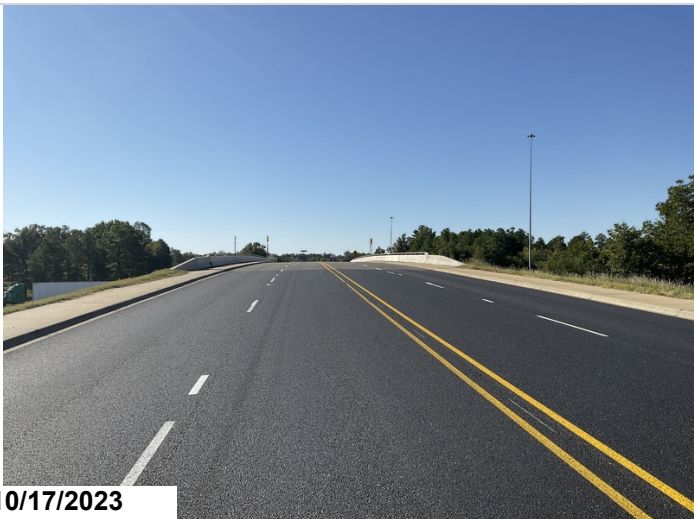
Top view / inventory

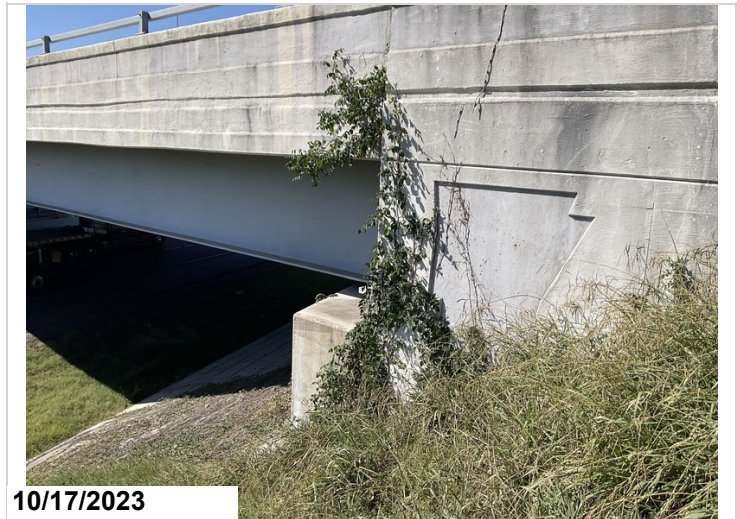
Vines growing onto bridge abutment #1 left side.

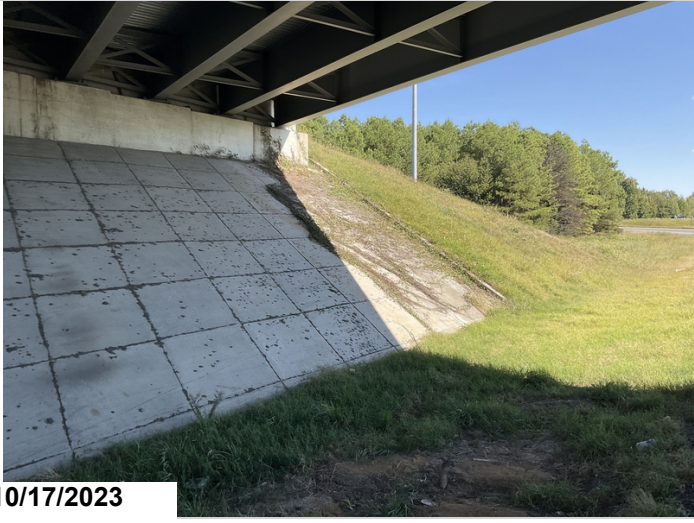
Vines growing on abutment #1 slope pavement left side.

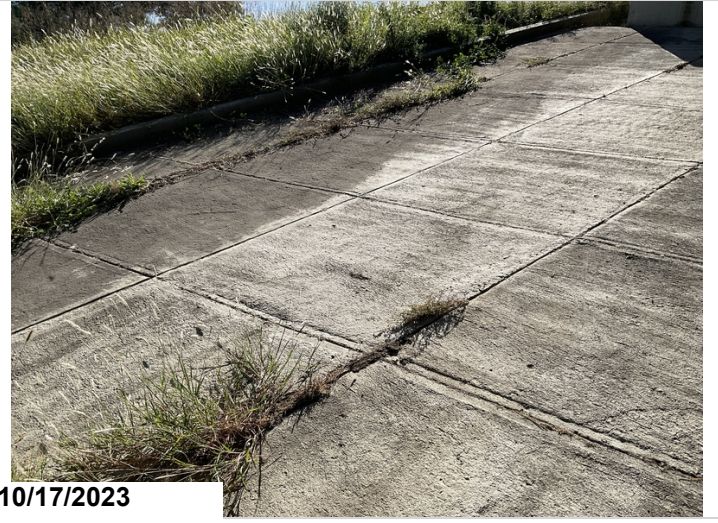
Vegetation growing left side of abutment #2 slope pavement.

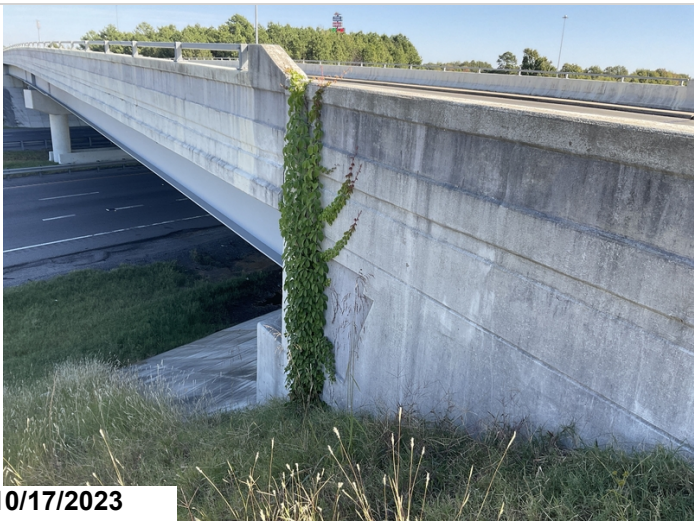
Vines growing up onto bridge abutment #2 right side.

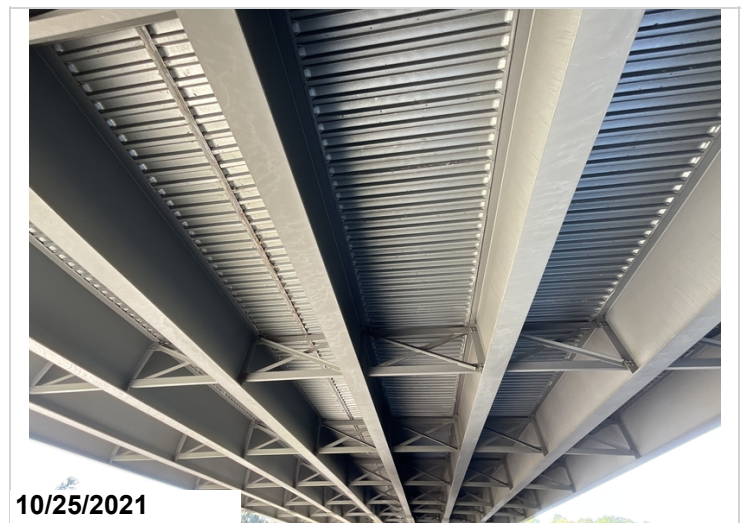
Stay in place forms in center where forms are joined together are starting to corroded.

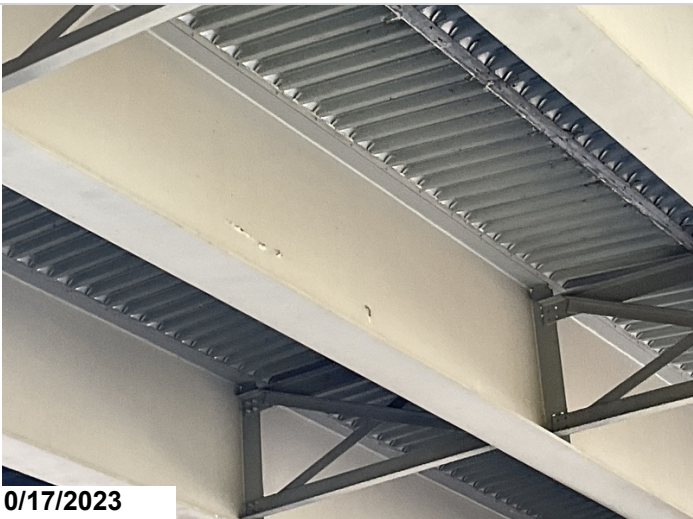
Diaphragms span #2 last 6 of them on right side are welded instead of bolted between girders #4,5.

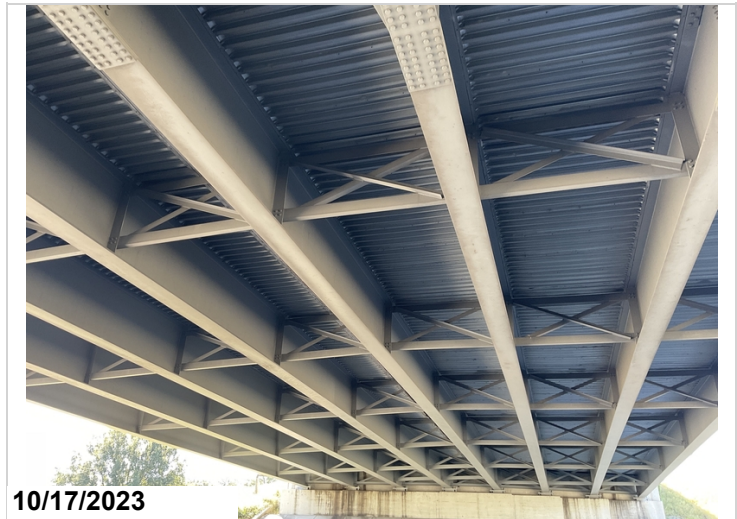
Span #2 girder #5 left side has one foot of paint beginning to peel.

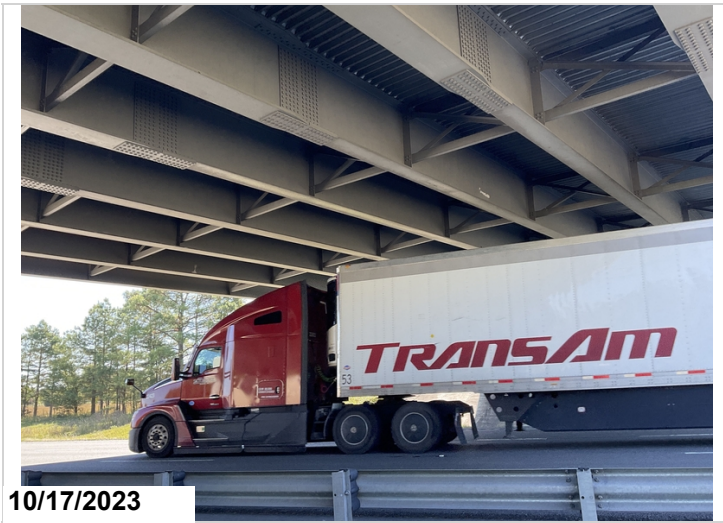
Paint peeling span #2 girders #2 and 6 right side

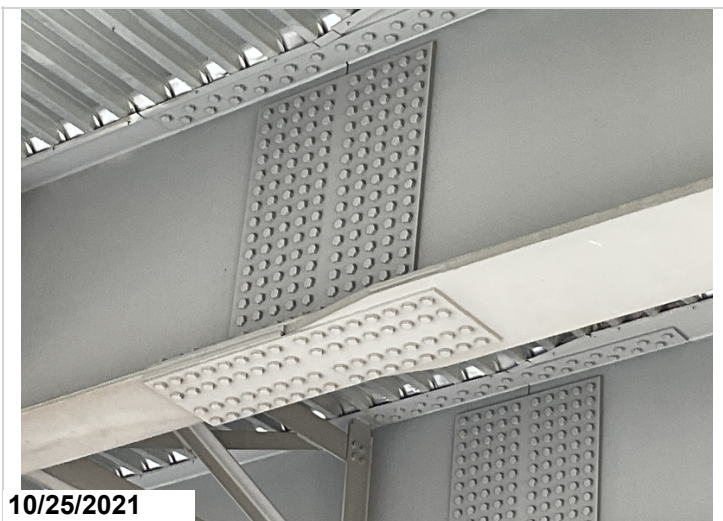
Typical field splice

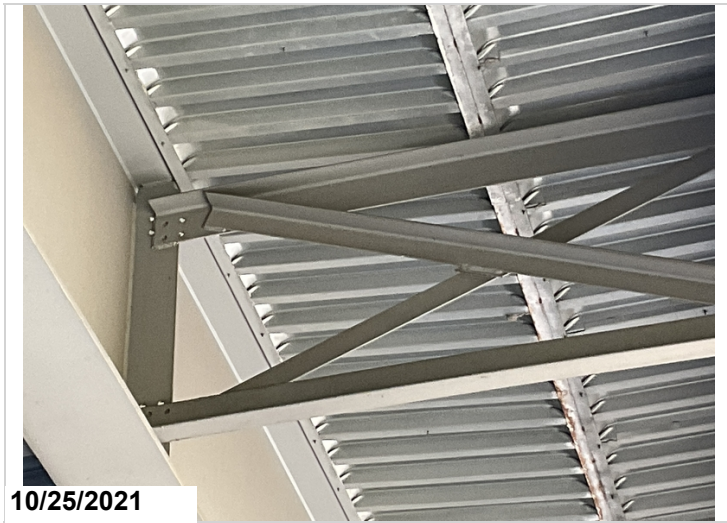
(107) Diaphragms span #2 last 6 of them on right side are welded instead of bolted between girders #4,5. Span #2 girders #2,6 have 1' each of peeling paint right side only. Span #2 girder #5 left side has one foot of paint beginning to peel.							
205	Reinforced Concrete Column	EA	4	4	0	0	0
215	Reinforced Concrete Abutment	LF	208	173	35	0	0
1090	Exposed Rebar	LF	1	0	1	0	0
1120	Efflorescence/Rust Staining	LF	34	0	34	0	0

Typical welded rather than bolted diaphragm.

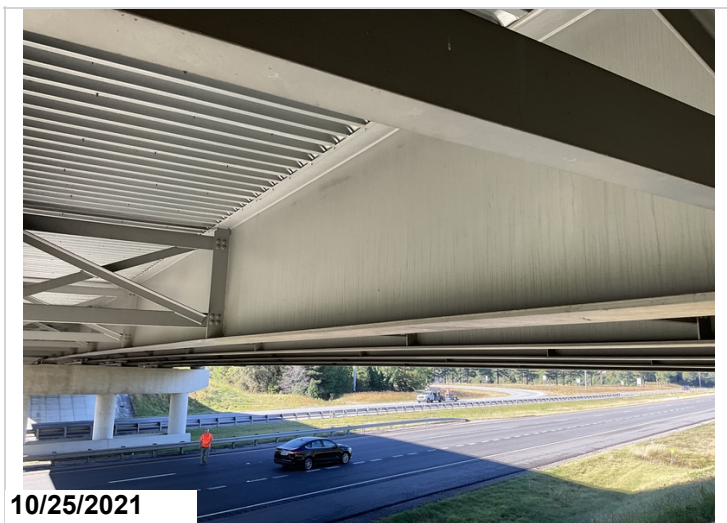
Typical interior girder condition.

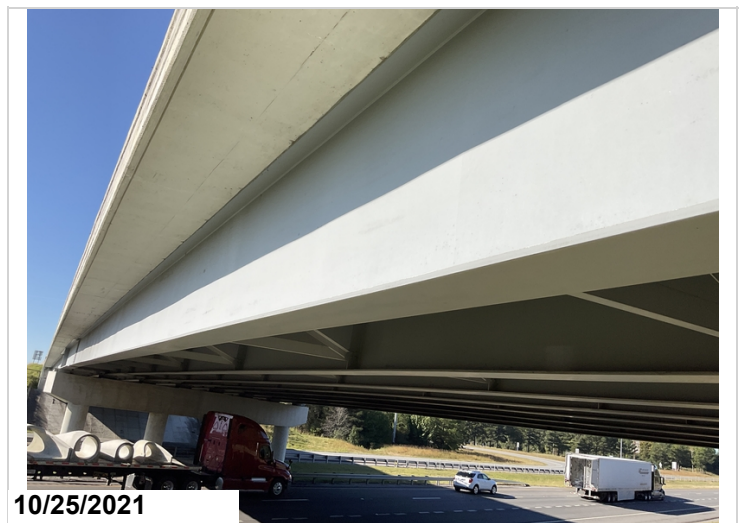
Typical outside girder condition

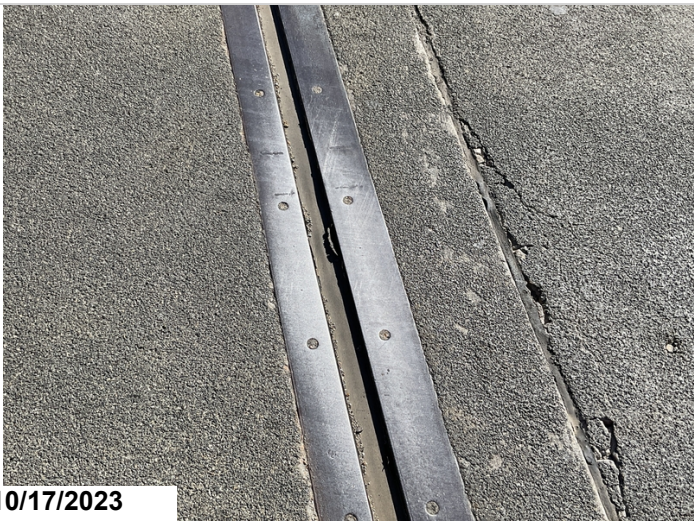
Abutment #2 joint seal right outside lane has one foot of lost adhesion

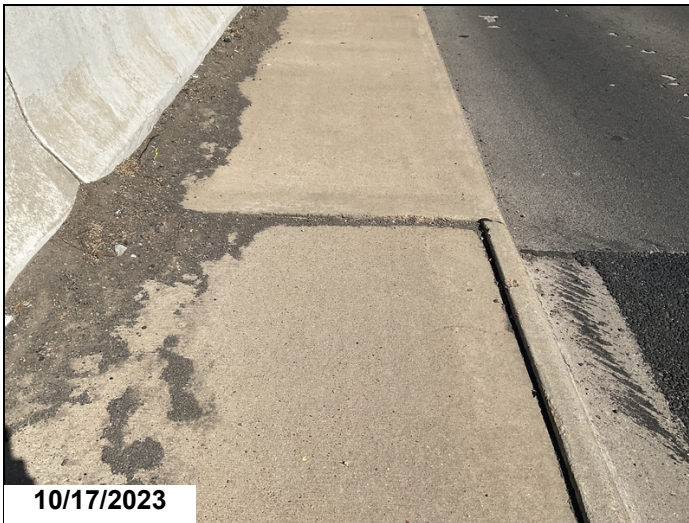
Abutment #2 right sidewalk settlement

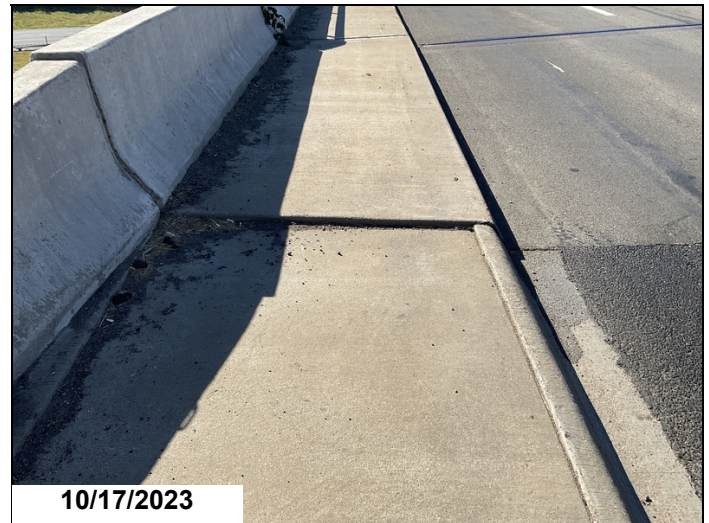
Abutment #1 left approach sidewalk has settled

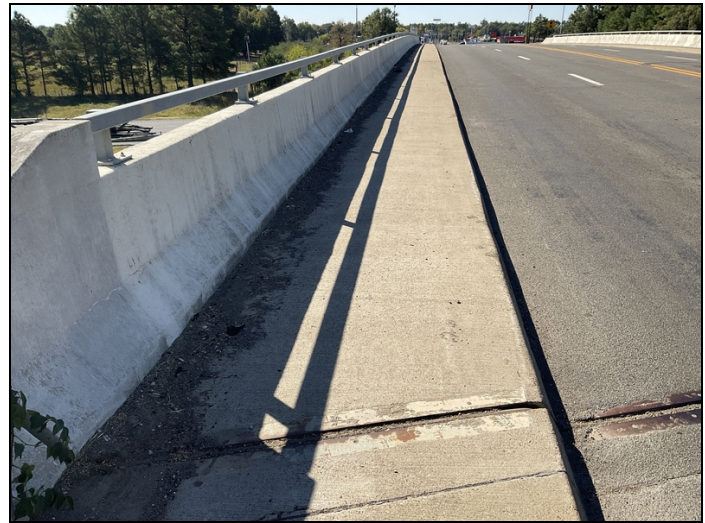
Dirt and debris on sidewalks

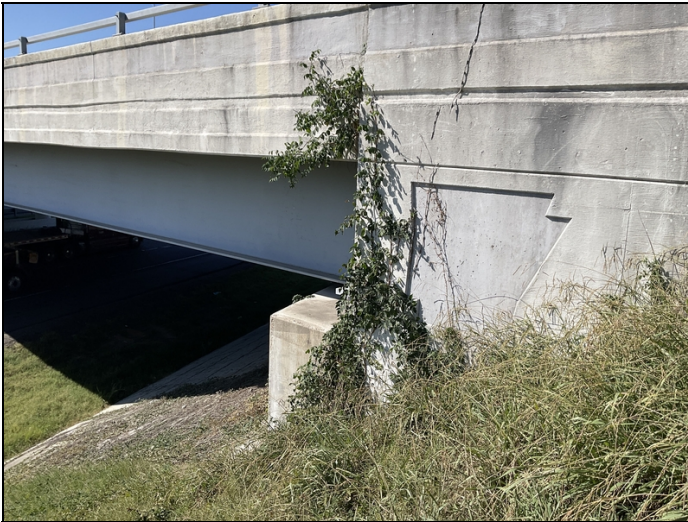
Vines growing onto bridge abutment #1 left side.

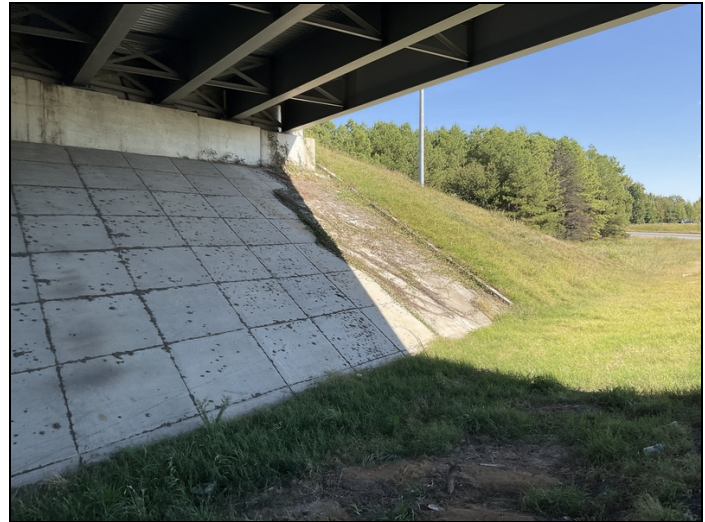
Vines growing on abutment #1 slope pavement left side.

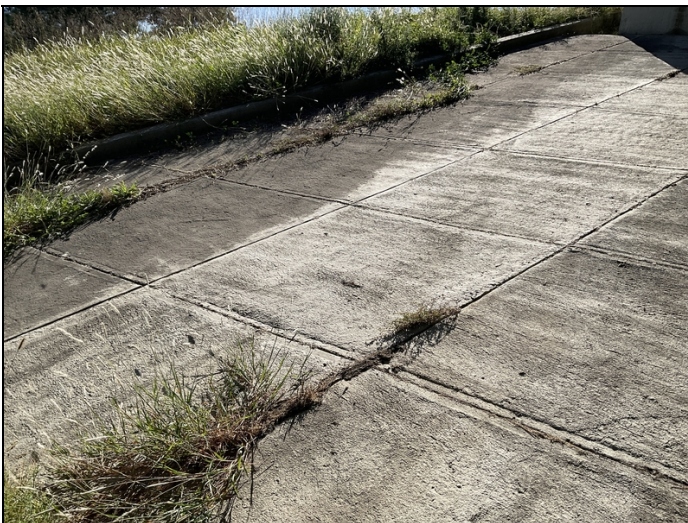
Vegetation growing left side of abutment #2 slope pavement.

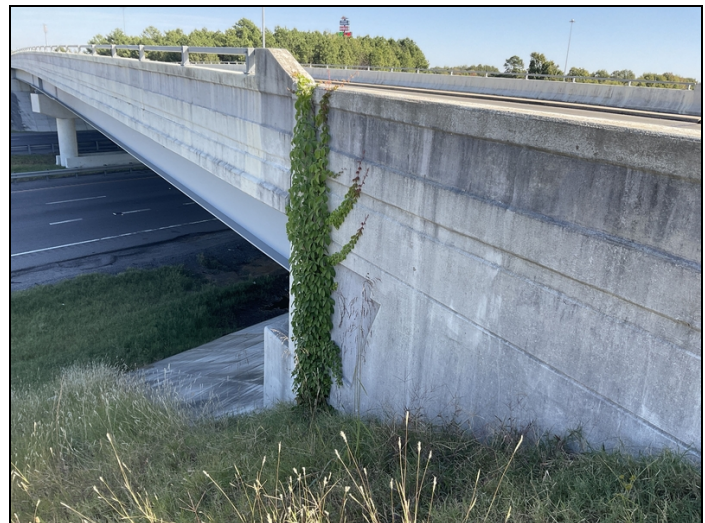
Vines growing up onto bridge abutment #2 right side.
