Bridge A6518 Inspection Report

National Bridge Inventory Data Sheet

Team Lead: Myron Futrell, Inspection Date: 04/07/2025

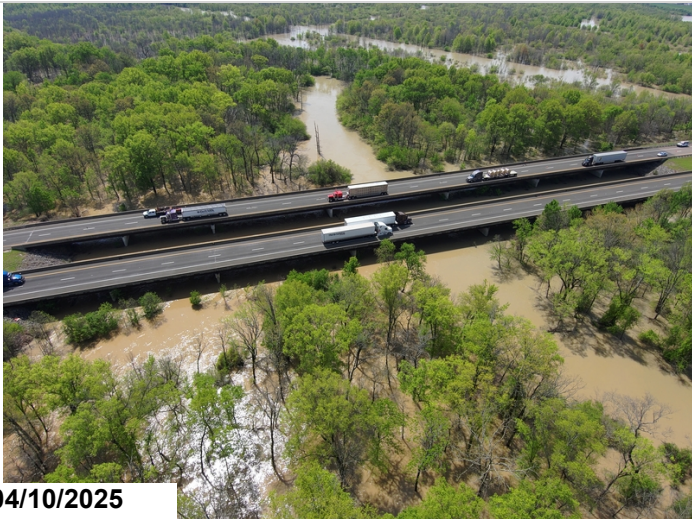
Side view / elevation

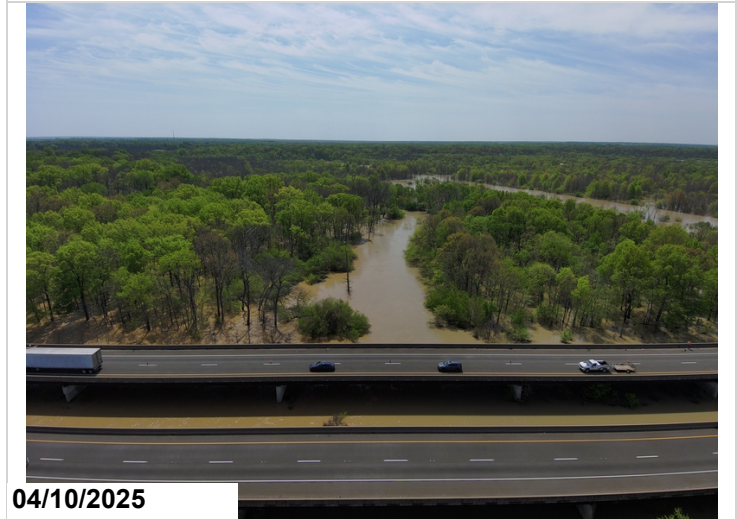
Channel, right side

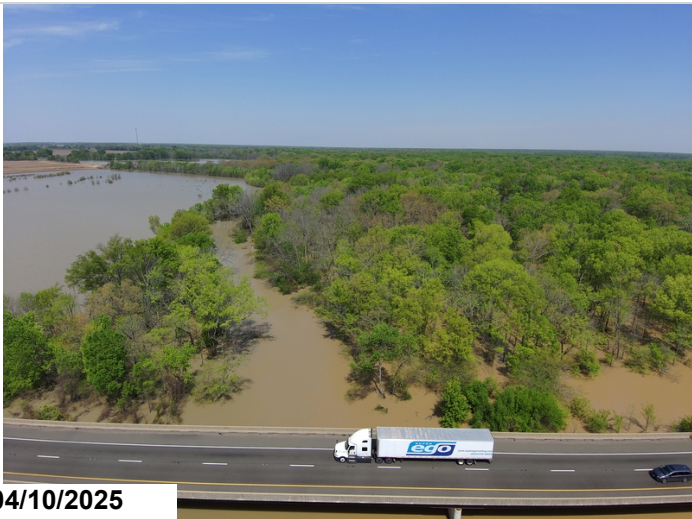
Channel, left side

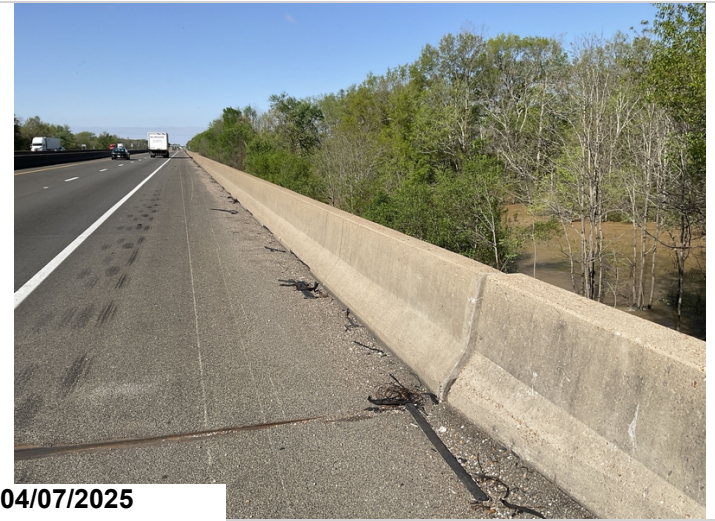
Minor cracking with light efflorescence and a few minor spalls.

Bridge rail, left side

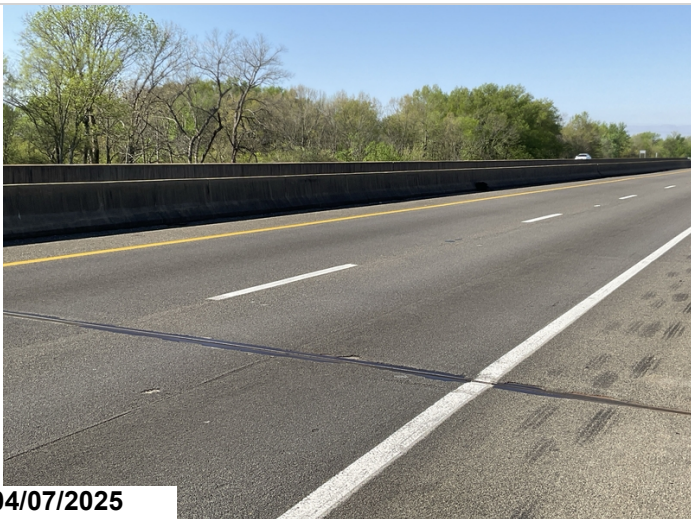
Bridge rail, right side

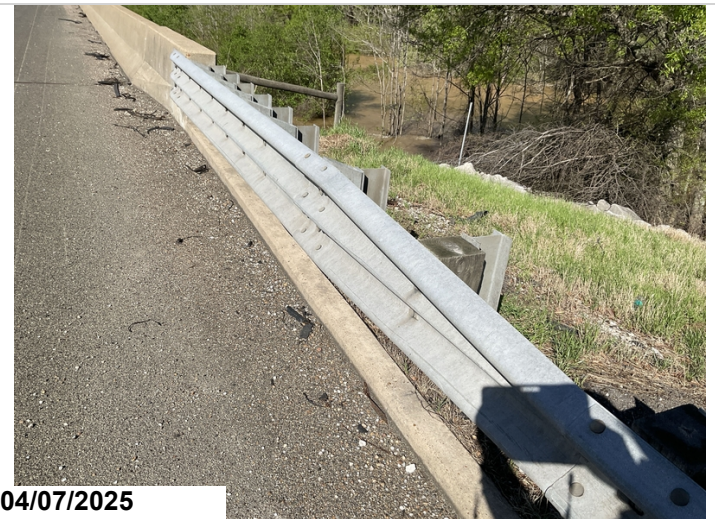
Abutment 2, left transition

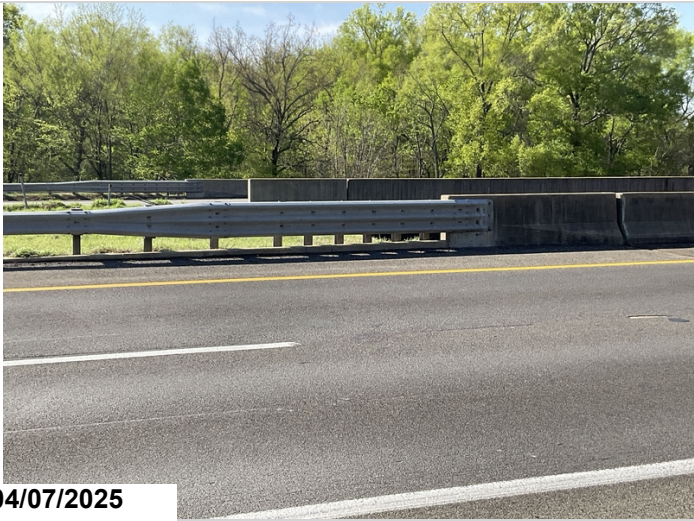
Abutment 2, right transition

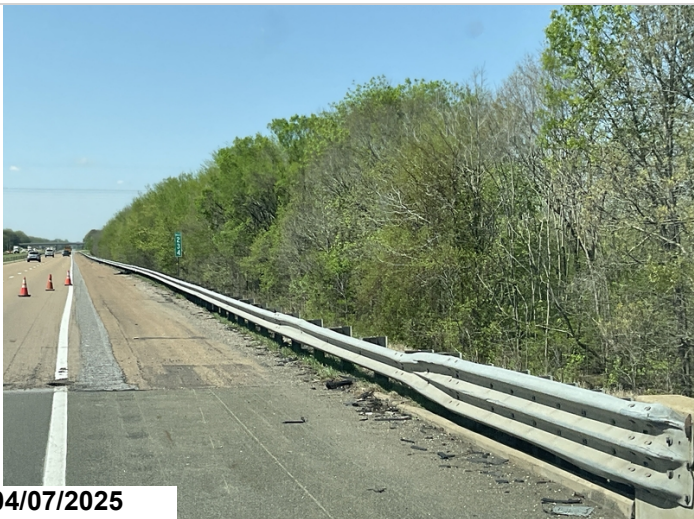
Abutment 1 left transition has very minor damage.

Abutment 1, transition and approach rail left side.

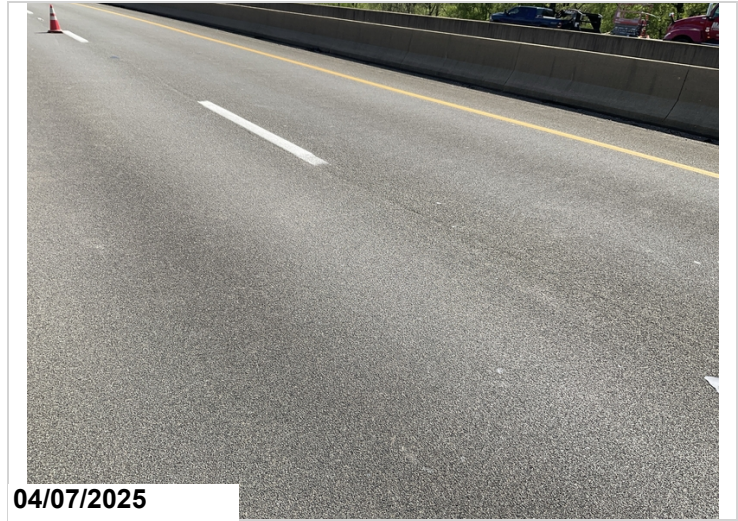
Reinforced concrete deck is in overall good condition. Deck has epoxy overlay and metal stay in place forms. Deck surface cracks have been sealed with epoxy overlay, undersurface of overhangs have transverse cracks with light to moderate efflorescence.

Typical deck.

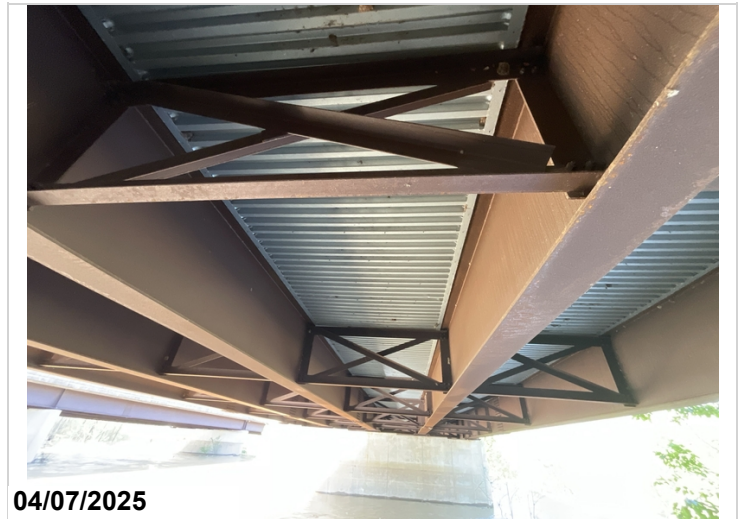
Typical undersurface of deck

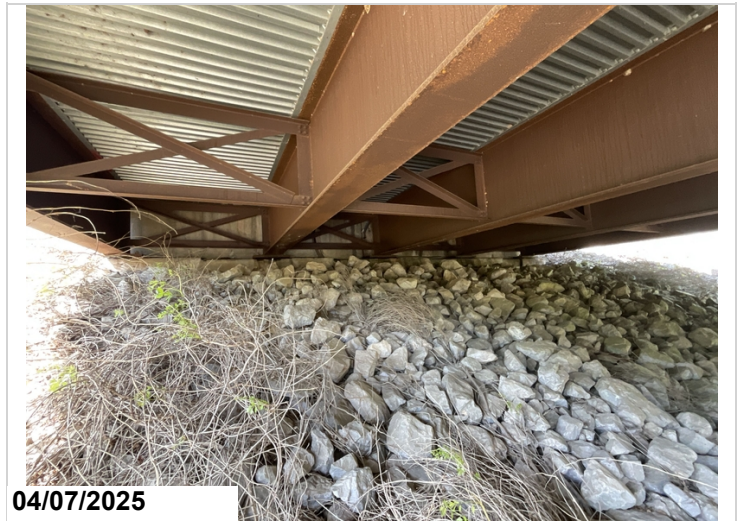
Abutment 1

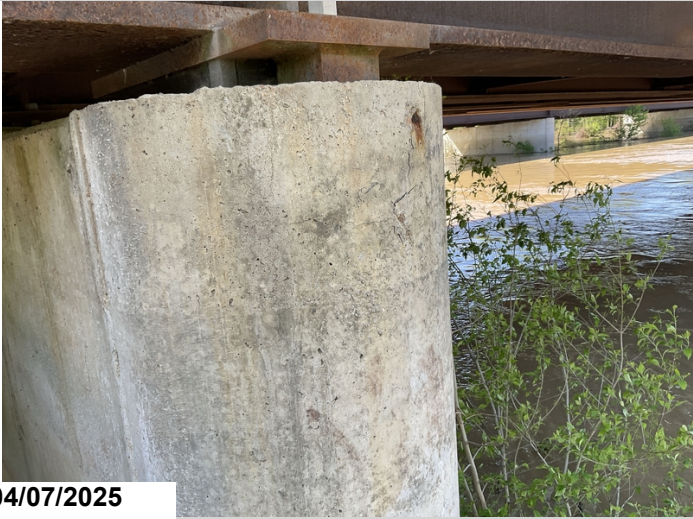
Bent 5, pier wall, left end: small, delaminated area with small piece of reinforcing steel exposed at top.

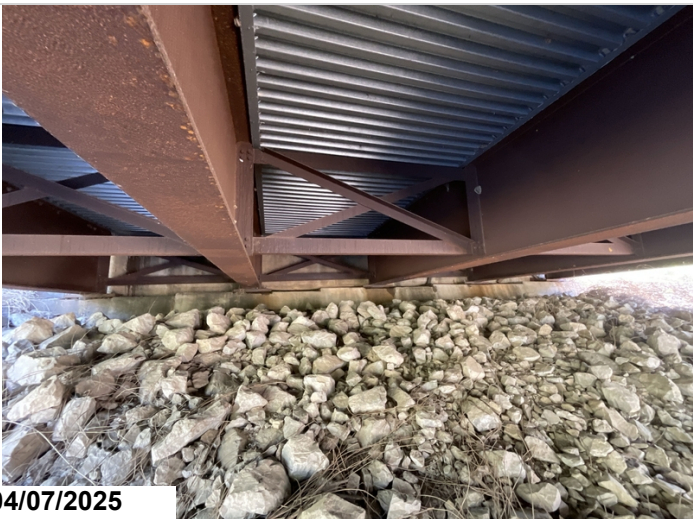
Abutment 2

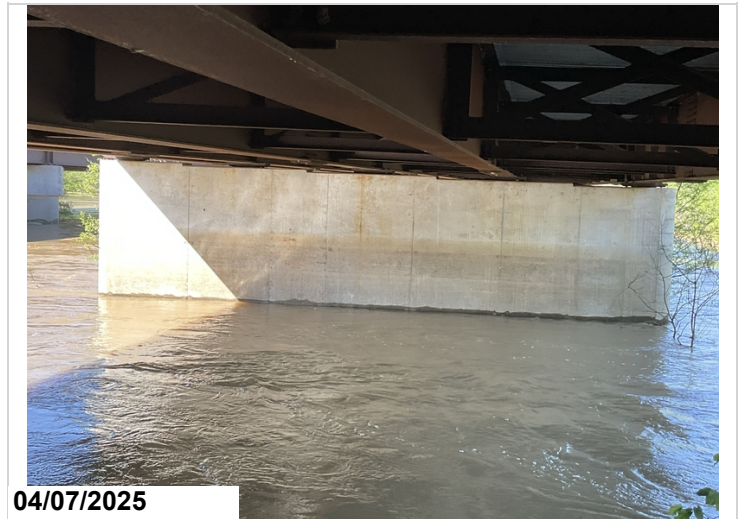
Typical intermediate bent

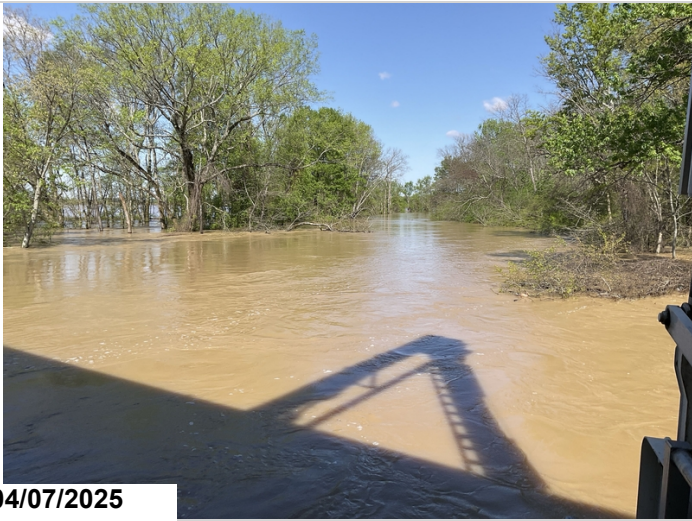
Channel is in overall fair condition. Channel alignment is good, and slopes are well vegetated. Trees and brush restrict flow slightly.

Channel, left side

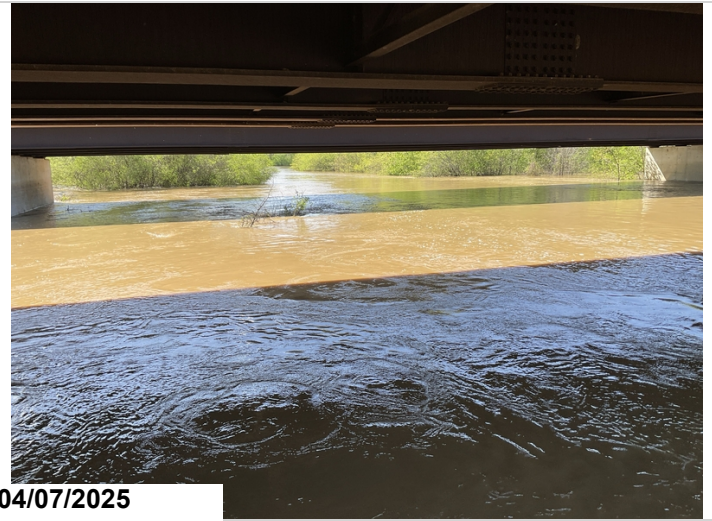
Channel, right side

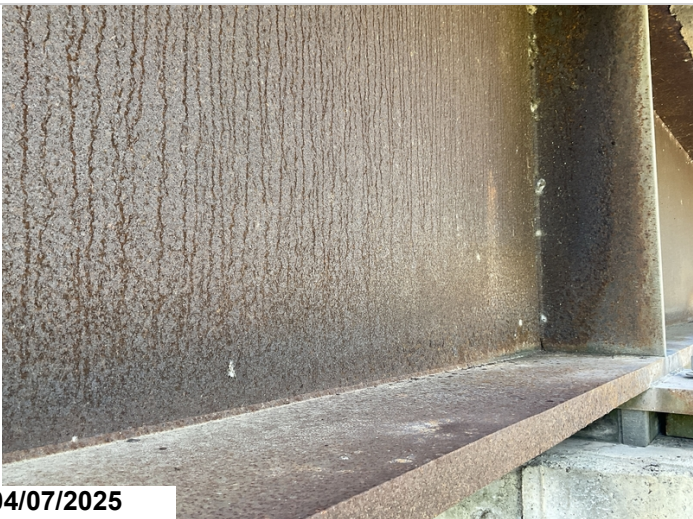
Span 5, girder 1, bent 5, first 3': minor scaling on outside web and bottom flange. Bottom of bottom flange also has minor scaling. Corrosion 3LF CS3

Span 5, girder 1, bent 5, first 3': minor scaling on outside web and bottom flange.

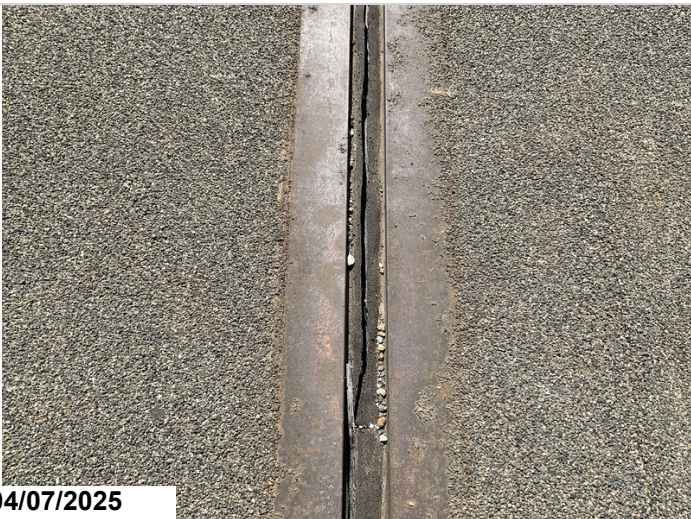
Pourable joint seals at abutments are split causing leakage.

Abutment 1, pourable joint seal: split full width, typical split.

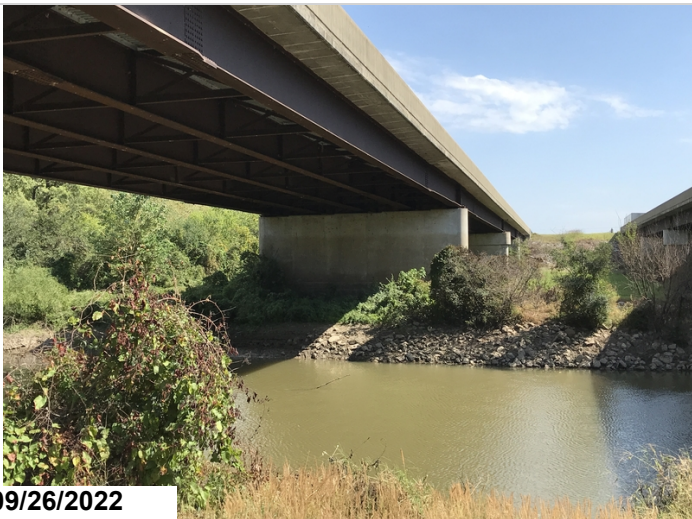
Bent 5: out of water at time of under water inspection

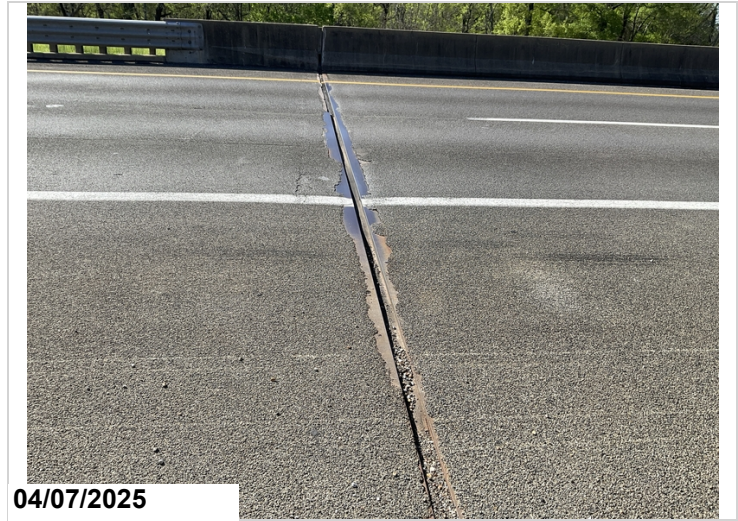
Abutment 2, pourable joint seal.

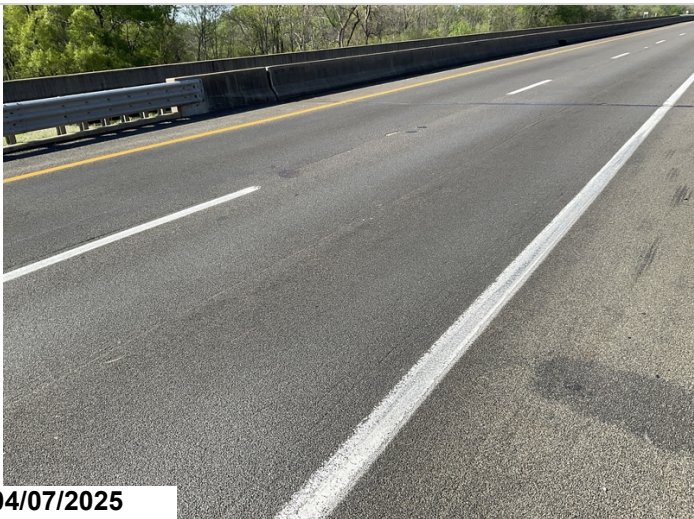
ELEMENTS	DESCRIPTION	UNITS	TOTAL	CS1	CS2	CS3	CS4
Abutment 2, approach slab, wearing surface: 1' spalled off at centerline and a small spall in left lane. Wearing surface Spall 2SF CS2							
331	Reinforced Concrete Bridge Railing	LF	1584	1186	398	0	0
1080	Delamination/Spall/Patched Area	LF	2	0	2	0	0
1120	Efflorescence/Rust Staining	LF	396	0	396	0	0
(331) Reinforced concrete bridge rails: vertical cracks with light efflorescence. Right bridge rail cracked spaced approximately 3' and approximately 60LF longitudinal cracking near top with light efflorescence. Efflorescence 456LF CS2 Reinforced concrete bridge rails, span 2, left side: two 1' shallow spalls no reinforcing steel exposed due to collision mid span. Spall 2LF CS2

Abutment 2, approach slab

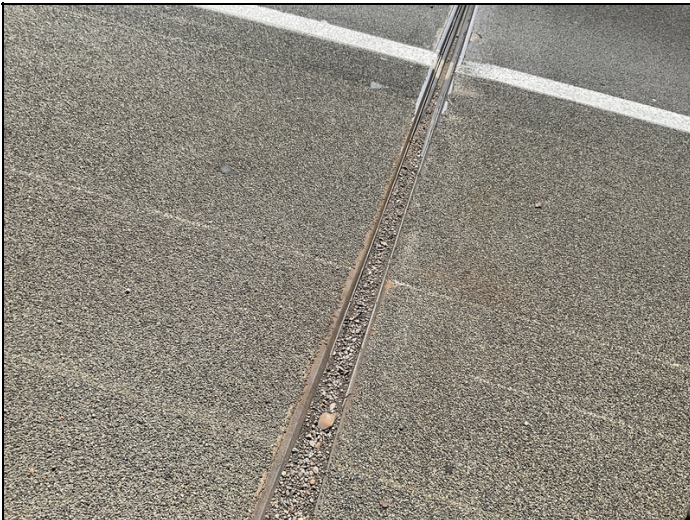
Seals have debris in them in gutters.

Typical dirt and debris in joint.

A-56 - Joint Cleaning/Flushing Needed (Yes)

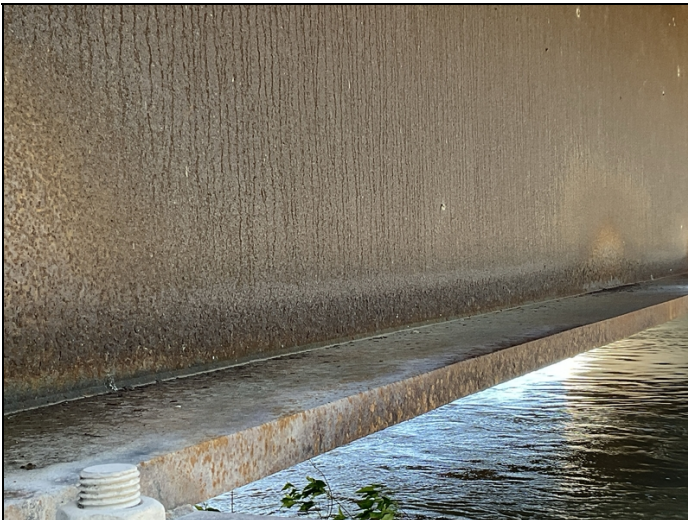
Span 4, girder 1, bent 5 last 10': minor scaling on outside web and bottom flange. Bottom of bottom flange also has minor scaling. Corrosion 10LF CS3

Span 4, girder 1, bent 5 last 10': minor scaling on outside web and bottom flange.

A-57 - Girder End and Bearing Painting Needed (Yes)

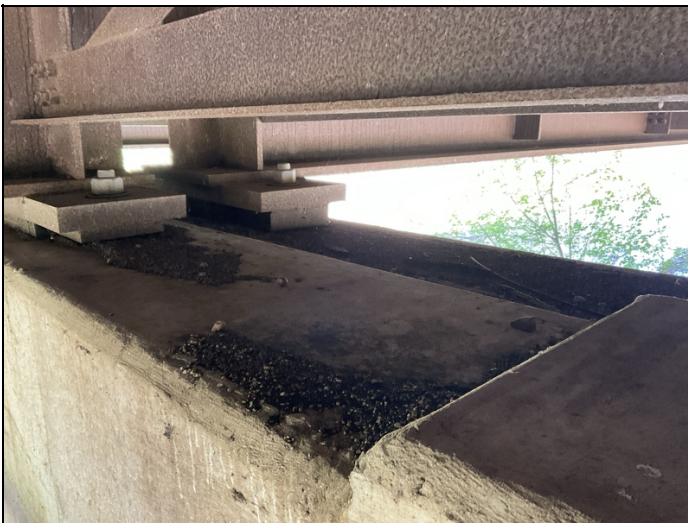
Bent 3 and abutments, pier caps: dirt and debris on caps.

Typical dirt and debris on bent 3 pier cap.

A-58 - Cap Cleaning/Flushing Needed (Yes)
