## Bridge B3724 Inspection Report

| IDENTIFICATION | |
|---|---|
| (7) Facility Carried | I-40EB/Se43/209.29 |

| INSPECTIONS * | | | |
|---|---|---|---|
| (90) Inspection Date | 06/05/2025 | | |

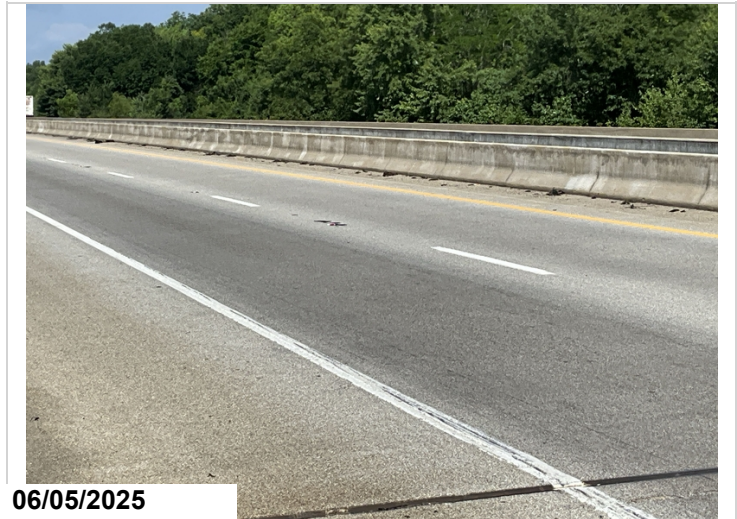
Deck is in good condition with deck surface having an epoxy overlay. Undersurface overhangs have transverse hairline cracks, some with light efflorescence. Some stay in place forms are rusted through.

Typical deck

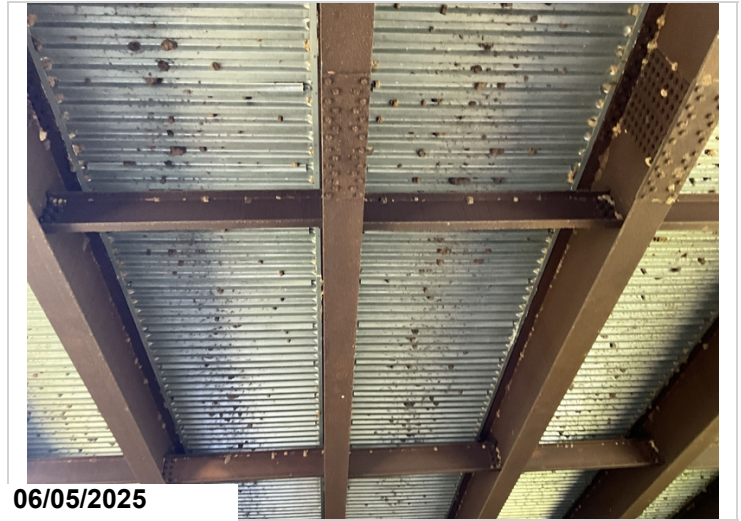
Typical undersurface

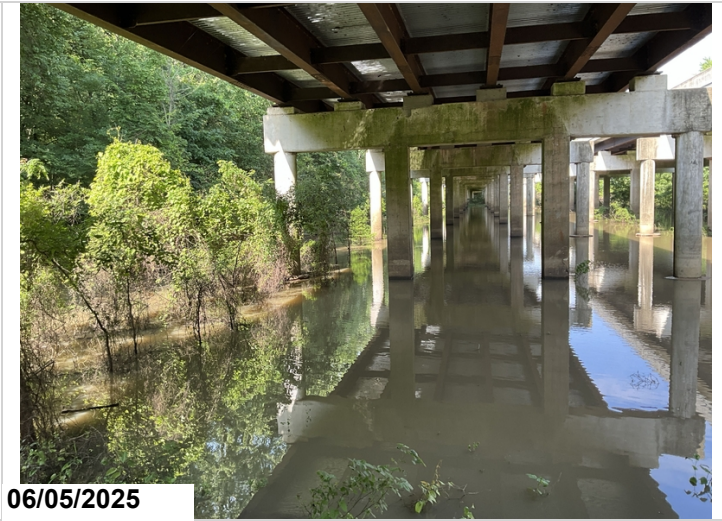
Channel has good alignment and is in fair condition. An over abundance of trees and vegetation growing under and beside bridge restriction channel flow rate.

Channel under structure

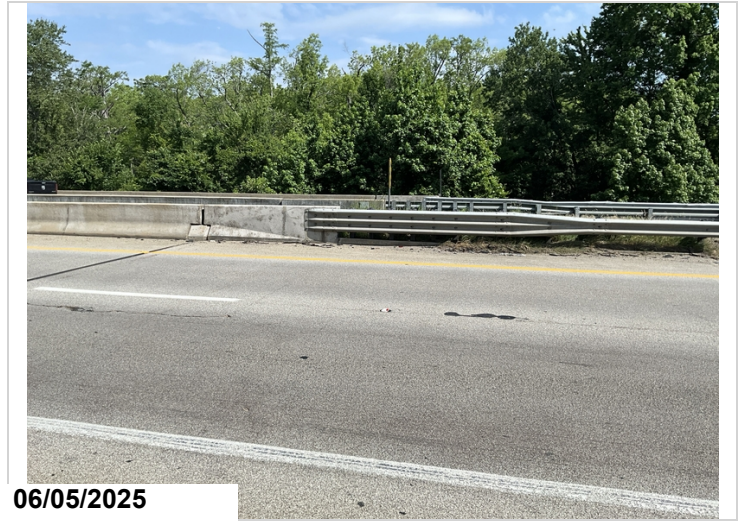
Bridge railing transitions are in very good condition with no note worthy defects.

Typical approach rail transition

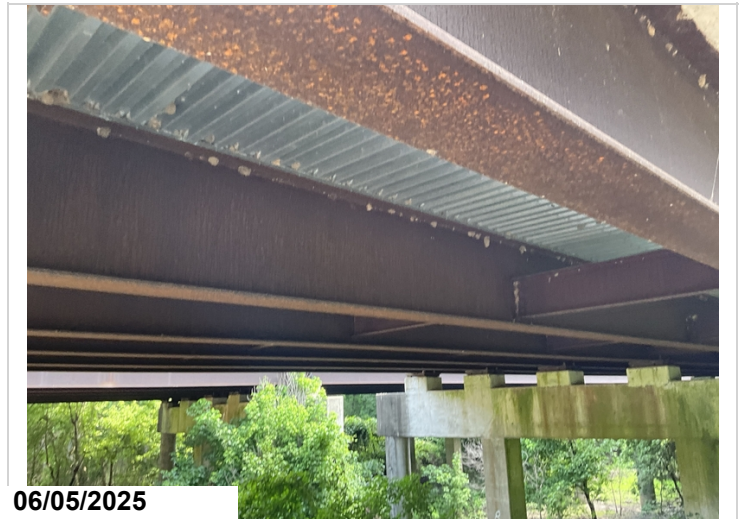
Typical girder condition

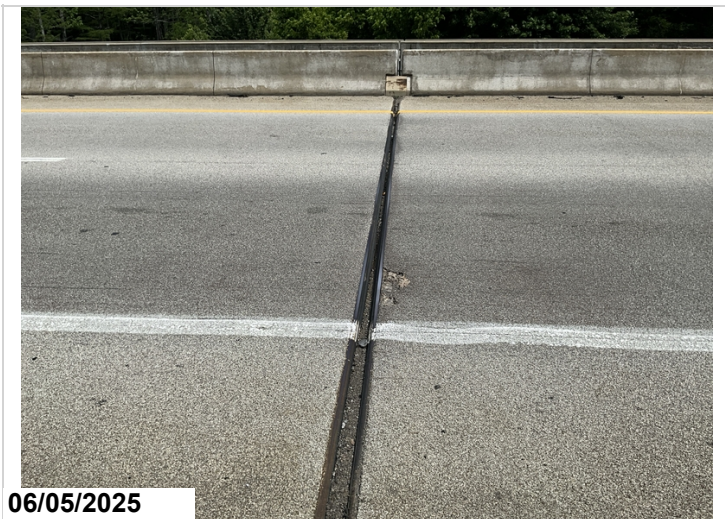
Joint Trough, Bent 8, Right: Last 3' failed.

Joint bent 8

### A-59 - Joint Repair Needed (Y)

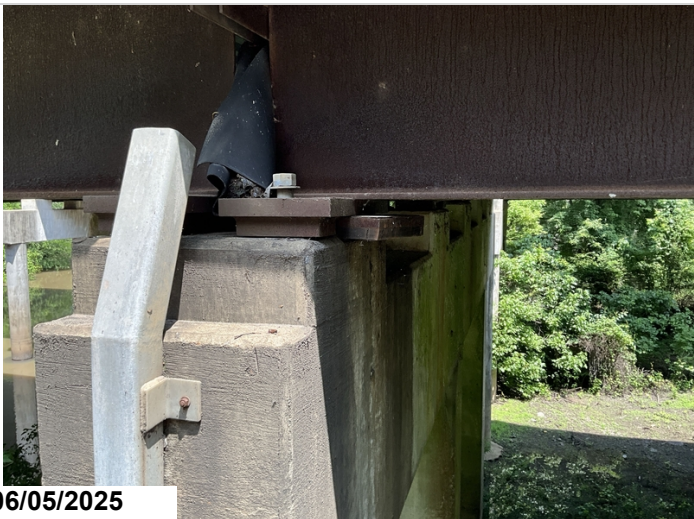
Bridge bearings are in fair condition with a few bears out of place and one close to coming completely out.

Span 8, Bent 8, Bearing 6: Bearing pad has sild half way out from under girder.

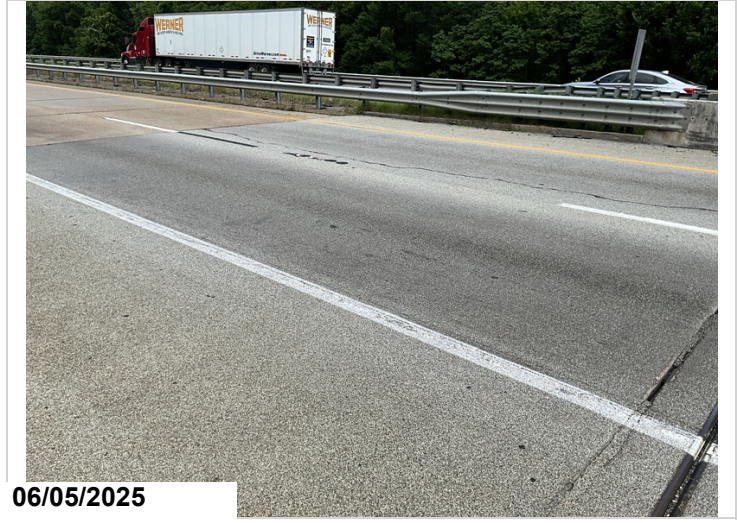
Abutment 1, Approach Slab, Left Lane: Full length longitudinal crack reflecting through overlay.

Abutment 1 approach slab

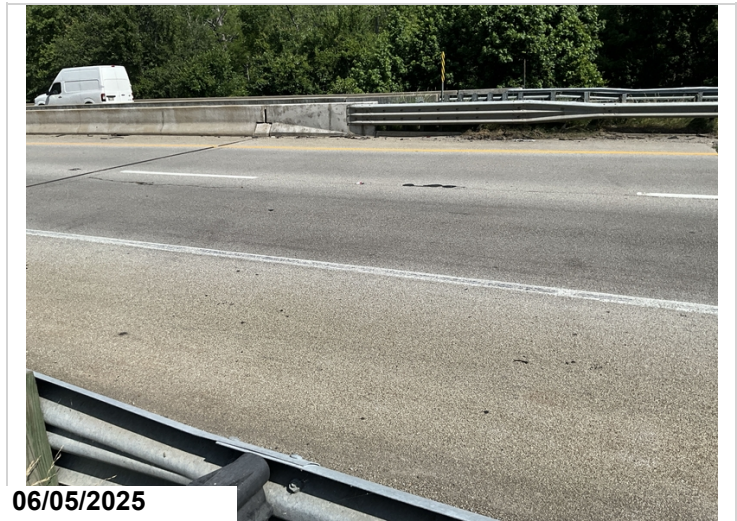
Abutment 2, Approach Slab: Several cracks reflecting through the epoxy coating.

Abutment 2 approach slab

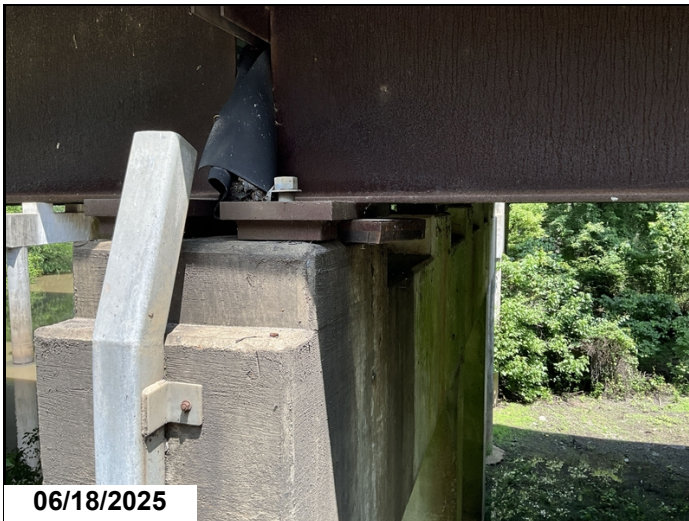
Span 8, Bent 8, Bearing 6: Bearing pad has sild half way out from under girder.

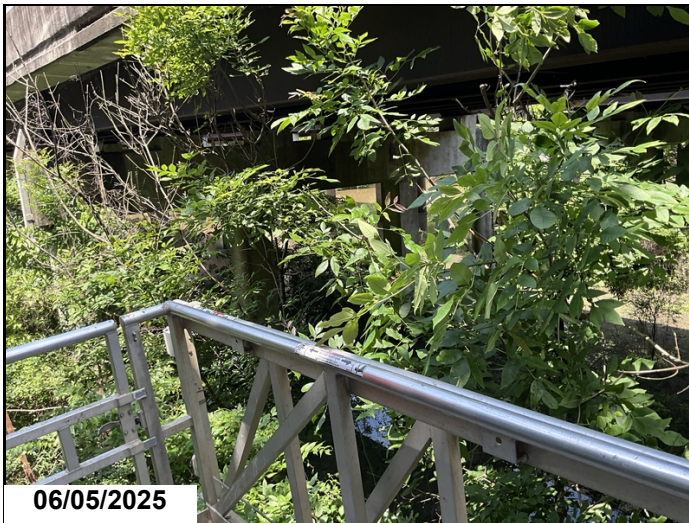
Over abundance of trees and vegetation is growing under and beside bridge hindering access for bridge inspection.

Vegetation

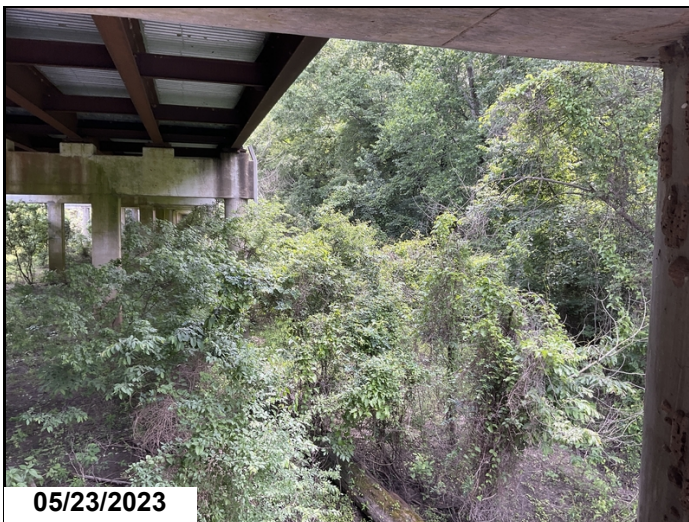
Trees and vegetation growing beside and under bridge

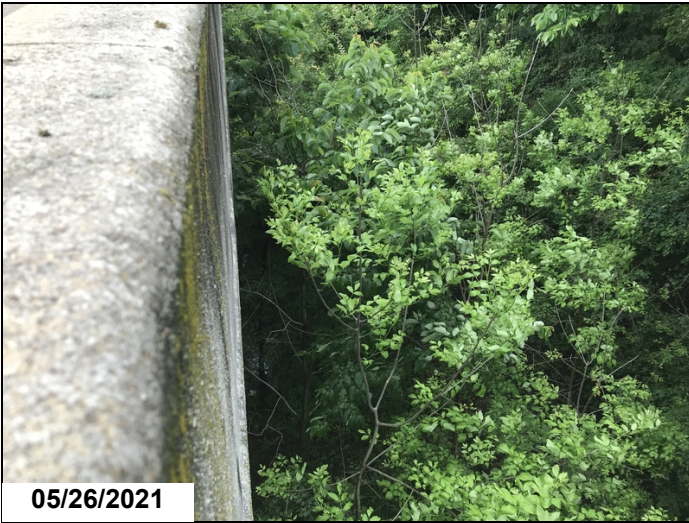
Typical vegetation hindering inspection access.

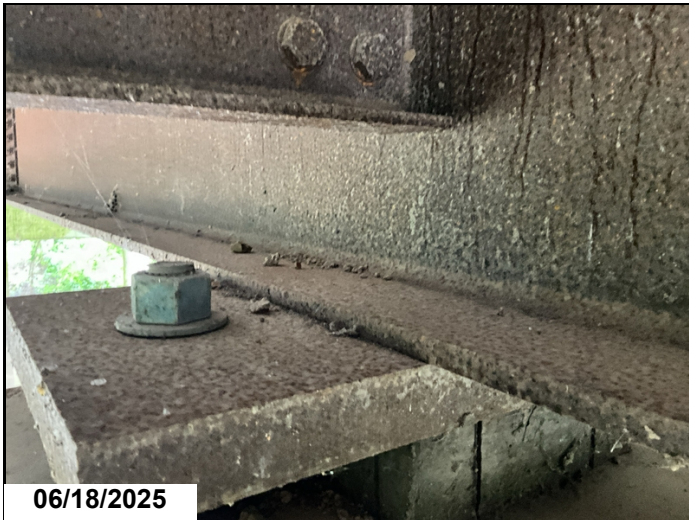
Bent 20, Girder 4, Girder To Soul Plate Weld: Not welded.  
Bent 20, Girder 5, Girder To Soul Plate Weld: Not welded.

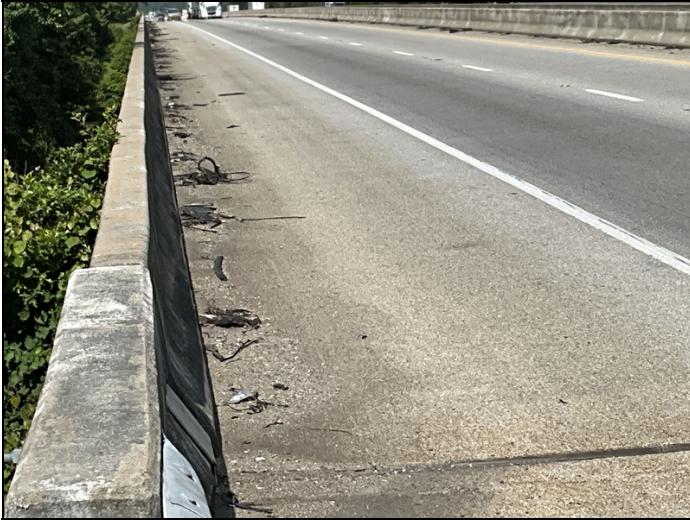
Deck Gutters, Full Length: Dirt and debris.

Typical debris in gutters

**A-55 - Deck Washing Needed (Yes)**

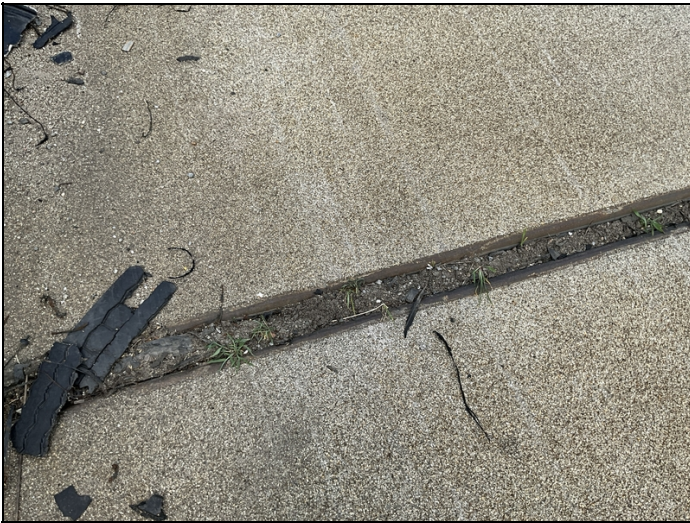
Joints, In Gutters: Debris impaction.

Typical debris in joints

**A-56 - Joint Cleaning/Flushing Needed (Yes)**
