Bridge 05223 Inspection Report

Route:42 Section:03 Log:8.25

Team Lead: Drew Melton, Inspection Date: 10/07/2024

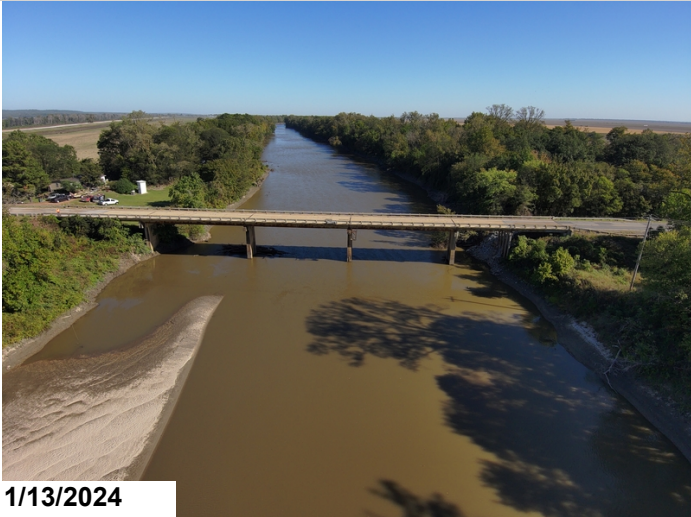
Side view-elevation aerial

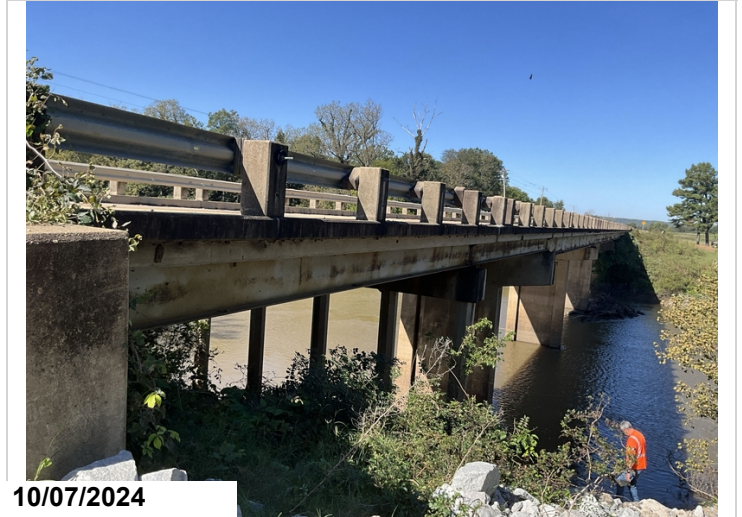
Side view-elevation

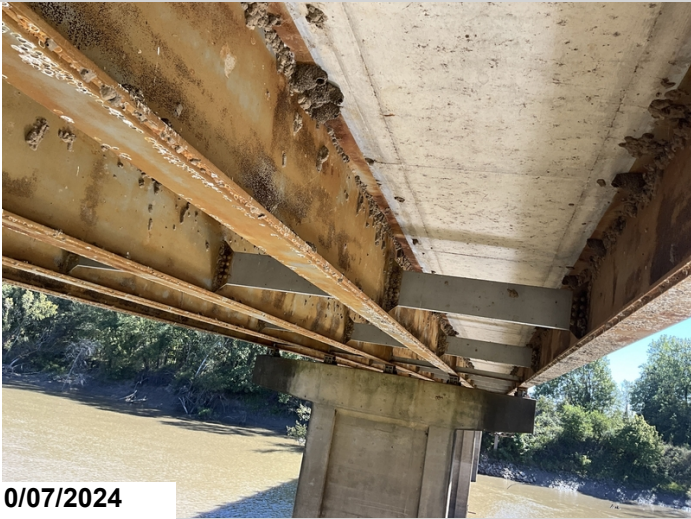
Typical deck undersurface over water

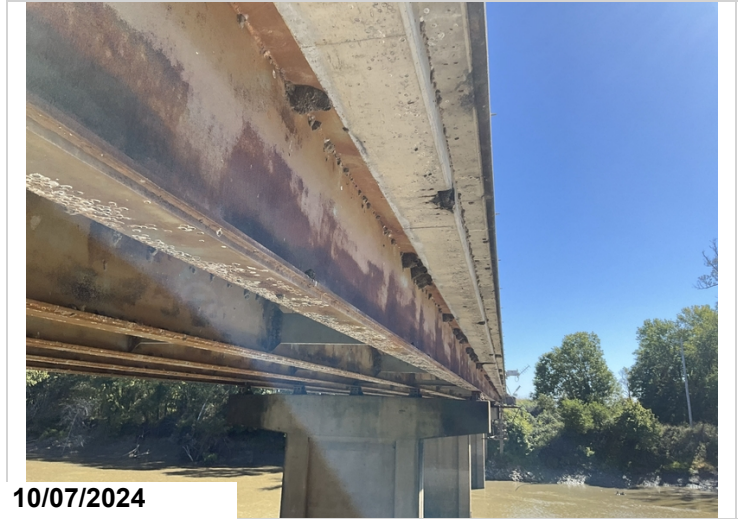
Typical deck undersurface over water

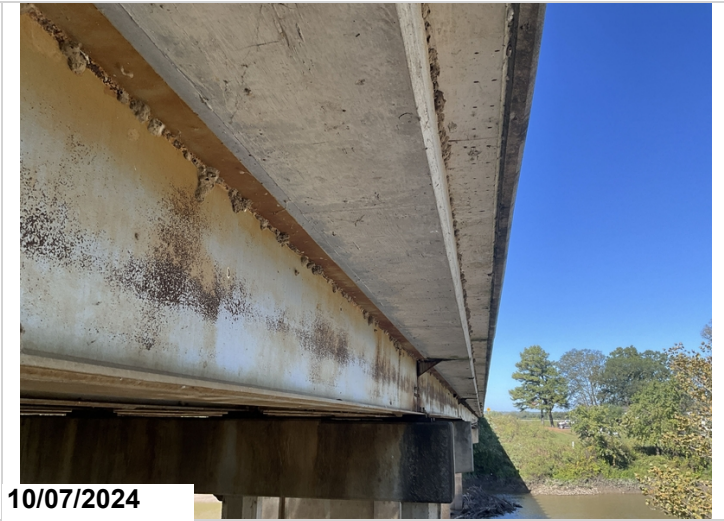
Typical deck undersurface overhang

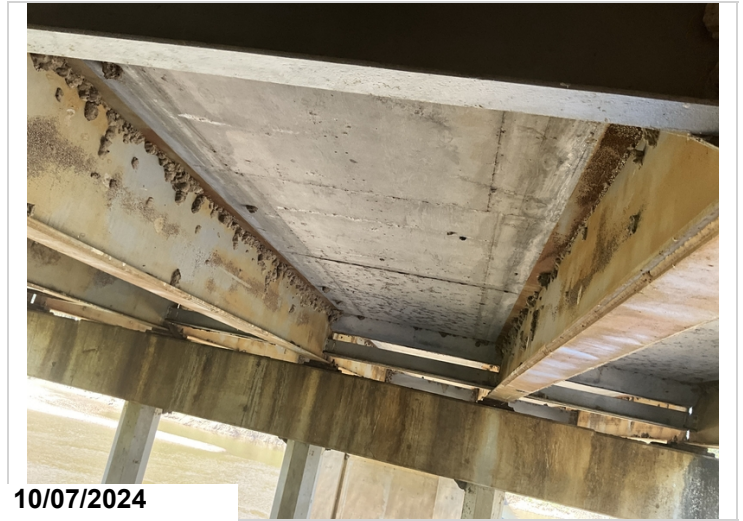
Typical deck undersurface

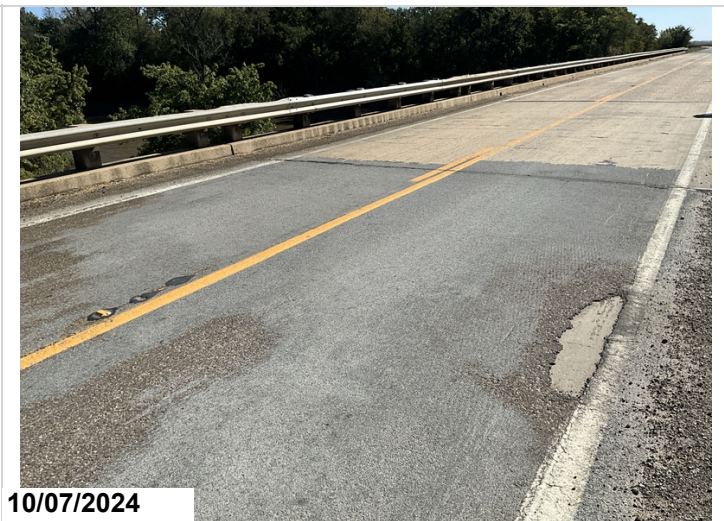
Typical deck surface

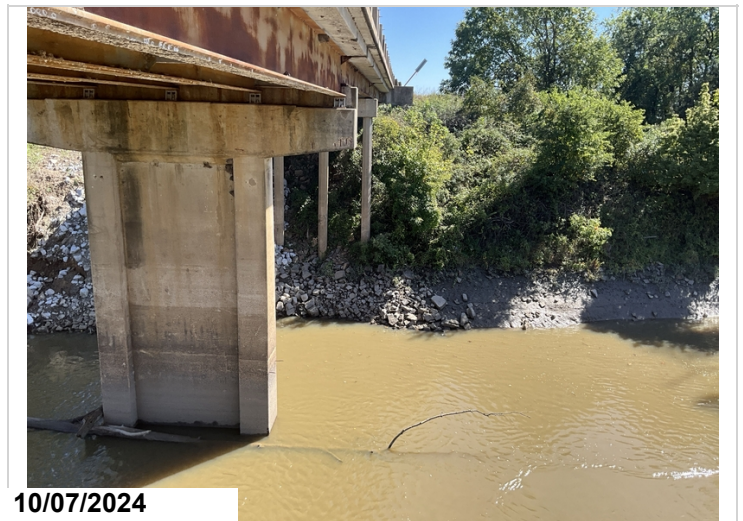
Abutment 2 slope right side

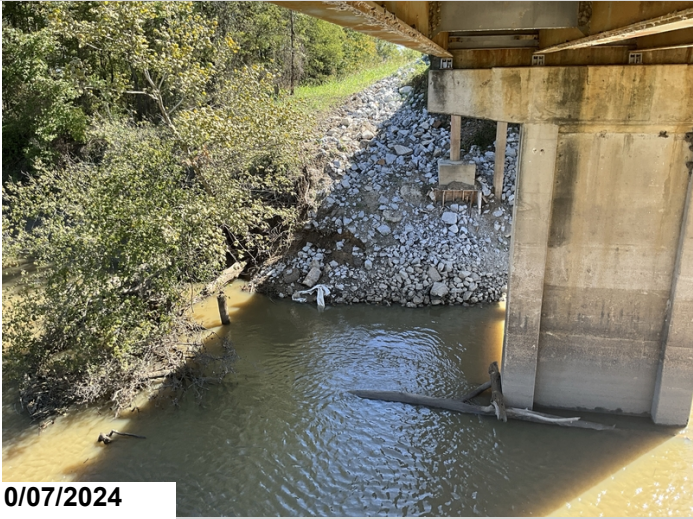
Abutment 2 slope left side

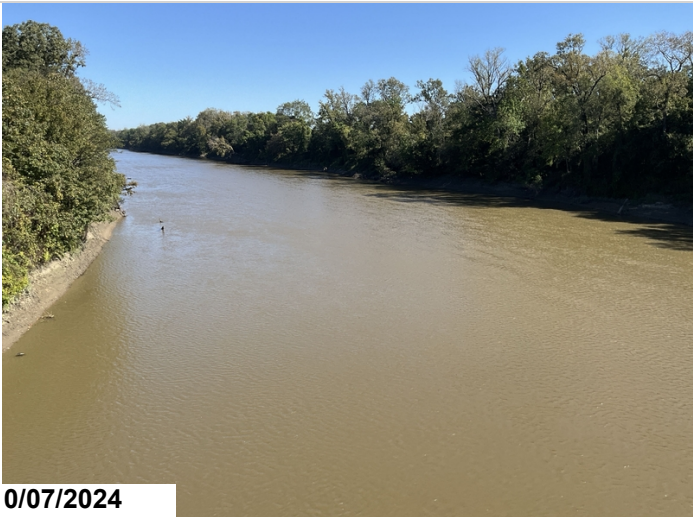
Channel left

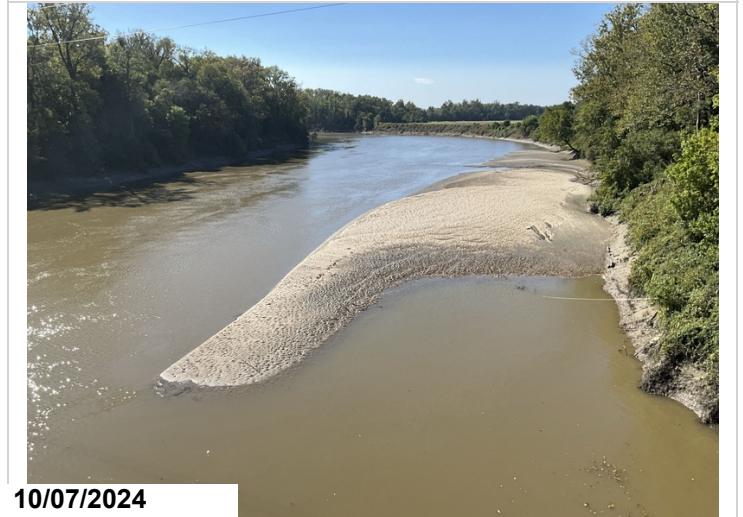
Channel right

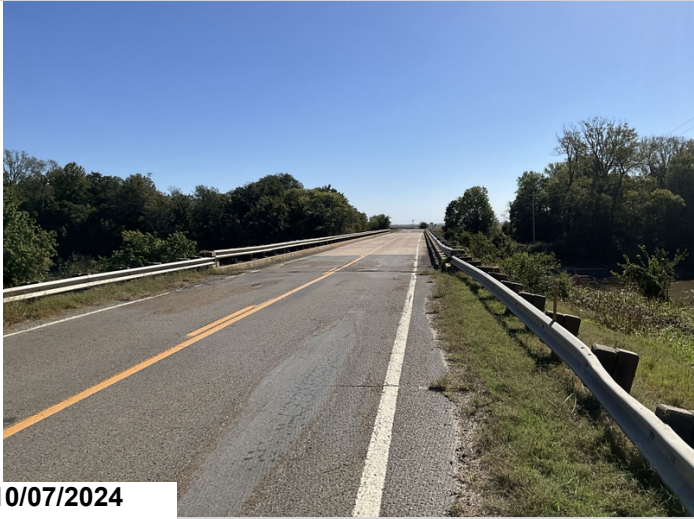
Top view-Inventory

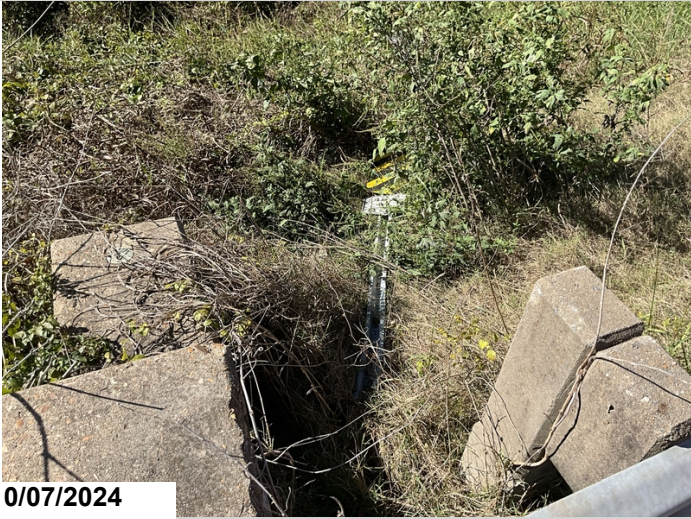
Abutment 1 log mile sign laying down

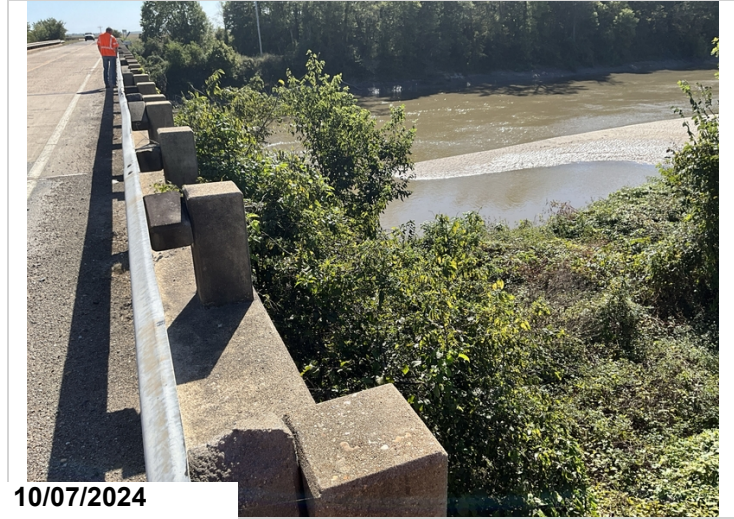
Typical vegetation

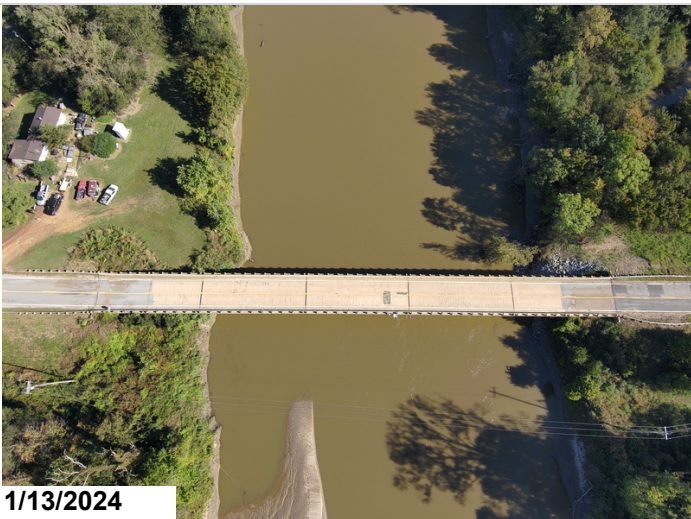
Deck view aerial

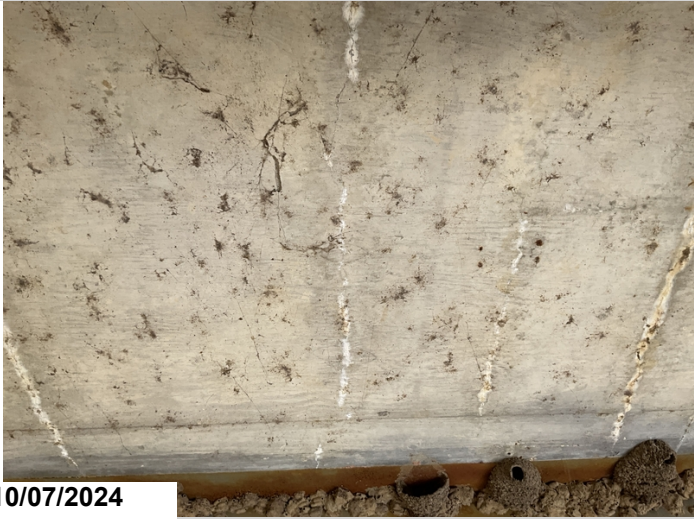
Span 5, Deck Undersurface, Bay 4, 1/4 Span: 1' delamination.

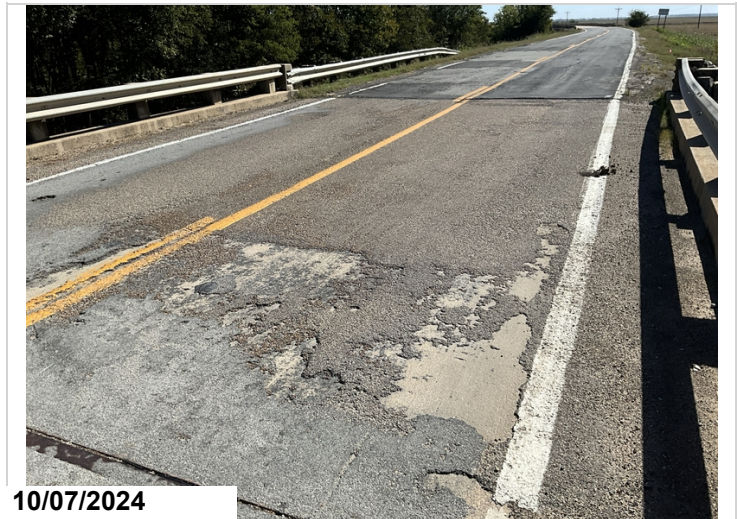
Span 7 deck

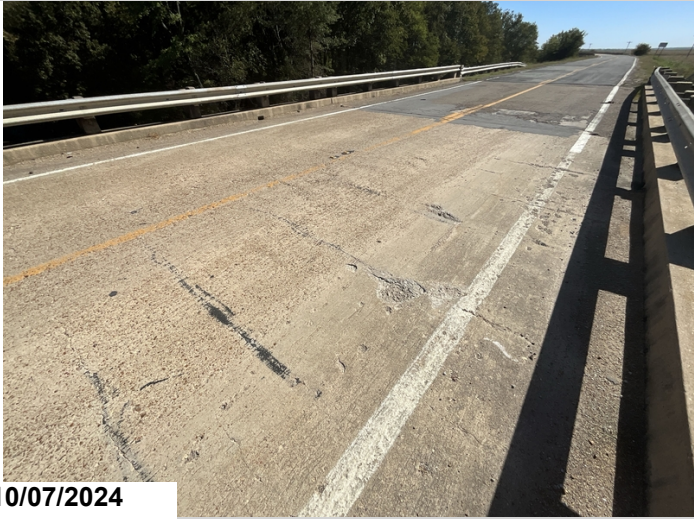
Span 6 deck

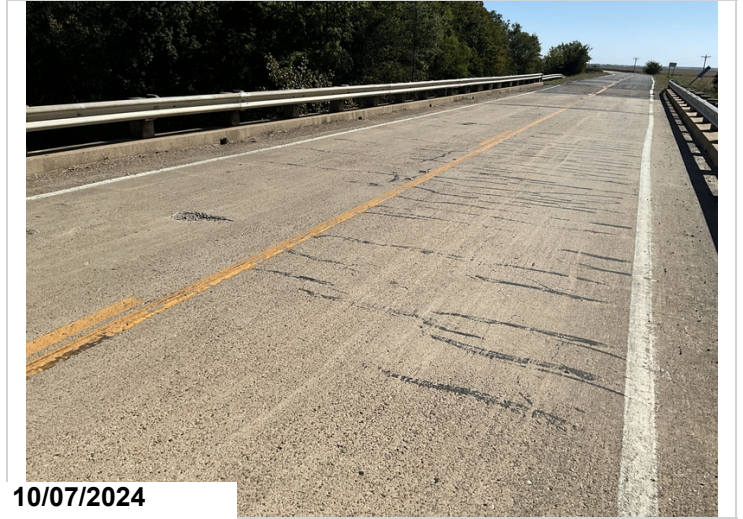
Span 5 deck

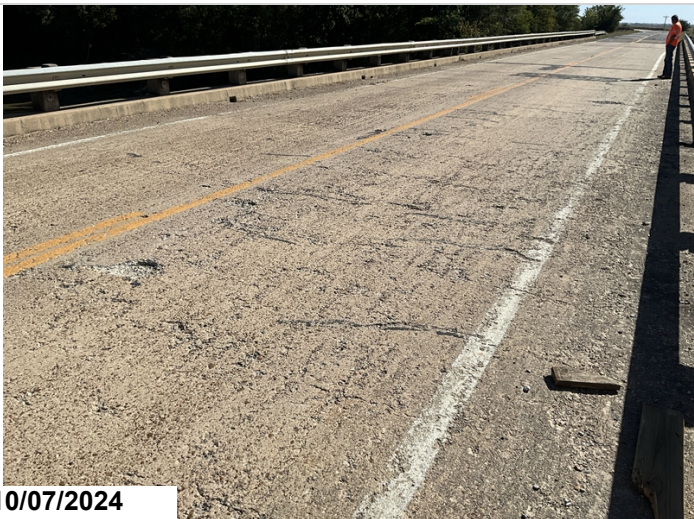
Span 4 deck

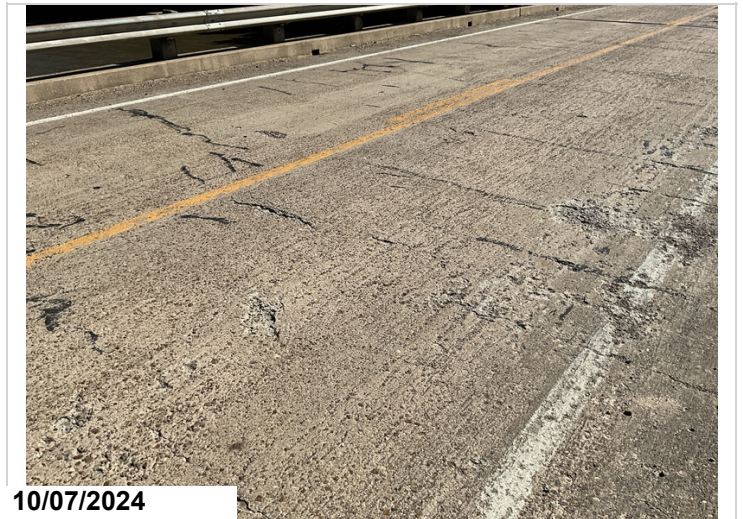
Span 3 deck center

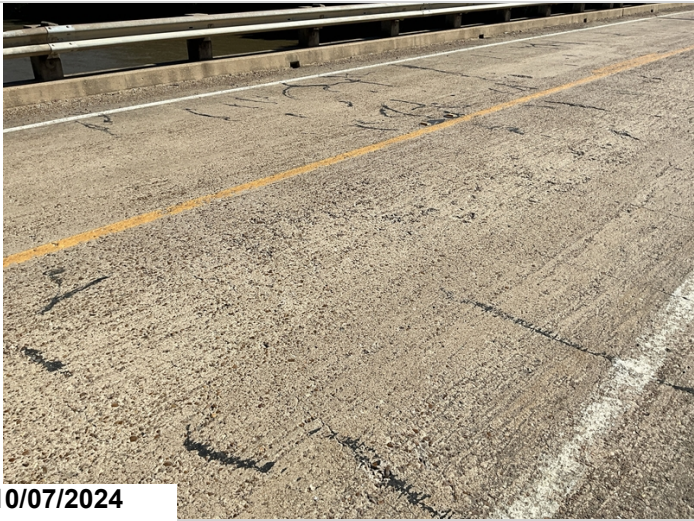
Typical deck abrasion

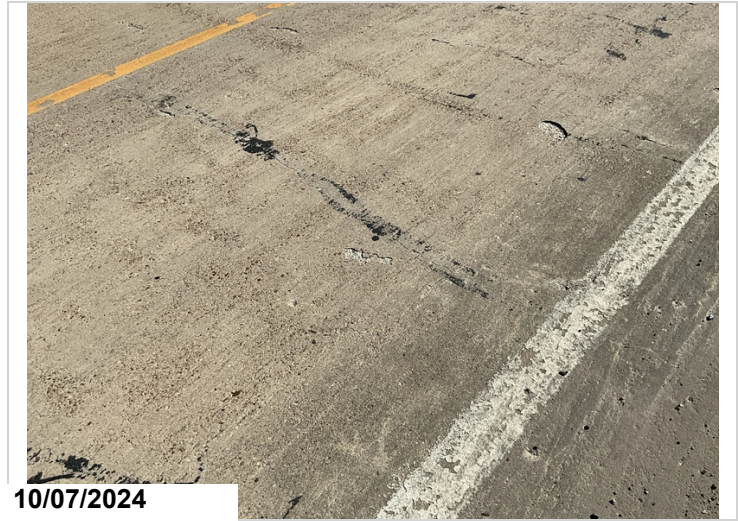
Deck Surface, Full Length: Transverse cracks some are sealed and spaced 2' apart.

Typical deck crack

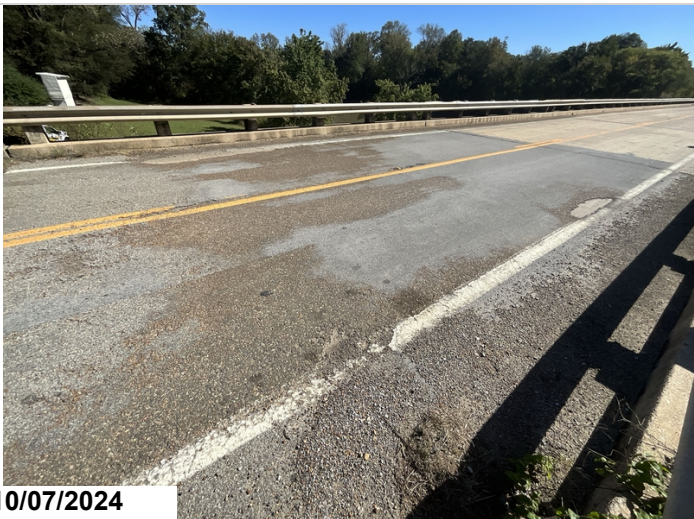
Span 1 deck

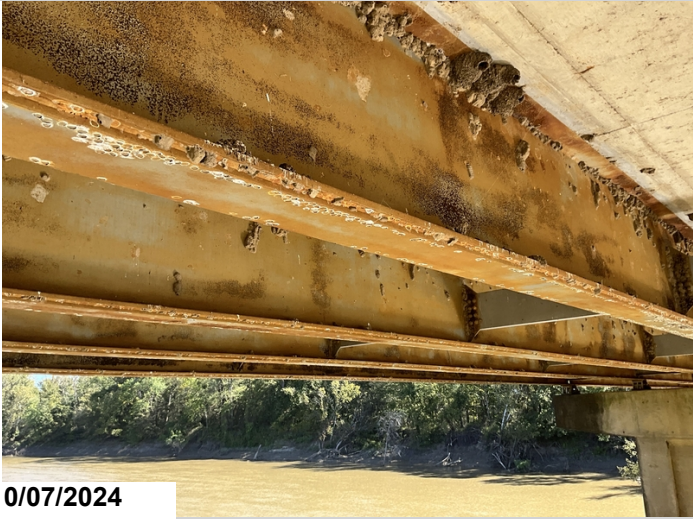
Typical girders over water

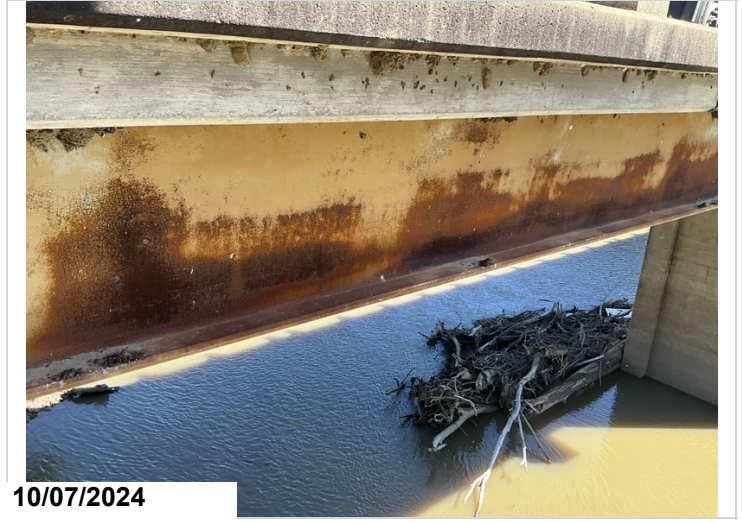
Typical outside girder over water

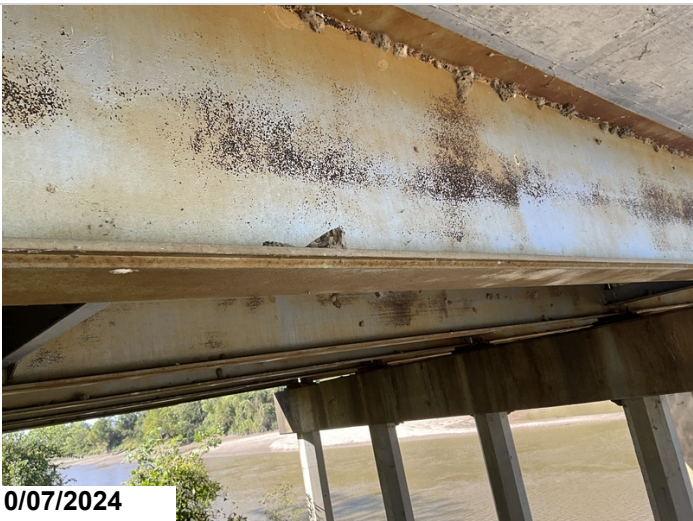
Girders, All Spans, Full Length: Rusty with 25% bare steel 50% rust bleeding through paint. Rest of paint is chalky and has loss of color pigment.

Typical girder condition

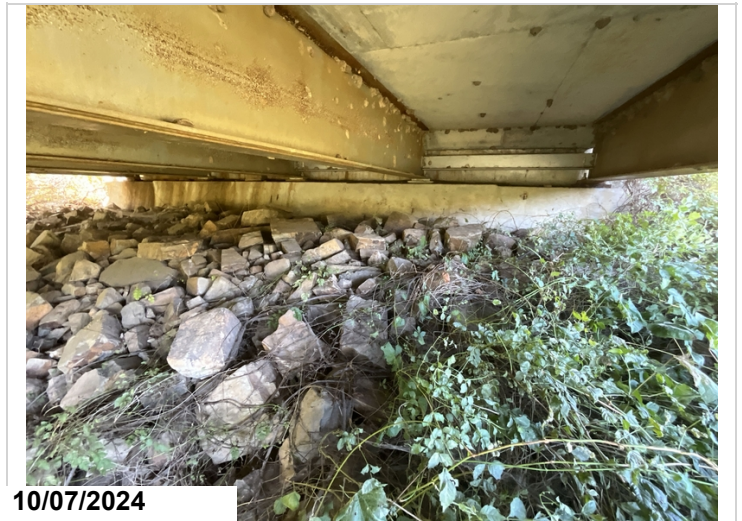
Abutment 1

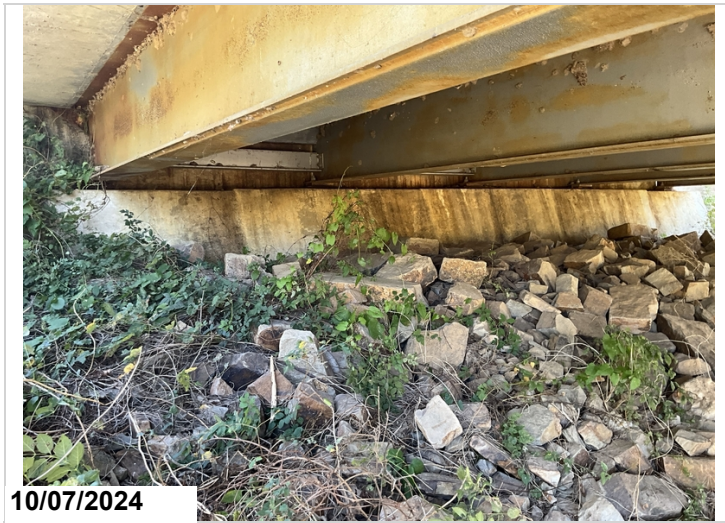
Abutment 2

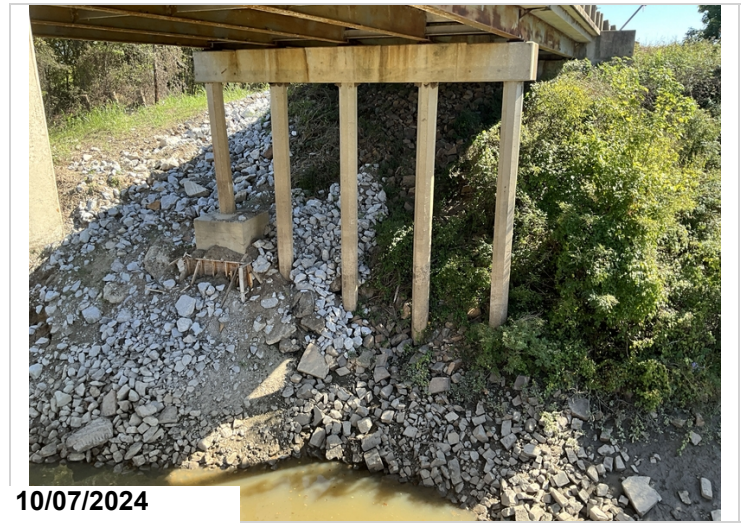
Bent 7

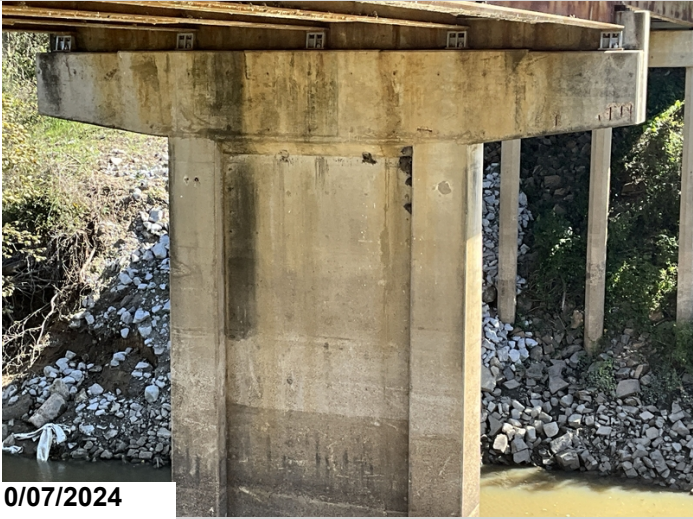
Bent 6, Cap, Back: 2' of exposed reinforcing steel due to poor concrete coverage. Reinforcing steel has moderate section loss.

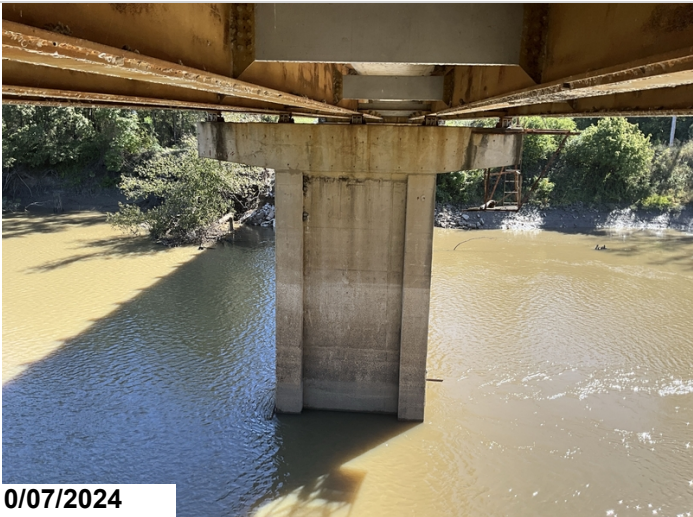
Bent 5, Cap, Back: 2' of exposed reinforcing steel due to poor concrete coverage. Reinforcing steel has moderate section loss.

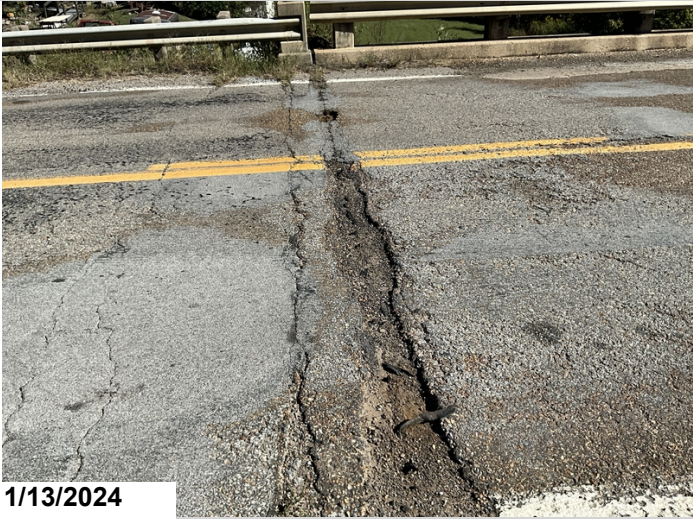
All Joint Seals: Cracked, broken and deteriorated.

Abutment 1 joint

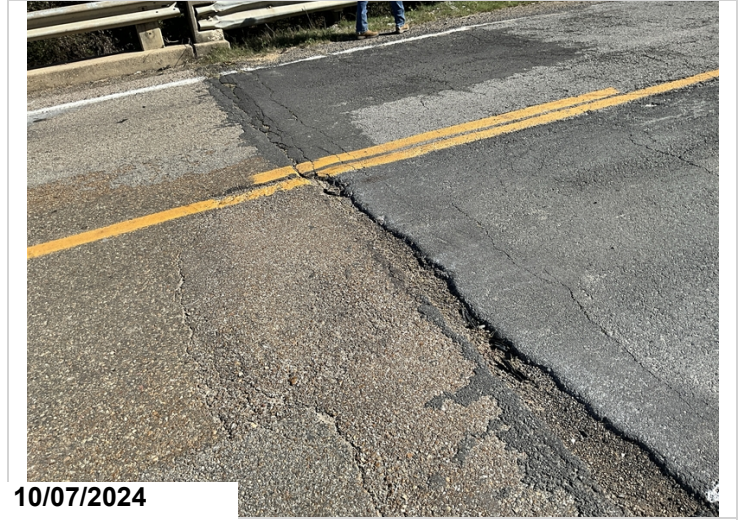
Abutment 2 joint

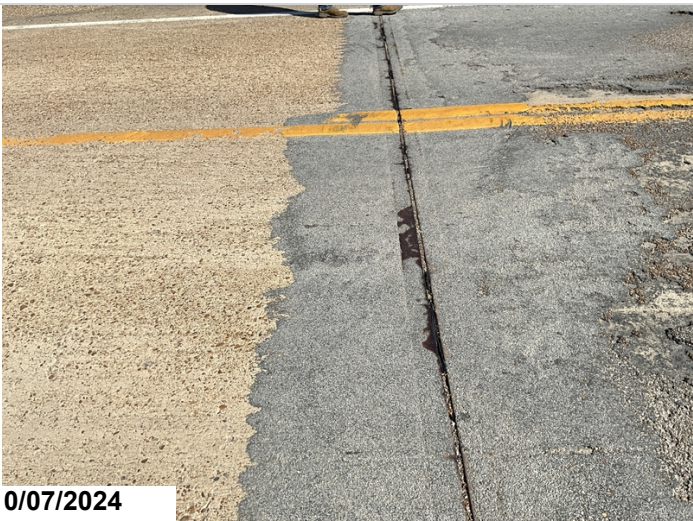
Bent 7 joint

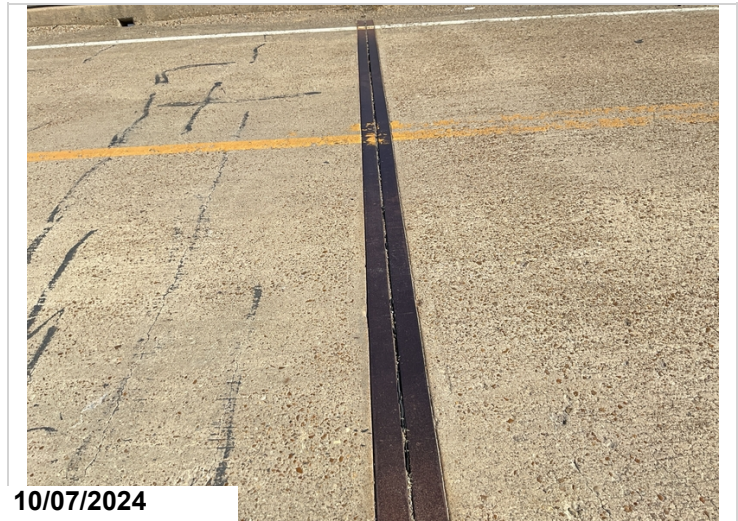
Bent 6 joint

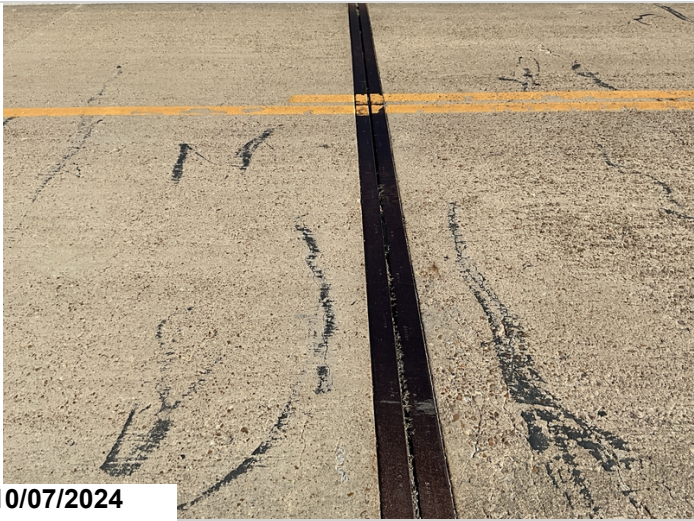
Bent 3 joint

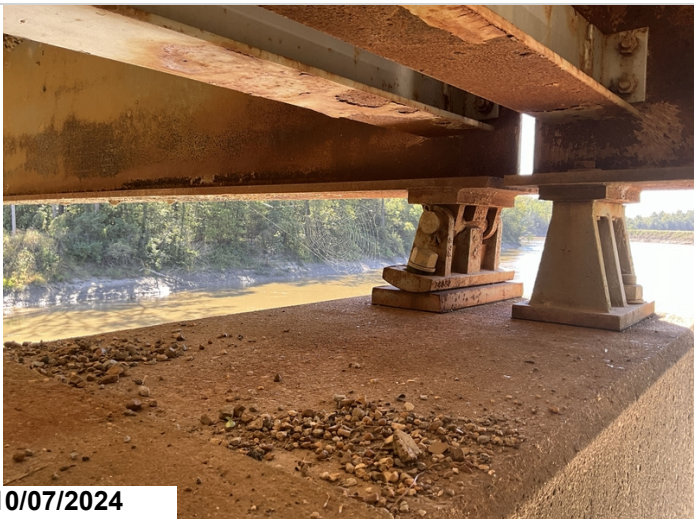
Bent 2 joint

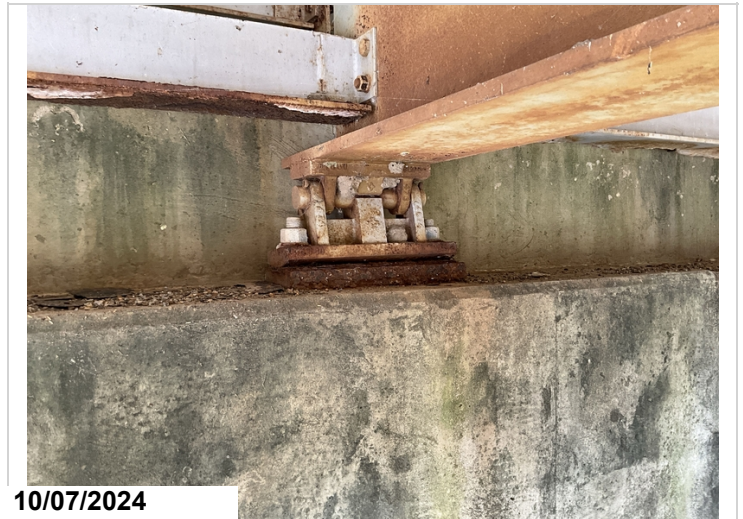
Bent 4, Span 4, Bearing 1: Rocked back 15 degrees.

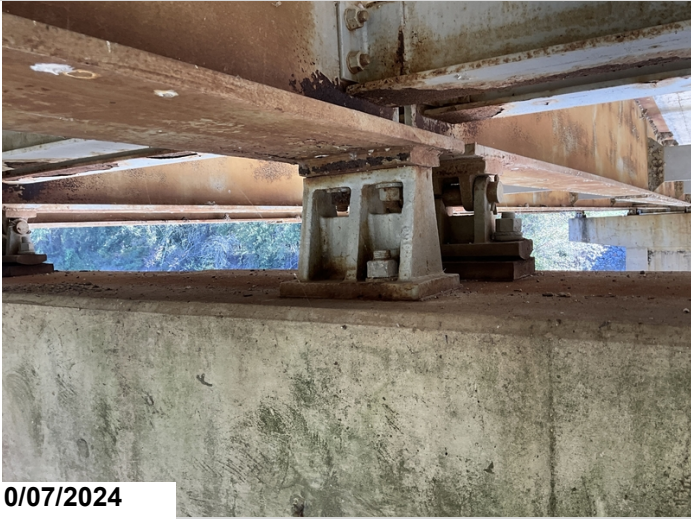
Typical movable bearing

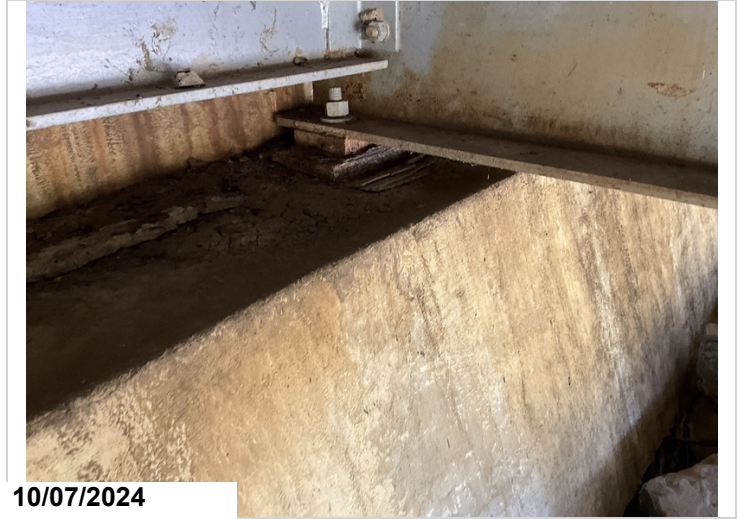
Typical fixed bearing

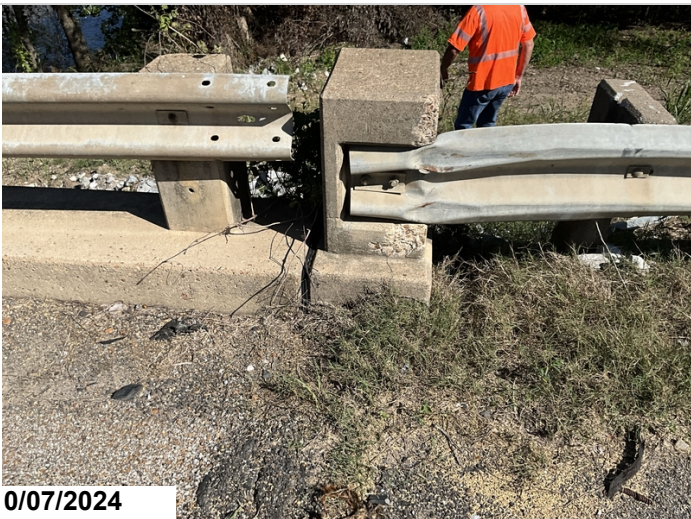
Typical abutment bearing

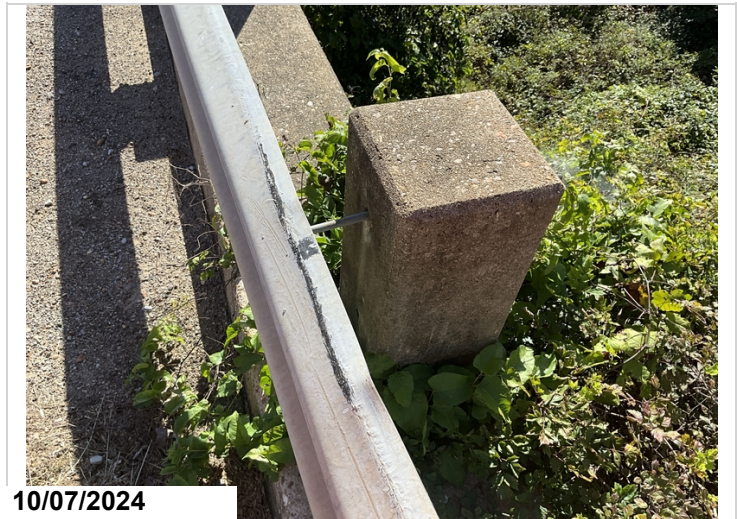
Abutment 2 left monument post

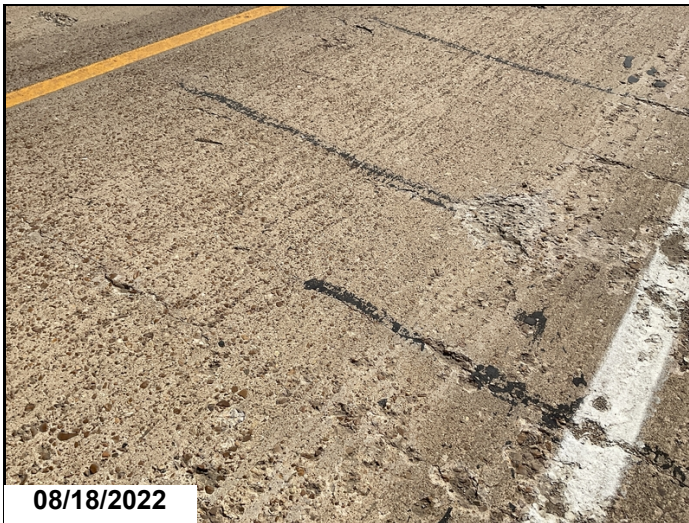
Deck spans #3,4 have moderate areas of scaling with depths up to ½" deep.

Typical scaling in span #3 deck

Type of Work: Repair (General)

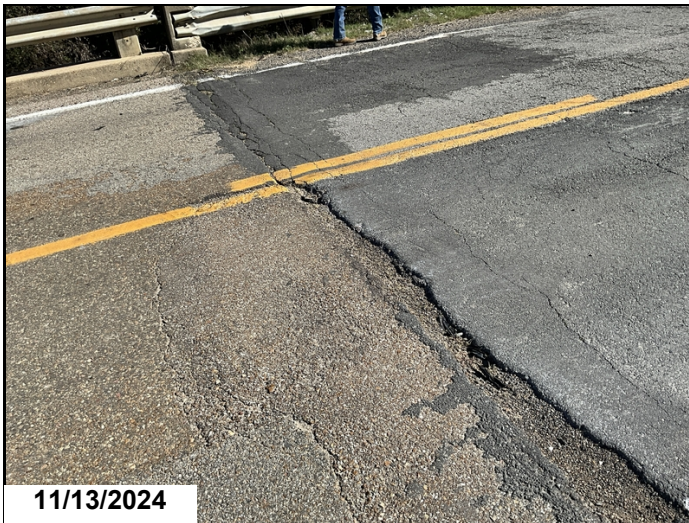
Abutment 1 & 2, Approach Roadways: Settled.

Abutment 2 approach roadway.

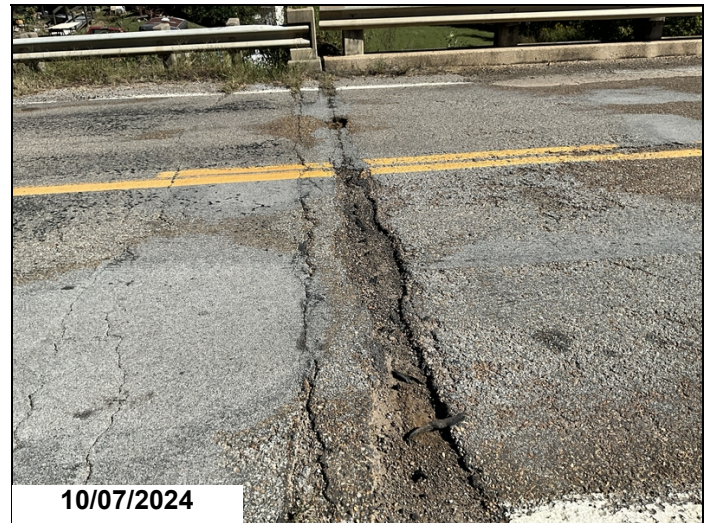
Abutment 1 approach roadway.

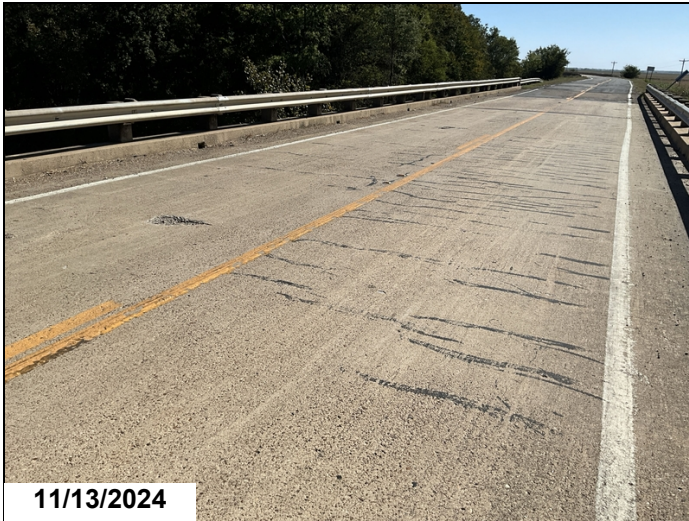
Span 5, Deck Surface, Left Lane: Two 1' shallow spalls and one 2' by 1' spall no exposed reinforcing steel.

Span 5 deck

Type of Work: Deck Repair

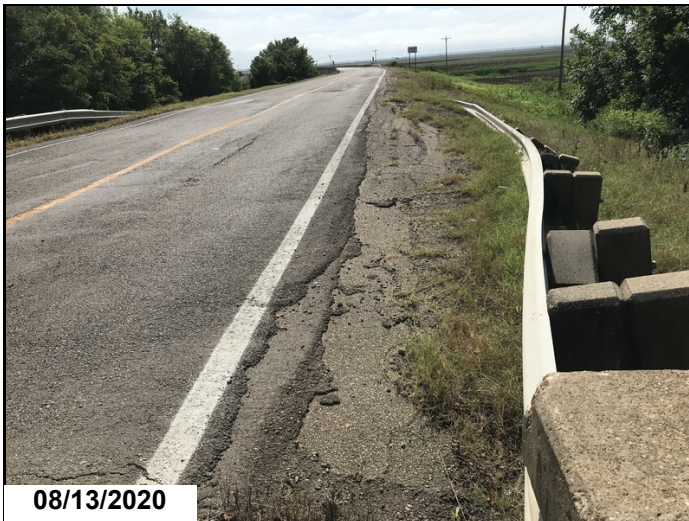
Abutment 2, Approach Rail, Right Side: Low and leaning away from roadway.

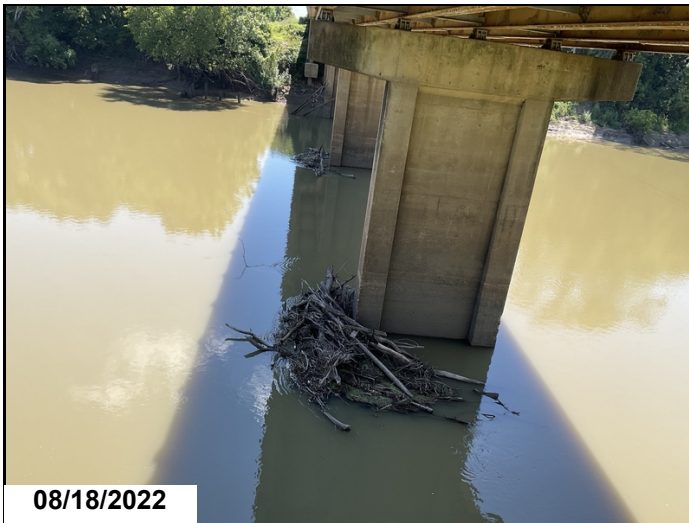
Channel, Left Side: Moderate drift.

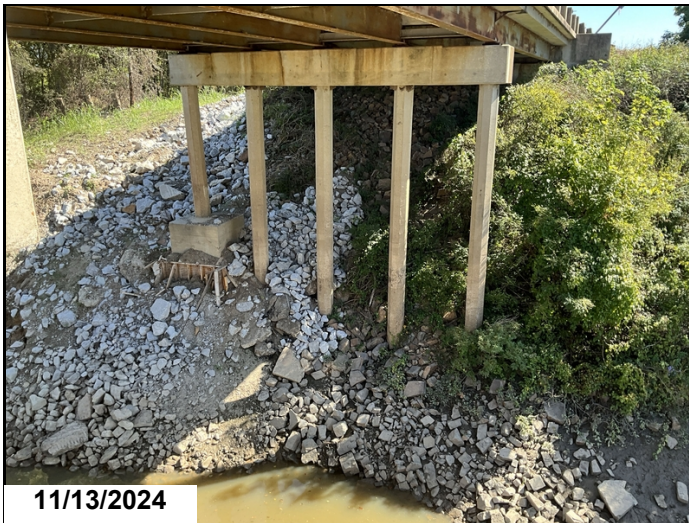
Bent 7

Bent #7 pile #1 repair is undermined up to four feet due to erosion.

Undermining has been repaired since last inspection.

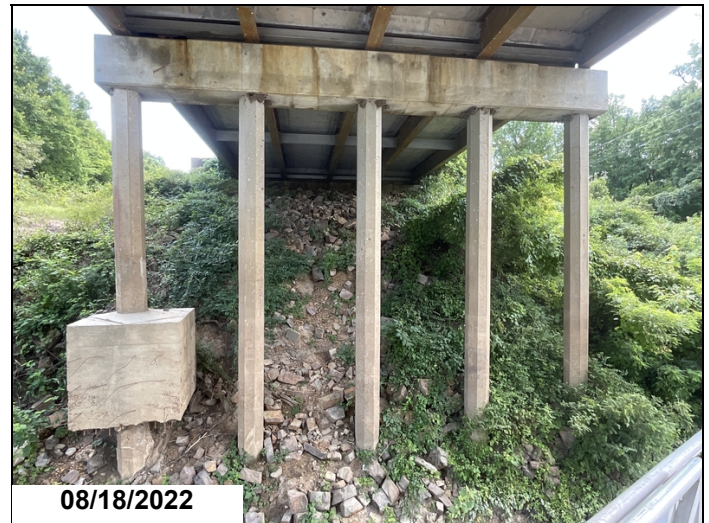
Bent #7 back face

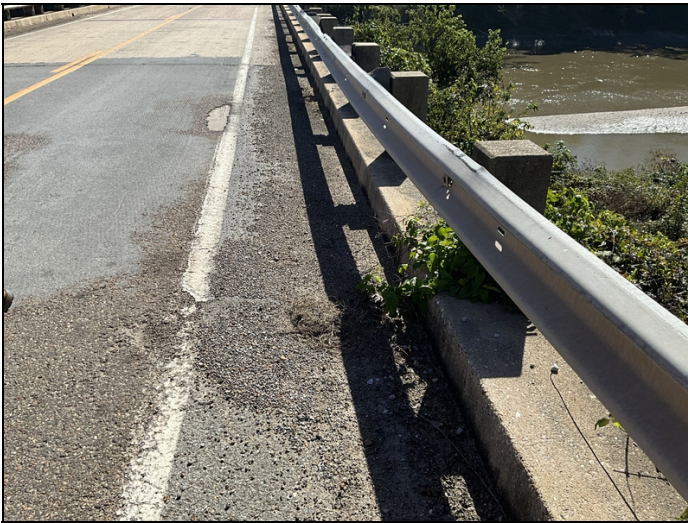
Deck Gutters: Dirt and debris.

A-55 - Deck Washing Needed (Yes)

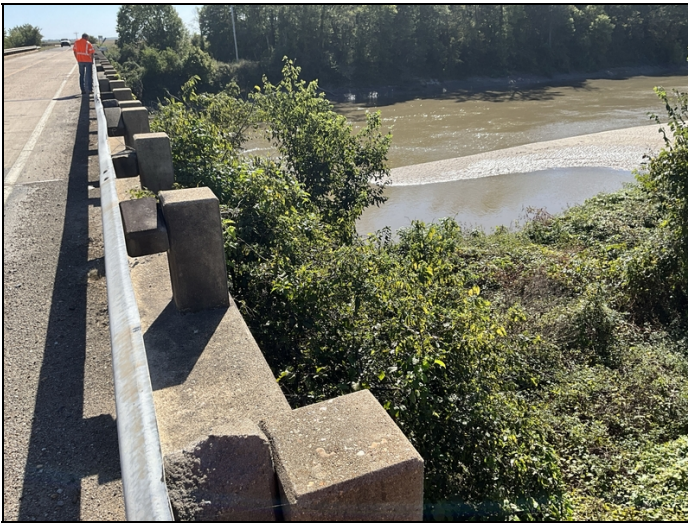
Vegetation is growing beside and under bridge.

Typical vegetation

A-64 - Vegetation Removal Requested (Yes)
