Asset #06087(Routine)

US 412-09- LM 0.06 over 2ND ST &SLSW RR

Location: .95 MI E Jct US 49

Team Lead: Richard Jones Inspection Date: 10/28/2024

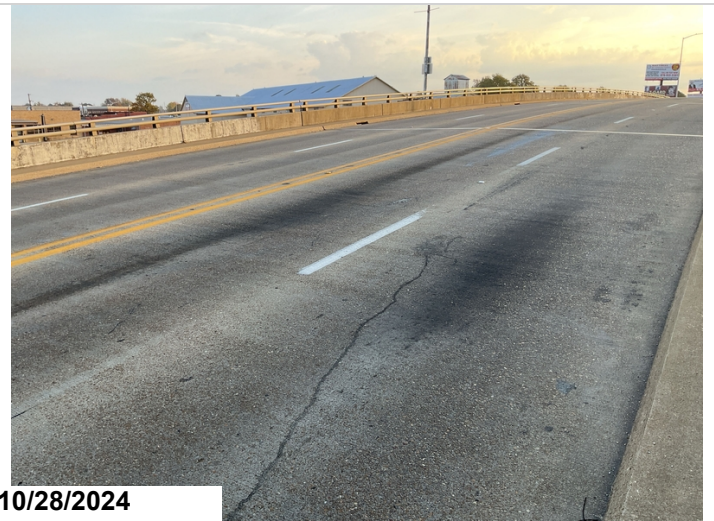
Deck is in overall good condition, but has a few unsealed cracks and areas of abrasion/traffic wear.

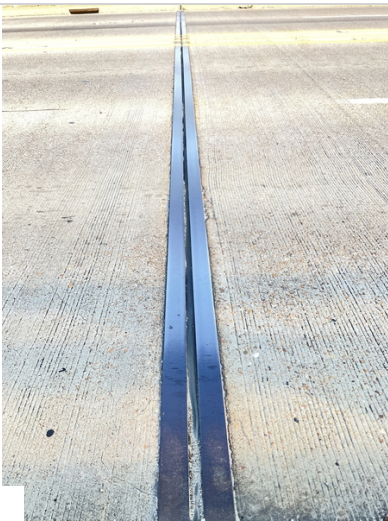
(301) Bent 7 joint has loss of adhesion. 58' CS4							
302	Compression Joint Seal	LF	529	0	30	380	119
2320	Seal Adhesion	LF	30	0	30	0	0
2330	Seal Damage	LF	499	0	0	380	119
<p>(302) Compression seals are ripped and torn with sections partially pulled out. 380 CS3 Bent 2 and 5 seals are missing. 119' CS4 Bent 6 seal has some loss of adhesion. 30' CS2</p>							
311	Movable Bearing	EA	72	0	62	10	0
1000	Corrosion	EA	72	0	62	10	0
<p>(311) Rocker bearings have corrosion throughout. 62 CS2 A few have pack rust or section loss, some are missing anchor bolts. 10 CS3 Span 4 bent 5 bearings 1 and 8 have a loose cap screw on side of bearing. Span 4 bent 5 bearings 3, 4, and 6 are each missing 1 anchor bolt. Span 6 bent 7 bearings 4 and 6 are each missing 1 anchor bolt.</p>

Bent 7 poured adhesion

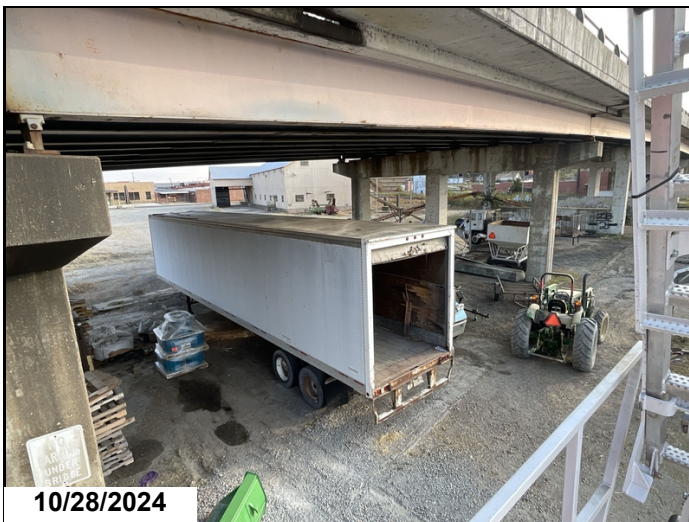
Span 2 under bridge storage

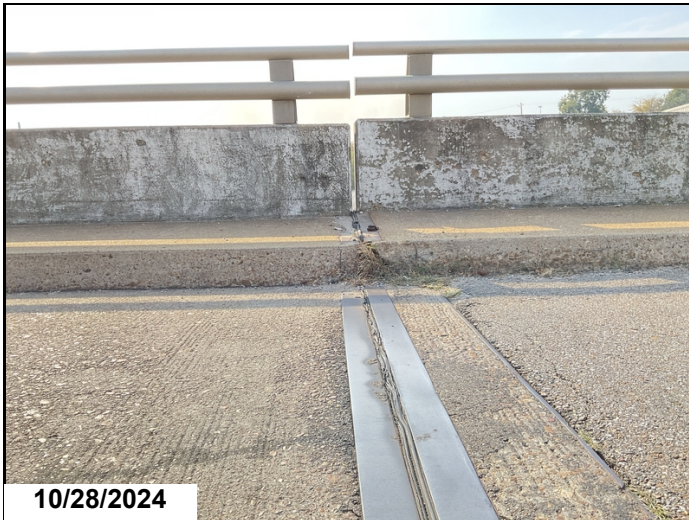
Bent 1 Rt

Approach roadways at bents 1 and 10 have some settlement.
Sidewalks have settlement at bents 1 and 10.

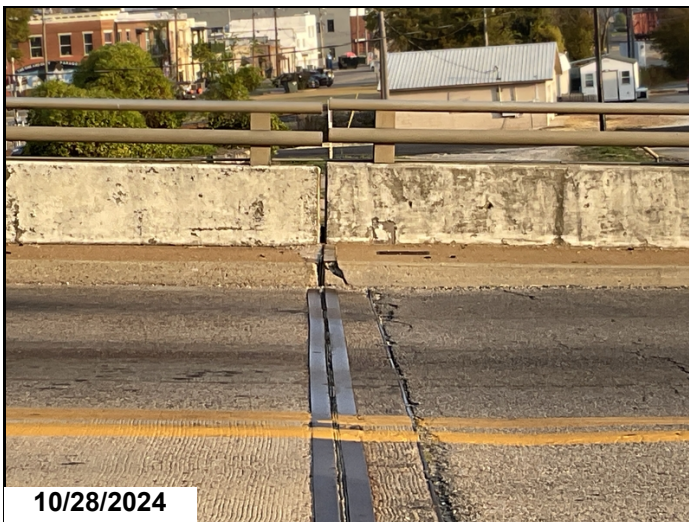
Typical settlement at bents 1 and 10

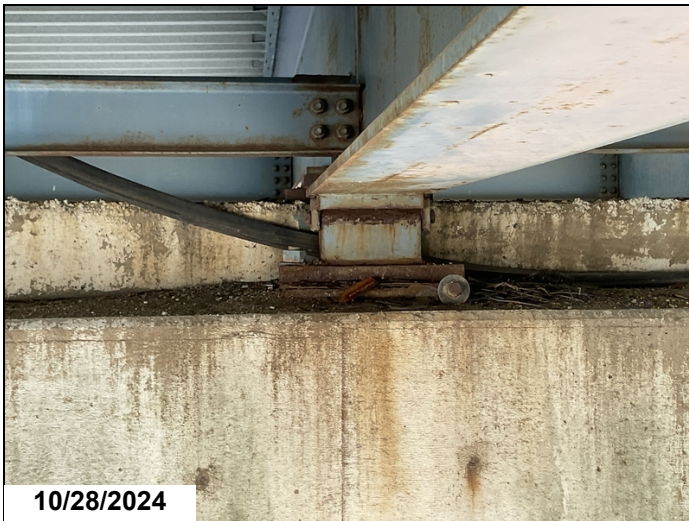
Span 6 bent 7 bearing 4 has 1 anchor bolt sheared off

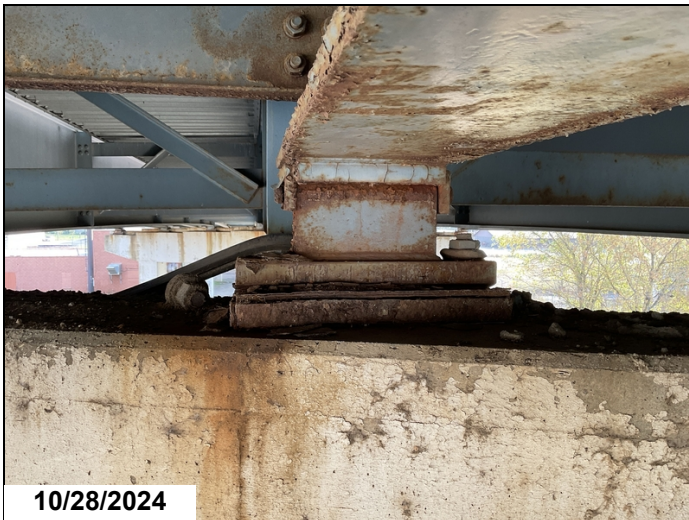
Span 4 bent 5 bearing 4 has 1 anchor bolt sheared off

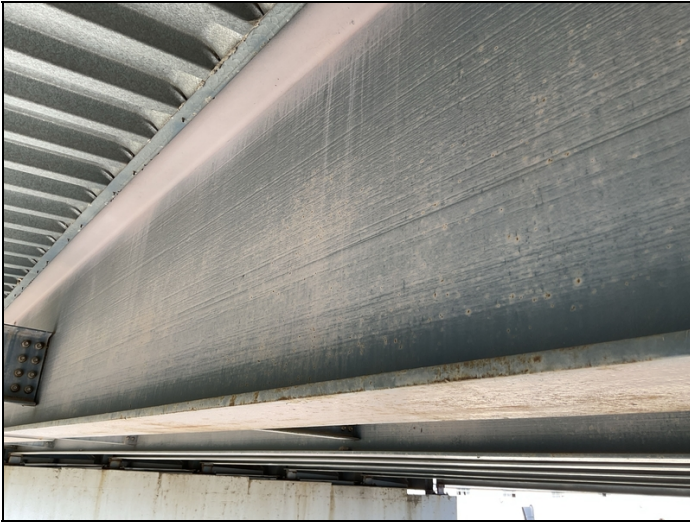
Typical faded paint

A-60 - Full Girder Painting Needed (Yes)
