Bridge 03023 Inspection Report

Route:62 Section:20 Log:2.58

Arnold Road ID:11x62x20xA, Arnold Log mile:2.593

(4) Place Code	0
(6) Features Intersected	BLACK RIVER
(7) Facility Carried	US 62-20- LM 2.58
(9) Location	2.58 MI E US 67
(11) Mile Point	2.58 mi
(12) Base Highway Network	Yes

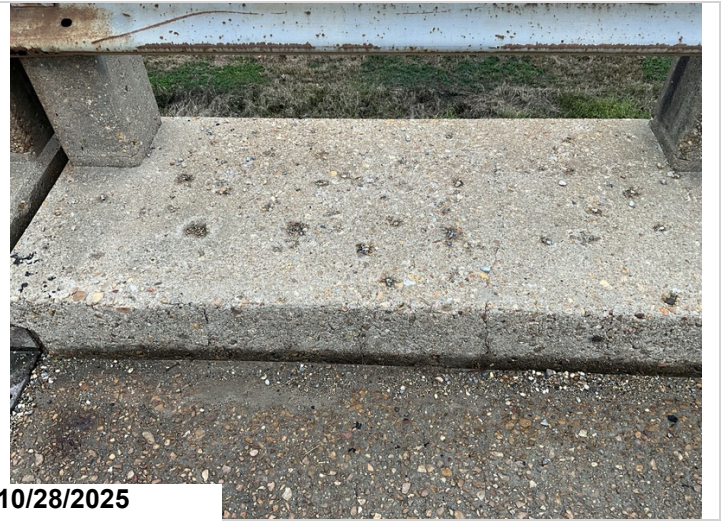
Multiple transverse cracks in curbs.

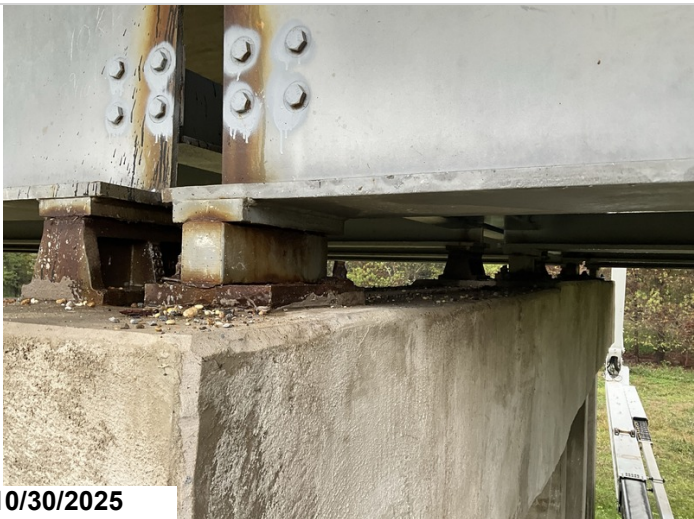
All bearings needing paint.

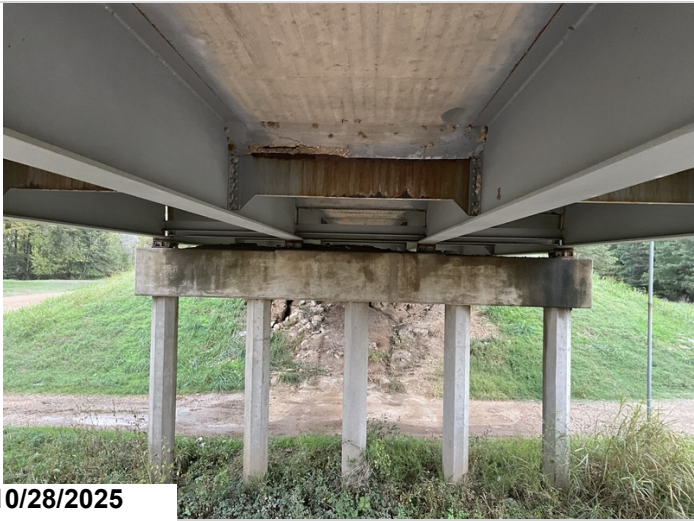
Bent 7, Cap: Needs cleaned.

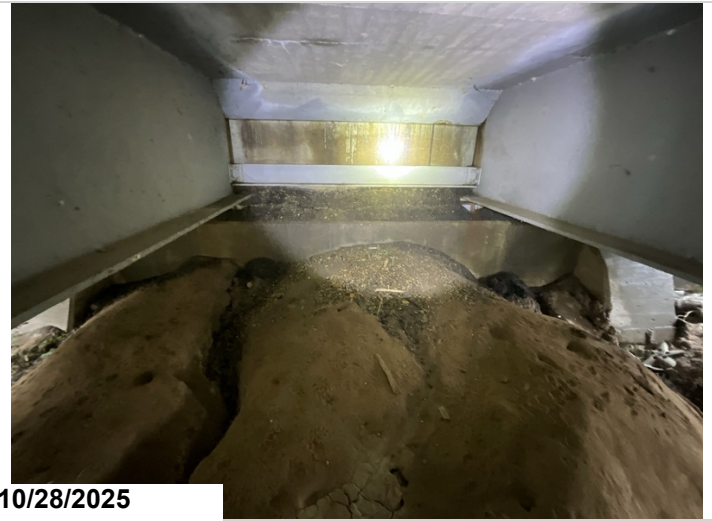
Bent 1: Cap needs cleaned.

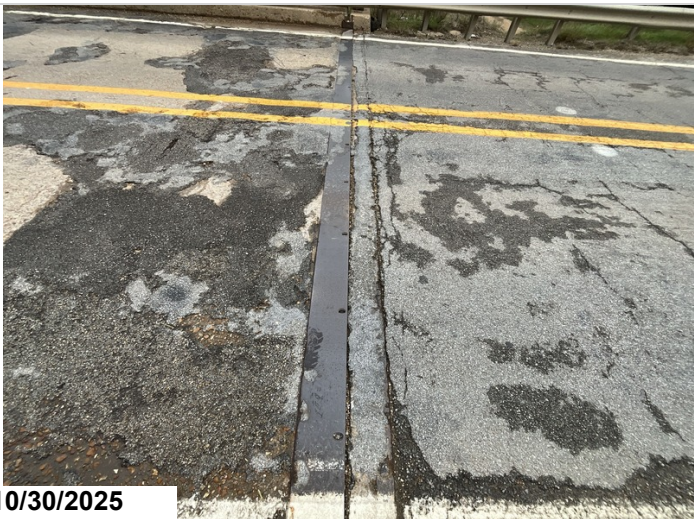
Bent 8, Joint: Debris impact, full length. 26LF CS3 debris impact.

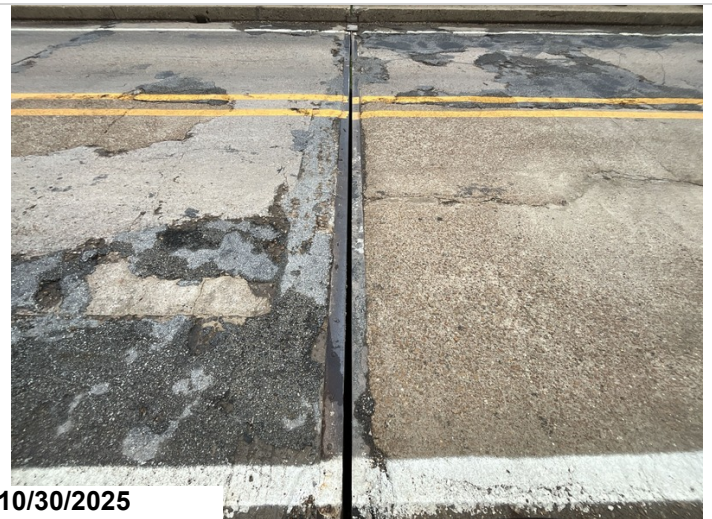
Bent 7, Joint: Armor missing for the full length. 26LF CS4 metal deterioration.

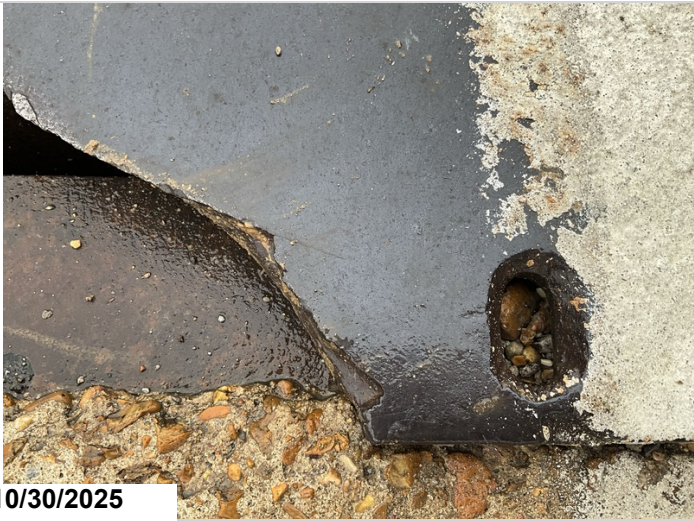
Bent 6, Joint: Cracking in the joint armor. 1LF CS3. metal deterioration.

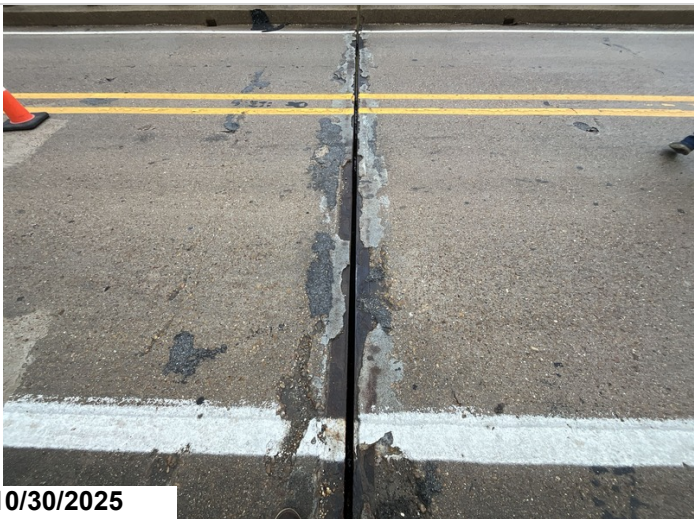
Bent 5, Joint: Armor missing for the full length. 26LF CS4 metal deterioration.

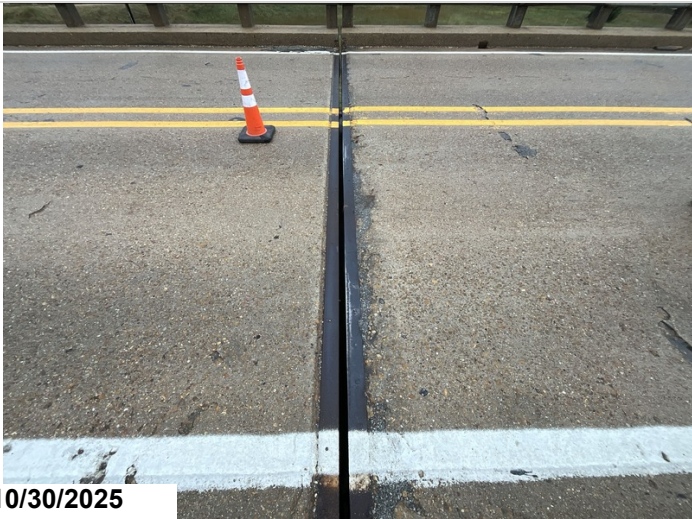
Bent 2, Joint: Armor missing for the full length. 26LF CS4 metal deterioration.

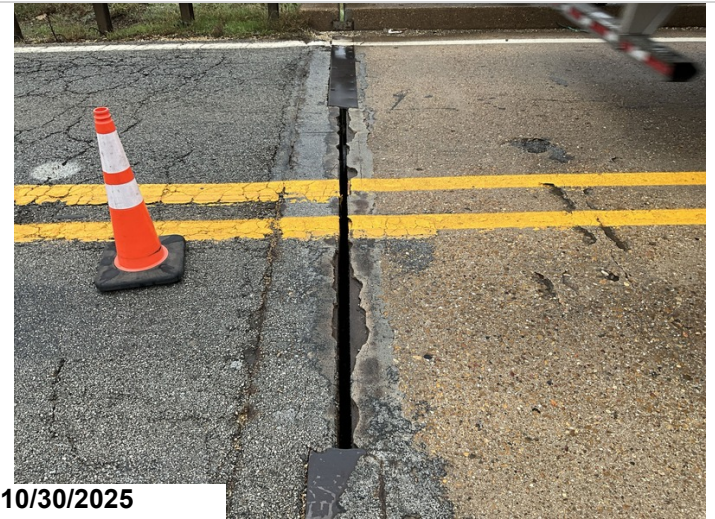
Bent 1, Joint: Armor missing. 12LF CS4 metal deterioration.

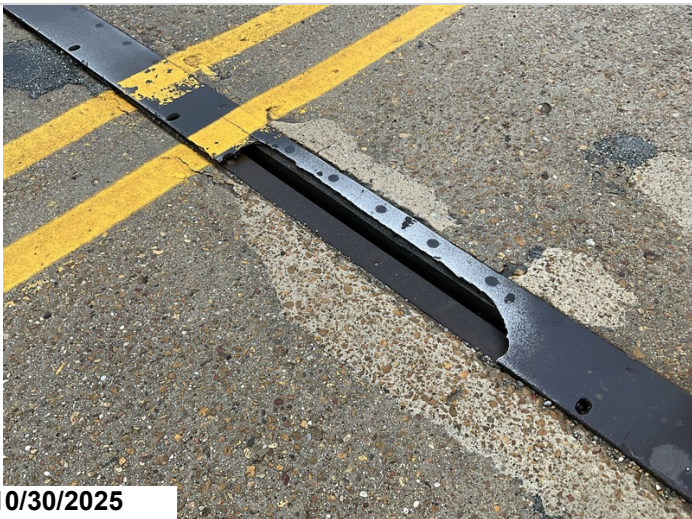
Bent 3, Joint: Armor missing. 4LF CS4 metal deterioration.

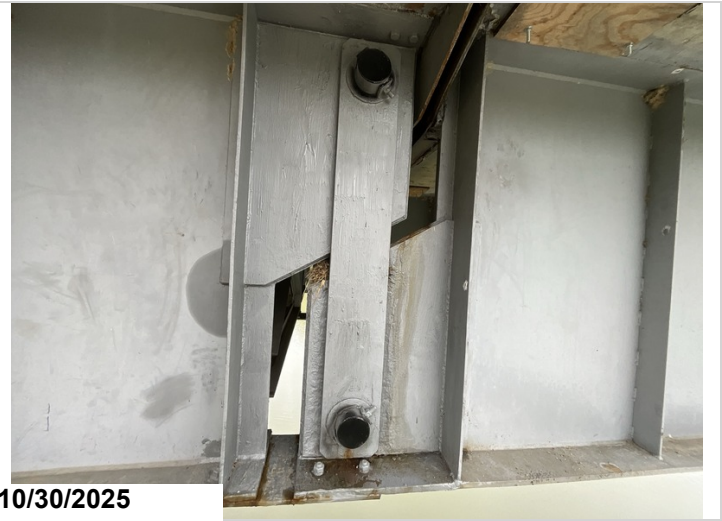
Superstructure condition rating was raised at this inspection from a "4" to a "5" due to the replaced Pin and Hanger Assemblies.

Span 8, First set of Pin and Hanger Assembly's: Pin and Hanger Assembly's have been replaced since the last inspection.

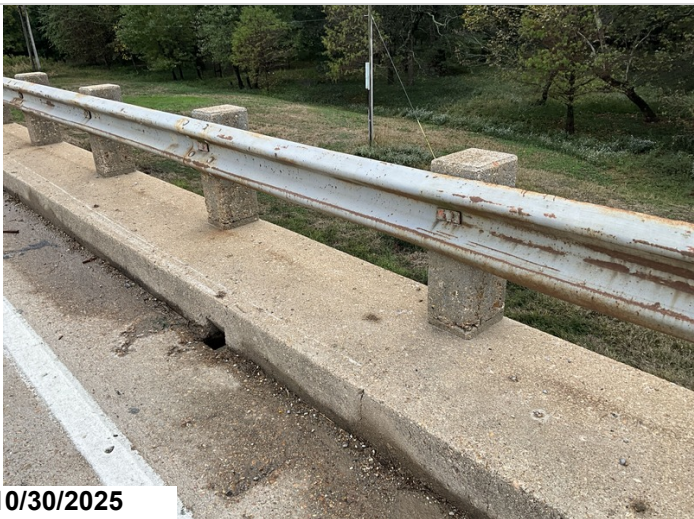
Span 2: Cracked bridge railing post.

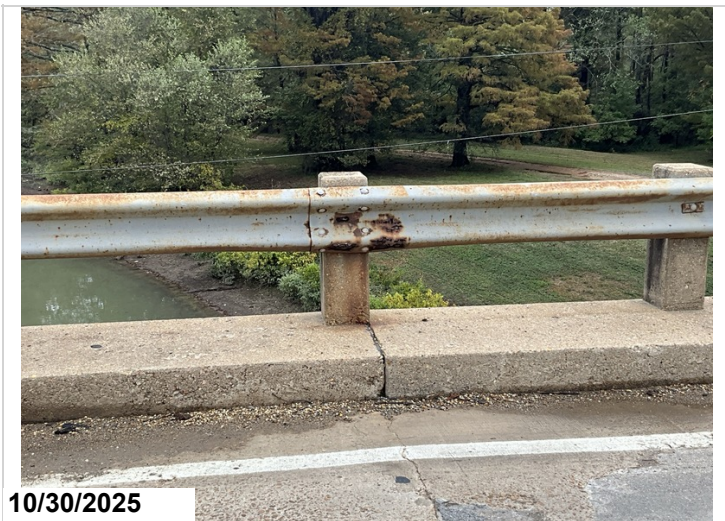
Span 8, Left, Last post: Missing bolt from railing to post.

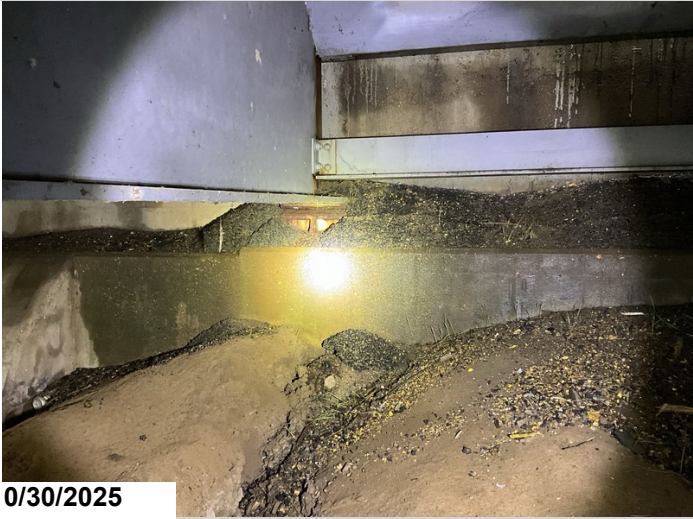
Bent 1, Bearings 1 - 4: Active corrosion with pack rust. 4EA CS3 corrosion.

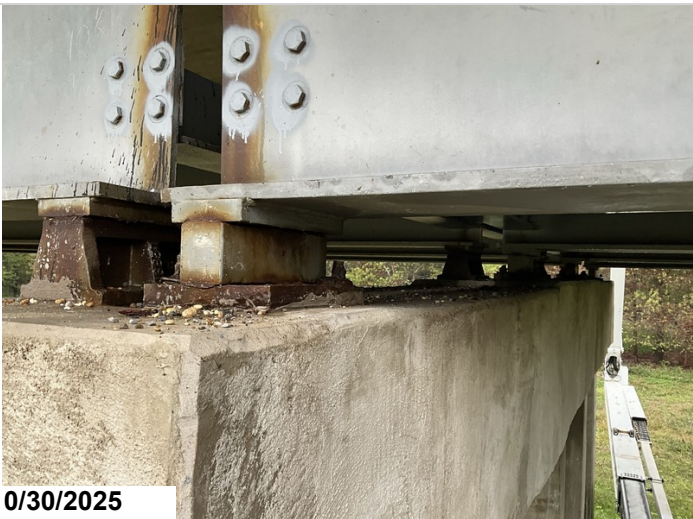
Span 1, Bent 2, Bearings: Active corrosion with pack rust. 4EA CS3 corrosion.

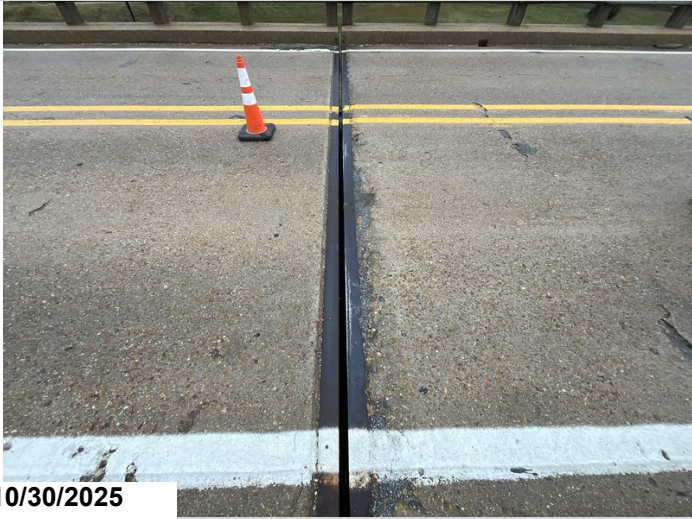
Bent 2, Joint: Armor missing for the full length. 26LF CS4 metal deterioration.

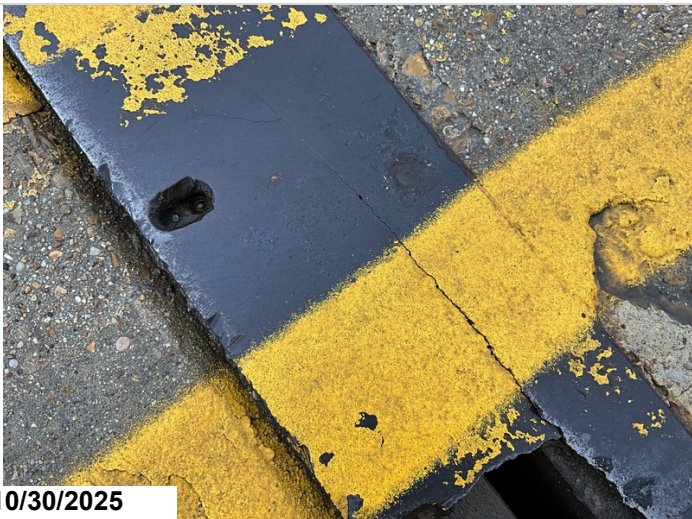
Bent 3, Joint. Cracking in the joint armor. 1LF CS3 metal deterioration.

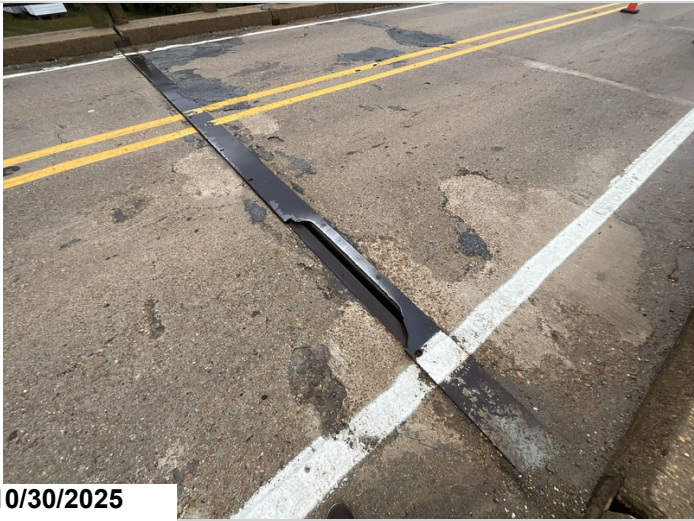
Bent 6, Joint: Joint armor missing. 4LF CS4 metal deterioration.

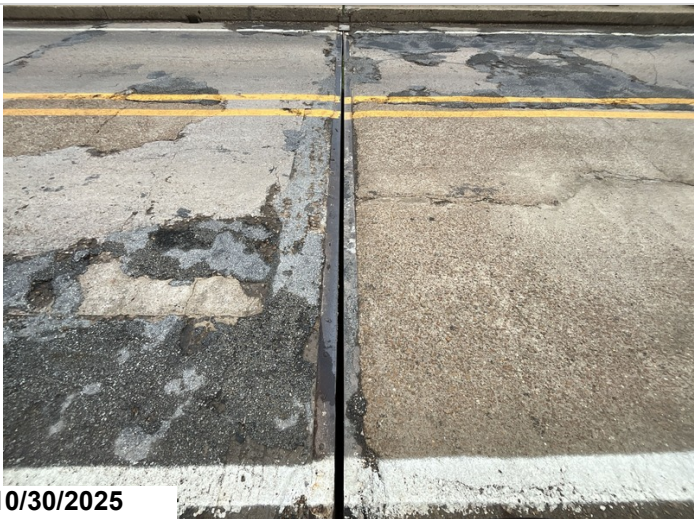
Bent 7, Joint: Armor missing for the full length. 26LF CS4 metal deterioration.

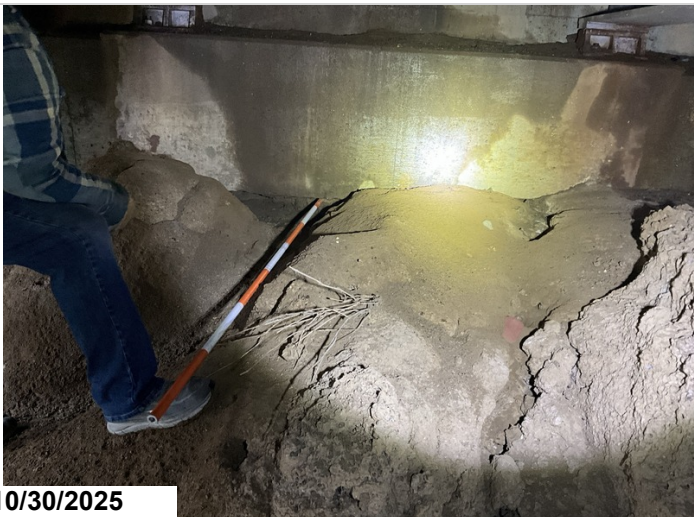
Bent 8: Erosion along the bottom of the bridge seat with undermining up to 1.5'. 18LF CS2 Scour.

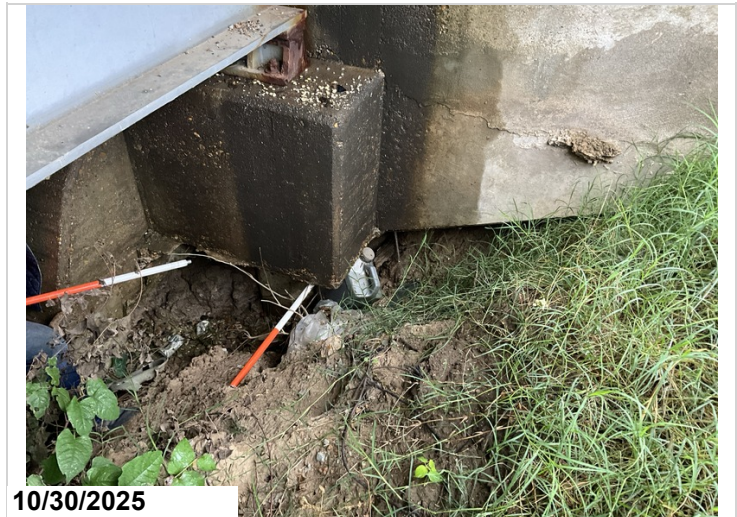
Bent 1: Erosion up to 2' below the bottom of the bridge seat under Girders 1 and 4, worst being under Girder 1 with undermining up to 2.5'. 6LF CS2 erosion, 10LF CS3 erosion.

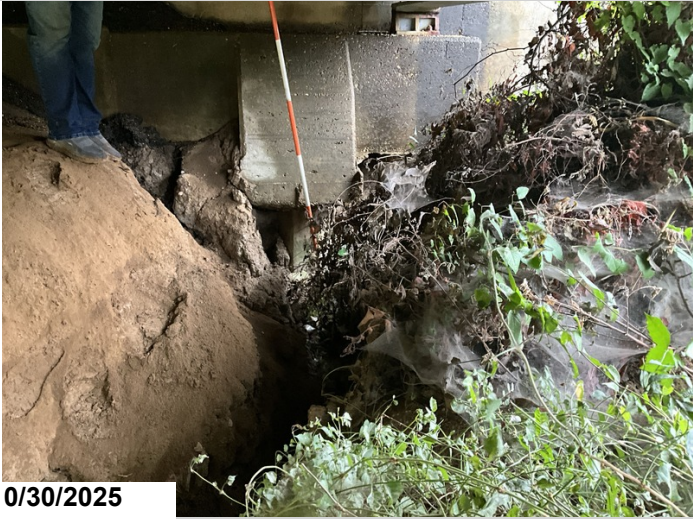
Bent 1: Erosion up to 2' below the bottom of the bridge seat under Girders 1 and 4, worst being under Girder 1 with undermining up to 2.5'. 6LF CS2 erosion, 10LF CS3 erosion.

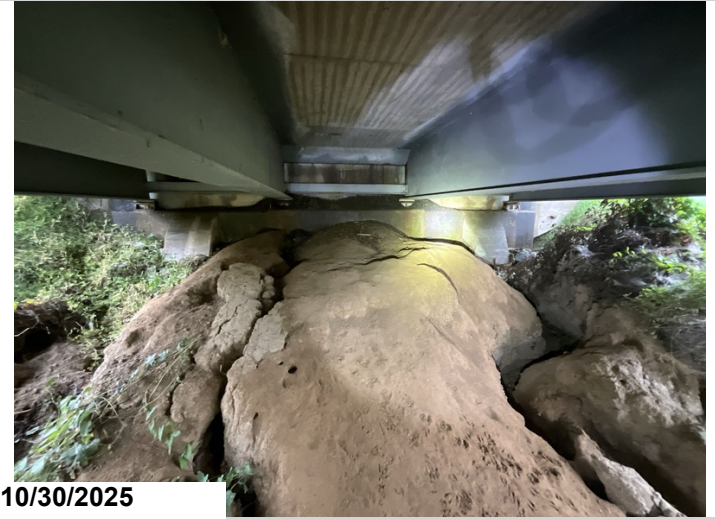
Bent 1: Erosion up to 2' below the bottom of the bridge seat under Girders 1 and 4, worst being under Girder 1 with undermining up to 2.5'. 6LF CS2 erosion, 10LF CS3 erosion.

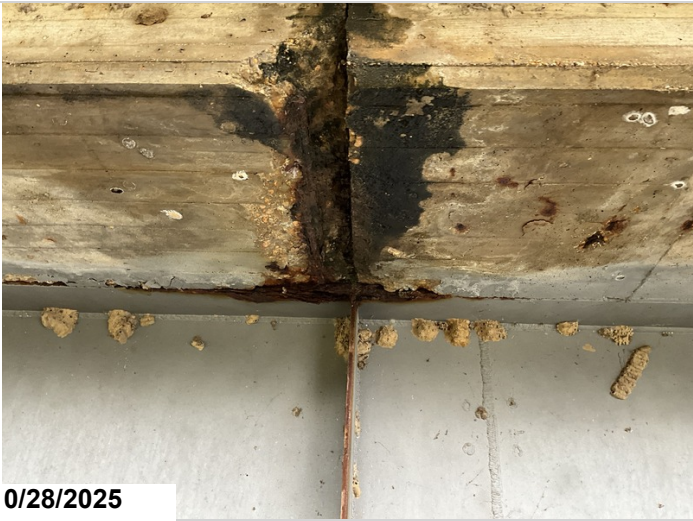
Span 9, Left overhang: Spalling with exposed reinforcing steel with section loss. 8SF CS3 Spalling.

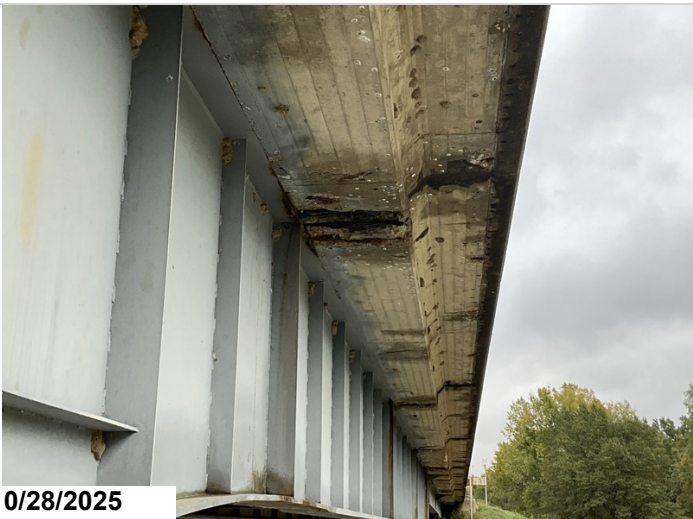
Span 9, Right overhang: Spalling with exposed reinforcing steel with section loss. 19sf CS3 corrosion.

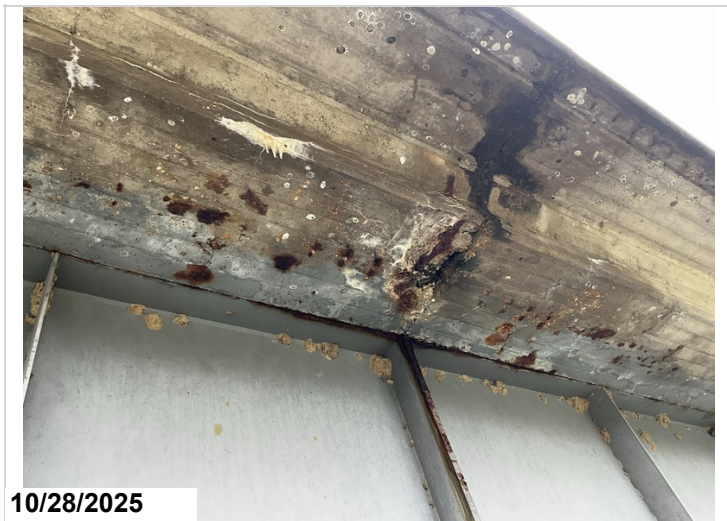
Span 8, Left overhang: Spalling with exposed reinforcing
steel with section loss. 12SF CS3 exposed reinforcing steel.

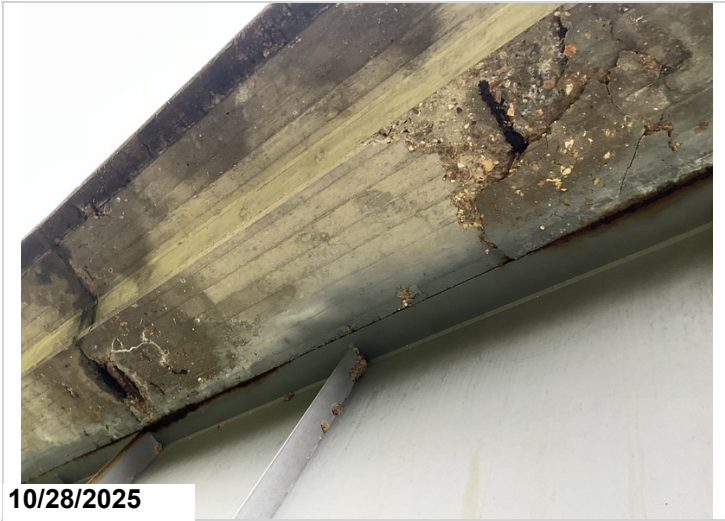
Span 7, Right overhang: Spalling with exposed reinforcing steel with section loss. 18SF CS3 exposed reinforcing steel.

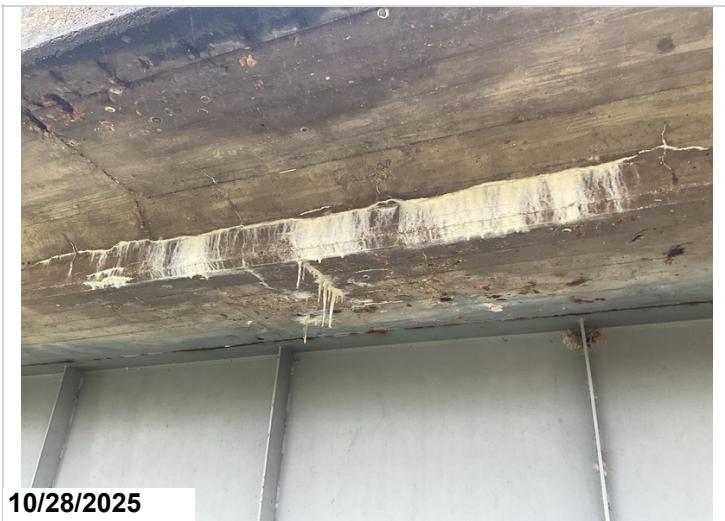
Span 7, Left overhang: Cracking with efflorescence. 18SF CS3 efflorescence.

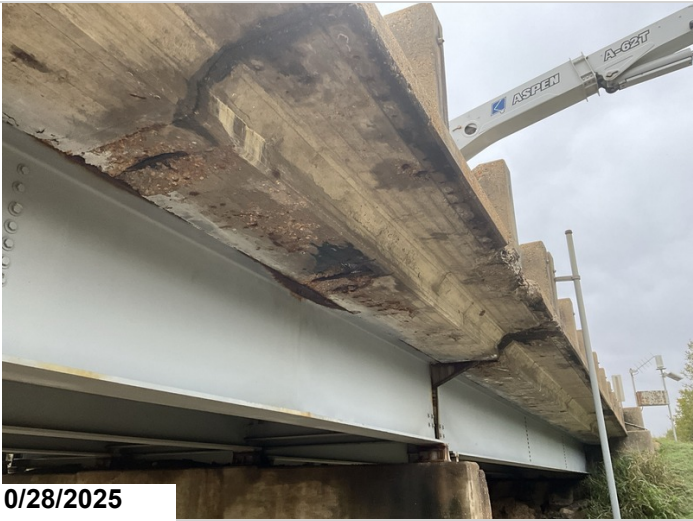
Span 10, Right overhang: Spalling with exposed reinforcing steel with section loss. 8SF CS3 exposed reinforcing steel.

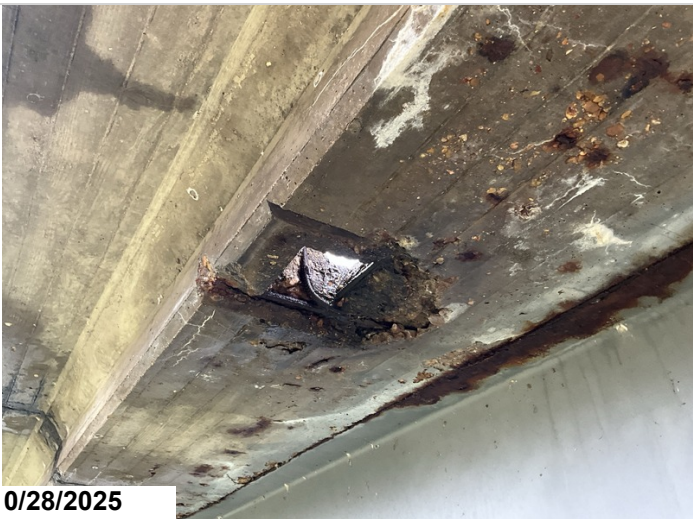
Span 6, Left overhang: Spalling with exposed reinforcing steel with section loss. 11SF CS3 exposed reinforcing steel.

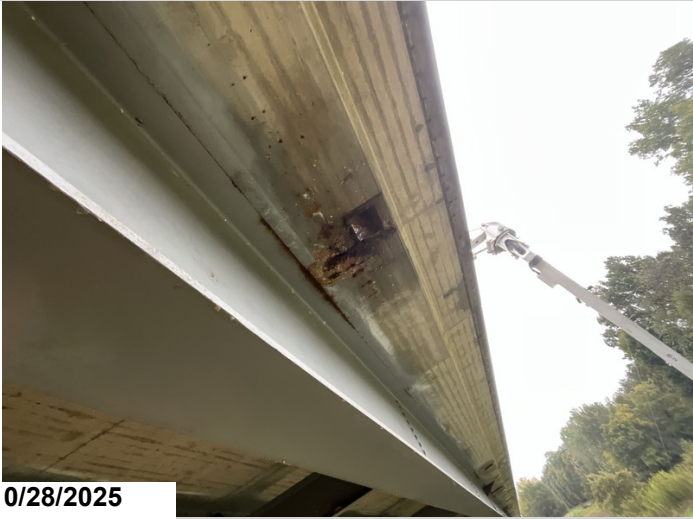
Span 5, Right overhang: Spalling with exposed reinforcing steel with section loss at the drain locations. 2SF CS3 exposed reinforcing steel.

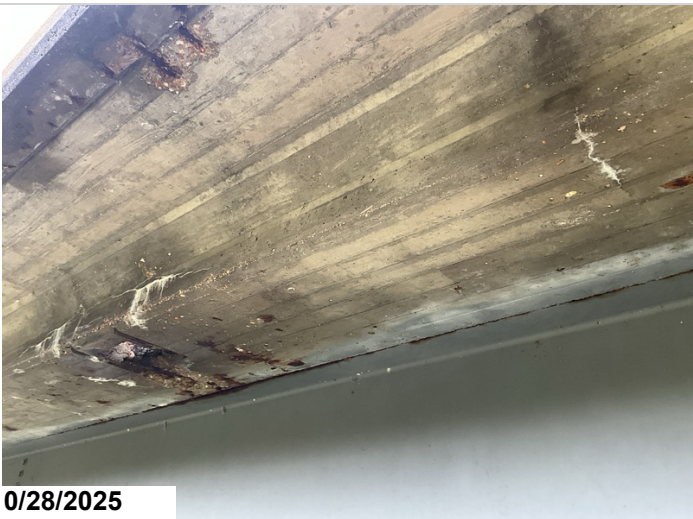
Span 4, Right overhang: Cracking with efflorescence build. 5SF CS3 efflorescence.

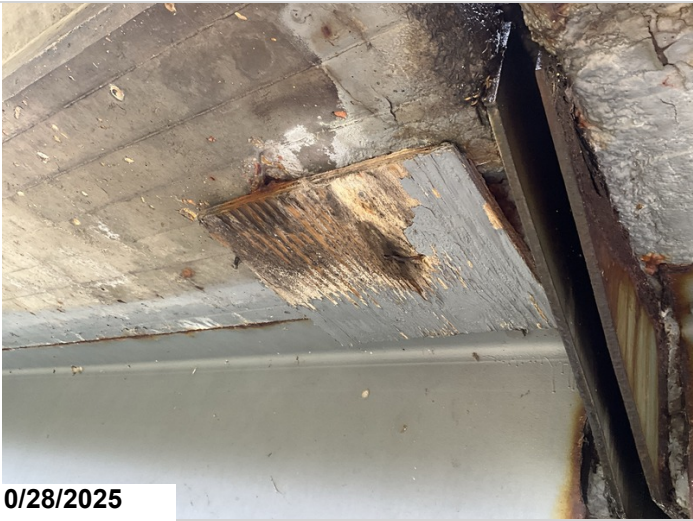
Span 3, Right overhang, near Bent 4: Patched area. 2SF CS3 unsound patch.

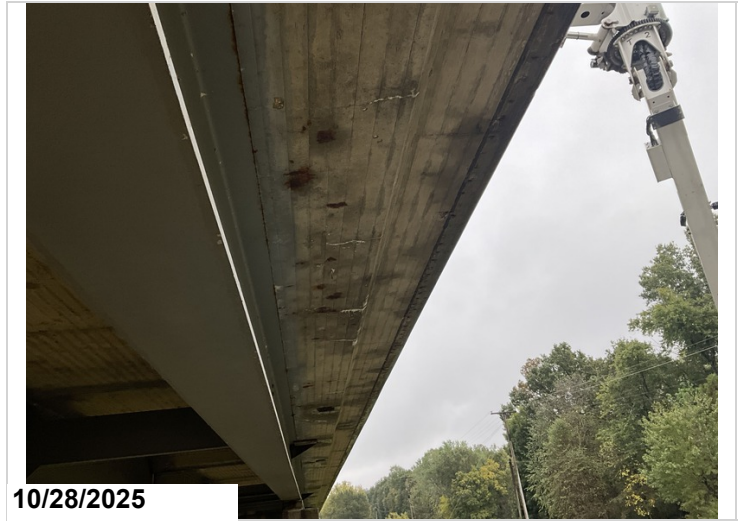
Span 3, Right overhang: 17SF CS3 efflorescence/rust staining.

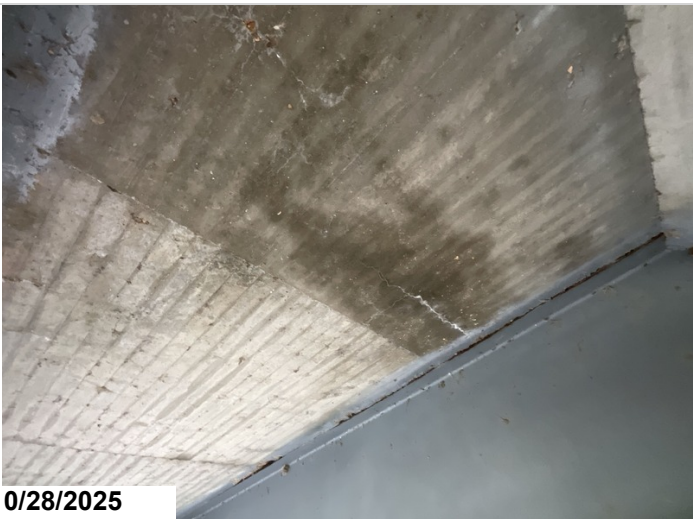
Span 3, All bays: 12SF CS2 efflorescence.

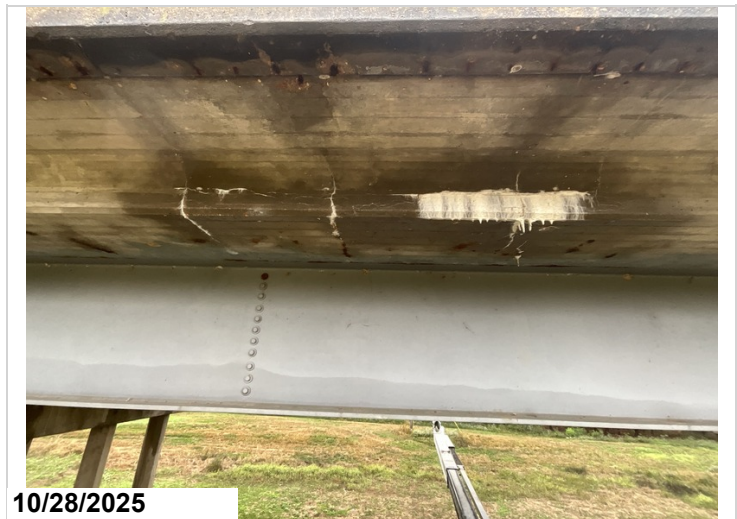
Span 3, Left overhang: Cracking with efflorescence build up and rust staining. 25sf CS3 efflorescence/rust staining.

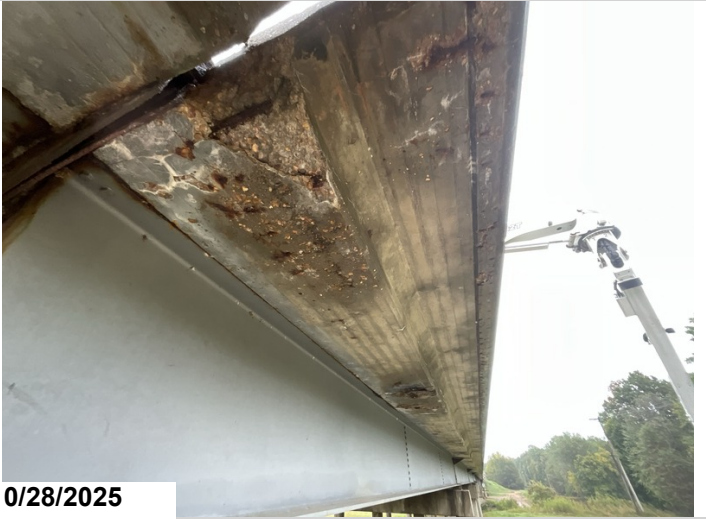
Span 3, Right overhang: Spalling with exposed reinforcing steel with section loss. 3SF CS3 exposed reinforcing steel.

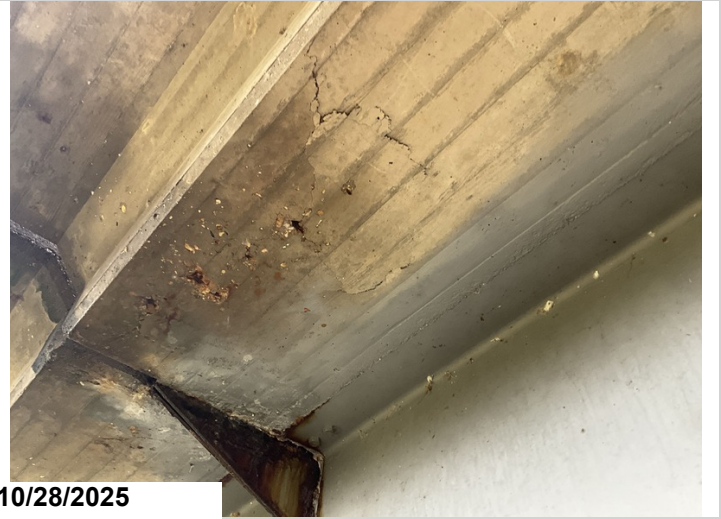
Span 2, Left overhang, Adjacent to Bent 3: Delamination area. 2SF CS2 delam.

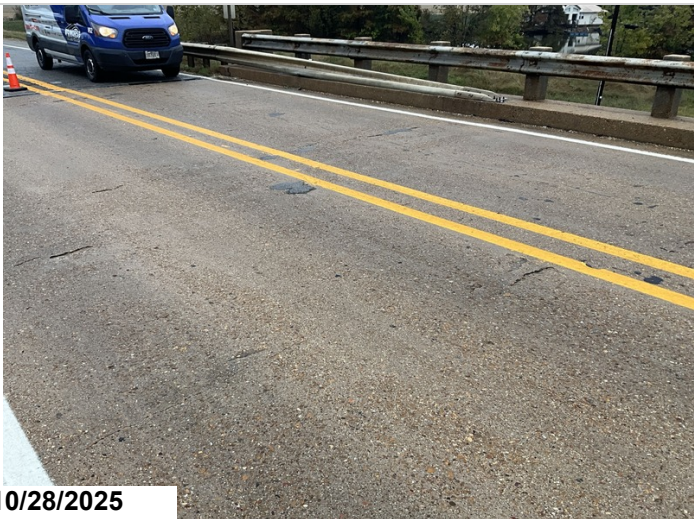
Span 1: Transverse cracking. 71SF CS3 cracking.

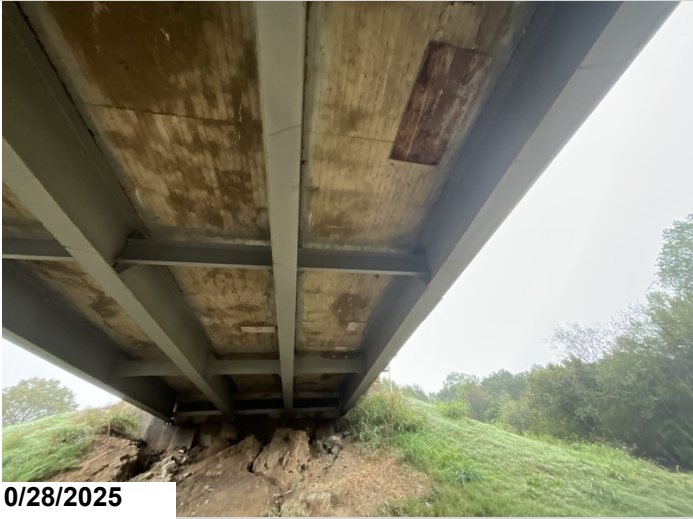
Span 11, Bays 2 and 3: Patched areas. 12SF CS3 Spalling.

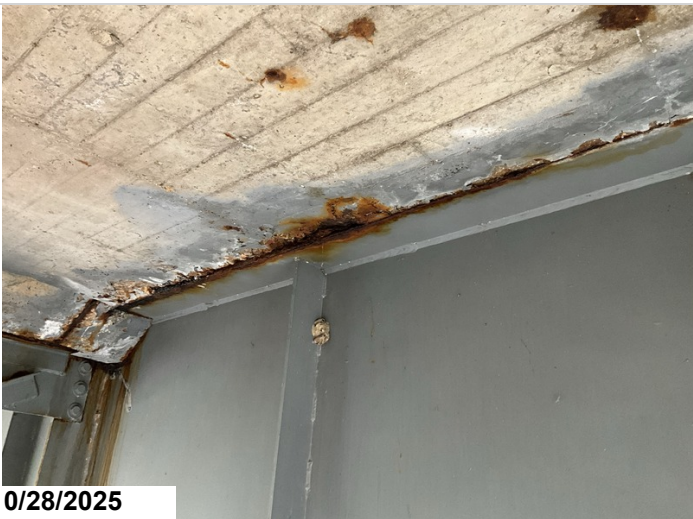
Span 9, back of Pier 4, Girder 4, Left: Active corrosion with flaking rust along the Top Flange. 12LF CS3 corrosion.

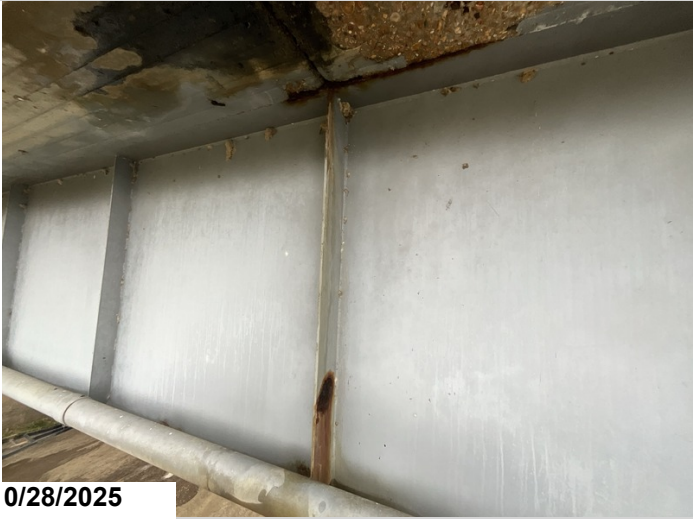
Span 9, Girder 1, Left, at second saw joint: Active corrosion with flaking rust along the Top Flange and corrosion to vertical stiffener. 3LF CS3 corrosion.

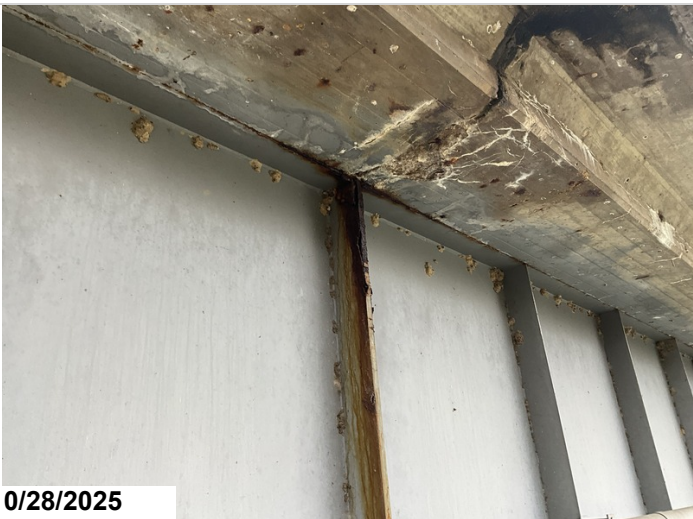
Span 9, Pier 3, Girder 1, Left: Active corrosion with flaking rust along the Top Flange. 4LF CS3 corrosion.

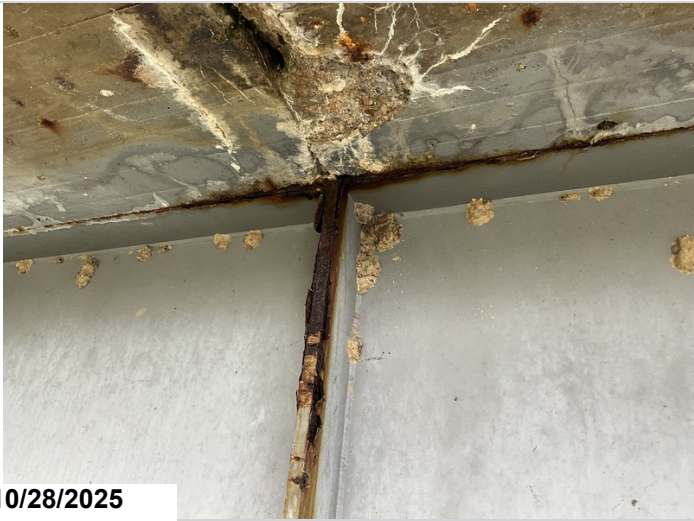
Span 8, Girder 4, Right: Active corrosion with flaking rust along the Top Flange and vertical bearing stiffener. 4LF CS3 corrosion.

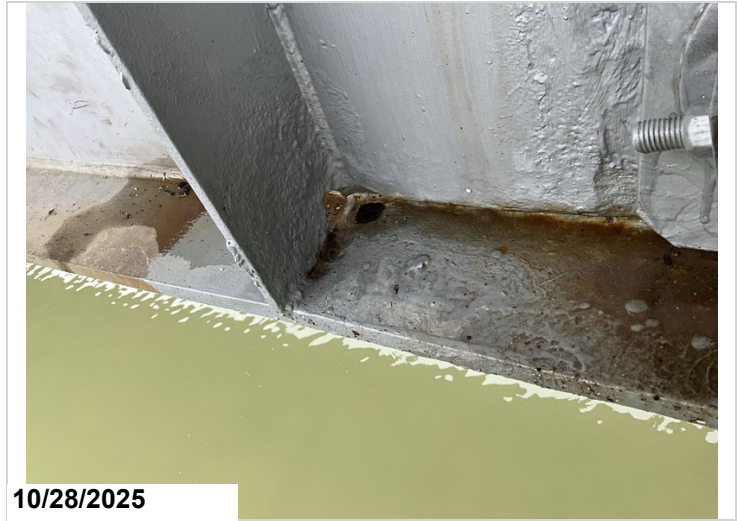
Span 8, Pier 3, Girder 1, Left: Active corrosion with flaking rust along the Top Flange and vertical bearing stiffener. 4LF CS3 corrosion.

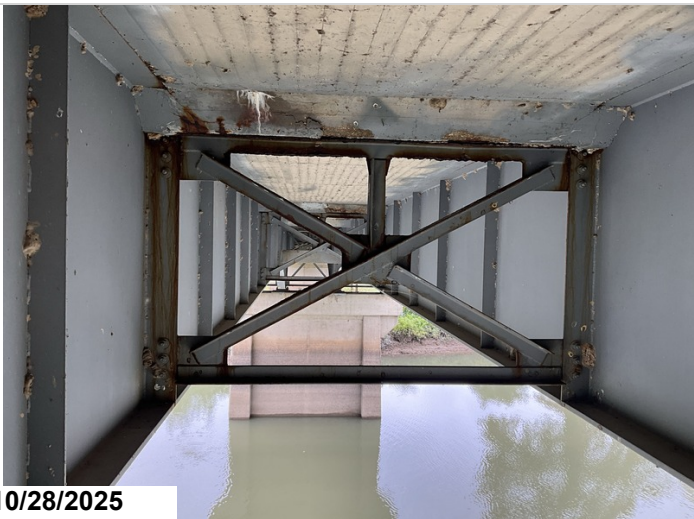
Span 8, Girder 4, Right, Last stiffener before second Pin and Hanger Assembly: Hole in vertical Stiffener.

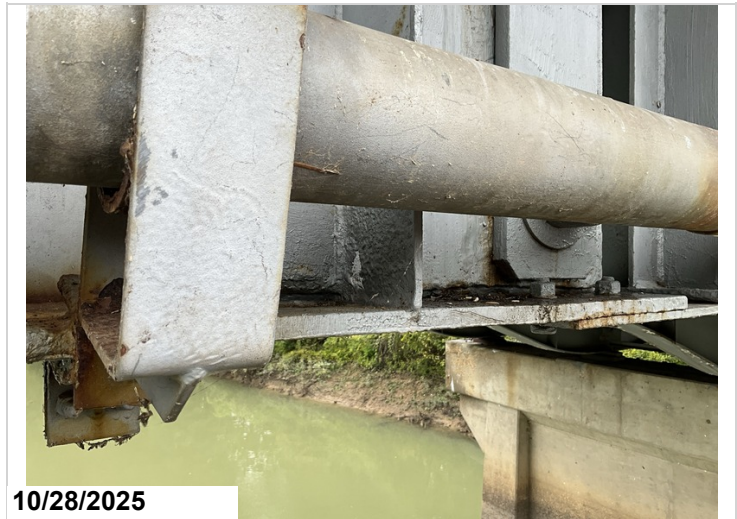
Span 8: Typical corrosion around diaphragms.

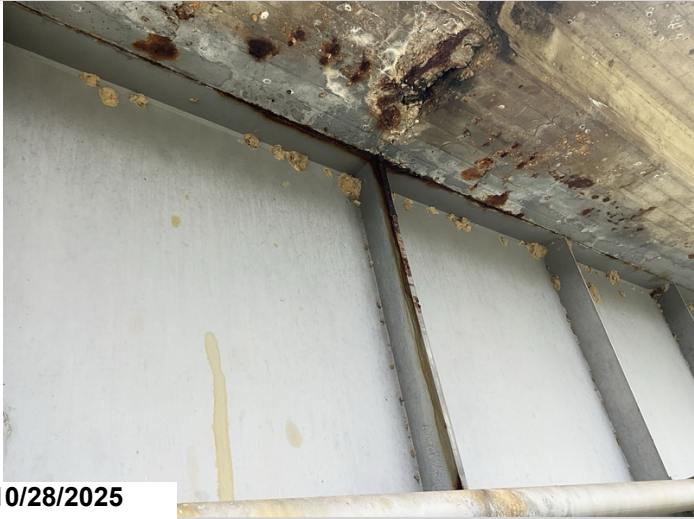
Span 8, Girder 1, First stiffener after first Pin and Hanger Assembly: Hole in vertical stiffener.

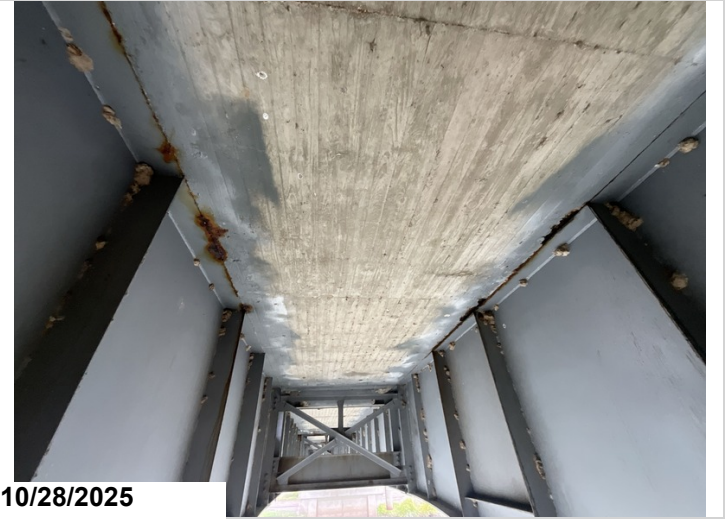
Span 8, Girder 1, Left: Active corrosion with flaking rust along the Top Flange and vertical bearing Stiffener. 6LF CS3 corrosion.

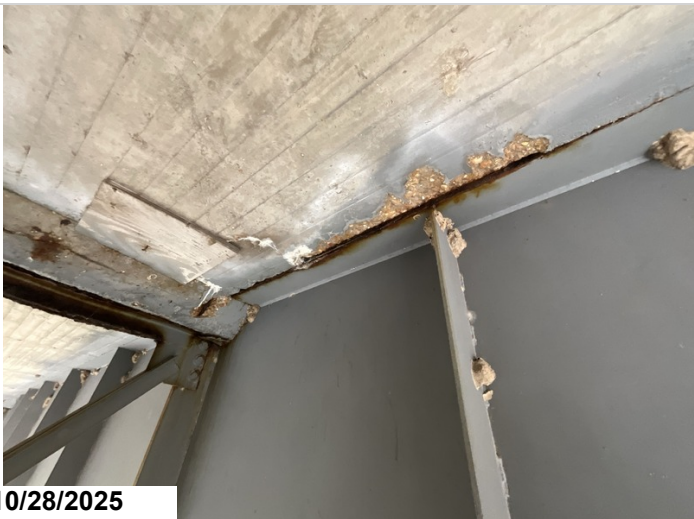
Span 8, Girders 1 and 2: Active corrosion with flaking rust along the Top Flange. 8LF CS3 corrosion.

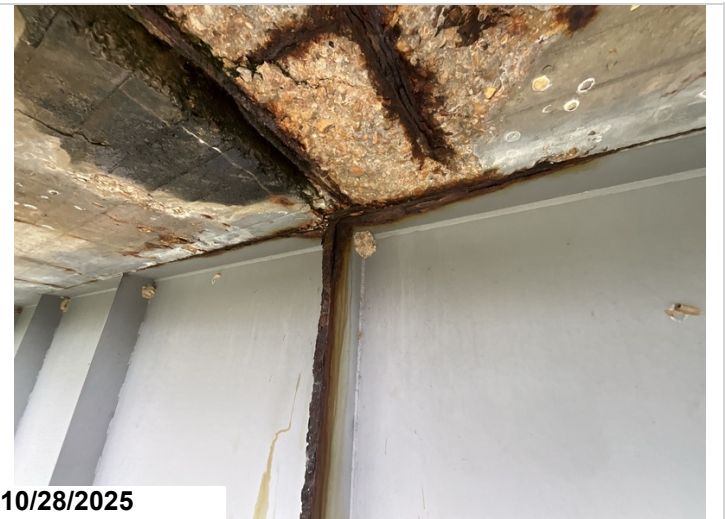
Span 8, Girder 3, Right: Active corrosion with flaking rust along the Top Flange. 11LF CS3 corrosion.

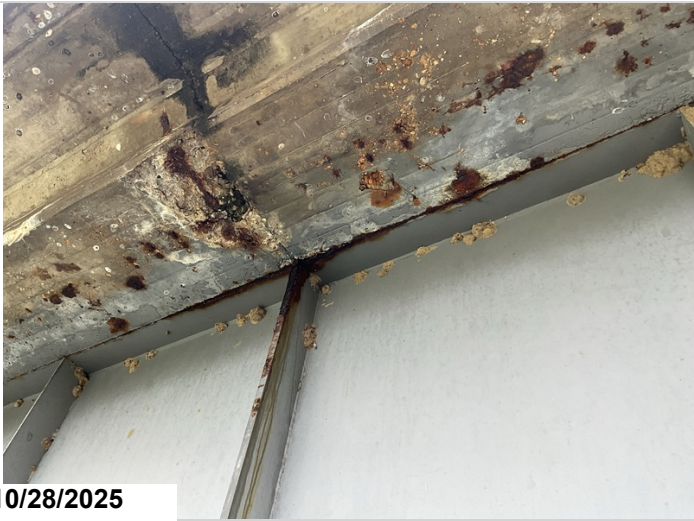
Span 8, Girder 4, Right: Active corrosion with flaking rust along the Top Flange and vertical bearing Stiffener. 6LF CS3 corrosion.

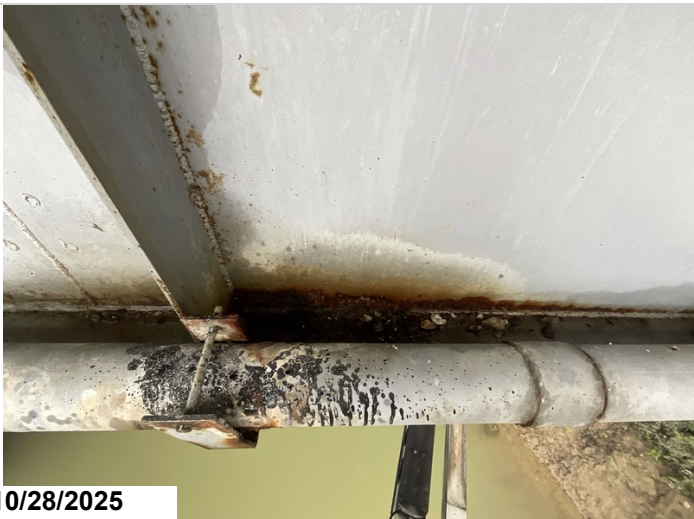
Span 7, Girder 1, Bottom Flange: Active corrosion with section loss up to 7/16" below the last saw joint before Pier 2.

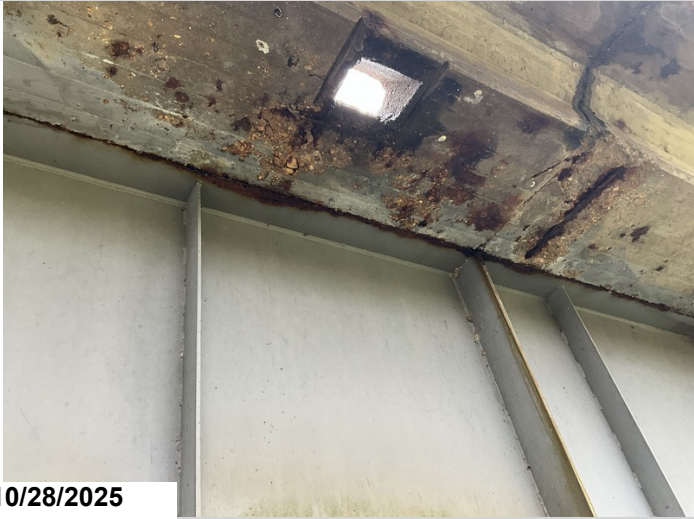
Span 7, Girder 1, Left, Top Flange: Active corrosion with flaking rust along the Top Flange below last saw joint before Pier 2. 8LF CS3 corrosion.

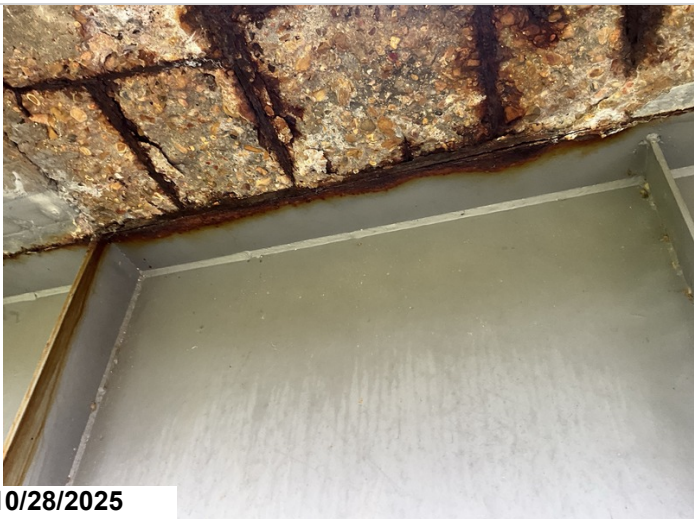
Span 7, Girder 2, Right: Active corrosion with flaking rust along the Top Flange. 7LF CS3 corrosion.

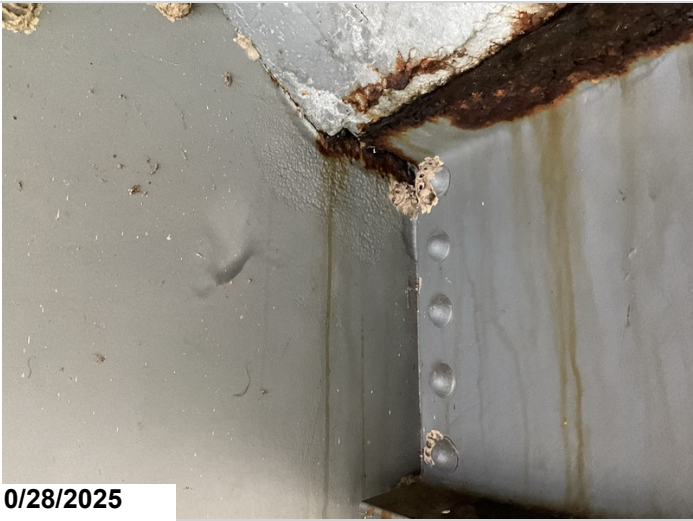
Span 6, Girders 1 - 4, at center Two diaphragms: Active corrosion with with flaking rust and section loss up to 3/16" to the web at the haunch areas. 8LF CS3 corrosion.

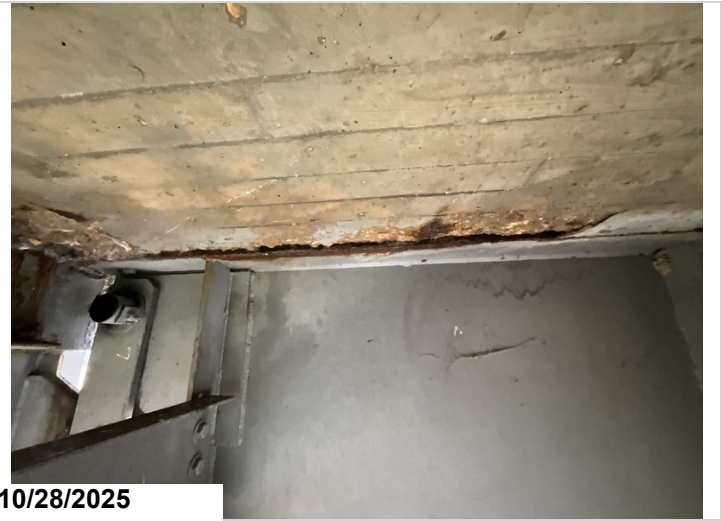
Span 6, Girders 1 - 4, at center Two diaphragms: Active corrosion with with flaking rust and section loss up to 3/16" to the web at the haunch areas. 8LF CS3 corrosion.
