Bridge 03023 Inspection Report

Route:62 Section:20 Log:2.58

Arnold Road ID:11x62x20xA, Arnold Log mile:2.593

(4) Place Code	0
(6) Features Intersected	BLACK RIVER
(7) Facility Carried	US 62-20- LM 2.58
(9) Location	2.58 MI E US 67
(11) Mile Point	2.58 mi
(12) Base Highway Network	Yes

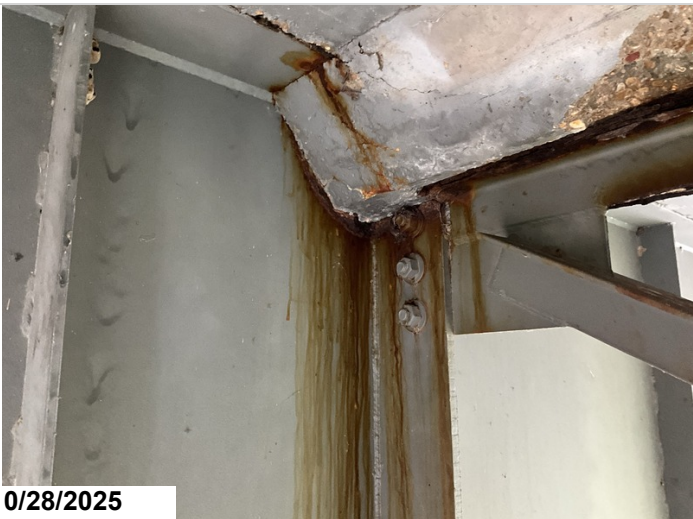
Span 6, Girder 1, Right, Between Pin and Hanger Assembly and Pier 1: Active corrosion with flaking rust along the Top Flange. 5LF CS3 corrosion.

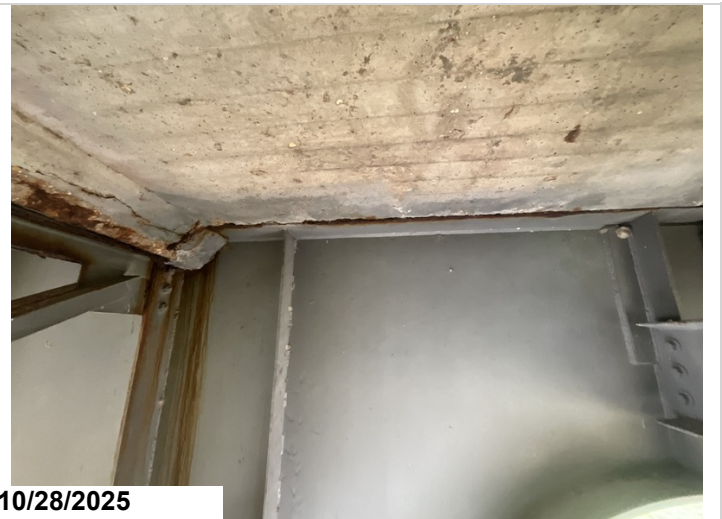
Span 6, Pier 1, Girders: Typical Active corrosion with flaking rust to the web at the concrete haunch areas.

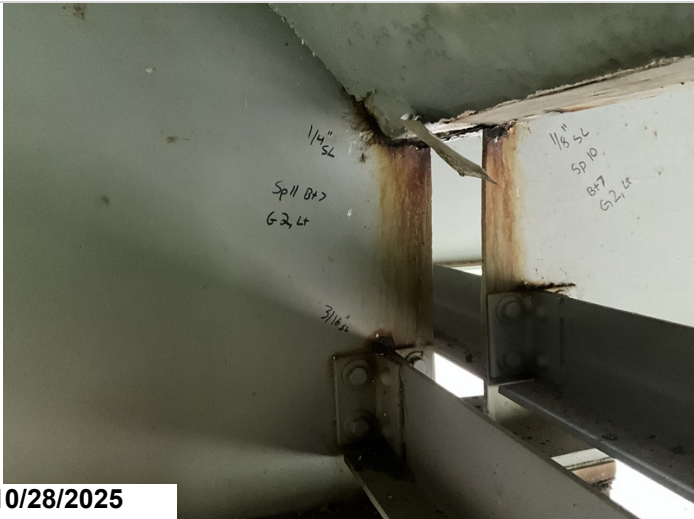
Span 6, Girder 4, Left. Between Pin and Hanger Assembly and Pier 1: Active corrosion with flaking rust along the Top Flange. 8LF CS3 corrosion.

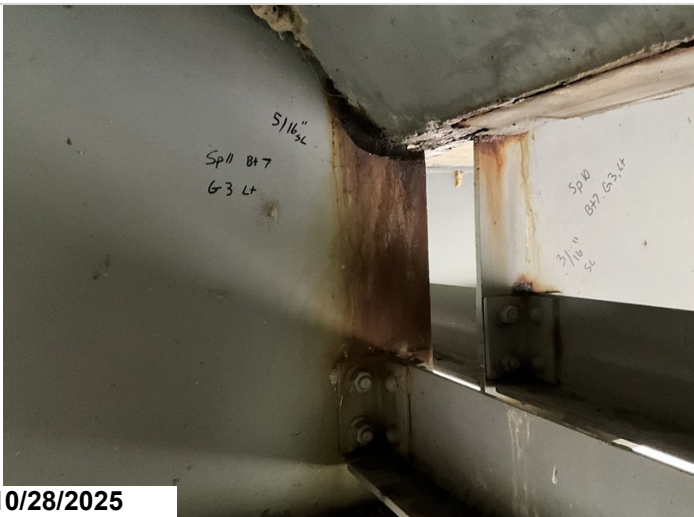
Span 11, Bent 7, Girder 1, Right: Active corrosion with section loss up to 3/16" to the web at the haunch area and pack rust up to 1/2" between the girder web and concrete haunch. 1LF CS3 corrosion.

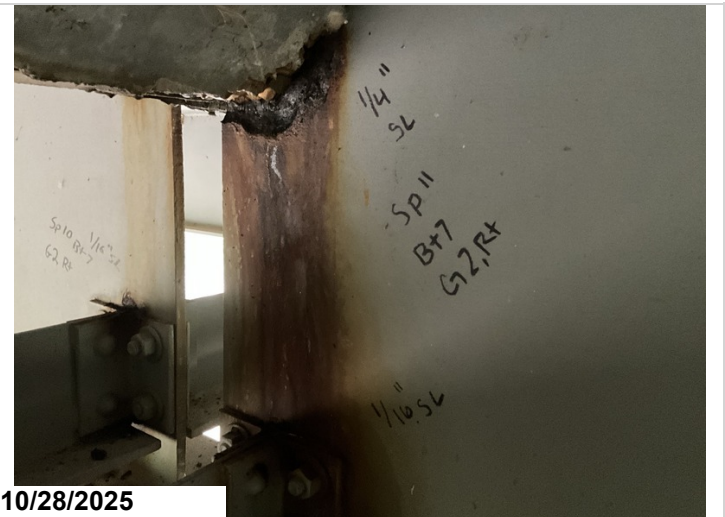
Span 11, Bent 7, Girder 3, Left: Active corrosion with section loss up to 5/16" to the web at the haunch area and a 1" X 1 1/4" hole in the web at the haunch area. 1LF CS4 corrosion.

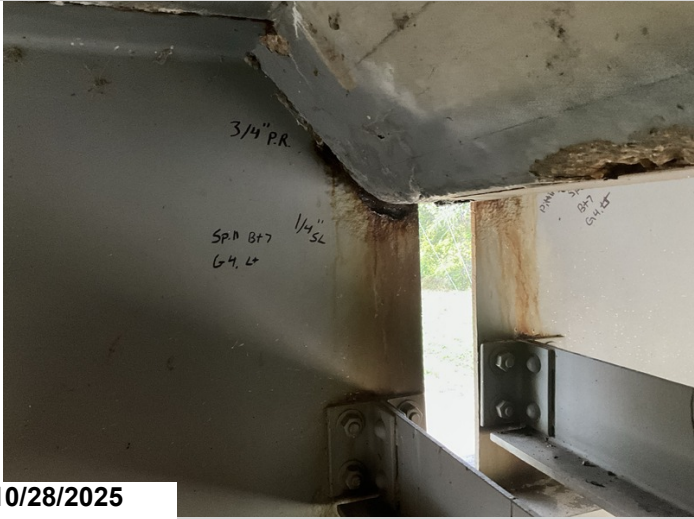
Span 11, Bent 7, Girder 2, Right: Active corrosion with section loss up to 1/4" to the web at the haunch area and section loss up to 1/16" to the web at the diaphragm connection. 1LF CS3 corrosion.

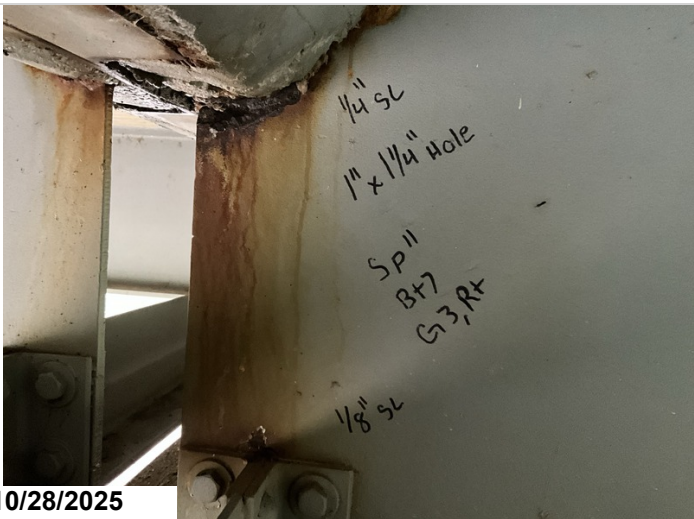
Span 11, Bent 7, Girder 3, Right: Active corrosion with section loss up to 5/16" to the web at the haunch area, a 1" X 1 1/4" hole in the web at the haunch area and section loss up to 1/8" to the web at the diaphragm connection. 1LF CS4 corrosion.

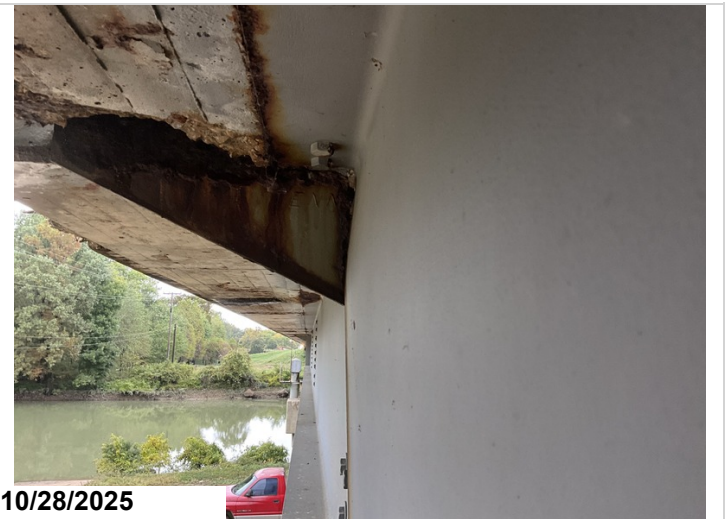
Span 11, Bent 7, Girder 3, Right: Active corrosion with section loss up to 5/16" to the web at the haunch area, a 1" X 1 1/4" hole in the web at the haunch area and section loss up to 1/8" to the web at the diaphragm connection. 1LF CS4 corrosion.

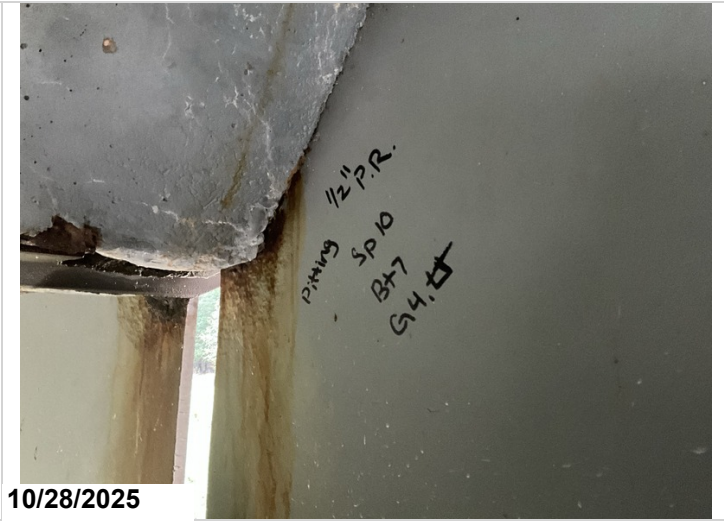
Span 11, Bent 7, Girder 4: Distortion in web due to pack rust between Girder web and concrete haunch.

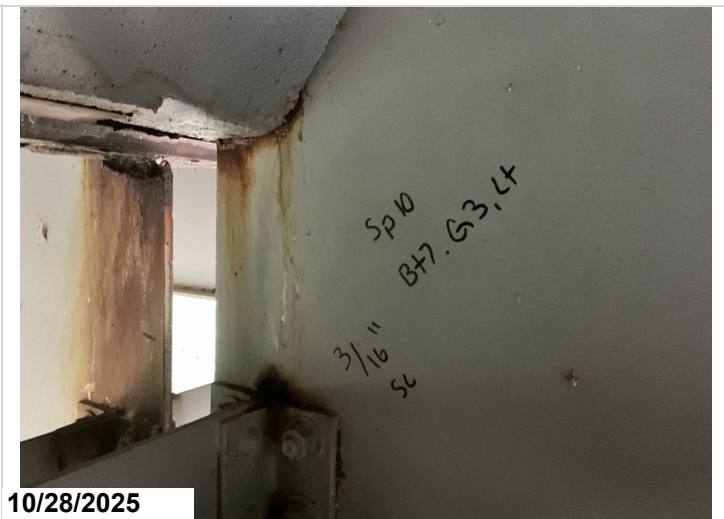
Span 10, Bent 7, Girder 2, Right: Active corrosion with section loss up to 1/16" to the web at the diaphragm connection. 1LF CS3 corrosion.

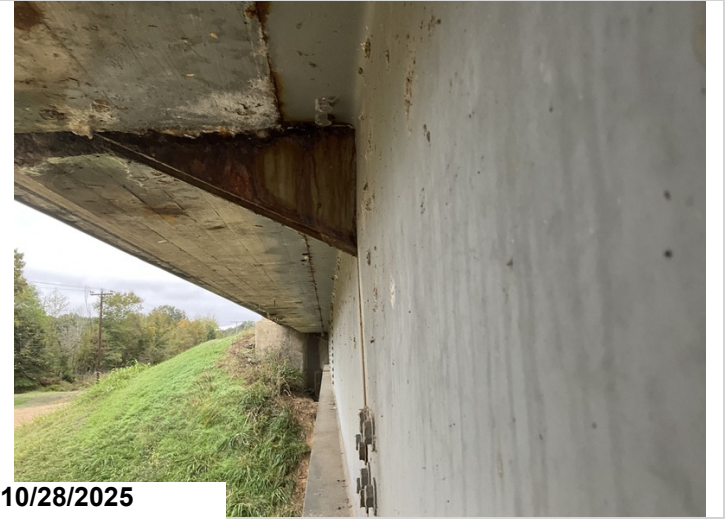
Span 10, Bent 7, Girder 2, Left: Active corrosion with section loss up to 1/8" to the web at the haunch area. 1LF CS3 corrosion.

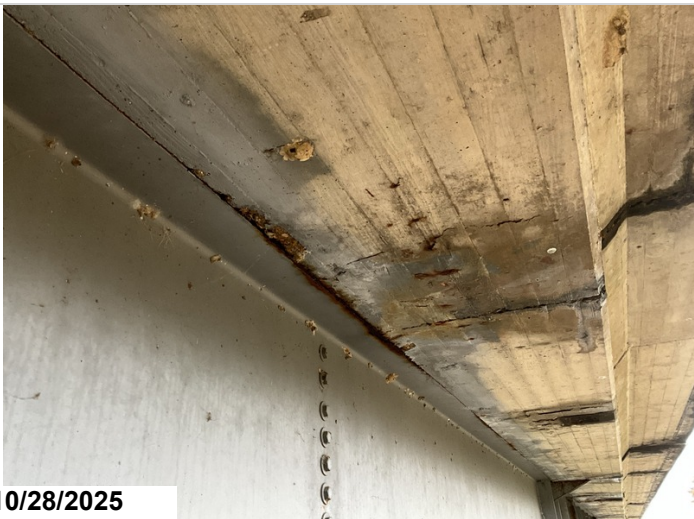
Span 10, Bent 7, Girder 1: Distortion in the web due to pack rust between the Girder web and concrete haunch.

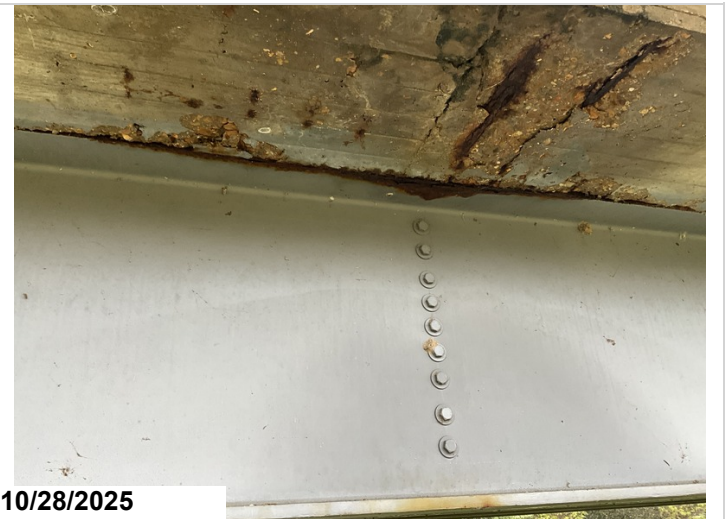
Span 10, Girder 1, Left: Active corrosion with flaking rust along the Top Flange. 7LF CS3 corrosion.

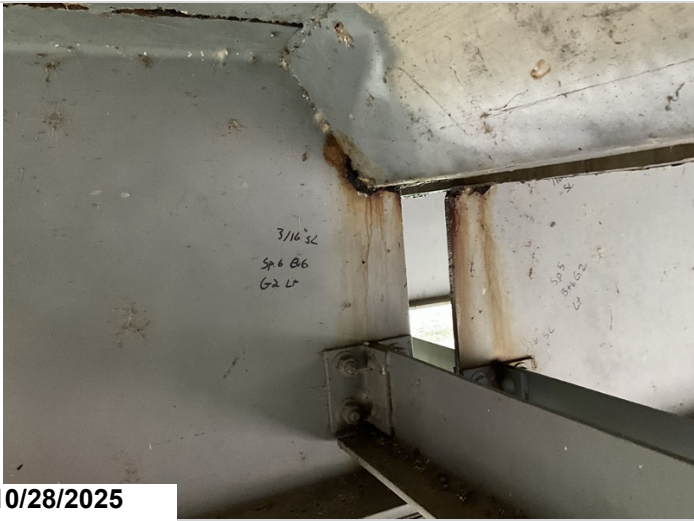
Span 6, Girder 1, Left: Active corrosion with flaking rust along the Top Flange. 7LF CS3 corrosion.

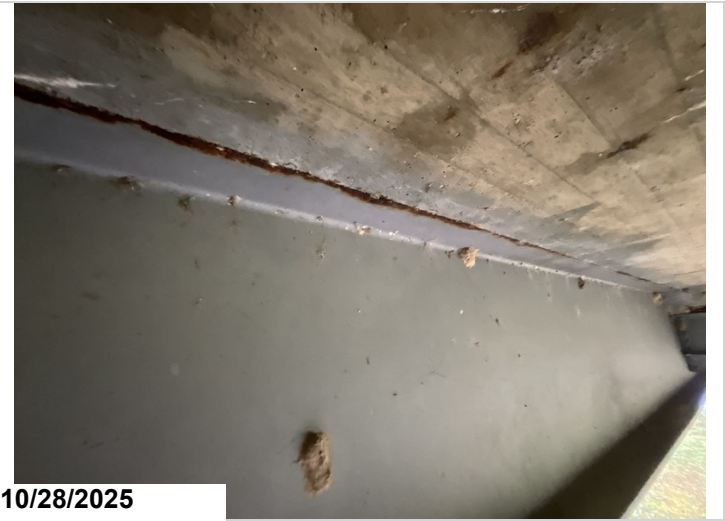
Span 6, Bent 6, Girder 2, Left: Active corrosion with section loss up to 3/16" to the web at the haunch area. 1LF CS3 corrosion.

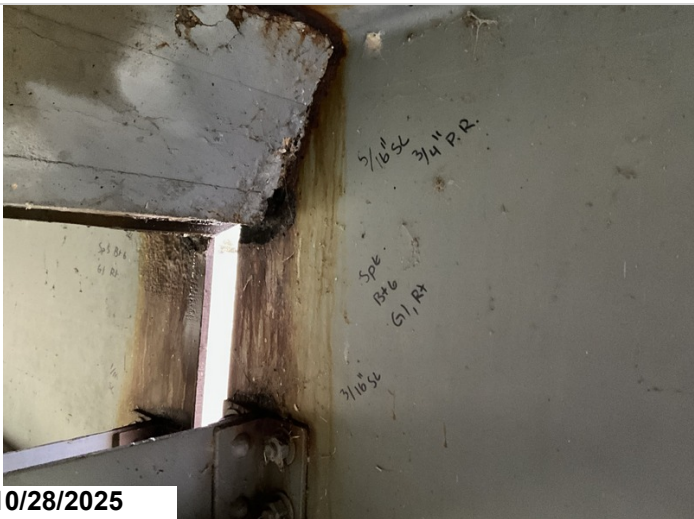
Span 6, Girder 1, Right, Top Flange: Active corrosion with flaking rust along the Top Flange. 12LF CS3 corrosion. Left side mirrors.

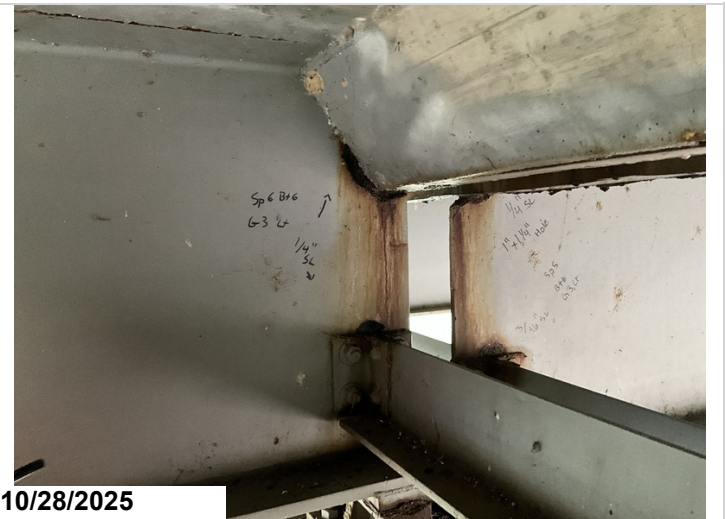
Span 6, Bent 6, Girder 1, Right: Active corrosion with section loss up to 5/16" to the web at the haunch area, section loss up to 3/16" to the web at the diaphragm connection, and pack rust up to 3/4" between the girder web and the concrete haunch. 1LF CS3 corrosion.

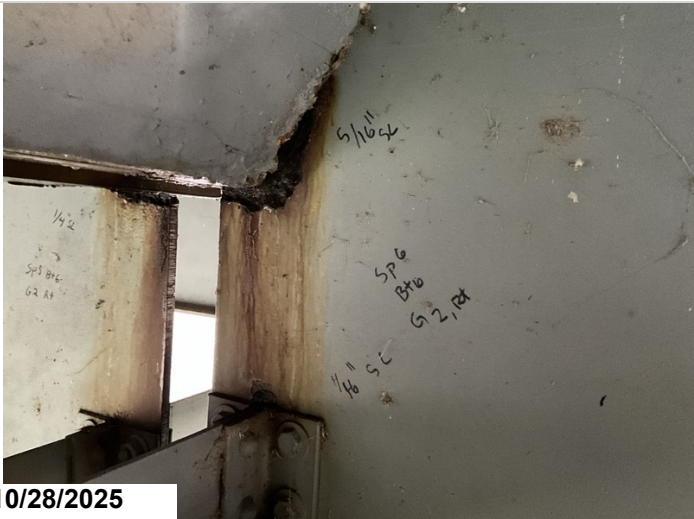
Span 6, Bent 6, Girder 3, Left: Active corrosion with section loss up to 1/4" to the web at the haunch and diaphragm connection areas. 1LF CS3 corrosion.

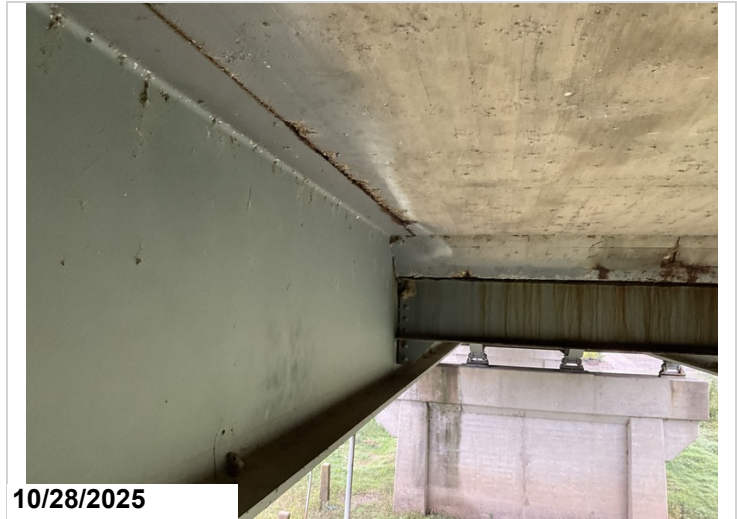
Span 6, Bent 6, Girder 2, Right: Active corrosion with section loss up to 5/16" to the web at the haunch area and section loss up to 1/16" to the web at the diaphragm connection. 1LF CS3 corrosion.

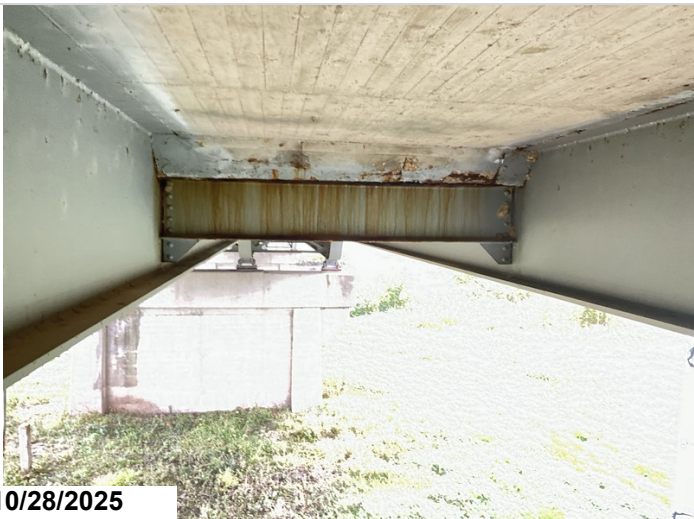
Span 6, Girder 2, Right: Active corrosion with flaking rust along the Top Flange. 6LF CS3 corrosion.

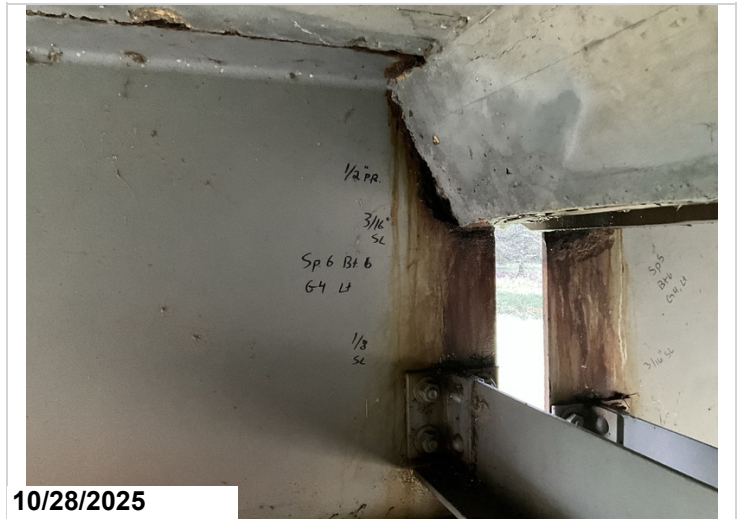
Span 6: Typical condition at intermediate diaphragms.

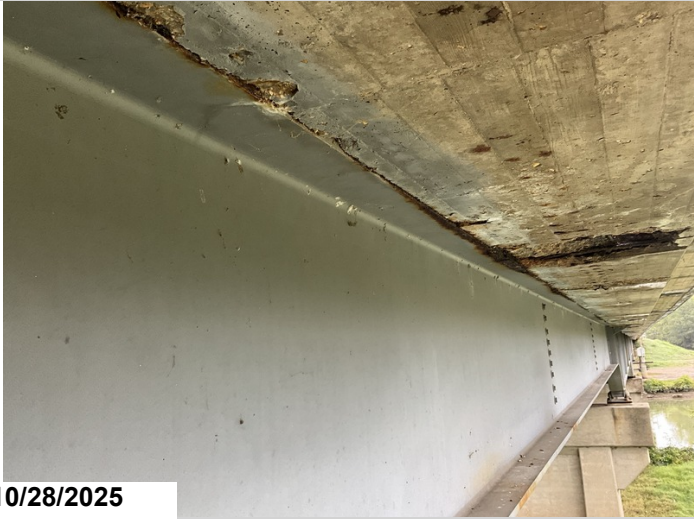
Span 6, Bent 6, Girder 4, Left: Active corrosion with section loss up to 3/16" to the web at the haunch area, section loss up to 1/8" to the web at the diaphragm connection, and pack rust up to 1/2" between the girder web and the concrete haunch. 1LF CS3 corrosion.

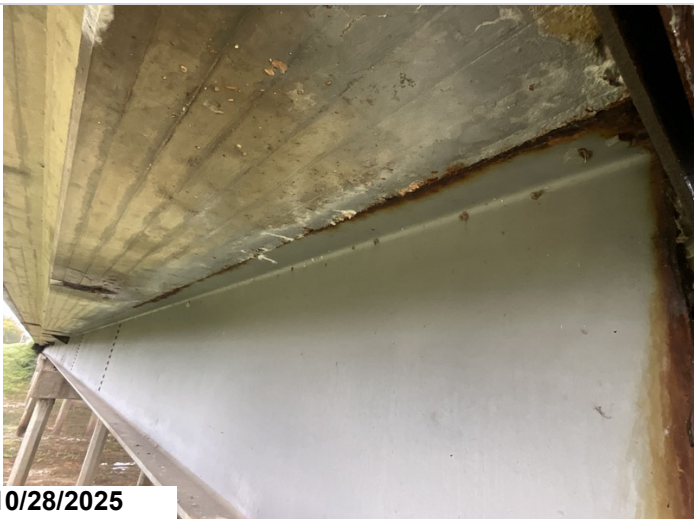
Span 6, Bent 6, Girder 4: Distortion in the web due to pack rust between the Girder web and the concrete haunch.

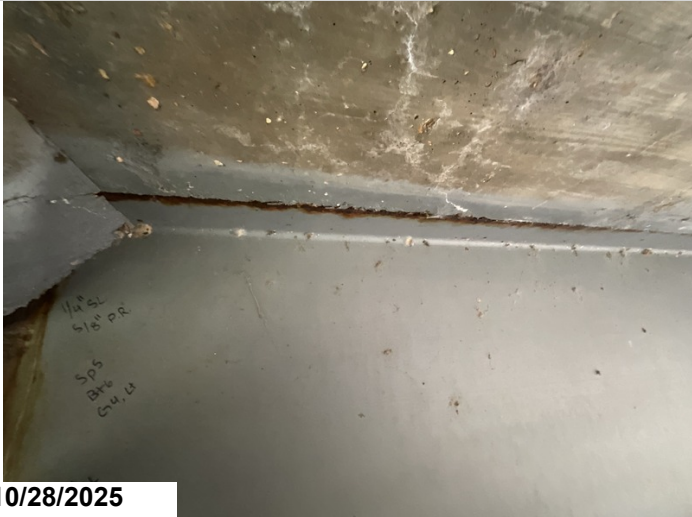
Span 5, Bent 6, Girder 3, Right: Active corrosion with section loss up to 1/8" to the web at the haunch and diaphragm connection areas. 1LF CS3 corrosion.

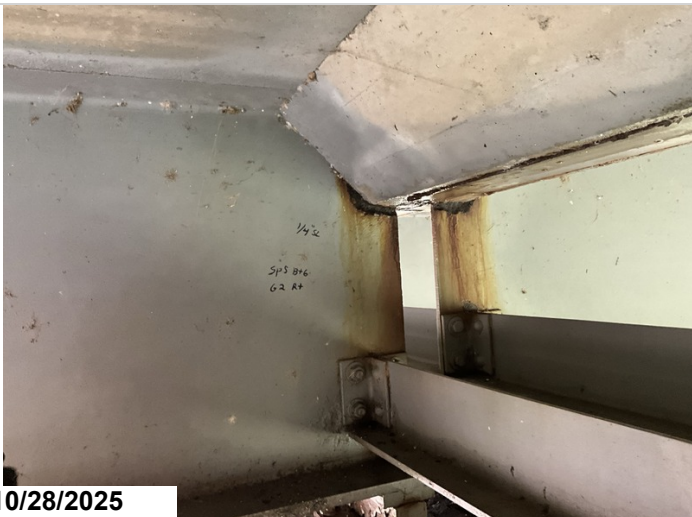
Span 5, Bent 6, Girder 4, Left: Active corrosion with section loss up to 1/4" to the web at the haunch area, section loss up to 3/16" to the web at the diaphragm connection, and pack rust up to 5/8" between the girder web and the concrete haunch. 1LF CS3 corrosion.

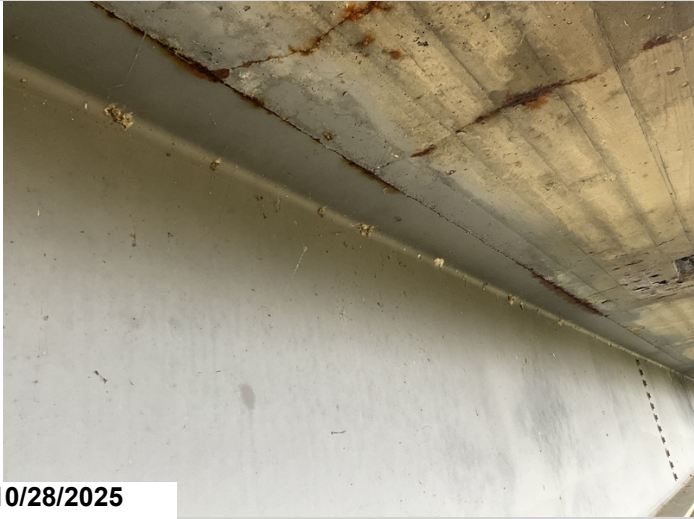
Span 5, Bent 6, Girder 1, Right: Active corrosion with section loss up to 3/16" to the web at the haunch area, section loss up to 1/16" to the web at the diaphragm connection, and pack rust up to 3/4" between the girder web and the concrete haunch. 1LF CS3 corrosion.

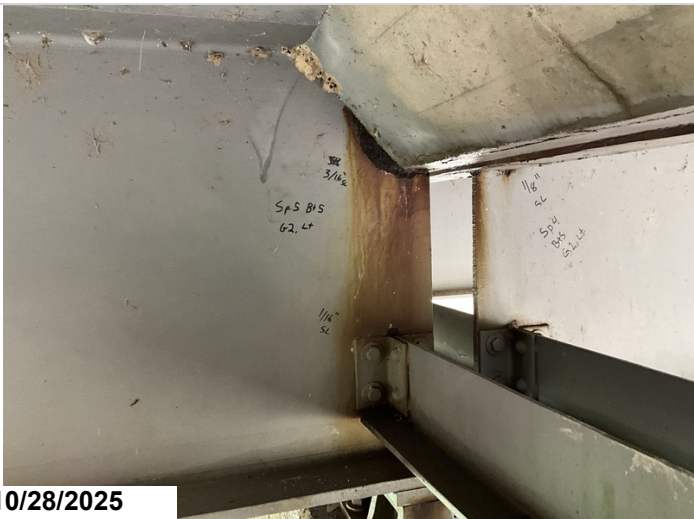
Span 5, Bent 6, Girder 1: Distortion in the web due to pack rust between Girder web and concrete haunch.

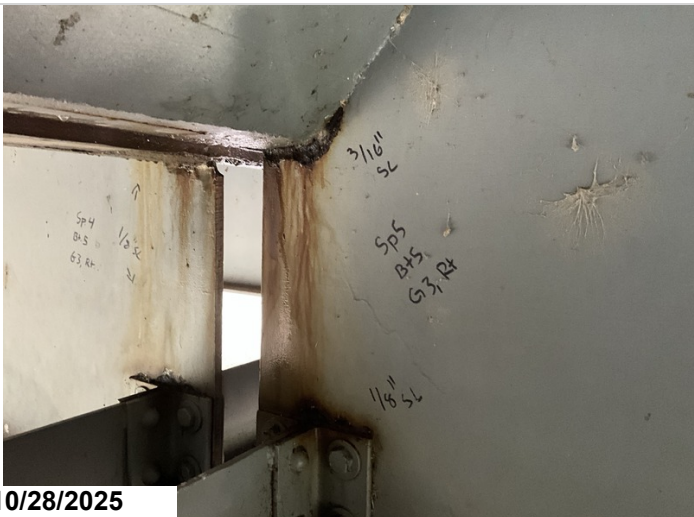
Span 5, Bent 5, Girder 4, Left: Active corrosion with section loss up to 5/16" to the web at the haunch area, section loss up to 1/8" to the web at the diaphragm connection, and pack rust up to 1/2" between the girder web and the concrete haunch. 1LF CS3 corrosion.

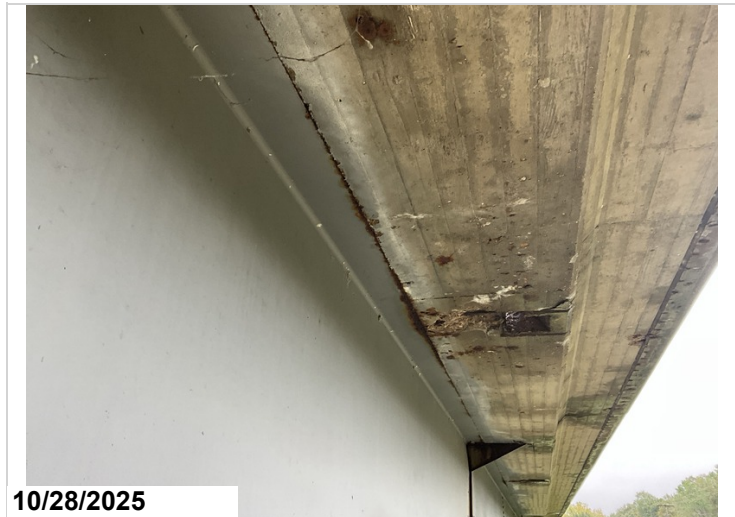
Span 5, Bent 5, Girder 3, Right: Active corrosion with section loss up to 3/16" to the web at the haunch area and section loss up to 1/8" to the web at the diaphragm connection. 1LF CS3 corrosion.

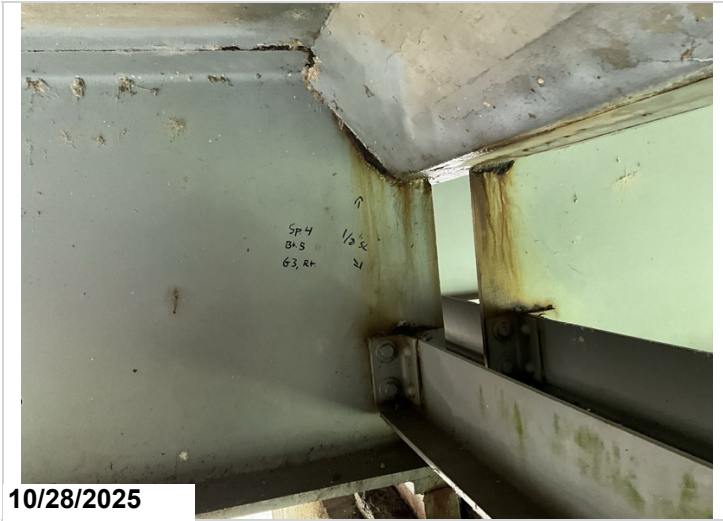
Span 4, Girder 4, Right: Active corrosion with flaking rust along the Top Flange. 11LF CS3 corrosion.

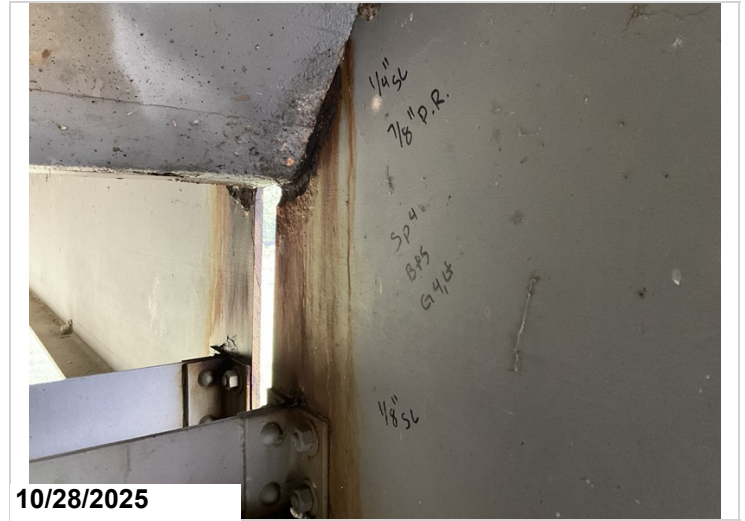
Span 4, Bent 5, Girder 3, Right: Active corrosion with section loss up to 1/8" to the web at the haunch and diaphragm connection areas. 1LF CS3 corrosion.

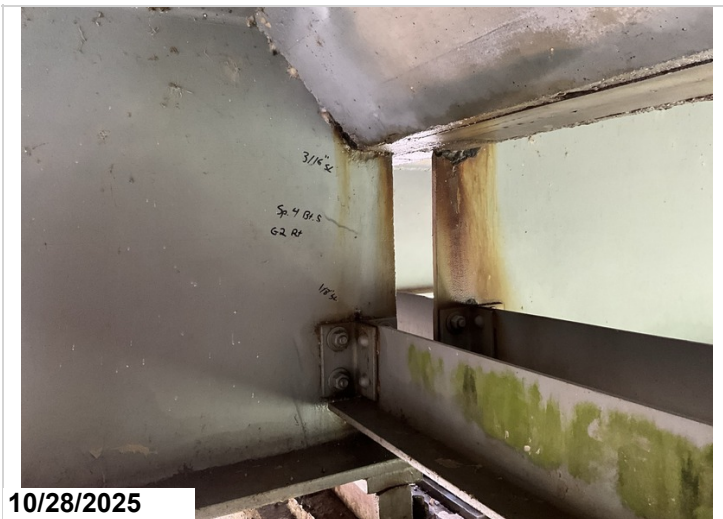
Span 4, Bent 5, Girder 4, Left: Active corrosion with section loss up to 1/4" to the web at the haunch area, section loss up to 1/8" to the web at the diaphragm connection, and pack rust up to 7/8" between the girder web and the concrete haunch. 1LF CS3 corrosion.

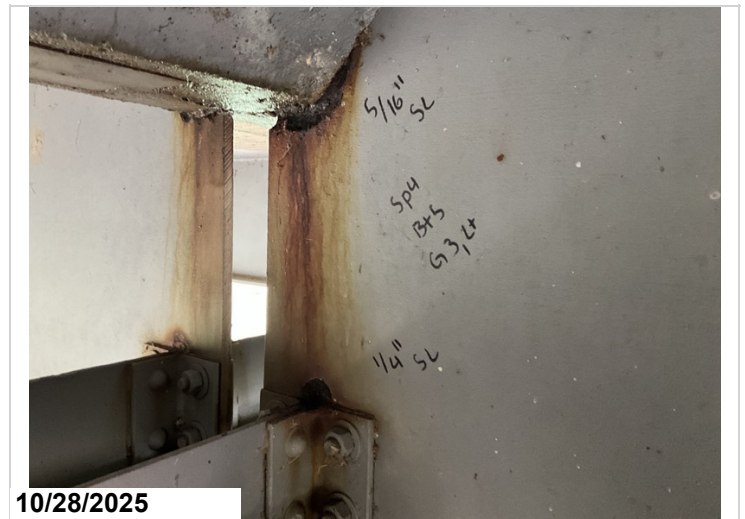
Span 4, Bent 5, Girder 2, Right: Active corrosion with section loss up to 3/16" to the web at the haunch area and section loss up to 1/8" to the web at the diaphragm connection. 1LF CS3 corrosion.

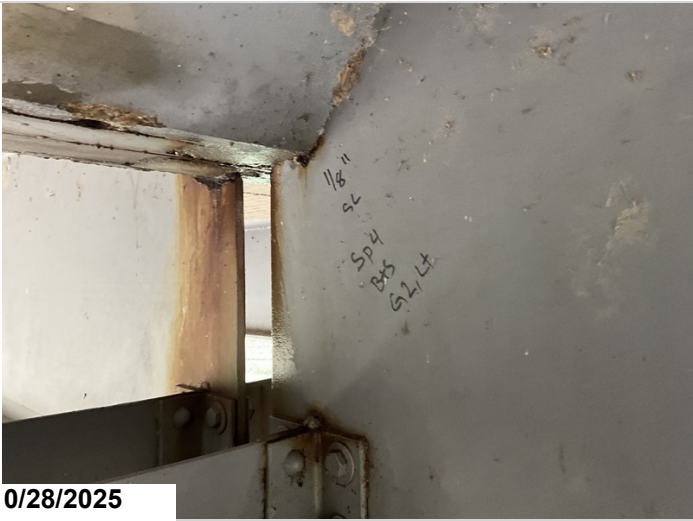
Span 4, Bent 5, Girder 3, Left: Active corrosion with section loss up to 5/16" to the web at the haunch area and section loss up to 1/4" to the web at the diaphragm connection. 1LF CS3 corrosion.

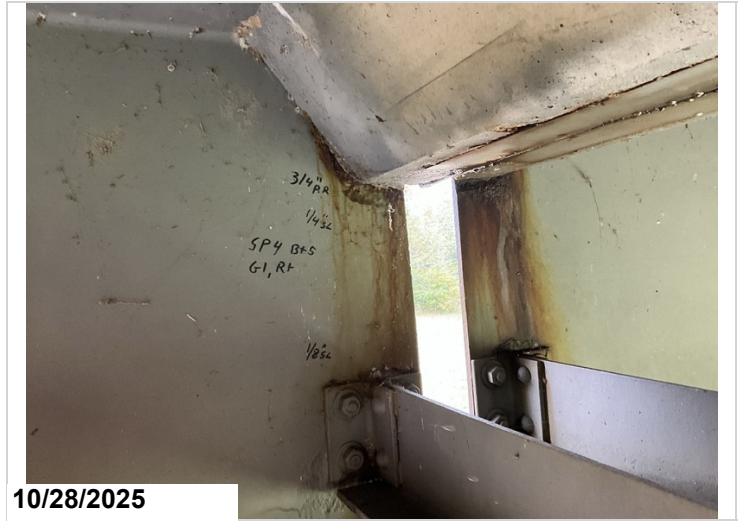
Span 4, Bent 5, Girder 2, Left: Active corrosion with section loss up to 1/8" to the web at the haunch area. 1LF CS3 corrosion.

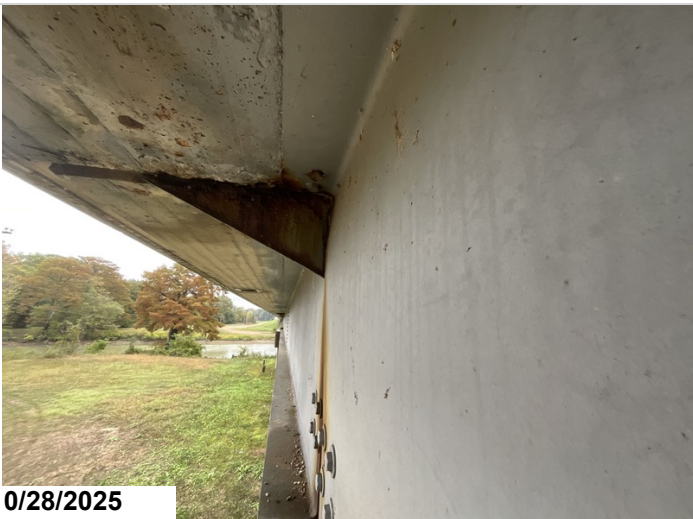
Span 4, Bent 5, Girder 1, Right: Active corrosion with section loss up to 1/4" to the web at the haunch area, section loss up to 1/8" to the web at the diaphragm connection, and pack rust up to 3/4" between the girder web and the concrete haunch. 1LF CS3 corrosion.

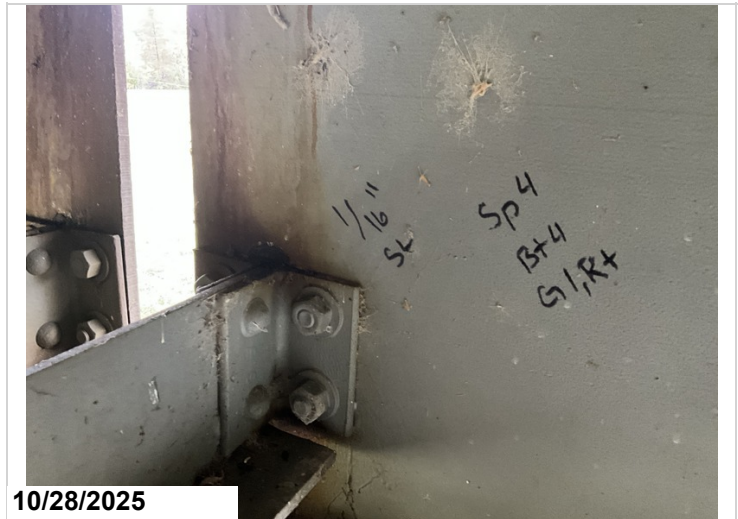
Span 4, Bent 5, Girder 1: Minor distortion in the web due to pack rust between the Girder web and concrete haunch.

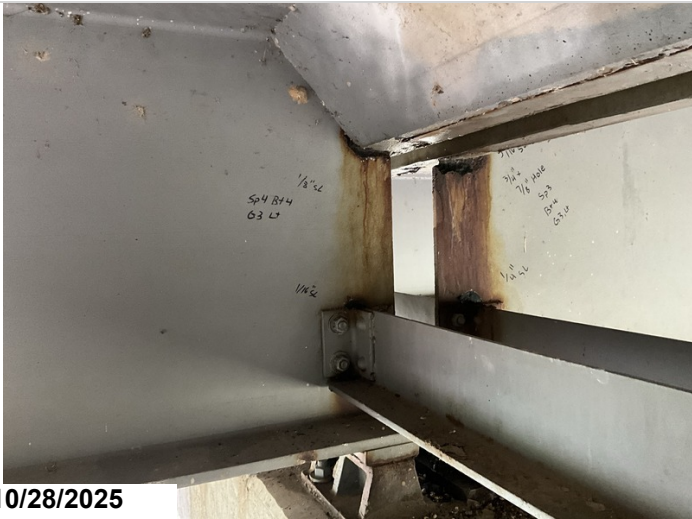
Span 4, Bent 4, Girder 1, Right: Active corrosion with section loss up to 1/16" to the web at the diaphragm connection. 1LF CS3 corrosion.

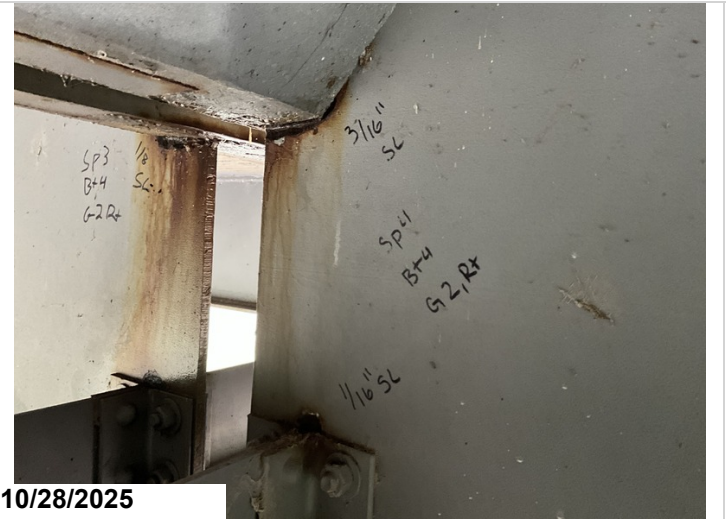
Span 4, Bent 4, Girder 3, Left: Active corrosion with section loss up to 1/8" to the web at the haunch area and section loss up to 1/16" to the web at the diaphragm connection. 1LF CS3 corrosion.

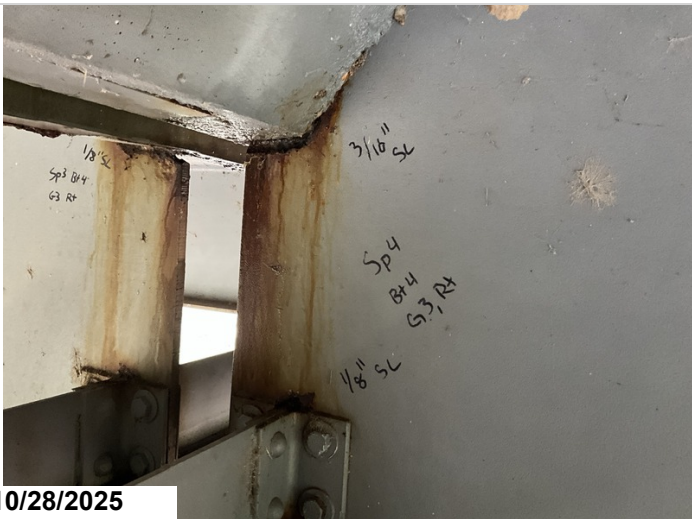
Span 4, Bent 4, Girder 2, Right: Active corrosion with section loss up to 3/16" to the web at the haunch area and section loss up to 1/16" to the web at the diaphragm connection. 1LF CS3 corrosion.

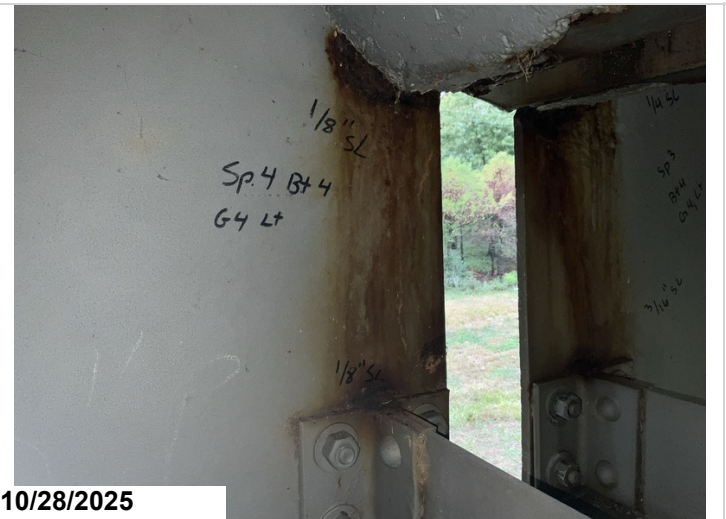
Span 4, Bent 4, Girder 3, Right: Active corrosion with section loss up to 3/16" to the web at the haunch area and section loss up to 1/8" to the web at the diaphragm connection. 1LF CS3 corrosion.

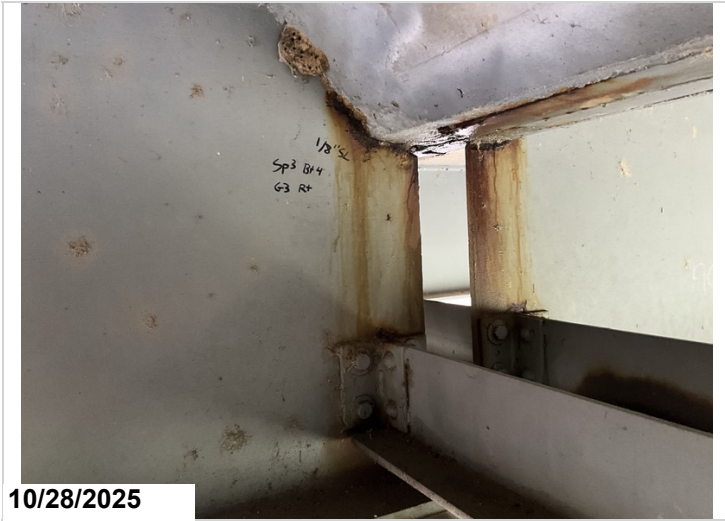
Span 4, Bent 4, Girder 4, Left: Active corrosion with section loss up to 1/8" to the web at the haunch and diaphragm connection areas. 1LF CS3 corrosion.

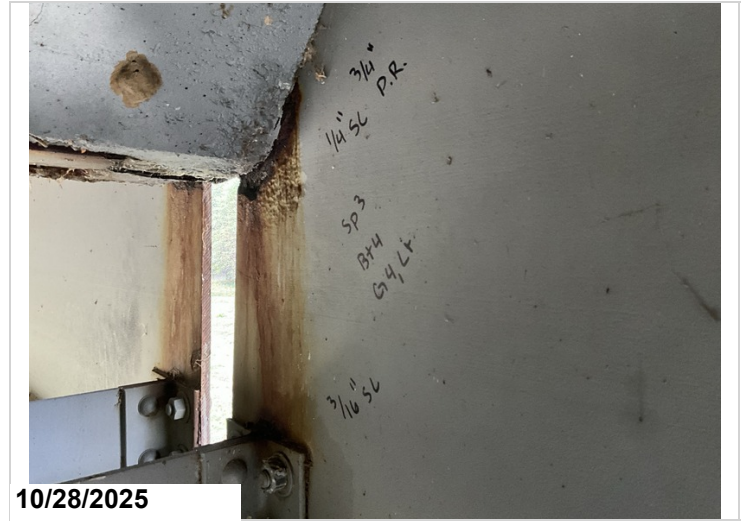
Span 3, Bent 4, Girder 3, Right: Active corrosion with section loss up to 1/8" to the web at the haunch area. 1LF CS3 corrosion.

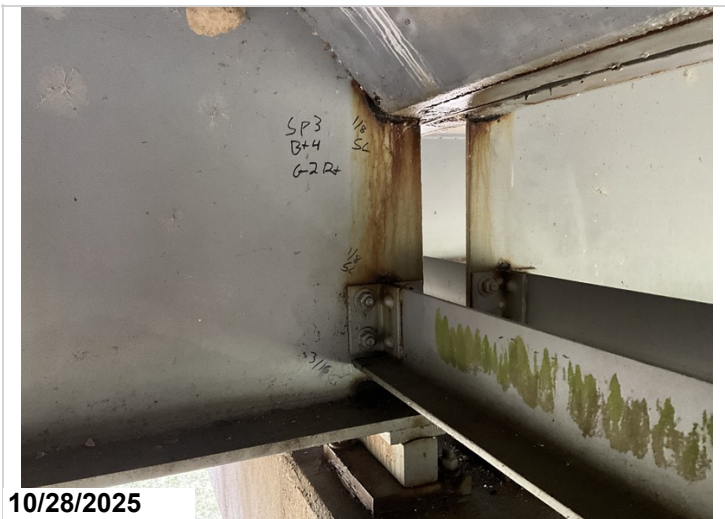
Span 3, Bent 4, Girder 4, Left: Active corrosion with section loss up to 1/4" to the web at the haunch area, section loss up to 3/16" to the web at the diaphragm connection, and pack rust up to 3/4" between the girder web and the concrete haunch. 1LF CS3 corrosion.

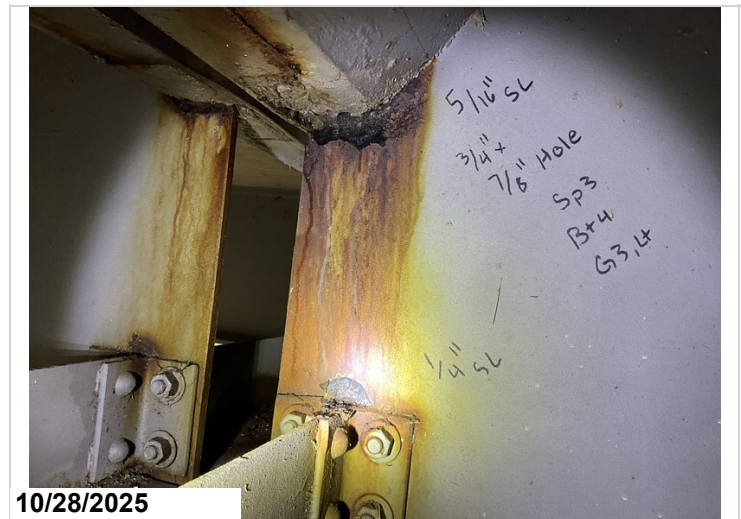
Span 3, Bent 4, Girder 2, Right: Active corrosion with section loss up to 1/8" to the web at the haunch and diaphragm connection areas and section loss up to 3/16" to the web at the bottom flange/web juncture. 1LF CS3 corrosion.

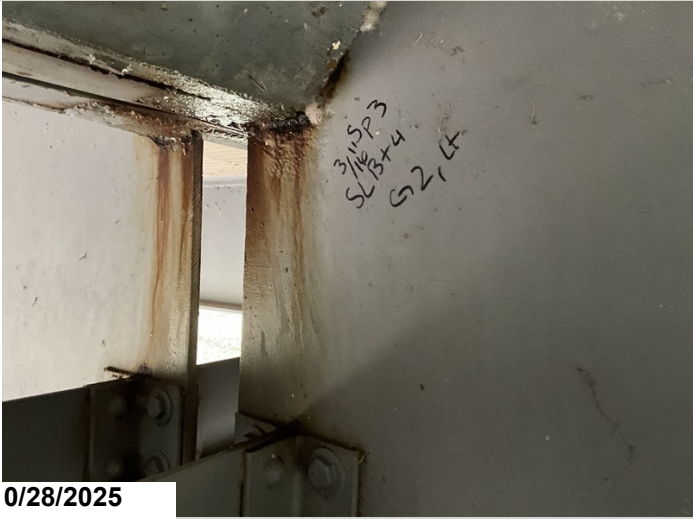
Span 3, Bent 4, Girder 3, Left: Active corrosion with section loss up to 5/16" to the web at the haunch area, a 3/4" X 7/8" hole in the web at the haunch area, and section loss up to 1/4" to the web at the diaphragm connection. 1LF CS4 corrosion.

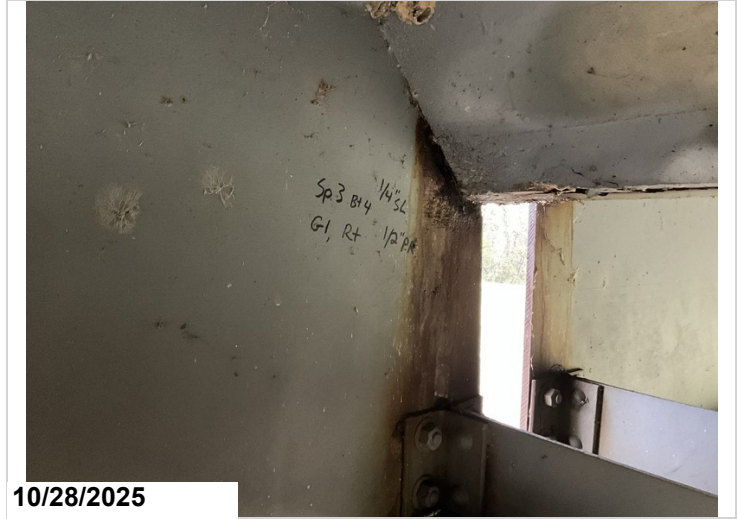
Span 3, Bent 4, Girder 2, Left: Active corrosion with section loss up to 3/16" to the web at the haunch area. 1LF CS3 corrosion.

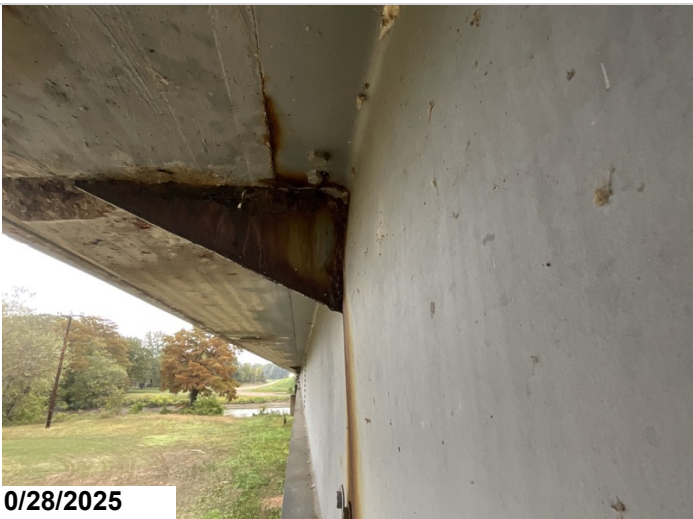
Span 3, Bent 4, Girder 1, Right: Active corrosion with section loss up to 1/4" to the web at the haunch area and pack rust up to 1/2" between the girder web and the concrete haunch. 1LF CS3 corrosion.

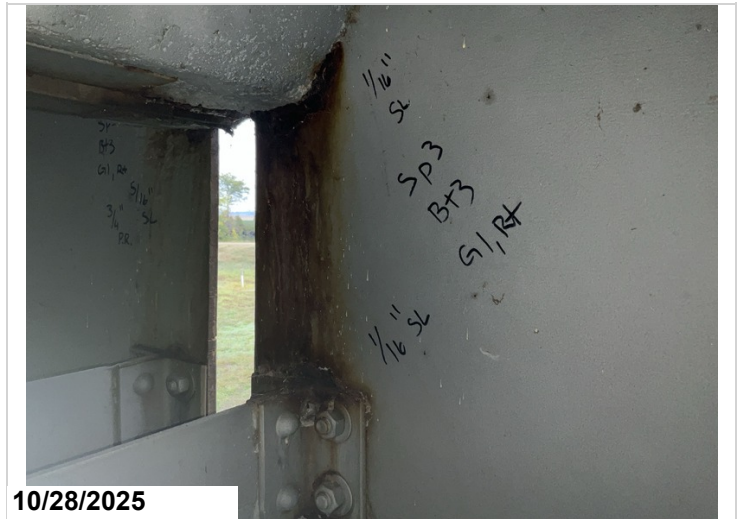
Span 3, Bent 4, Girder 1: Minor distortion in web due to pack rust between the Girder web and concrete haunch.

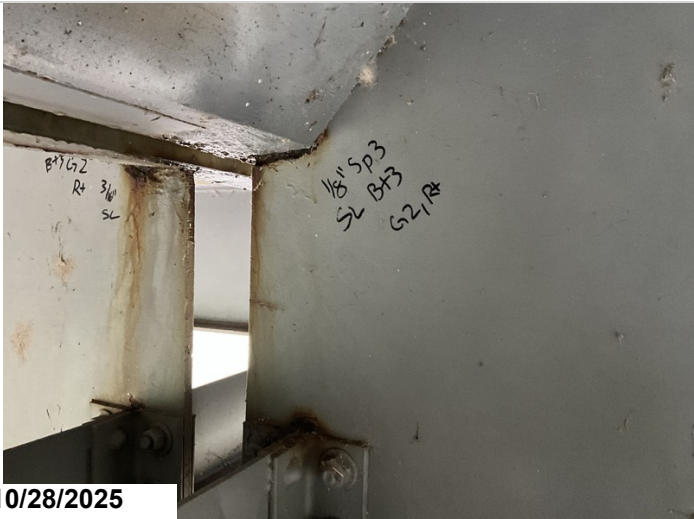
Span 3, Bent 3, Girder 1, Right: Active corrosion with section loss up to 1/16" to the web at the haunch and diaphragm connection areas. 1LF CS3 corrosion.

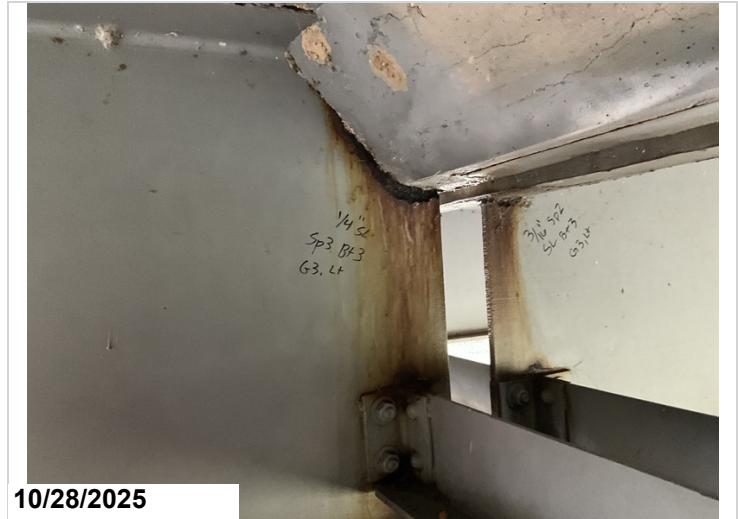
Span 3, Bent 3, Girder 2, Right: Active corrosion with section loss up to 1/8" to the web at the haunch area. 1LF CS3 corrosion.

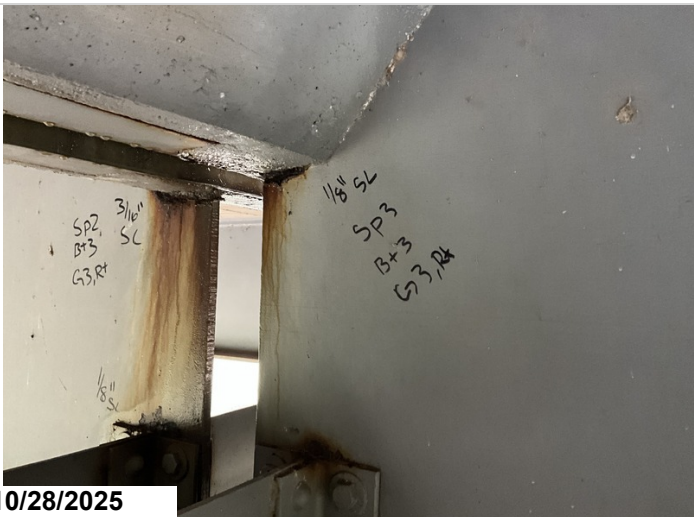
Span 3, Bent 3, Girder 3, Left: Active corrosion with section loss up to 1/4" to the web at the haunch area. 1LF CS3 corrosion.

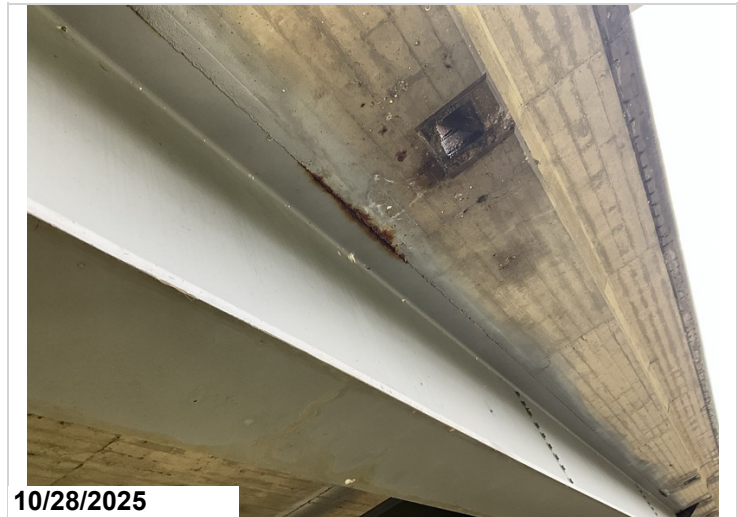
Span 3, Bent 3, Girder 3, Right: Active corrosion with section loss up to 1/8" to the web at the haunch area. 1LF CS3 corrosion.

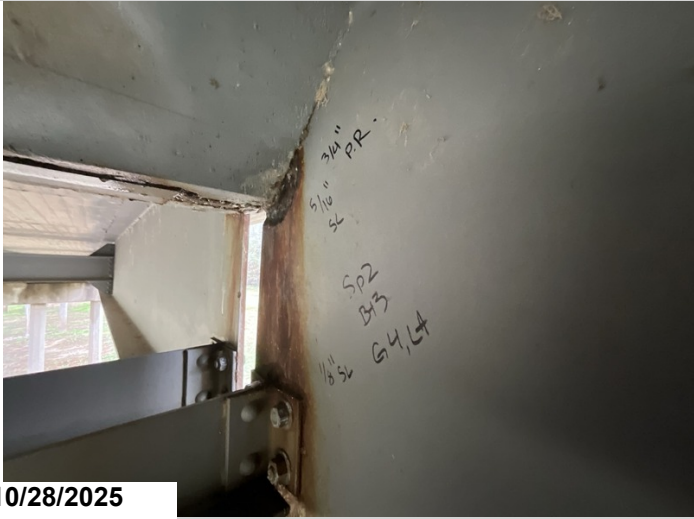
Span 2, Girder 4, Right, Top Flange: Active corrosion with flaking rust along the Top Flange. 6LF CS3 corrosion.

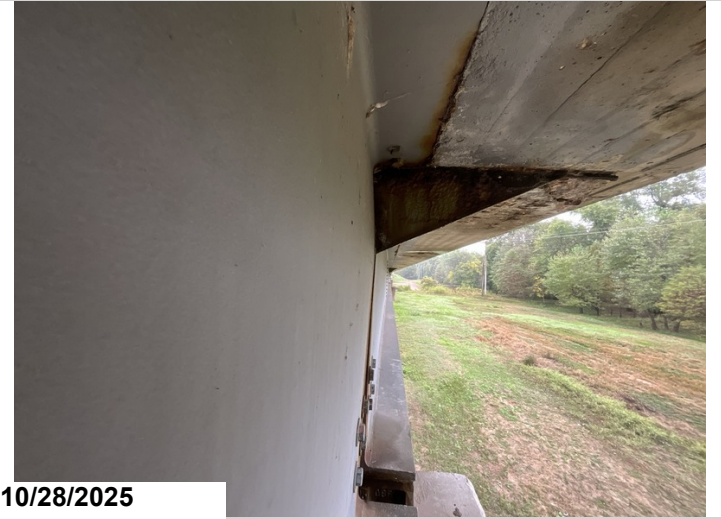
Span 2, Bent 3, Girder 4, Left: Active corrosion with section loss up to 5/16" to the web at the haunch area, section loss up to 1/8" to the web at the diaphragm connection, and pack rust up to 3/4" between the girder web and the concrete haunch. 1LF CS3 corrosion.
