Bridge 03023 Inspection Report

Route:62 Section:20 Log:2.58

Arnold Road ID:11x62x20xA, Arnold Log mile:2.593

(4) Place Code	0
(6) Features Intersected	BLACK RIVER
(7) Facility Carried	US 62-20- LM 2.58
(9) Location	2.58 MI E US 67
(11) Mile Point	2.58 mi
(12) Base Highway Network	Yes

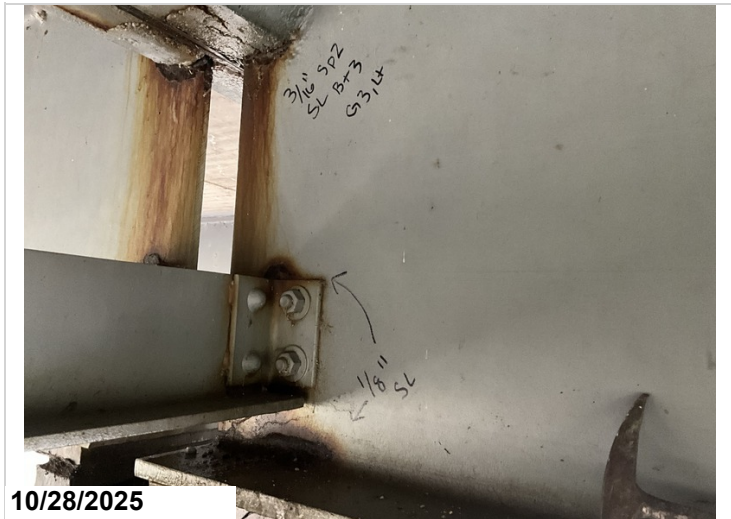
Span 2, Bent 3, Girder 3, Right: Active corrosion with section loss up to 3/16" to the web at the haunch area and section loss up to 1/8" to the web at the diaphragm connection. 1LF CS3 corrosion.

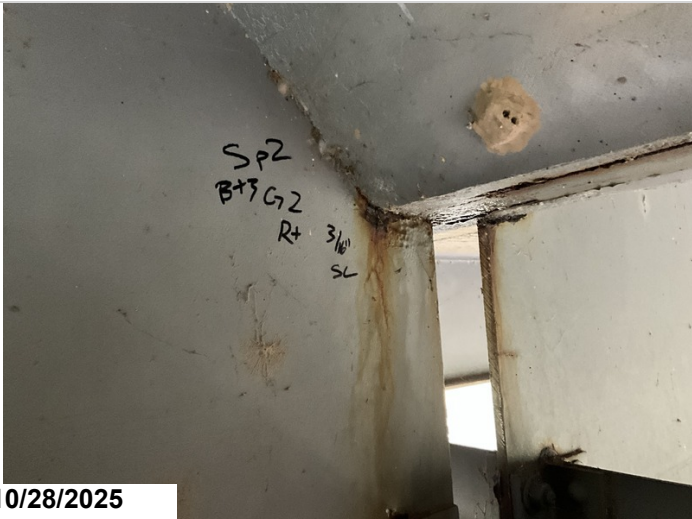
Span 2, Bent 3, Girder 3, Left: Active corrosion with section loss up to 5/16" to the web at the haunch area, section loss up to 1/8" to the web at the diaphragm connection, and section loss up to 1/8" to the web at the bottom flange/web juncture. 1LF CS3 corrosion.

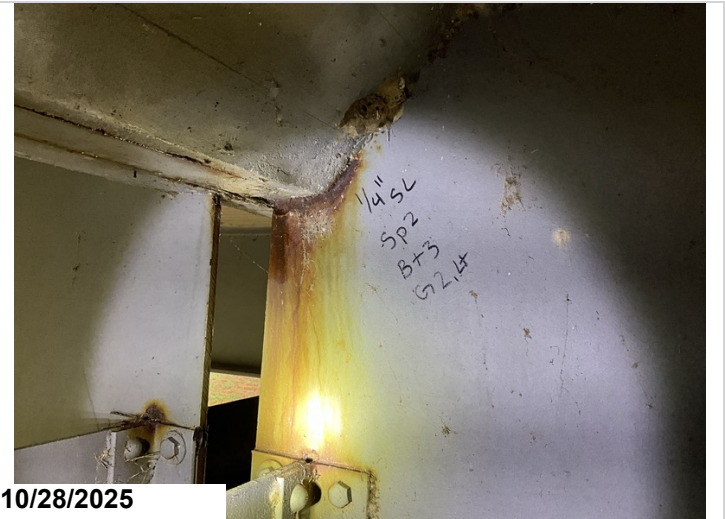
Span 2, Bent 3, Girder 2, Right: Active corrosion with section loss up to 3/16" to the web at the haunch area. 1LF CS3 corrosion.

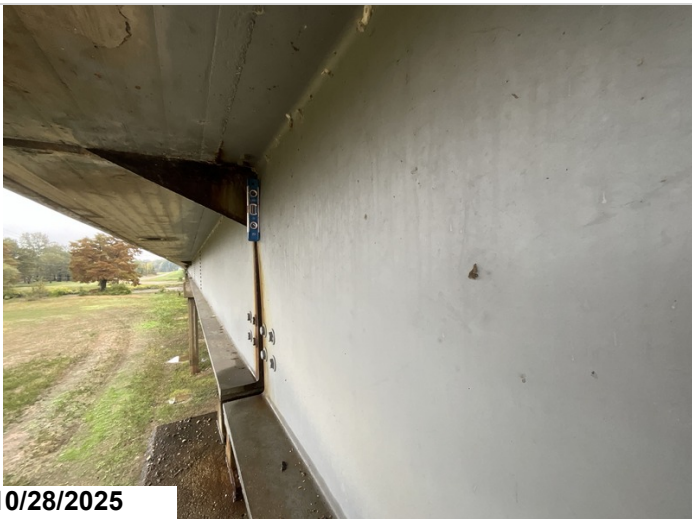
Span 2, Bent 3, Girder 2, Left: Active corrosion with section loss up to 1/4" to the web at haunch area. 1LF CS3 corrosion.

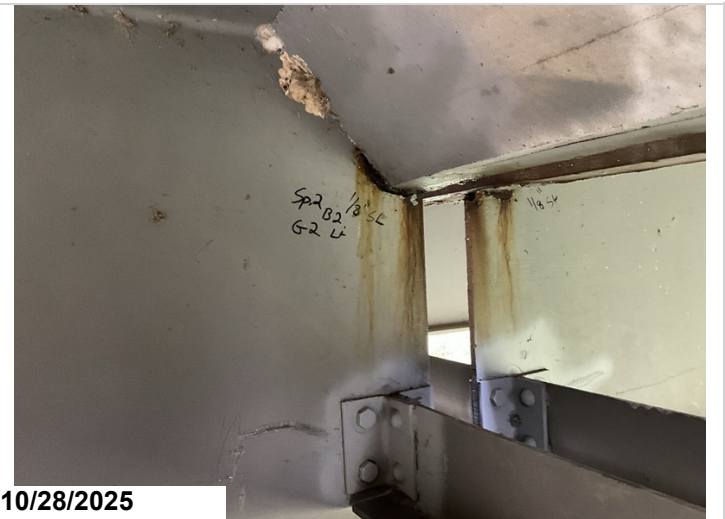
Span 2, Bent 3, Girder 1, Left: Minor distortion in the web due to pack rust between Girder web and concrete haunch.

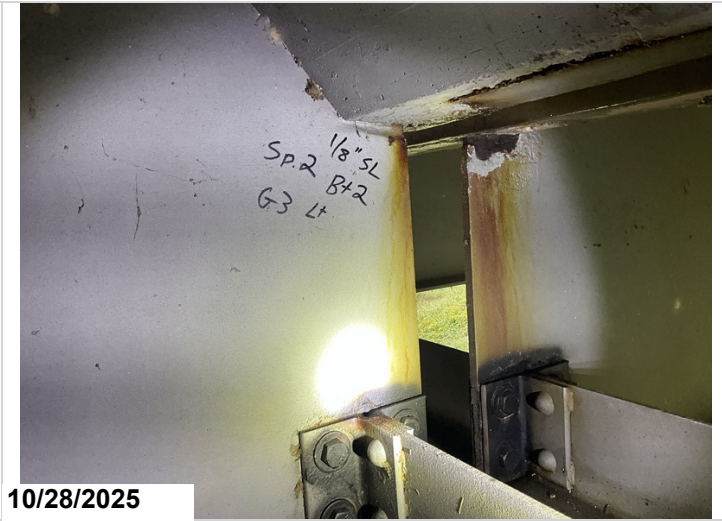
Span 2, Bent 2, Girder 2, Left: Active corrosion with section loss up to 1/8" section loss to the web in the haunch area. 1LF CS3 corrosion.

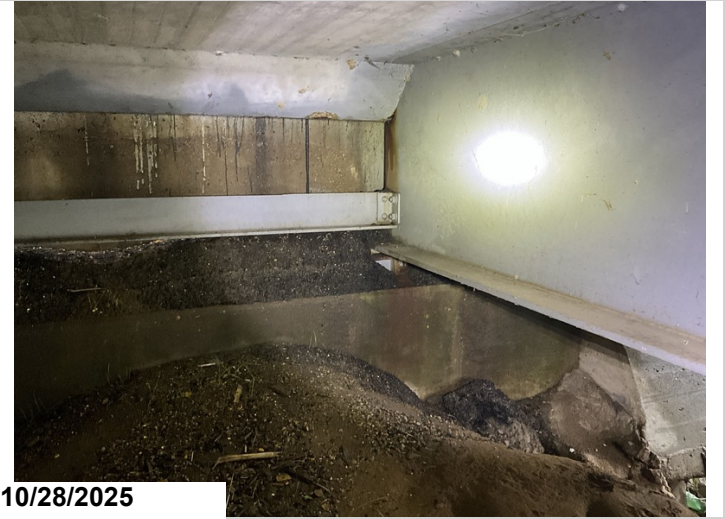
Span 1, Bent 2, Girder 4: Active corrosion with section loss up to 1/4" to the web at the haunch area. 1LF CS3 corrosion

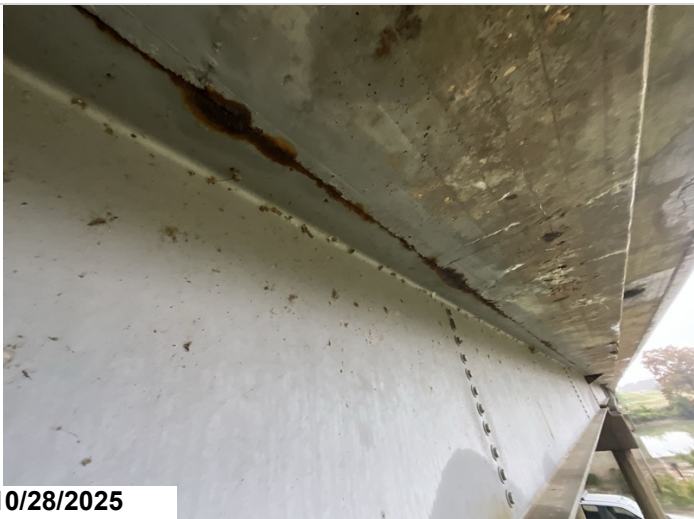
Span 1, Bent 1, Girders 1 - 4: Active corrosion with flaking rust to the web in the haunch areas. 4LF CS3 corrosion.

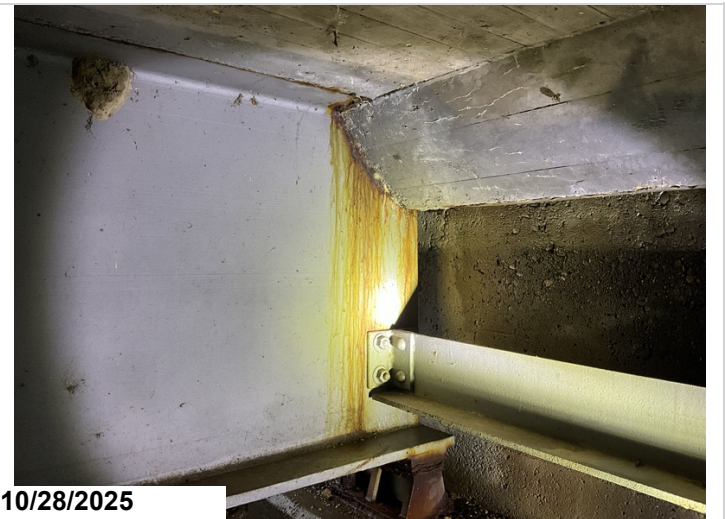
Span 11, Girders 1 - 4: Active corrosion with flaking rust along the Top Flange. 115LF CS3 corrosion.

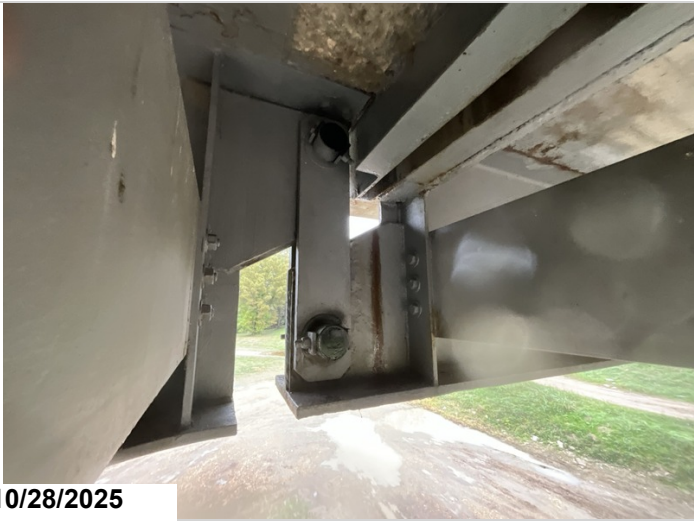
Span 11, Bent 8, Girder 1: Active corrosion with flaking rust. 1LF CS3 corrosion.

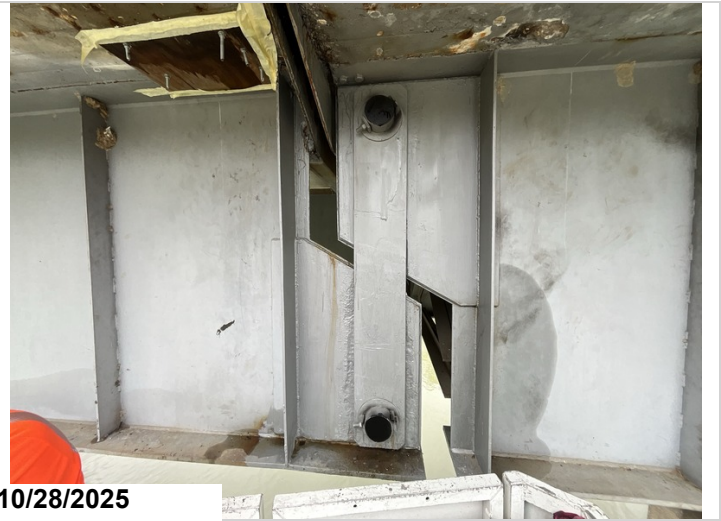
Span 10, Pin and Hanger Assembly: Pin and Hanger Assembly's have been replaced since the last inspection.

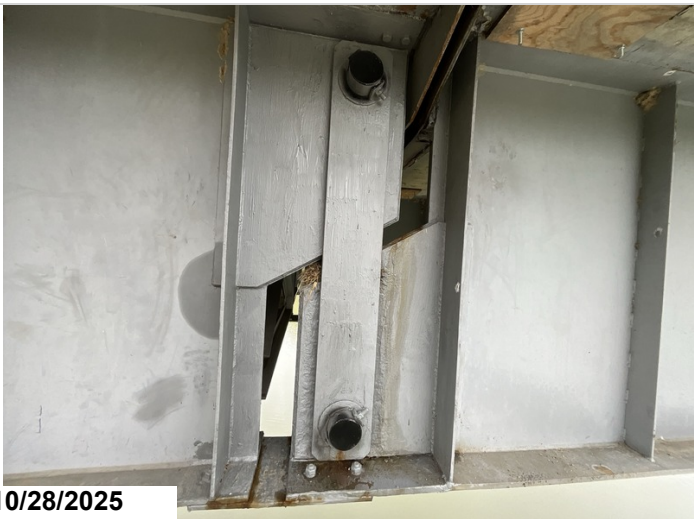
Span 8, Second Pin and Hanger Assembly's: Pin and Hanger Assembly's have been replaced since the last inspection.

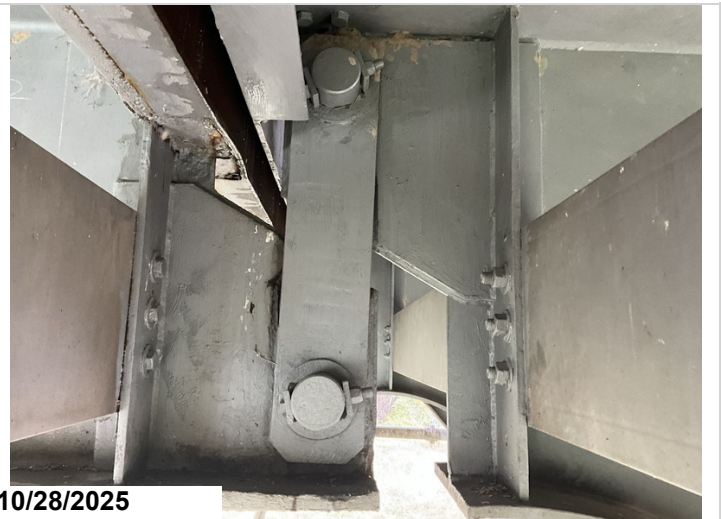
Span 8, First set of Pin and Hanger Assembly's: Pin and Hanger Assembly's have been replaced since the last inspection.

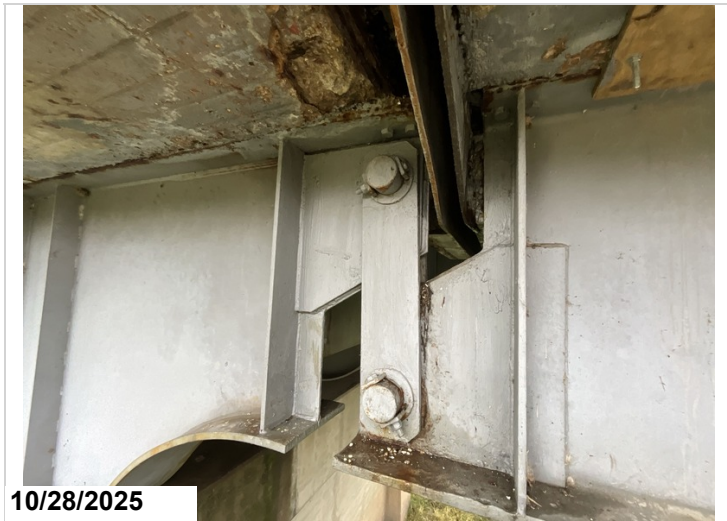
Span 6, Pin and Hanger Assemblies: Replaced since last inspection.

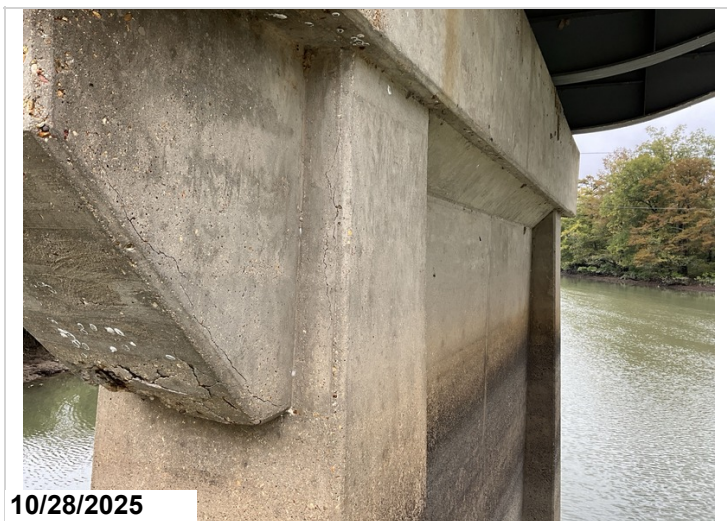
Pier 3, Column 2, Ahead: Spalling with exposed reinforcing steel with section loss near bottom of cap. 1EA CS3 exposed reinforcing steel.

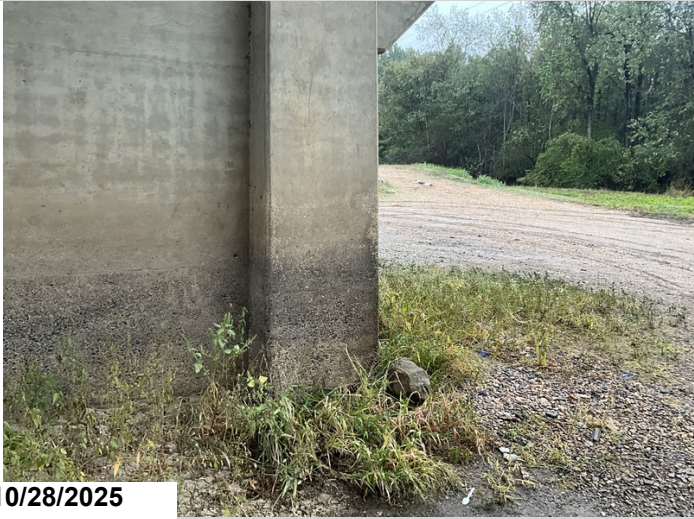
Pier 4, Column 1, Back: Spalling with exposed reinforcing steel. 1EA CS3 exposed reinforcing steel.

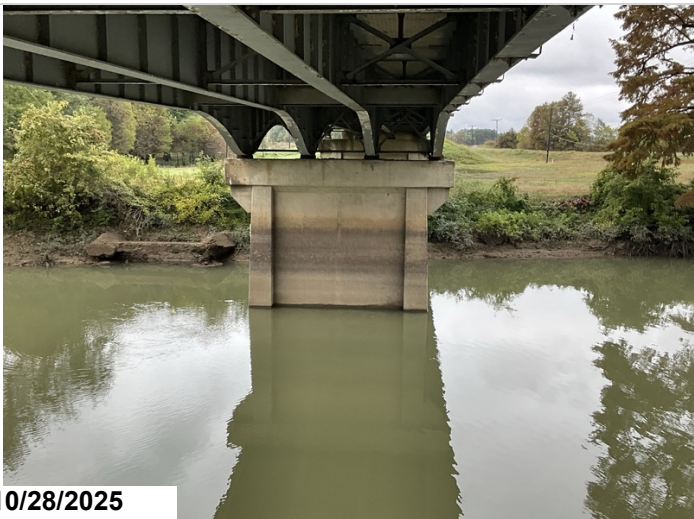
Pier 3, Back, Wall: Vertical cracking Right of centerline. 1LF CS2 cracking.

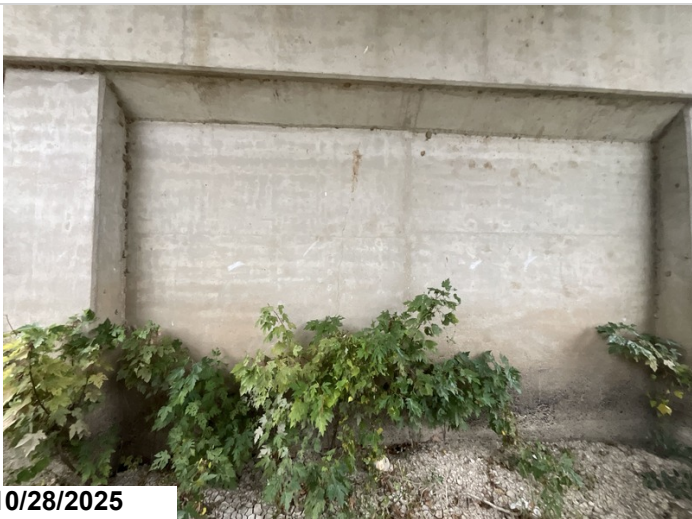
Pier 4, Wall, Ahead and Back: Abrasion from ground line to 3' above ground line. Rest in CS2 Abrasion.

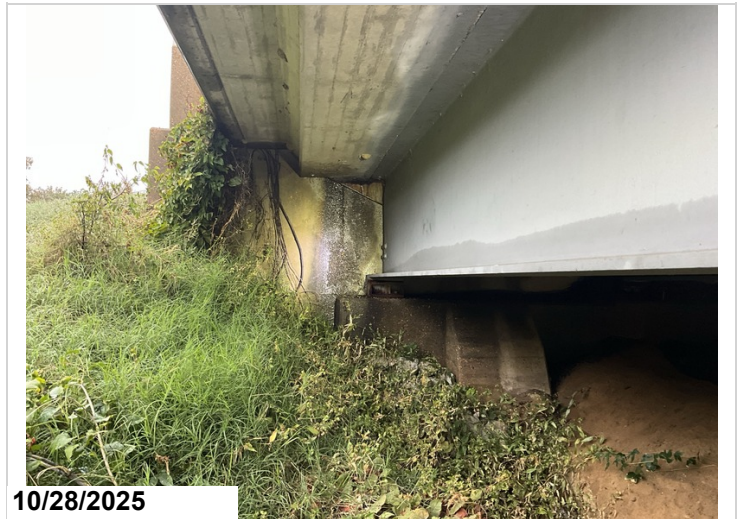
Pier 4, Wall, Ahead: Vertical cracking just right of centerline. Back side mirrors crack. 1LF CS2 cracking.

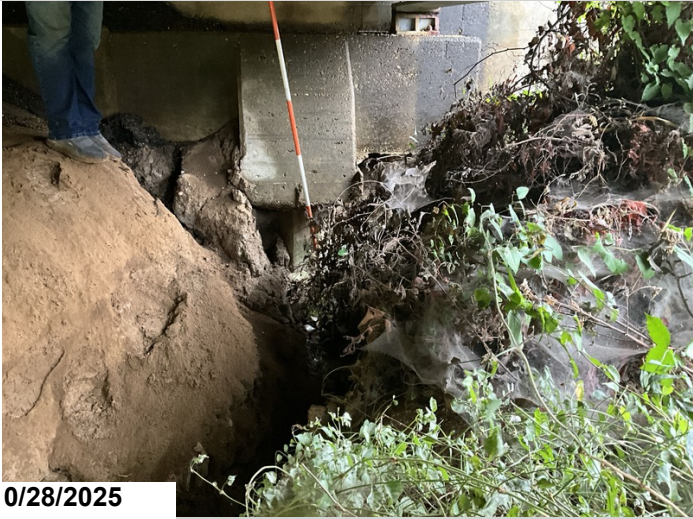
Bent 1, behind Girder 4, Backwall: Spalling. 1LF CS3 Spalling.

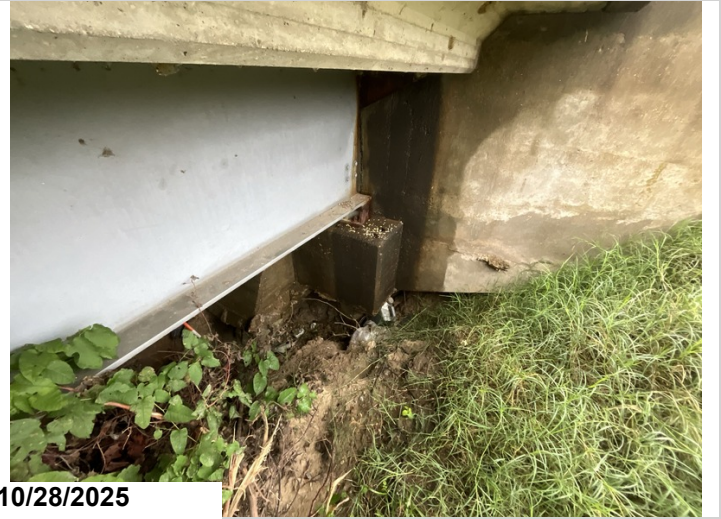
Bent 1: Erosion up to 2' below the bottom of the bridge seat under Girders 1 and 4, worst being under Girder 1 with undermining up to 2.5'. 6LF CS2 erosion, 10LF CS3 erosion.

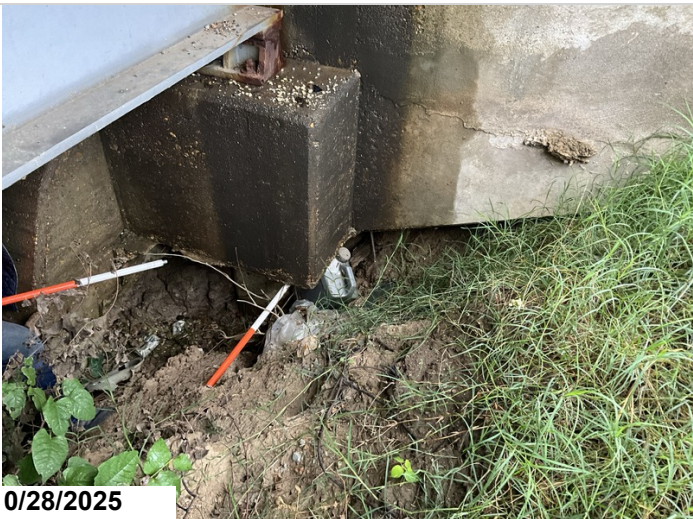
Bent 1: Erosion up to 2' below the bottom of the bridge seat under Girders 1 and 4, worst being under Girder 1 with undermining up to 2.5'. 6LF CS2 erosion, 10LF CS3 erosion.

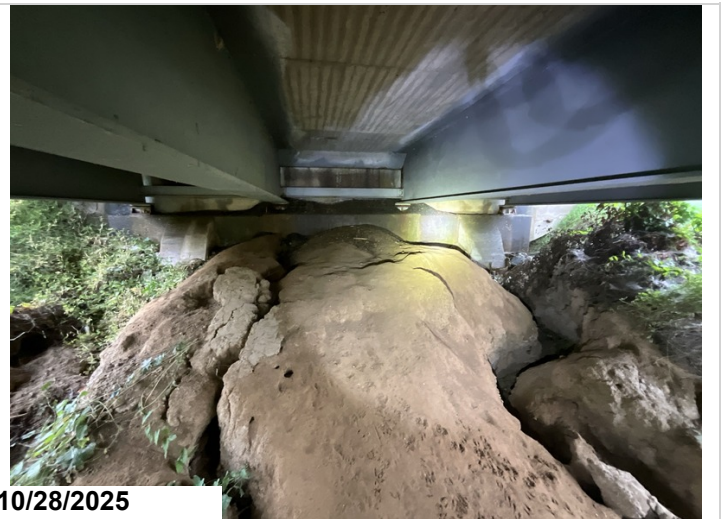
Bent 1: Erosion up to 2' below the bottom of the bridge seat under Girders 1 and 4, worst being under Girder 1 with undermining up to 2.5'. 6LF CS2 erosion, 10LF CS3 erosion.

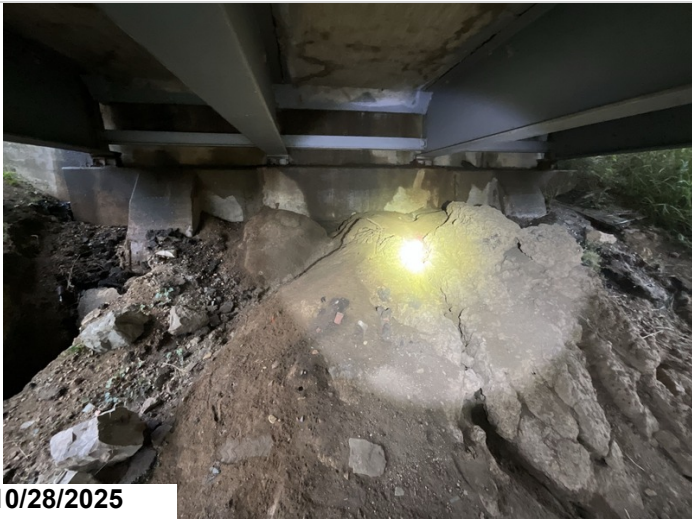
Bent 1: Erosion up to 2' below the bottom of the bridge seat under Girders 1 and 4, worst being under Girder 1 with undermining up to 2.5'. 6LF CS2 erosion, 10LF CS3 erosion.

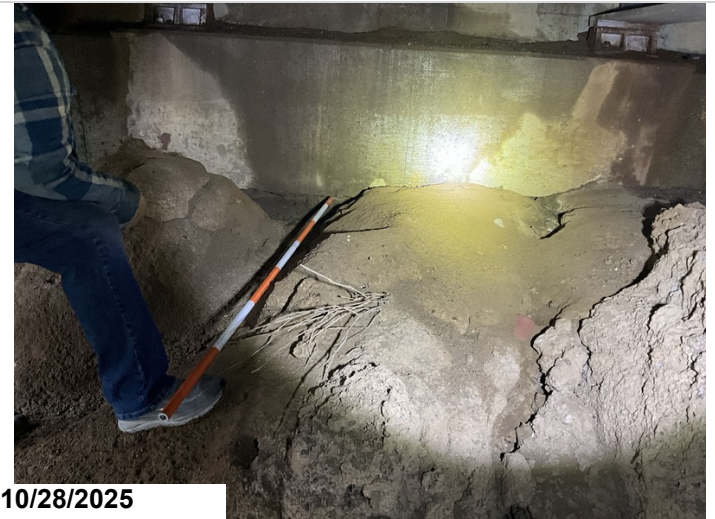
Bent 8: Erosion along the bottom of the bridge seat with undermining up to 1.5'. 18LF CS2 Scour.

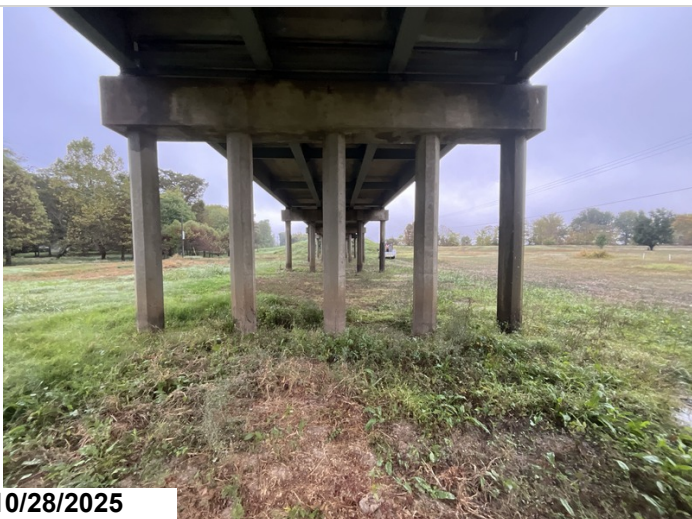
Bent 8: Erosion along the bottom of the bridge seat with undermining up to 1.5'. 18LF CS2 Scour.

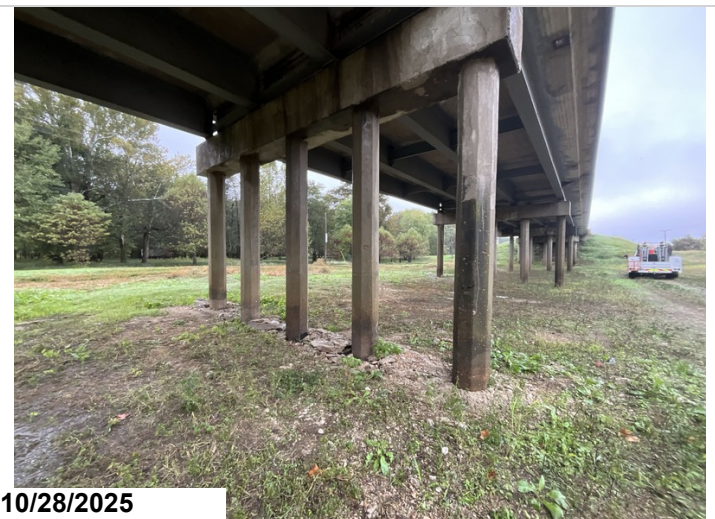
Bent 6, Piles 1 - 5: Minor abrasion. 5EA CS2 abrasion.

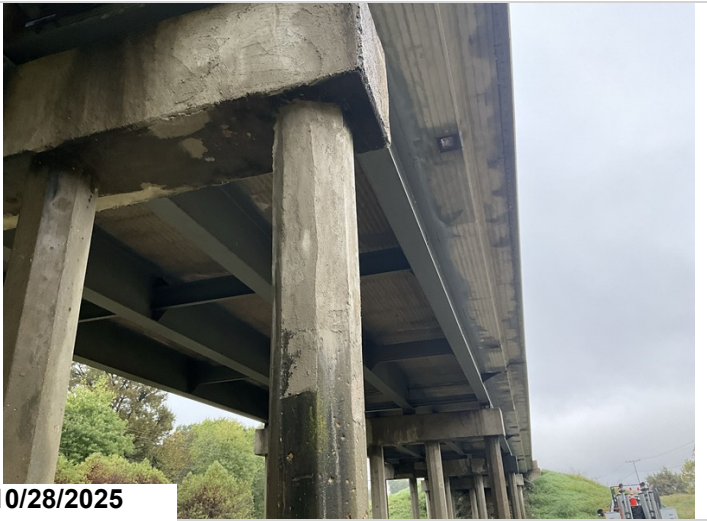
Bent 5, Piles 1 - 5: Minor abrasion. 5EA CS2 abrasion.

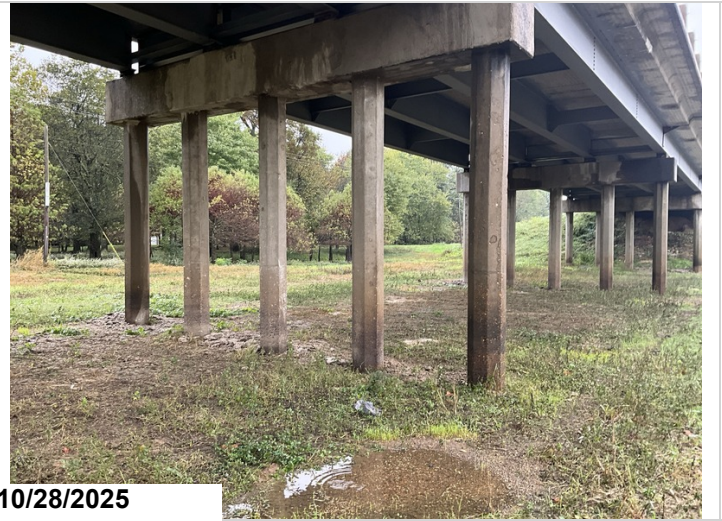
Bent 5, Pile 1: Repair. 1EA CS2 Patched area.

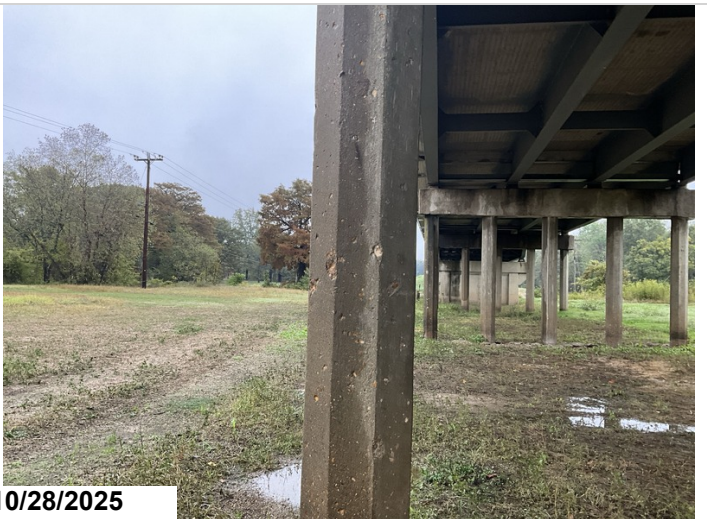
Bent 4, Piles 1 - 5: Minor abrasion. 5EA CS2 abrasion.

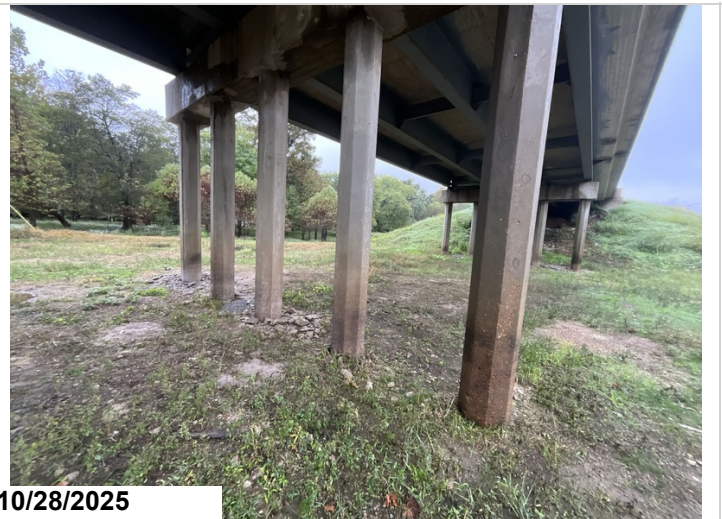
Bent 4, Pile 1: Minor spalling on the back side. 1EA CS2 Spalling.

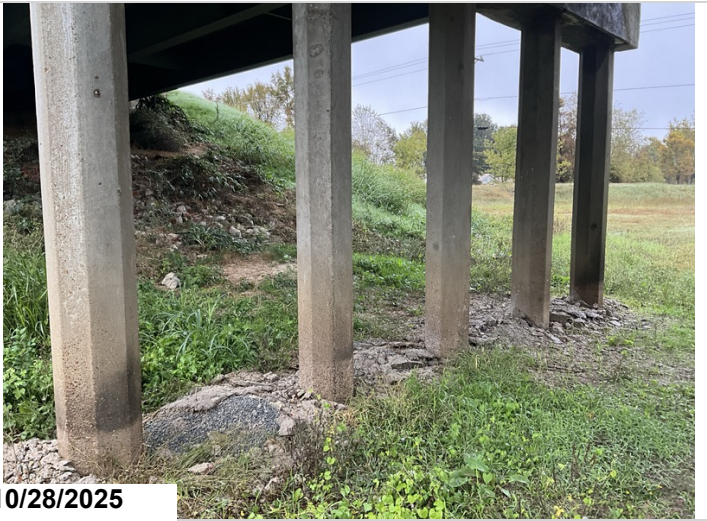
Bent 3, Piles 1 - 5: Minor abrasion. 5EA CS2 abrasion.

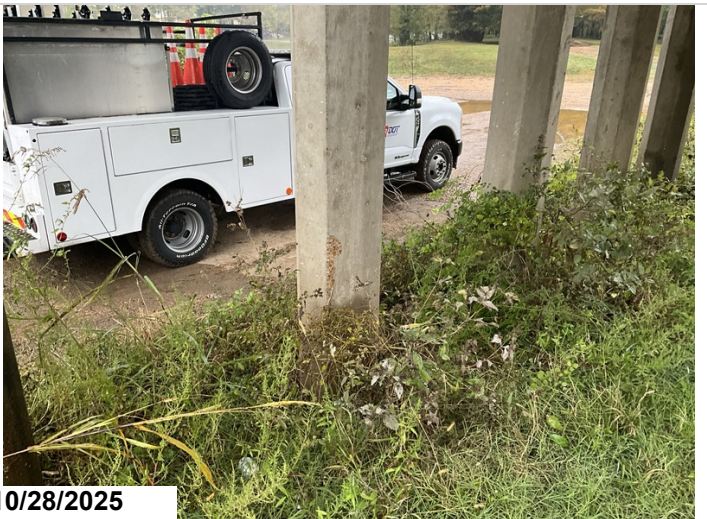
Bent 7, Pile 1, Ahead and Left: Vertical cracking with rust staining. 1EA CS3 rust staining.

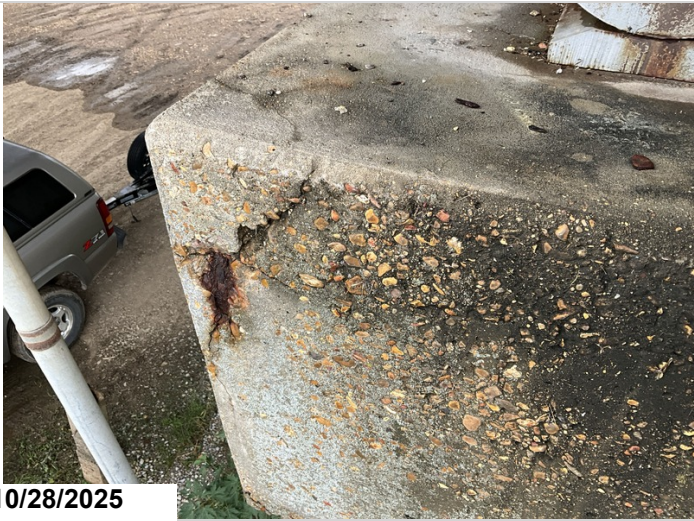
Pier 4, Right, back corner: Spalling with exposed reinforcing steel with section loss. 1LF CS3 exposed reinforcing steel.

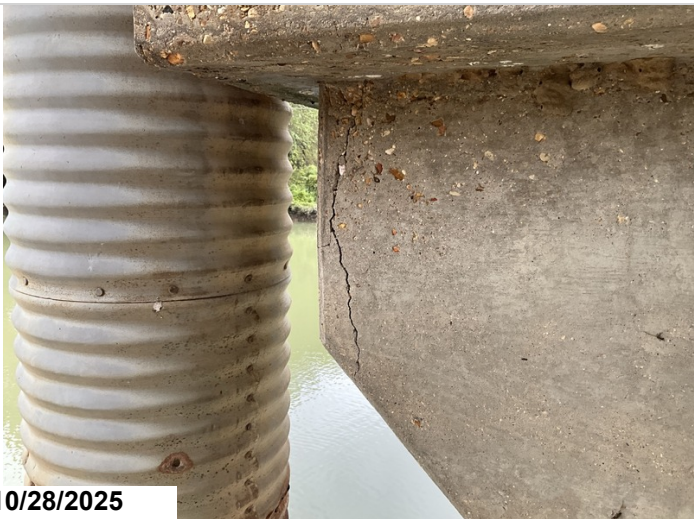
Pier 3, Ahead, Cap, below Girder 1: Horizontal cracking. 4LF CS3 cracking.

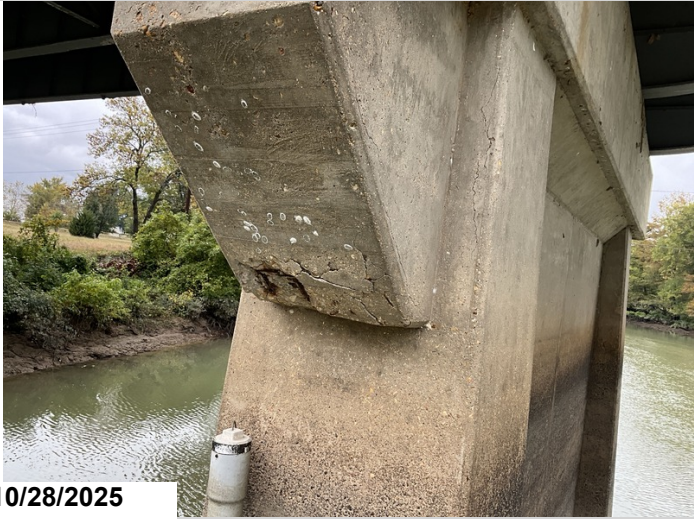
Pier 3, Cap, Left: Spalling with exposed reinforcing steel with section loss. 1LF CS3 exposed reinforcing steel.

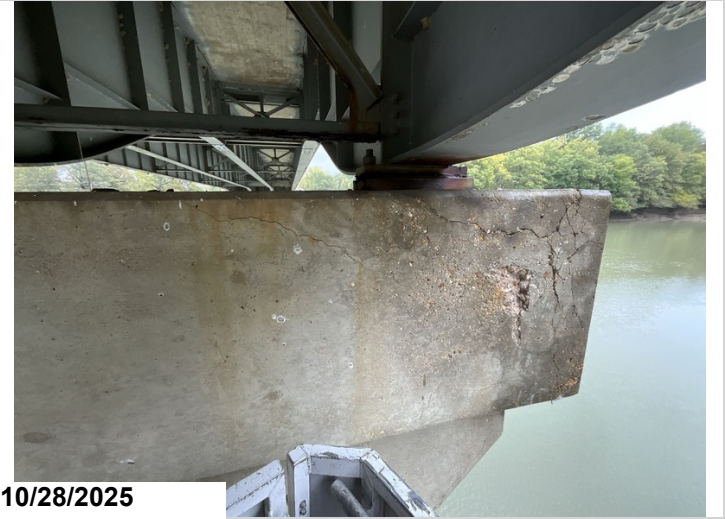
Pier 2, Right, Bottom cap: Spalling with exposed reinforcing steel with section loss. 1LF CS3 corrosion.

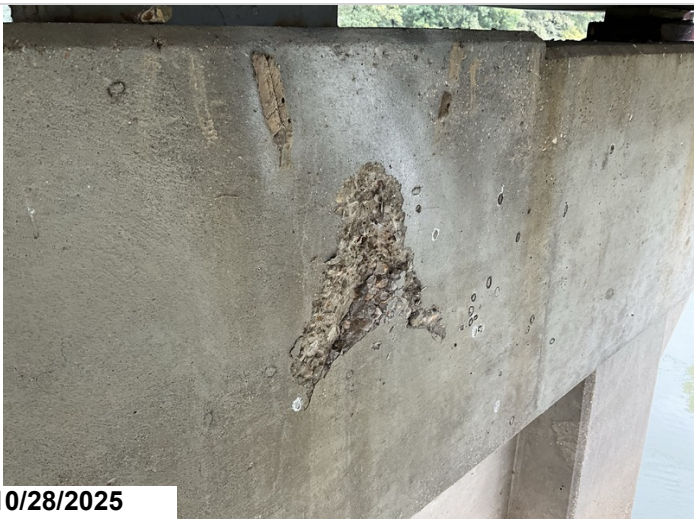
Pier 2, Cap, Back: Cracking and spalling under Girder 4. 5LF CS3 cracking and 1LF CS3 spalling.

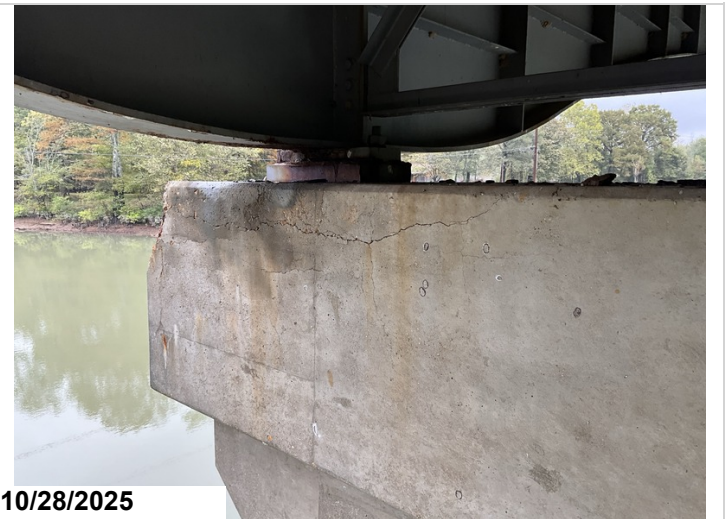
Pier 2, Cap, Back: Spalling below Girder 3. 2LF CS3 spalling.

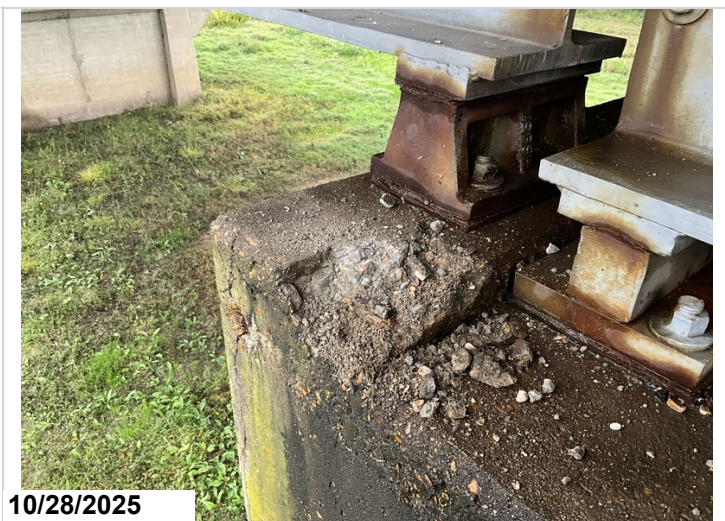
Bent 7, Ahead, Right: Spalling with exposed reinforcing steel with section loss. 1LF CS3 exposed reinforcing steel.

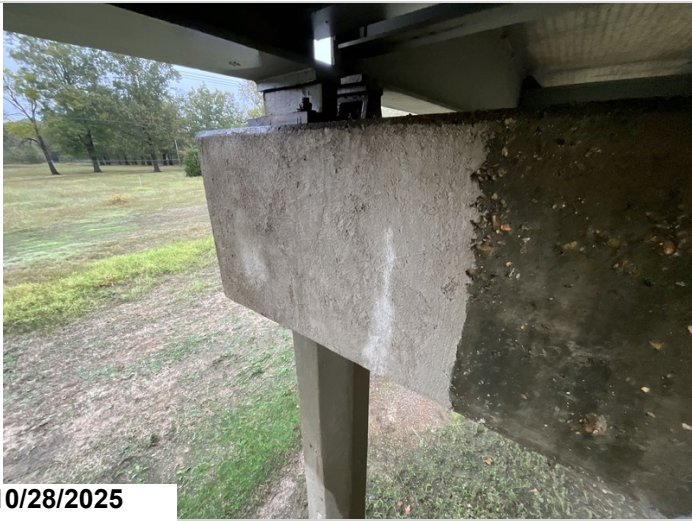
Bent 3, back, under Girder 4: Repair. 4LF CS2.

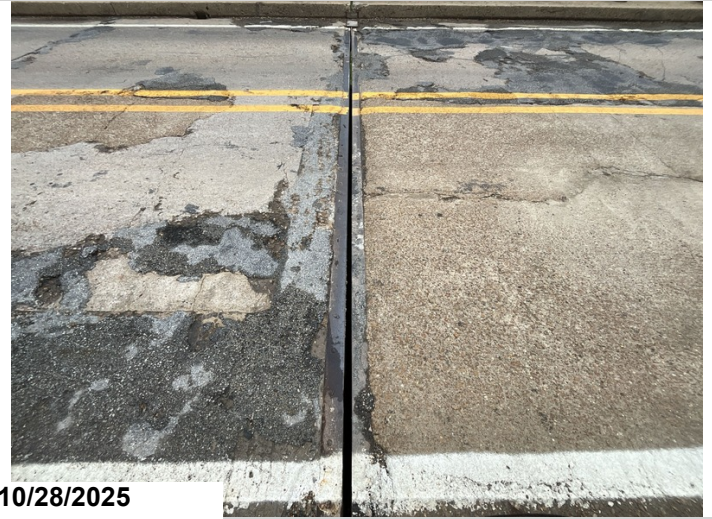
Bent 8, Joint: Debris impact, full length. 26LF CS3 debris impact.

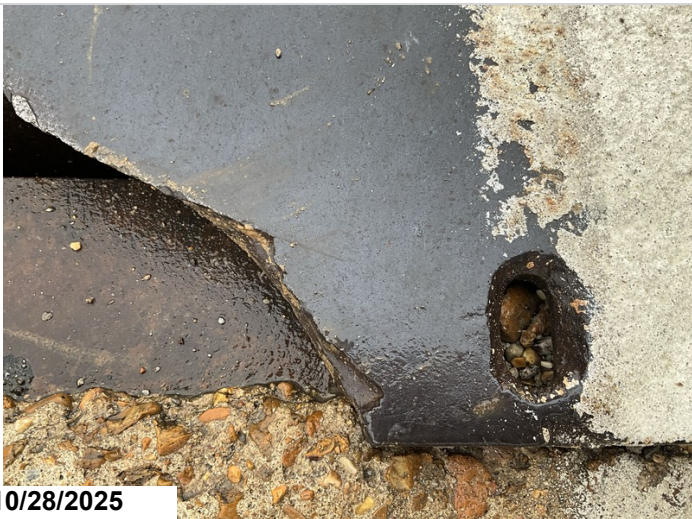
Bent 7, Joint: Armor missing for the full length. 26LF CS4 metal deterioration.

Schedule for deck rehab job. Should address joints during job. KAW 11/14/2024

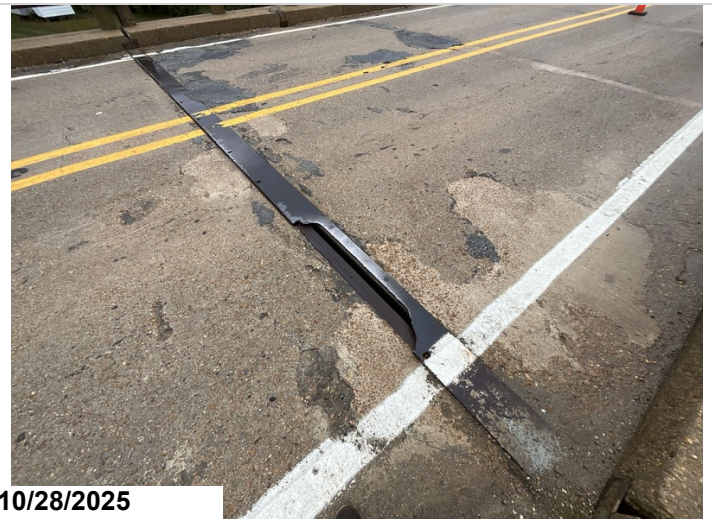
Bent 6, Joint: Cracking in the joint armor. 1LF CS3. metal deterioration.

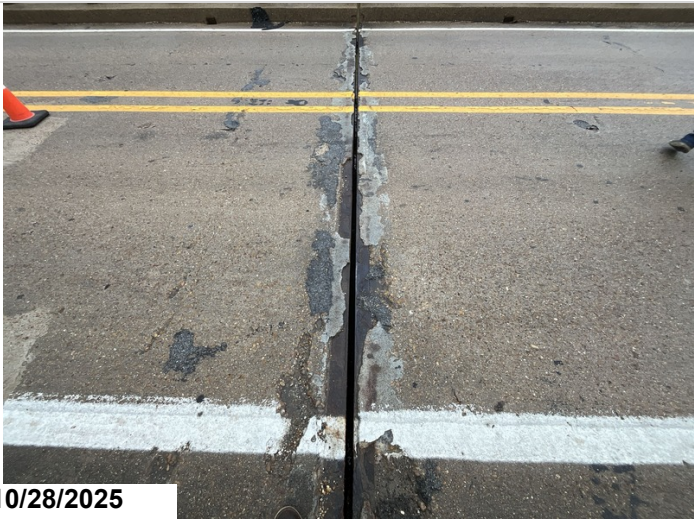
Bent 6, Joint: Joint armor missing. 4LF CS4 metal deterioration.

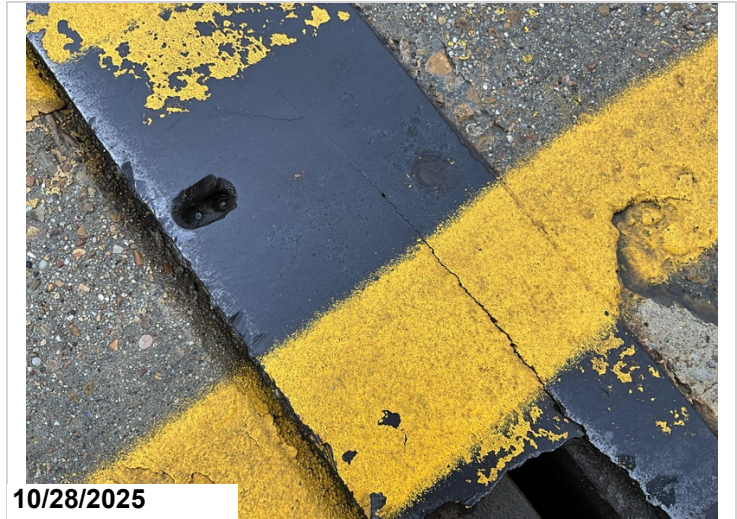
Bent 5, Joint: Armor missing for the full length. 26LF CS4 metal deterioration.

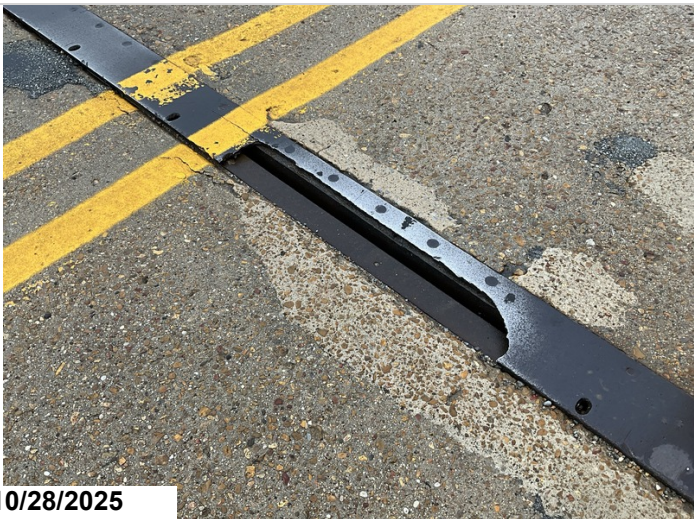
Bent 3, Joint. Cracking in the joint armor. 1LF CS3 metal deterioration.

Bent 3, Joint: Cracking in the joint armor. 1LF CS3 metal deterioration.

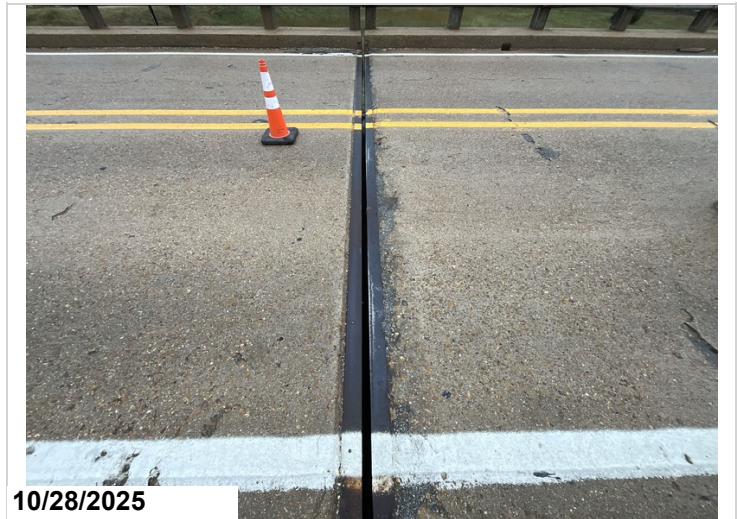
Bent 3, Joint: Armor missing. 4LF CS4 metal deterioration.

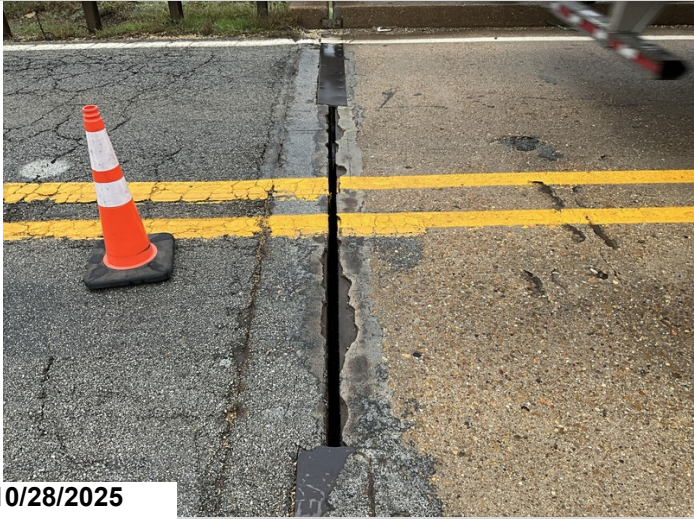
Bent 2, Joint: Armor missing for the full length. 26LF CS4 metal deterioration.

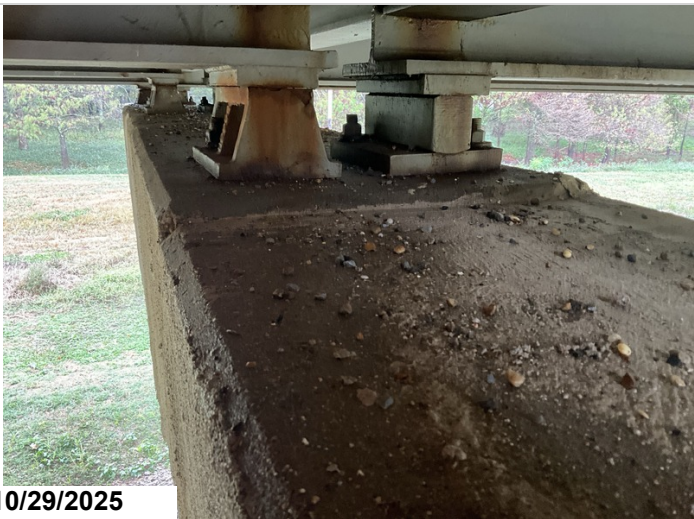
Pier 1: Typical bearings.

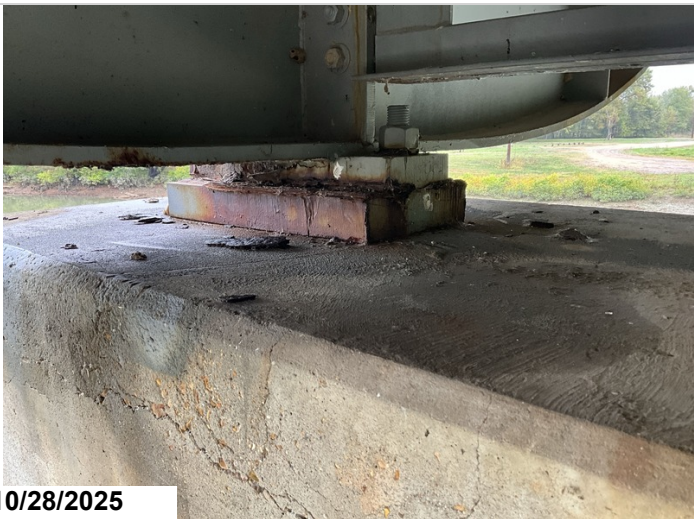
Pier 3, Bearings 1 - 4: Active corrosion with pack rust between the sole and masonry plate. 4EA CS3 corrosion.

Pier 3, Bearings 1 - 4: Active corrosion with pack rust
between the sole and masonry plate. 4EA CS3 corrosion.

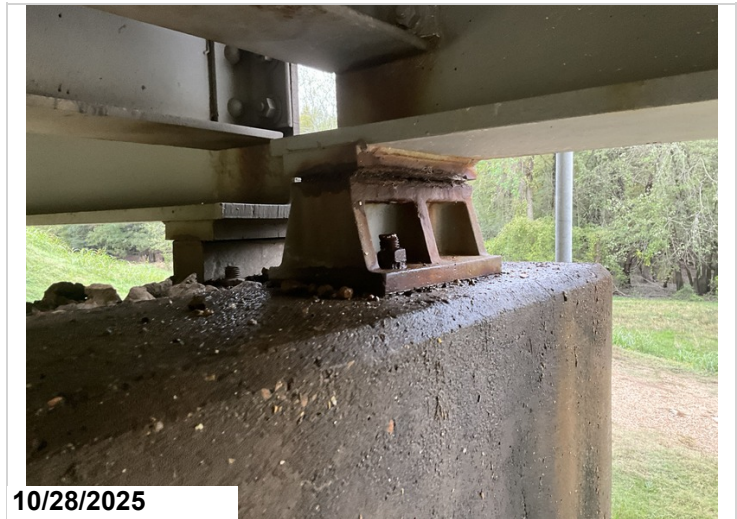
Pier 2, Bearings 1 - 4: Active corrosion with pack rust
between the sole and masonry plate. 4EA CS3 corrosion.

Pier 2, Bearings 1 - 4: Active corrosion with pack rust between the sole and masonry plate. 4EA CS3 corrosion.

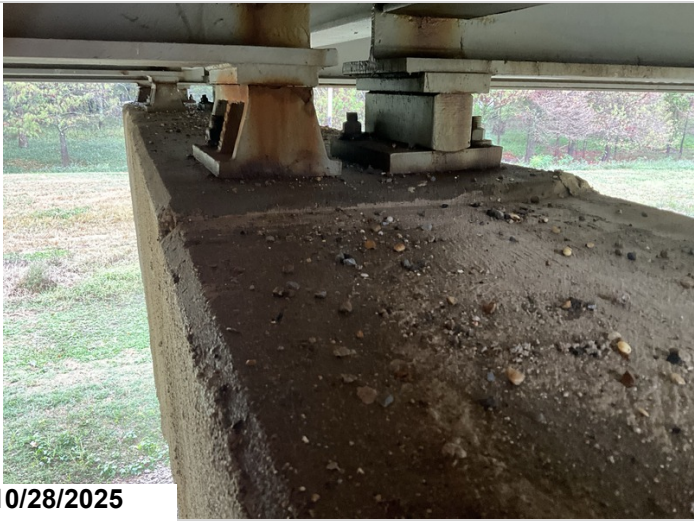
Span 10, Bent 7, Bearings 1 - 4: Active corrosion with pack
rust. 4EA CS3 corrosion.

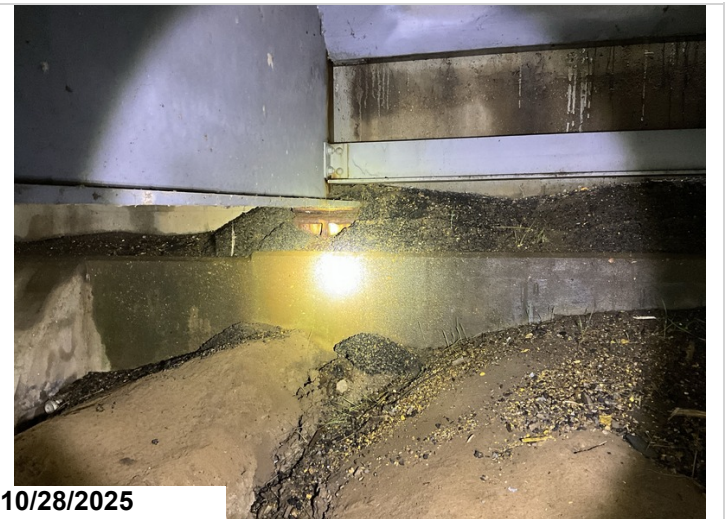
Span 2, Bent 2, Bearings: Active corrosion with pack rust up to 1" between bearing and sole plate. 4ea CS3 corrosion.

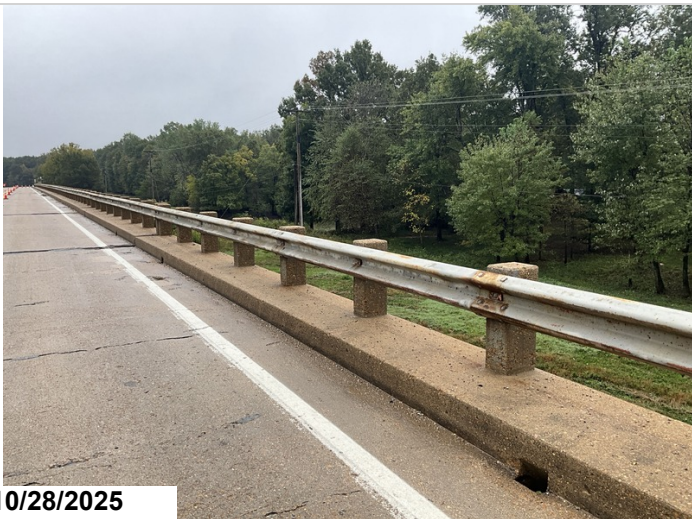
Spans 6 and 7: Typical bridge railing.

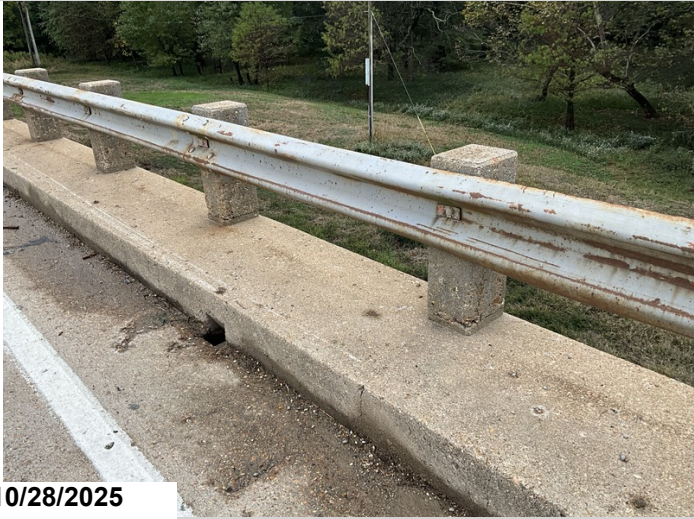
Span 10, Left: Active corrosion to the railing.

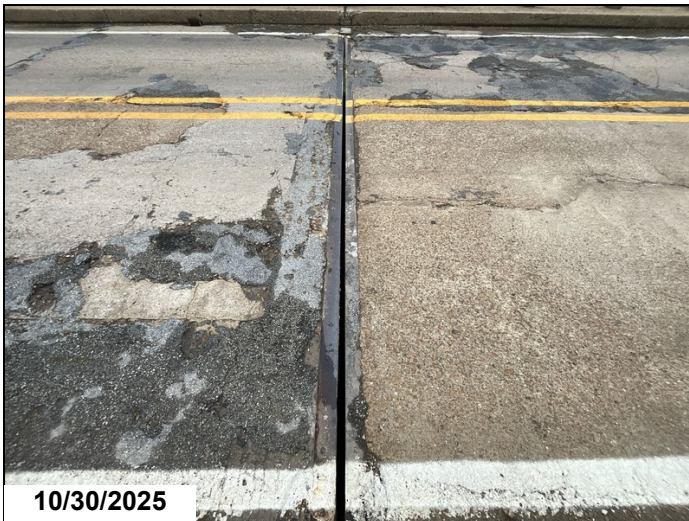
Bent 7, Joint: Armor missing for the full length. 26LF CS4 metal deterioration.

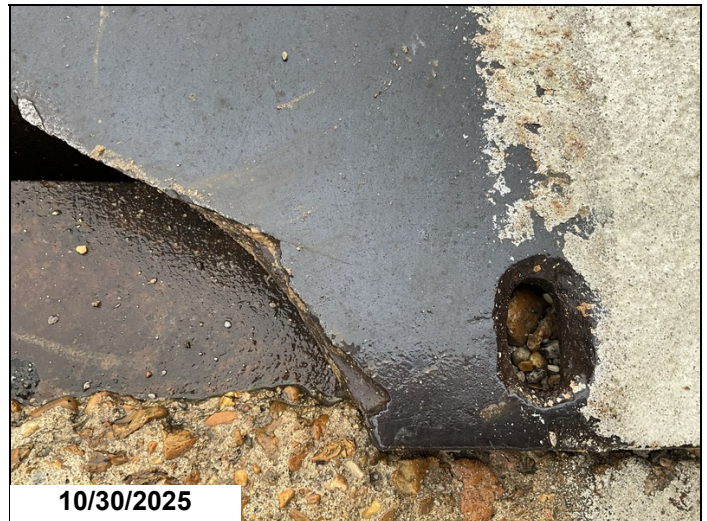
Bent 6, Joint: Cracking in the joint armor. 1LF CS3. metal deterioration.
