Bridge 03023 Inspection Report

Route:62 Section:20 Log:2.58

Arnold Road ID:11x62x20xA, Arnold Log mile:2.593

(4) Place Code	0
(6) Features Intersected	BLACK RIVER
(7) Facility Carried	US 62-20- LM 2.58
(9) Location	2.58 MI E US 67
(11) Mile Point	2.58 mi
(12) Base Highway Network	Yes

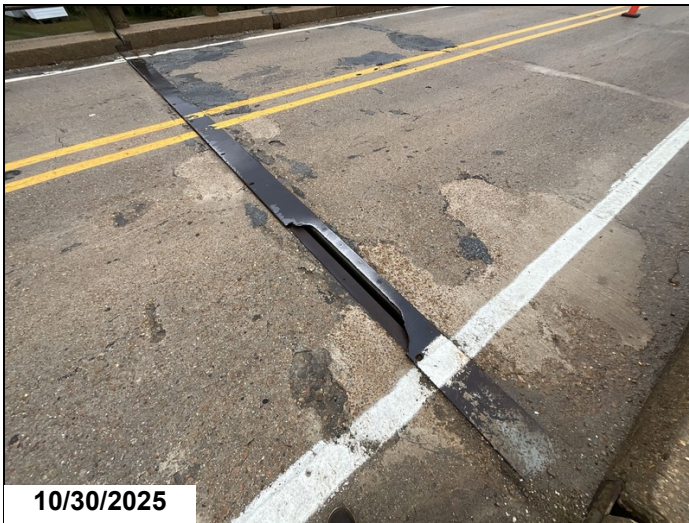
Bent 6, Joint: Joint armor missing. 4LF CS4 metal deterioration.

Schedule for deck rehab job. Should address joints during job. KAW 11/14/2024

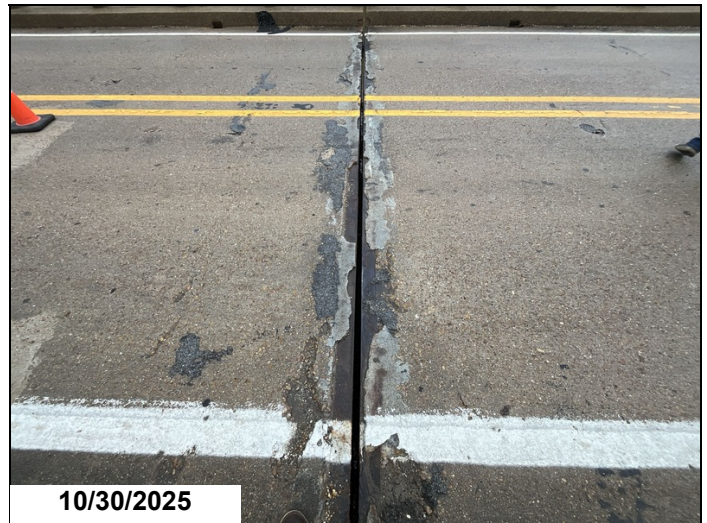
Bent 5, Joint: Armor missing for the full length. 26LF CS4 metal deterioration.

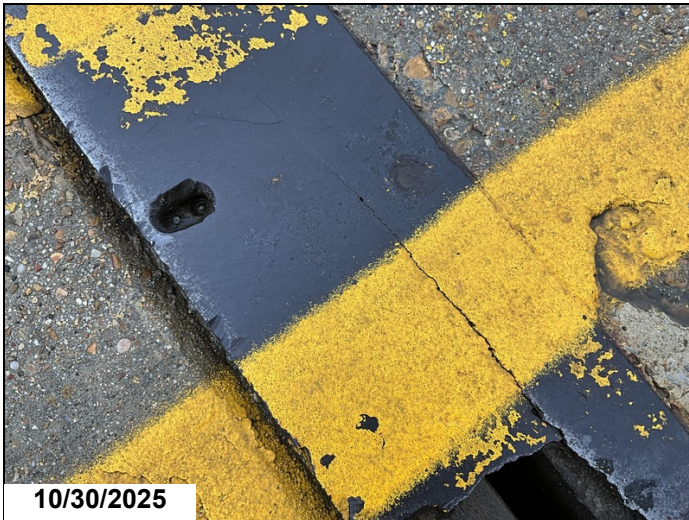
Bent 3, Joint. Cracking in the joint armor. 1LF CS3 metal deterioration.

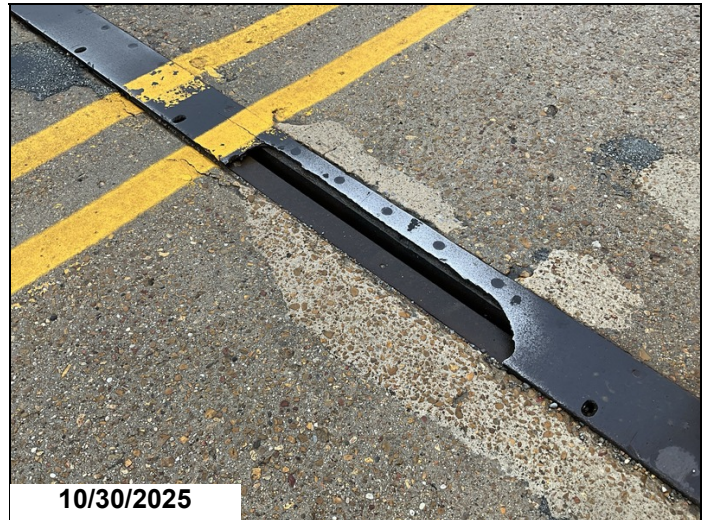
Bent 3, Joint: Armor missing. 4LF CS4 metal deterioration.

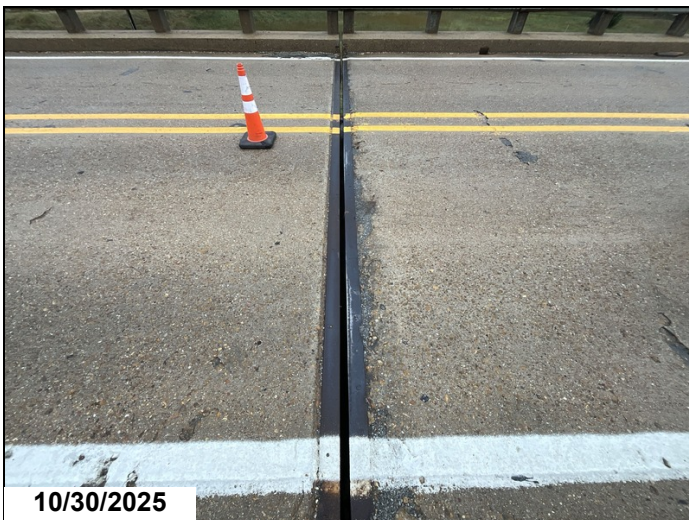
Bent 2, Joint: Armor missing for the full length. 26LF CS4 metal deterioration.

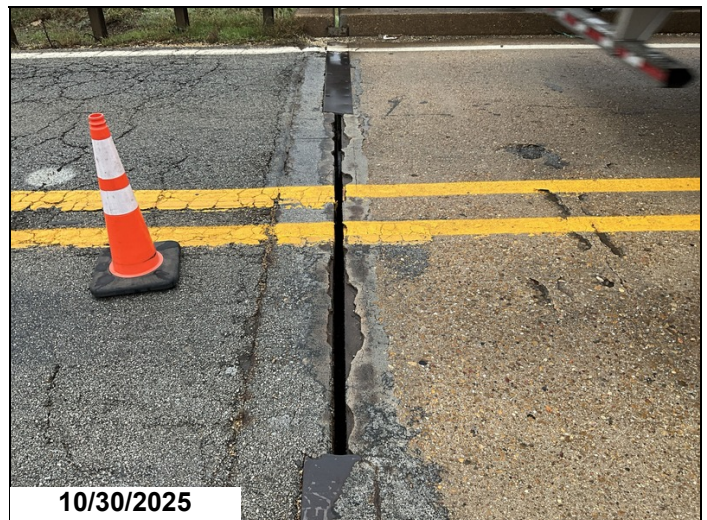
Bent 1, Joint: Armor missing. 12LF CS4 metal deterioration.

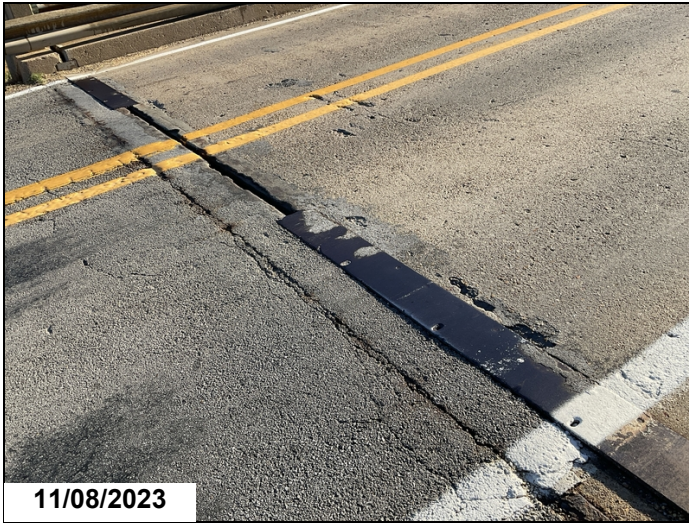
Bent 1 joint

Bent 1, Joint: Armor missing. 12LF CS4 metal deterioration.

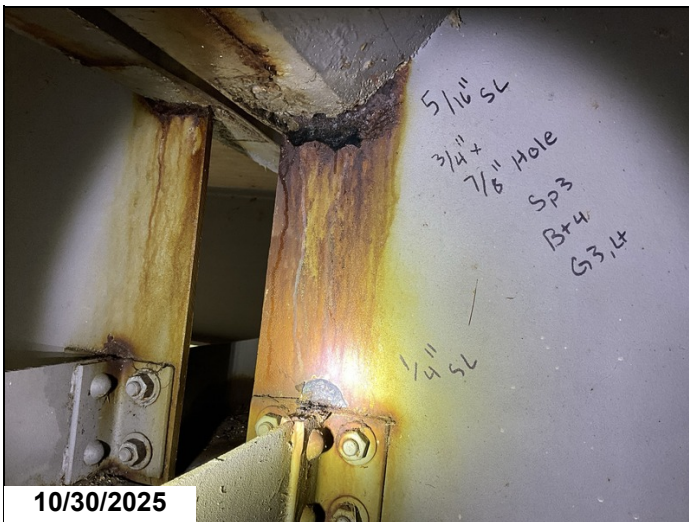
Span 3, Bent 4, Girder 3, Left: Active corrosion with section loss up to 5/16" to the web at the haunch area, a 3/4" X 7/8" hole in the web at the haunch area, and section loss up to 1/4" to the web at the diaphragm connection. 1LF CS4 corrosion.

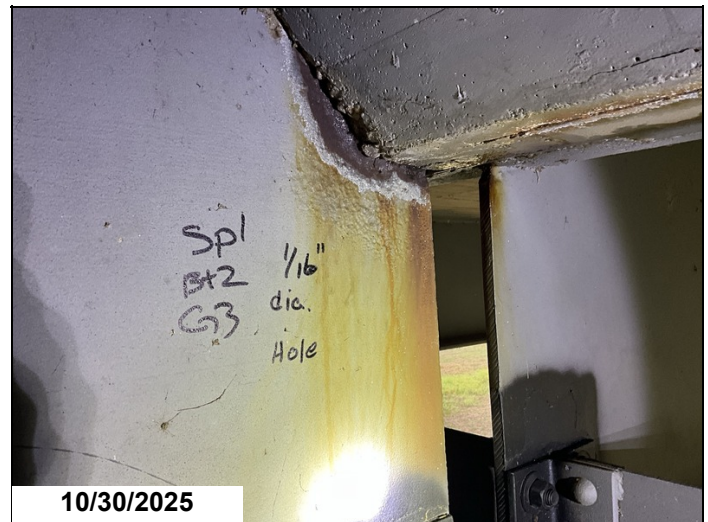
Span 1, Bent 2, Girder 3: Active corrosion with a 1/16" diameter hole in the web at the haunch area. 1LF cs4.

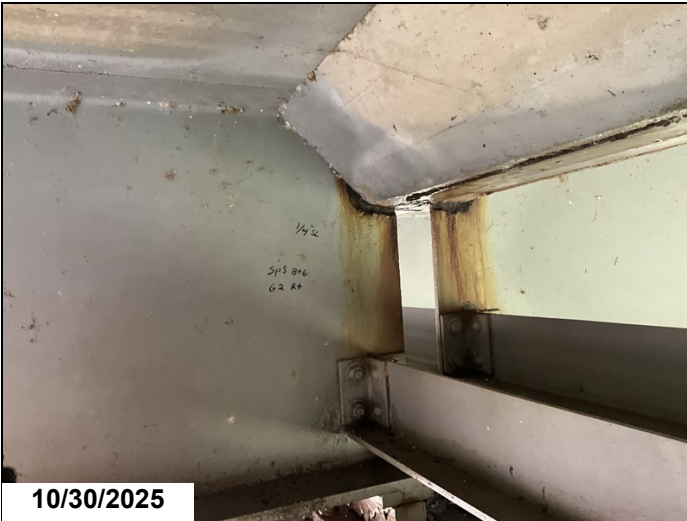
Span 5, Bent 6, Girder 2, Right: Active corrosion with section loss up to 1/4" to the web at the haunch area. 1LF CS3 corrosion.

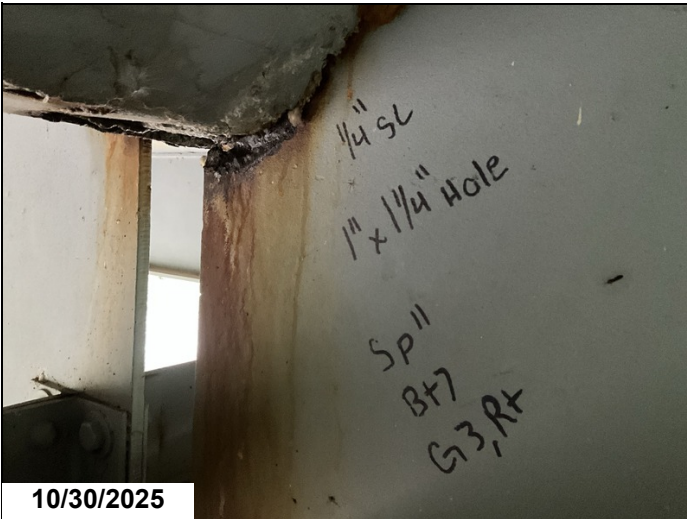
Span 11, Bent 7, Girder 3, Right: Active corrosion with section loss up to 5/16" to the web at the haunch area, a 1" X 1 1/4" hole in the web at the haunch area and section loss up to 1/8" to the web at the diaphragm connection. 1LF CS4 corrosion.

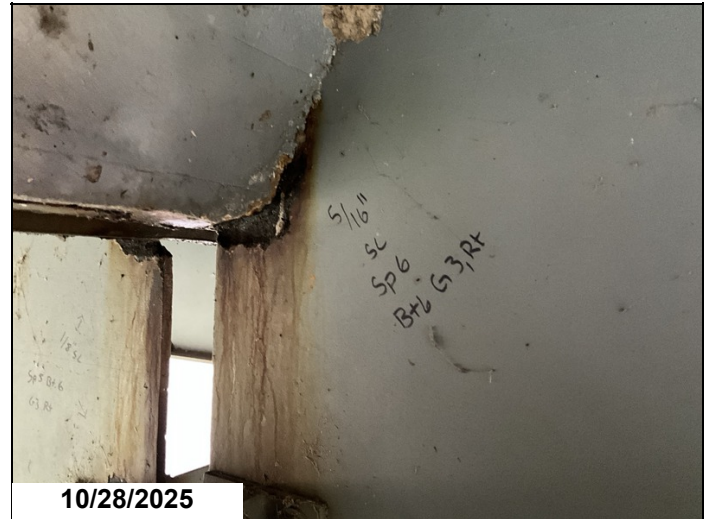
Span 6, Bent 6, Girder 3, Right: Active corrosion with section loss up to 5/16" to the web at the haunch area. 1LF CS3 corrosion.

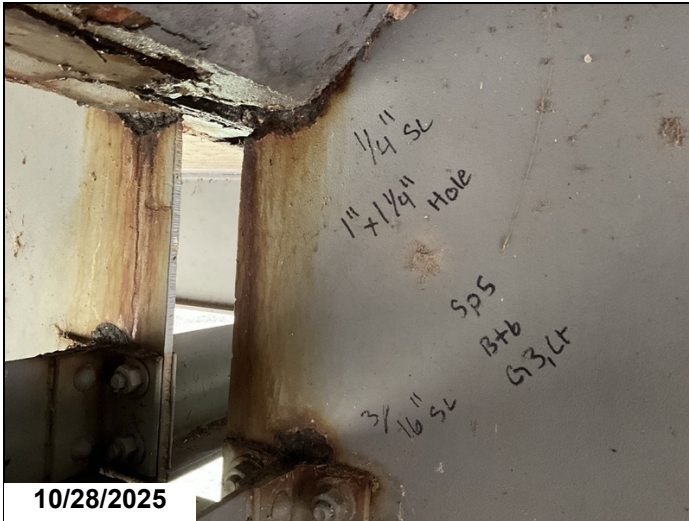
Span 5, Bent 6, Girder 3, Left: Active corrosion with section loss up to 1/4" to the web at the haunch area, a 1" X 1 1/4" hole in the web at the haunch area and section loss up to 3/16" to the web at the diaphragm connection. 1LF CS4 corrosion.

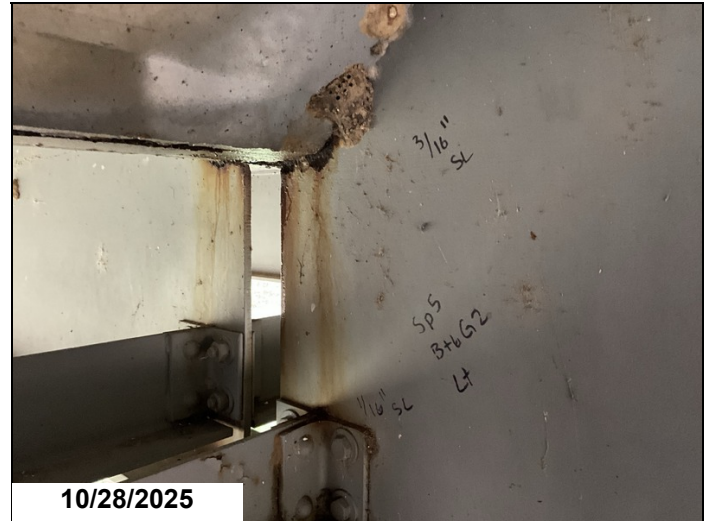
Span 5, Bent 6, Girder 2, Left: Active corrosion with section loss up to 3/16" to the web at the haunch area and section loss up to 1/16" to the web at the diaphragm connection. 1LF CS3 corrosion.

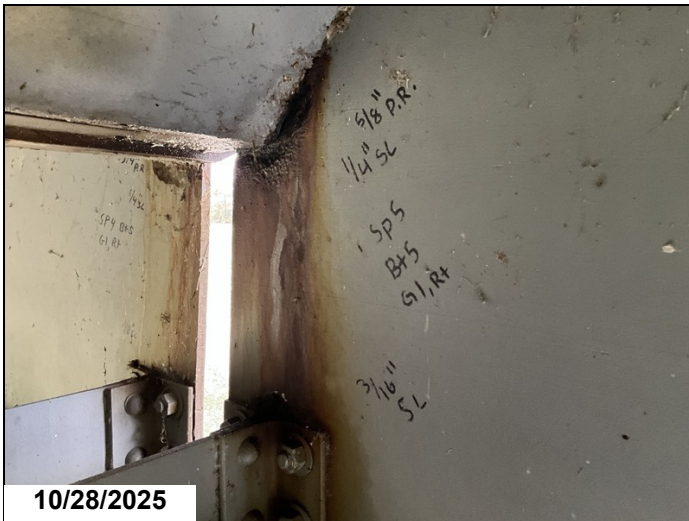
Span 5, Bent 5, Girder 1, Right: Active corrosion with section loss up to 1/4" to the web at the haunch area, section loss up to 3/16" to the web at the diaphragm connection, and pack rust up to 5/8" between the girder web and the concrete haunch. 1LF CS3 corrosion.

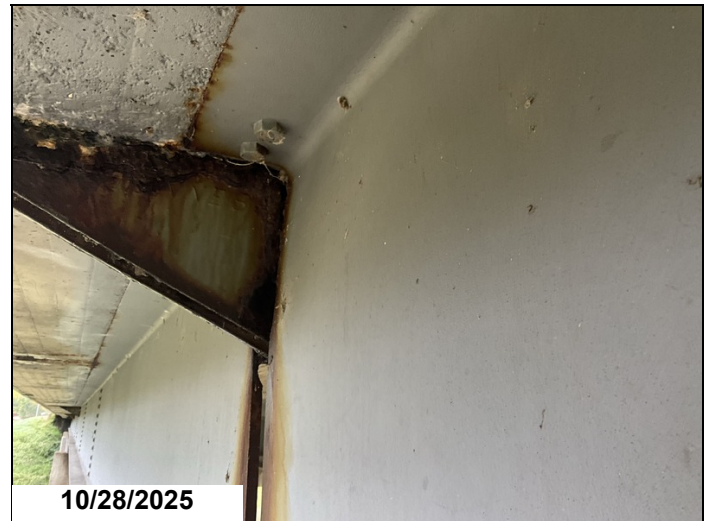
Span 5, Bent 5, Girder 4: Distortion in the web due to pack rust between the Girder web and the concrete haunch.

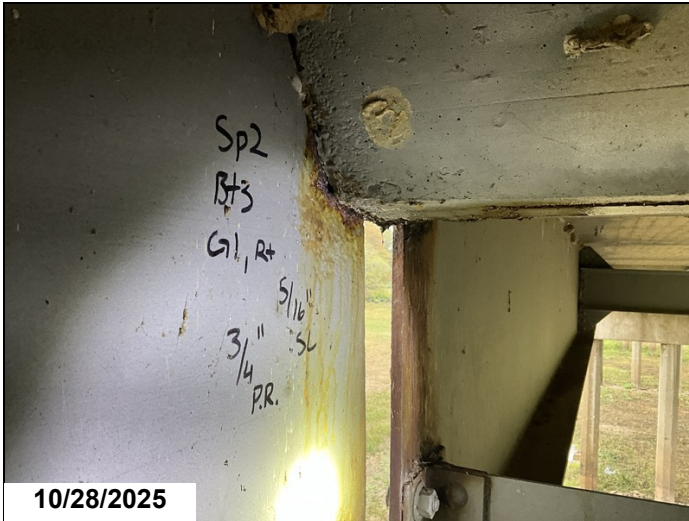
Span 2, Bent 3, Girder 1, Right: Active corrosion with section loss up to 5/16" to the web at the haunch area and pack rust between the girder web and the concrete haunch. 1LF CS3 corrosion.

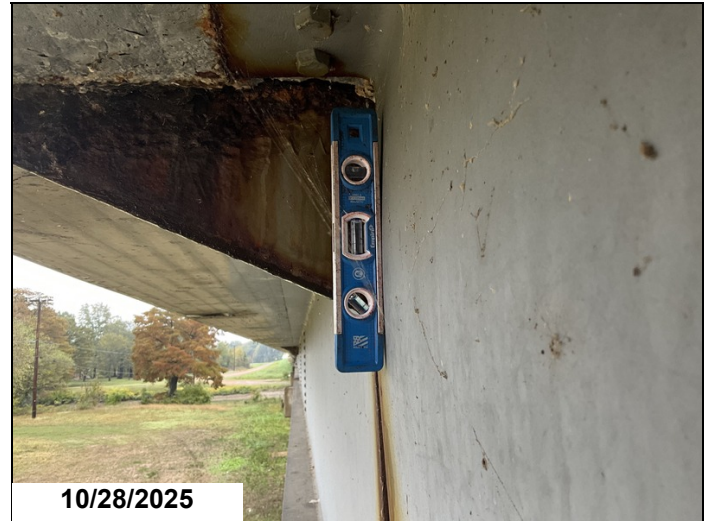
Span 2, Bent 3, Girder 1, Left: Minor distortion in the web due to pack rust between Girder web and concrete haunch.

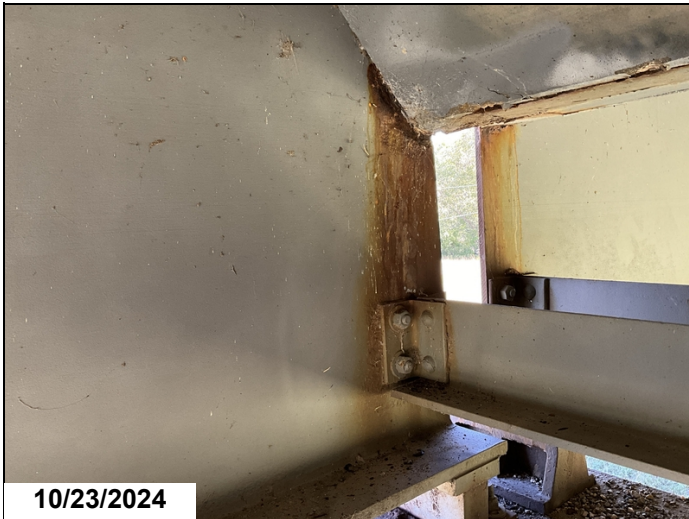
Span 3, bent 4, girder 1, right: corrosion with up to 5/16" section loss to upper web below haunch and 1/8" around diaphragm.

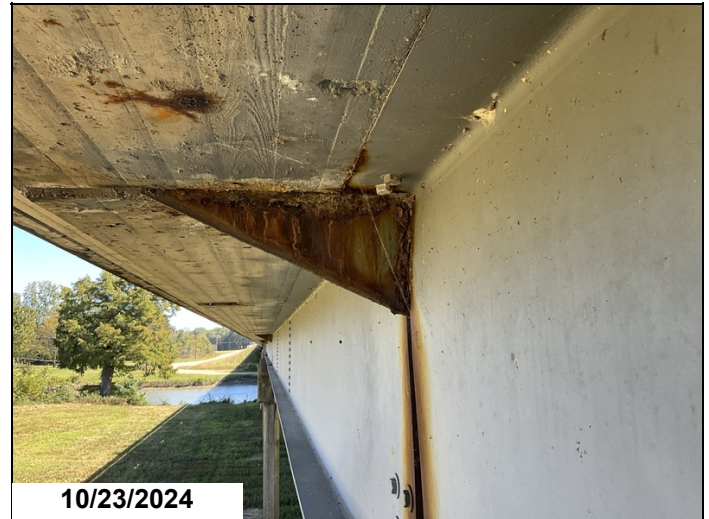
Span 3, bent 4, girder 1, left: distortion up to 15/16" to upper web caused by pack rust between haunch and web on opposite side of girder. Typ girder 4, right. CS3 2 LF

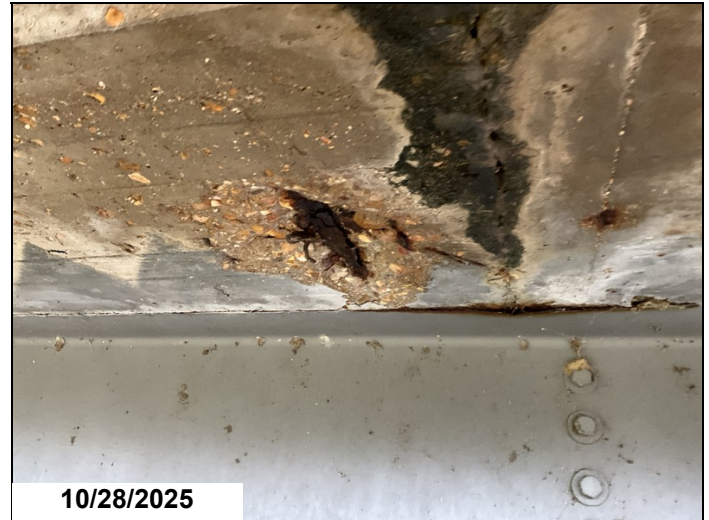
Span 10, Left overhang: Spalling with exposed reinforcing steel with section loss. 3SF CS3 exposed reinforcing steel.

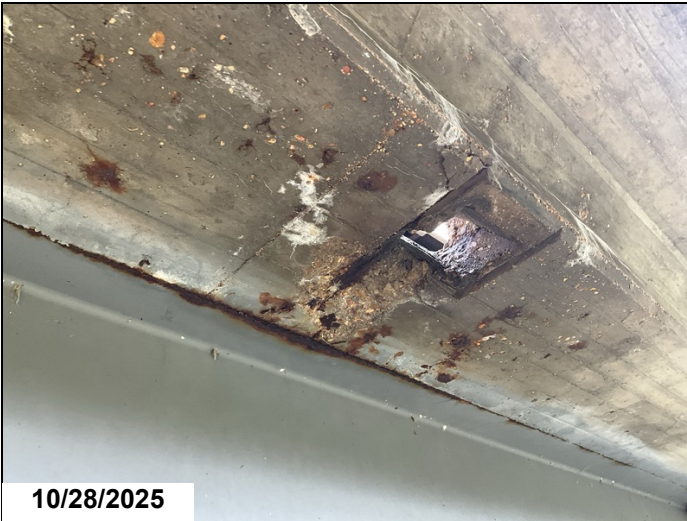
Span 4, Right overhang: Spalling with exposed reinforcing steel at the drains. 2SF CS3 exposed reinforcing steel.

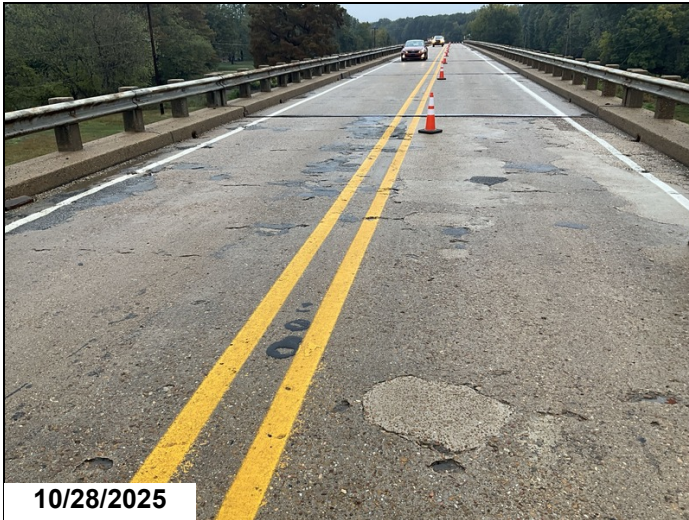
Span 3: Unsound patches, sound patches, cracking, abrasion, and spalling.

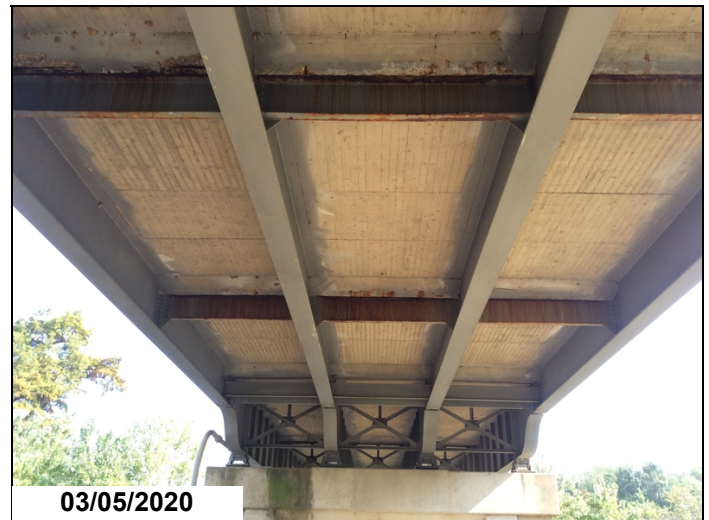
Span 6 leakage thru deck onto diaphragms

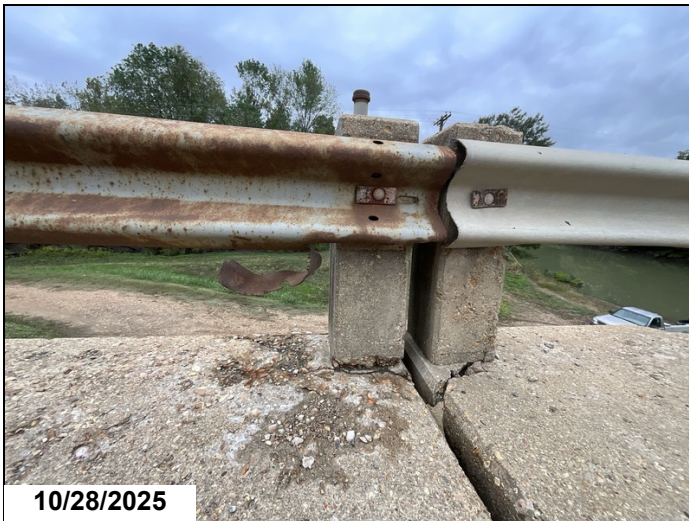
Span 11, Right: Damage to bridge railing. 2LF CS3 damage.

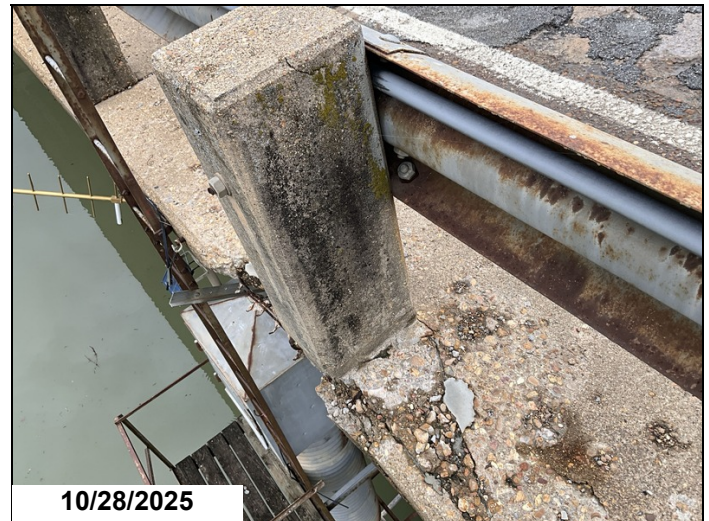
Span 9, Right: Spalling at bridge railing post.

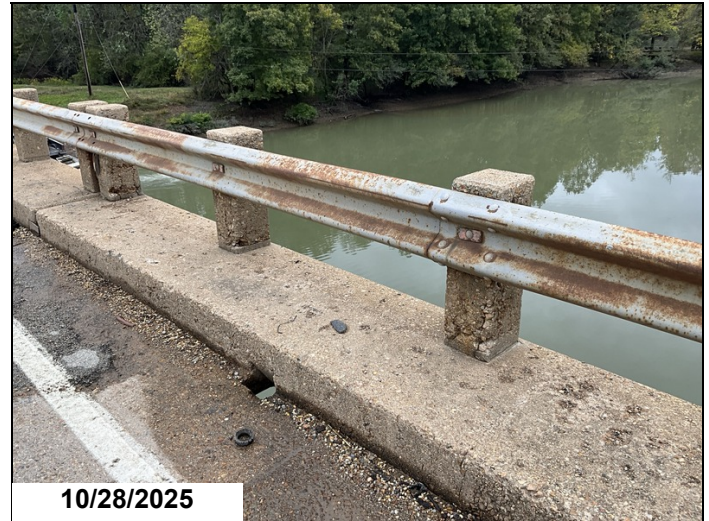
Span 8, Right: multiple post with cracking and spalling.

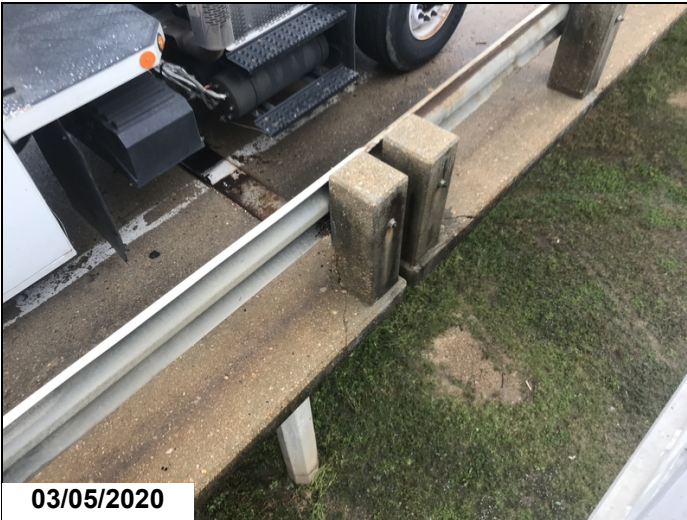
Span 8, Right: multiple post with cracking and spalling.

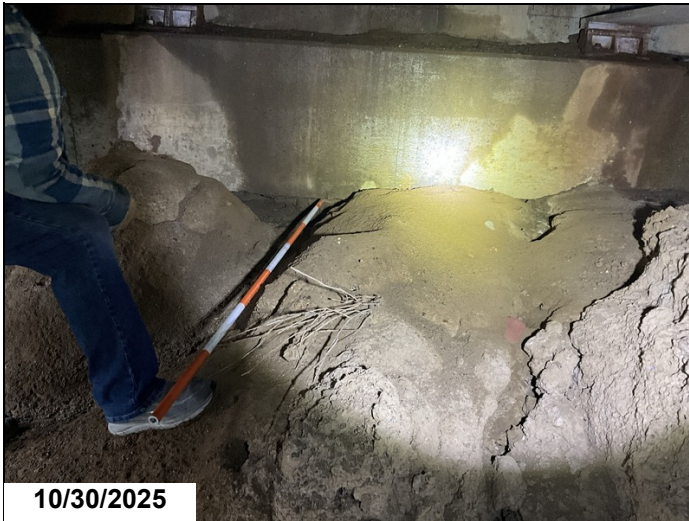
Bent 8: Erosion along the bottom of the bridge seat with undermining up to 1.5'. 18LF CS2 Scour.

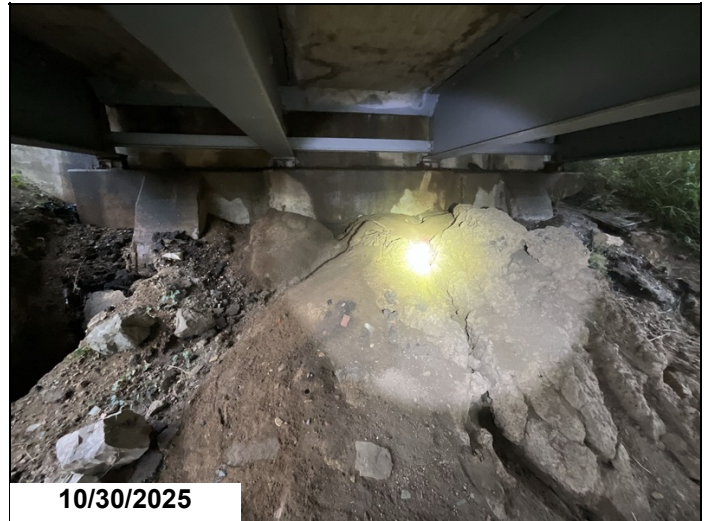
Bent 8: Erosion along the bottom of the bridge seat with undermining up to 1.5'. 18LF CS2 Scour.

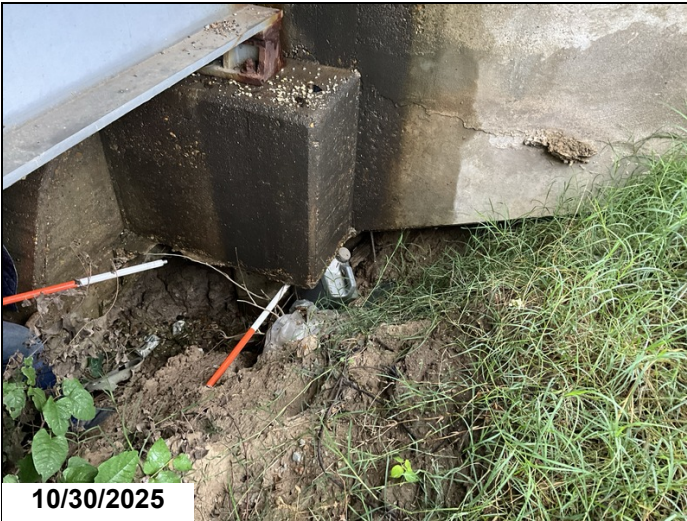
Bent 8: Erosion along the bottom of the bridge seat with undermining up to 1.5'. 18LF CS2 Scour.

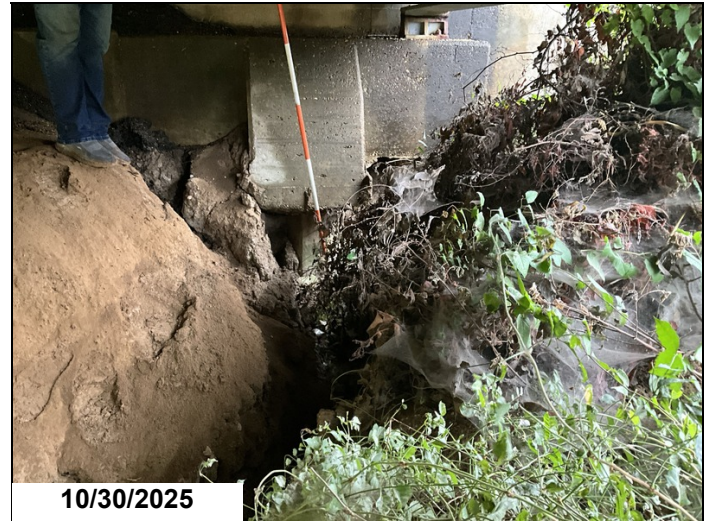
Bent 1: Erosion up to 2' below the bottom of the bridge seat under Girders 1 and 4, worst being under Girder 1 with undermining up to 2.5'. 6LF CS2 erosion, 10LF CS3 erosion.

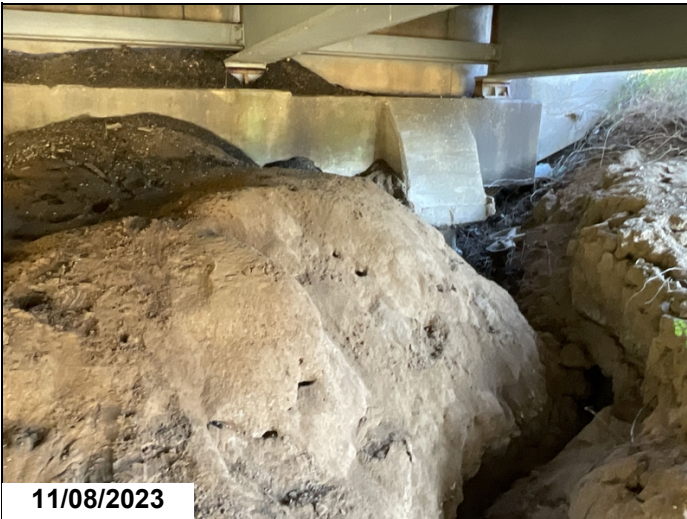
Bent 1: Erosion up to 2' below the bottom of the bridge seat under Girders 1 and 4, worst being under Girder 1 with undermining up to 2.5'. 6LF CS2 erosion, 10LF CS3 erosion.

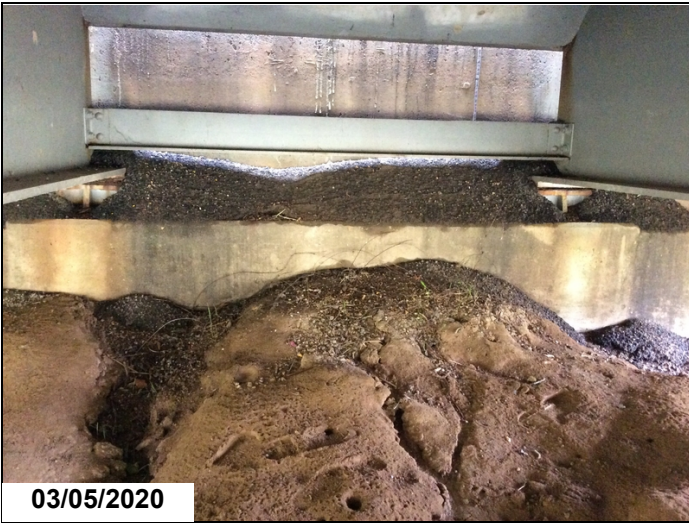
Bent 1 embankment erosion.

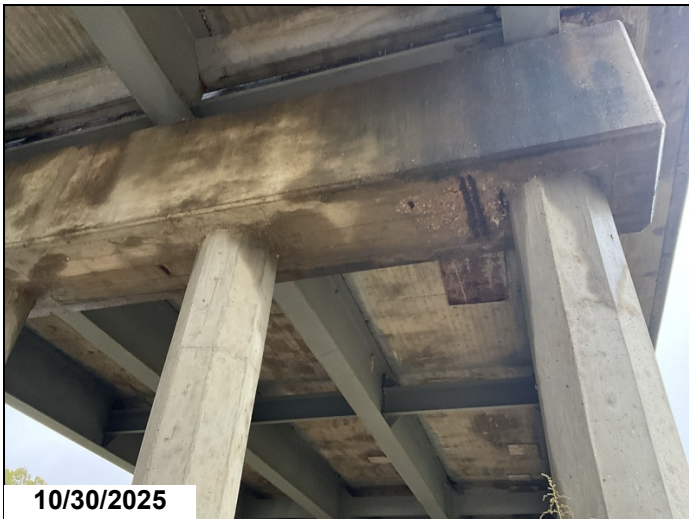
debris at end bents

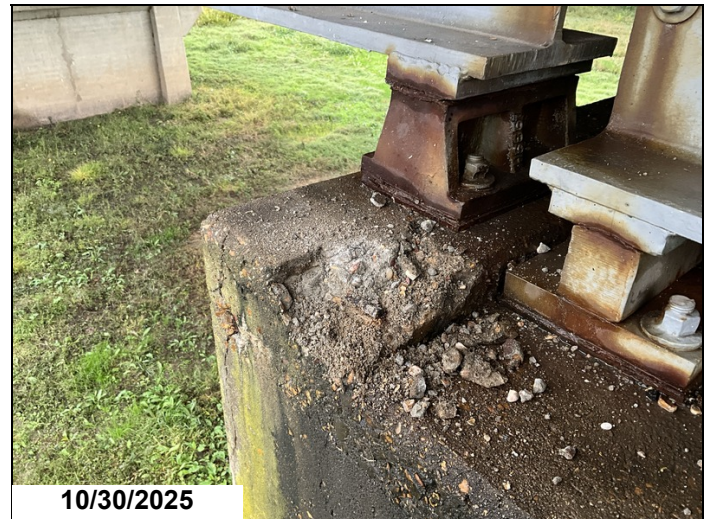
Bent 7, Cap, Bottom: Spalling with exposed reinforcing steel with section loss. 8LF CS3 exposed reinforcing steel.

Bent 7, Cap: Spalling with exposed reinforcing steel with section loss. 8LF CS3 exposed reinforcing steel.

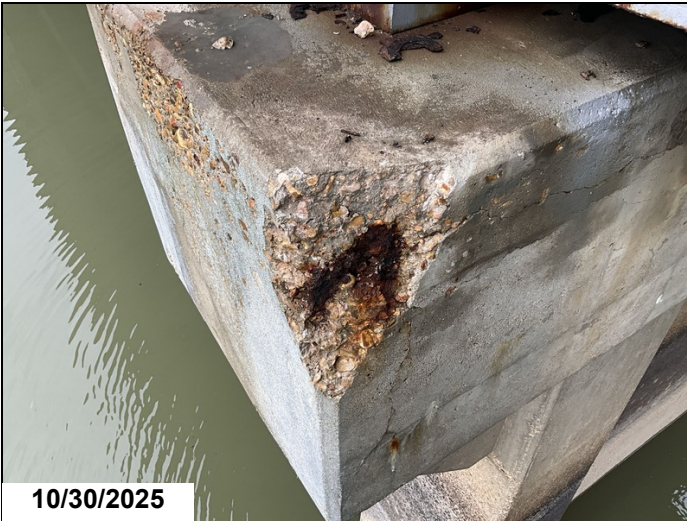
Bent 6, Cap, Left: Spalling with exposed reinforcing steel with section loss. 1LF CS3 exposed reinforcing steel.

Bent 6, Left: Spalling with exposed reinforcing steel with section loss. 1LF CS3 exposed reinforcing steel.

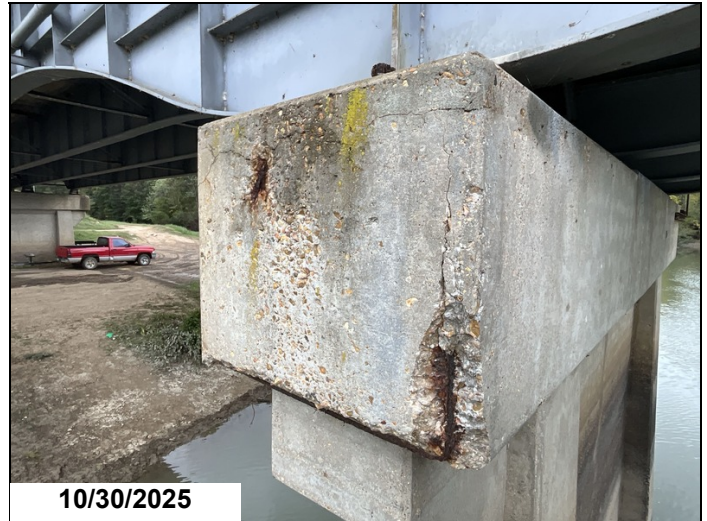
Pier 2, Back, Left corner: Spalling with exposed reinforcing steel with section loss. 1LF CS3 exposed reinforcing steel.

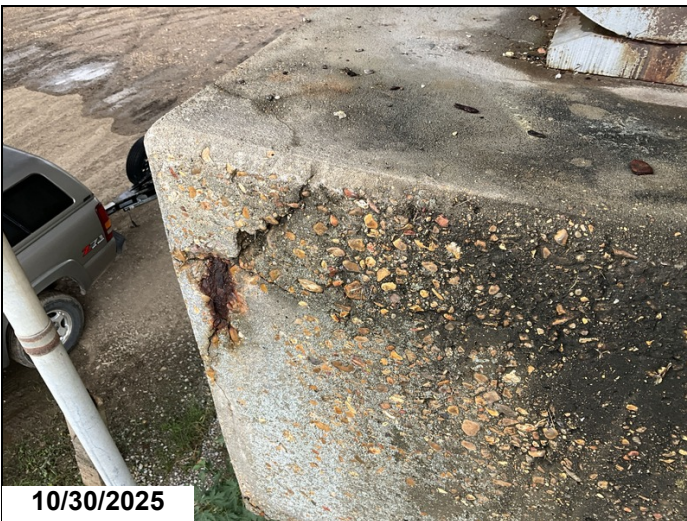
Pier 3, Cap, Left: Spalling with exposed reinforcing steel with section loss. 1LF CS3 exposed reinforcing steel.

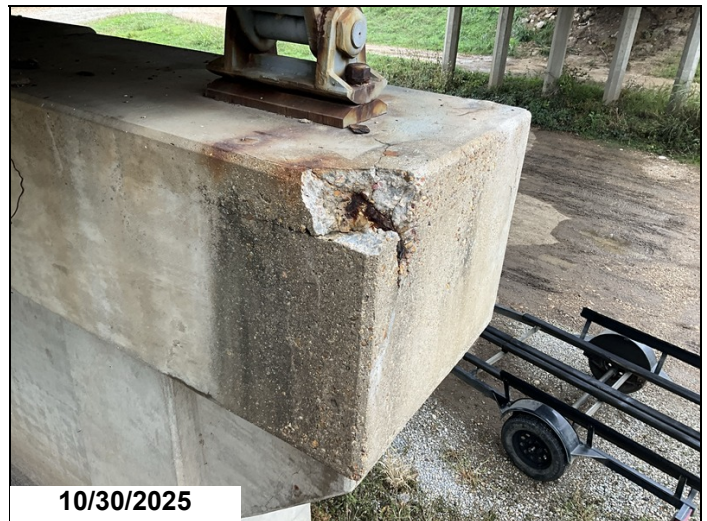
Pier 4, Left, Cap: Spalling with exposed reinforcing steel with section loss. 1LF CS3 exposed reinforcing steel.

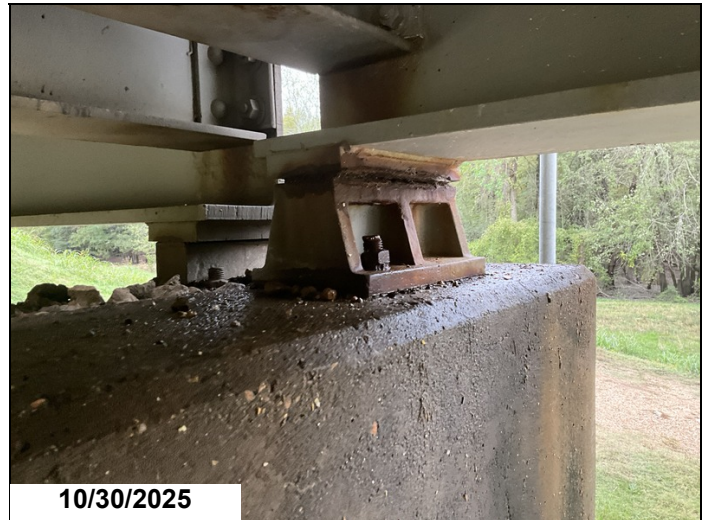
Span 10, Bent 7, Bearings 1 - 4: Active corrosion with pack rust. 4EA CS3 corrosion.

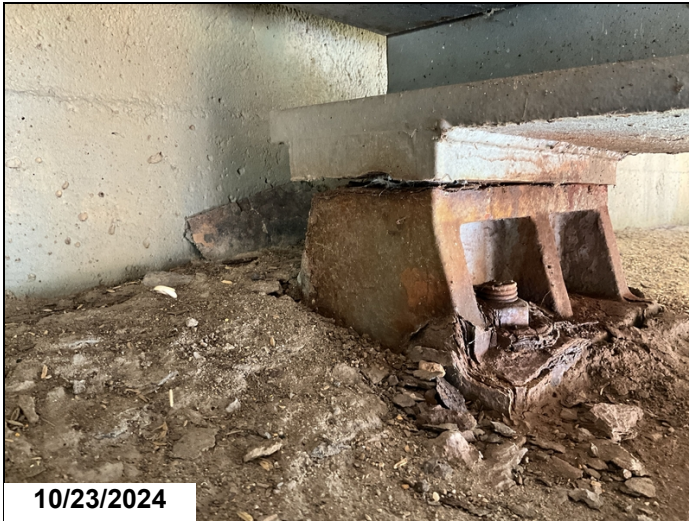
Bent 8, bearing 3: floating bearing.

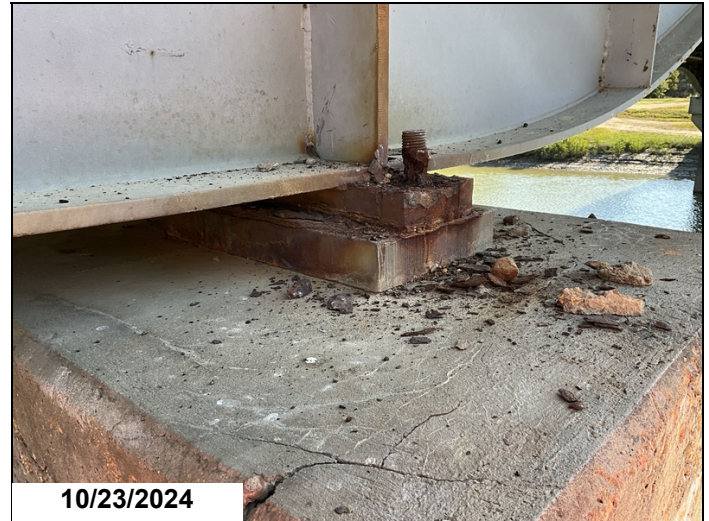
Corrosion with pack rust typ all bearings.

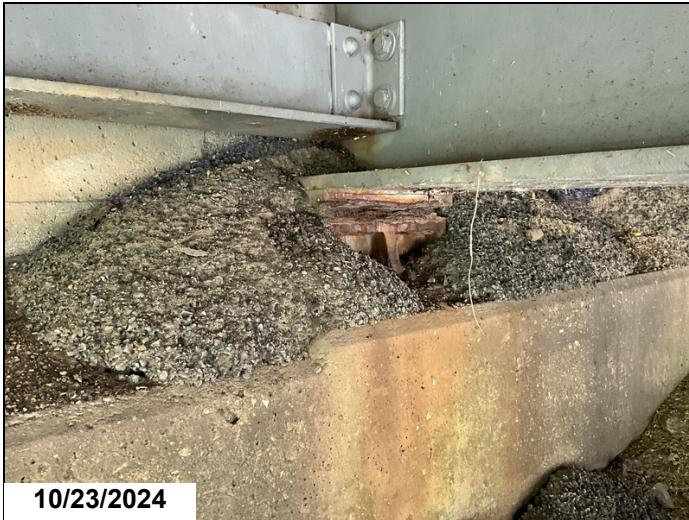
Bent 1, bearing 3: corrosion with severe pack rust raising girder elevation and severe asphalt debris accumulation around bearing. Typ at bearing 2. CS3 2 EA

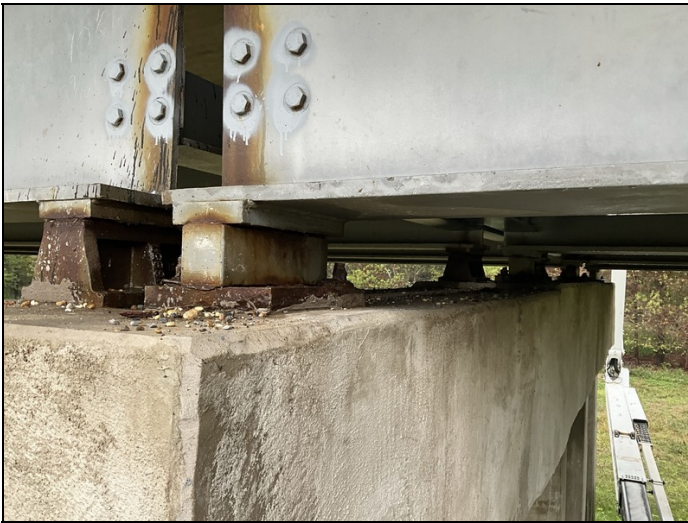
All bearings needing paint.

Painting is recommended at all joint locations along with all bearings.

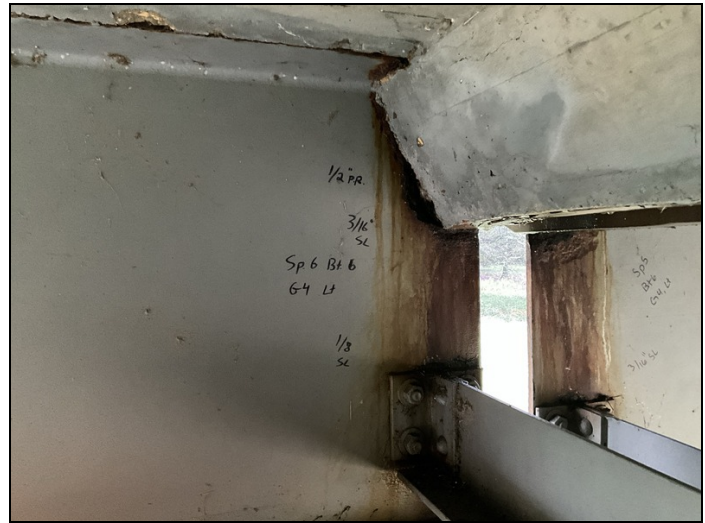
This defect is common throughout the structure at girder ends.

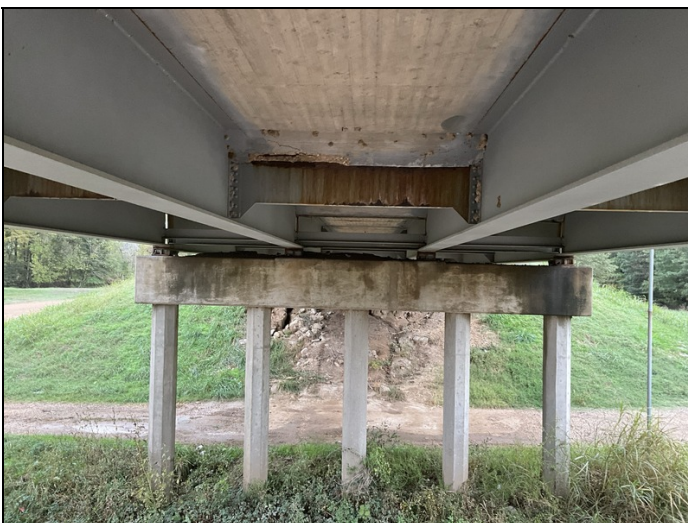
Bent 7, Cap: Needs cleaned.

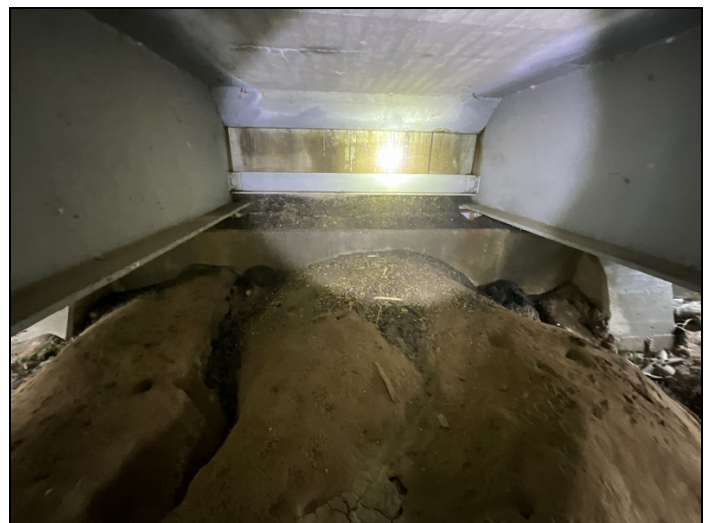
Bent 1: Cap needs cleaned.

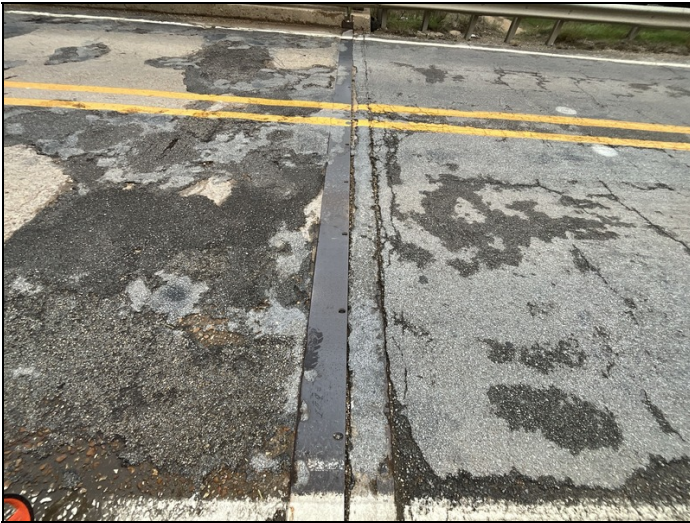
Bent 8, Joint: Debris impactation, full length. 26LF CS3 debris impactation.

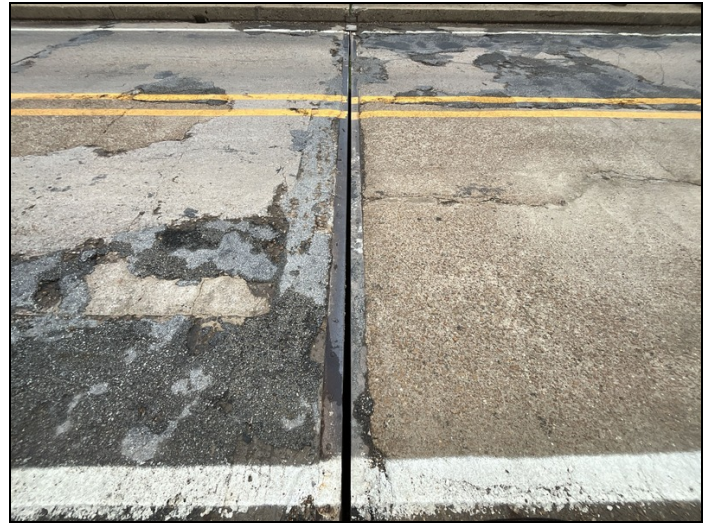
Bent 7, Joint: Armor missing for the full length. 26LF CS4 metal deterioration.

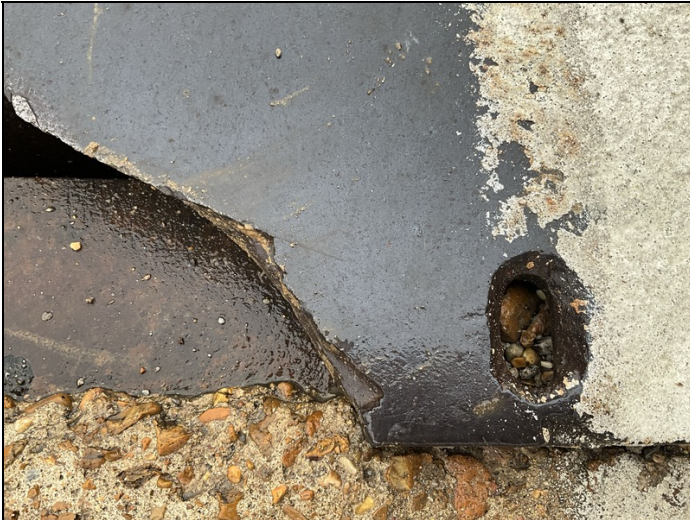
Bent 6, Joint: Cracking in the joint armor. 1LF CS3. metal deterioration.

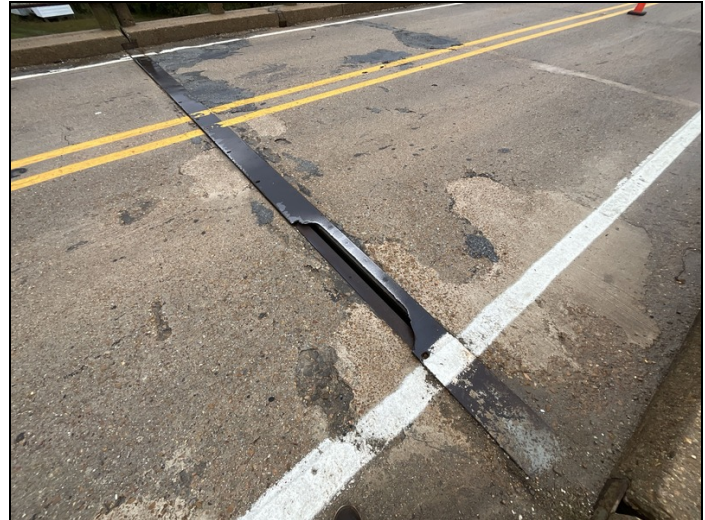
Bent 6, Joint: Joint armor missing. 4LF CS4 metal deterioration.

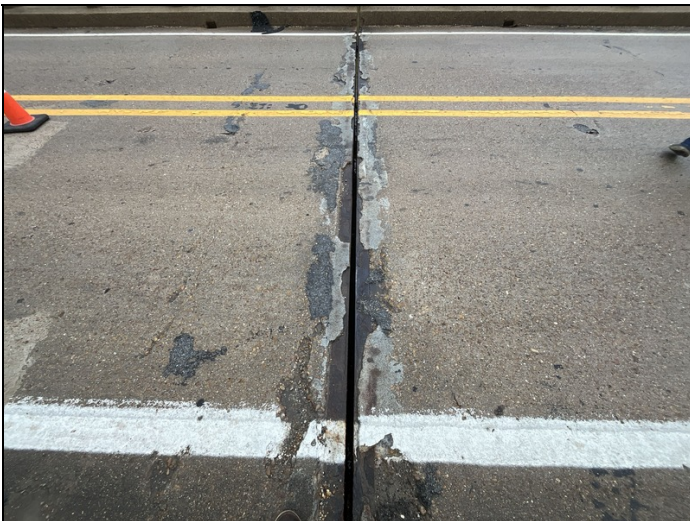
Bent 5, Joint: Armor missing for the full length. 26LF CS4 metal deterioration.

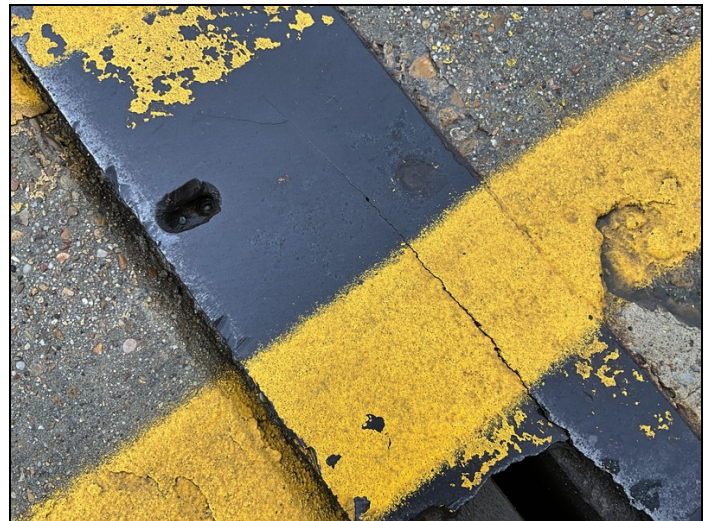
Bent 3, Joint. Cracking in the joint armor. 1LF CS3 metal deterioration.

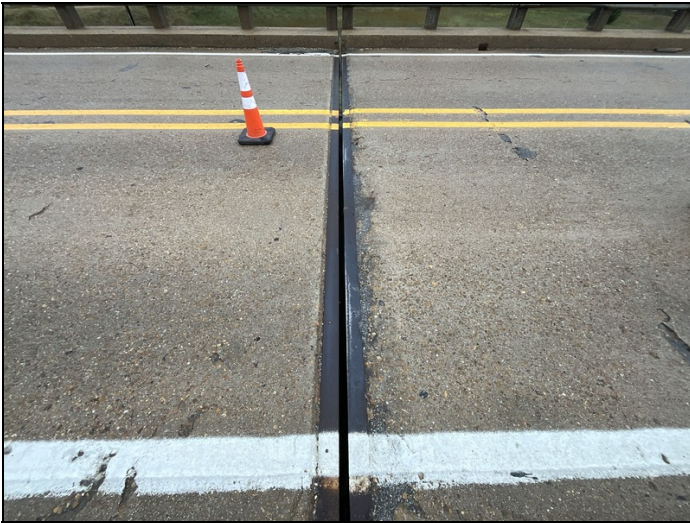
Bent 2, Joint: Armor missing for the full length. 26LF CS4 metal deterioration.

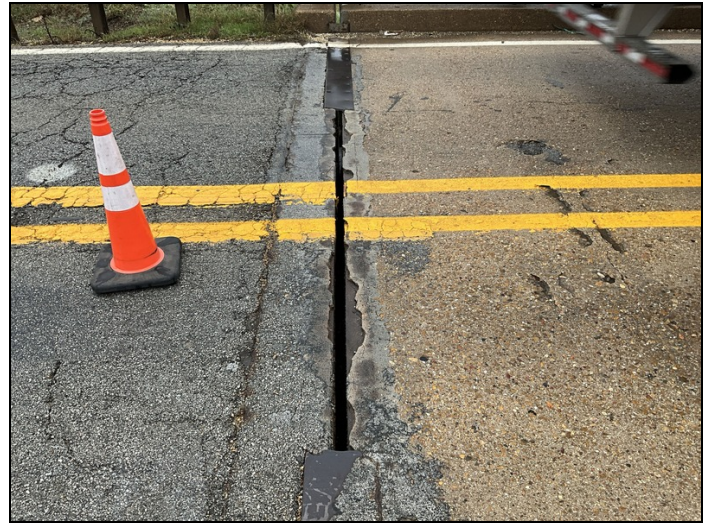
Bent 1, Joint: Armor missing. 12LF CS4 metal deterioration.

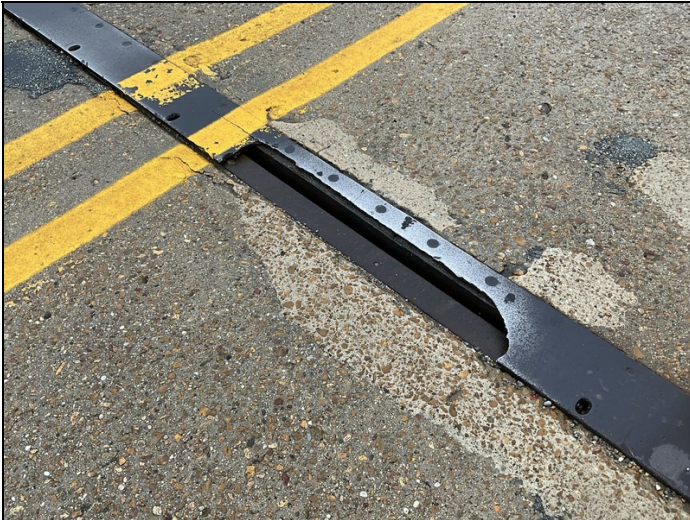
Bent 3, Joint: Armor missing. 4LF CS4 metal deterioration.

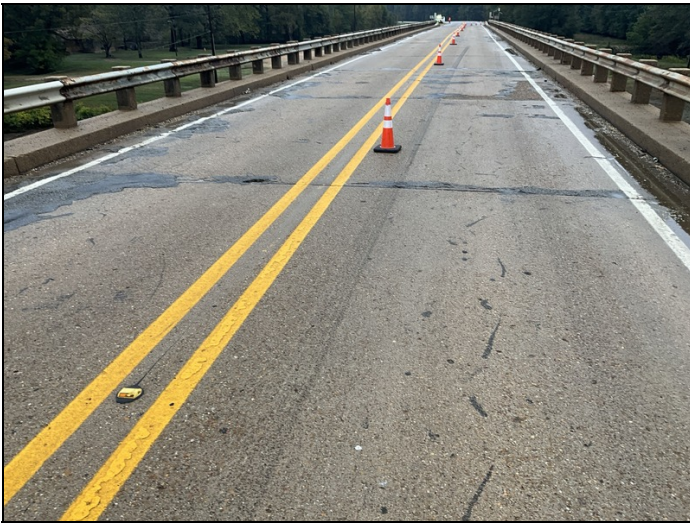
Typical deck.

A-62 - Hydro and LMC Advised (Yes)
Deck condition recommends hydro and LMC.

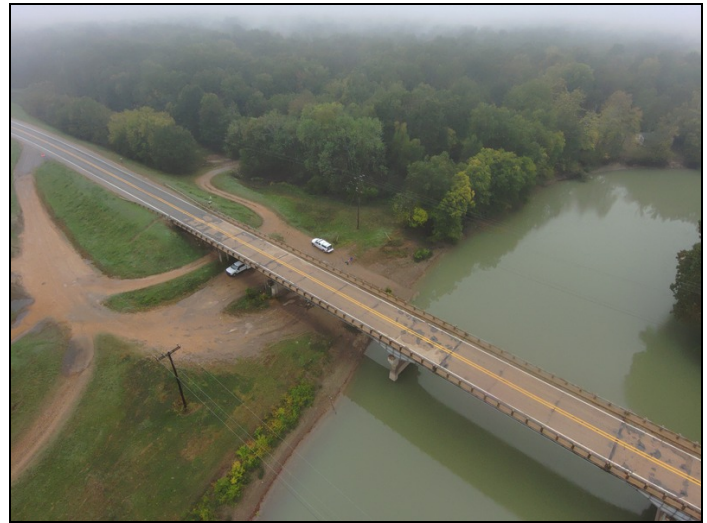
Overall view of the deck.
