Bridge 03023 Inspection Report

Route:62 Section:20 Log:2.58

Arnold Road ID:11x62x20xA, Arnold Log mile:2.593

(4) Place Code	0
(6) Features Intersected	BLACK RIVER
(7) Facility Carried	US 62-20- LM 2.58
(9) Location	2.58 MI E US 67
(11) Mile Point	2.58 mi
(12) Base Highway Network	Yes

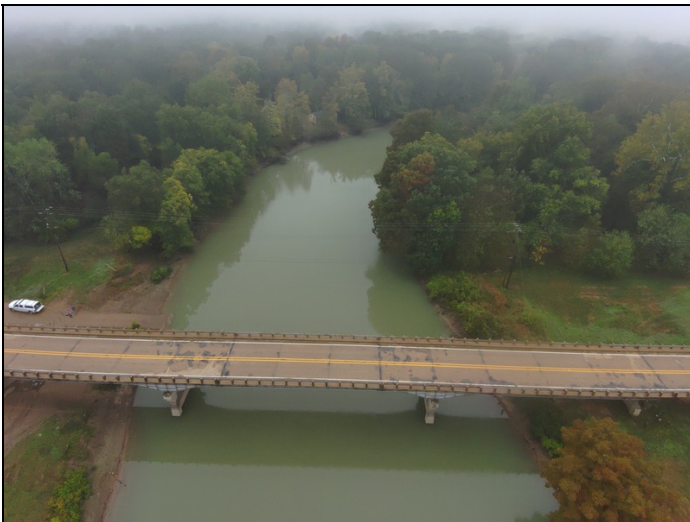
Overall view of the deck.

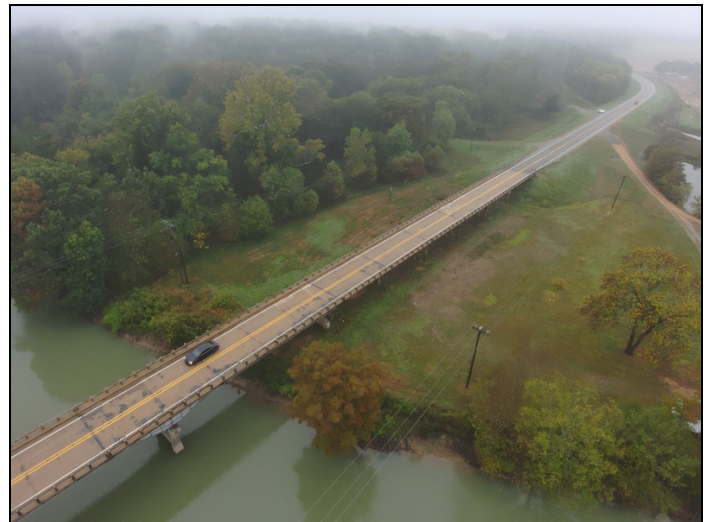
Overall view of the deck.
