Bridge 03024 Inspection Report

Route:62 Section:20 Log:3.55

District 10, 21 - Clay County

Team Lead: Brandon Sutton, Inspection Date: 10/30/2025

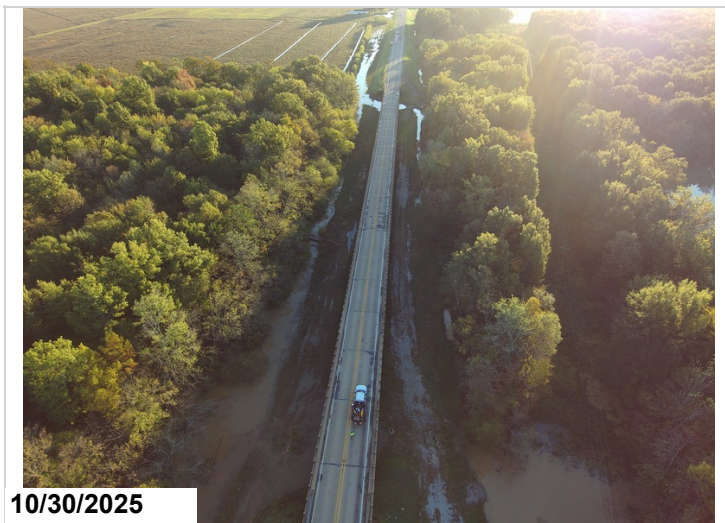
Deck is in overall satisfactory condition. Deck has numerous spalls and cracks.

Overall view of deck

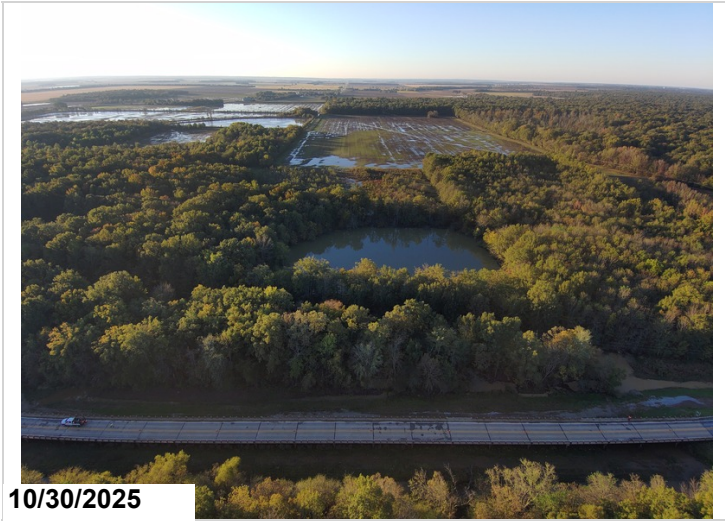
Downstream channel view

Channel is in overall good condition, it is a relief bridge and usually does not have water.

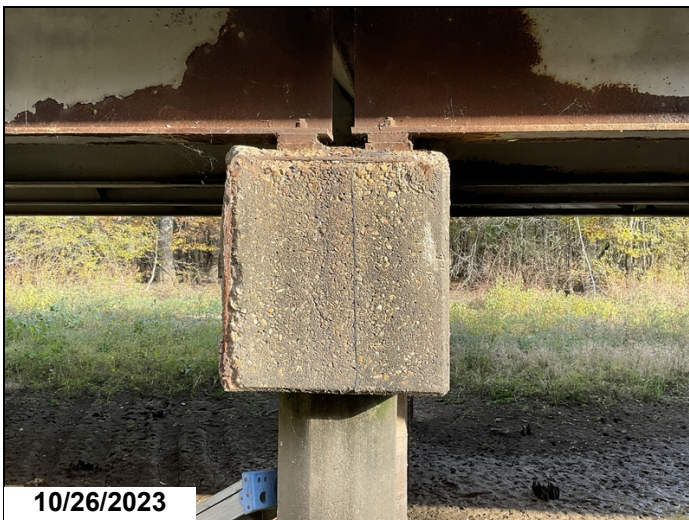
Bent 19 cap right
10-26-2023

Substructure is in overall satisfactory condition. Caps have numerous cracks and areas of exposed rebar.

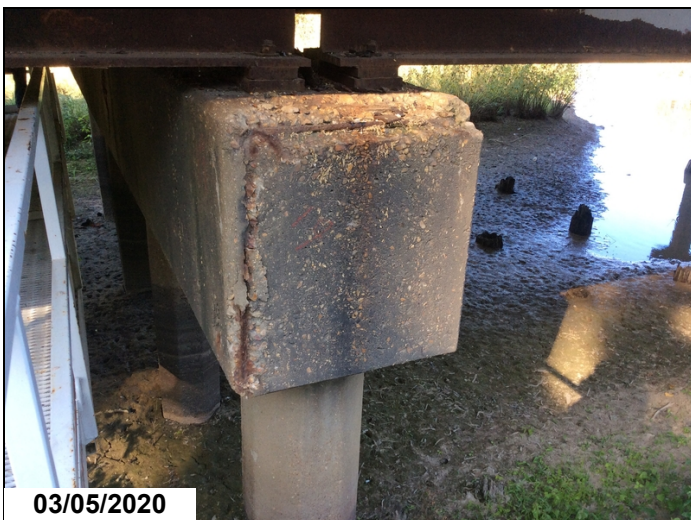
Bent 19 right end of cap.

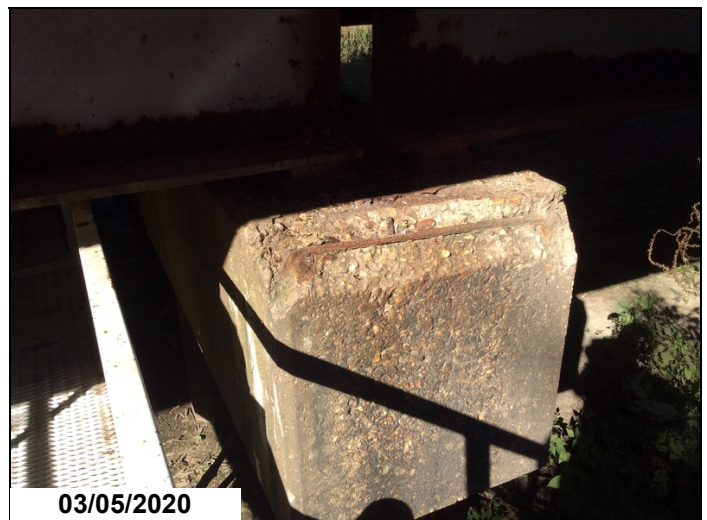
Bent 17 right end of cap.

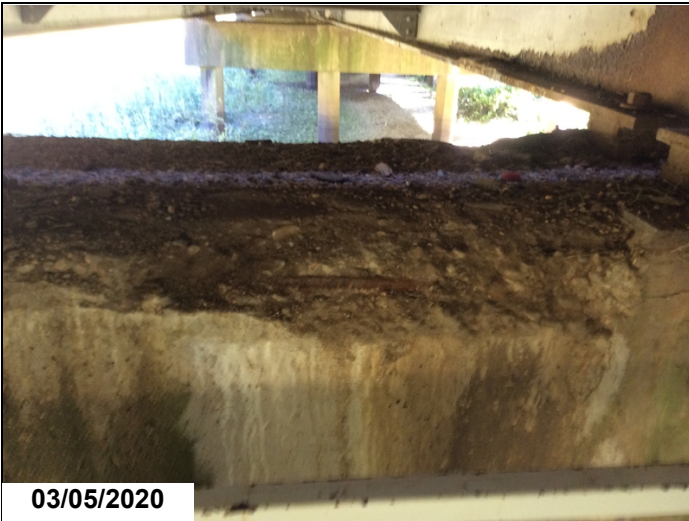
Bent 12 cap span 11 side between girders 1 & 2.

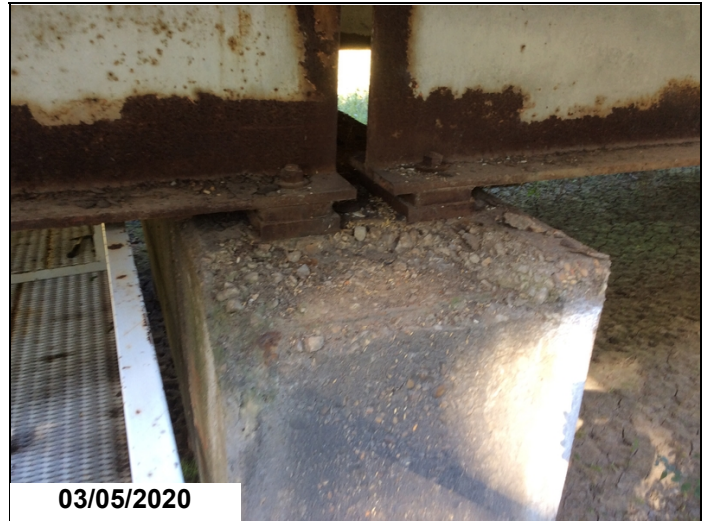
Bent 15 right end of cap under girder 4 bearings.

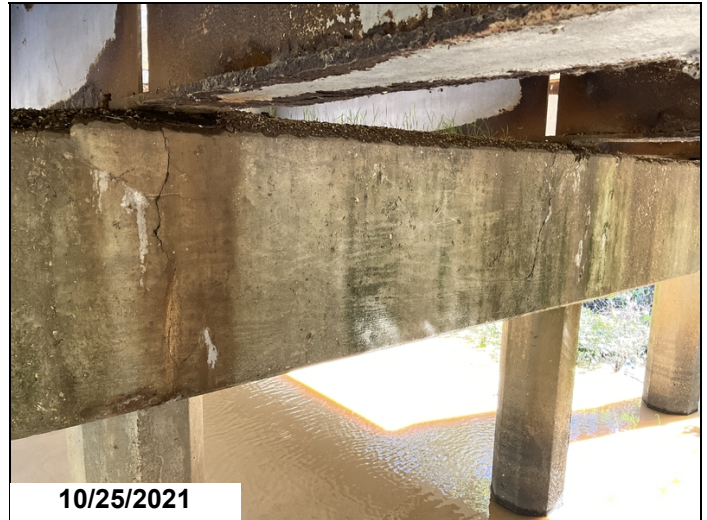
Bent 8 cap over piles 2 and 3

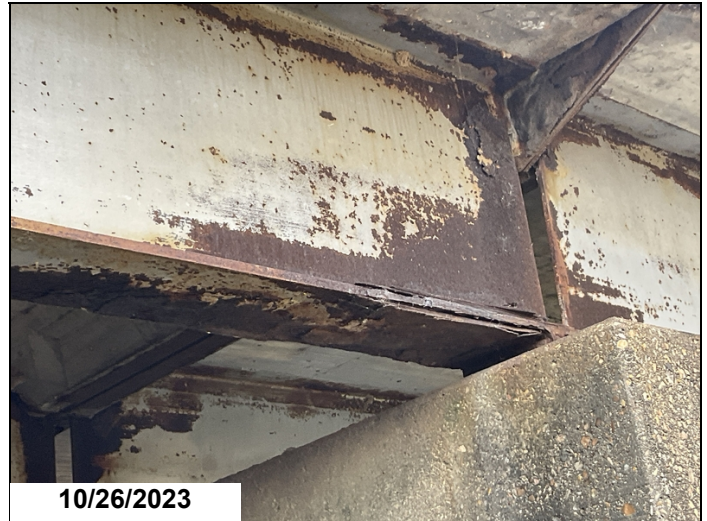
Span 21 bent 21 girder 4
10-26-2023

Superstructure is in overall fair condition. Girders have numerous holes in web below haunch and areas of rust with section loss.

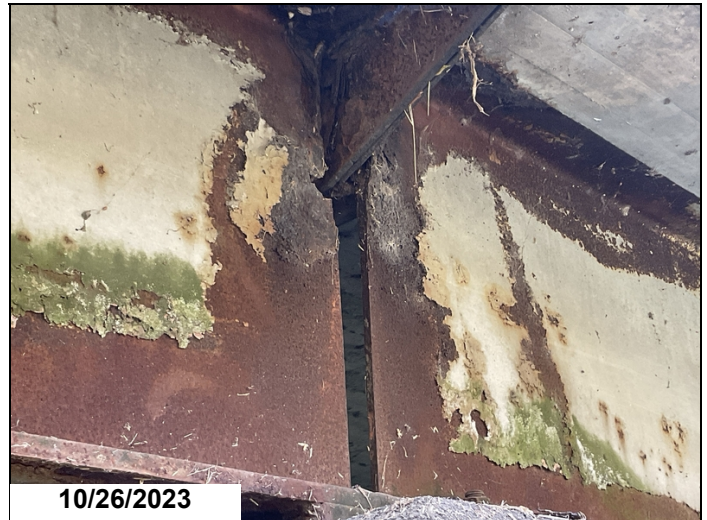
Span 12&13 bent 13 girder 1
10-26-2023

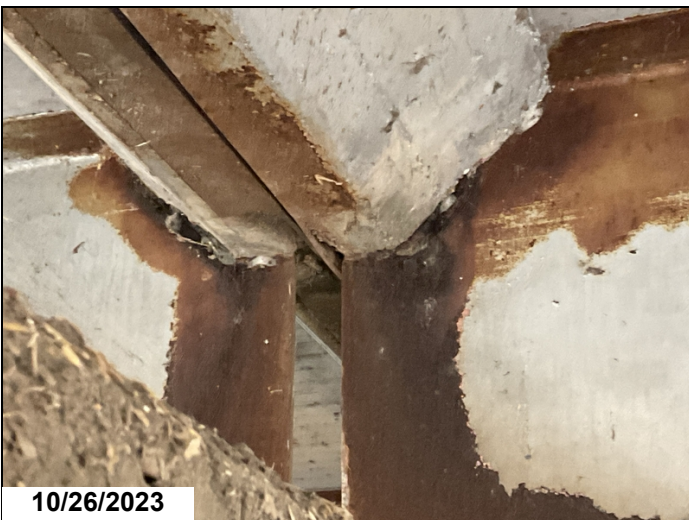
Span 12&13 bent 13 girder 3
10-26-2023

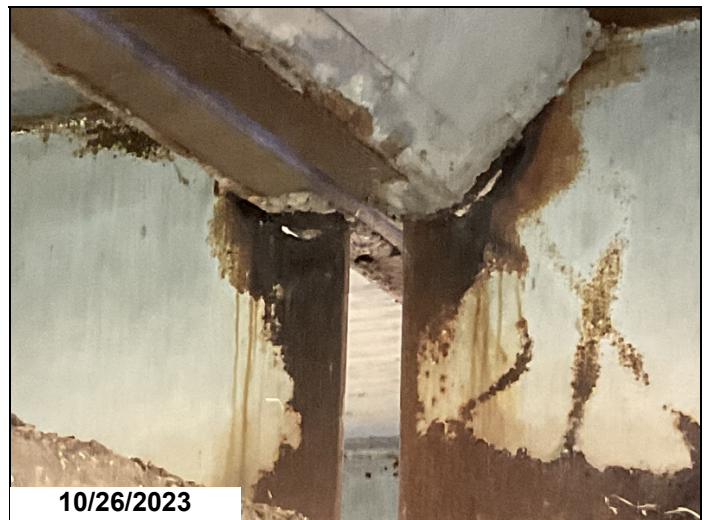
Span 11&12 bent 12 girder 3
10-26-2023

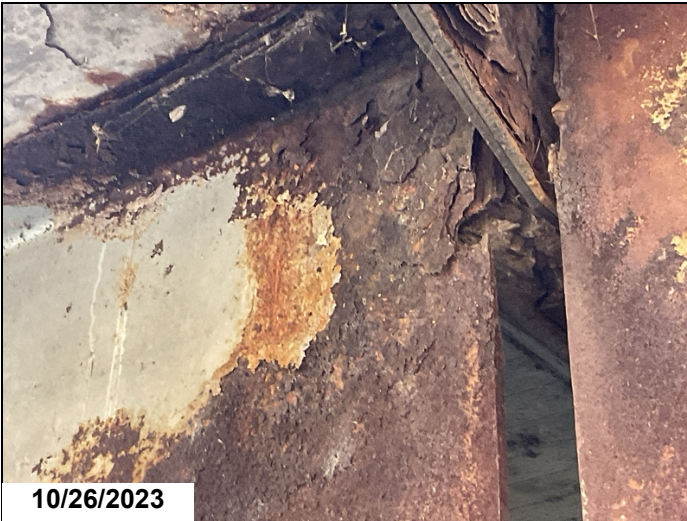
Span 11 bent 11 girder 4
10-26-2023

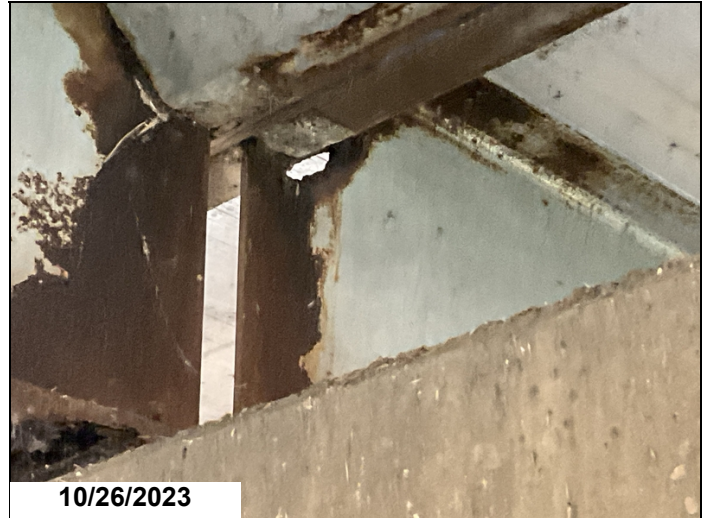
Span 6 bent 7 girder 3 has a 6" x 1" hole in web below
haunch 1LF CS3.

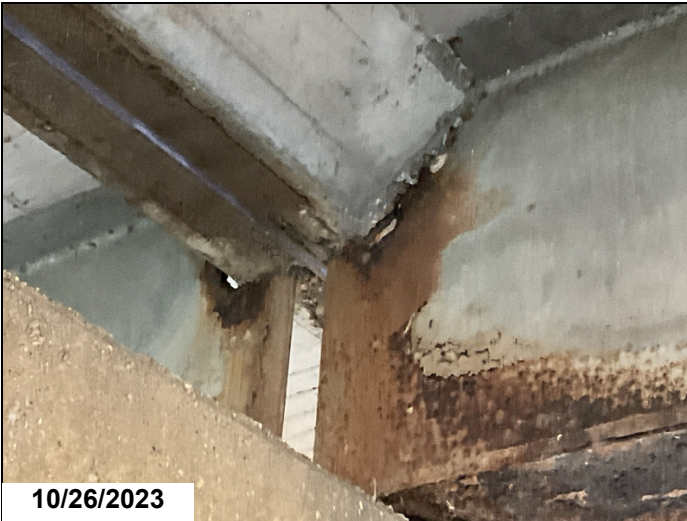
Span 5 bent 6 girder 3 has a 3" x 1" hole in web below haunch 1LF CS3.

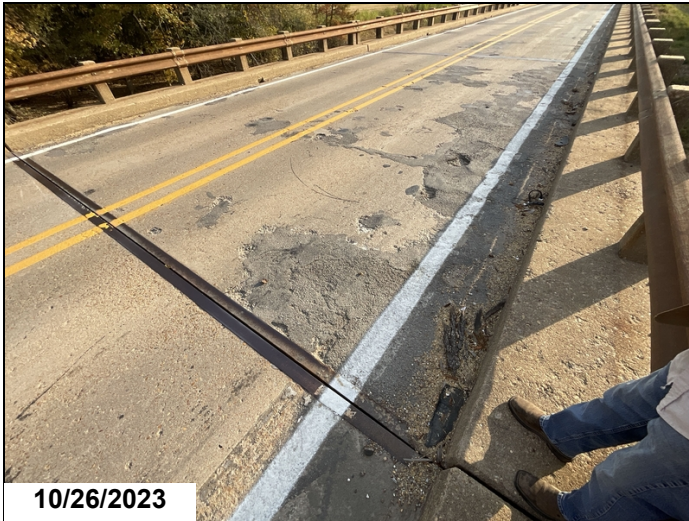
Span 18
10-26-2023

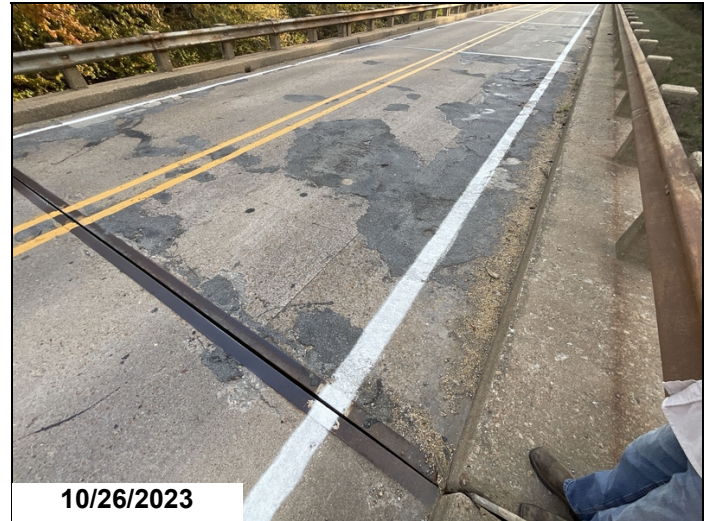
Span 8
10-26-2023

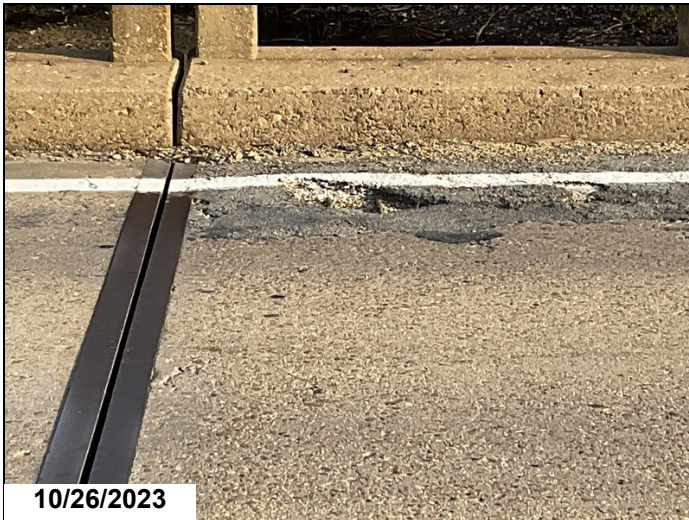
Span 3 westbound lane
10-26-2023

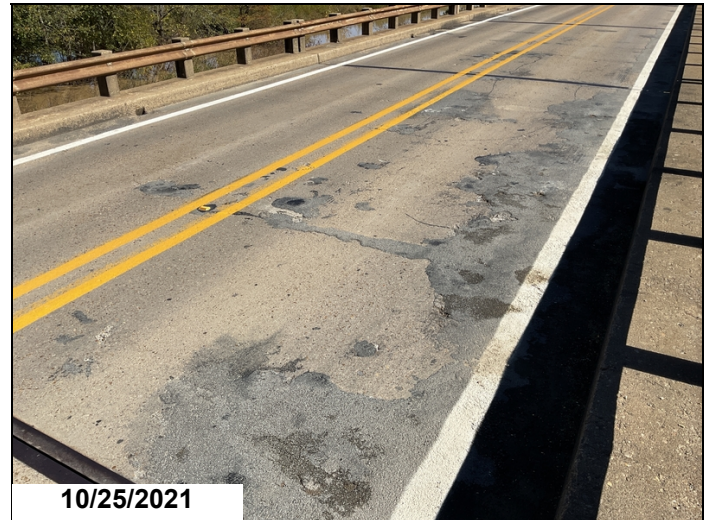
2021 - Span 18

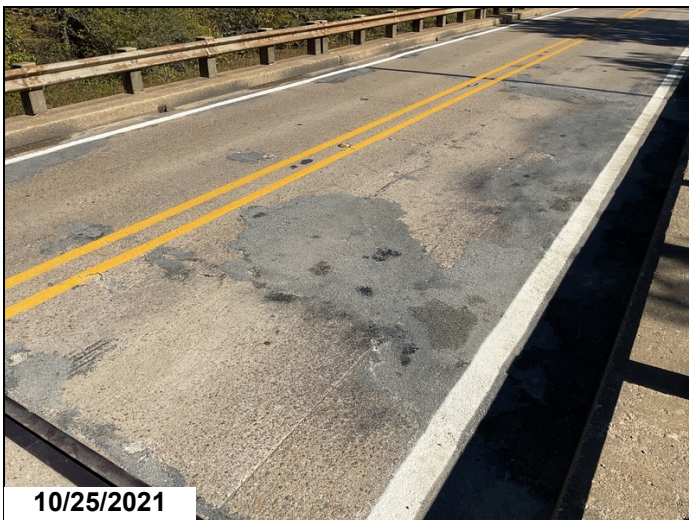
2021 - Span 8

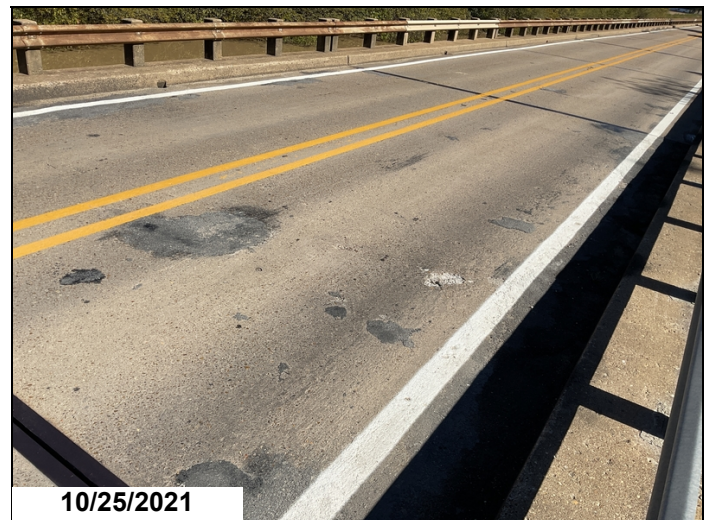
2021 - Span 3

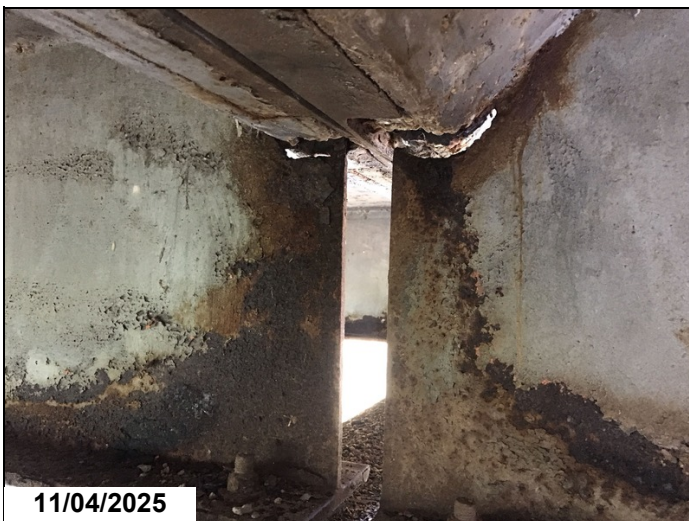
Span 2 bent 2 girder 2 has a 6" x 1" hole in web below haunch 1LF CS3.

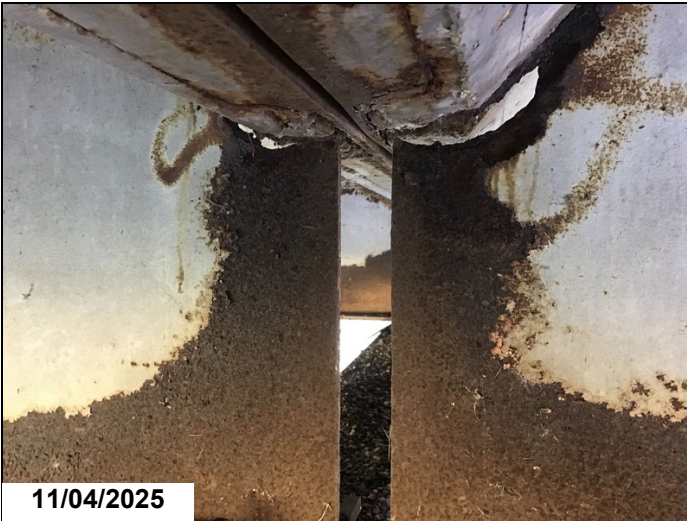
Span 9 bent 9 girder 3 has a 6" x 1" hole in web below haunch 1LF CS3.

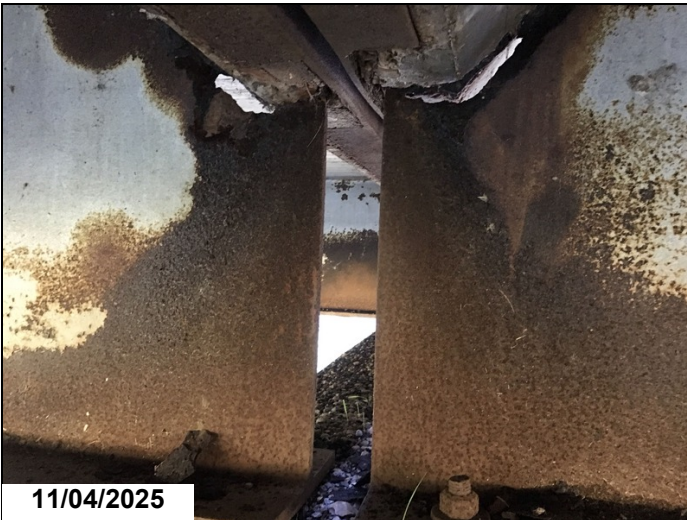
Span 10 bent 10 girder 3 has a 5" x 1" hole in web below haunch 1LF CS3.

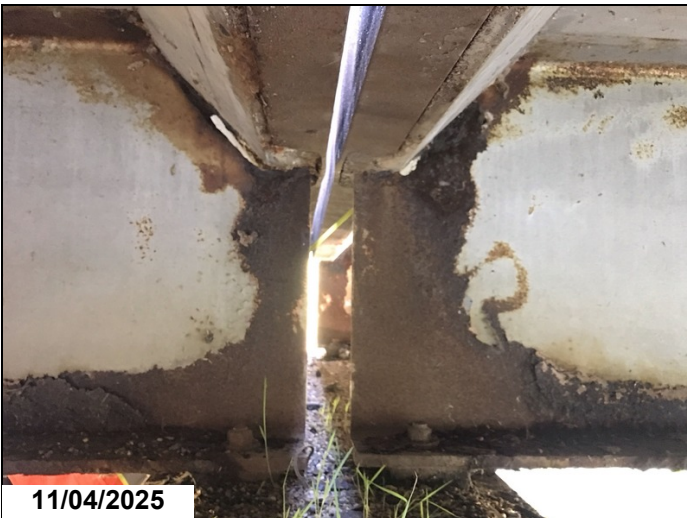
Span 12 bent 12 girder 2 has a 3" x 1" hole in web below haunch 1LF CS3.

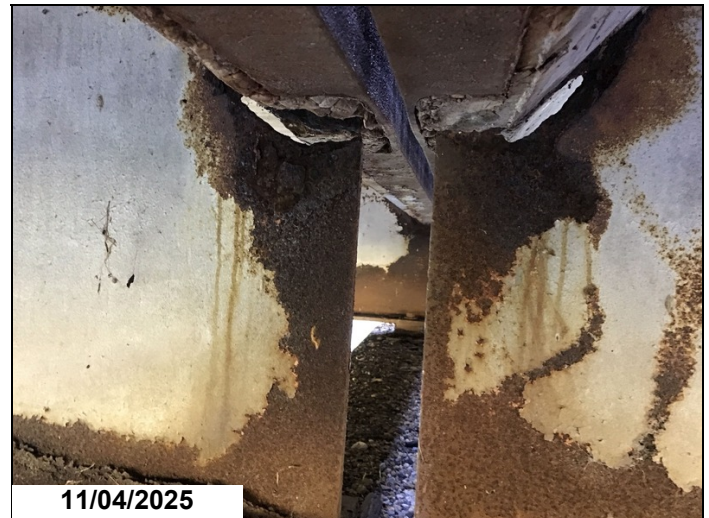
Span 12 bent 12 girder 3 has a 7" x 1" hole in web below haunch 1LF CS3.

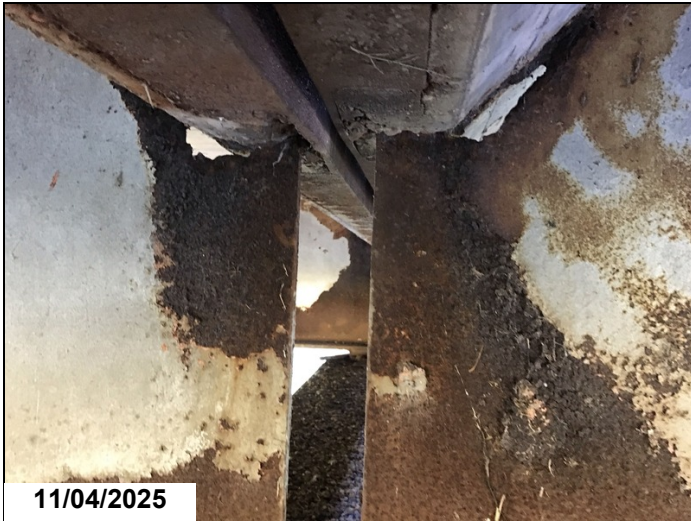
Span 13 bent 13 girder 3 has a 5" x 1" hole in web below haunch 1LF CS3.

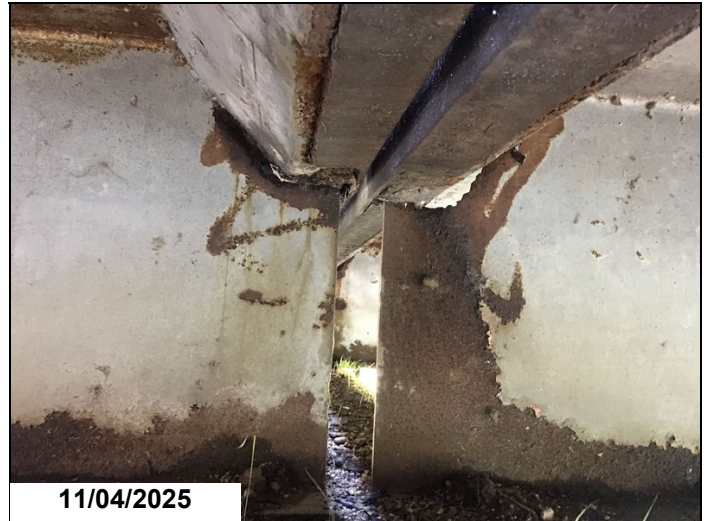
Span 13 bent 13 girder 2 has a 6" x 2" hole in web below haunch 1LF CS3.

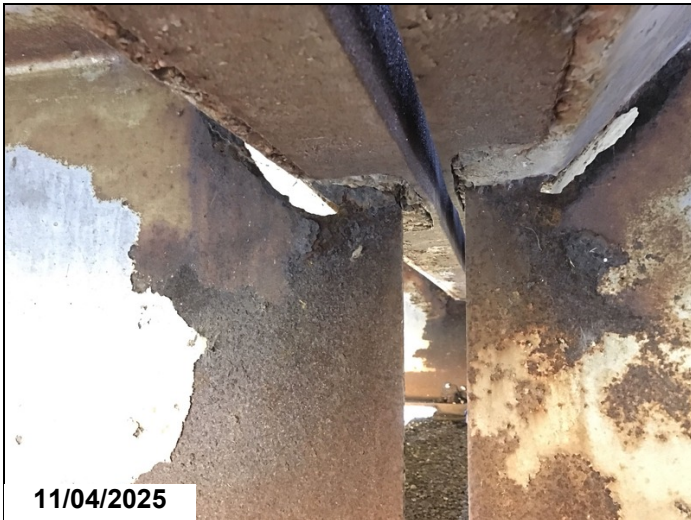
Span 14 bent 14 girder 3 has a 7" x 1" hole in web below haunch 1LF CS3.

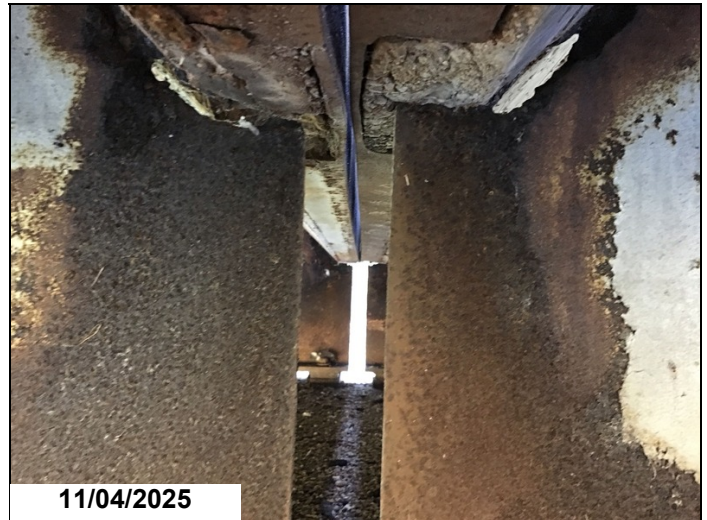
Span 15 bent 15 girder 3 has a 6" x 1" hole in web below haunch 1LF CS3.

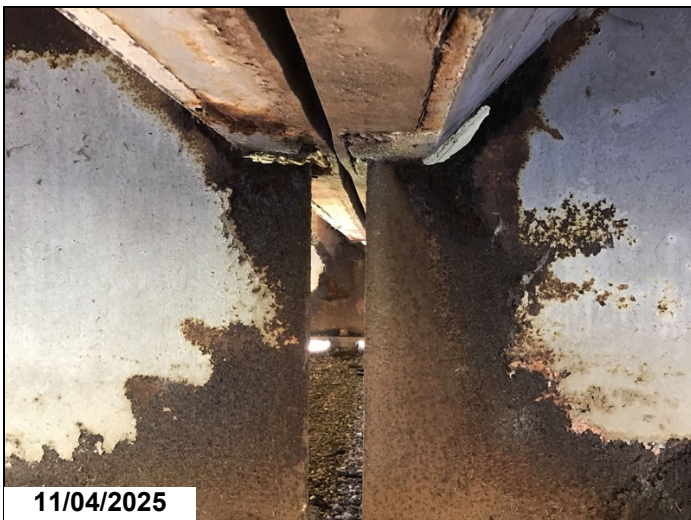
Span 16 bent 16 girder 3 has a 4" x 1" hole in web below haunch 1LF CS3.

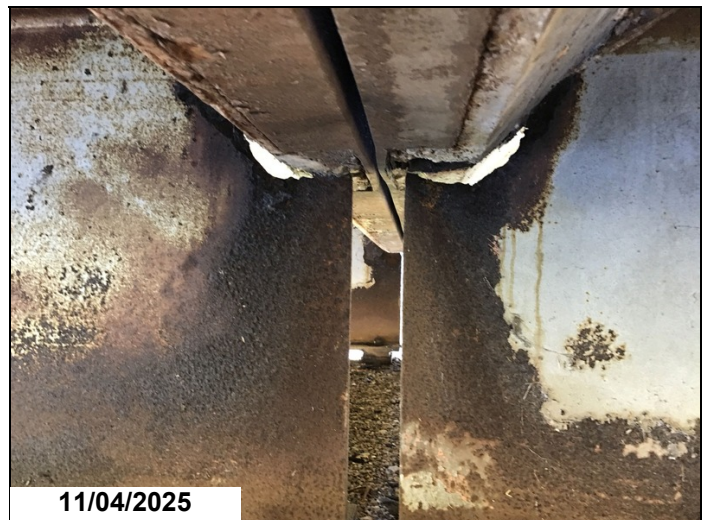
Span 17 bent 17 girder 3 has a 5" x 1" hole in web below haunch 1LF CS3.

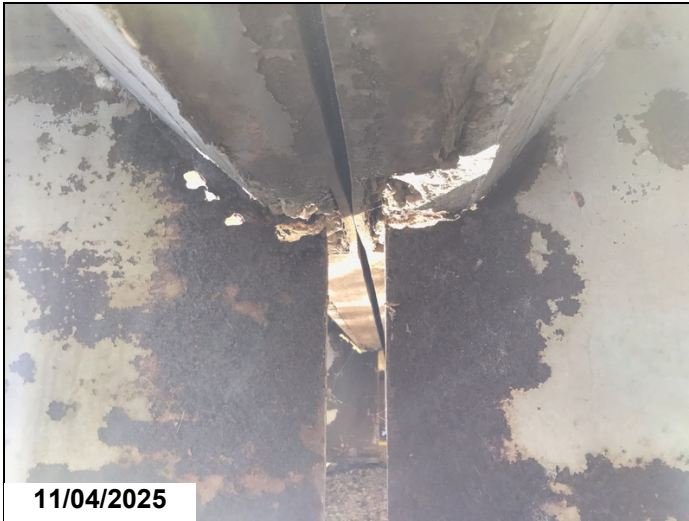
Span 19 bent 19 girder 2 has a 4.5" x 1" hole in web below haunch 1LF CS3.

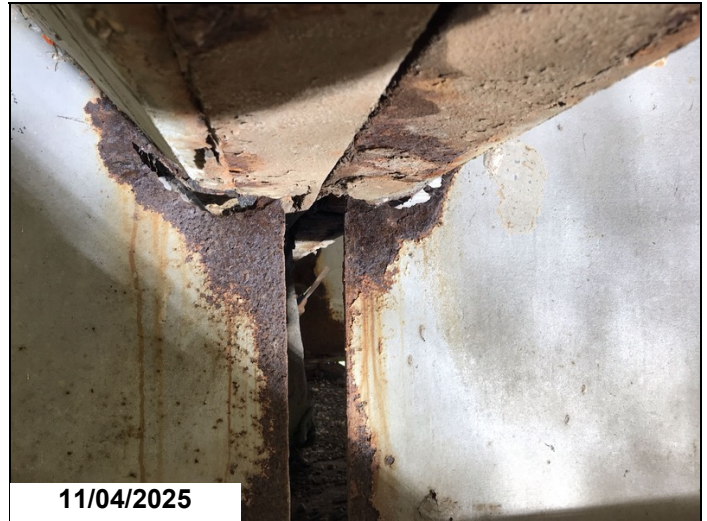
Span 20 bent 20 girder 2 has a 4" x 1" hole in web below haunch 1LF CS3.

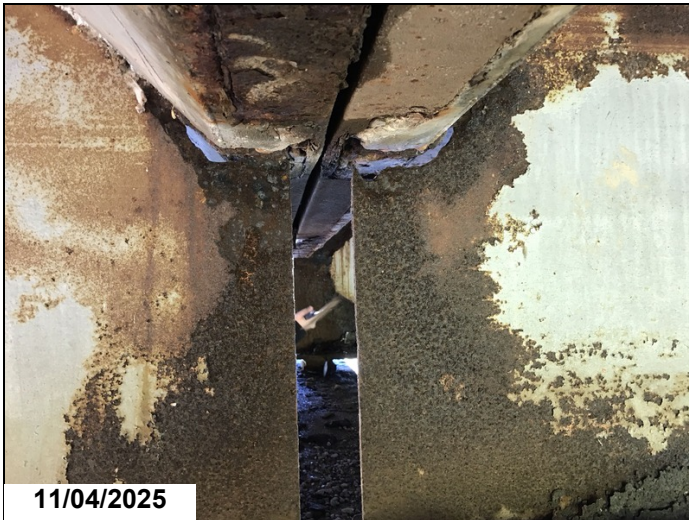
Span 21 bent 21 girder 2 has a 6" x 1" hole in web below haunch 1LF CS3.

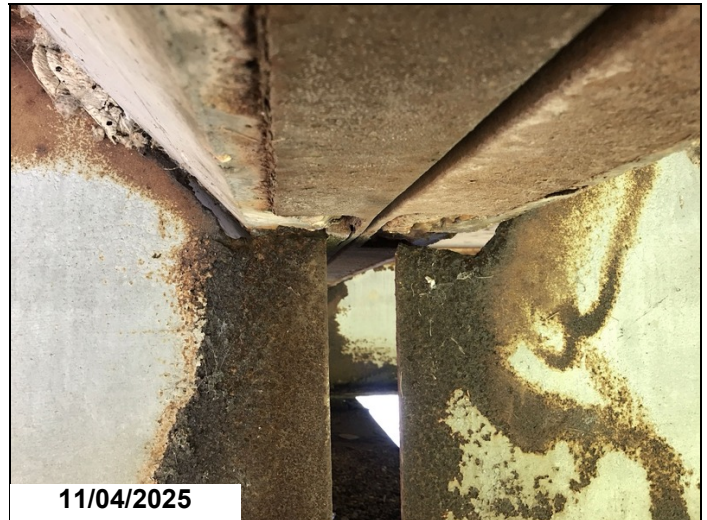
Span 21 bent 21 girder 3 has a 7" x 1" hole in web below haunch 1LF CS3.

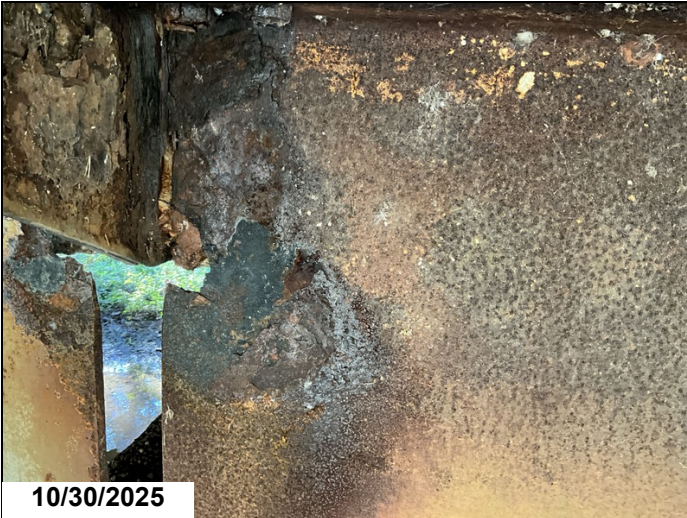
Span 13 bent 14 girder 1 has a 2" x 3" hole in web below haunch 1LF CS3.

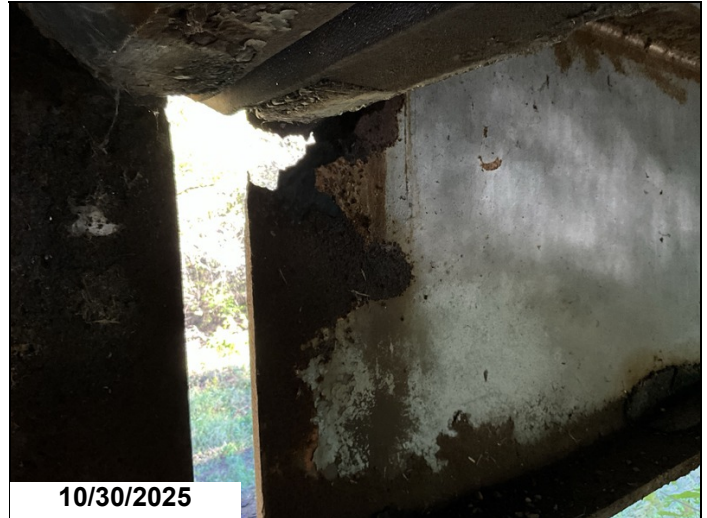
Span 13 bent 13 girder 1 has a 4" x 3" hole in web below haunch 1LF CS3.

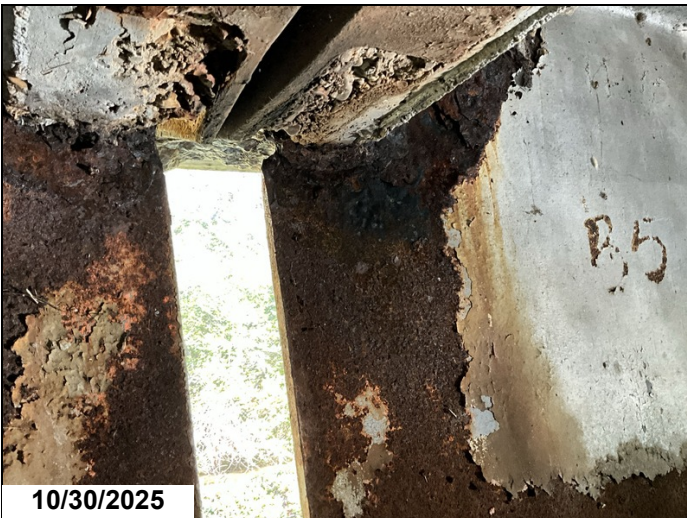
Span 12 Bent 12 Girder 1 1" diameter hole in web below haunch.

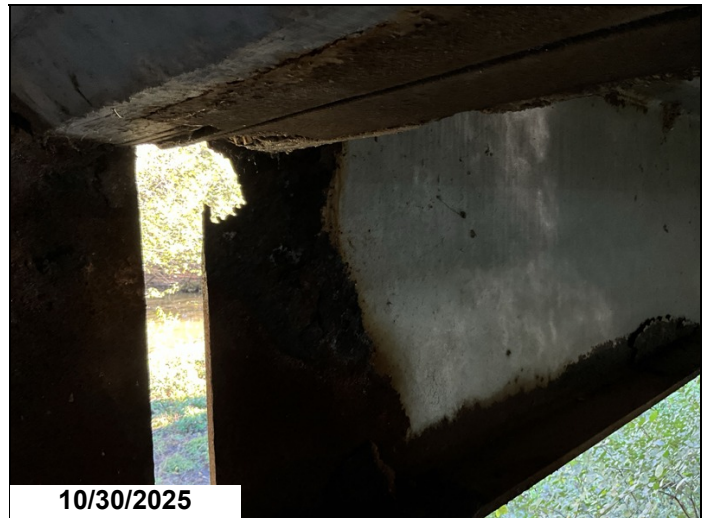
Span 11 bent 11 girder 1 has a 3" x 4" hole in web below haunch 1LF CS3.

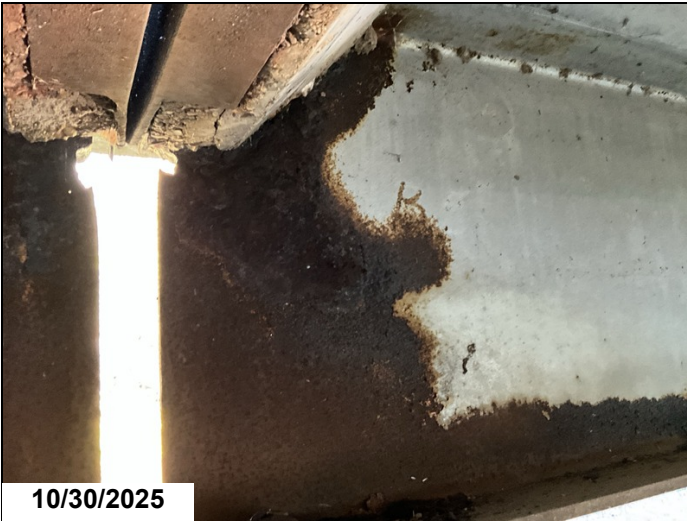
Span 10 bent 10 girder 1 has a 1" diameter hole in web below haunch 1LF CS3.

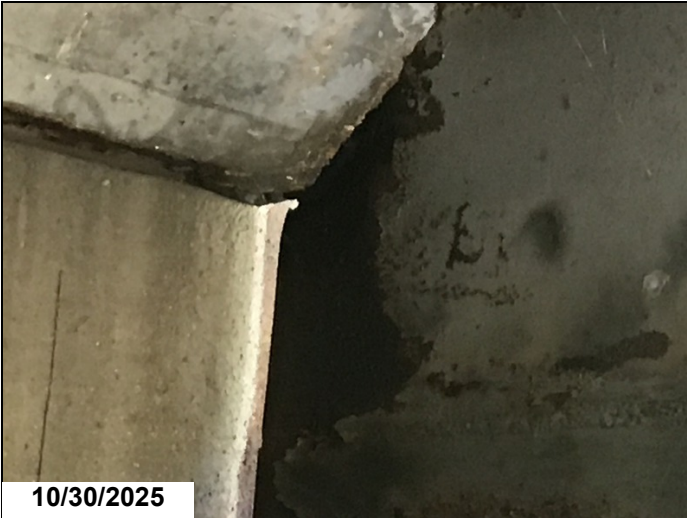
Span 21 bent 22 girder 4 bottom of web was t-spliced in the past, web below haunch has a 1" diameter hole 1LF CS3.

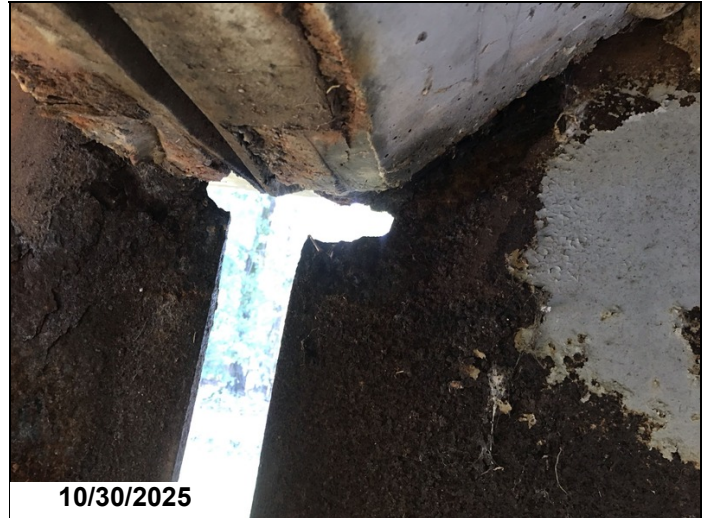
Span 15 bent 16 girder 4 has a 3" x 1" hole in web below haunch 1LF CS3.

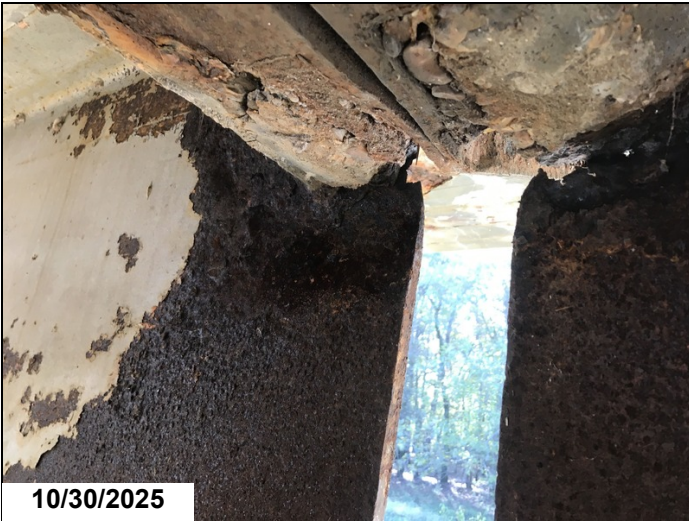
Span 19 bent 19 has a 1" hole in web below haunch.

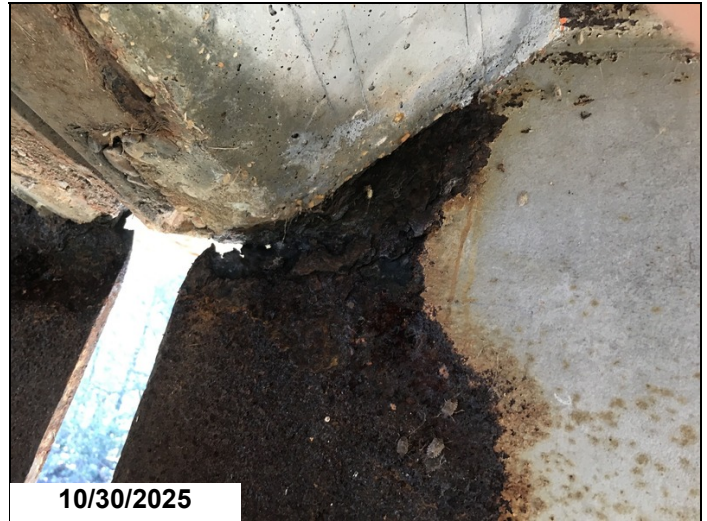
Span 18 bent 19 girder 4 has a 3" x 1" hole in web below haunch 1LF CS3.

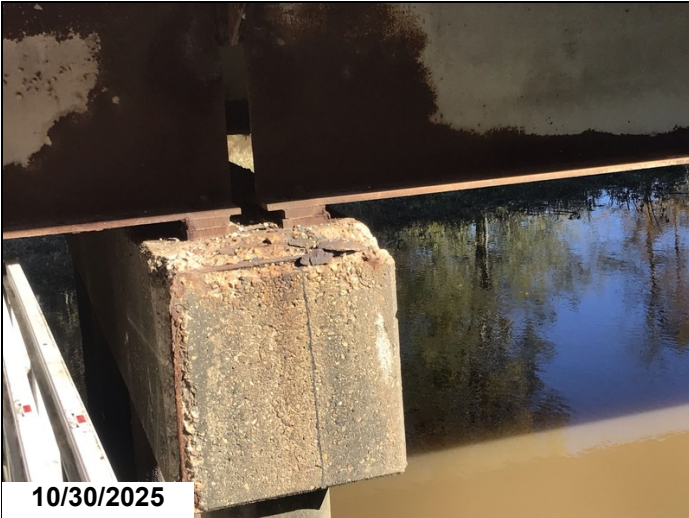
Bent 19 cap right end.

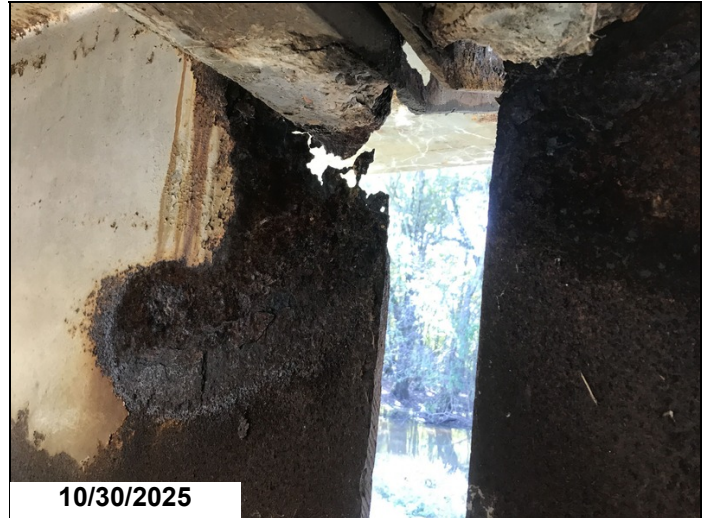
Span 18 bent 18 girder 4 has a 6" x 3" hole in web below haunch 1LF CS3.

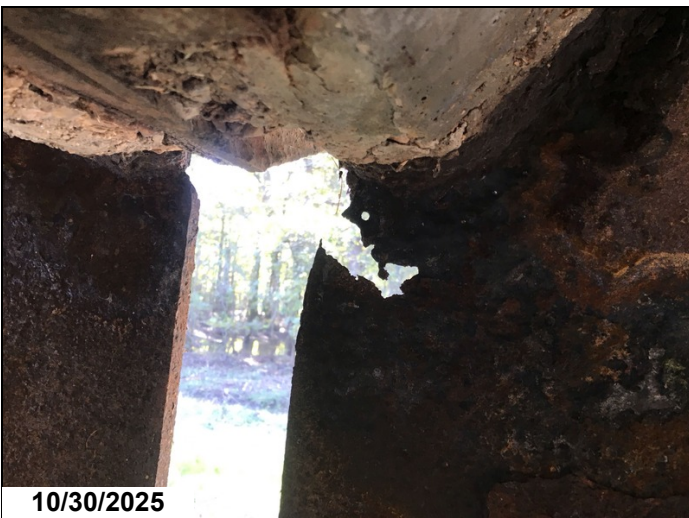
Span 16 bent 17 girder 4 has a 3" x 2" hole in web below haunch 1LF CS3.

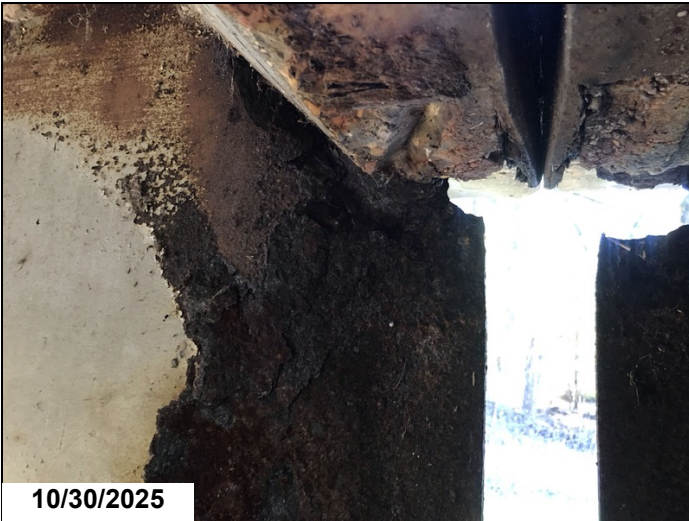
Bent 17 cap right end.

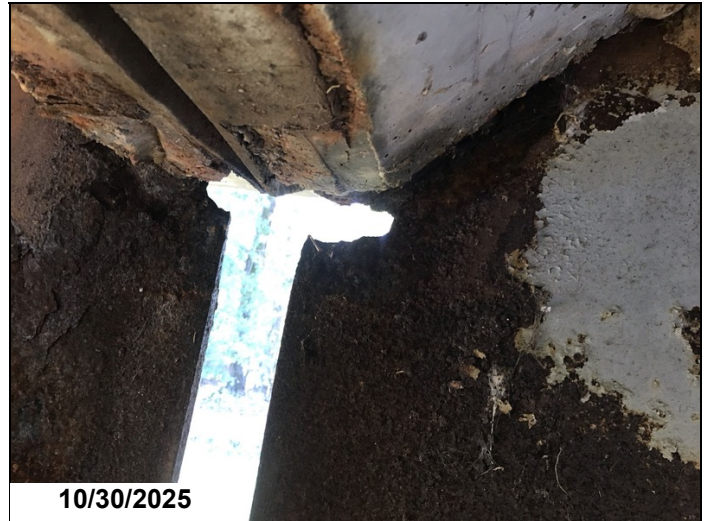
Span 16 bent 16 girder 4 has a 2" diameter hole in web below haunch 1LF CS3.

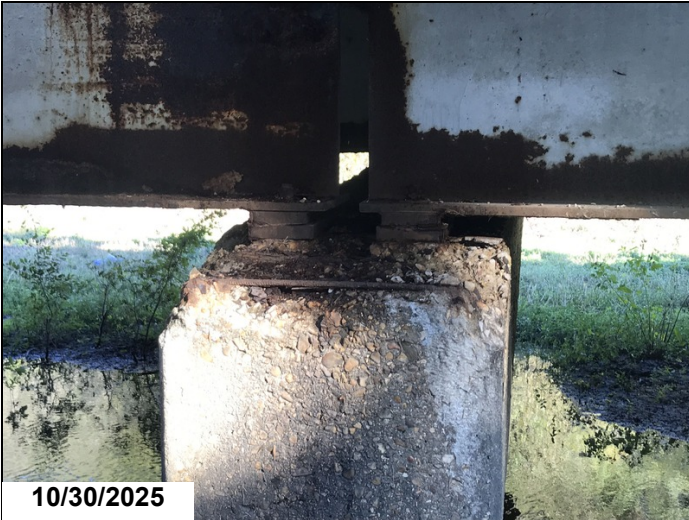
Span 15 bent 16 girder 4 has a 3" x 1" hole in web below haunch.

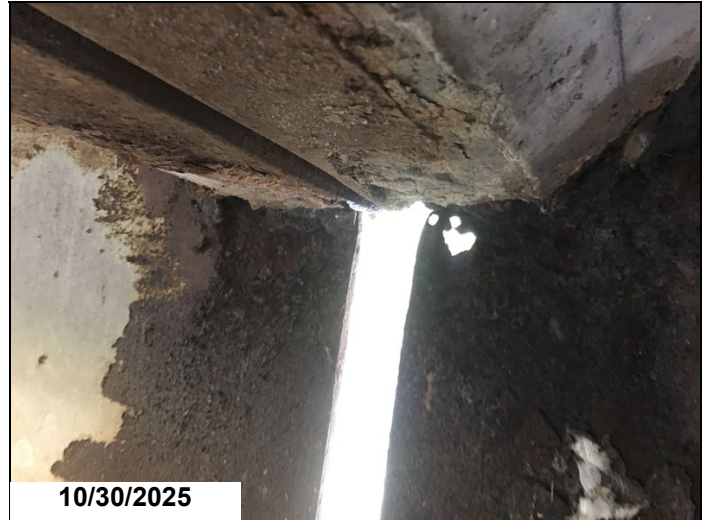
Bent 15 cap has some concrete disintegration at top on Rt end. Cap is spalled with exposed rebar.

Bent 15 cap right end.

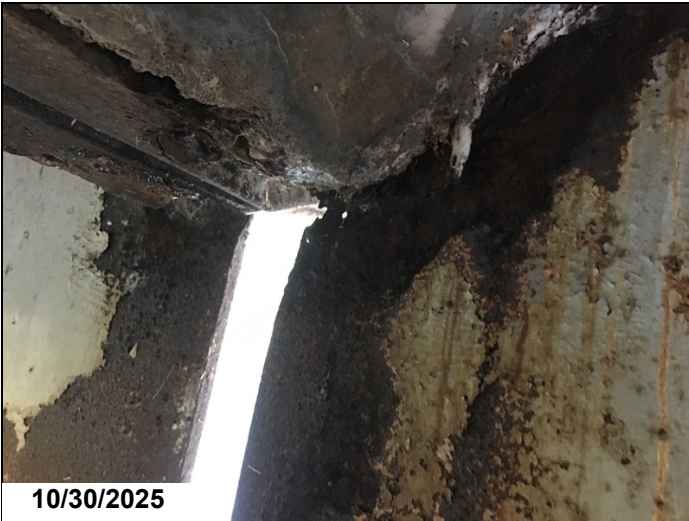
Span 12 bent 13 girder 4 has a 1" diameter hole in web below haunch 1LF CS3.

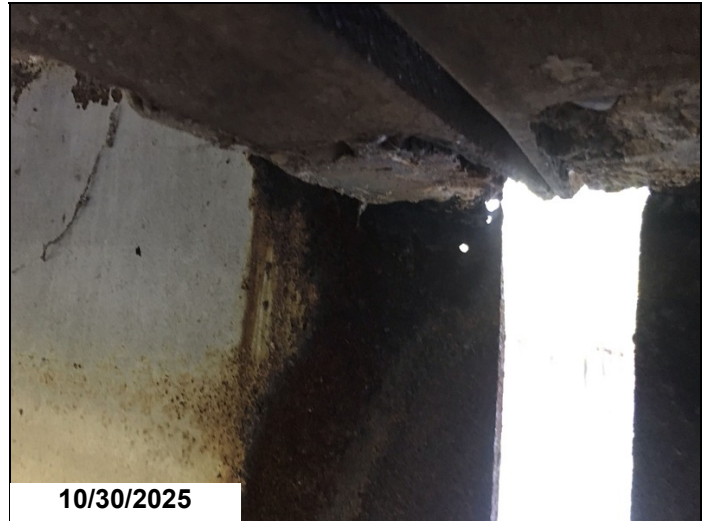
Span 11 bent 12 girder 4 has a 2" x 2" hole in web below haunch 1LF CS3.

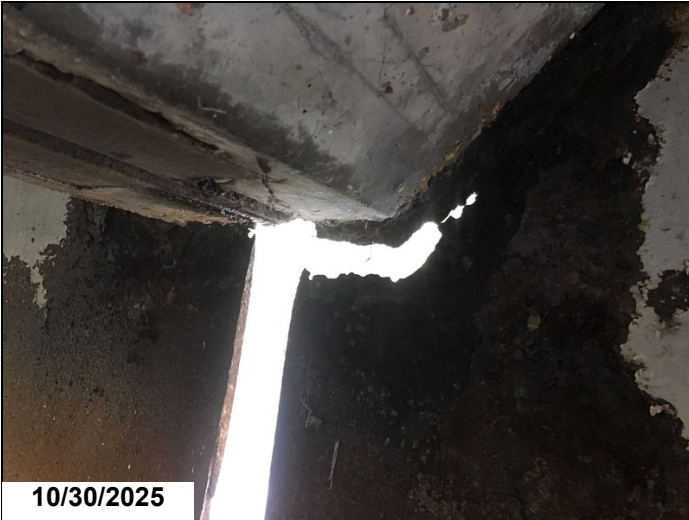
Span 11 bent 11 girder 4 has a 2" x 1" hole in web below haunch 1LF CS3.

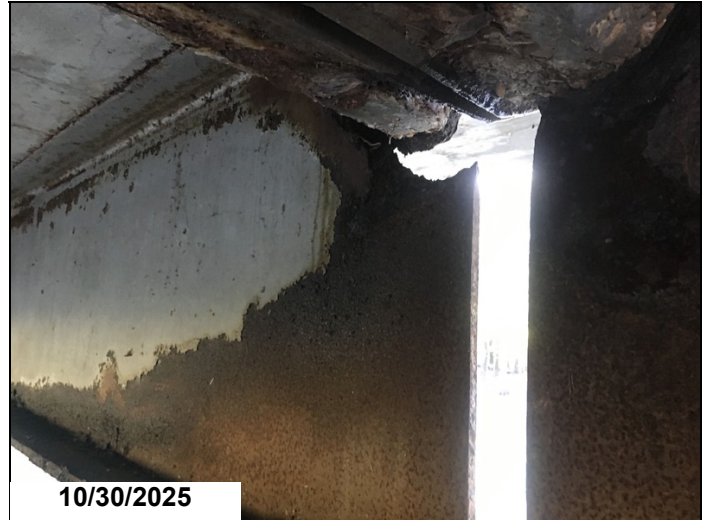
Span 9 bent 10 girder 4 has a 8" x 1" hole in web below haunch 1LF CS3.

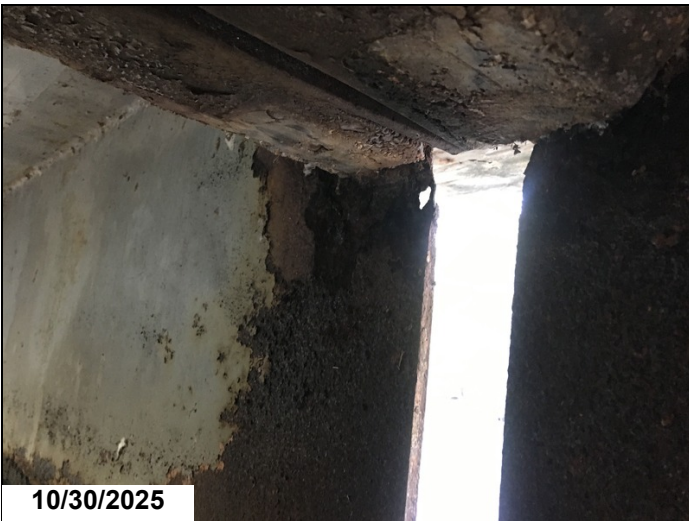
Span 9 bent 9 girder 4 has a 7" x up to 2" hole in web below haunch 1LF CS3.

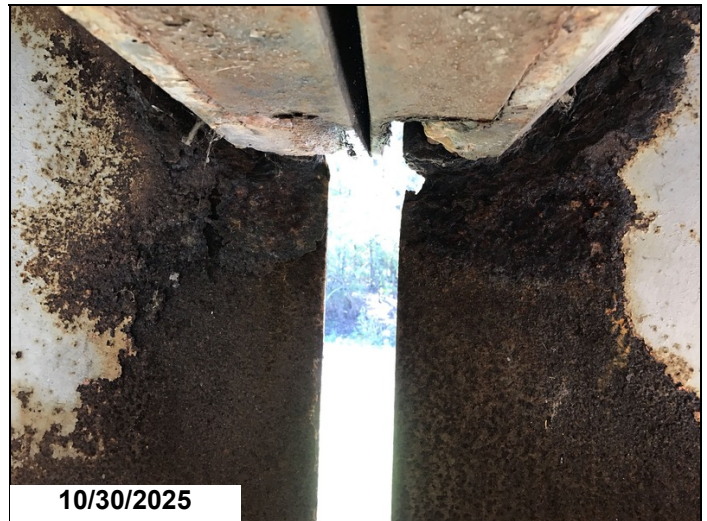
Span 6 bent 6 bearing 4 has a 1" diameter hole in web below haunch 1LF CS3.

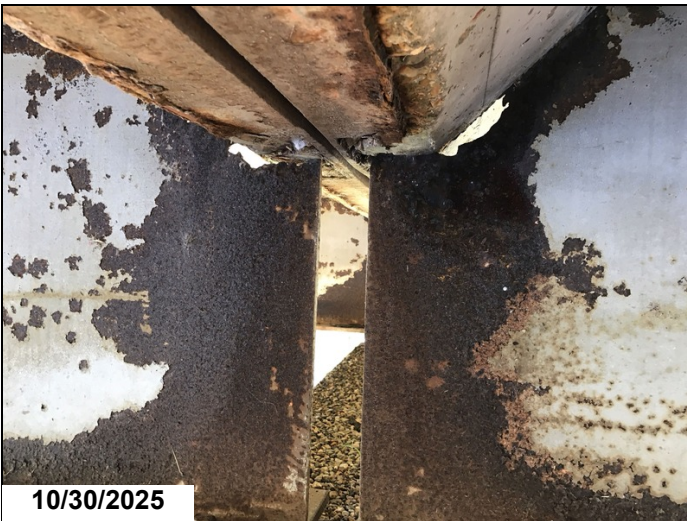
10/30/2025
Span 18 bent 19 girder 2 has a 5" x up to 1" hole in web below haunch 1LF CS3.

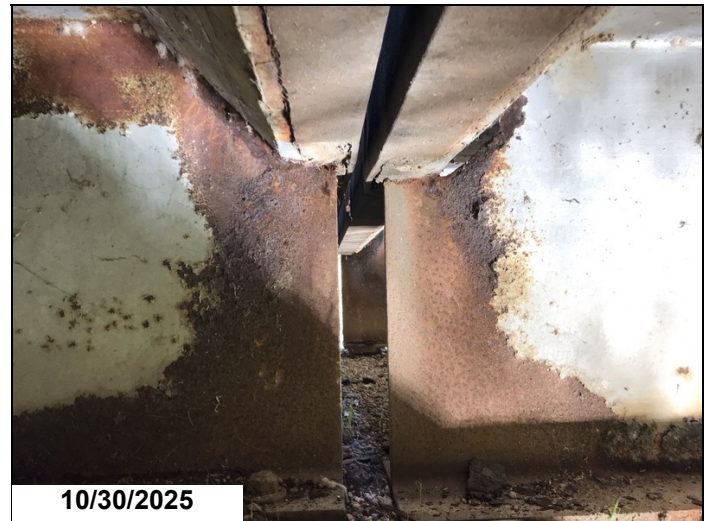
10/30/2025
Span 18 bent 19 girder 3 has a 4" x 1" hole in web below haunch 1LF CS3.

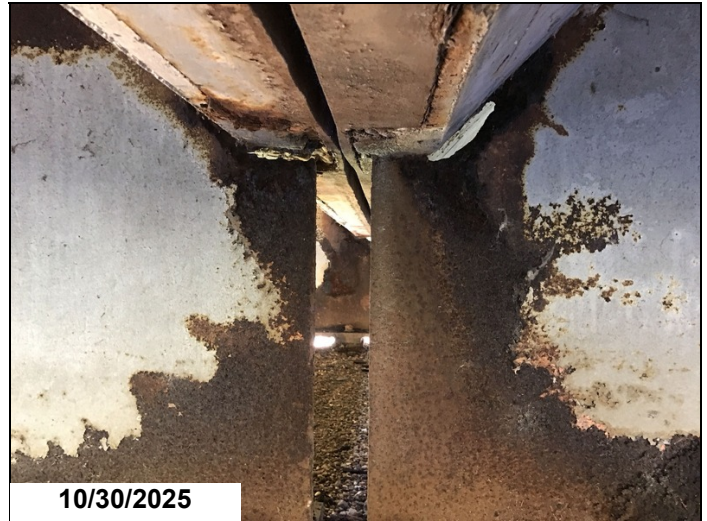
Span 16 bent 17 girder 3 has a 8" x 1" hole in web below haunch 1LF CS3.
