Bridge 03024 Inspection Report

Route:62 Section:20 Log:3.55

District 10, 21 - Clay County

Team Lead: Brandon Sutton, Inspection Date: 10/30/2025

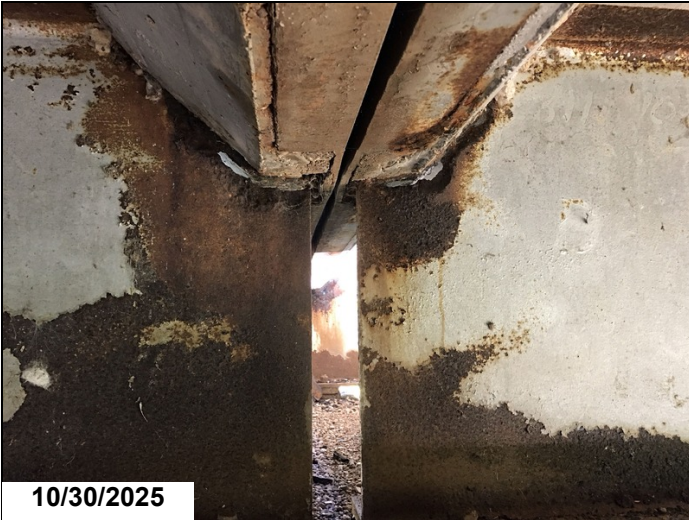
Span 15 bent 16 girder 3 has a 5" x 1" hole in web below haunch 1LF CS3.

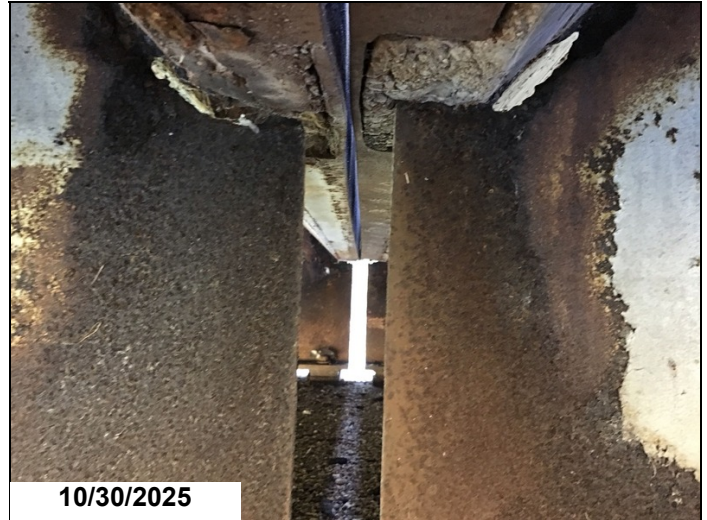
Span 15 bent 16 girder 2 has a 7" x 1" hole in web below haunch 1LF CS3.

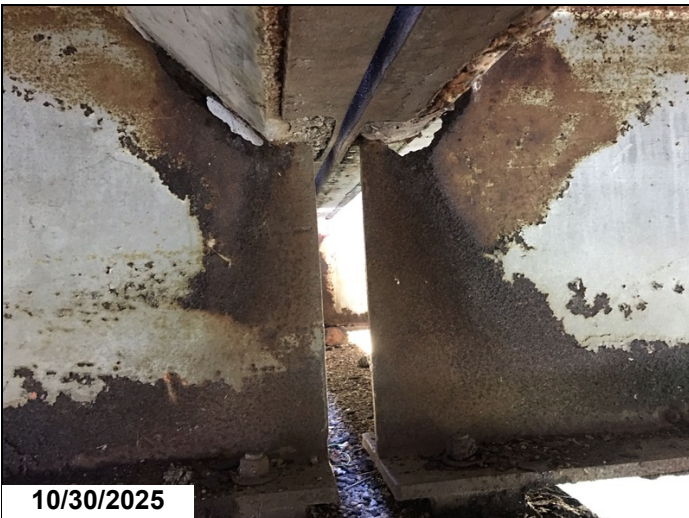
Span 14 bent 15 girder 3 has a 4" x 1" hole in web below haunch 1LF CS3.

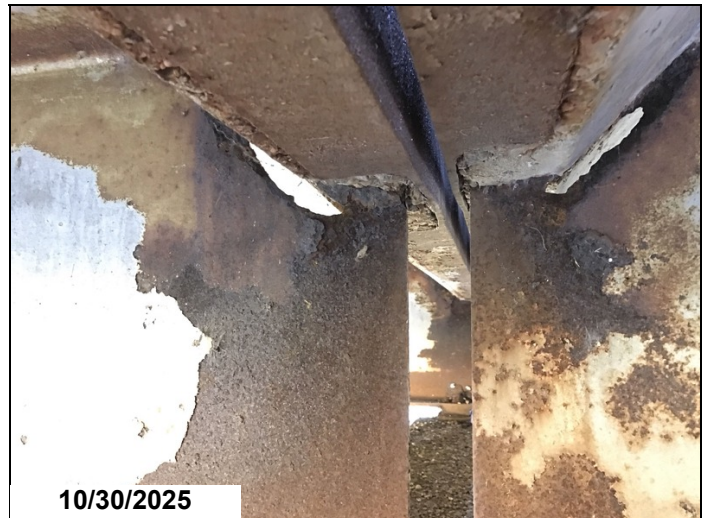
Span 14 bent 15 girder 2 has a 5" x 1" hole in web below haunch 1LF CS3.

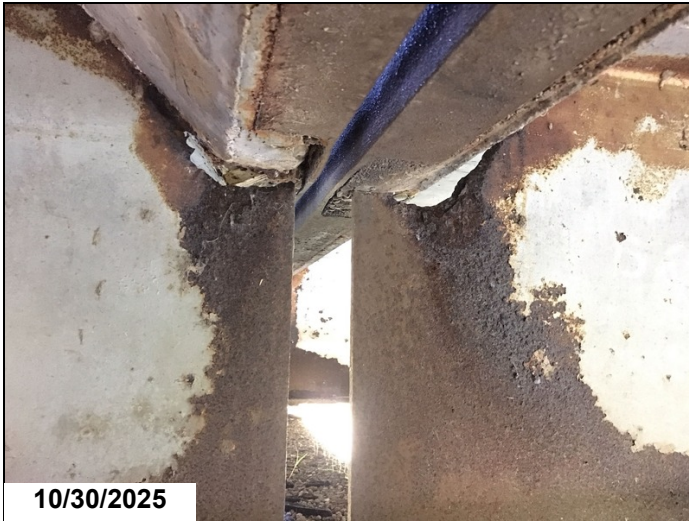
Span 13 bent 14 girder 3 has a 6" x 1" hole in web below haunch 1LF CS3.

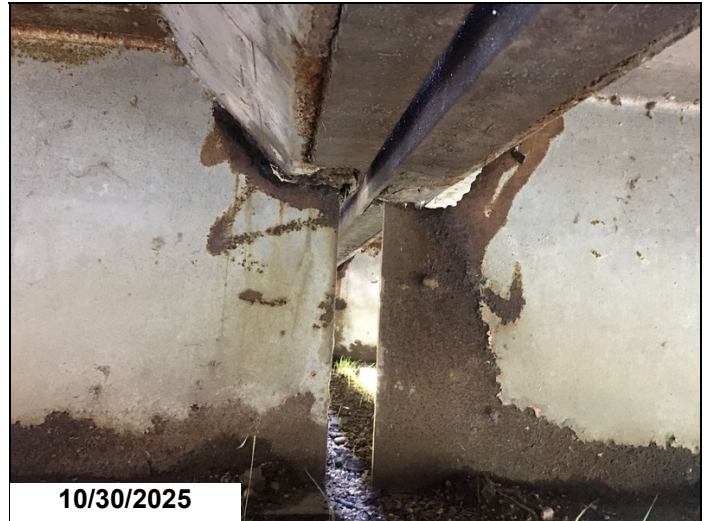
Span 13 bent 14 girder 2 has a 7" x 1" hole in web below haunch 1LF CS3.

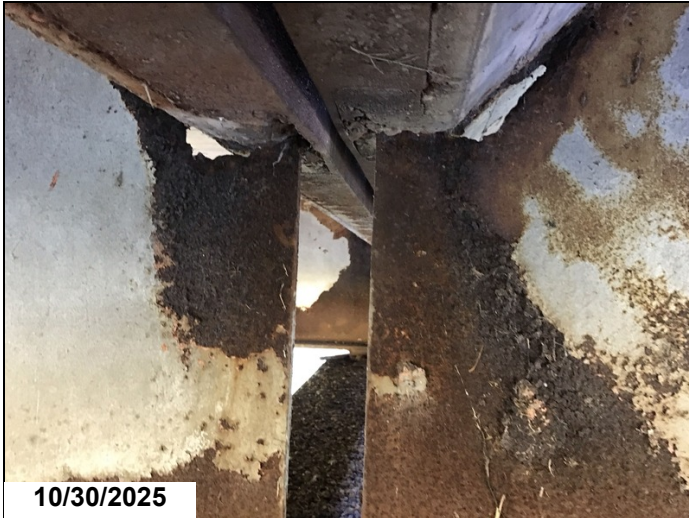
Span 12 bent 13 girder 2 has a 6" x 1" hole in web below haunch 1LF CS3.

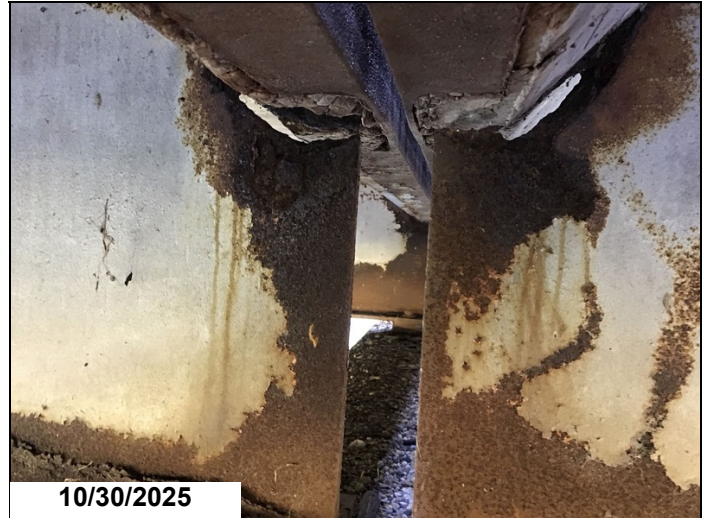
Span 12 bent 13 girder 3 has a 5" x 1" hole in web below haunch 1LF CS3.

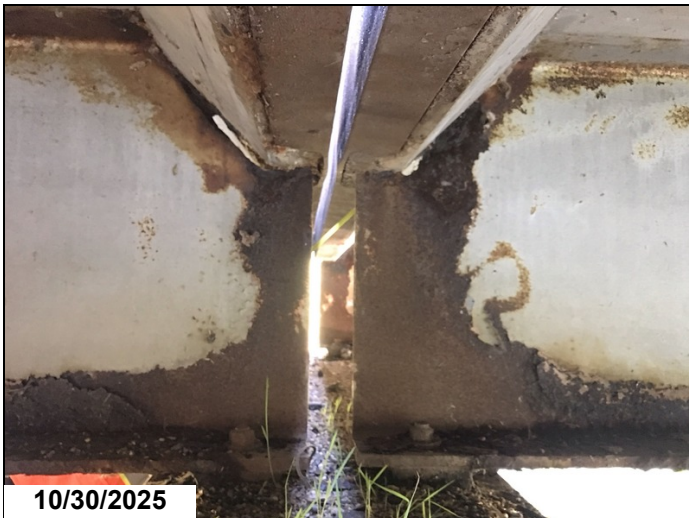
Span 11 bent 12 girder 3 has 5" x 1" hole in web below haunch 1LF CS3.

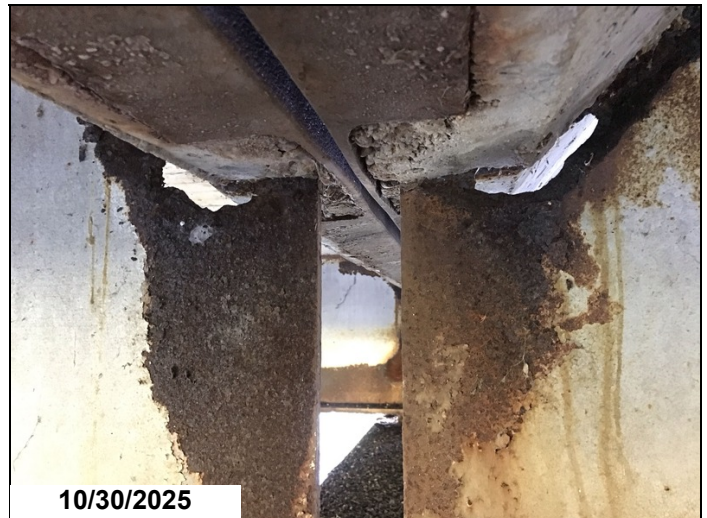
Span 11 bent 12 girder 2 has a 10" x 1" hole in web below haunch 1LF CS3.

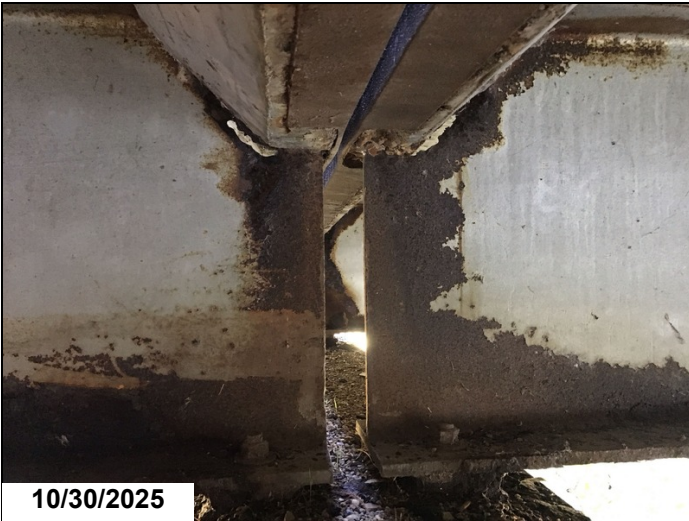
Span 10 bent 11 girder 3 has a 5" x 1" hole in web below haunch 1LF CS3.

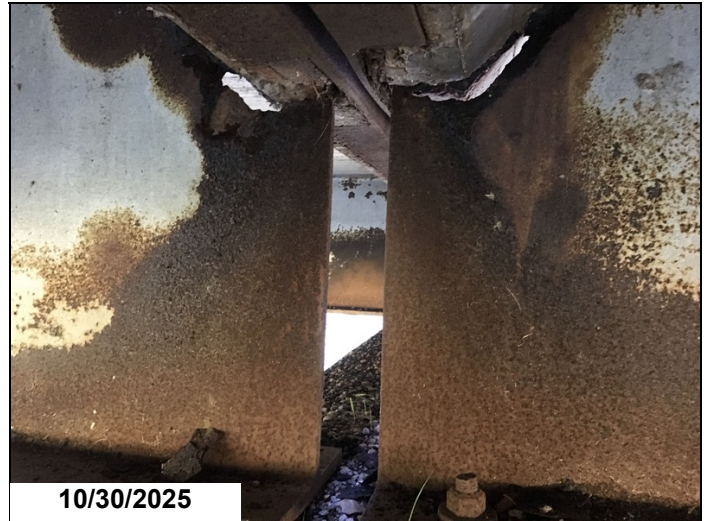
Span 10 bent 11 girder 2 has a 4" x 1" hole in web below haunch 1LF CS3.

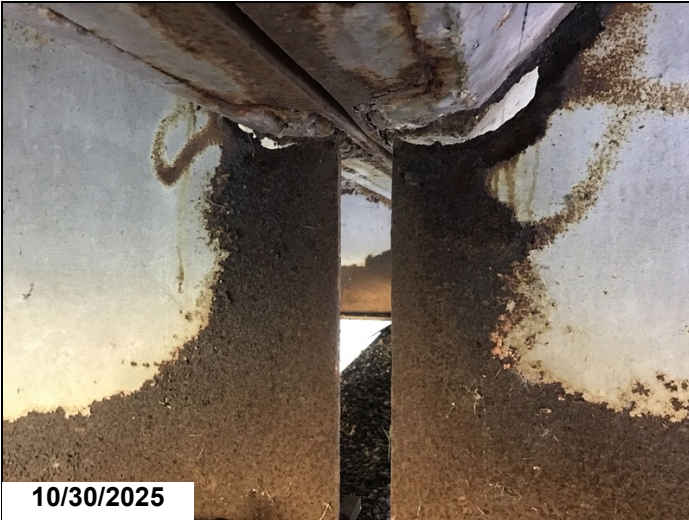
Span 9 bent 10 girder 3 has a 7" x 1" hole in web below haunch 1LF CS3.

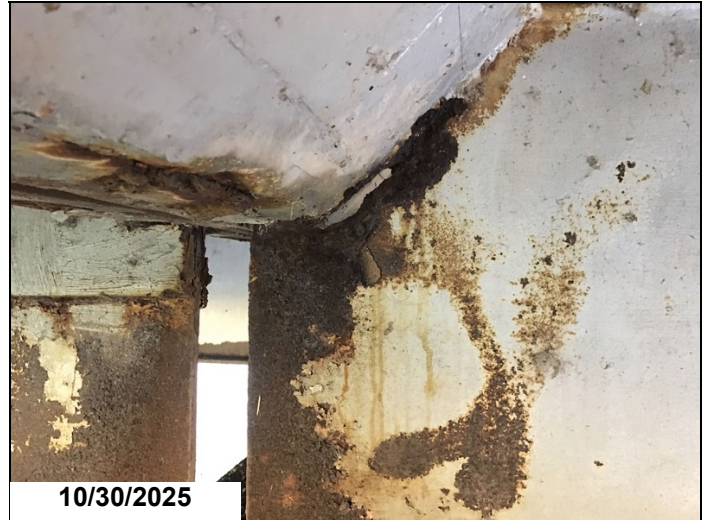
Span 8 bent 9 girder 3 has a 8" x 1" hole in web below haunch 1LF CS3.

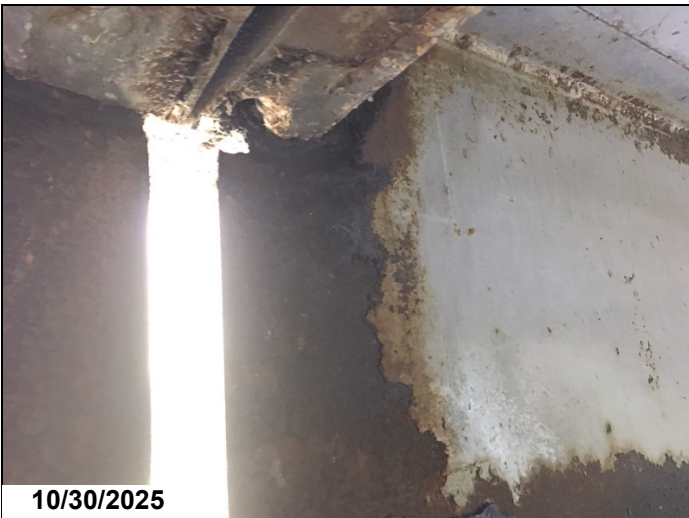
Span 8 bent 9 girder 2 has 3" x 1" hole in web below haunch 1LF CS3.

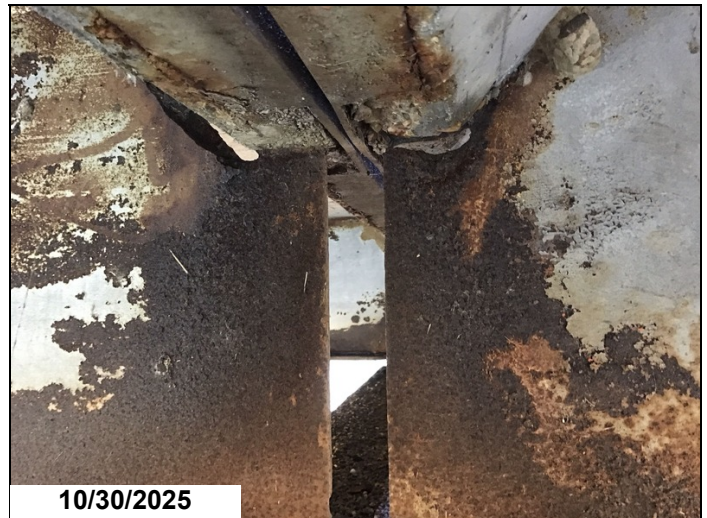
Span 9 bent 9 girder 1 has 1" diameter hole in web below haunch 1LF CS3.

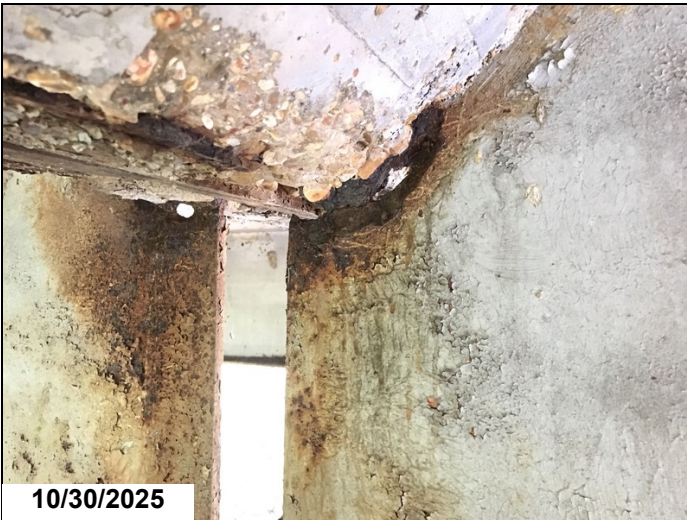
Span 1 bent 2 girder 2 has a 5" x 1" hole in web below
haunch 1LF CS3.
