Bridge 03254 Inspection Report

SH 93-01- LM 5.78 over ELEVEN POINT RIVER

Location: 5.78 MI NW JCT SH 93 & 90

Team Lead: Richard Jones Inspection Date: 09/10/2025

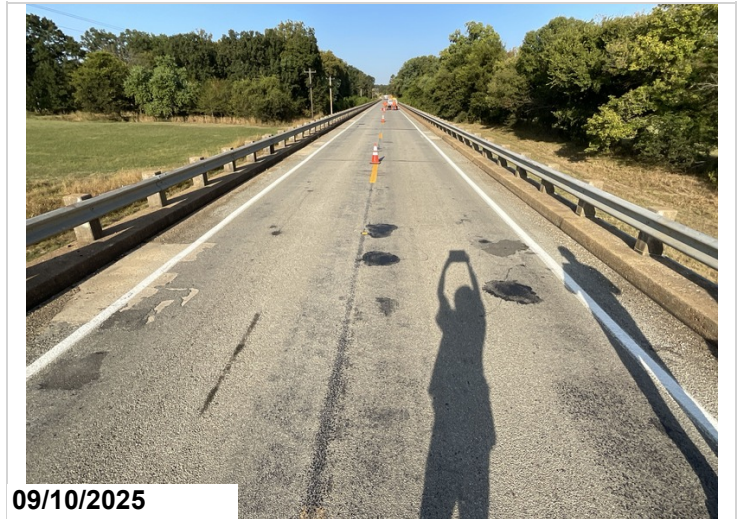
Wearing surface

Top has several patched areas through wearing surface, especially along gutters.

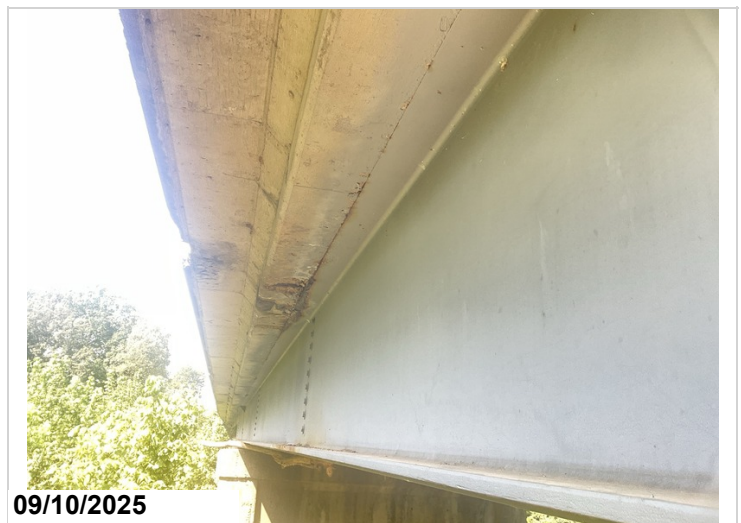
Span 13 Lt overhang at mid

Overhangs have several spalls with exposed rebar.

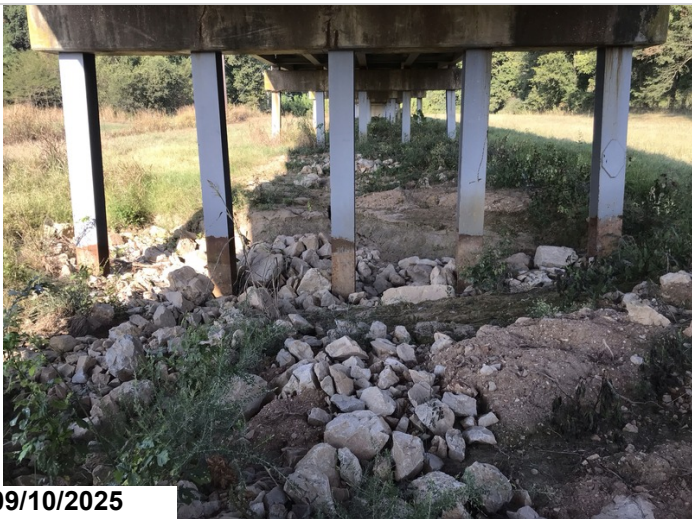
Bent 3 piles past washouts filled with rip rap

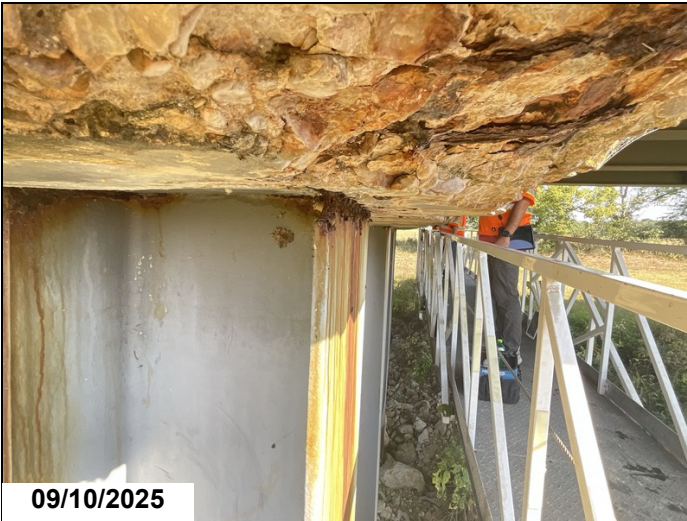
Bent 4 pile 1 Lt back flange 1/8" deep section loss CS3

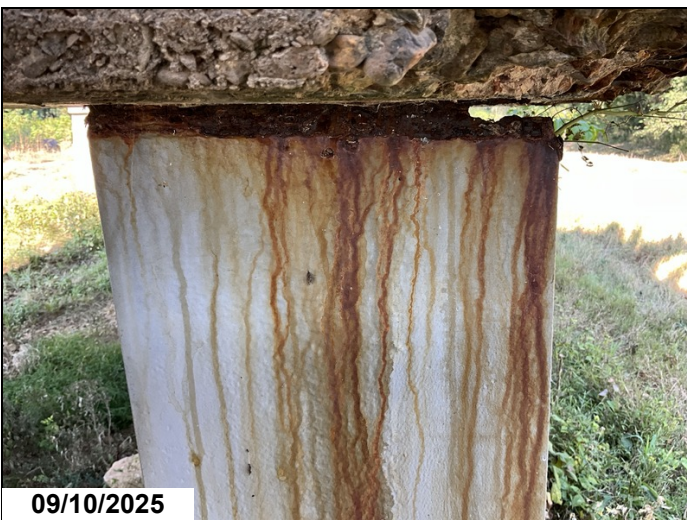
Bent 7 Pile 5 back flange has a 3" x 1/2" hole CS3

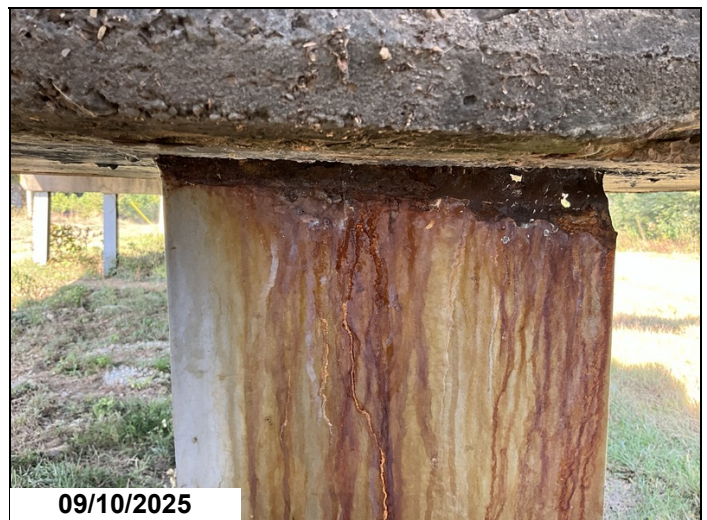
Bent 6 Pile 5 back flange has a 2" x 1/2" hole CS3

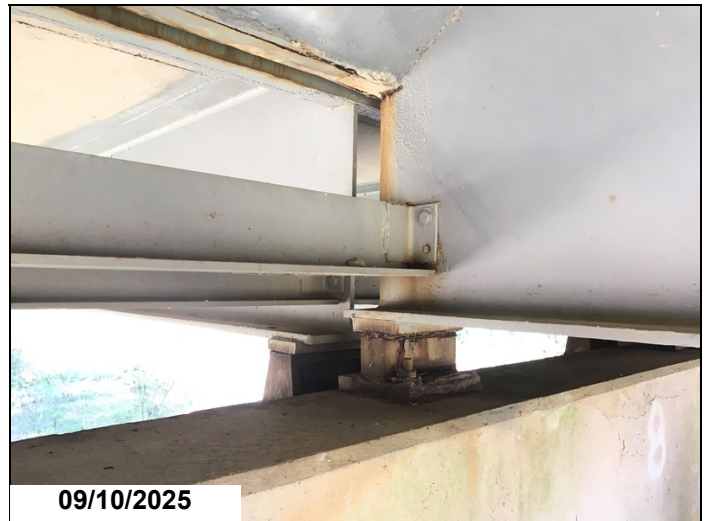
Span 7 bent 8 bay 2 girder 3 diaphragm bolt head is sheared off

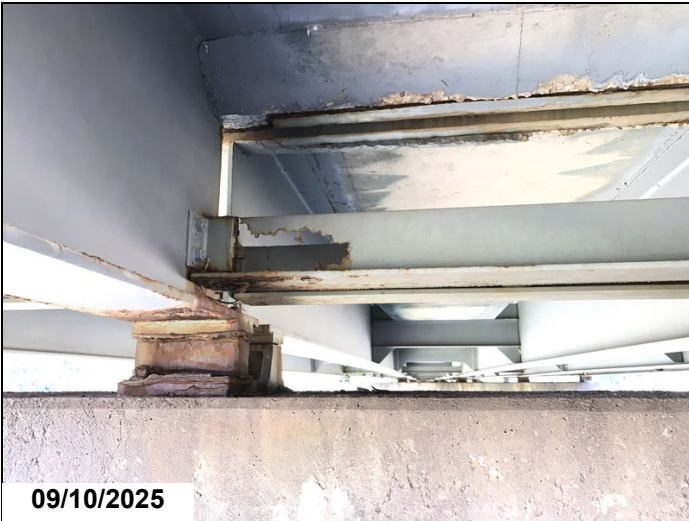
Span 4 bent 5 bay 2 10" x 5" hole in diaphragm

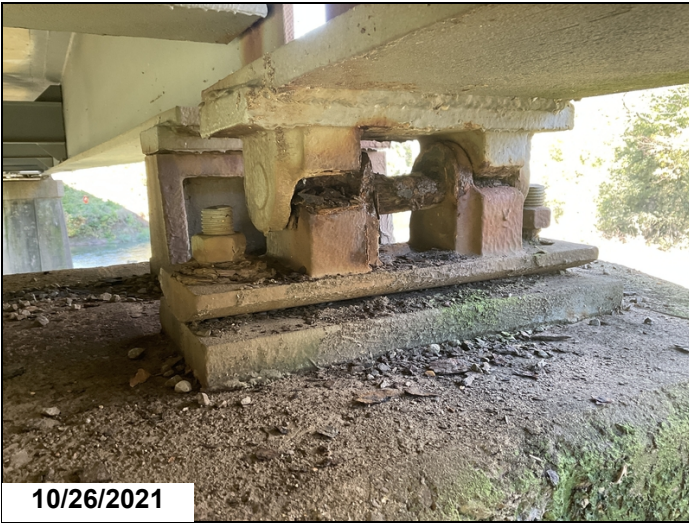
Majority of bearings have heavy pack rust and section loss. A few anchor bolts and nuts are missing. Several bearings have up to 1/8" of pack rust between bearings and masonry plates. Several rocker pins at main spans have section loss. (up to 1/8")

Span 8 bent 9 bearing 5

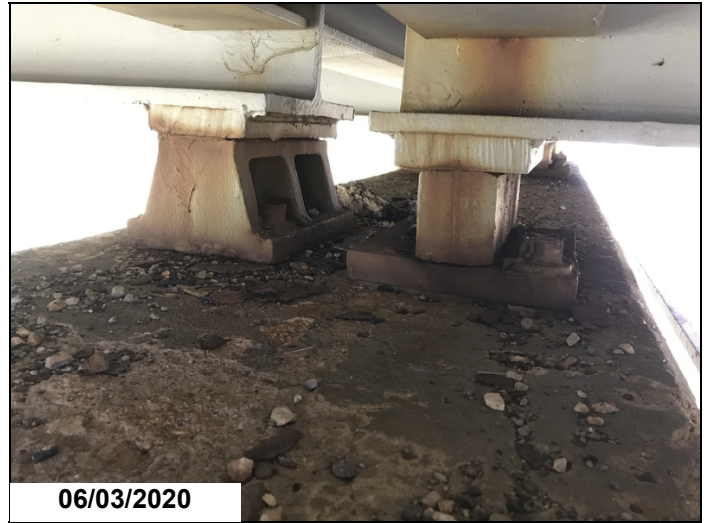
Span 8 bent 9 bearing 5

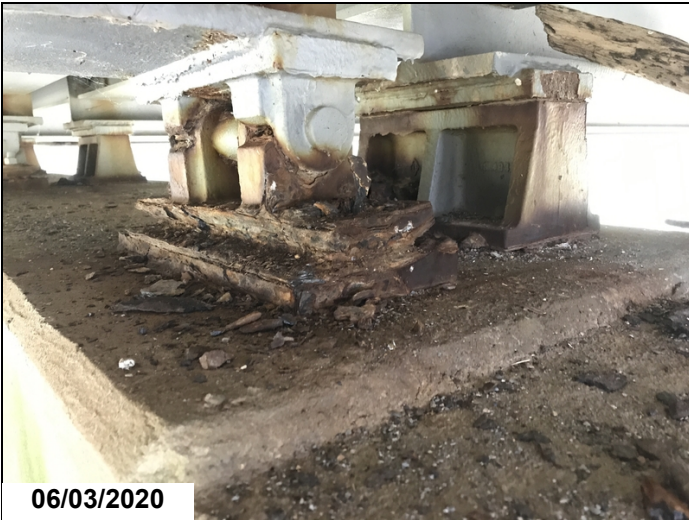
Bearing

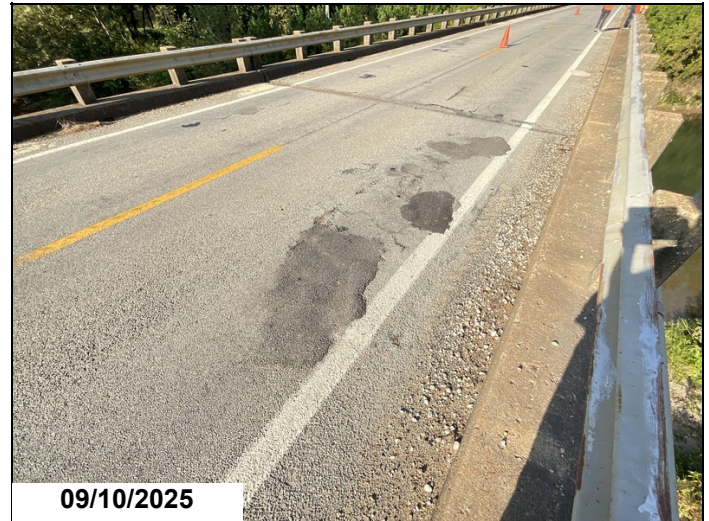
Undersurface has several areas with efflorescent map cracks, especially in bays 1 and 4 under gutter lines and has a few spalls with rebar exposed.

Span 8 near bent 9

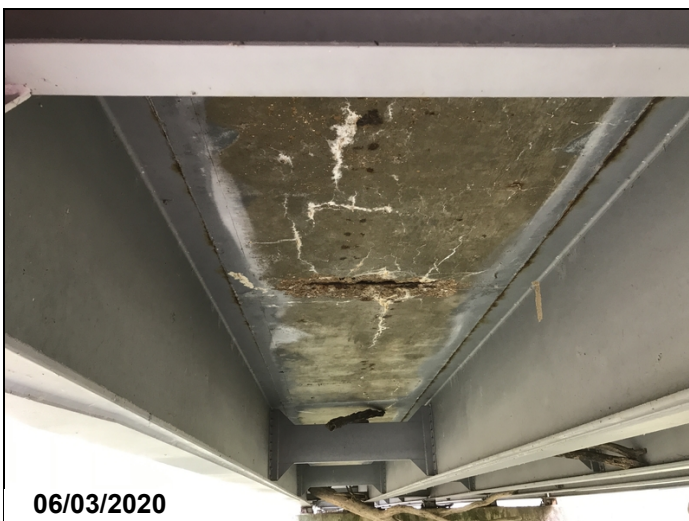
Span 12 bay 4

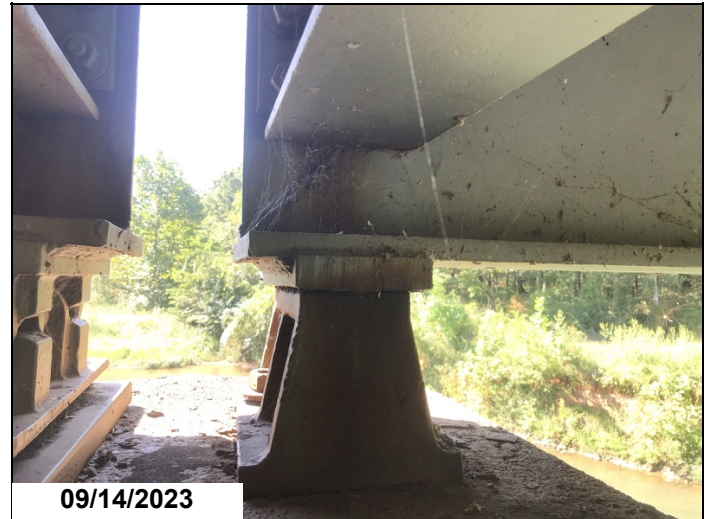
Span 17 bent 17 bearing 3 has up to 1/8" gap between cap and bearing.

Span 17 bent 17 bearings shifted
