Asset #02900(Routine, Underwater type 2)
Us79/Sec-16/L-3.35 over St.francis Div. Channel

Location: 3.4 Mi North Of Marianna

Team Lead: Myron Futrell, Inspection Date: 09/02/2021

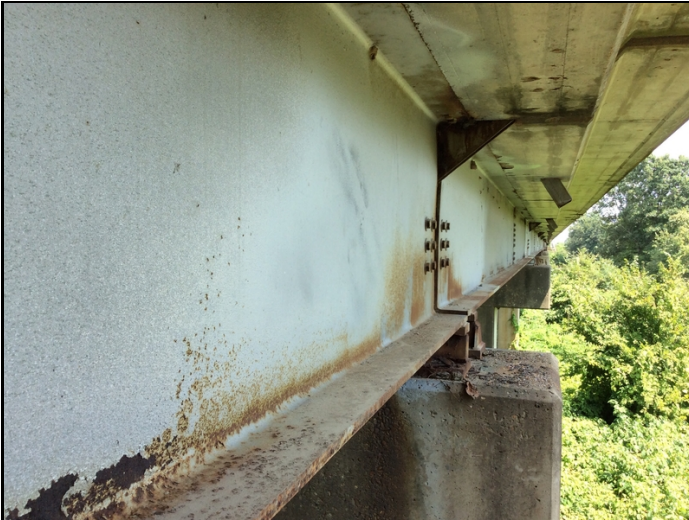
Typical paint

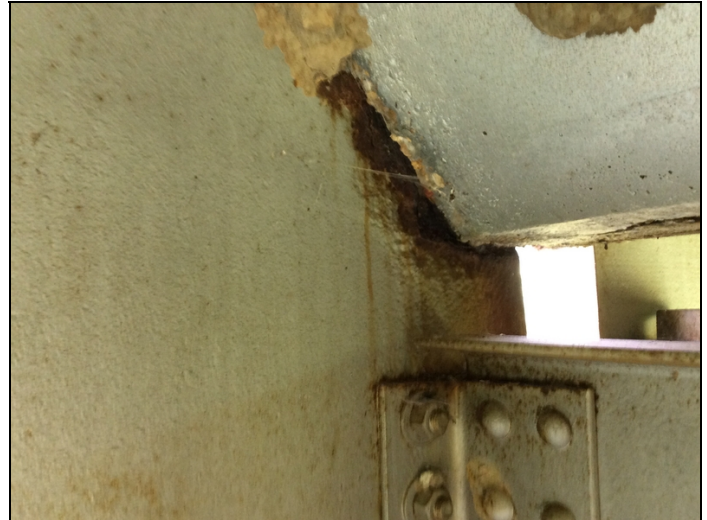
All girder ends at bents have section loss around haunch with up to 10% section loss unless otherwise noted.

Typical girder end at haunch

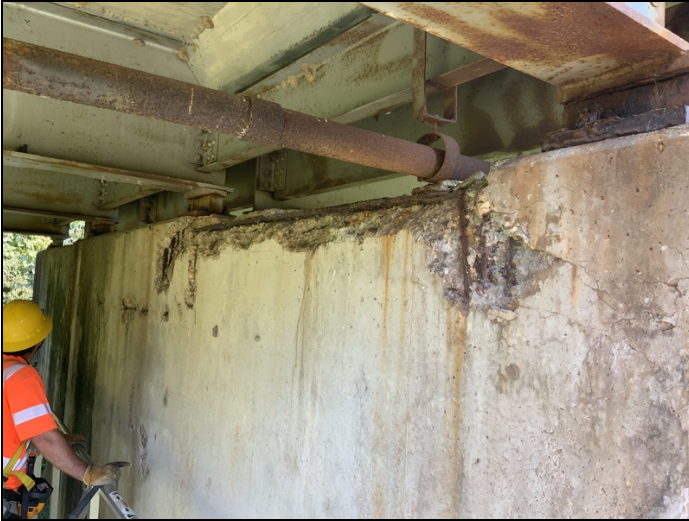
Bent #5 cap back face right side under girders #3 and 4.

<p>Bent #5 cap back face has 6' long spall with exposed rebar with 20% section loss at top corner between girders #3 and 4, right end spalled with exposed rebar.</p> <p>Bent #5 cap back face has open horizontal crack at top, spalls with exposed rebar with 20% section loss, and large delaminations.</p> <p>Bent #5 cap back face has 2' spall below girder #1 and a 3' spall below girder #2 with exposed rebar with 5% section loss.</p> <p>Bent #5 cap front face has horizontal crack near top full length of cap, and a 2' spall with exposed rebar with 15% section loss and 15' of delamination.</p> <p>Bent #12 cap back face has longitudinal wide horizontal crack full length near top and vertical cracks and delaminations at top.</p> <p>Bent #12 cap back face left side under girder #1 has two foot spall with exposed rebar with 25% section loss.</p> <p>Bent #12 cap back face has graffiti.</p> <p>Bent #12 cap front face has 1' spall under girder #3 and longitudinal crack near top.</p>

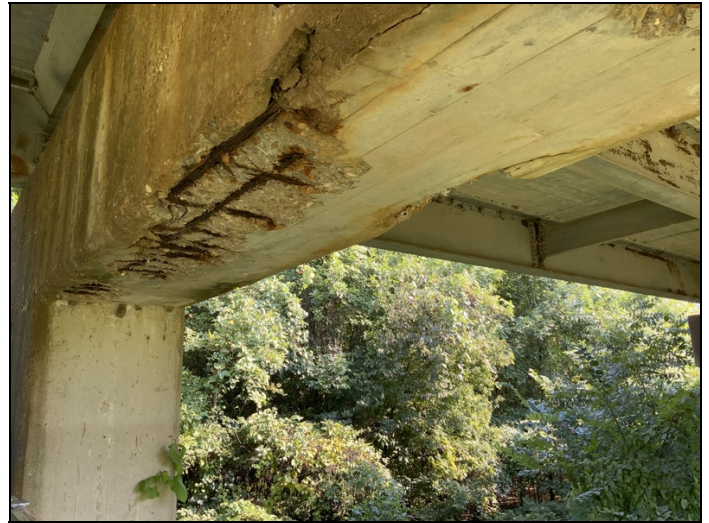
Bent #4 cap bottom face.

ELEMENTS	DESCRIPTION	UNITS	TOTAL	CS1	CS2	CS3	CS4
	<p>Bent #4 cap bottom face has eight feet of spalling with exposed rebar with up to 100% section loss.</p> <p>Bent #13 cap back face has two 2' spalls with exposed rebar with 30% section loss.</p> <p>Bent #13 cap right end both corners spalled with exposed rebar.</p> <p>Bent #13 cap back face has 15' of wide cracking horizontally near top.</p> <p>Bent #14 cap back face has longitudinal cracks near top and bottom.</p> <p>Bent #14 cap back face has 1' spall above column #2 with exposed rebar with 5% section loss.</p> <p>Bent #14 cap back face has delaminations full length and 3' spall in center bottom corner with exposed rebar with 20% section loss.</p> <p>Bent #14 cap front face has longitudinal crack near top and a 1' spall above column #1 with exposed rebar with 5% section loss.</p> <p>Bent #15 cap bottom chord has 6' spall with exposed rebar with up to 100% section loss.</p> <p>Bent #15 cap back face has horizontal wide crack 3/4 length of cap near top.</p> <p>Bent #15 cap front face has wide cracks, and delaminations full length with a 5' spall in center at bottom with exposed rebar with section loss.</p> <p>Bent #16 cap back face has open horizontal wide crack full length 6" from top 3/4 length of cap with one 1' and two 2' spalls above column #1 with exposed rebar with 30% section loss.</p> <p>Bent #16 cap back face has 1' spall on left corner with rebar exposed with 5% section loss.</p> <p>Bent #16 cap on ahead face right end, and top spalled last two feet with exposed rebar with 30% section loss.</p>

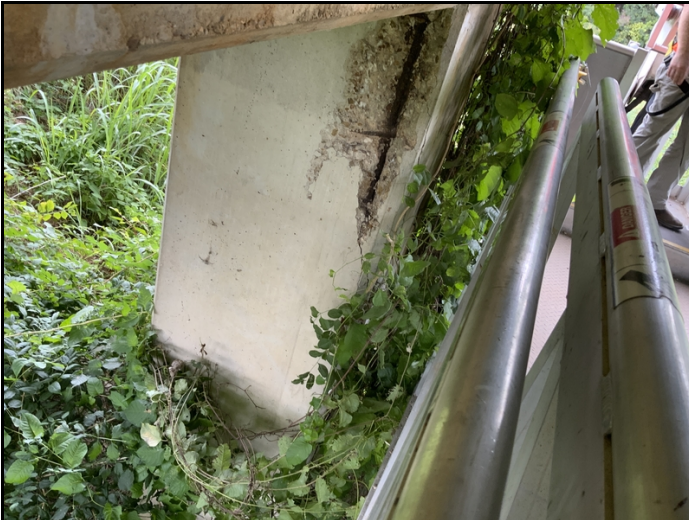
Bent #16 right column left side has 2' spall with exposed rebar with 20% section loss.

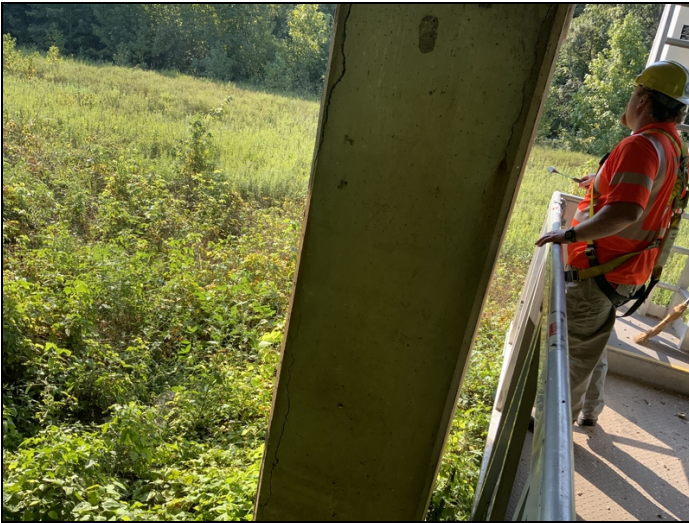
Bent #4 right column.

Bent #4 right column left and right sides have vertical cracks, ahead face has two foot delamination and spall with no exposed rebar.

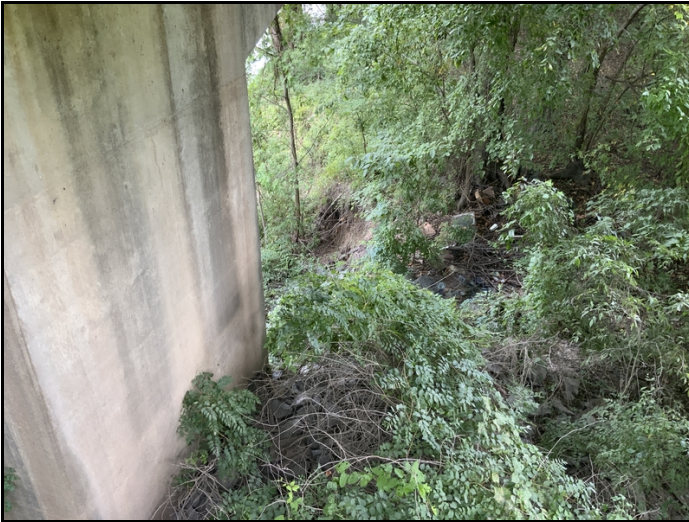
Bent #7,11 slopes are eroded within 2' of pier to near vertical drop.

Erosion at bent #11.

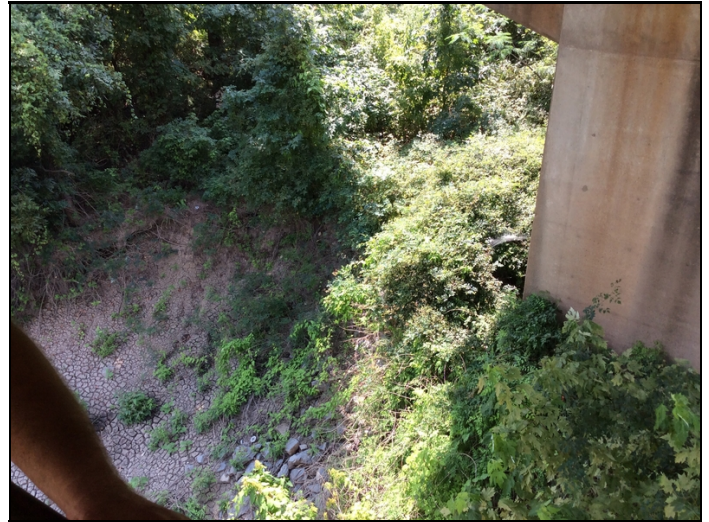
Slope to right of bent 7

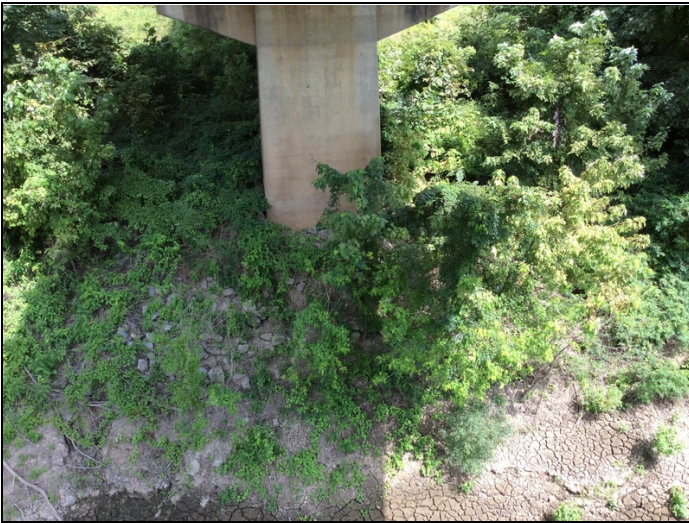
Bent 11 slope near vertical face at bent.

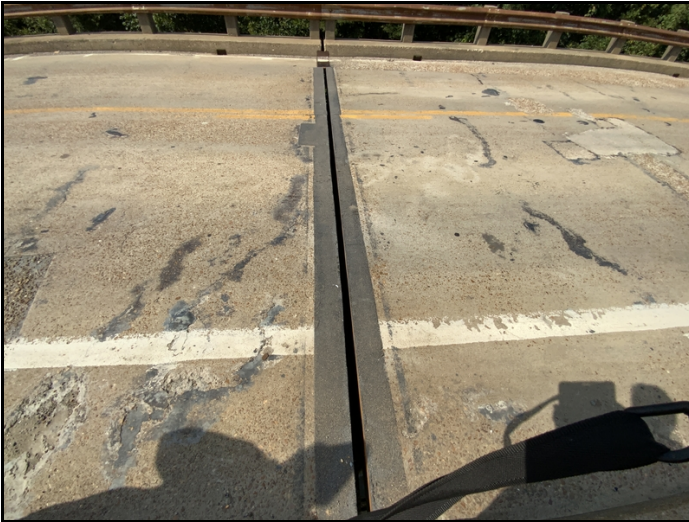
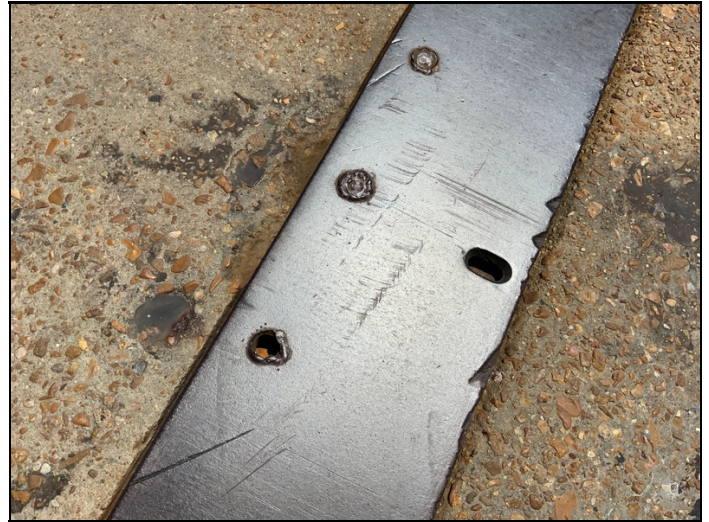
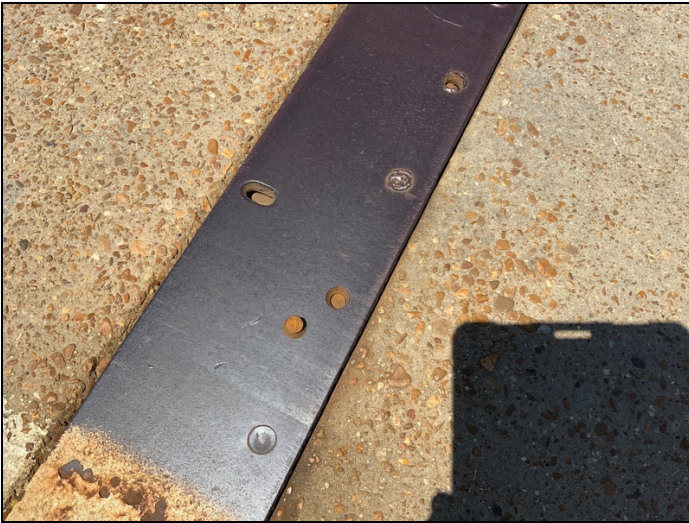
Bent #3 joint.

9/8/2021-Bent #3 joint steel has been removed now open joint no seal.

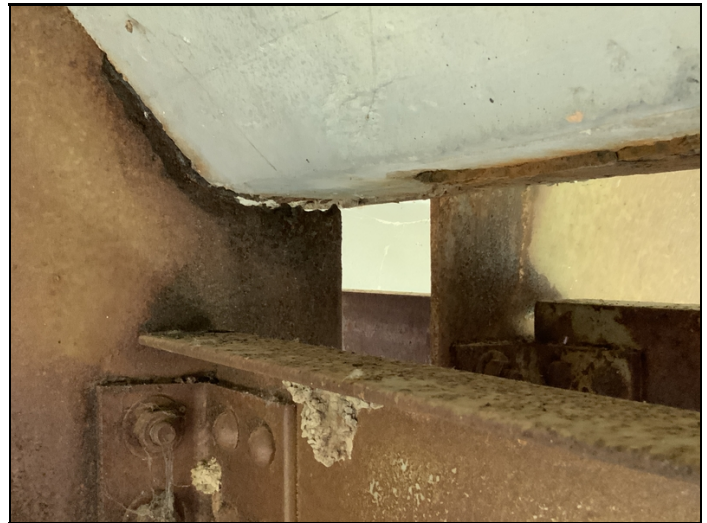
Span #14 bent #14 girder #3 has a four inch long hole at haunch.

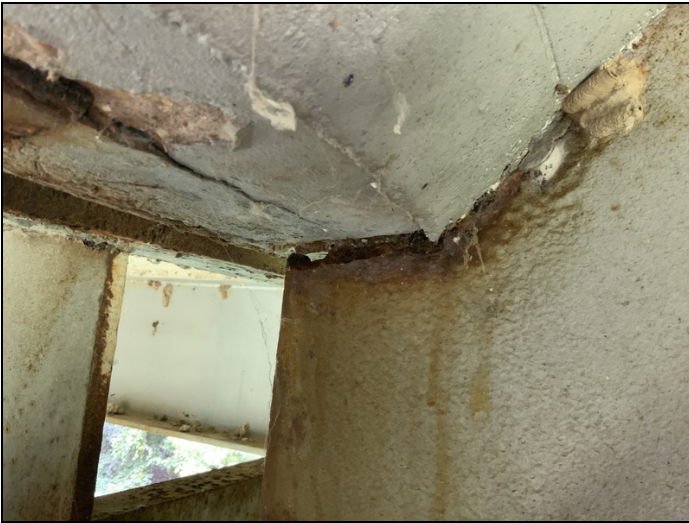
Span #12 girder #3 bent #12 one inch hole in web at haunch.

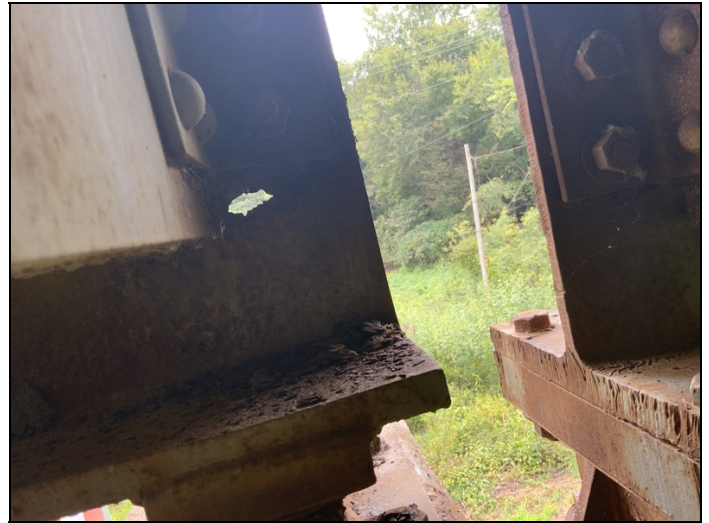
Span #12 bent #12 girder #4 has 2' hole in web at diaphragm connection.

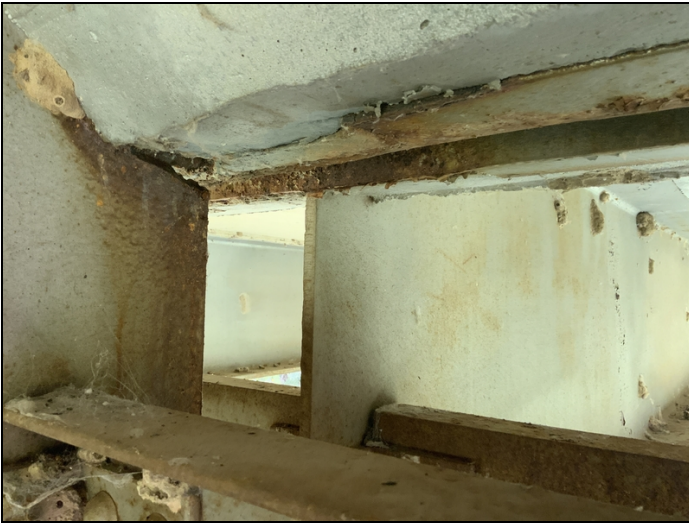
Span #12 girder #2 bent #12 one inch hole in web at haunch.

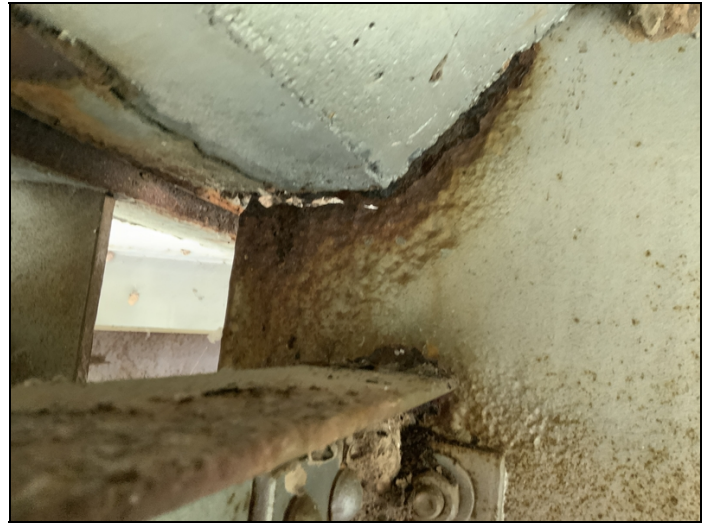
Span #3 girder #3 at bent #4 has a six inch long hole in web at haunch.

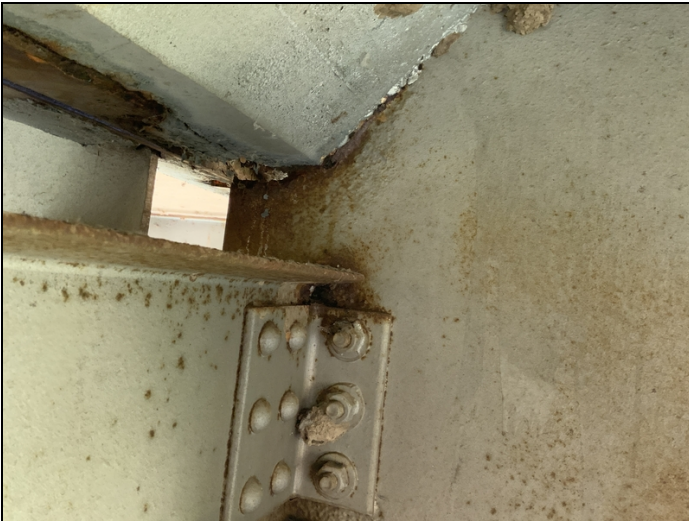
Span #2 girder #3 at bent #3 has a 2" long hole corroded in web at haunch.

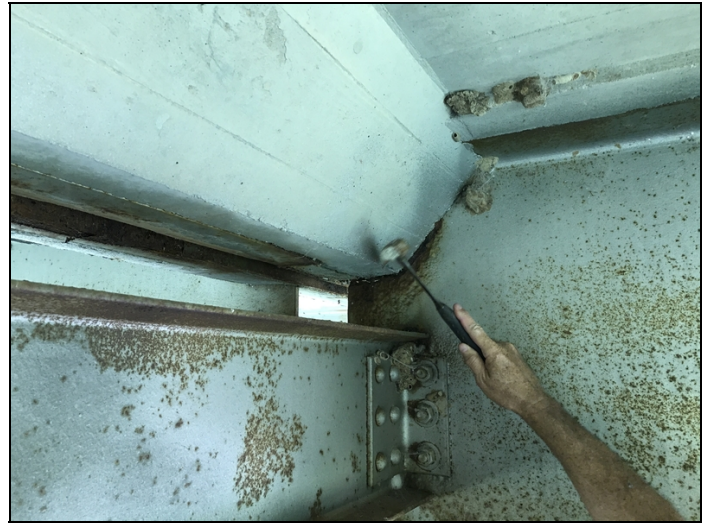
Span #3 girder #3 at bent #4 has a six inch long hole at haunch.

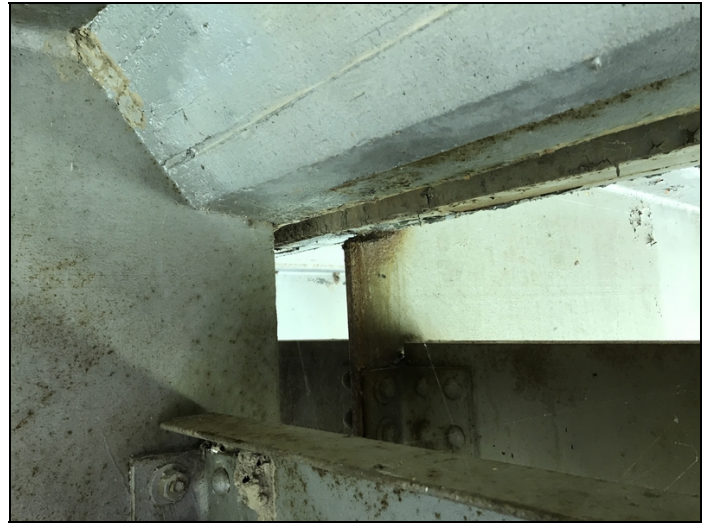
Span #12 girder #2 bent #12 one inch hole in web at haunch.

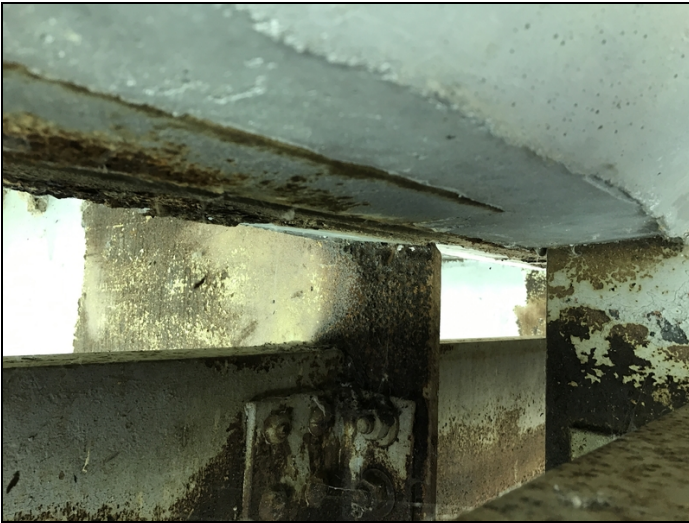
Span #15 bent #15 girder #2 has a one inch long hole at haunch.

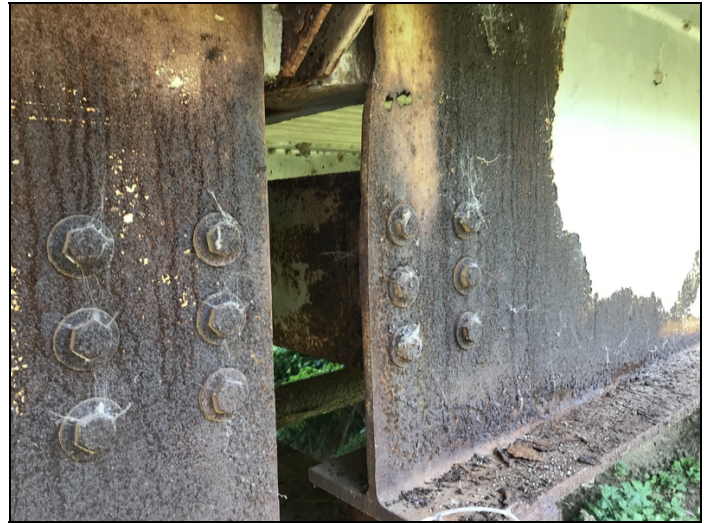
Span #16 bent #16 girder #4 has a two inch hole in web and web bowing outward at haunch.

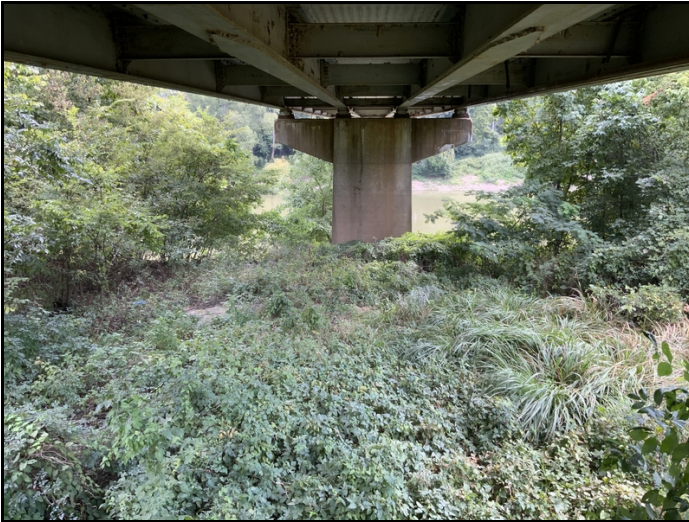
Vegetation is growing under and beside bridge and onto columns and bents.

Trees and vegetation growing beside and under bridge.

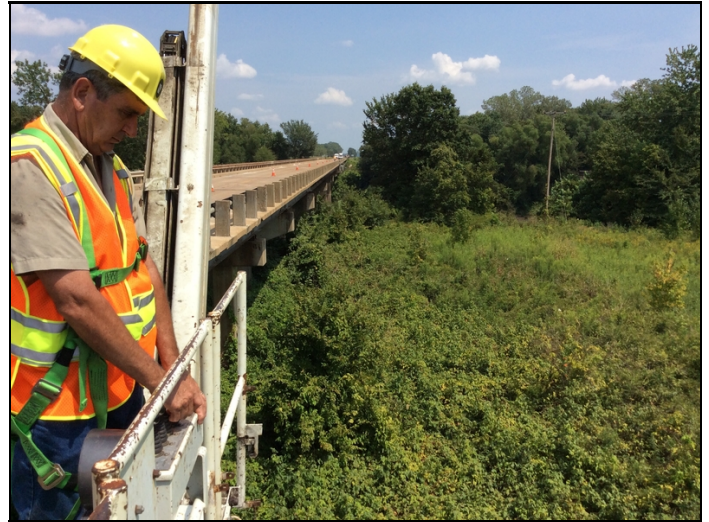
Typical vegetation

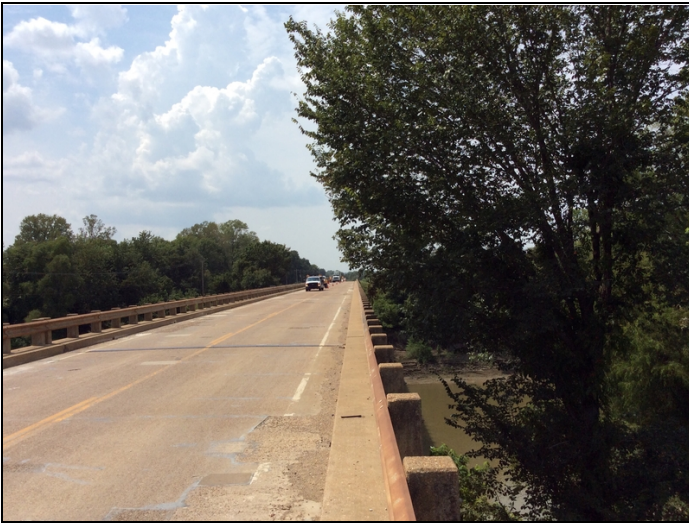
Tree growing over bridge rail left side.

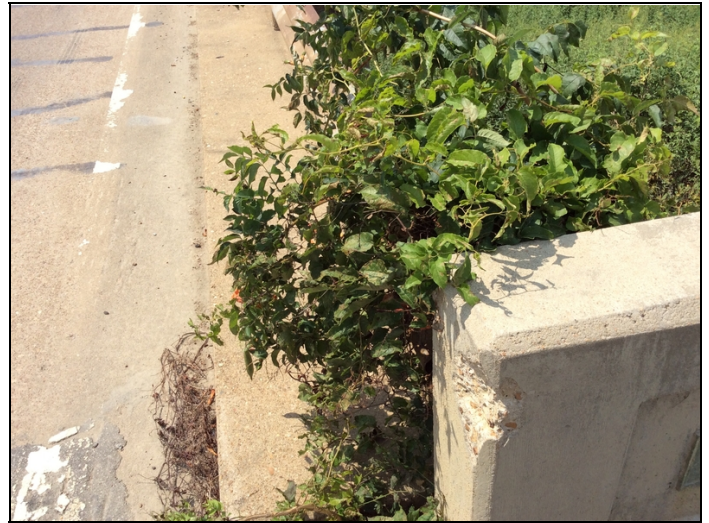
Abutment 2 left side vegetation growing onTo bridge.

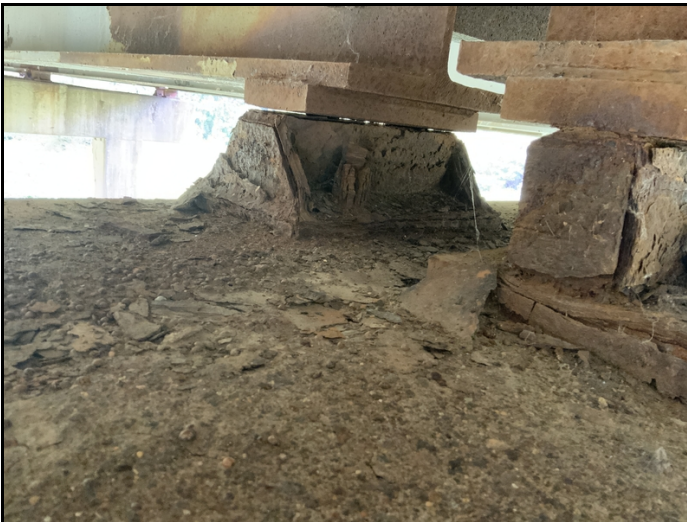
Span #2 bent #2 girders #2,3 are floating.
Span #2 bent #3 girder #2 is floating.
Span #4 girders #2,3 are floating.
Bent #15 span #14 girder #2,3 are floating.
Bent #16 span #15 girder #2 is floating.
Span #14 girder #3 bearing is twisted under girder.

Span #14 bent #15 girder #3 floating, typical of girder #2.

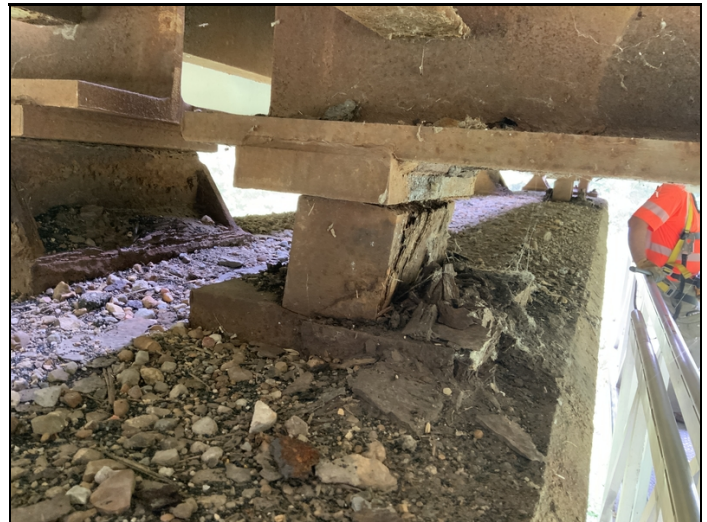
Span #14 girder #3 bearing is twisted under girder.

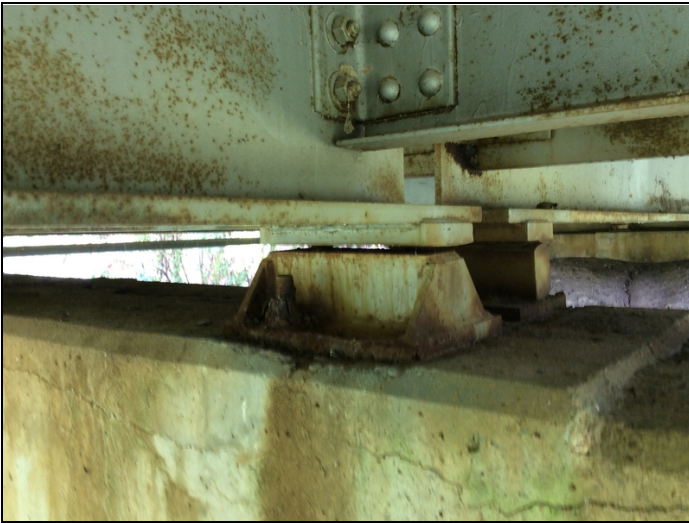
Typical floating girder.

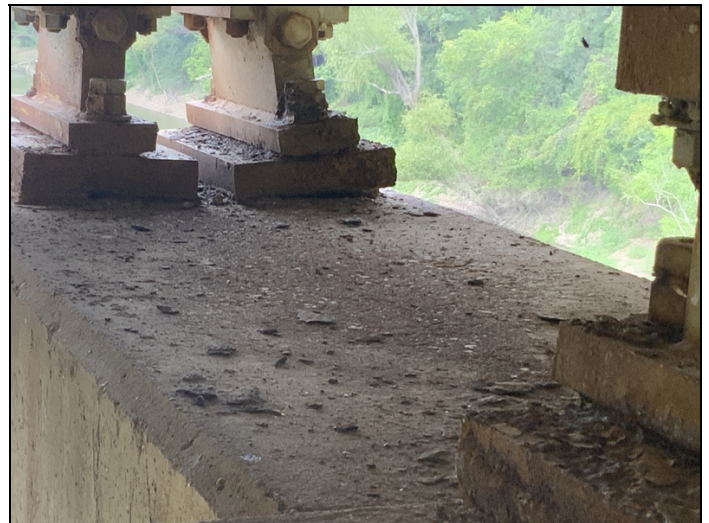
Bent #9 span #8 bearing #4 is shimmed with pack rust between cap and masonry plate.

Bent #9 span #9 bearing #1,2,3,4 are all shimmed with pack rust between cap and masonry plate.

Bent #9 bearings .

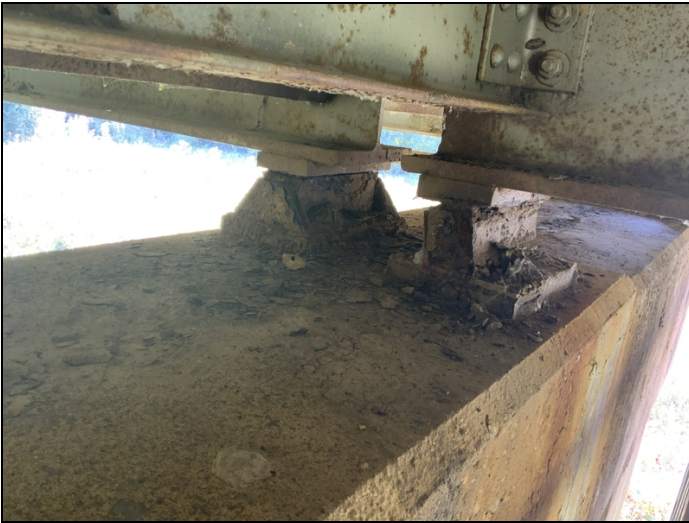
All bearings on outside girders have rust with laminations and section loss up to 10% with no paint.

All bearings on inside girders have surface rust with 50% bare steel with little to no section loss.

Bent #4 bearings.

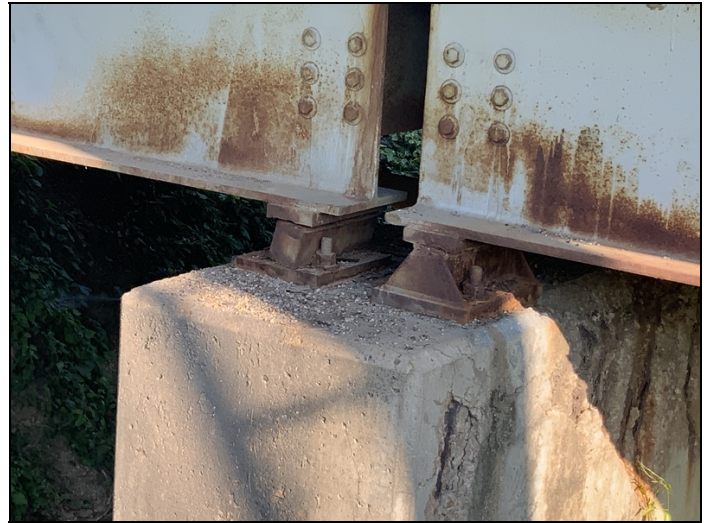
Bent #2 bearings.

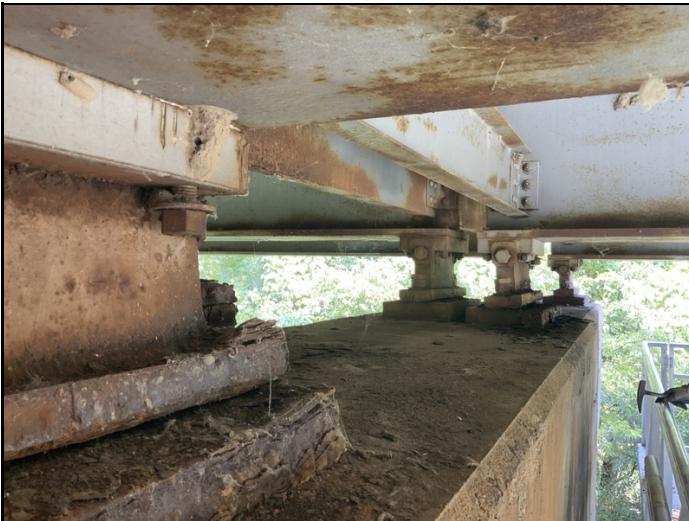
Bent #7 span #7 girders #2 and 3 each have loose bearing to girder bolt.

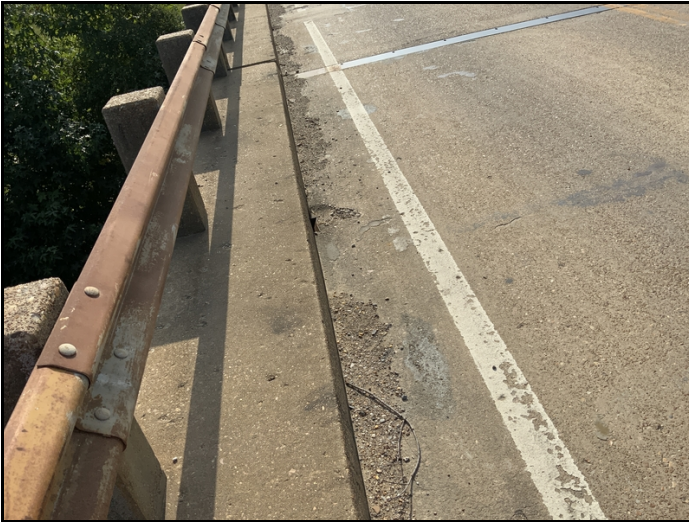
Gutters have dirt and debris in them.

Dirt and debris in gutters.

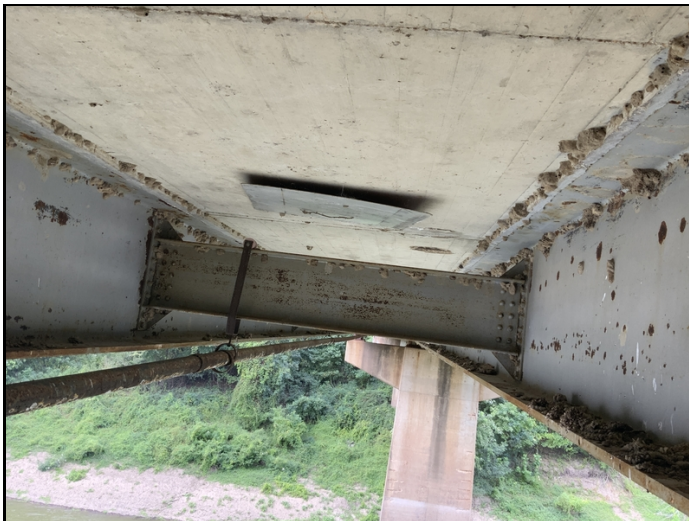
Span #8 bay #3 has form left in place near bent #9.

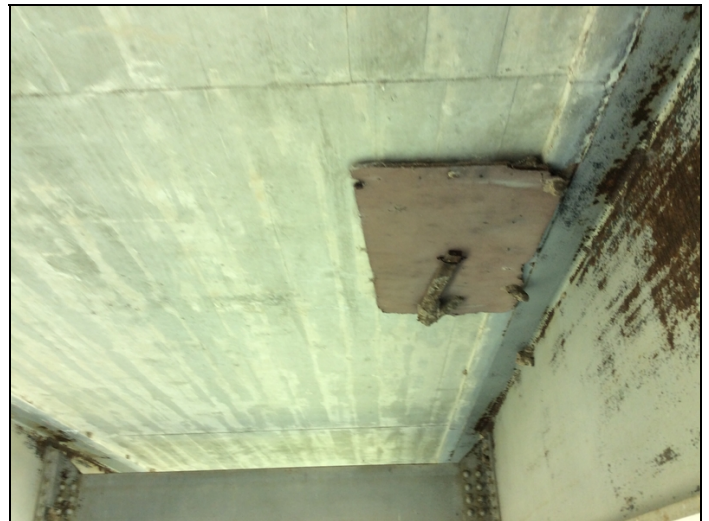
Span #2 bay #3 soffit has form left in place.
Span #3 bay #2 soffit has 1 form left in place.
Span #3 bay #3 soffit has 1 form left in place.
Span #9 bay #1 soffit has 1 form left in place.
Span #11 bay #1 soffit has 1 form left in place.
Span #11 bay #3 soffit has 1 form left in place.
Span #12 bay #2 soffit has 1 form left in place.
Span #12 bay #3 soffit has 1 form left in place.

Typical form left in place.
