Asset #06830(Routine)

US 79 -SEC 13 over White River; RR;River Rd

Team Lead: Jacob Turner, Inspection Date: 03/29/2021

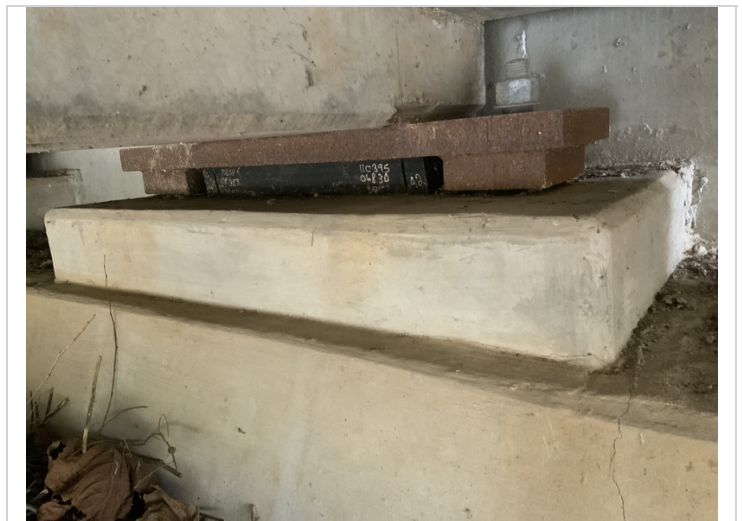
Typical bearings at bent 1

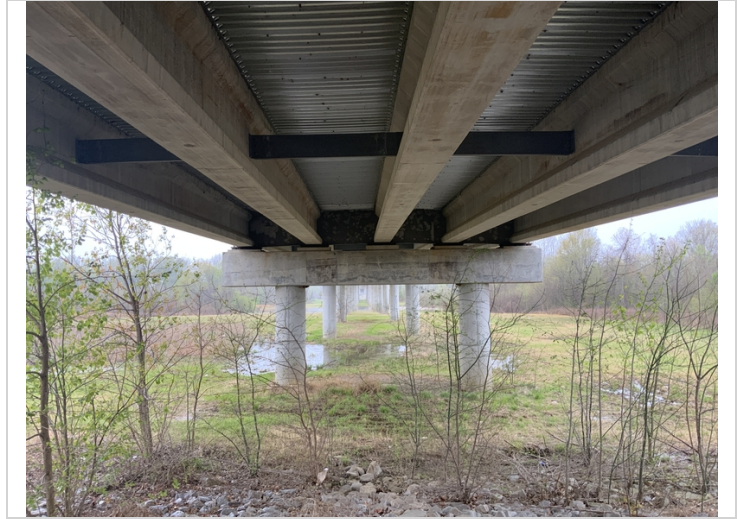
Typical under surface of the prestressed girder units

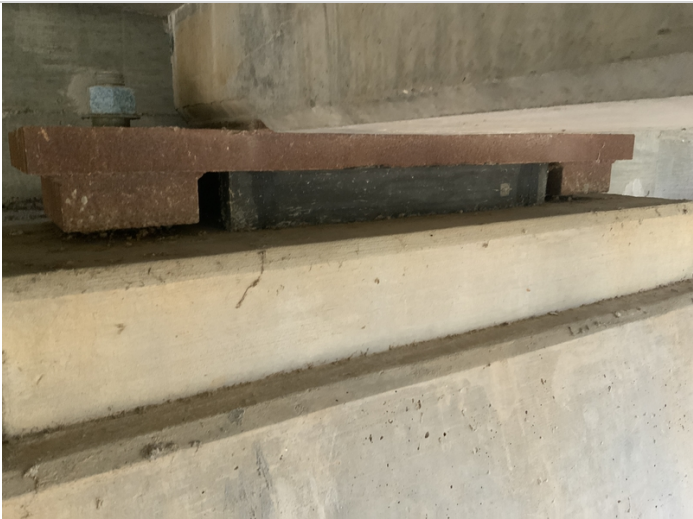
Typical bearings at bent 97

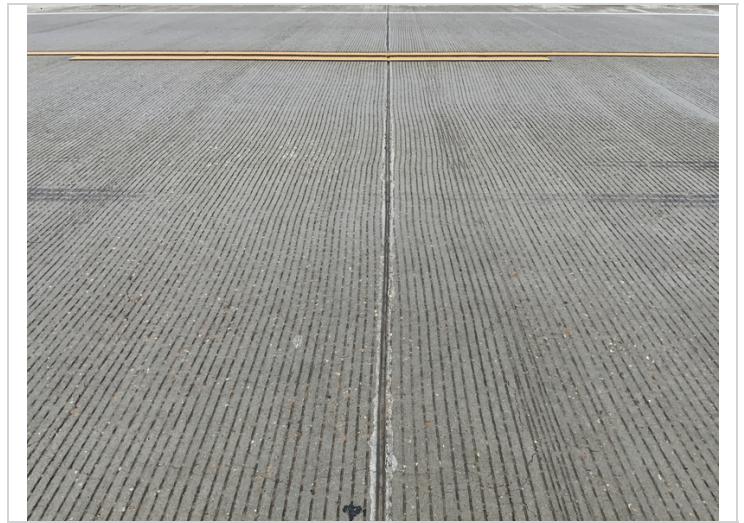
Typical saw joints

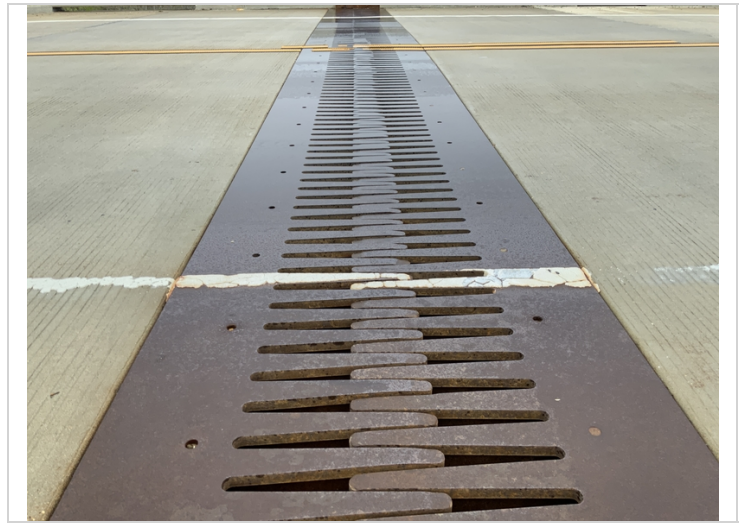
Typical finger joints

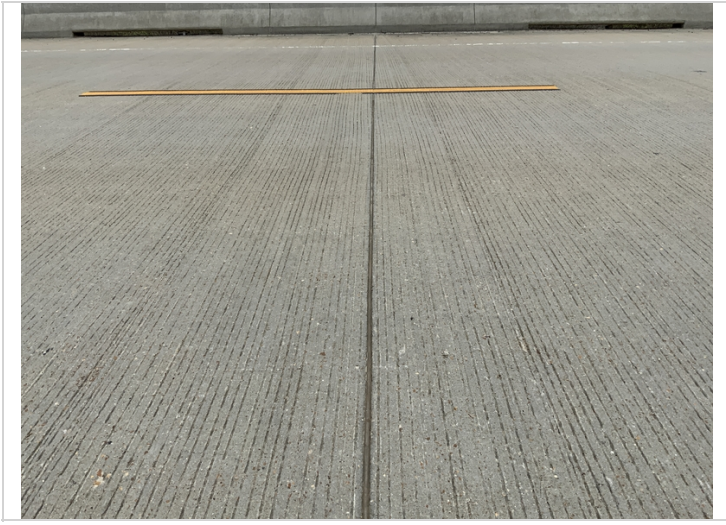
Typical saw joints

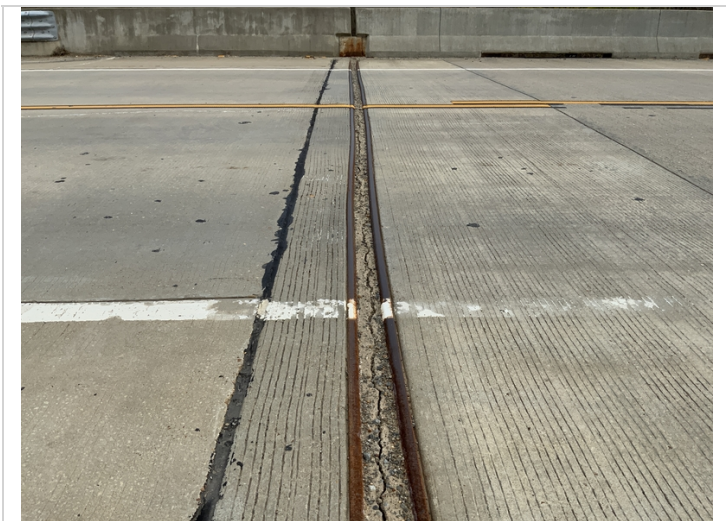
Bent 1 joint has debris impactation

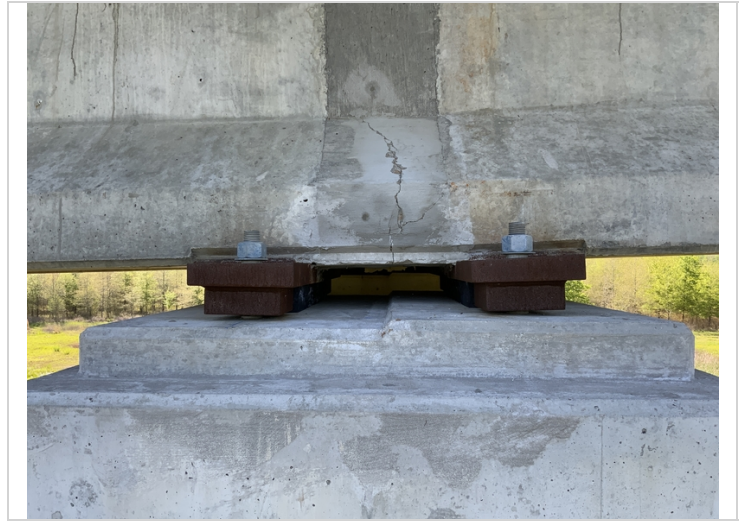
Typical bearings along the North prestressed girder unit on 04/12/2021 @ 9:45am with temps at 68 degrees

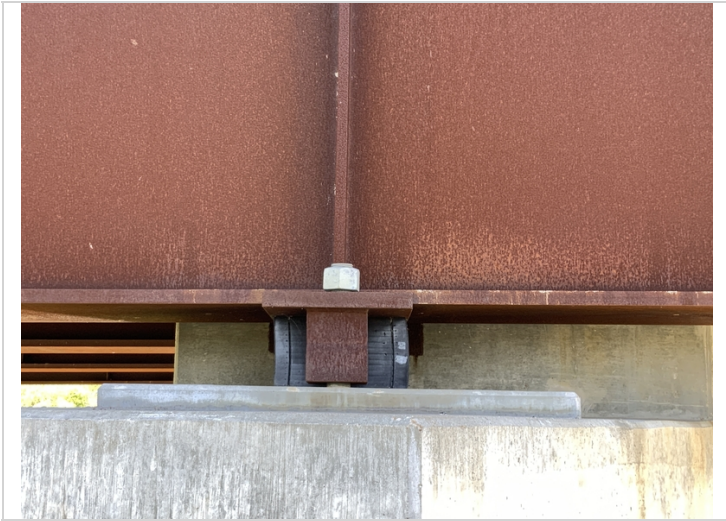
Typical bearings on 04/12/2021 @ 11:28am with temperature at 81 degrees

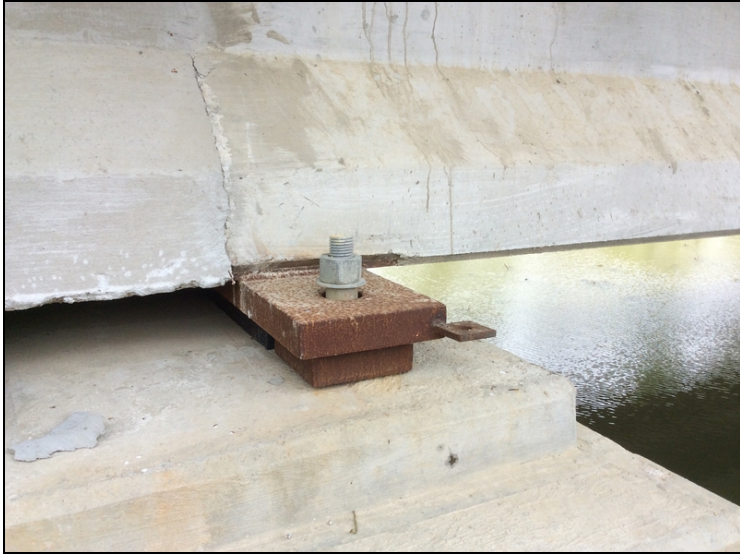
Bent 4 girder 1 bearing has a piece of metal welded to bearing plate.

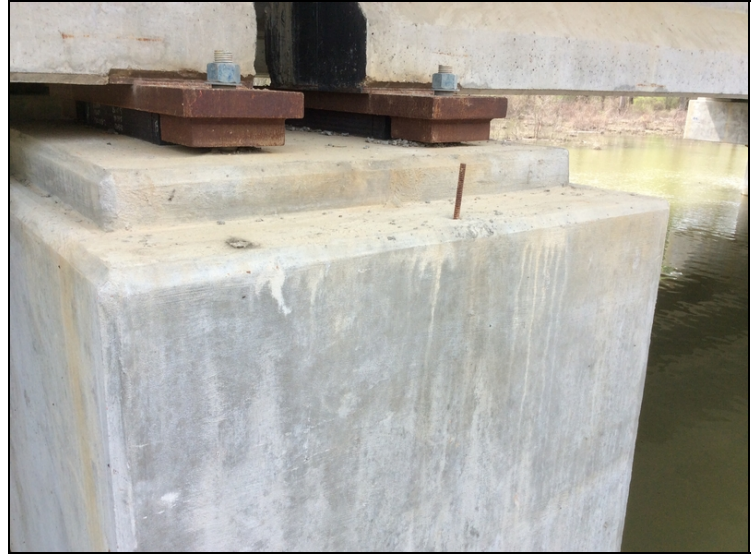
Left side bent 5 piece of all thread sticking up out of cap.

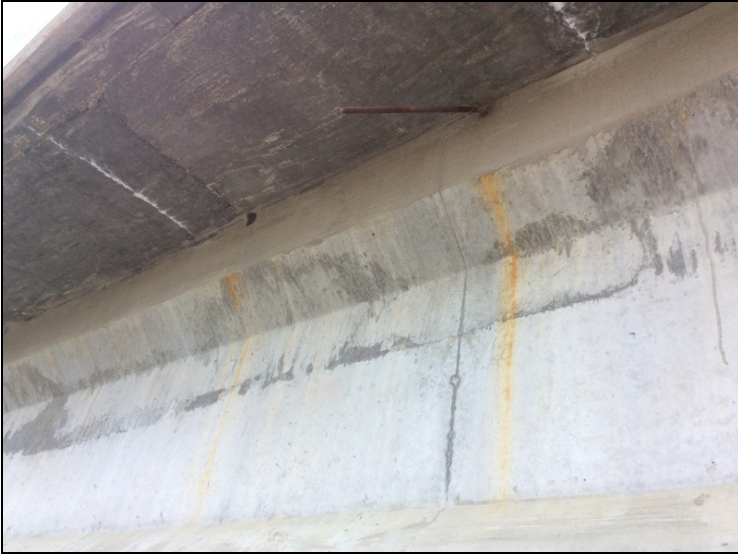
Span 52 girder 1 a piece of all thread was left.

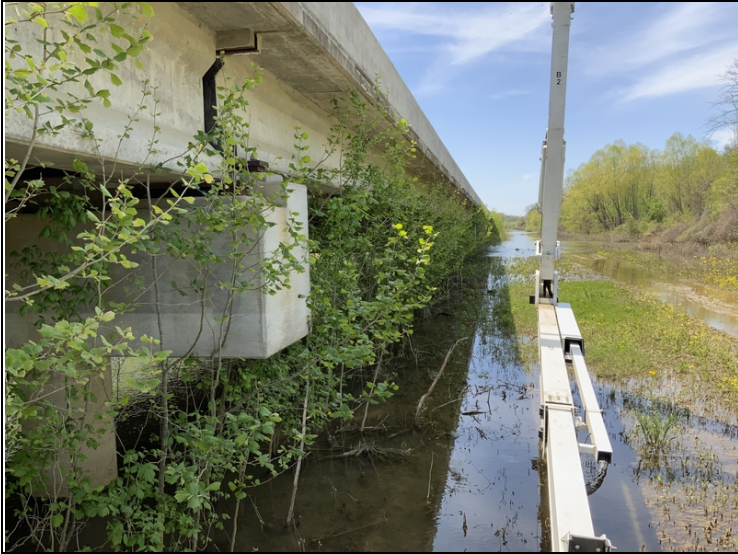
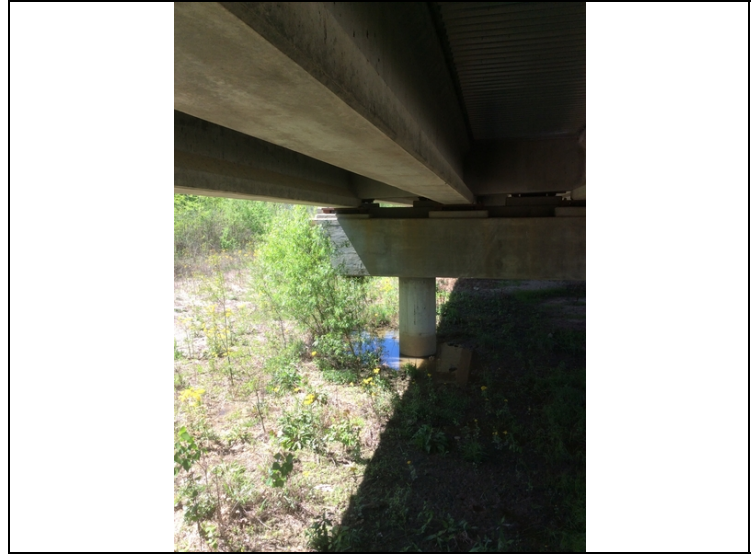
Trees at bent 45

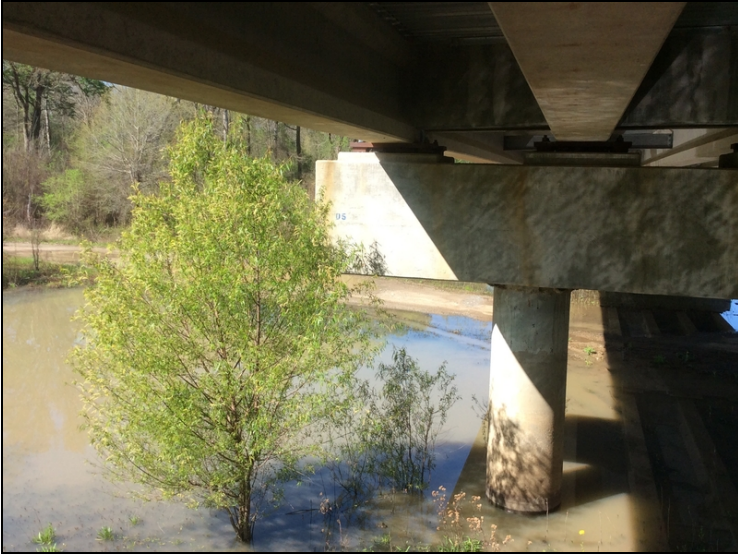
Bent 5 tree needs to be removed. Bent 14 similar.

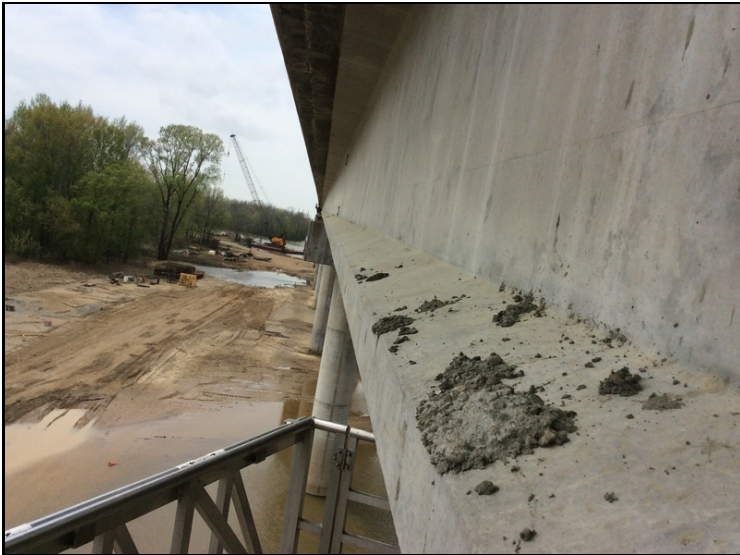
Span 88 girder 6 concrete debris on outside of Girder.
