Asset #M3331(Routine, Underwater type 2)

Sh-50/Sec-1/L13.54 over Blackfish Bayou

Location: 1.4 Mi W Jct Sh 149 & 50

Team Lead: Myron Futrell Inspection Date: 03/25/2024

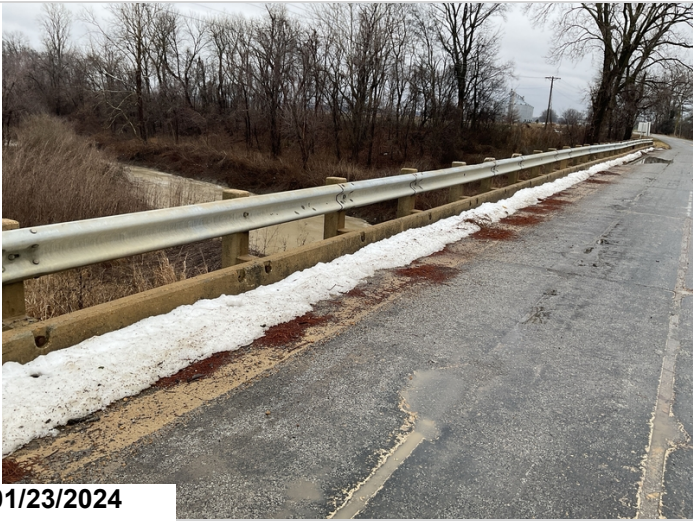
Bridge rail left side

(301) Joint material is missing allowing non compressible material to enter. 259LF CS3							
330	Metal Bridge Railing	LF	380	373	7	0	0
1900	Distortion	LF	6	0	6	0	0
7000	Damage	LF	1	0	1	0	0
<p>(330) Bridge rails have a few small areas of minor bent spots.</p> <p>Span #5 left first post spalled with exposed rebar.</p> <p>Span #6 left side mid span has 2' area rail is bent.</p>

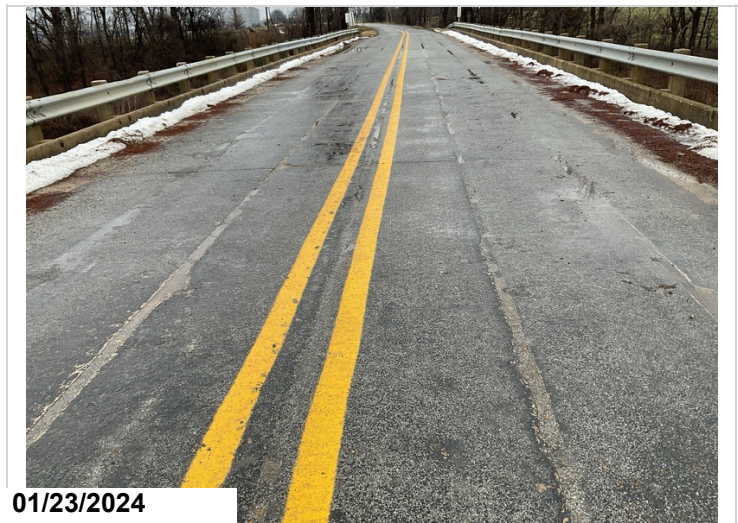
Typical deck

Channel beam unit deck is in fair overall condition; several units have spalling to surface and areas of scaling. Deck has light to moderate abrasion full length that has been covered by deck units 2 through 7 have been covered with chip seal in 2023. Grout joints between units have areas of spalling.

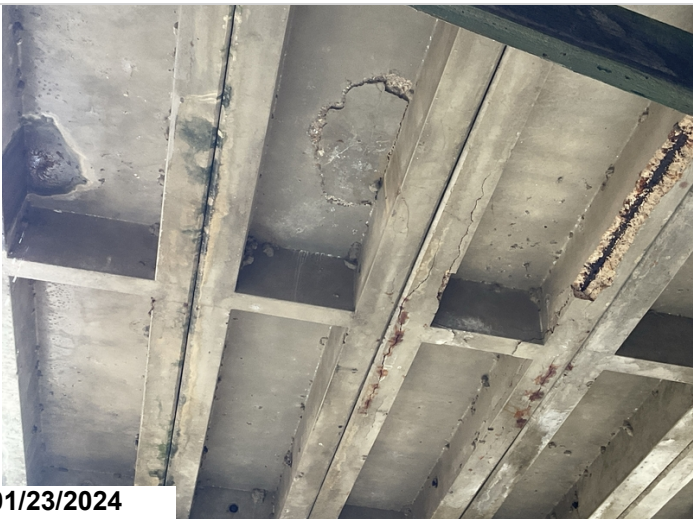
Span #3 girder #2 has two foot delaminated area in soffit near mid span.

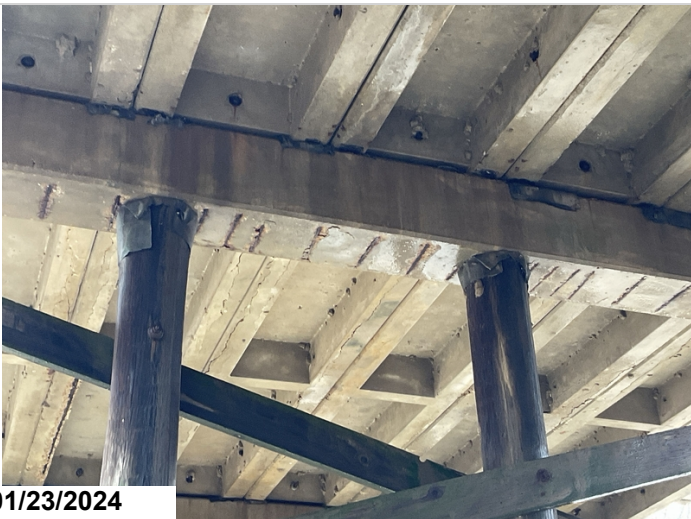
Typical exposed rebar on bottom of cap

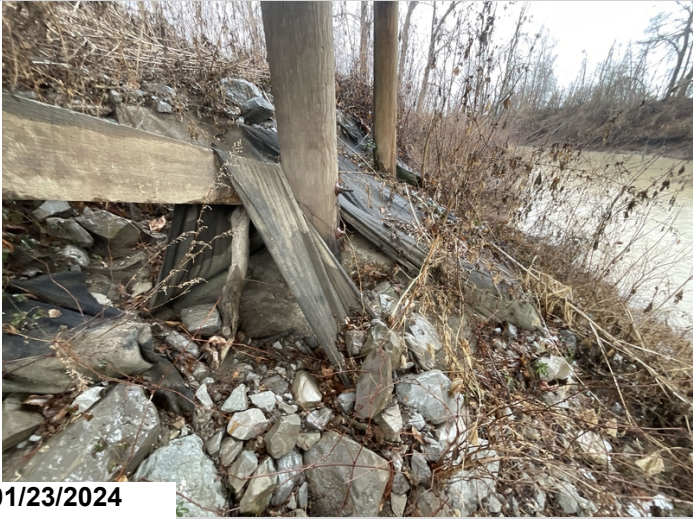
Displaced riprap and filter fabric east slope

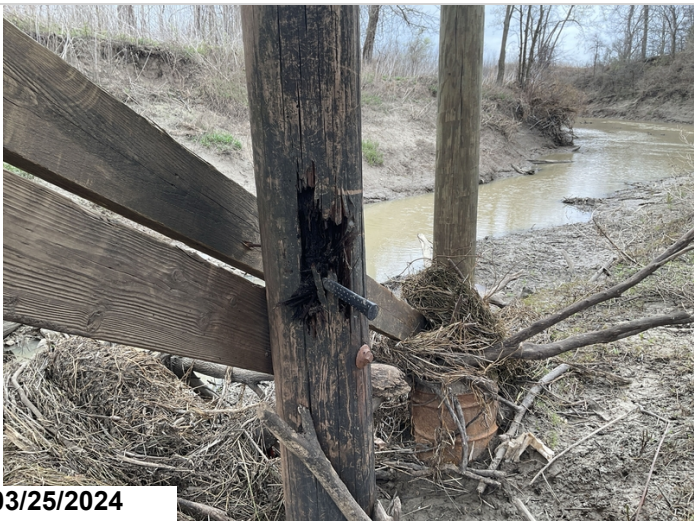
Bent #7 pile #4 sounds very hollow with hole in left face.

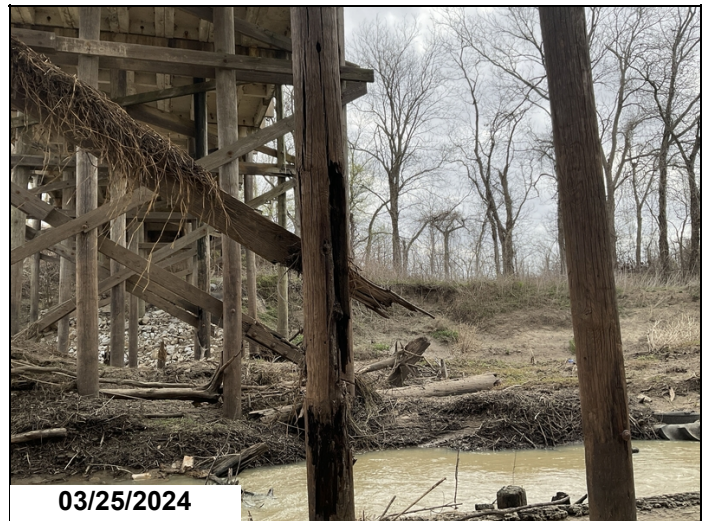
Bent #5 pile #4 is core decayed with large section loss and mushrooming.

01/24/2023 this should not be in repaired documented Bent #5 pile #4 is in bad condition.

Priority: A - Safety deficiency; requires prompt action

Type of Work: Replace (General)

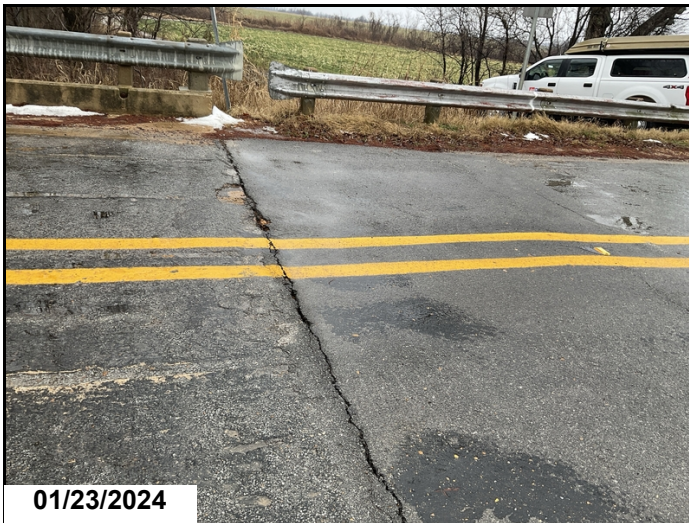
Abutment #1 approach roadway

5/16/2023-Abutment #1 roadway settlement has been repaired.

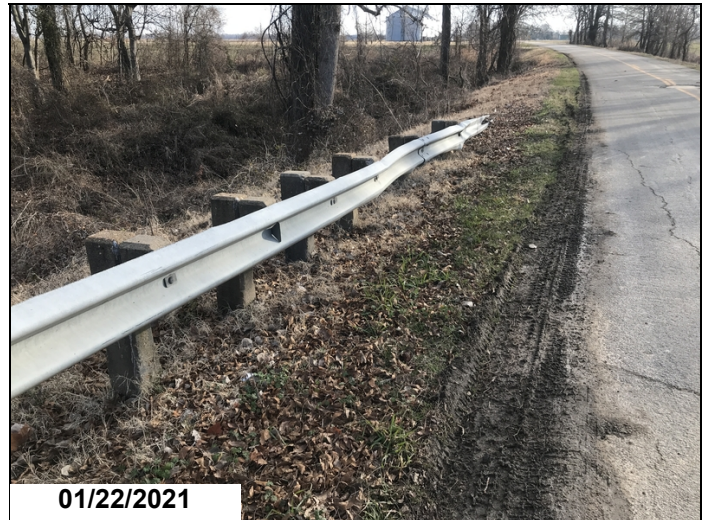
Abutment #1, left side, last approach rail post is broken.
Approach rail abutment #2 left side has collision damage.

Abutment #1 left side last approach rail post spalled with exposed rebar

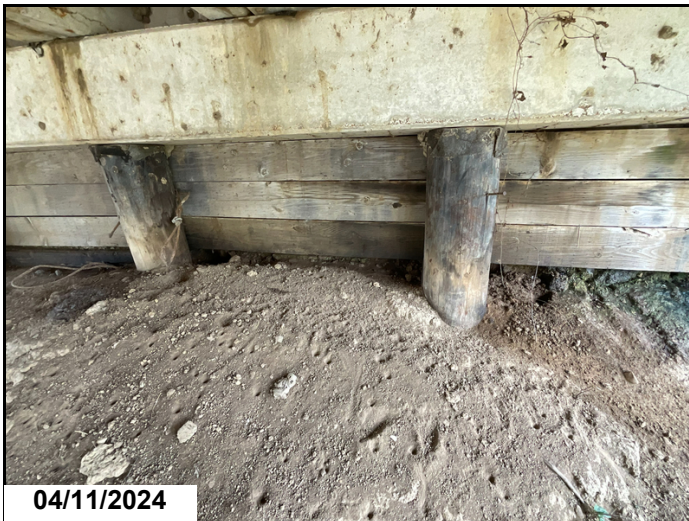
Abutment #2 back wall behind piles #3,4 have large void behind back wall from animal activity.

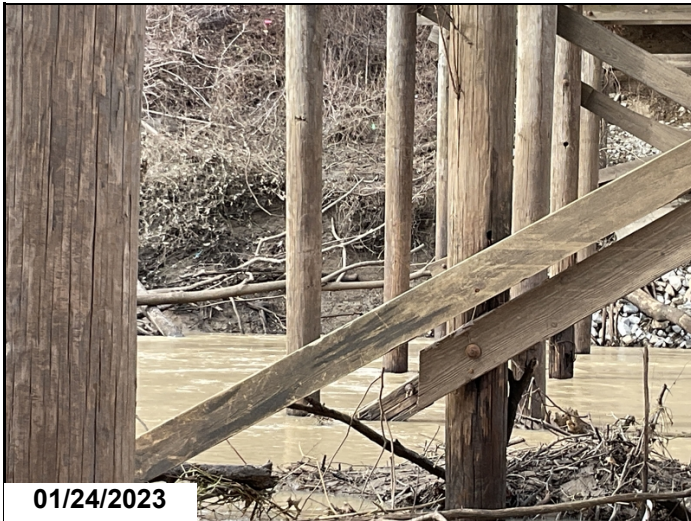
Bent #7 pile #2 sounds slightly hollow.

Bent #7 pile #4 sounds moderately hollow with hole in ahead face.

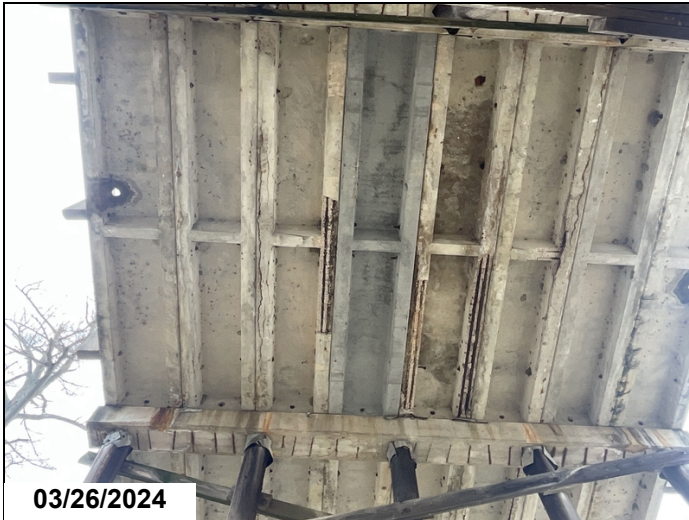
Span 5 soffit / under surface of deck

Span 5, Unit 4, Left Leg, First ½ of Span: Spalled with exposed, unbonded reinforcing steel with moderate section loss. 9LF CS4

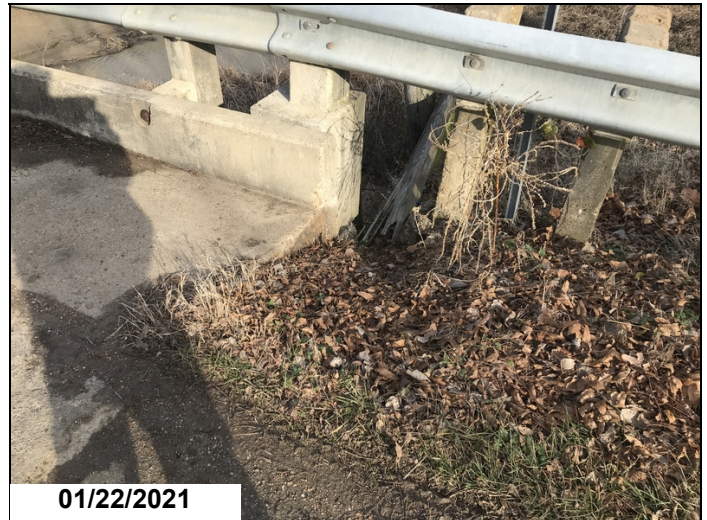
Void at abutment 2 left approach shoulder has been repaired at time of inspection.

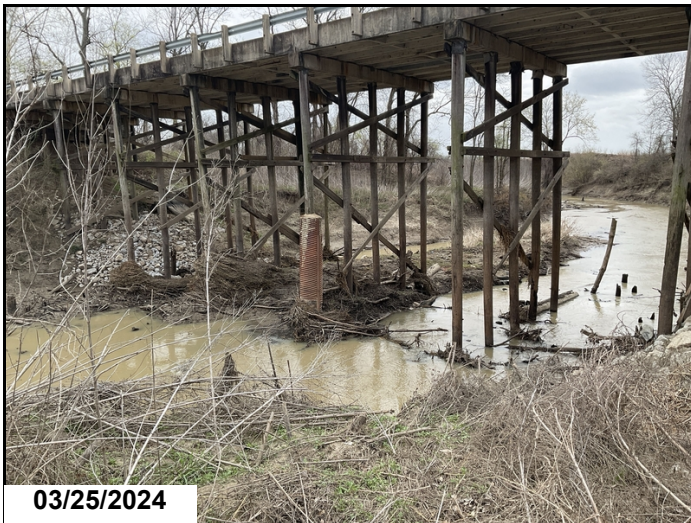
Large accumulation of debris and silt build up in channel under bridge and downstream of bridge.

Silt and debris in channel

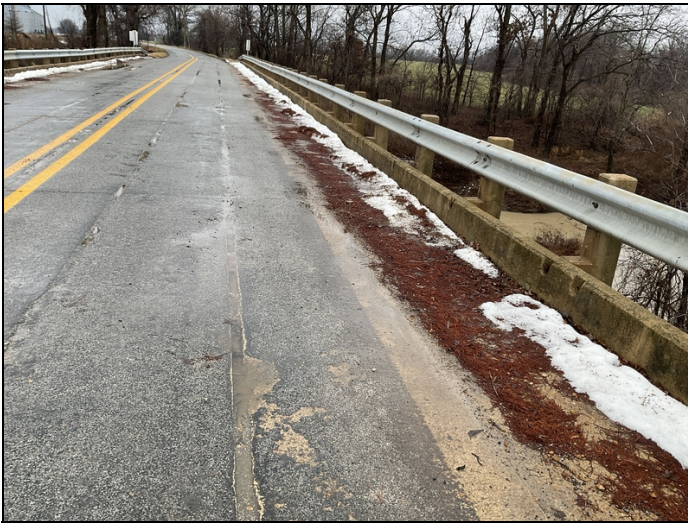
Gutters have dirt and debris in them.

Dirt and debris in gutters

A-55 - Deck Washing Needed (Yes)

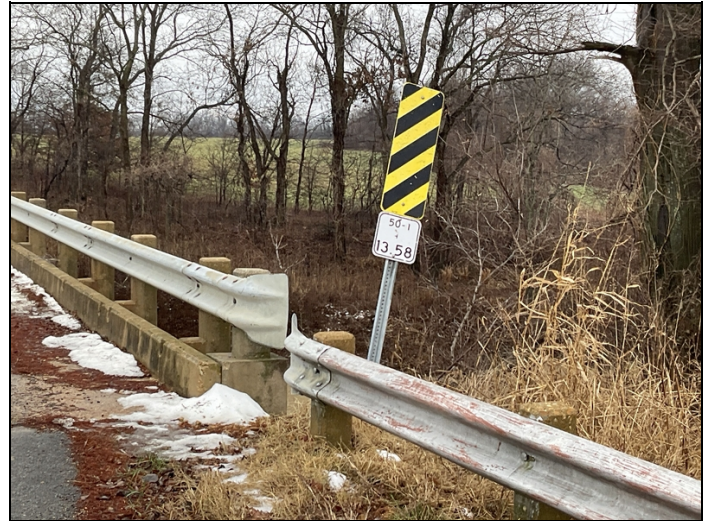
Abutment #1 log mile sign

A-63 - Missing/Incorrect Log Mile Signage (Yes)
