Route:50 Section:01 Log:15.35

Arnold Road ID:68x50x1xA, Arnold Log mile:15.345

District 01, 123 - St. Francis County

(4) Place Code	0
(6) Features Intersected	Big Rabbit Bayou
(7) Facility Carried	Sh-50/Sec-1/L15.35
(9) Location	.03 Mi W Jct Sh 149 & 50
(11) Mile Point	15.35 mi

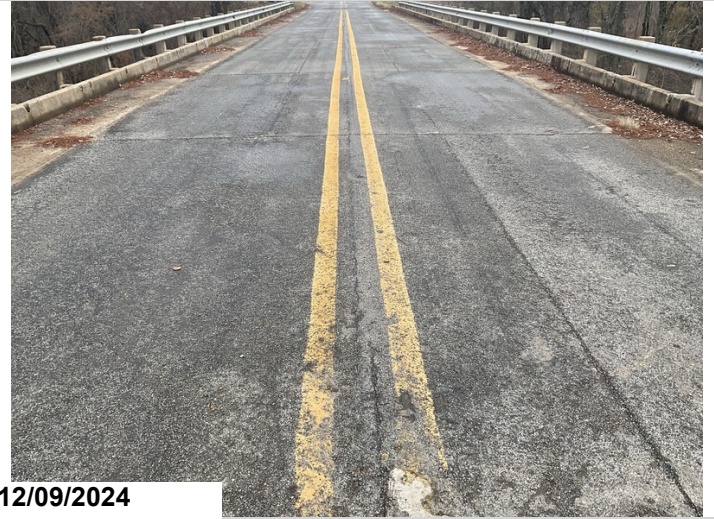
Typical deck

Reinforced concrete channel beam top flange deck is in overall satisfactory condition. Deck has several areas of small areas heavy scaling with loose aggregate and small spalls and delaminated areas. Deck has now been chip sealed across units 2-7. Several units have transverse cracks some reflecting through undersurface with light efflorescence. Several curb units have small pieces of exposed rebar due to poor concrete coverage.

12/9/2024-Lowered deck from 7 to 6 due to several small areas of heavy scaling with loose aggregate and a few hairline cracks in undersurface of units having light efflorescence.

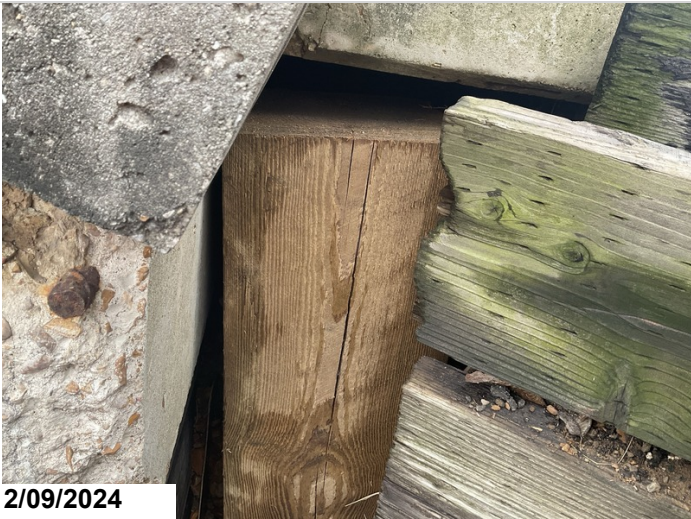
Abutment 2, right side void behind cap.

12/10/2024-Abutment 1 left side has sandbags in place. Abutment 2 right side has 12" x12" timber block placed in opening.

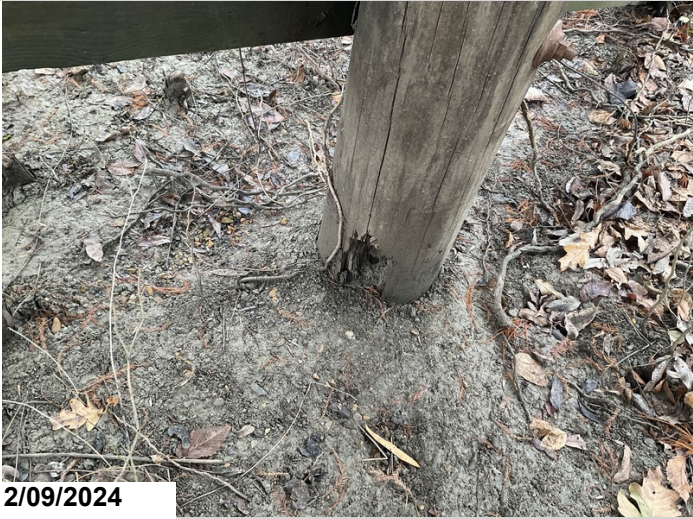
Bent 7 pile 2: 4" wide by 3" deep hole in outer shell at ground line.

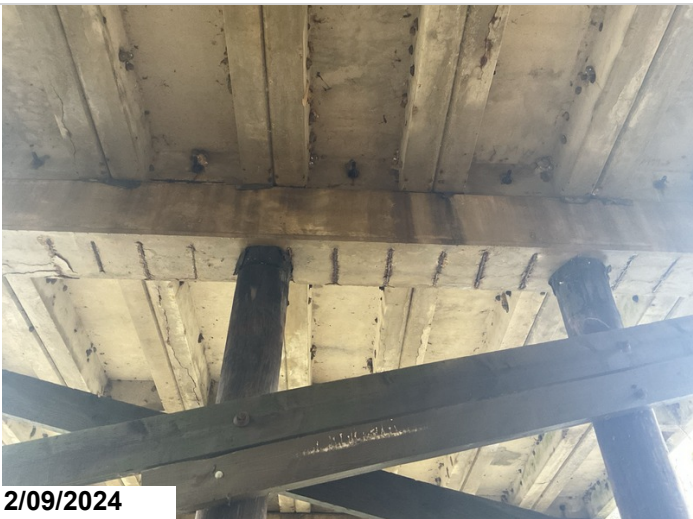
Typical exposed reinforcing steel on bottom of pile caps.

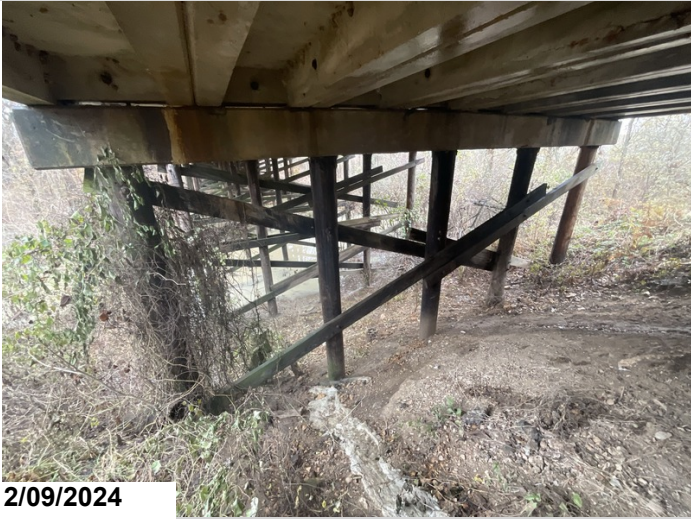
Typical intermediate bent

Substructure consists of timber piles and precast reinforced concrete caps. Substructure is in overall fair condition with multiple piles having been spliced and encased in concrete. Several piles have minor to moderate decay and minor splits. Concrete caps have exposed reinforcing steel due to poor concrete coverage, especially on bottoms. Timber backwalls are decayed with some areas at abutment 1 having sandbags in place.

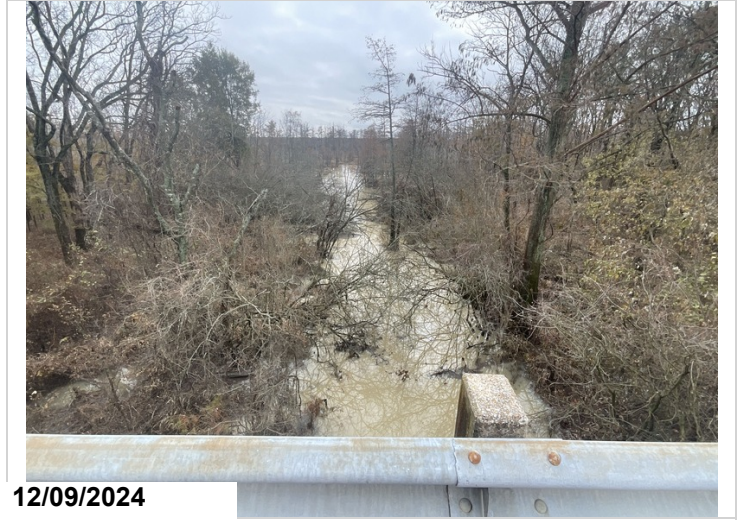
Channel, right side

Channel is in overall fair condition, alignment is good. Trees and brush are growing in channel both sides of structure.

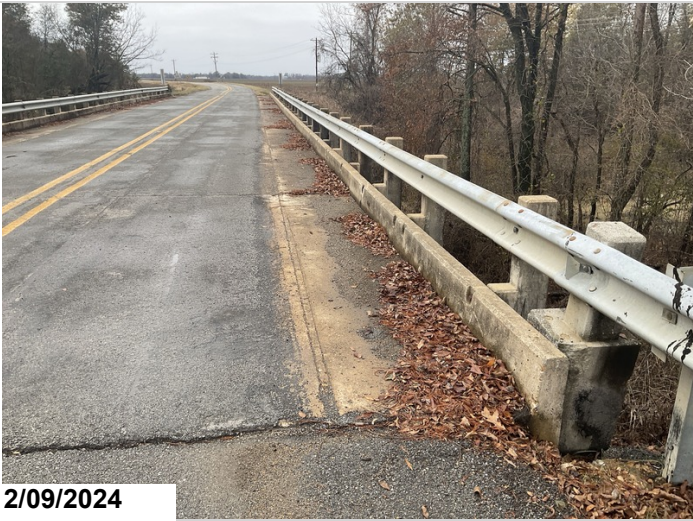
Dirt and debris in gutters

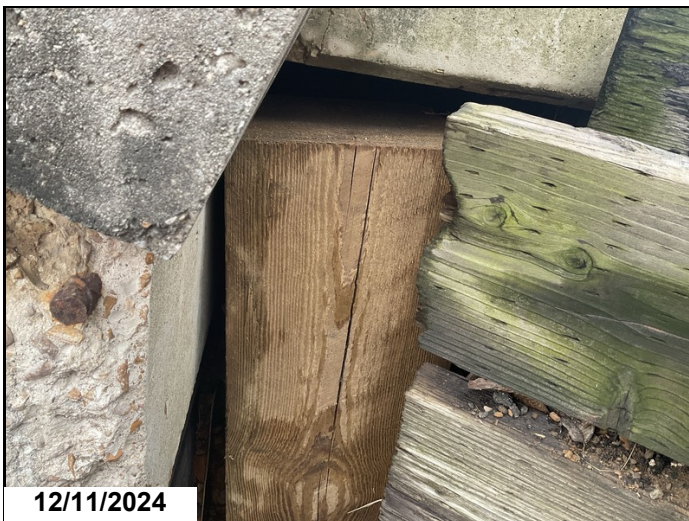
Abutment 2, right side void behind cap.

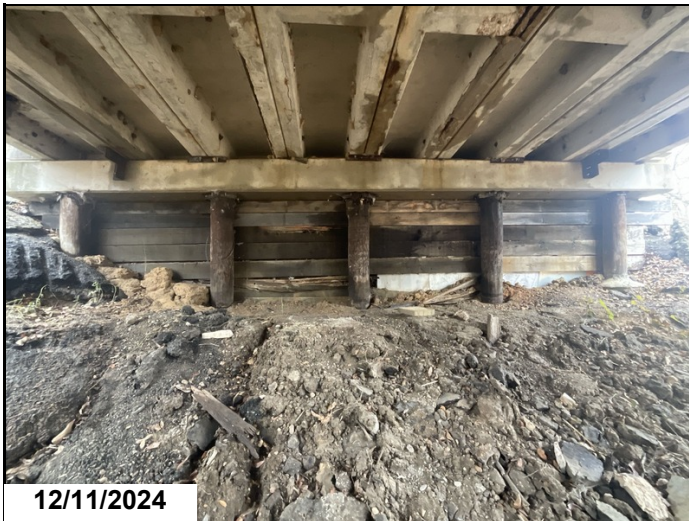
Abutment 2

Abutment #2 timber back wall is decayed full width with areas of 100% section loss allowing for erosion.

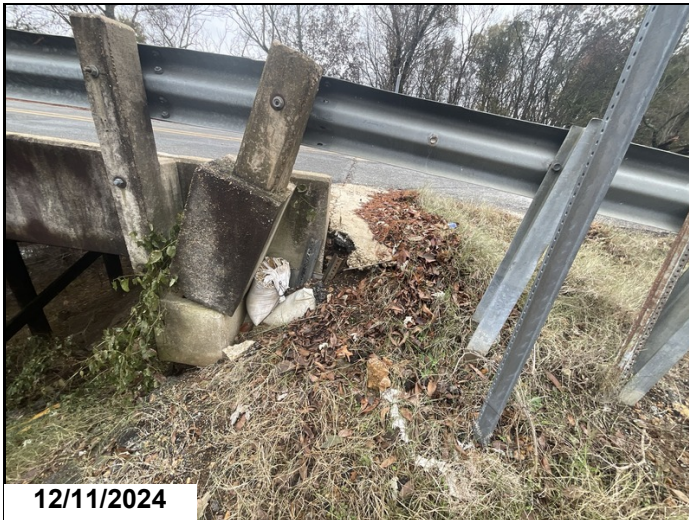
12/10/2024-Abutment 1 approach shoulders have been leveled at time of inspection.

Abutment 1, approach shoulder, left side

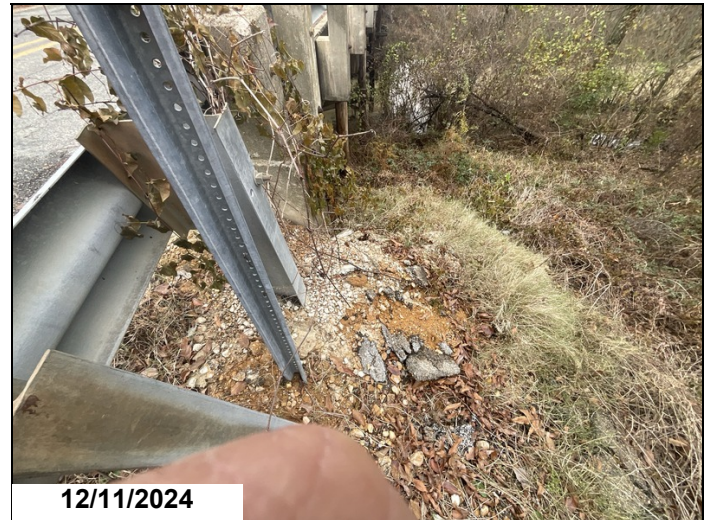
Abutment 1, approach shoulder, right side

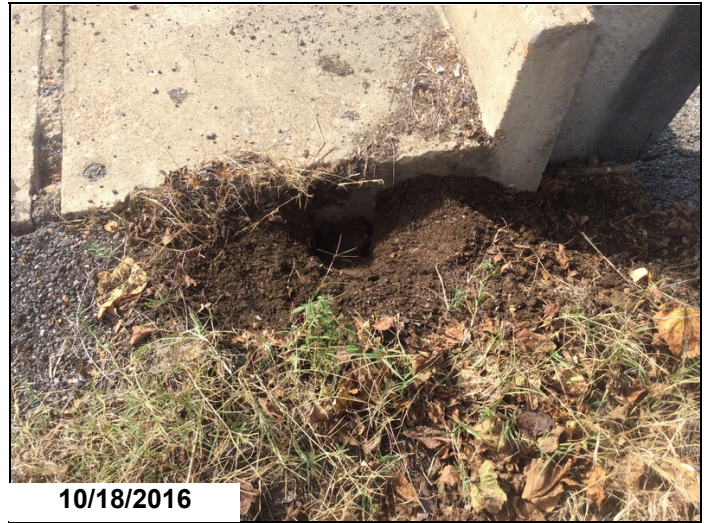
Typical approach shoulders.

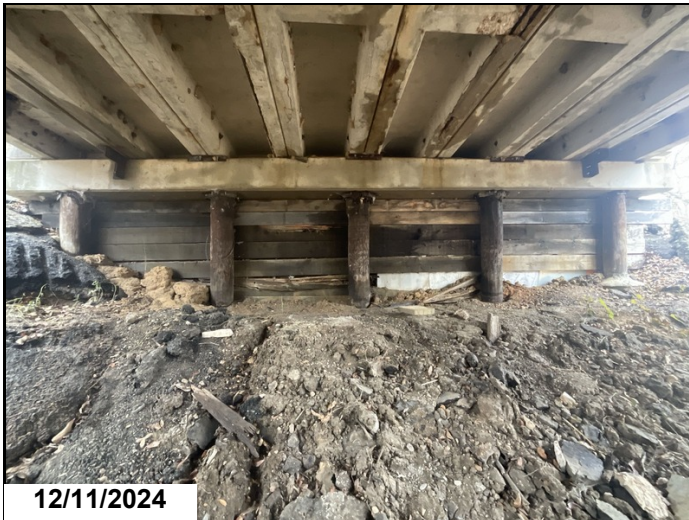
Abutment 2

Abutment backwalls: weathered and cracked, with several missing boards. Several boards decayed and missing. abutment 1 has sandbags in place, abutment 2 has patches behind backwall missing boards.

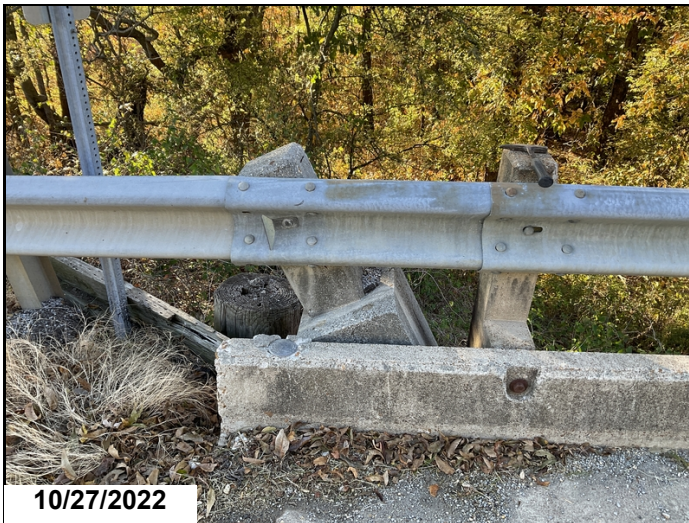
Abutment #2 right side last rail post leaning ahead

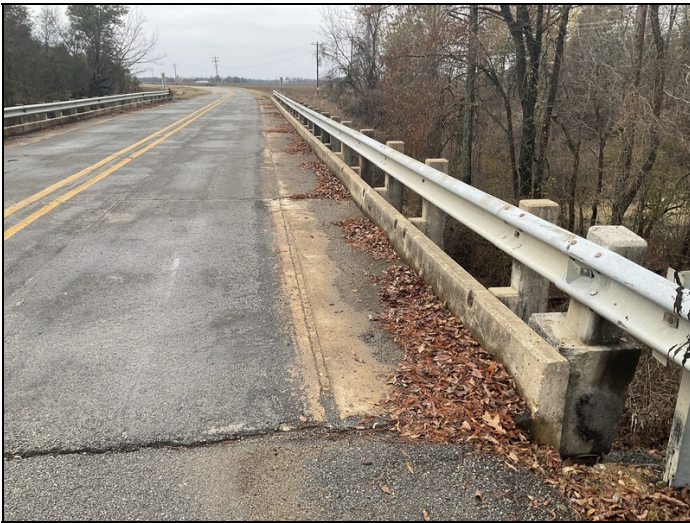
Dirt and debris in gutters.

Dirt and debris in gutters

**A-55 - Deck Washing Needed (Yes)**

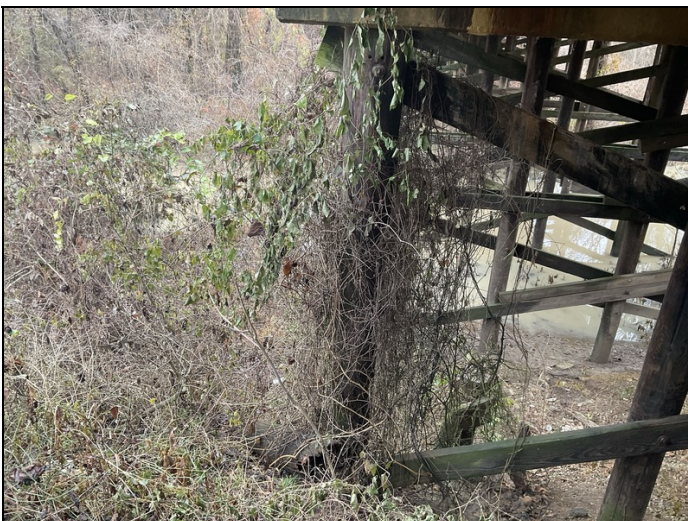
Small trees and vegetation growing beside, under and onto bridge.

Typical vegetation growing beside, under and onto bridge.

**A-64 - Vegetation Removal Requested (Yes)**
