Asset #M3333(Routine, Underwater type 2)

Sh-50/Sec-1/L16.22 over Little Rabbit Bayou

Location: 0.9 Mi E Jct Sh 50 & 149

Team Lead: Drew Melton Inspection Date: 01/25/2023

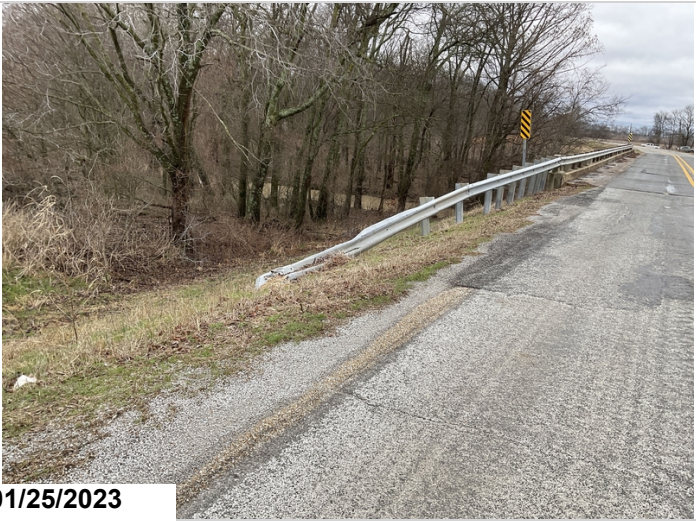
Abutment #2 right approach rail

Abutment #2 left side approach shoulder is sliding nearing roadway.
Trees and vegetation are growing beside and under bridge.
Abutment #2 slope has minor erosion due to roadway run off.
Abutment #2 approach rail right side has collision damage at terminal end.
Approach shoulders both sides both ends have settled six to eight inches at bridge ends.
Approach roadways have settled 1" increasing impact loading on bridge.

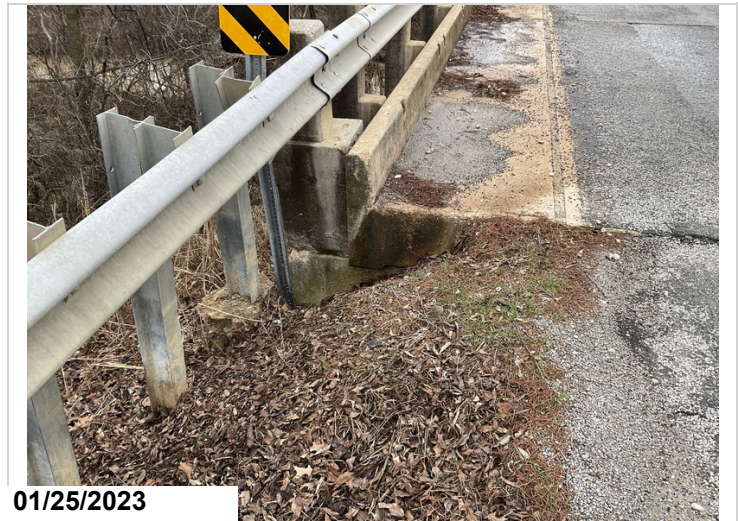
Abutment #1 left side erosion at bridge end.

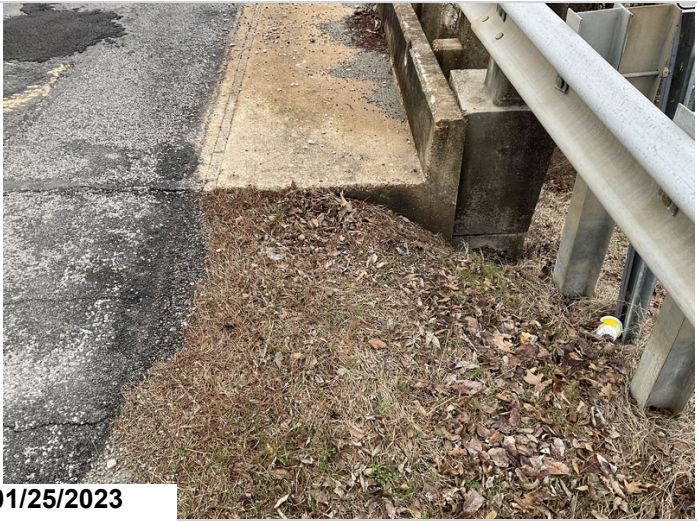
Abutment #1 right side erosion at bridge end.

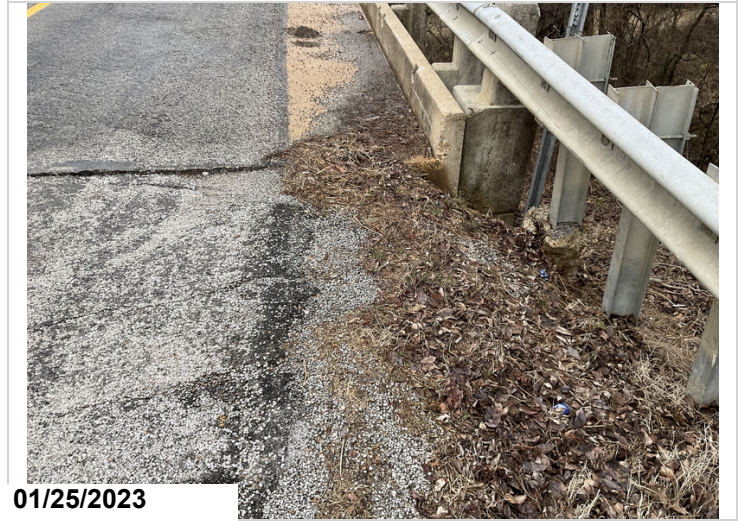
Abutment #2 left side erosion at bridge end

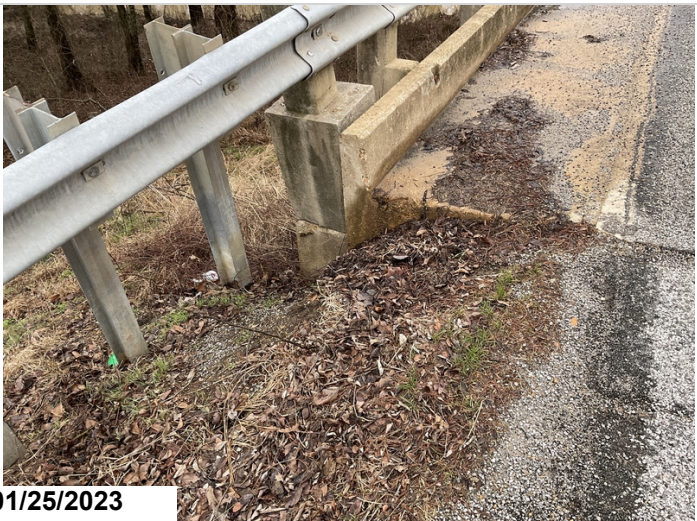
Abutment #2 right erosion at bridge end

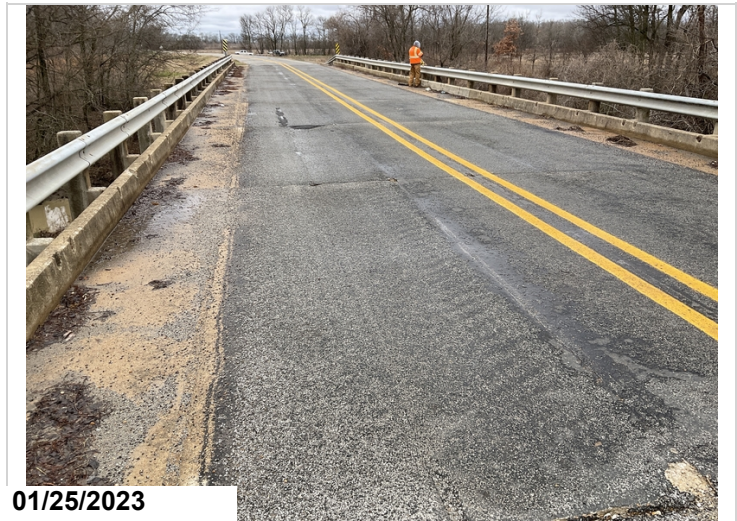
Typical deck

Deck has a chip seal in travel lanes only. Deck has areas of spalling in grout joints and a few other areas some with asphalt patches. Deck has some cracks in units some covered by chip seal.

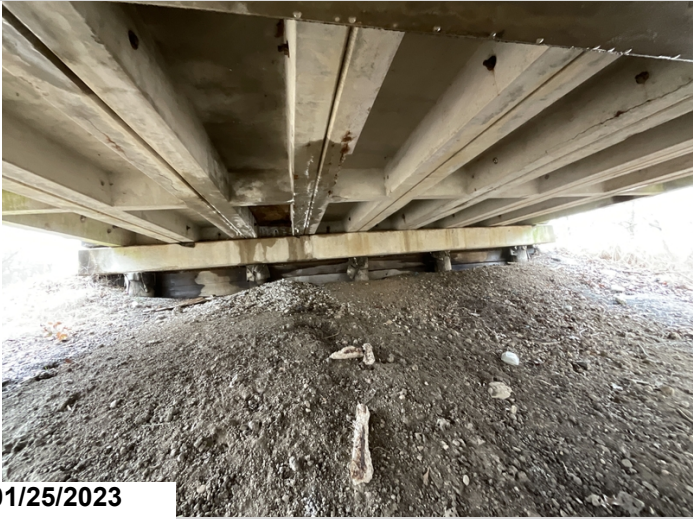
Span #1 girders

Span #1 unit #6 both legs have map cracking with moderate efflorescence first half of span.

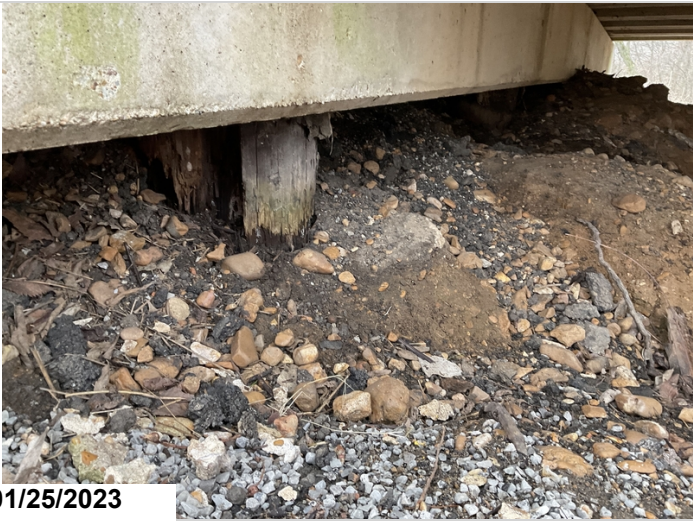
Bent #10 pile #1 sounds moderately hollow with hole in left side moderate section loss.

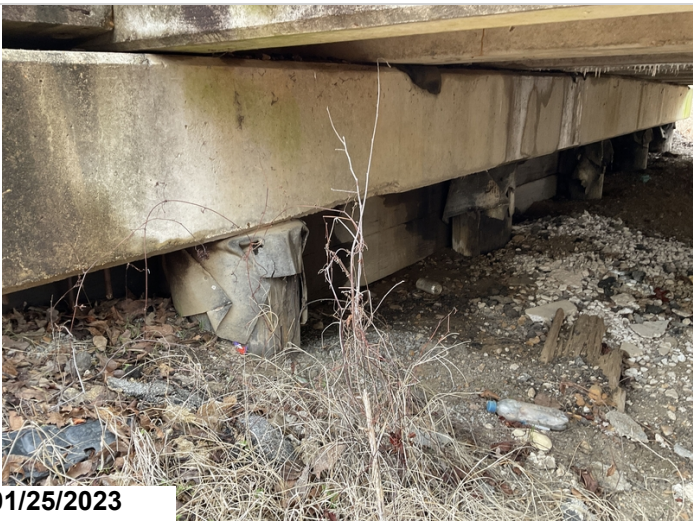
Abutment #1 beside pile #2 has a four foot void behind timber back wall.

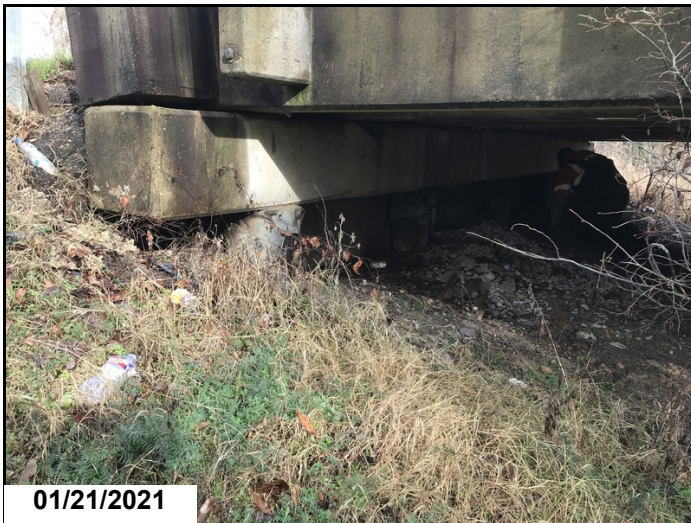
Abutment #1 beside pile #2 has a four foot void behind timber back wall.

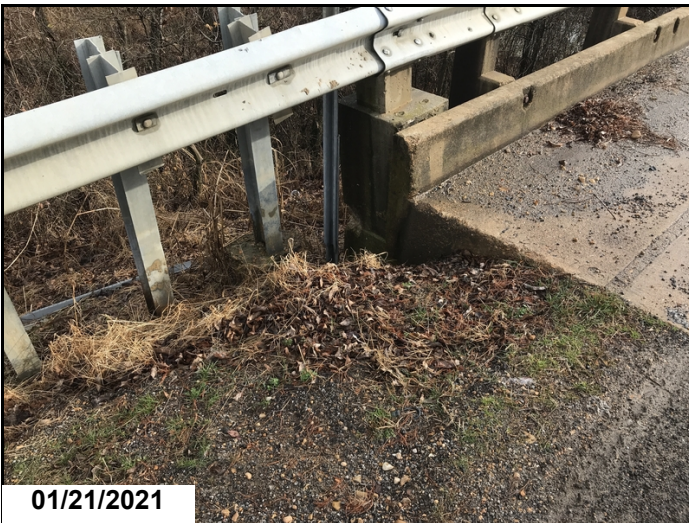
Abutment #1 left approach shoulder at bridge.

Approach shoulders both sides both ends have settled six to eight inches at bridge ends.

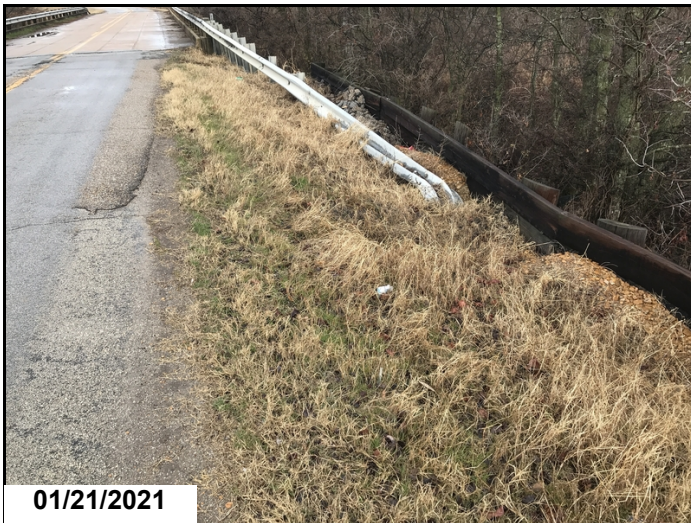
Abutment #2 left side approach shoulder is sliding near roadway.

Abutment #2 left approach shoulder

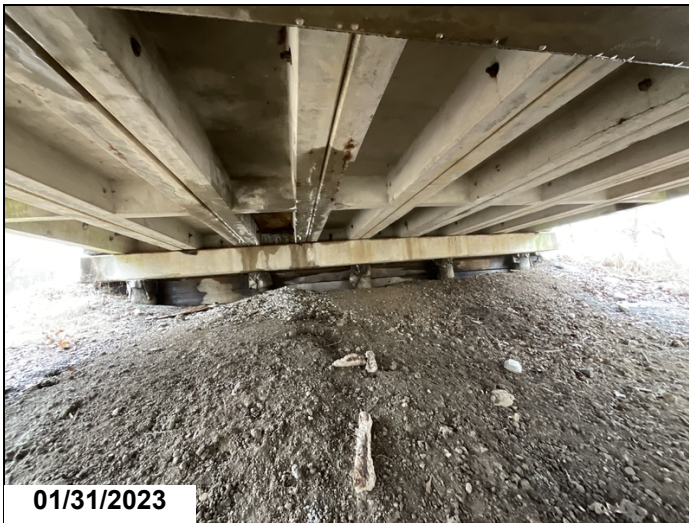
Span #1 unit #2 right leg has cs3, cs4 14' long crack that is delaminated on bottom and side in center span.
Span #1 unit #2 left leg has cs2 crack for 2' on bottom and side at 3/4 span.
Span #1 unit #3 right leg has cs2, cs3 cracks on bottom and side for 14' that is delaminated starting at 1/4 span.
Span #1 unit #3 left leg has cs2 crack on bottom and side for 4' center span.
Span #1 unit #4 left leg has cs3, cs4 cracks on side and bottom for 10' starting at 1/4 span and a 2' cs3 and delaminated on bottom at abutment #1.
Span #1 unit #4 right leg has cs2 cracks and delaminated for 10' side and bottom center span.
Span #1 unit #5 left leg has cs2 cracks on side and bottom for 2' at 1/4 span and 2' at 3/4 span.
Span #1 unit #5 right has cs3, cs4 cracks full length that is delaminated on sides and bottom with a 3' long spall with exposed rebar moderate section loss just ahead of mid span.
Span #1 unit #6 left leg cs3 cracks bottom and side full length with rust stains.

Span #1 unit #6 right leg has cs2 cracks in side second half of span with light efflorescence.
Span #1 unit #6 both legs have map cracking with moderate efflorescence first half of span.
Span #1 unit #7 left leg has cs3, cs4 cracks and delaminated bottom and side full length.
Span #1 unit #7 right leg cs2 cracks in side and bottom for 2' at mid span and 3/4 span.
Span #1 unit #8 left leg has cs2 cracks on side for 2' at mid span.

Span #1 girders

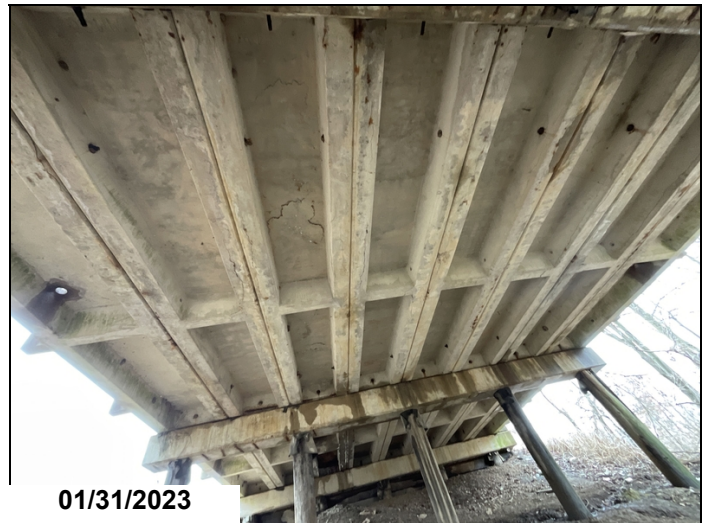
Span #2 unit #1 right leg has cs3 cracks and delaminated bottom and side for 3' at beginning of span, cs3 cracks on bottom and side for 3' mid span.
Span #2 unit #2 left leg has cs3, cs4 8' long crack at 3/4 span with rust stains.
Span #2 unit #2 right leg has cs4 cracks side and bottom full length and delaminated.
Span #2 unit #3 left leg has cs3 crack 12' long crack and delaminated side and bottom in center span.
Span #2 unit #3 right leg has cs2 cracks on side for 2' mid span light rust stains.
Span #2 unit #4 right leg has cs2, cs3 cracks full length with a six inch spall mid span no rebar exposed.
Span #2 unit #4 left leg has cs3, cs4 12' long crack and delaminated side and bottom starting at quarter span with rust stains.
Span #2 unit #5 left leg has cs2, cs3 cracks for 6' on bottom and side at mid span.
Span #2 unit #5 right leg has cs2, cs3 cracks on bottom for 14' starting at 1/4 span.
Span #2 unit #6 left leg has a 1' spall rebar exposed moderate section loss with a 12' cracks in side and bottom at beginning of span.

Span #2 unit #6 right leg has cs2, cs3 12' long cracks on bottom and side at beginning of span.
Span #2 unit #7 left leg has cs3, cs4 10' long cracks with delaminations in side and bottom starting at 1/4 span.
Span #2 unit #7 right leg has cs2 cracks in side for 4' at 3/4 span.
Span #2 unit #8 left leg has cs2, cs3 cracks for 4' bottom and side center span, 3/4 cs3 cracks bottom and side 2' long.

Span #2 girders

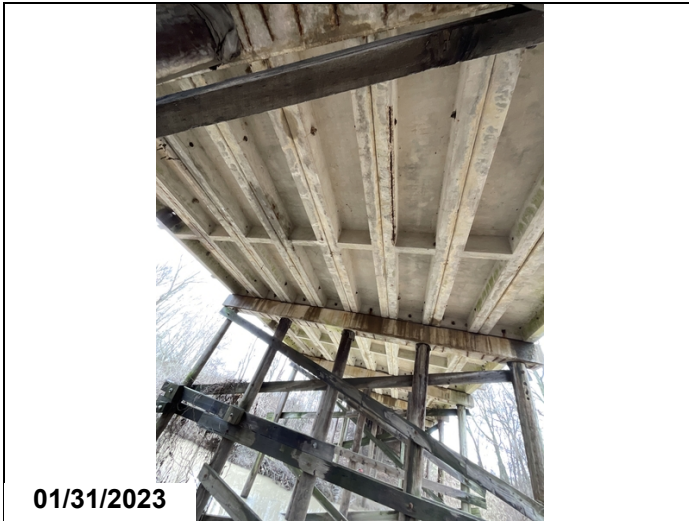
Span #3 unit #2 left leg has cs3, cs4 cracks and delaminated on bottom with rust staining full length.
Span #3 unit #2 right leg has cs4 crack in side for 5' mid span.
Span #3 unit #3 left leg has cs3 cracks bottom and side full length with rust stains.
Span #3 unit #3 right leg has cs3, cs4 cracks for 10' side and bottom at center span with rust staining.
Span #3 unit #4 left leg has cs2, cs3 cracks bottom and side for 10' starting at 1/4 span.
Span #3 unit #4 right leg has cs2 cracks on bottom for 6' starting 1/4 span with rust stains.
Span #3 unit #5 left leg has cs3 cracks in side for 2' mid span.
Span #3 unit #6 left has cs3 cracks and delaminated bottom and side for 10' starting at bent #3, and 6' spall exposed rebar moderate section at 1/4 span, a cs3 cracks in bottom for 3' at bent #4.
Span #3 unit #7 left has cs2 cracks for 3' on bottom at quarter span.
Span #3 unit #7 right leg has cs2, cs3 cracks on bottom for 6' at mid span.

Span #3 unit #8 left leg has cs3 cracks on bottom for 1' mid span with rust stains.

Span #3 girders

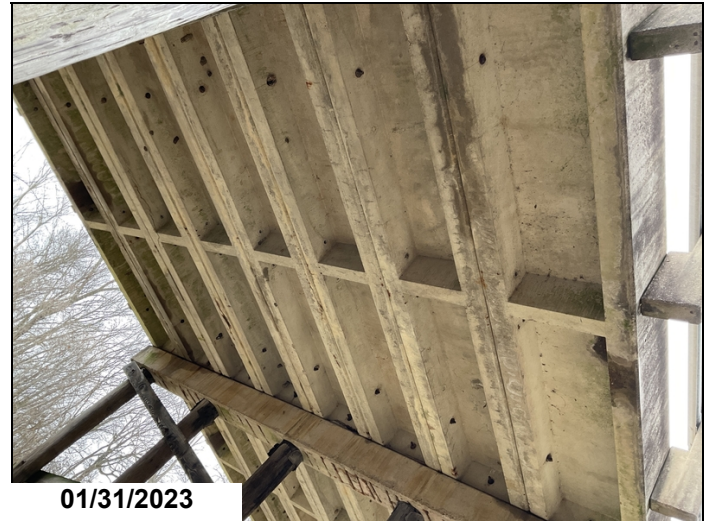
Span #4 unit #1 right leg has cs3, cs4 cracks in bottom for 5' mid span with rust stains.
Span #4 unit #2 left leg has cs3 cracks on side for 3' mid span with light rust stains.
Span #4 unit #2 right leg has cs3 1' long crack on bottom with rust staining center span.
Span #4 unit #3 right leg has a three foot long crack at three quarter span, and a one foot spall with exposed rebar with 10% section loss.
Span #4 unit #3 left leg has cs3, cs4 6' long crack and delaminated on bottom and side starting at 1/4 span.
Span #4 unit #3 right leg has cs4 cracks in bottom for 5' at 3/4 span with rust stains.
Span #4 unit #4 left leg has cs3 4' crack on bottom at 3/4 span with rust stains.
Span #4 unit #5 left leg has cs2 cracks on bottom for 3' mid span.
Span #4 unit #5 right leg has cs3, cs4 7' long crack with delaminations bottom and side with rust stains starting at mid span.
Span #4 unit #6 right leg has cs2 cracks on bottom 4' mid span, 3' cs3 cracks on side at bent #5.

Span #4 unit #8 left leg has cs2 cracks in side for 1' mid span.

Span #4 girders

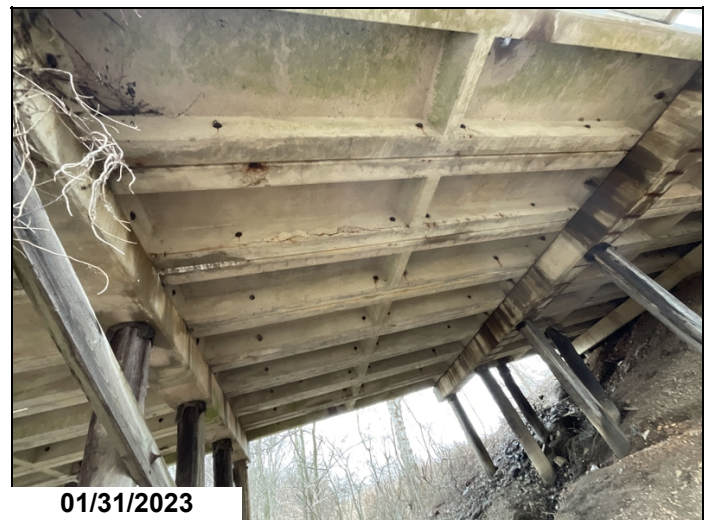
Span #8 unit #5 right leg has cs3 cracks on bottom for 2' at bent #9.

Span #8 girders

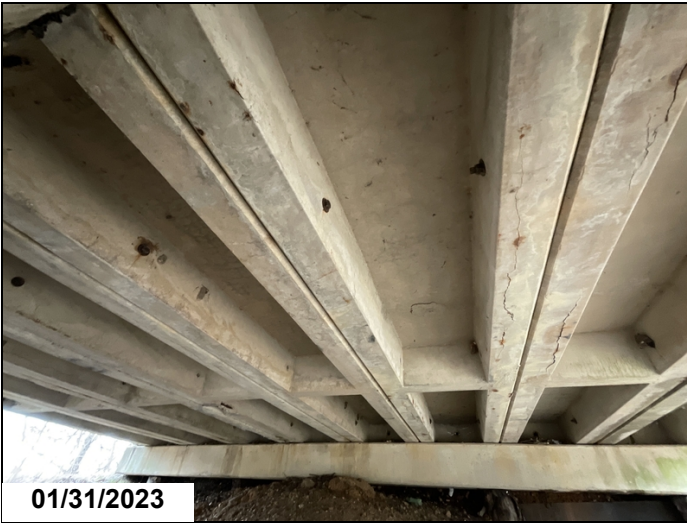
Span #9 unit #1 right leg has cs3 3' long crack and delaminated on bottom and side center span.

Span #9 unit #8 left leg has cs2 cracks on bottom and side for 3' mid span with rust stains.

Span #9 girders

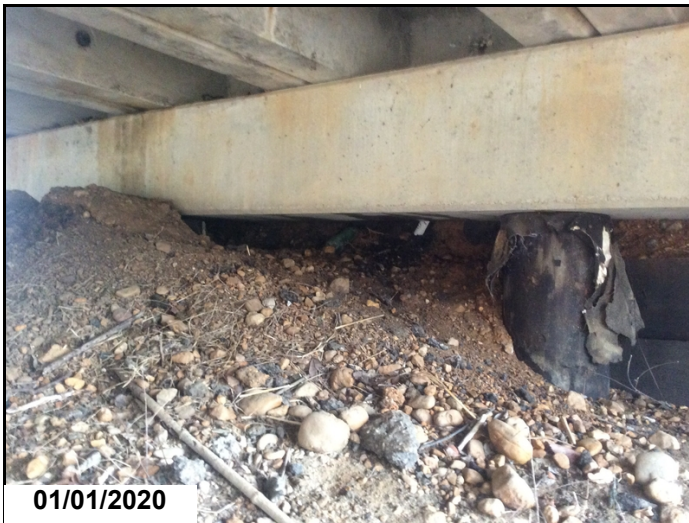
Timber back wall abutment #2 has settled allowing material to erode between cap and back wall.

Settlement of abutment-#2 back wall

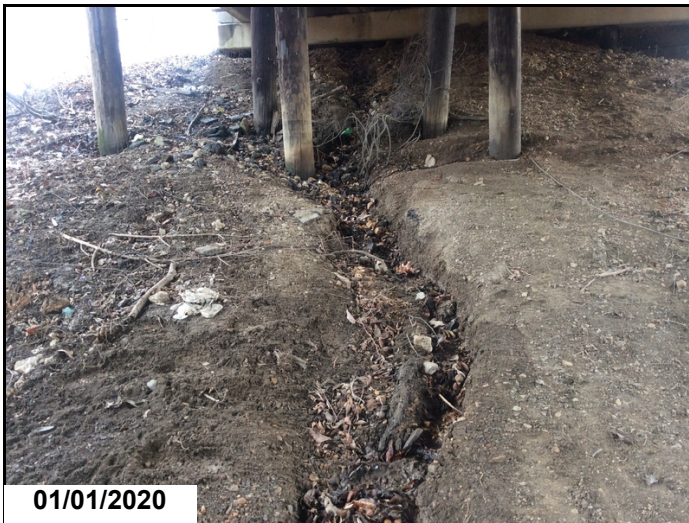
Abutment #2 slope has minor erosion due to roadway run off.

Minor erosion abutment #2 slope

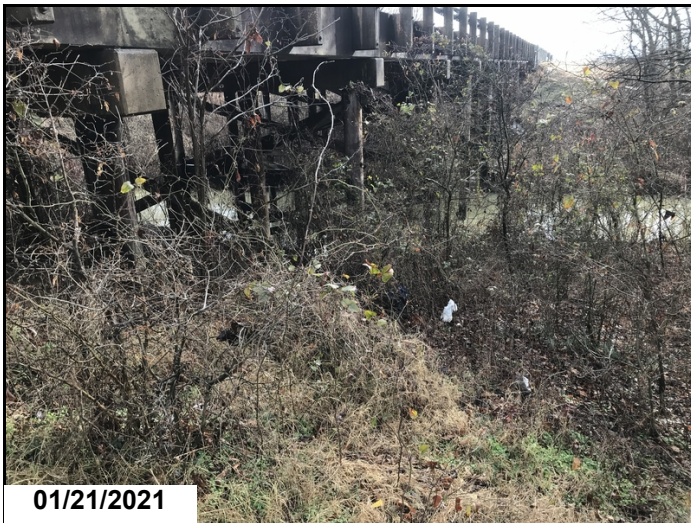
Trees and vegetation are growing beside and under bridge.

Typical vegetation

A-64 - Vegetation Removal Requested

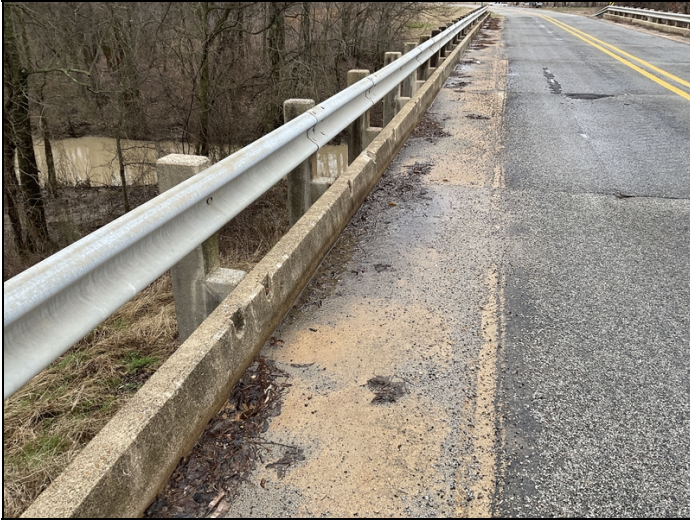
Gutters have dirt and debris in them.

Typical debris in gutters

A-55 - Deck Washing Needed (Yes)
