Bridge 03137 Inspection Report

National Bridge Inventory Data Sheet

Team Lead: Drew Melton, Inspection Date: 02/28/2024

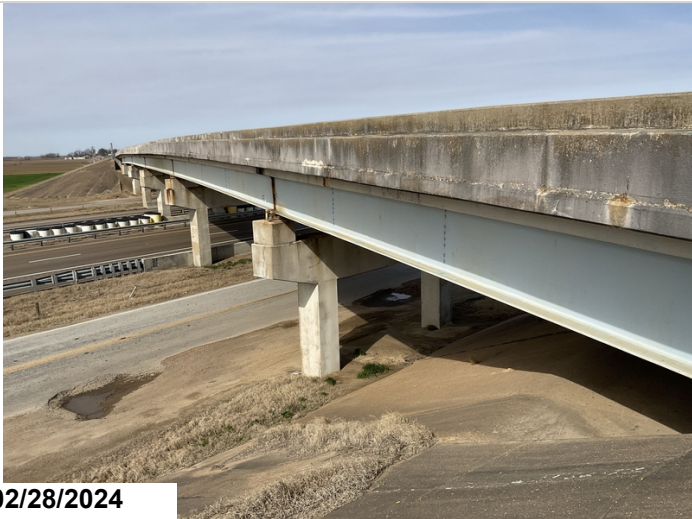
Side view/elevation

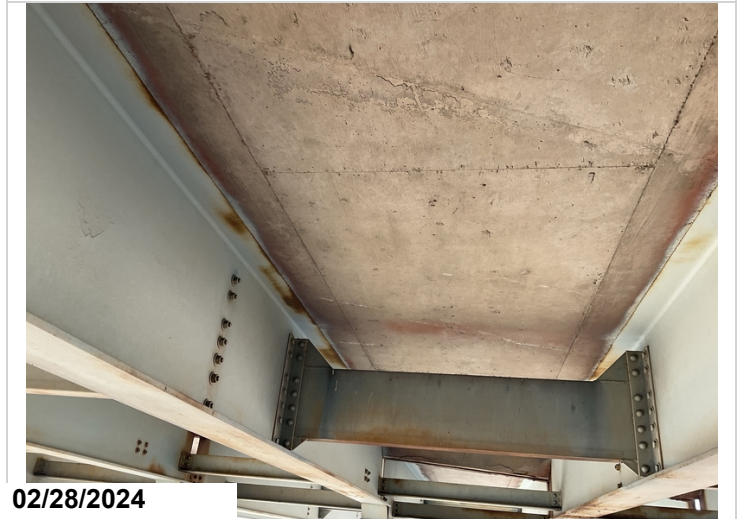
Deck is in good condition with surface having cracks and a few minor spalls, and deck under surface has cracks some with efflorescence.

Typical deck under surface

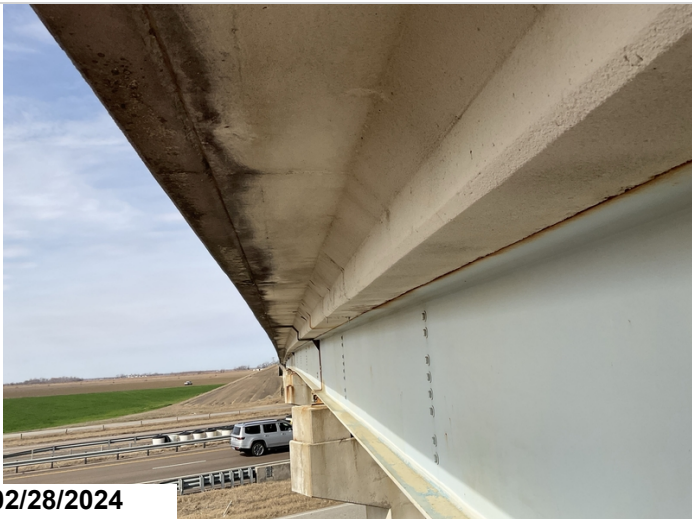
Typical deck under surface overhang

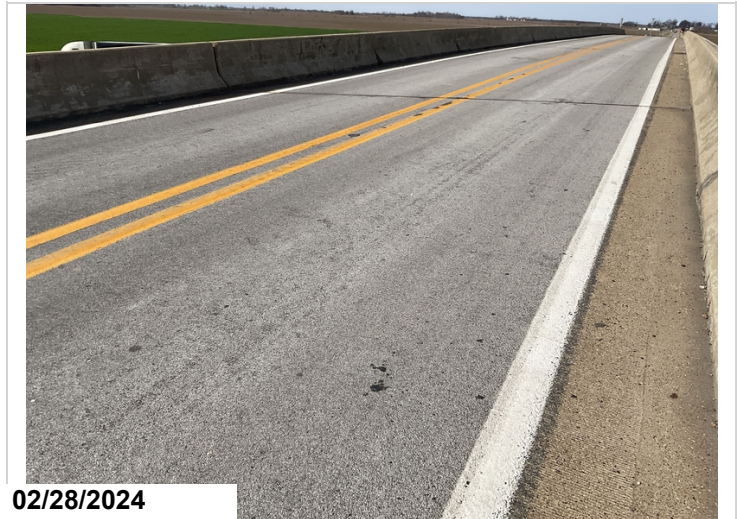
Typical deck

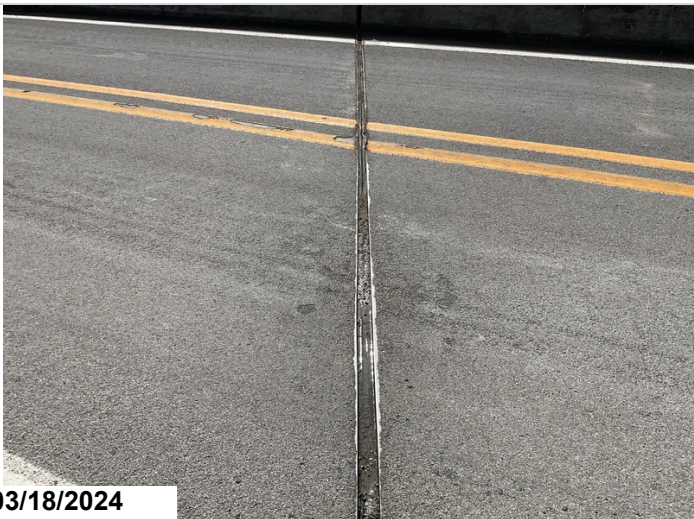
03/18/2024

Bent 6, Compression Joint Seal: 10' of lost adhesion seal is sagging. 10LF CS3

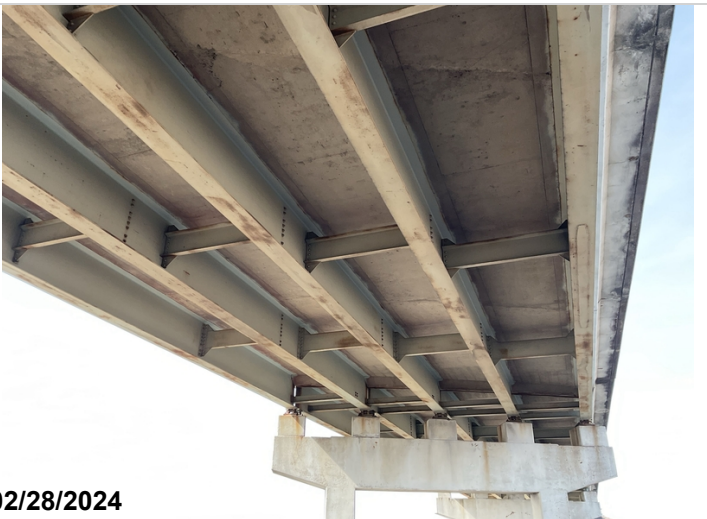
Girders over north bound lanes

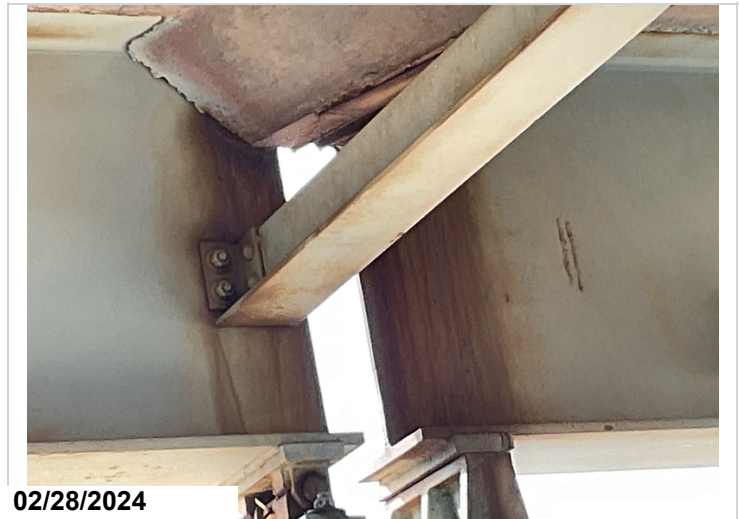
Typical girder ends

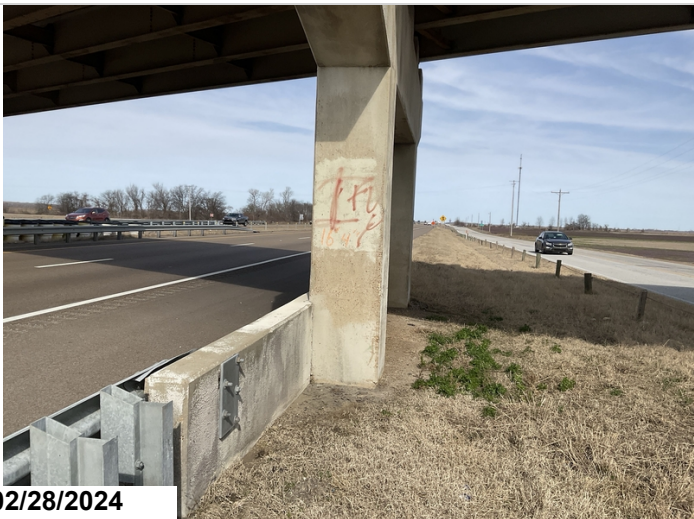
Bent 5, Column 2, Right: Graffiti

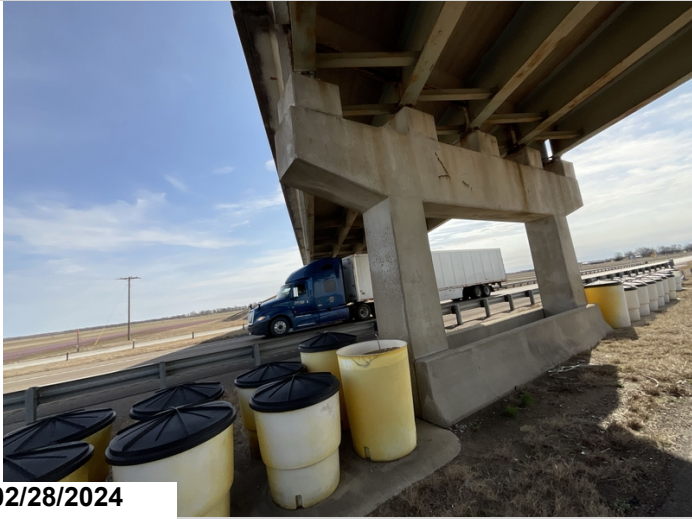
02/28/2024

Bent 4, Pier Cap, Back: 2' of reinforcing steel exposed due to poor concrete coverage. Reinforcing steel has no section loss. 2LF CS2

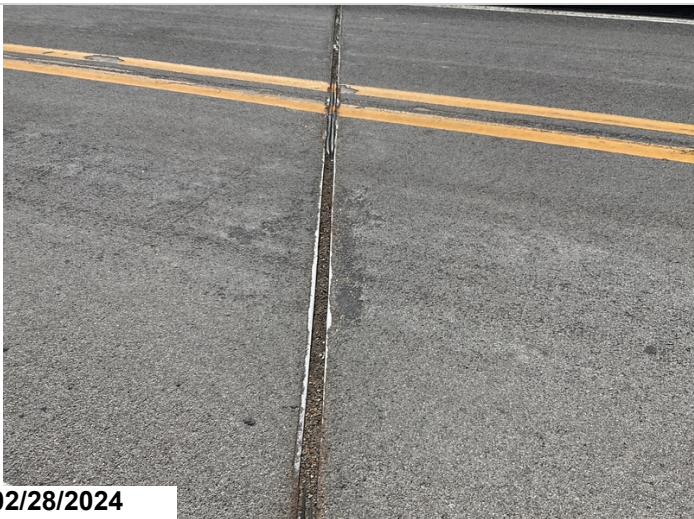
Bent 4, Compression Joint Seal: 18' of lost adhesion seal is sagging. 18LF CS3

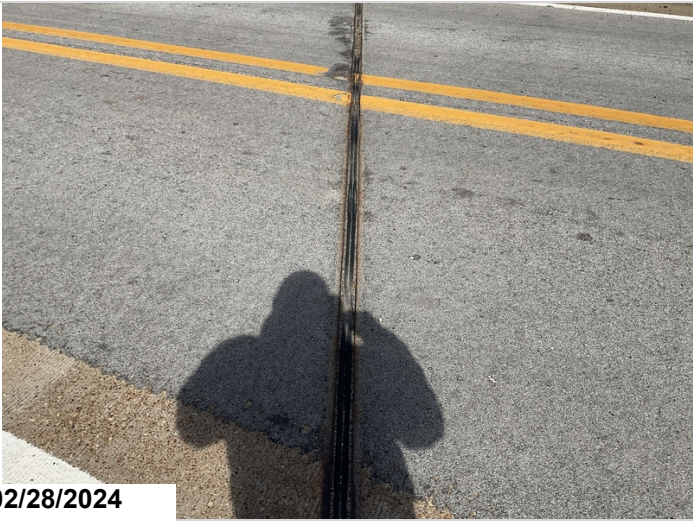
Bent 2, Compression Joint Seal: 7' of lost adhesion seal is sagging. 7LF CS3

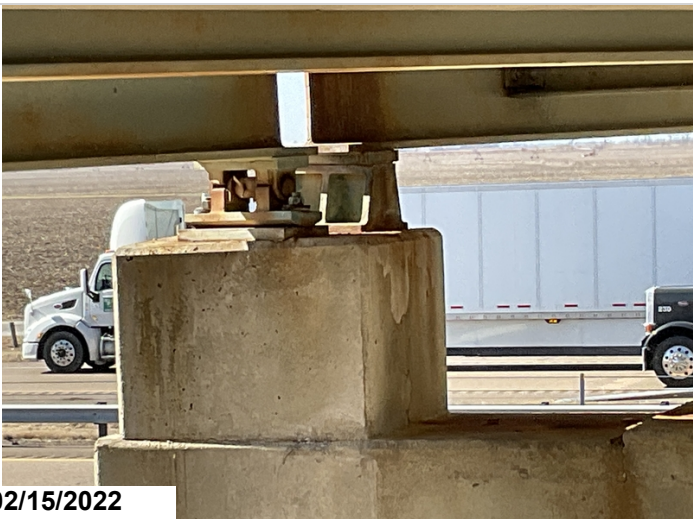
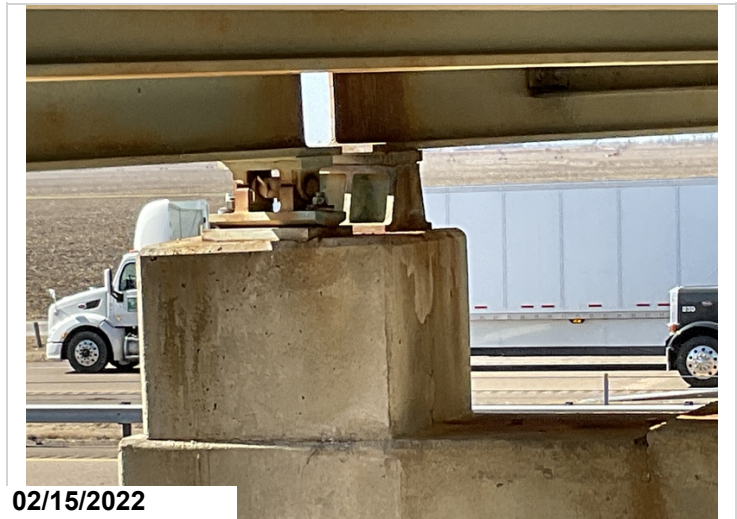
Bearing are in satisfactory condition with surface rust with some minor section loss at abutments.

Typical bearings

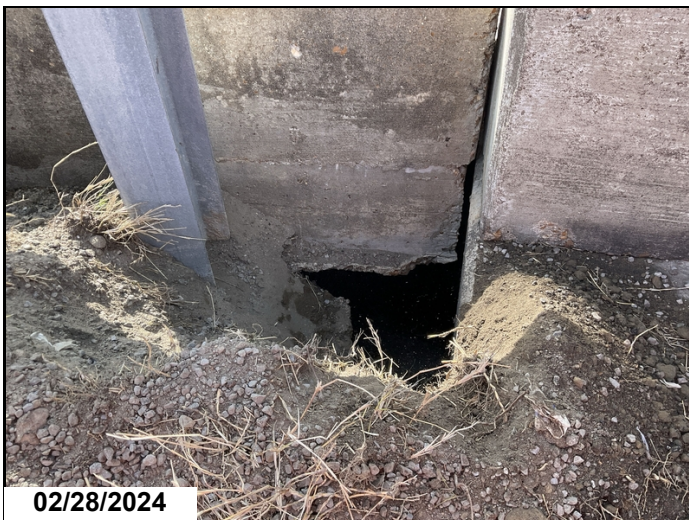
Abutment 2, Approach Roadway & Shoulder, Left: Large void 5' (depth) under roadway.

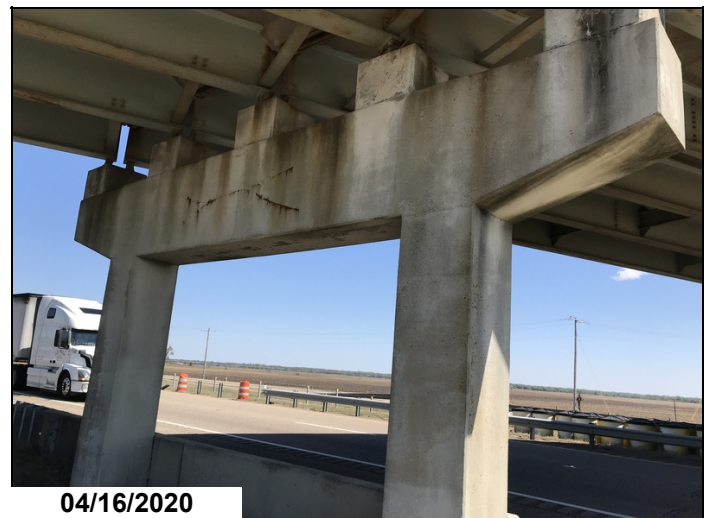
Bent #3 back face

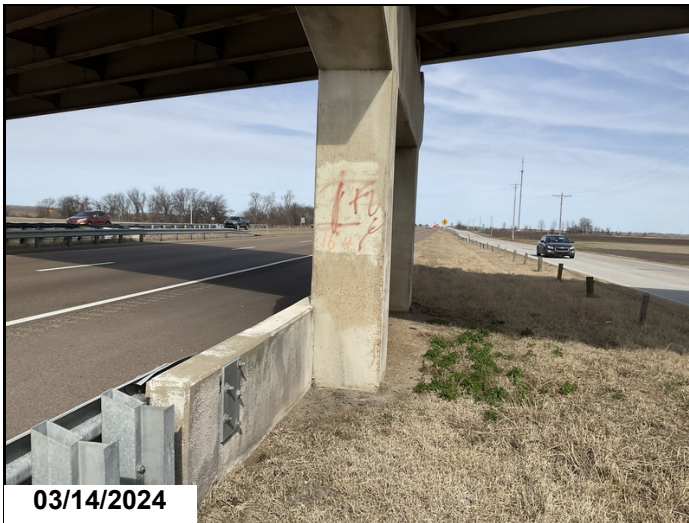
Bent 5, Column 2, Right: Graffiti

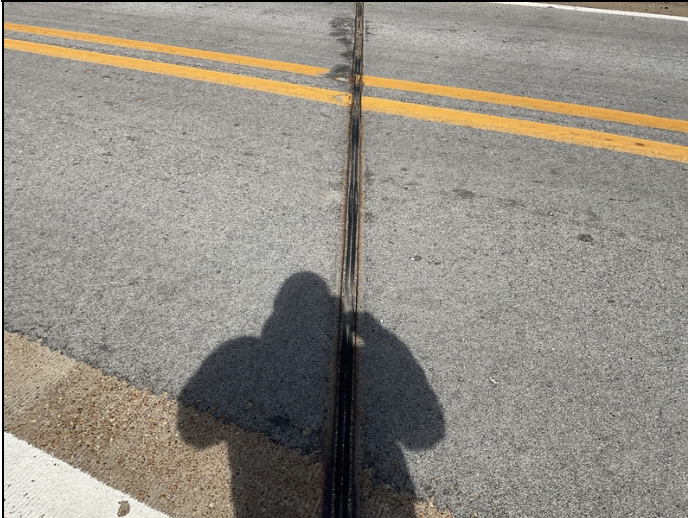
Bent 2, Compression Joint Seal: 7' of lost adhesion seal is sagging. 7LF CS3

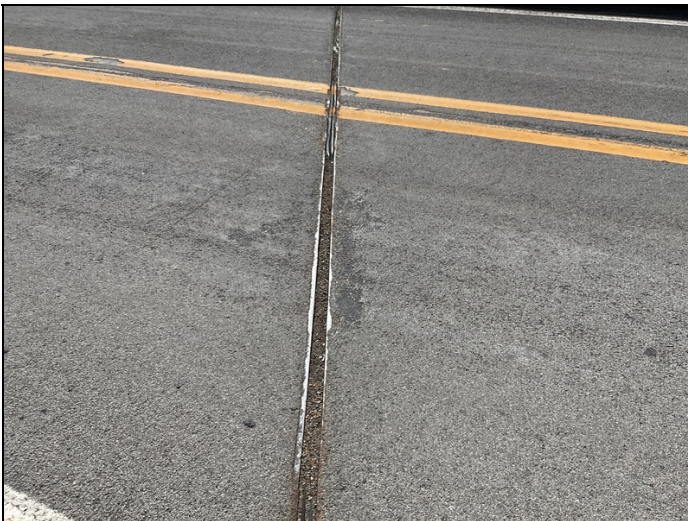
Bent 4, Compression Joint Seal: 18' of lost adhesion seal is sagging. 18LF CS3

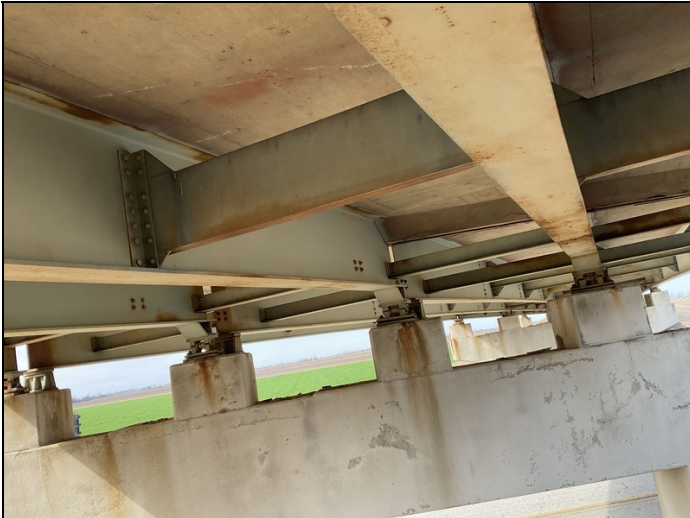
All Spans, All Girders, Full Length: Paint is discolored and oxidized with minor areas of bare steel full length.
6,445SF CS2, 6,446SF CS3, 678SF CS4

A-60 - Full Girder Painting Needed (Yes)
