Bridge 05825 Inspection Report

Route:1 Section:05 Log:13.94

Team Lead: Demetric Jones, Inspection Date: 07/14/2025

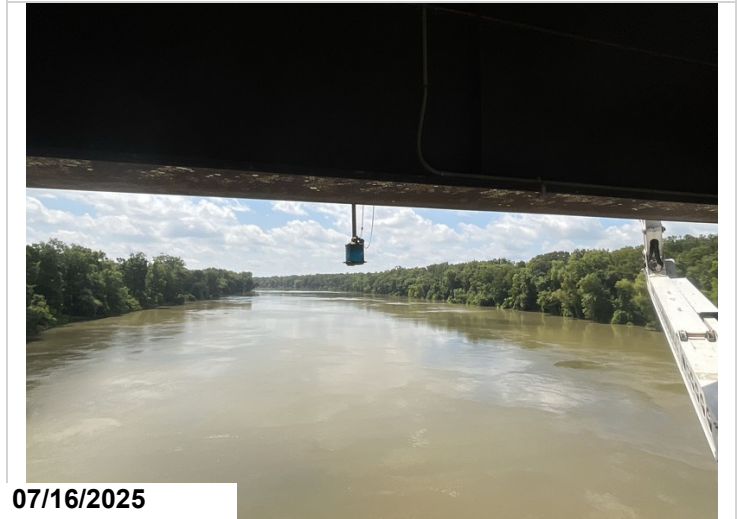
Span 7 Navigation lights right side

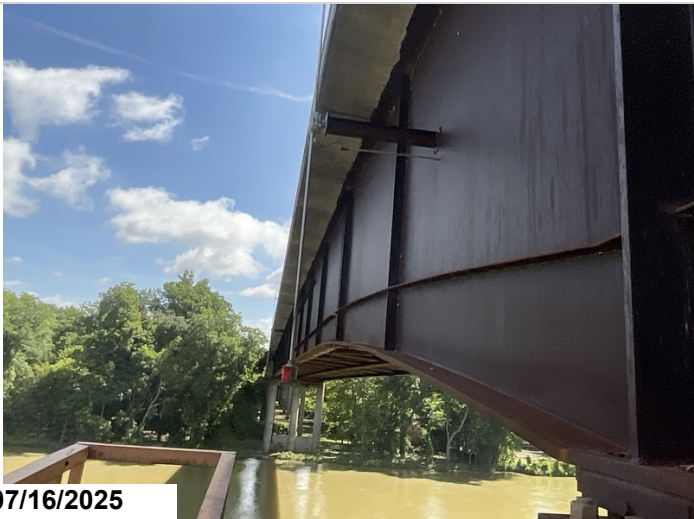
Typical navigation light

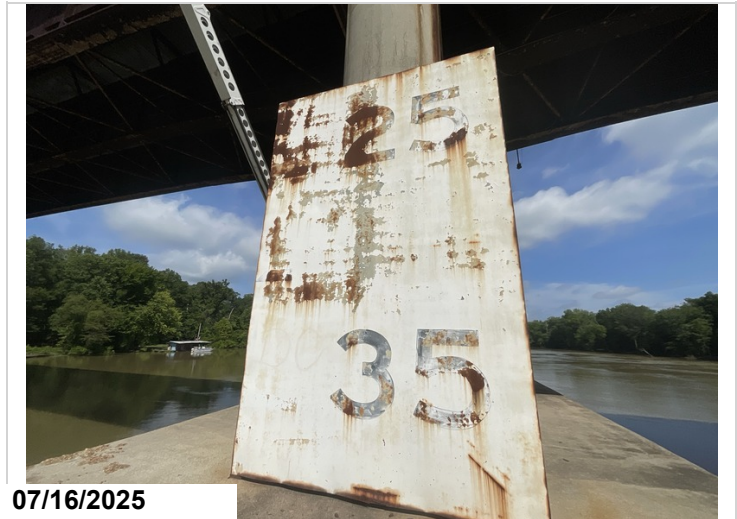
Navigation sign Right side, Bent 7

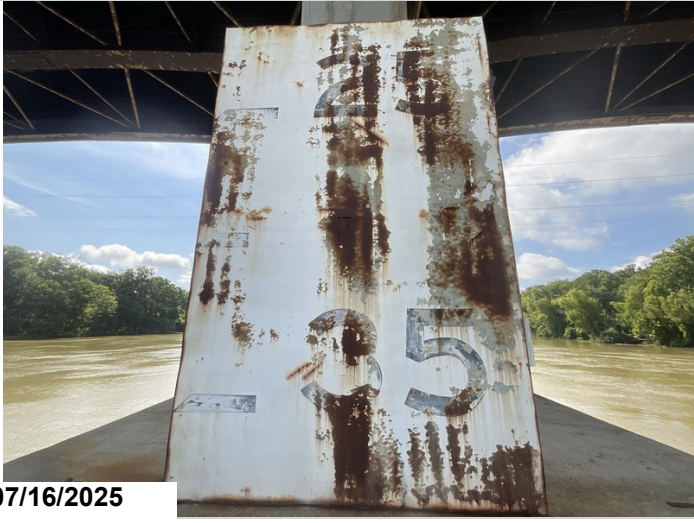
Navigation sign Left side, Bent 7

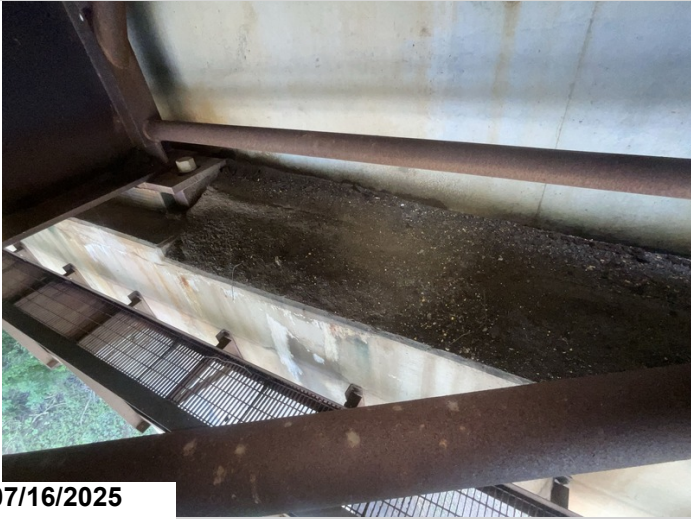
Span 7 Bent 8 cap debris buildup

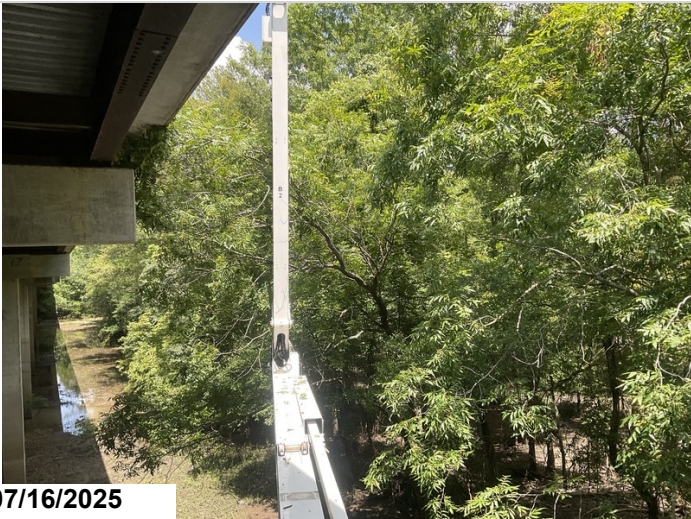
Vegetation removal

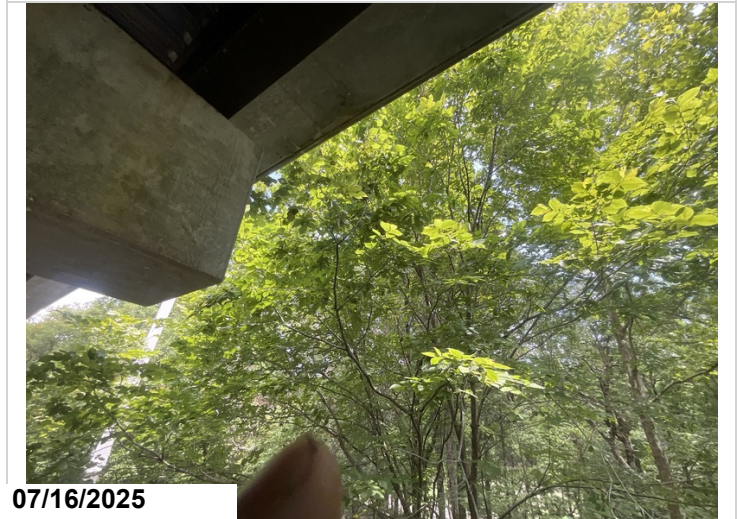
Vegetation removal

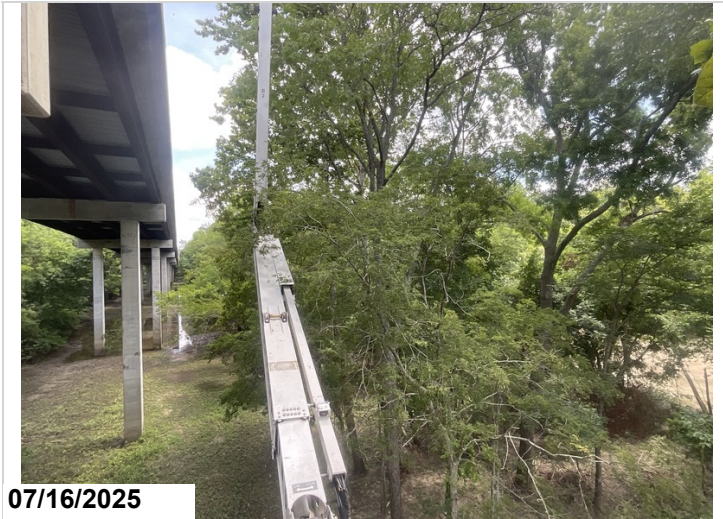
Trees interfering with inspection operation

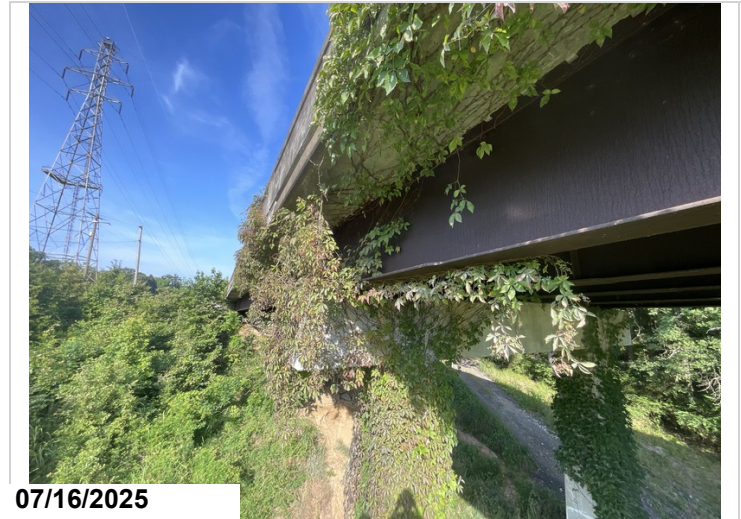
Bent 2 vegetation buildup

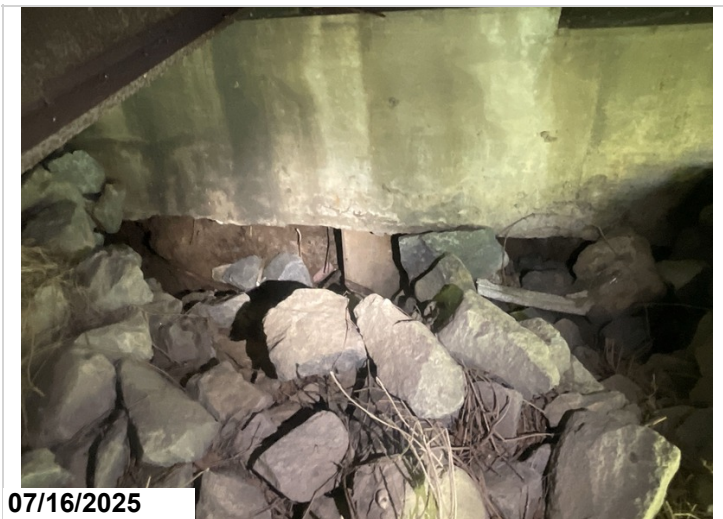
Overall, the scour condition is satisfactory, due to widespread minor erosion and isolated moderate undermining of abutment 23 under girder 4 exposing a pile.

Abutment 23, undermining under girder 4, full depth, 5 feet wide.

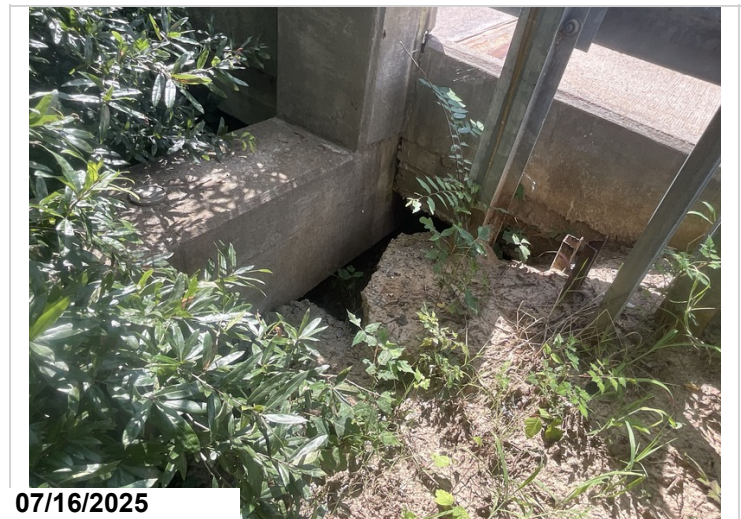
Abutment 23, right, undermining of approach slab.

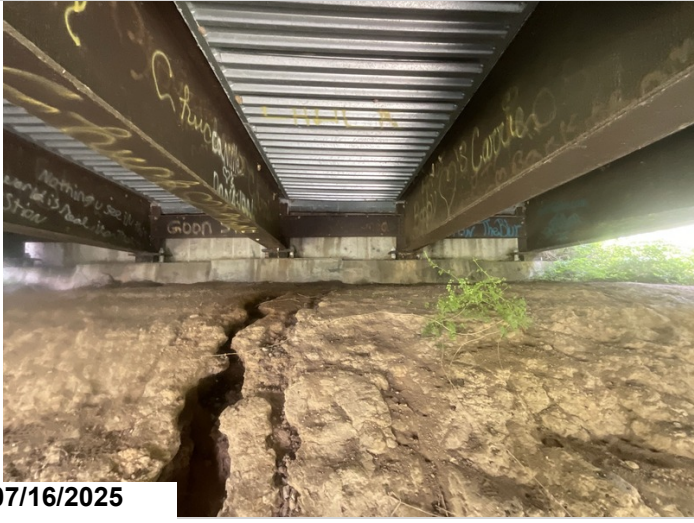
Abutment 1, erosion in the embankment under bay 2 and 3

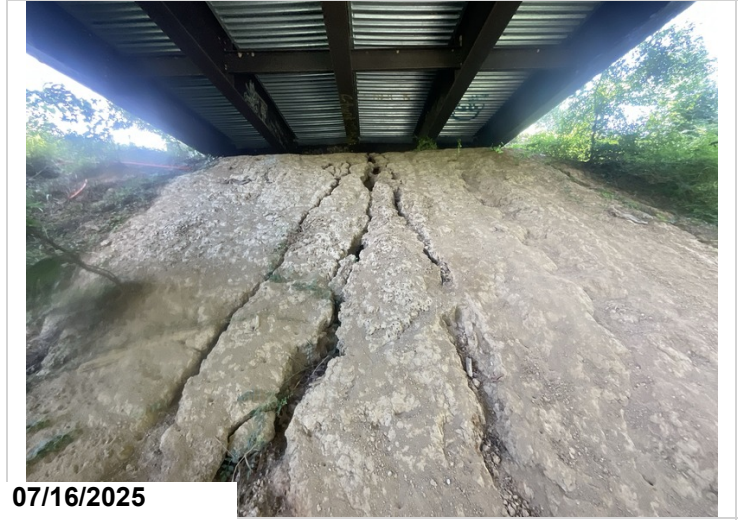
Abutment 1, erosion in the embankment under bay 2 and 3

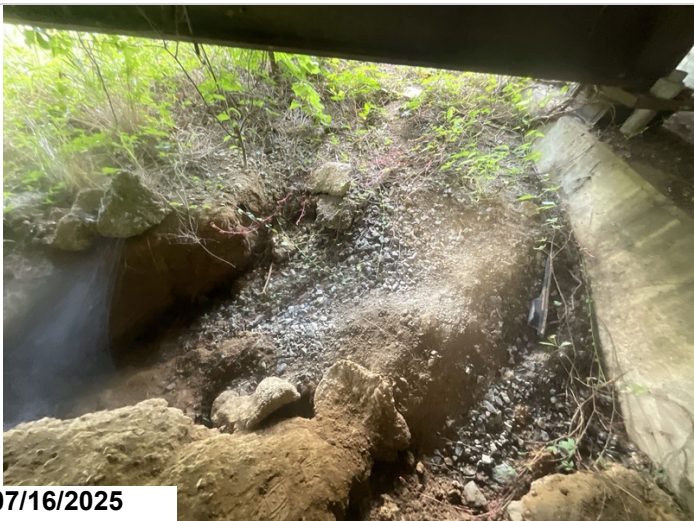
Abutment 1, under girder 5, erosion.

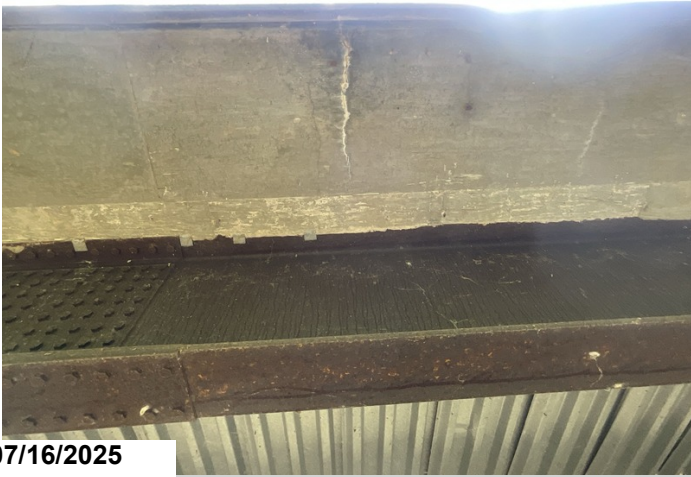
Span 16, left overhang, cracking with efflorescence, 14LF CS2.
Span 16, right overhang, cracking with efflorescence, 2LF CS2.

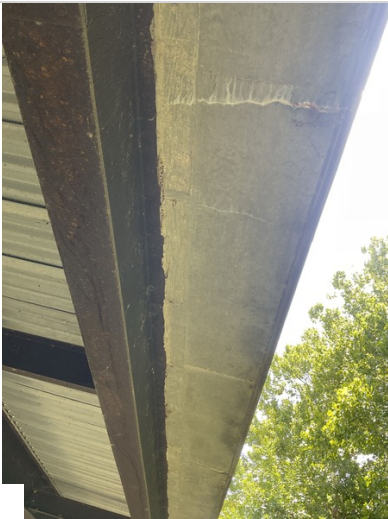
Span 15, left overhang, cracking with efflorescence, 10SF CS2.
Span 15, right overhang, cracking with efflorescence, 4SF CS2.

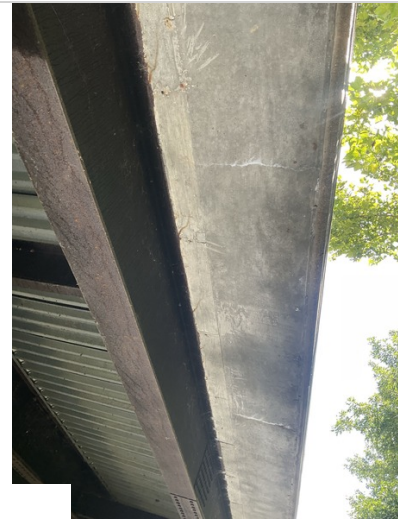
Span 14, left overhang, spalling, 1LF CS3, cracking with efflorescence, 8SF, CS2.
Span 14, right overhang, cracking with efflorescence, 4SF, CS2.

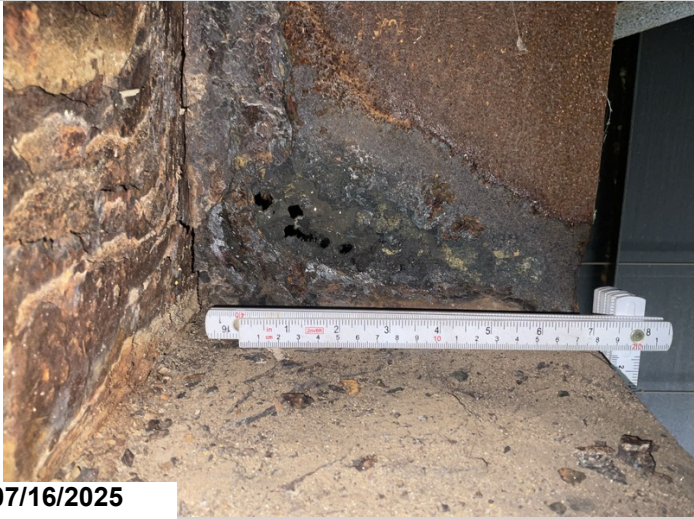
Overall, the superstructure is in satisfactory condition, due to some active corrosion around the joints and moderate corrosion to the girder ends at Bent 8, span 8.

Bent 8, Span 8, girder 3, beam end section loss up to 1/2" to web 3LF CS3
1"x3" hole

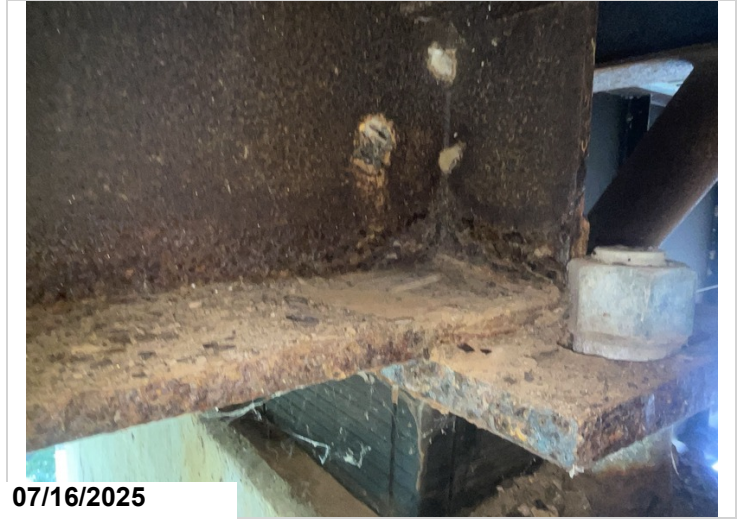
Bent 8, Span 8, typical girder in front of bearing stiffener.

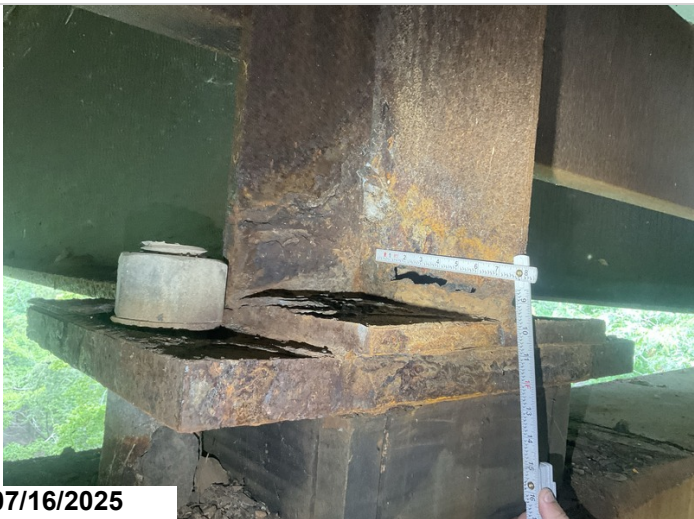
Bent 8, Span 8, girder 4, section loss beam end hole 1" x5"
hole 1LF CS3.

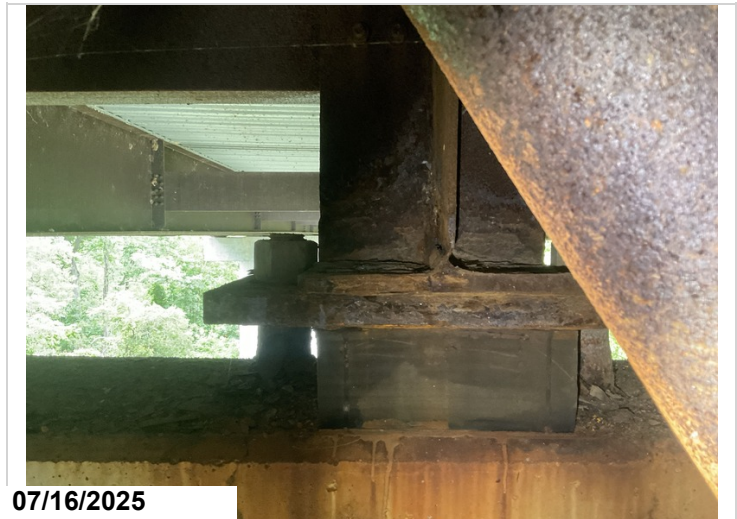
Bent 8, Span 8, girder 4, section loss beam end hole 1" x5"
hole 1LF CS3.

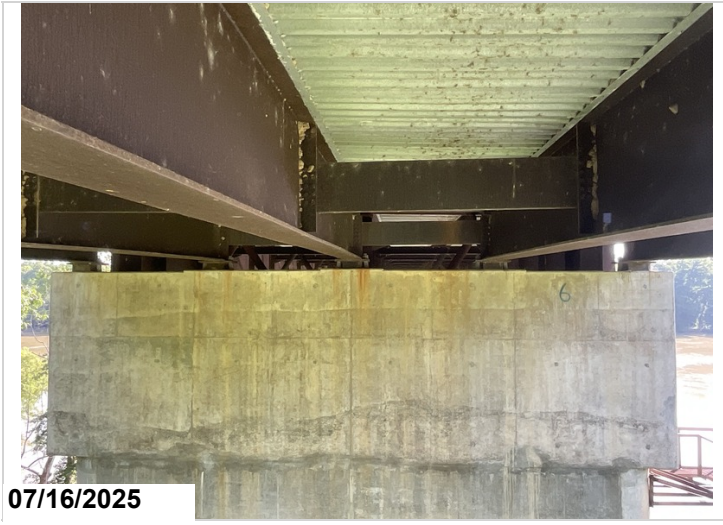
Bent 6 overview of bearing out of plane distortion.

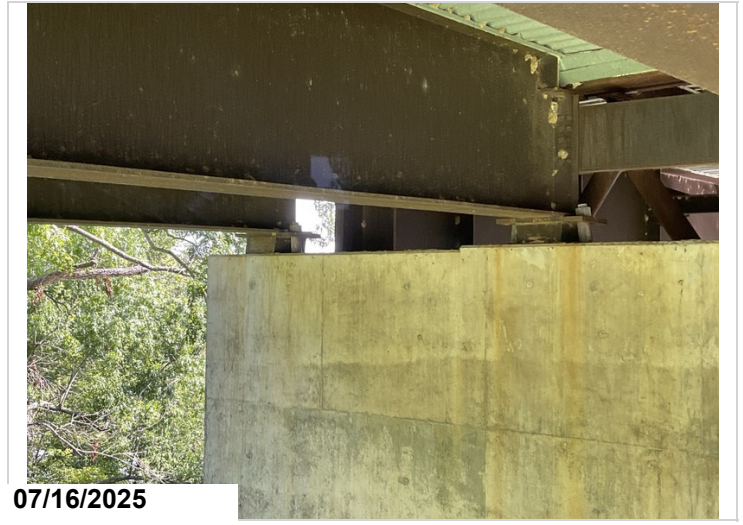
Bent 6 girder 1 out of plane distortion.

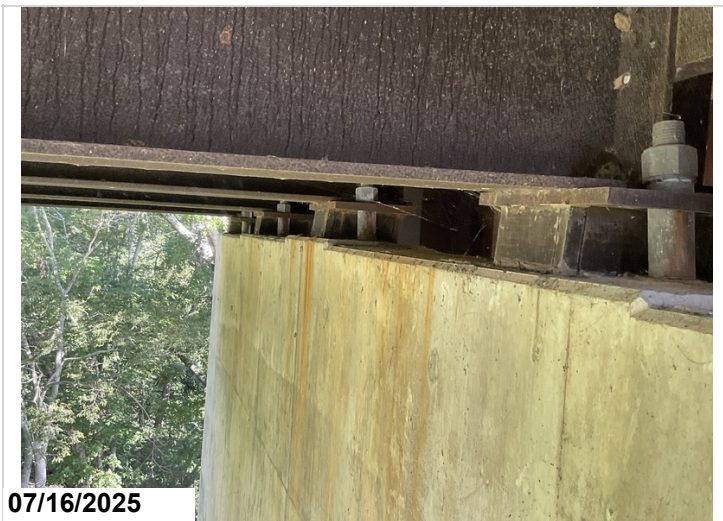
Bent 6 girder bearing distortion.

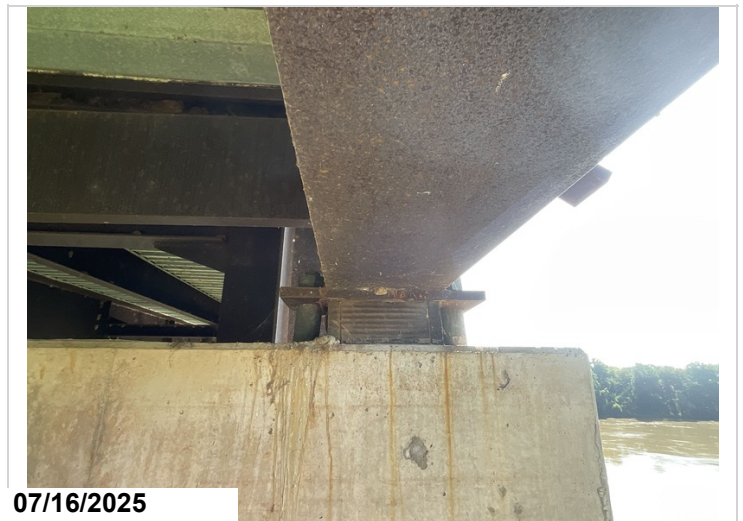
Bent 6 girder 5 bearing distortion.

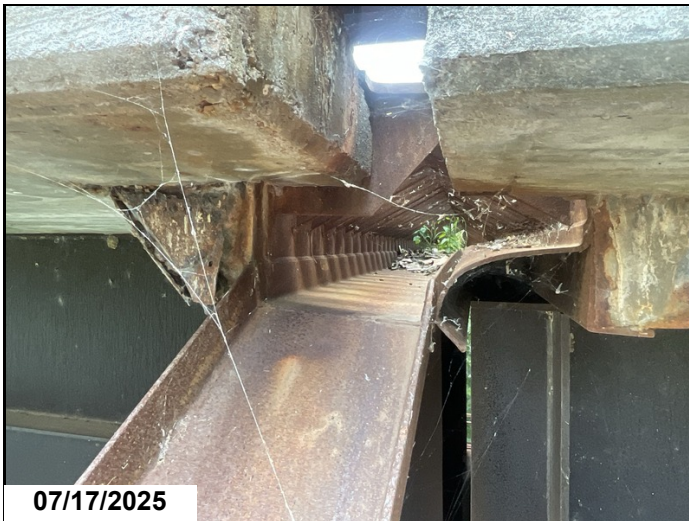
Corrosion caused by failed joint seal allowing water and material onto girder and cap, issues will continue without repair of joint seal as well.

Bent 8, Joint seal failure

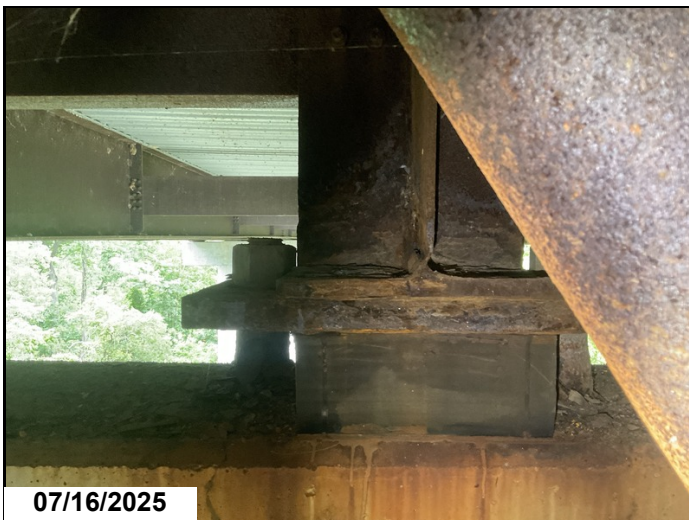
SUPERSTRUCTURE: - Bent 8, ahead girders 2, 3, and 4 significant corrosion around bearing stiffeners with holes in web in ends of girders 3 and 4. Girder 4 has started crushing due to section loss.

Span 7, Bent 8, Girder 4, section loss beam end hole with crushing action 1" x5" hole 1LF CS3.(CF)

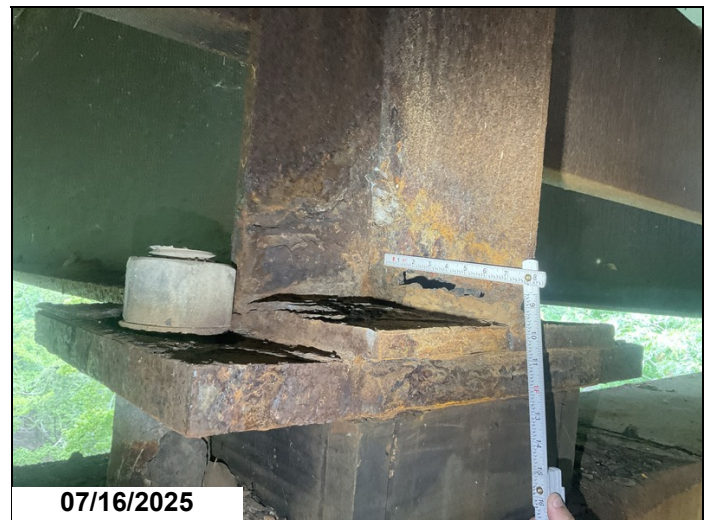
Span 7, Bent 8, Girder 4, section loss beam end hole 1" x5" hole 1LF CS3. Photo 2

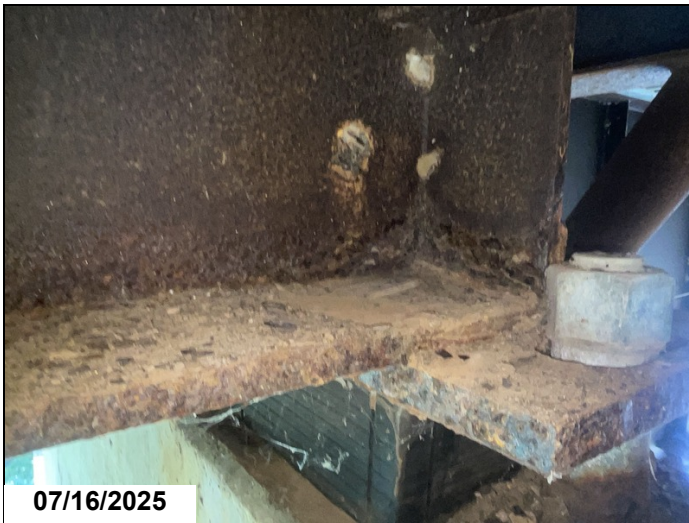
Span 7, Bent 8, typical girders in front of bearing stiffener.

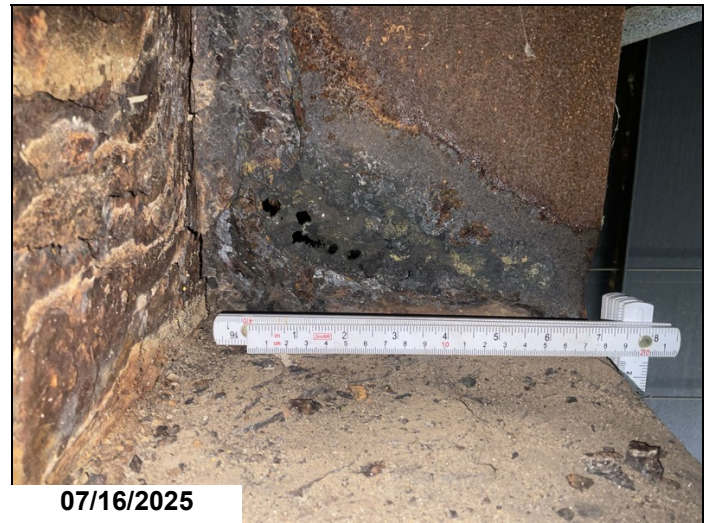
Span 7, Bent 8, girder 3, beam end with crushing action section loss up to 1/2" to web 3LF CS3 1"x3" hole.(CF)

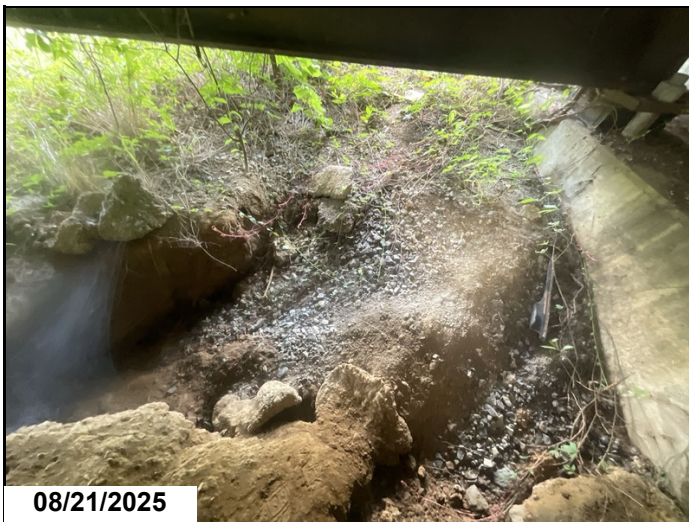
Abutment 1, under girder 5, erosion.

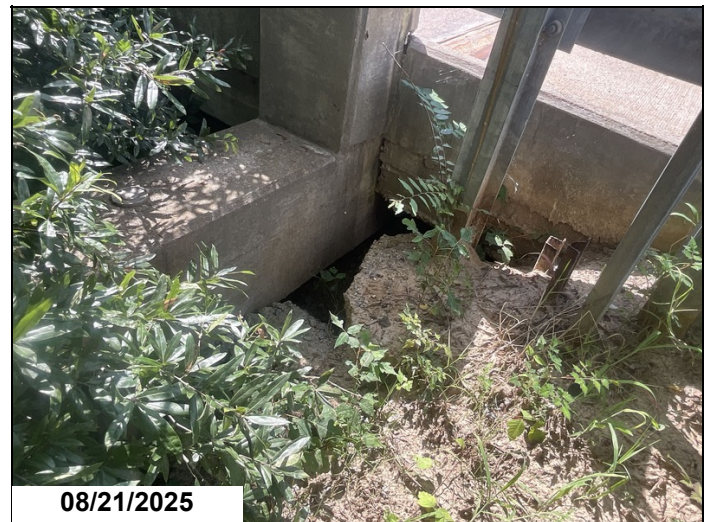
Abutment 23, right, undermining of approach slab.

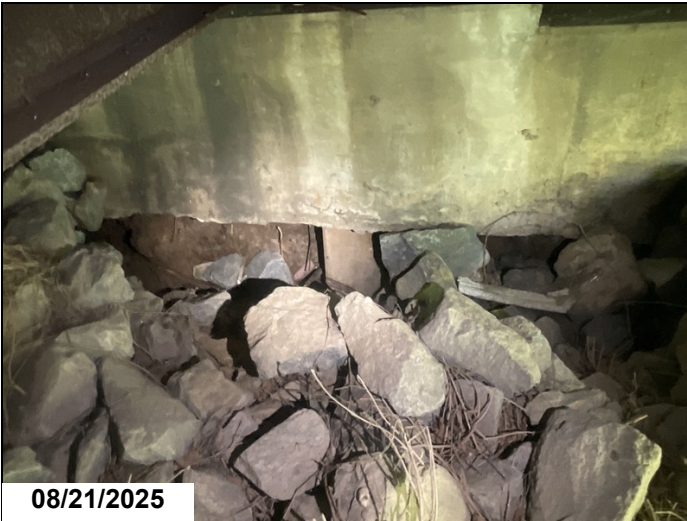
Abutment 23, undermining under girder 4, full depth, 5 feet wide.

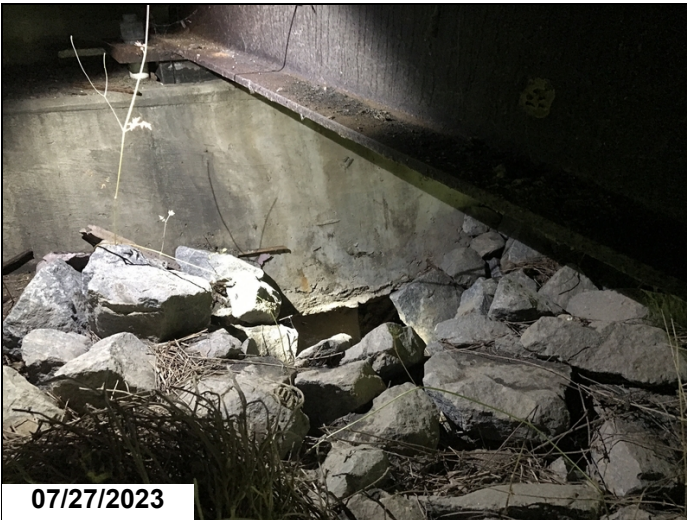
Bent 23, adjacent to girder 5, undermining 3' wide by 2' deep, exposing a pile.

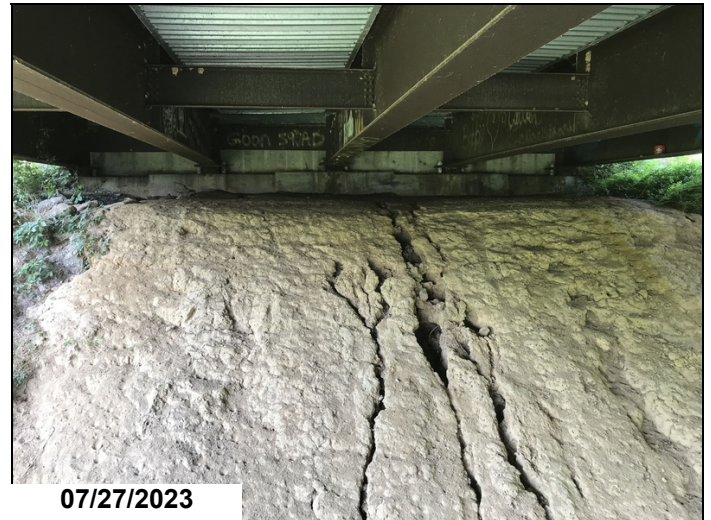
Bent 1, overall view.

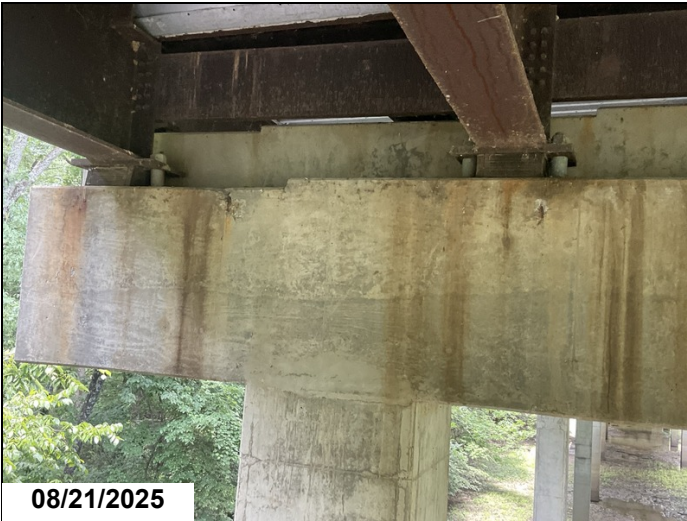
Bent 13, back, pier cap, exposed rebar, 2LF CS2, cracking with efflorescence, 1LF CS2.

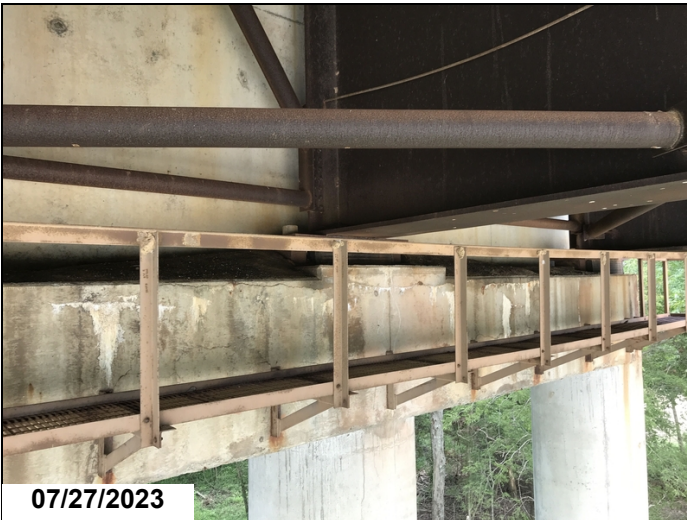
Bent 8, back, 15' of cracking with cs3 efflorescence. 7' of cs2 cracking.

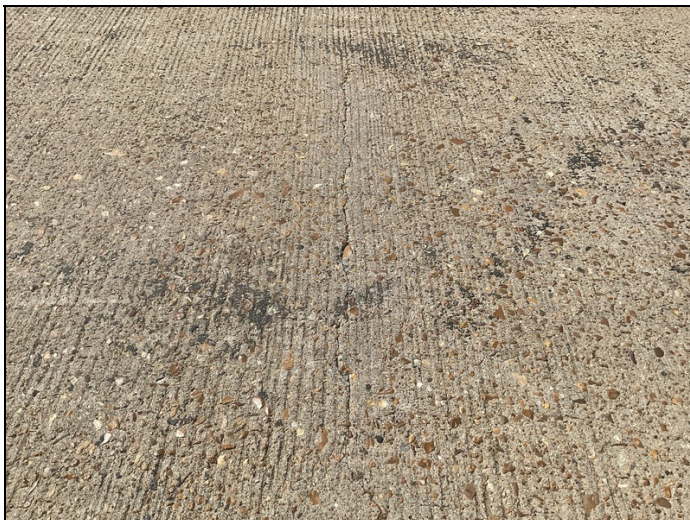
Unsealed moderate width cracks longitudinal and transverse 920 SF in CS2.

A-54 - Sealable Deck Cracks (Yes)

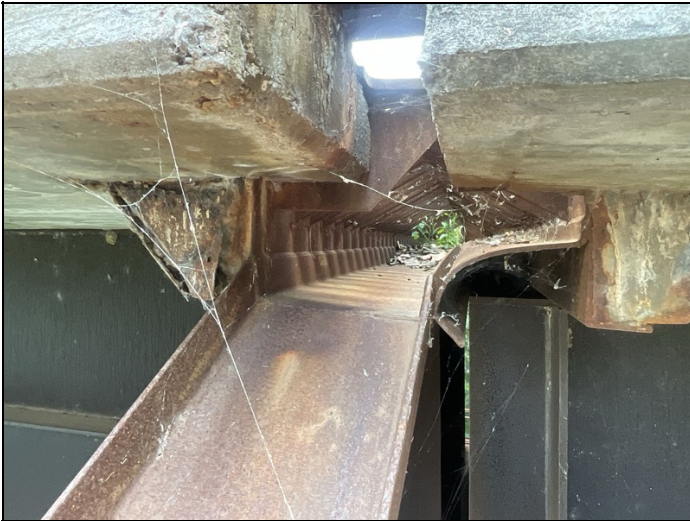
A-56 - Joint Cleaning/Flushing Needed (Yes)
Joints at bents 6, 8, and 13 have debris impaction.

Bent 8 debris impaction

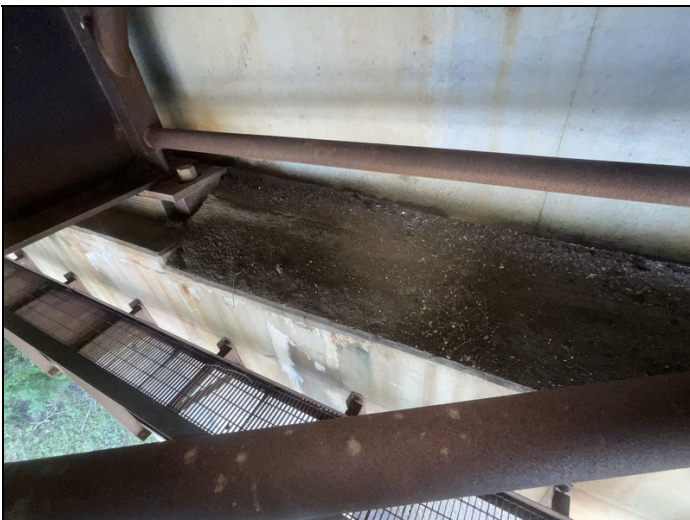
A-58 - Cap Cleaning/Flushing Needed (Yes)
Bents 6, 8, and 13 have debris build-up on the caps.

Span 7 Bent 8 cap debris buildup

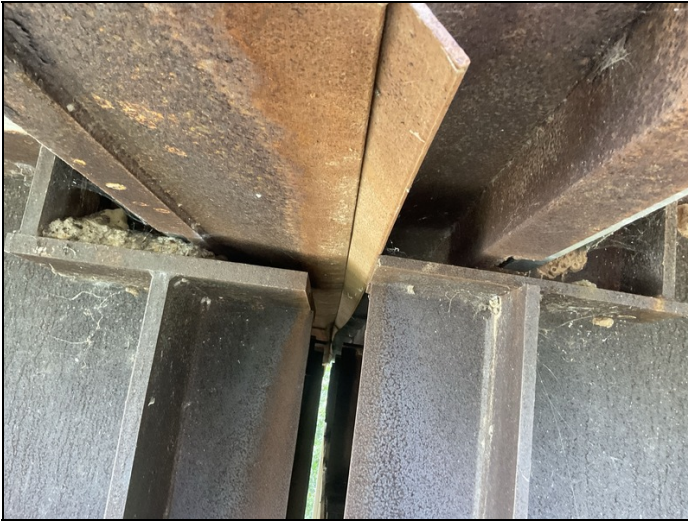
Joint at bent 8, 3 broken fingers in center of northbound lane.

Joint at bent 8, wiper plate distortion.

Bent 8 joint seal failure.

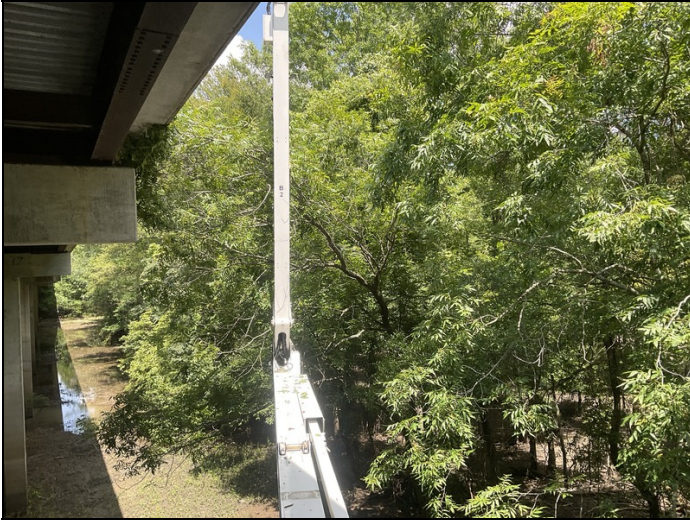
Bents 8 - 23, vegetation growth on both the left and right sides of the bridge.
Spans 13 - 16, right side, thickest vegetation growth.
Vegetation growth onto bents 2 and 22.

Vegetation removal

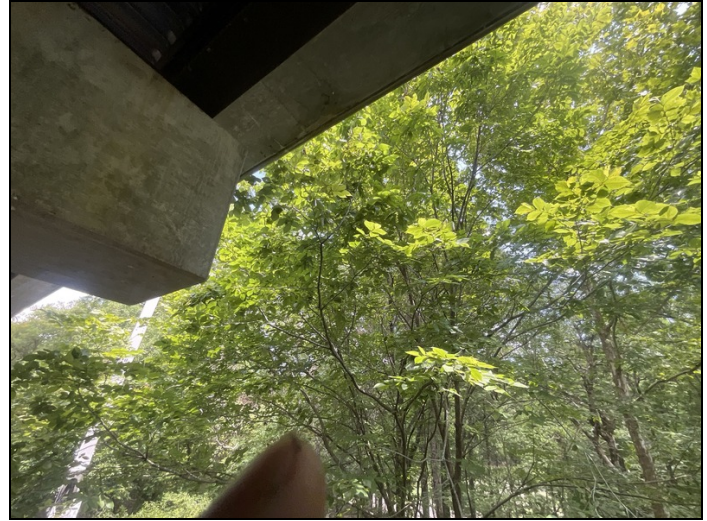
Vegetation removal

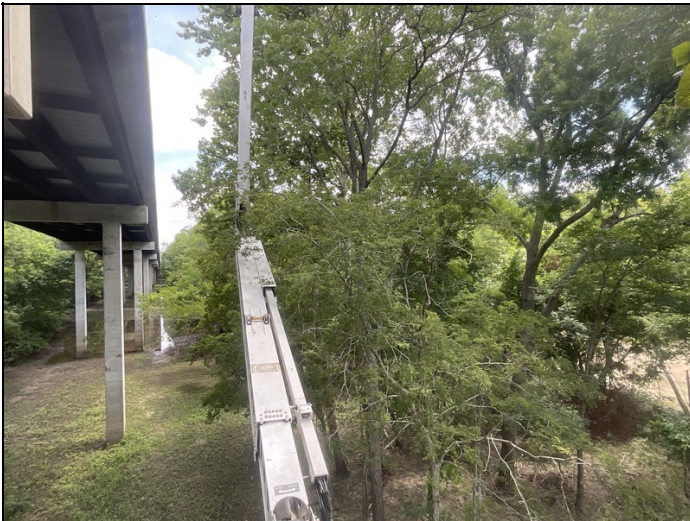
Trees interfering with inspection operation

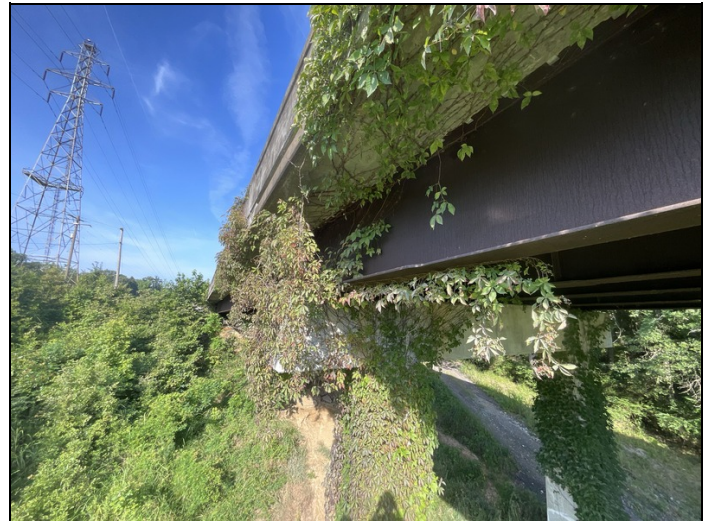
Bent 2 vegetation buildup
