Asset #05823(Routine)

US 67-SEC.01-18.51 over RED RIVER

Location: .2 W JCT SH 355

Team Lead: Jared Kegley, Inspection Date: 08/10/2023

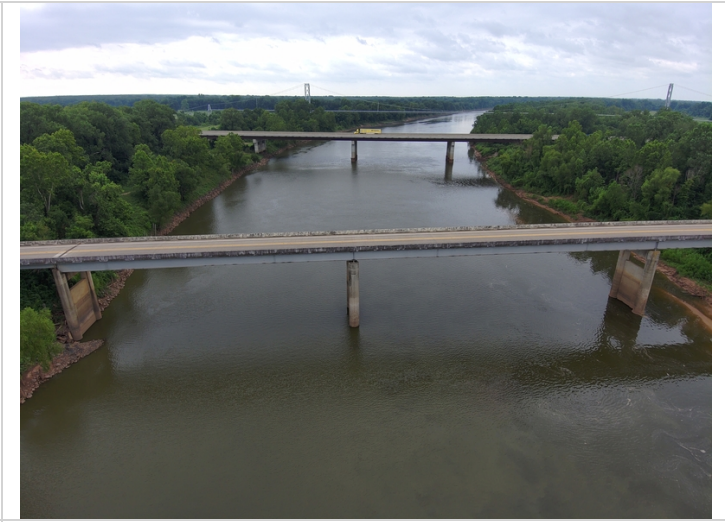
Channel overall

Overall, the channel is in good condition. The upstream channel is well aligned with the substructure units. There was timber debris on the piers that does not adversely affect flow through the channel. The south bank consists of sandbars at the shoreline and is well vegetated on the remainder of the slope. The north bank is lined with riprap at the shoreline and is well vegetated on the remainder of the slope.

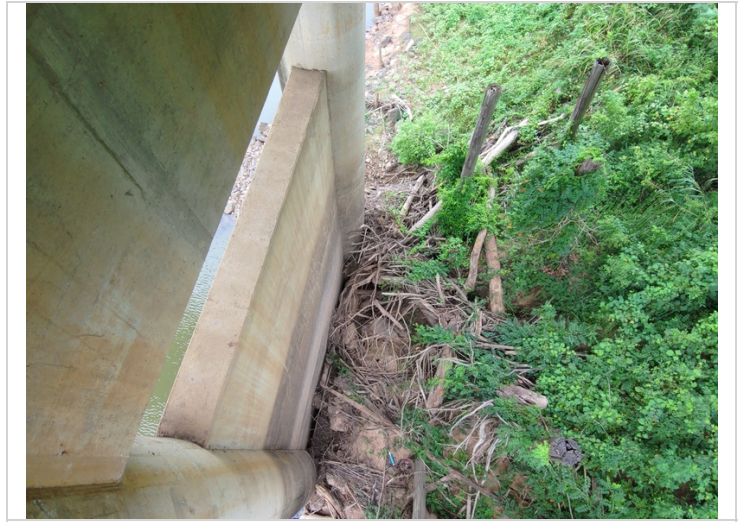
Debris buildup behind pier 7

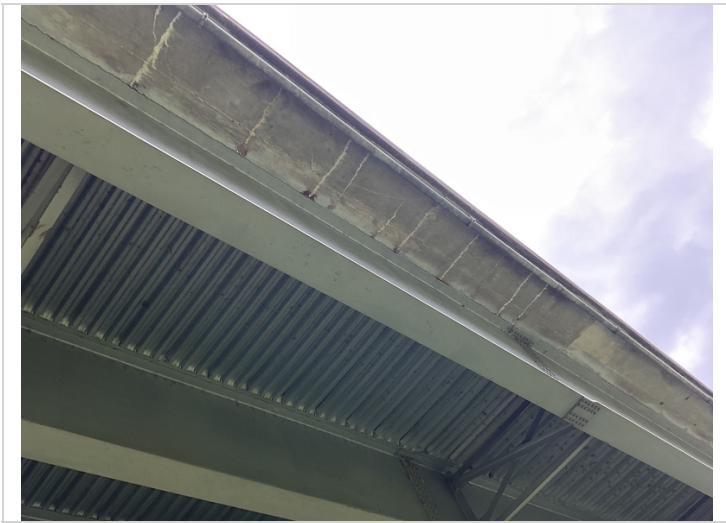
Utility pipe on left side deck overhang

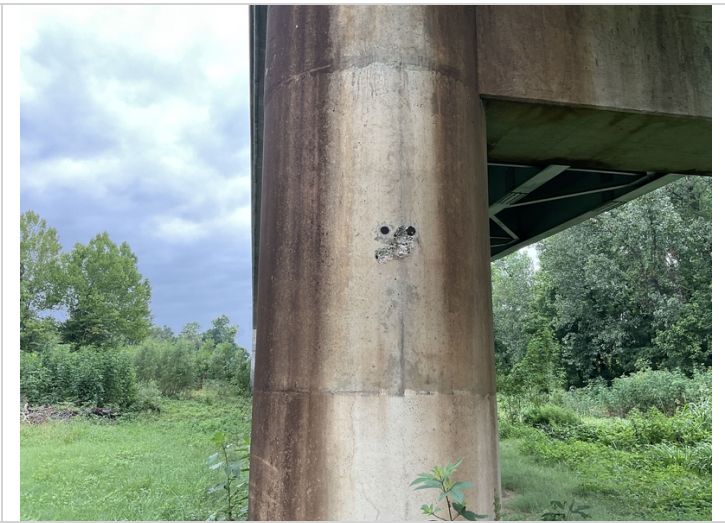
Overall the substructure units are in good condition with minor defects located throughout. These defects include scaling on the columns and scaling, spalls, and exposed rebar on the pier walls. There was also corrosion on the steel casings around the columns, which are incidental to the element. All defects are quantified in the element level portion of this report.

Pier 3 column 4 Delam

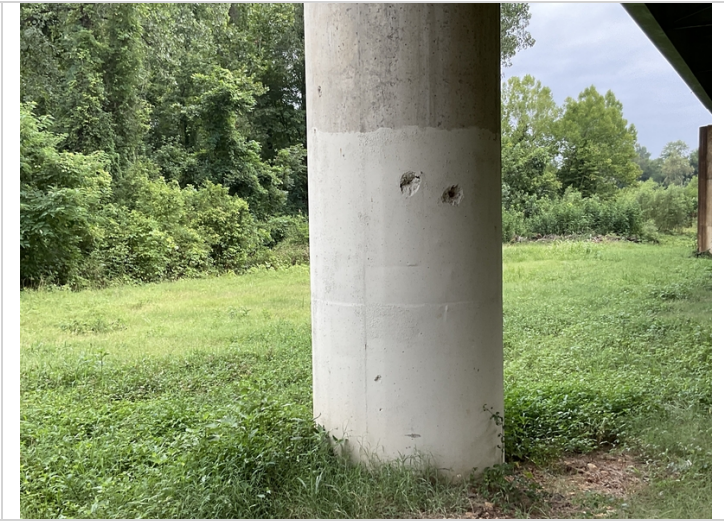
Pier 2 column 1 delams

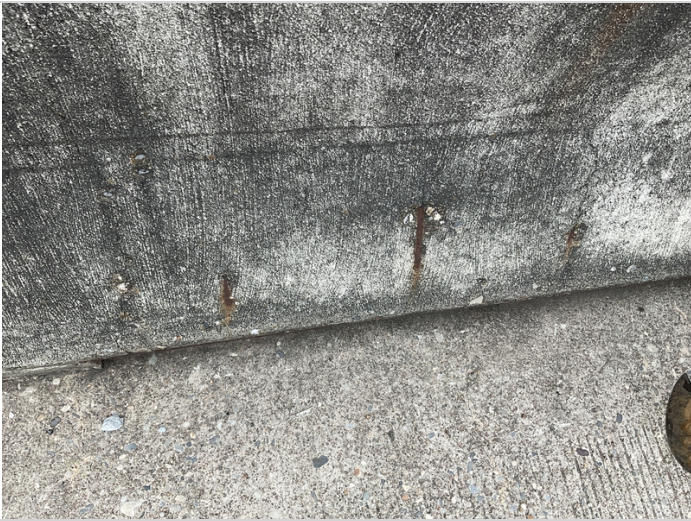
(331) Parapet wall has cracking in various locations some with efflorescence, spalling and rebar exposed is occurring in various locations.

Rebar exposed in various locations of parapet wall

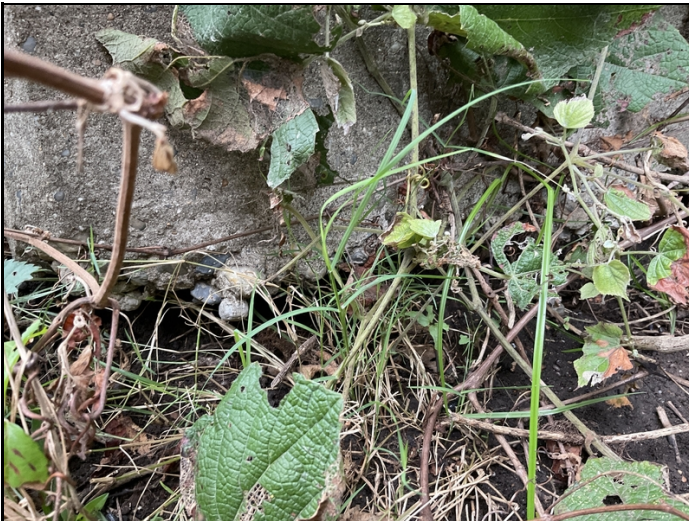
8/23 updated to a C and updated photos added erosion at bent 1

Erosion at bent 1 right side

Maintenance Crew will handle.

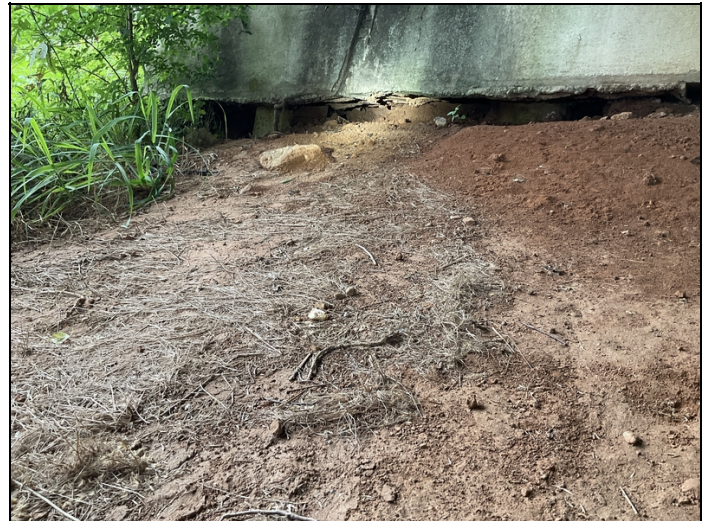
Updated erosion on bent 10

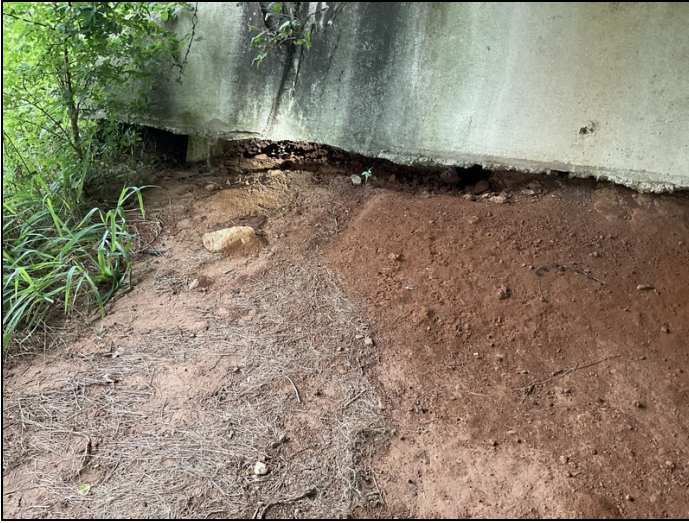
Updated erosion on bent 10

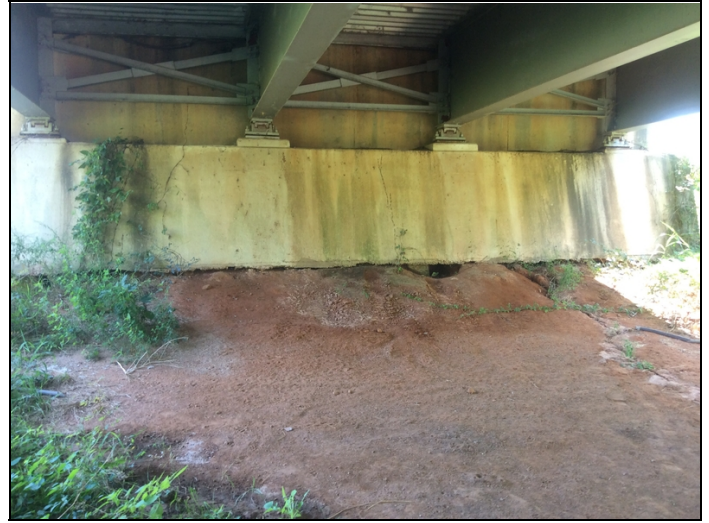
Bent 10 erosion under cap. Piling exposed

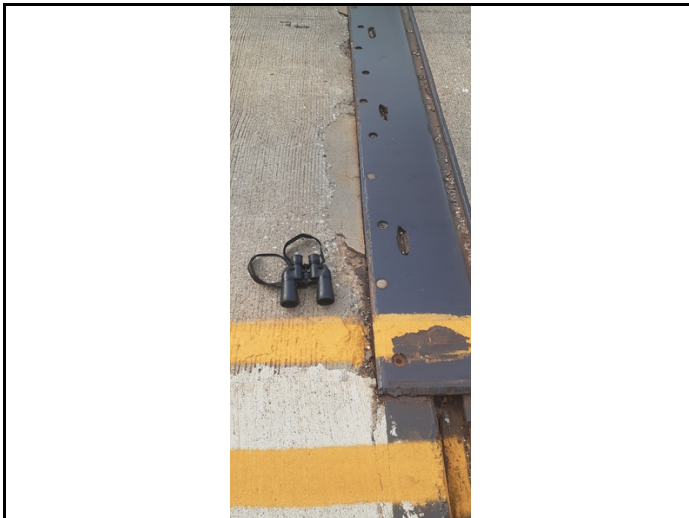
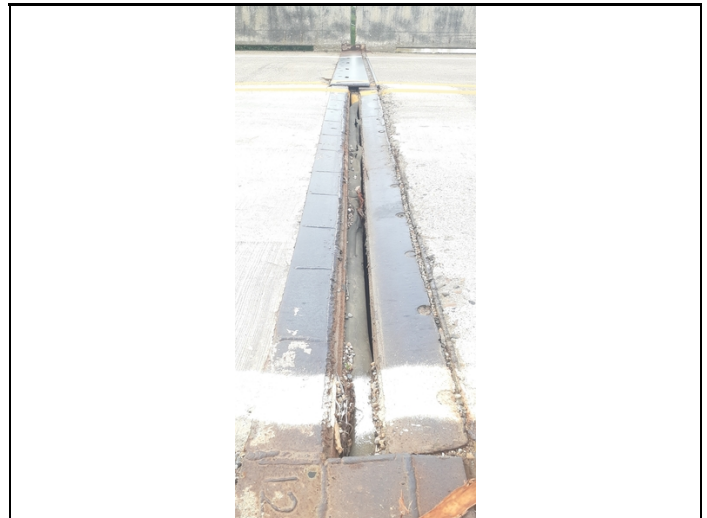
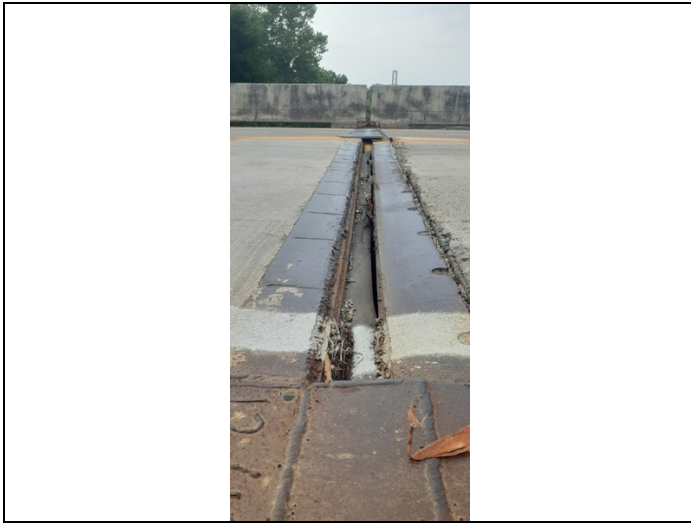
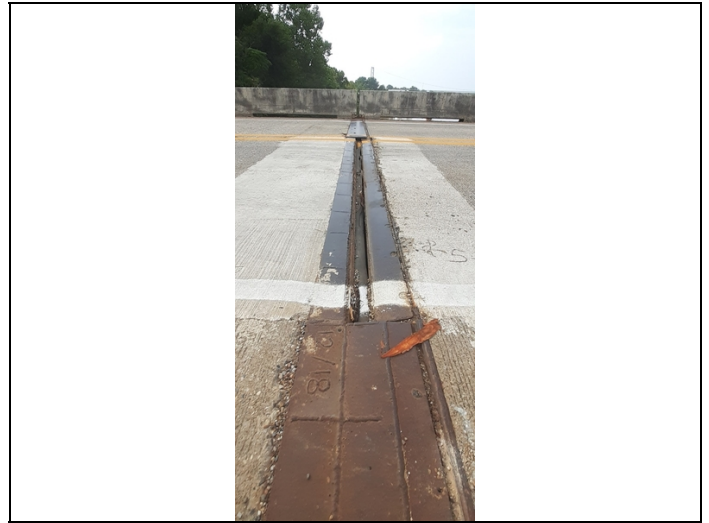
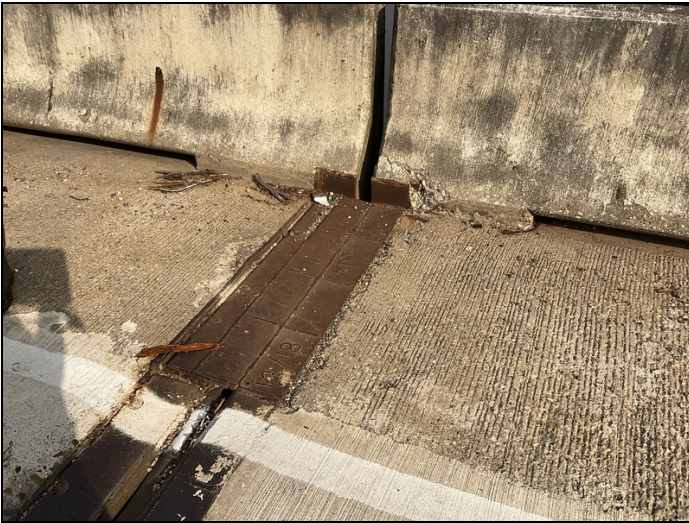
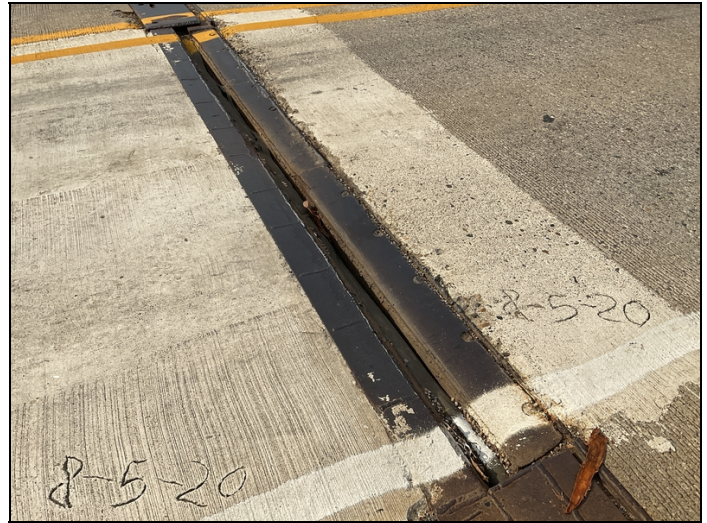
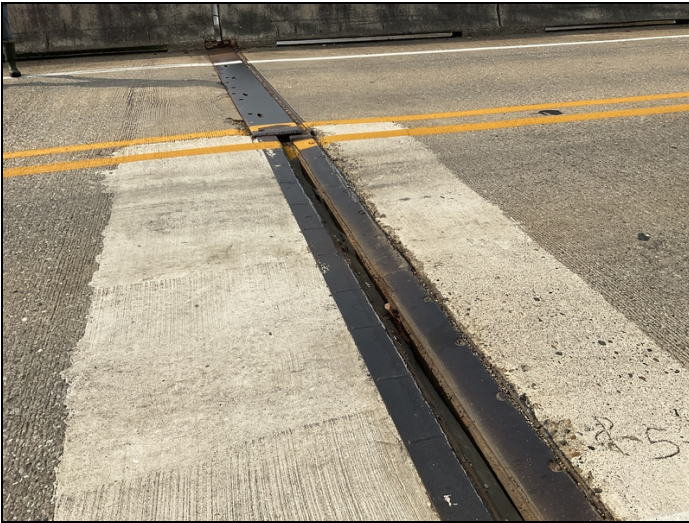
Joint Bent 8

Joints leaking beginning and end of bridge causing rust on bearings.

new photo taken in 08/2021 of bent 8 joint has some repairs done. part of top plate of joint has been taken out . Joint needs sealant added to prevent water from flowing through joint and on the bearings

some small spalls at joint line in concrete. .

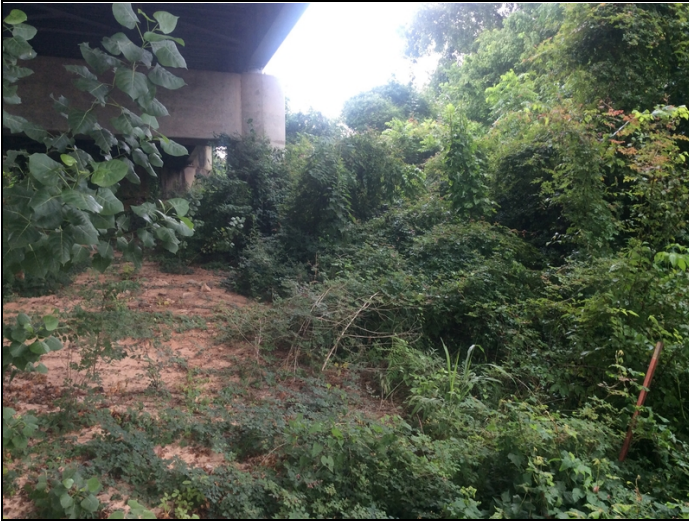
Vegetation growing along end of bridge right and left side.

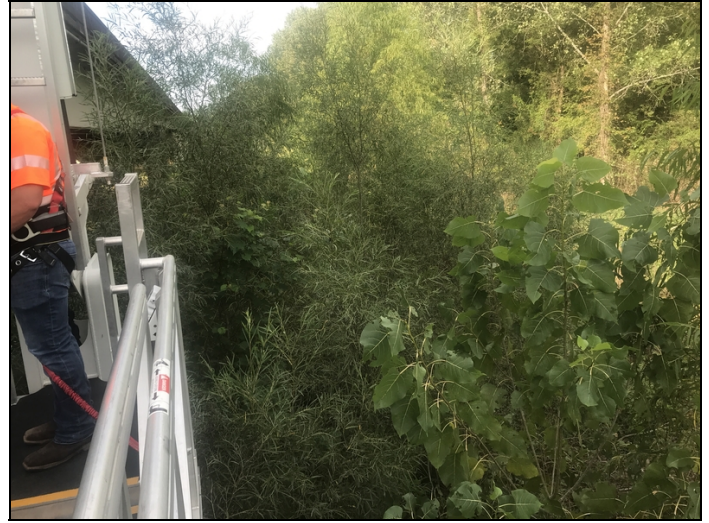
Trees need cut span 4 snoopers hitting trees at inspection

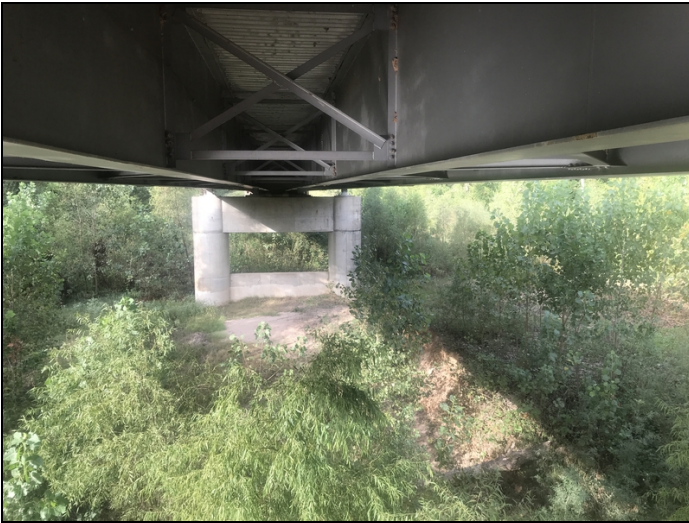
Trees growing

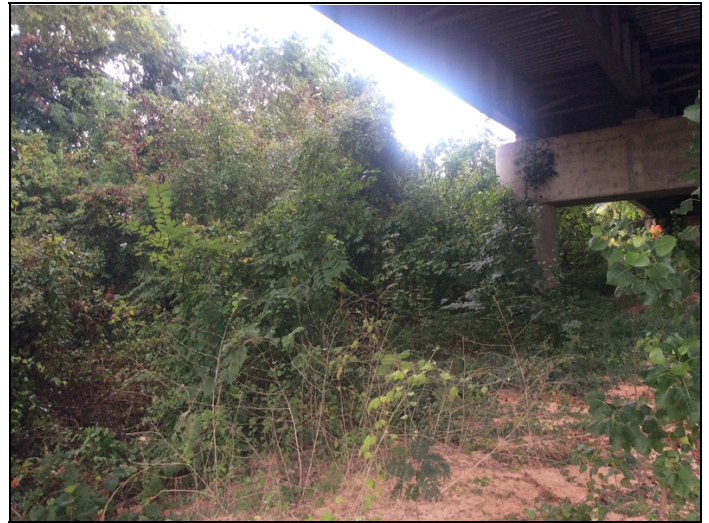
Vegetation growing along end of bridge right and left side.

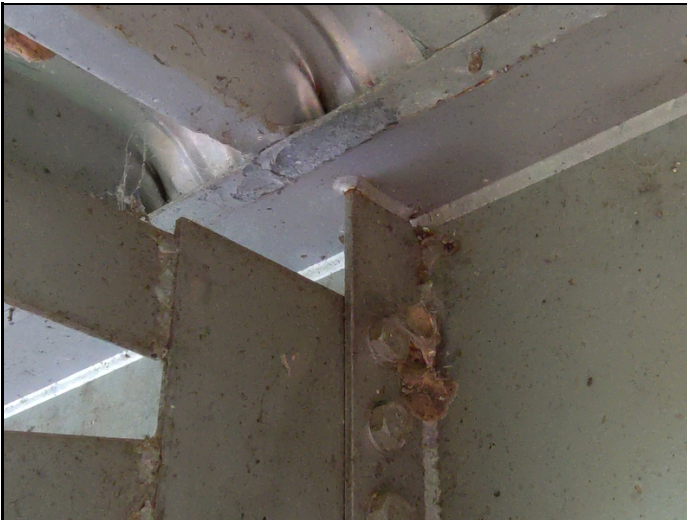
MINOR CRACK IN WELD @ TOP OF WEB STIFFNER @ CROSS BRACES

Span 9 brace weld between beams 1 and 2
