Asset #03749(Routine)

SH 160 SEC.02-9.00 over BODCAW CREEK

Location: 1.0 MI W JCT SH 160 & 53

Team Lead: John King Inspection Date: 05/15/2023

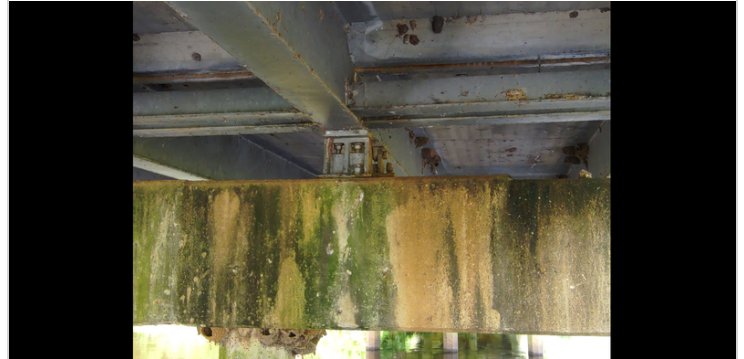
2023 drone photo bent 10

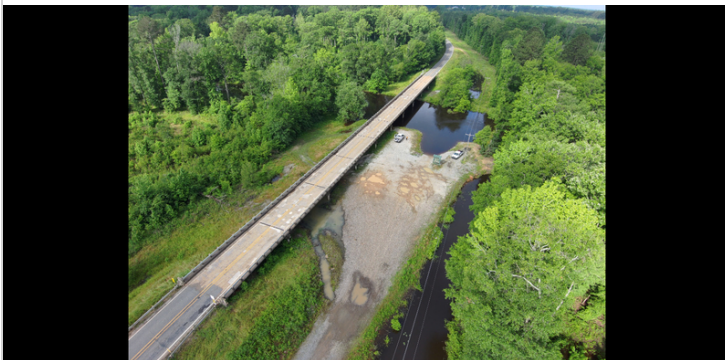
(313) Corrosion beginning on fixed bearings various locations.

drone photo of fix bearings

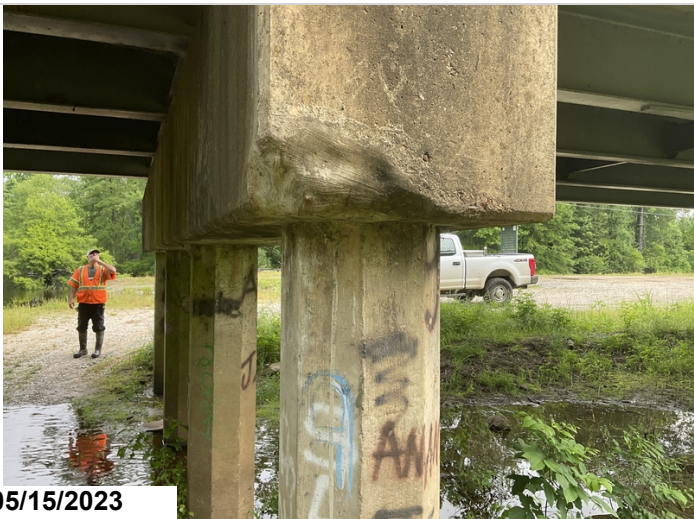
Bent 6 old patch

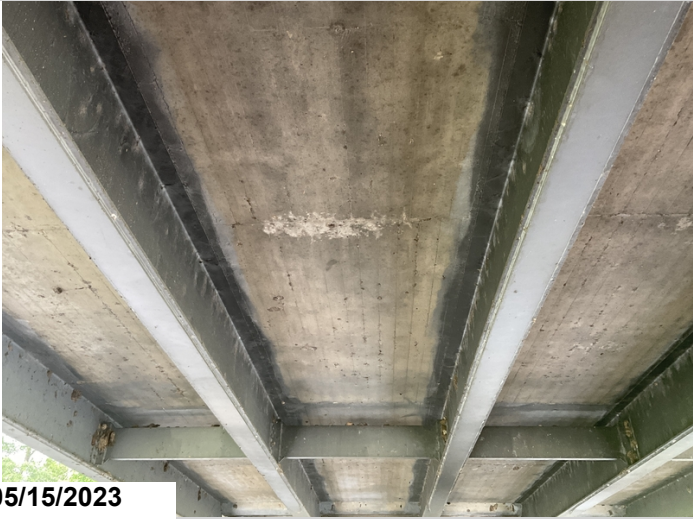
Span 5 bay 3 efflorescence

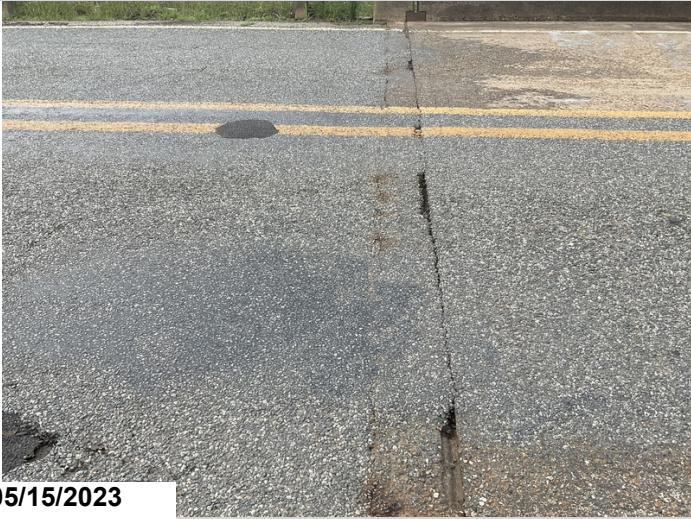
(303) Beginning of bridge debris impaction							
End of bridge debris impaction							
311	Movable Bearing	EA	45	0	25	20	0
1000	Corrosion	EA	45	0	25	20	0

End of bridge debris impaction

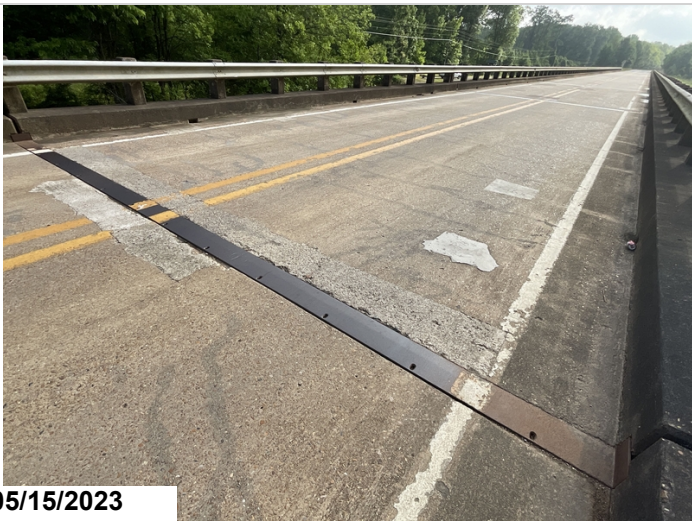
Bridge deck in poor condition due to spalls -patchwork-rebar exposed -cracking.

Old patches all across deck surfaces spanning all spans in various locations and sizes

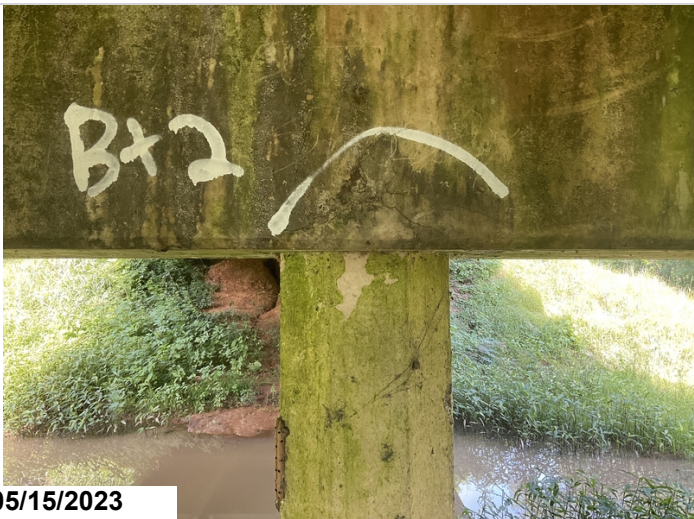
(234) Bent 2 cap Delam span 2 side.							
Bent 6 old patch.							
Map like cracking in bent 8 cap span 8 side.							
Map like cracking bent 10 span 9 side.							
303	Assembly Joint with Seal	LF	264	216	48	0	0
2350	Debris Impaction	LF	48	0	48	0	0

Bent 2 cap delam span 2 side

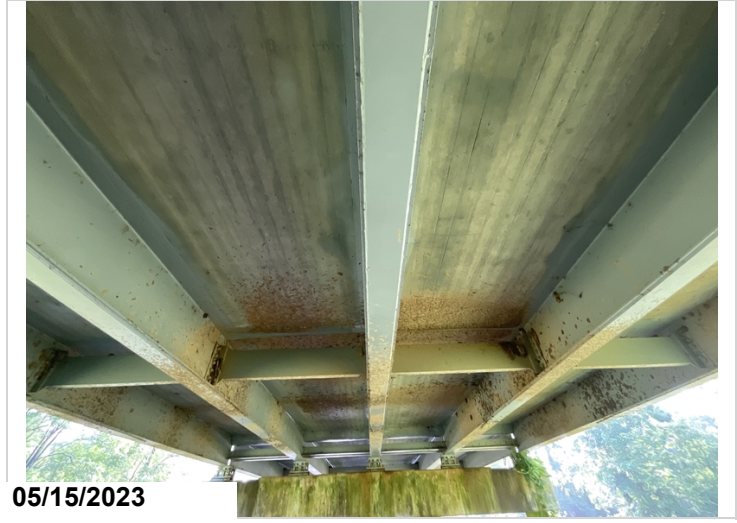
Underside of deck

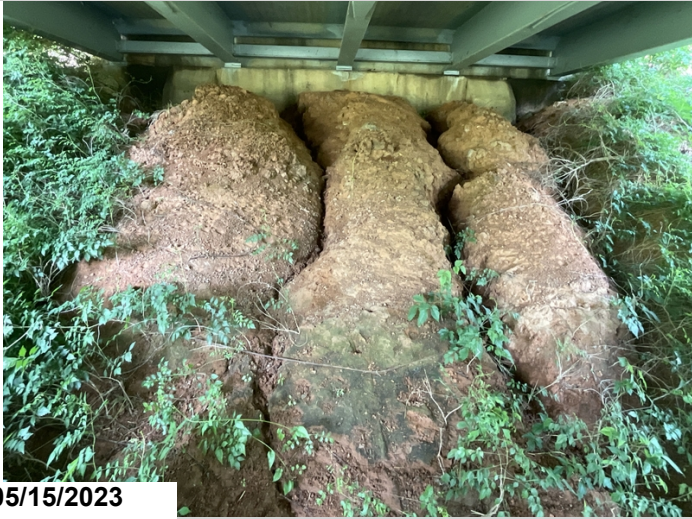
Erosion at bent 1

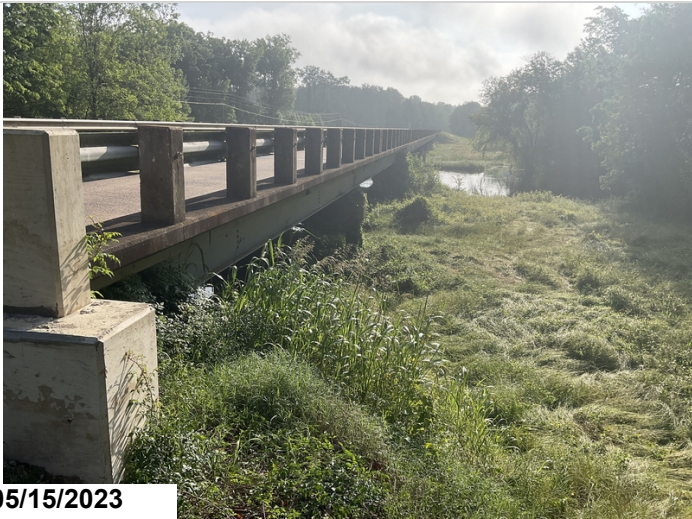
Elevation

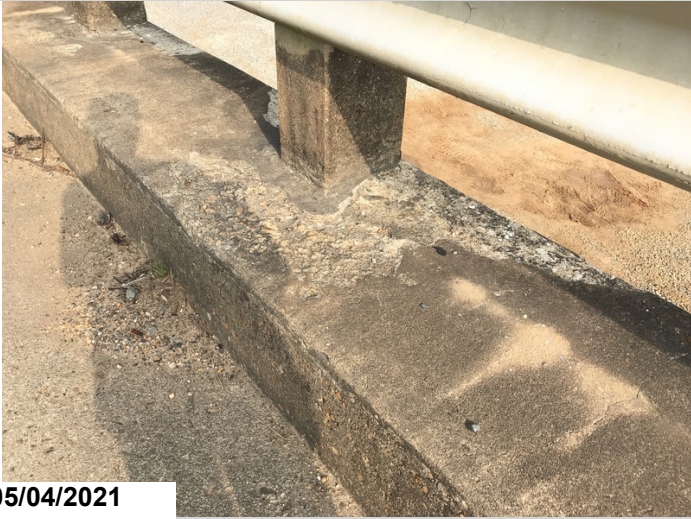
Large Delam right side curb

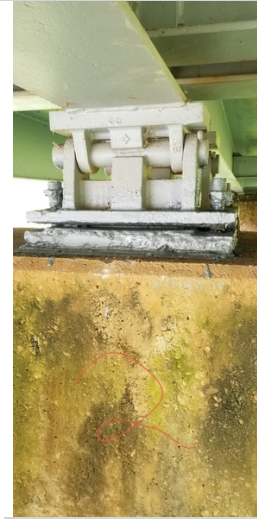
(311) Bearing at bent 10 left outer side span 9 side has movement in it when heavy loads are present.							
Movable bearings are beginning to corrode at all bents.							
(1000-311) bearings at bent 10 beams 2,3,4 shims were added and painted							
313	Fixed Bearing	EA	55	25	30	0	0
1000	Corrosion	EA	30	0	30	0	0

bearings at bent 10 beams 2,3,4 shims were added and painted

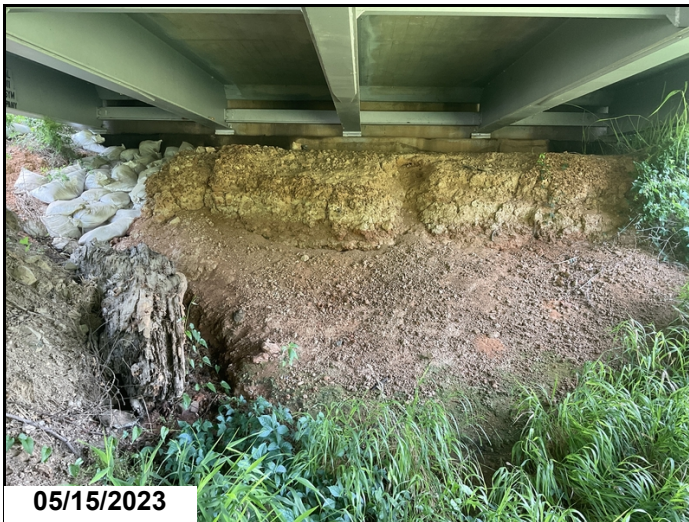
reopened to set to monitor. added bent 11 erosion.
NOTE!!!! LARGE BEEHIVES IN GROUND AT BENTS 1 AND 11!!!!

Erosion bent 11
