**Bridge #01196(Routine)**  
**US 71 B-Washington over Spring Creek**  
**Location: 0.89 MI S OF BENTON CO LN**

**Team Lead: Jacob Turner Inspection Date: September 30, 2021**

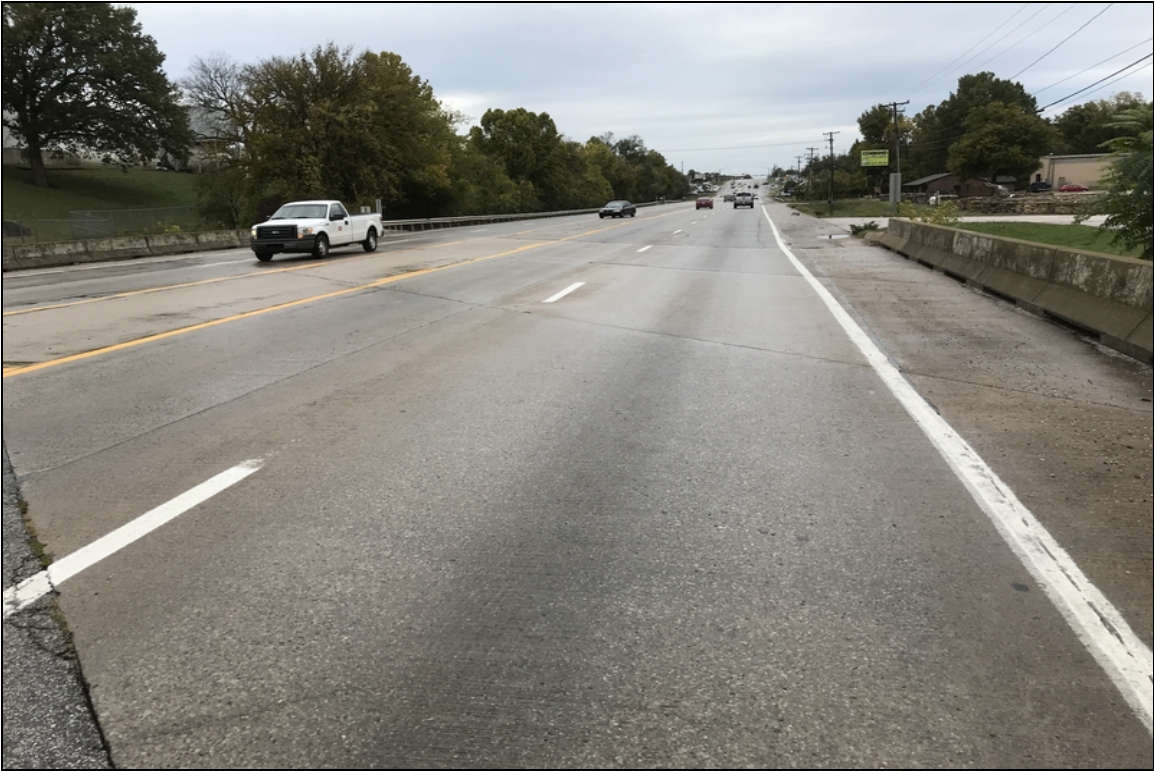
Typical deck

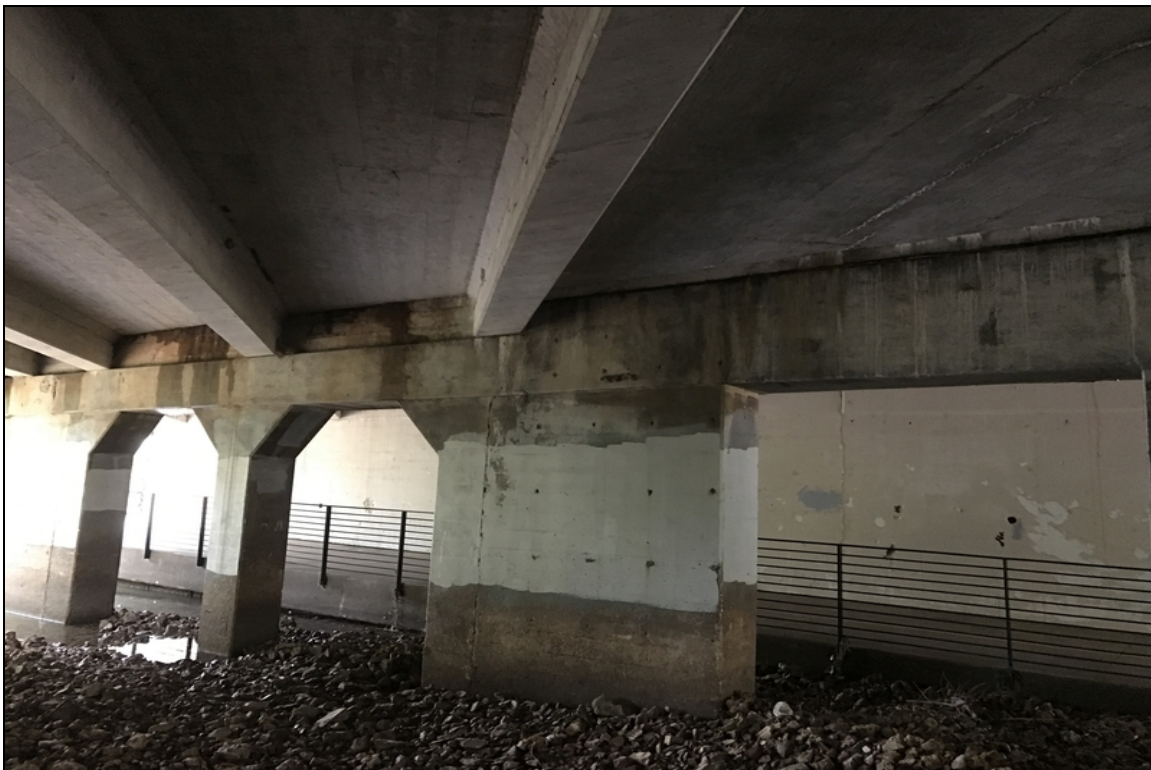
Typical under surface
