**Bridge #06110(Routine, Underwater type 2)**

**SH 80 - Scott Co. over Poteau Creek**

**Location: 1.04 MI SE JCT SH 28&80**

**Team Lead: Jeff Jones Inspection Date: September 29, 2021**

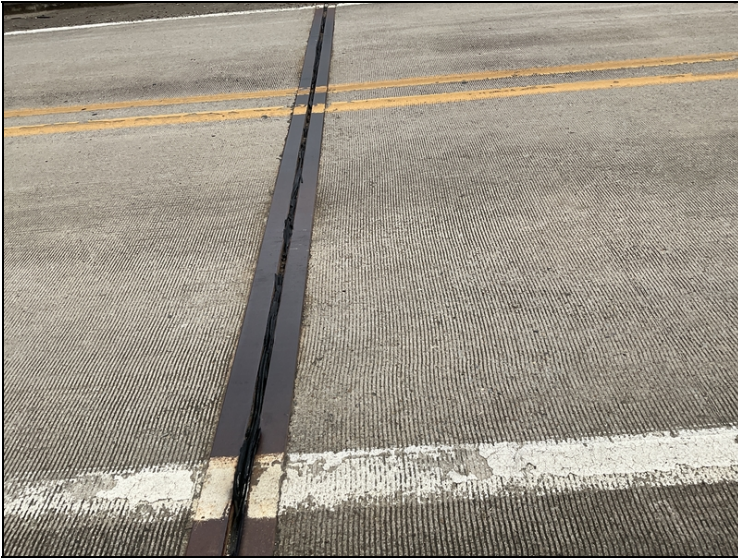
The deck joint seals are ripped, torn, and leak water on the superstructure and substructure.

Bent # 3 expansion joint seal.

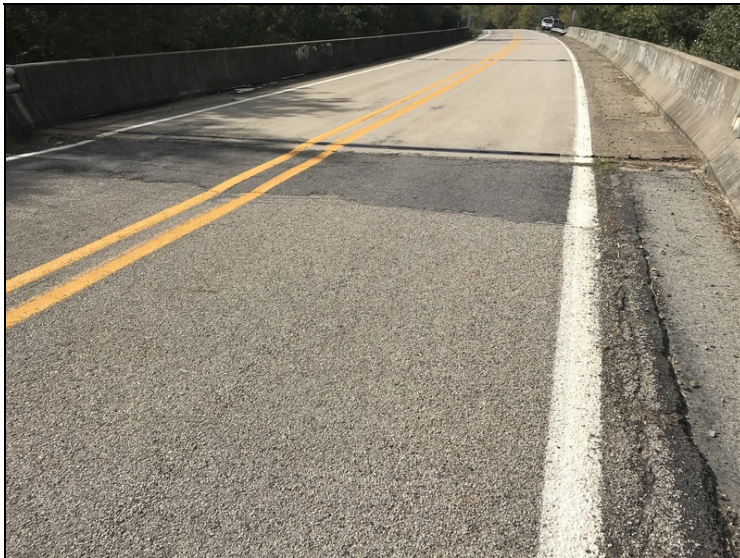
09/29/2021 - JCJ & TJL - Department Maintenance Forces have constructed a new asphalt leveling course at both approaches. There are still voids under the concrete approach gutters.

South approach roadway settlement.

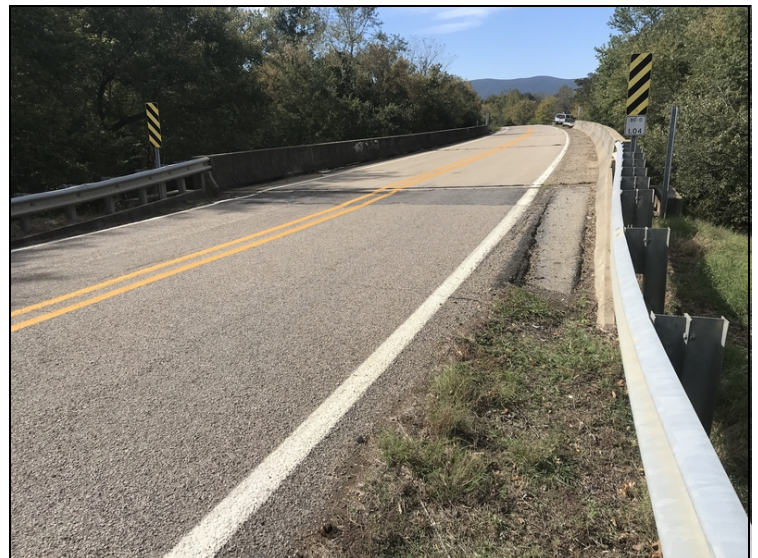
South approach roadway settlement.

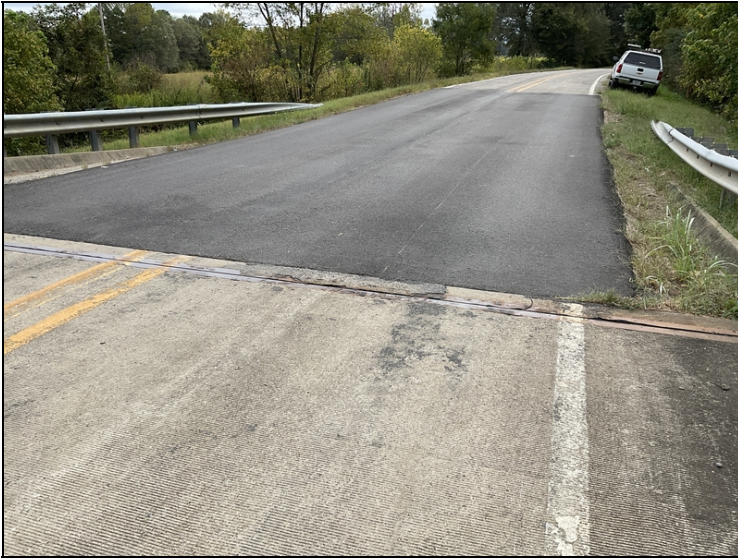
09/29/2021 - JCJ & TJL - New asphalt at the East approach.

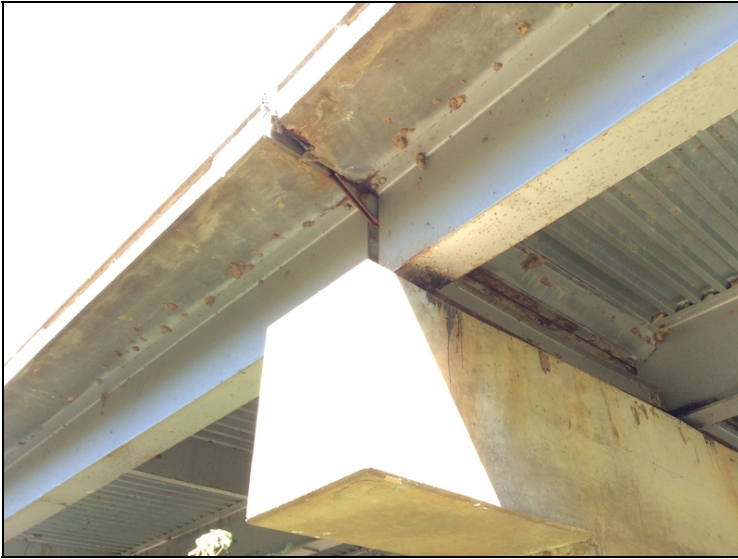
Deck soffit over Bent # 3.

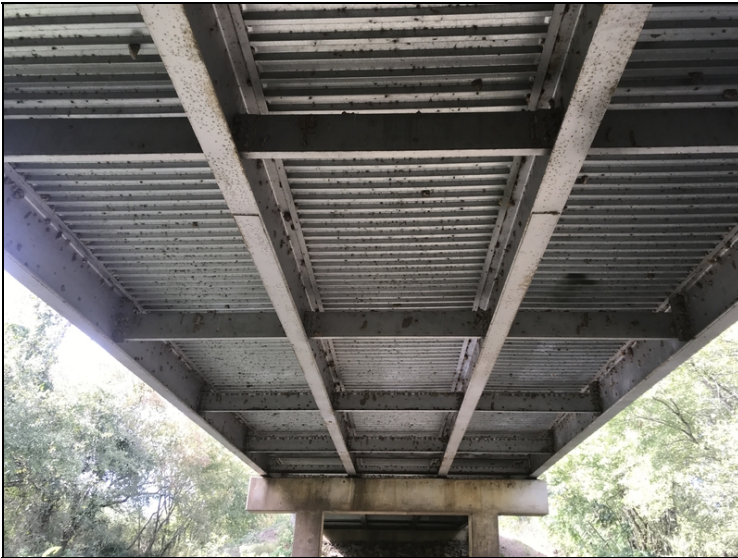
Typical undersurface of the deck.

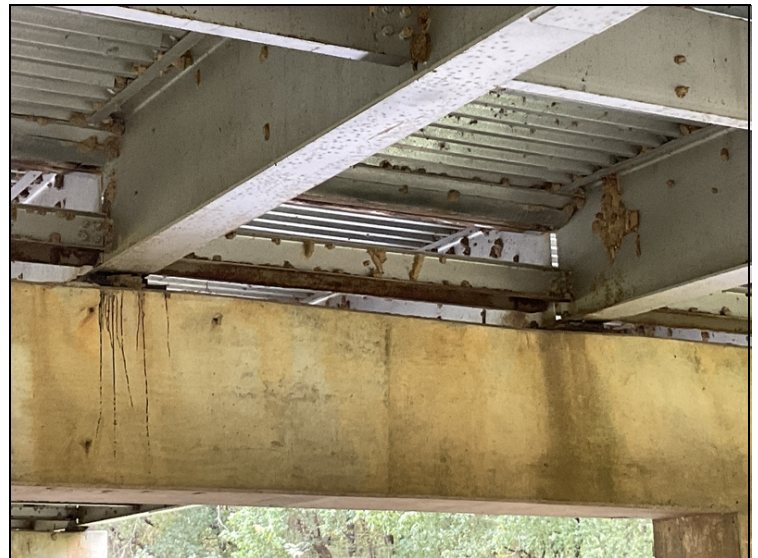
The superstructure has isolated areas with active corrosion and freckled rust typical throughout.

Beams over Bent # 2. Typical.
