Asset #00319(Routine)

US Highway 71 over Brushy Creek - Scott Co.

Location: 6.48 MI NO OF JCT SH 28

Team Lead: Jeff Jones, Inspection Date: 05/24/2021

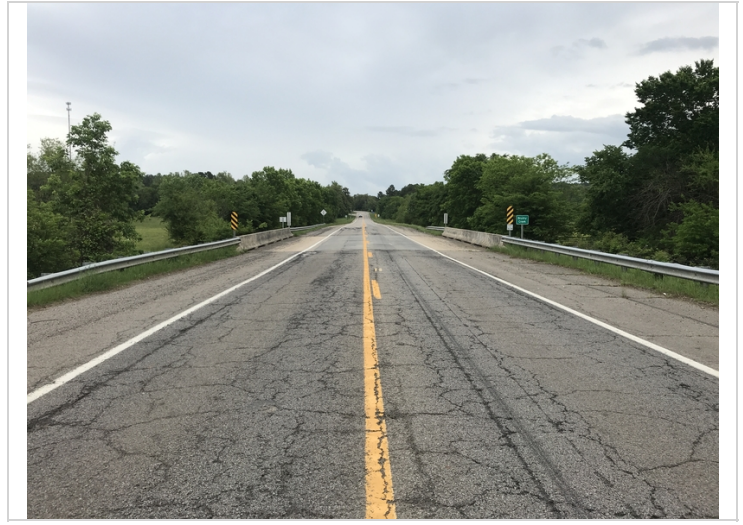
Approach roadway facing North.

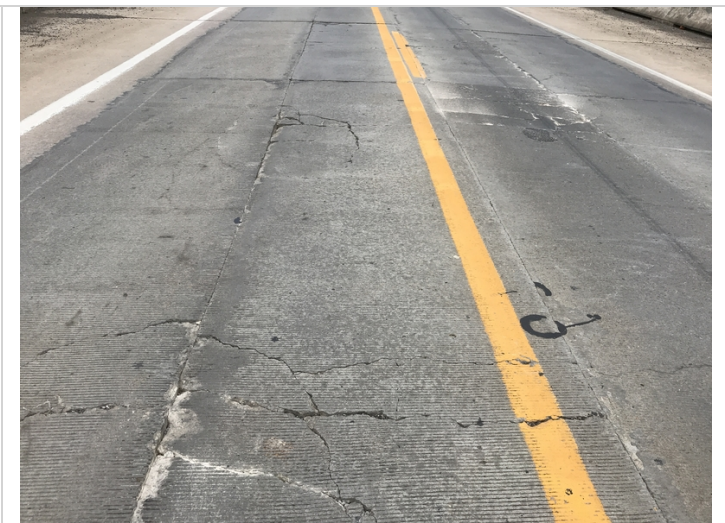
Deck. Typical.

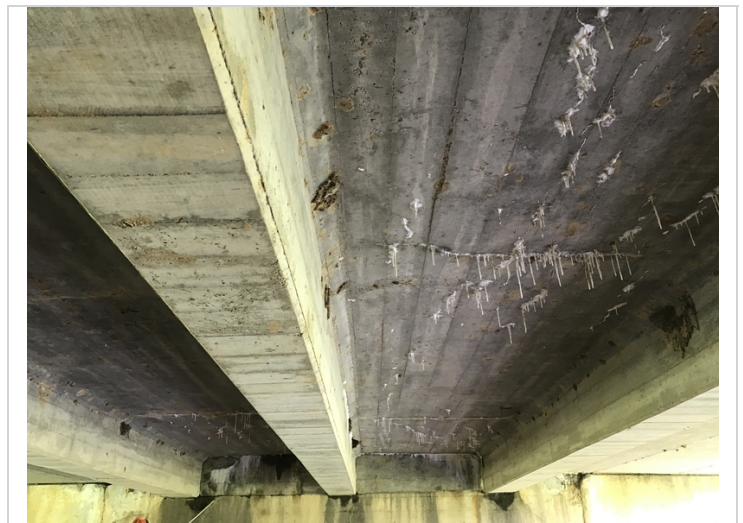
Span # 1 deck soffit.

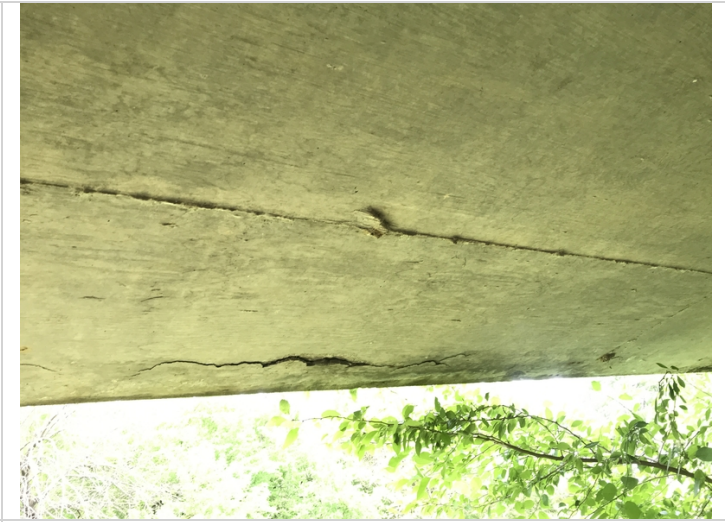
Span # 1 Right. Slab soffit.

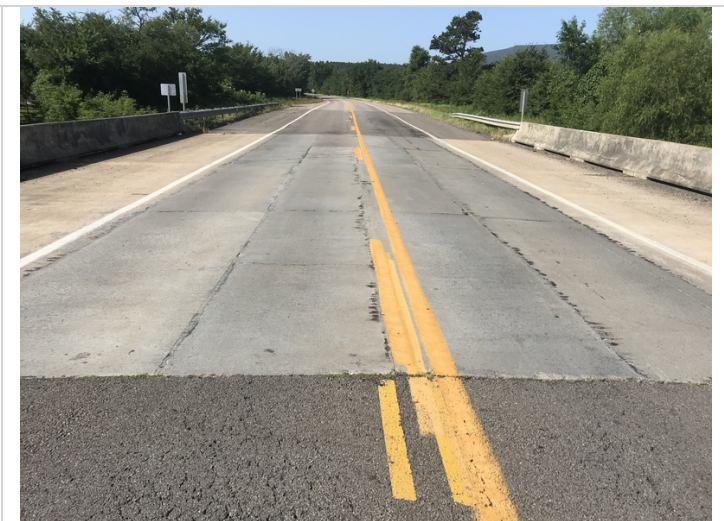
(16) Wearing Surface: -The concrete driving surface has lost bond with the deck and is audible when impacted by traffic. -The driving surface of the deck has been repaired by state maintenance forces in the past. Rigid concrete overlay repair was made in panel sections approximately half a travel lane wide to approximately mid-span of each span with offset construction joints along the length of the bridge. -Some repair panels have transverse cracks and are breaking apart in several areas. -Differential elevation in the wearing surface indicate possible reduction in section of the deck due to abrasion between the wearing surface and the original deck. Undersurface: -Both spans have map cracking with efflorescence and leaching visible from the undersurface of the deck. -Span # 1, Bay # 1 has shallow spalls with exposed reinforcing steel visible from the undersurface of the deck. -Span # 1 has some transverse and map cracks with efflorescence. -Span # 2 has map cracking with efflorescence visible from the undersurface of the deck under the driving lanes.

Typical driving surface of the deck.

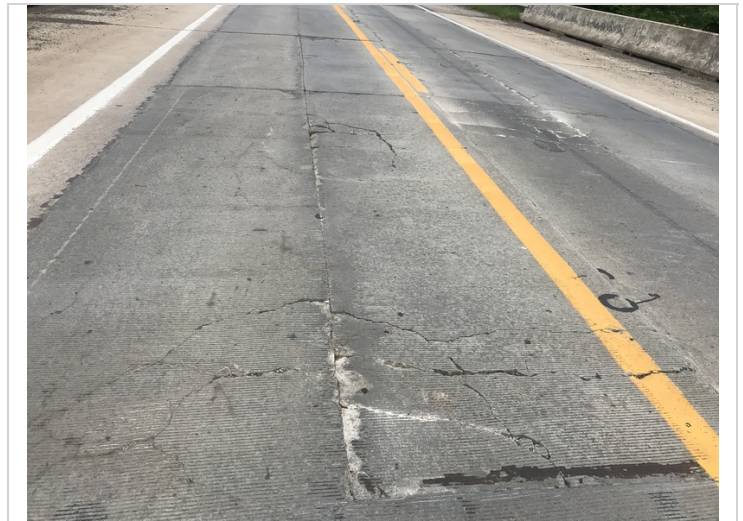
Deck. Left lane. Typical of driving surface.

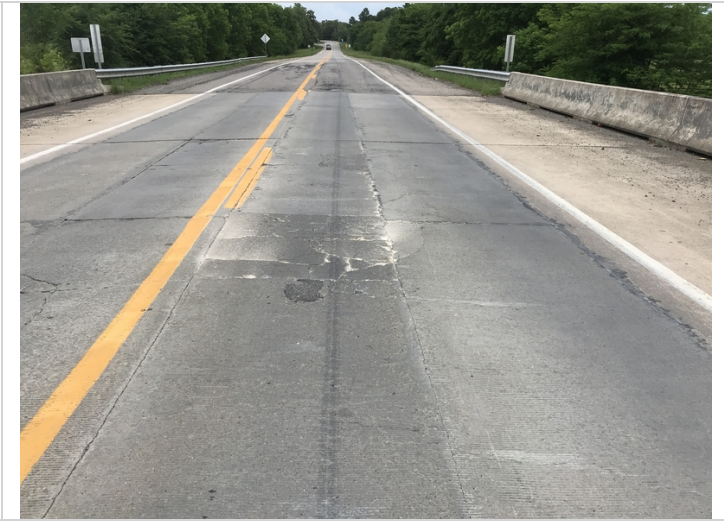
Deck. Right lane. Typical of driving surface.

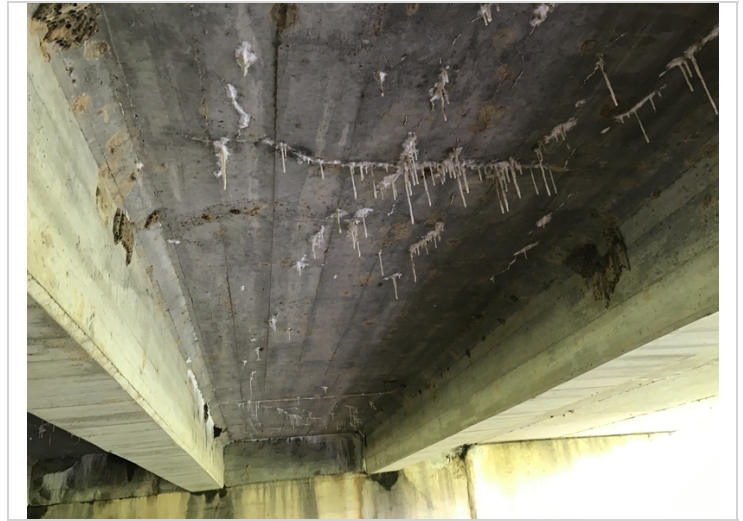
Deck soffit. Span # 1, Bay # 1.

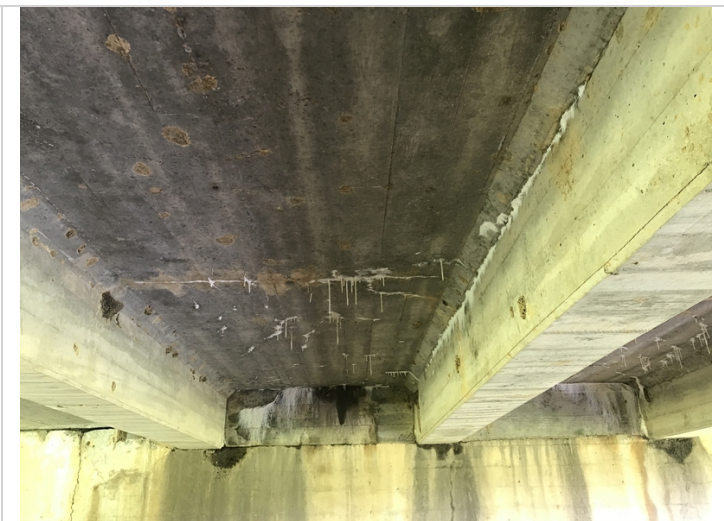
Deck soffit. Span # 1. Bay # 2.

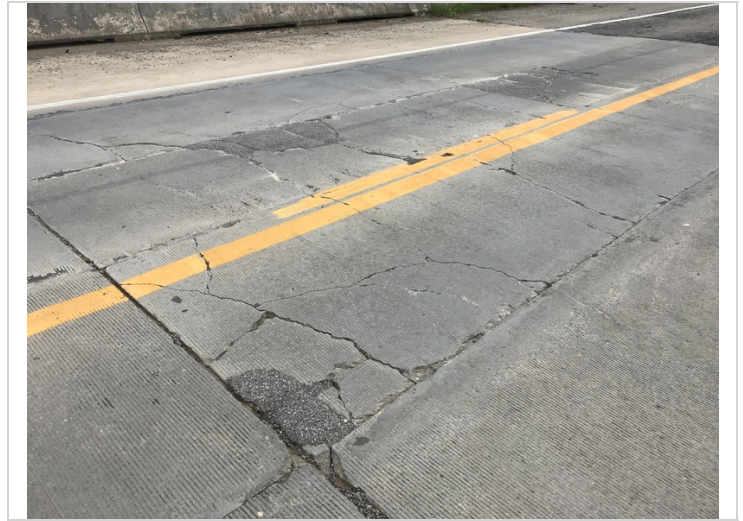
Span # 1 deck wearing surface.

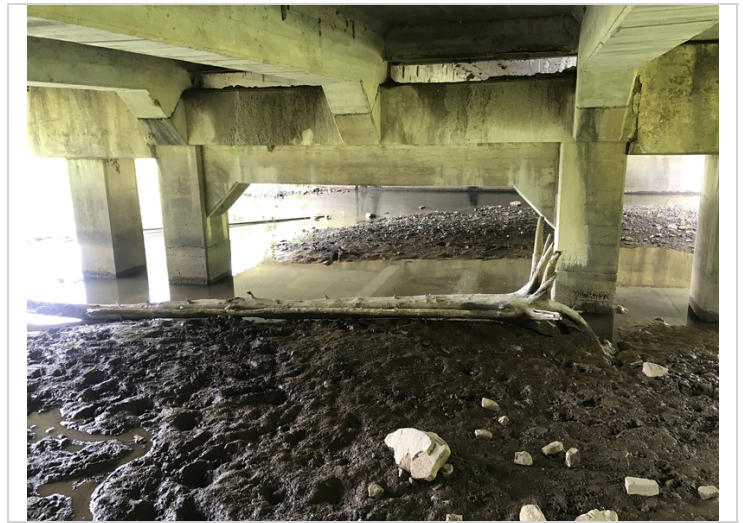
(205) -Columns # 3 & 4 have minor concrete deterioration at the construction joint. -There is light abrasion at the base of the columns.							
215	Reinforced Concrete Abutment	LF	101	16	82	3	0
1080	Delamination/Spall/Patched Area	LF	6	0	6	0	0
1090	Exposed Rebar	LF	1	0	0	1	0
1120	Efflorescence/Rust Staining	LF	27	0	25	2	0
1130	Cracking (RC and Other)	LF	11	0	11	0	0
1190	Abrasion/Wear (PSC/RC)	LF	40	0	40	0	0

Bent # 2 columns. Typical.

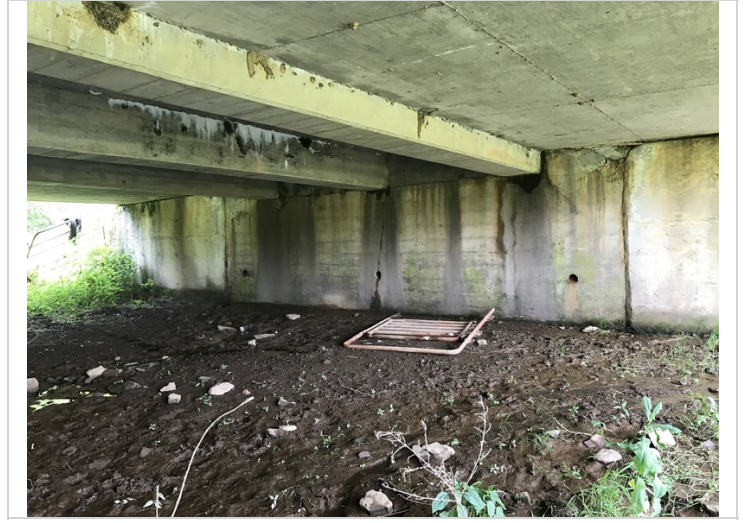
Bent # 1. Typical.

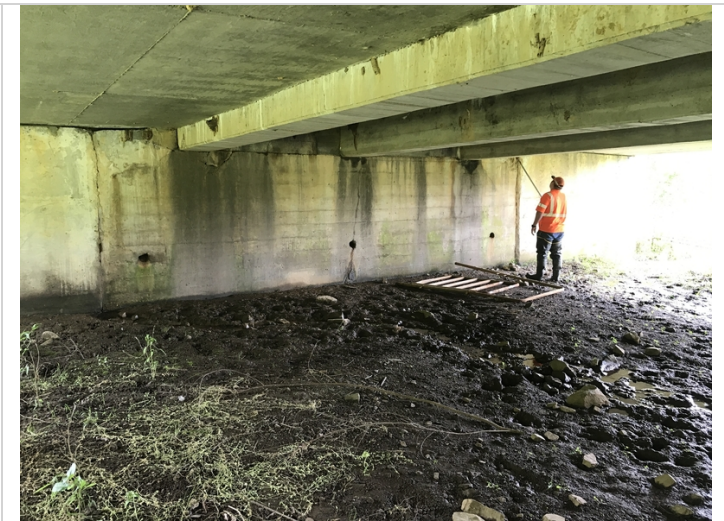
Bent # 1. Typical.

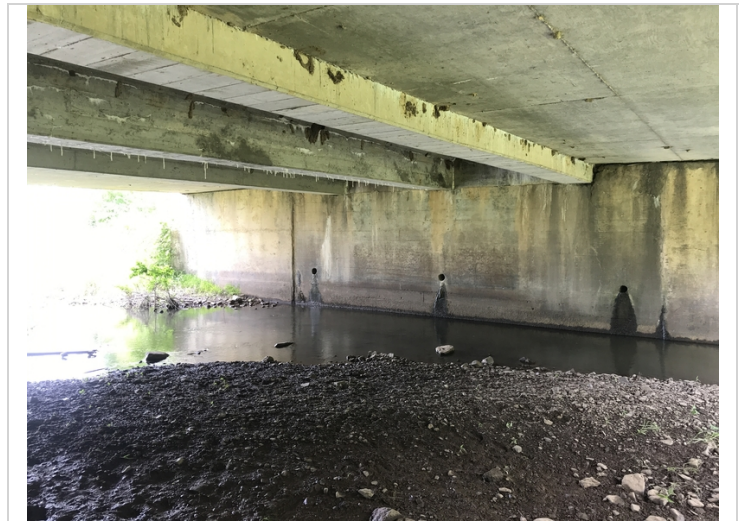
Bent # 3. Typical.

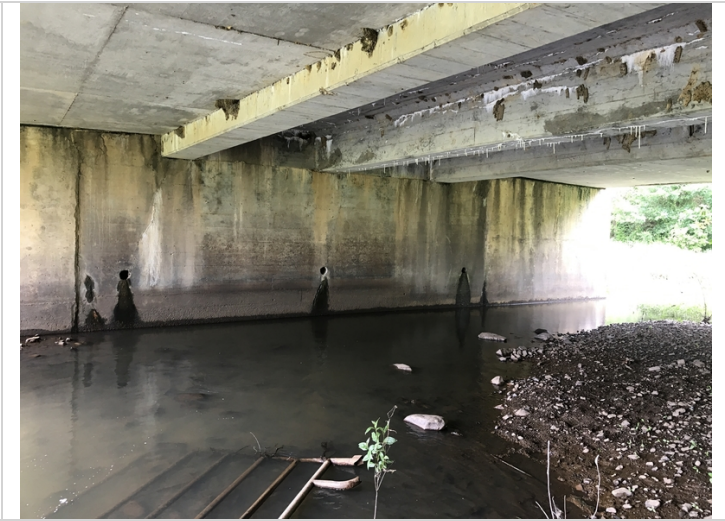
Bent # 3. Typical.

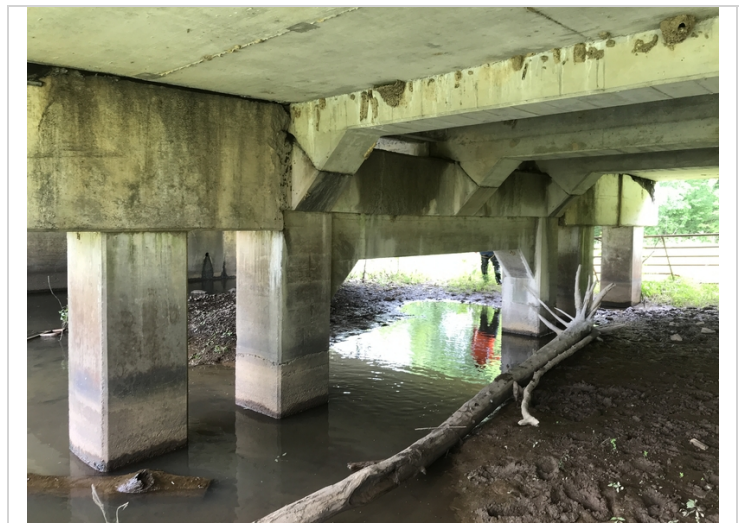
Bent # 2. Right side. Back face.

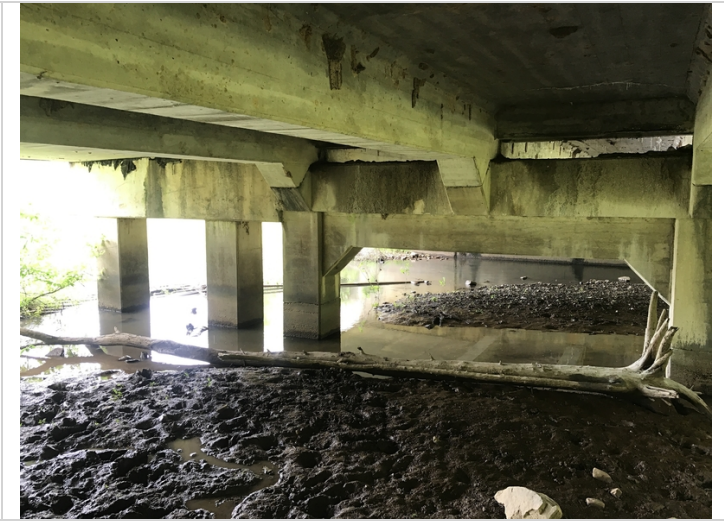
Bent # 2 Left side. Back face.

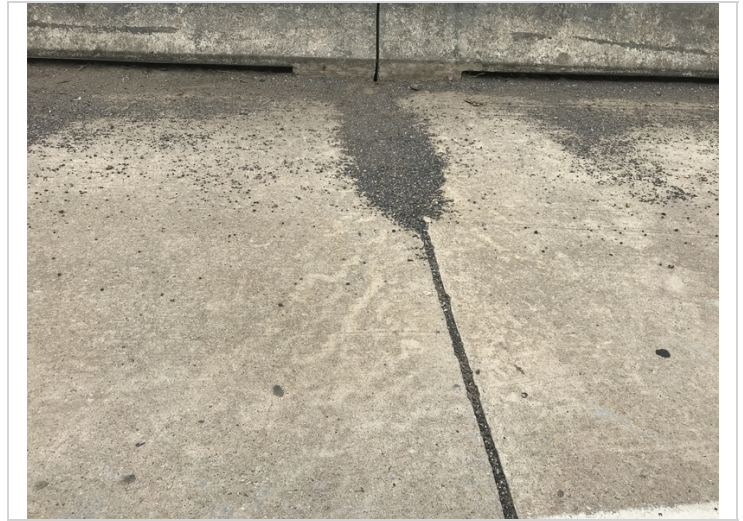
Expansion joint sealant over Bent # 2. Left side of structure.

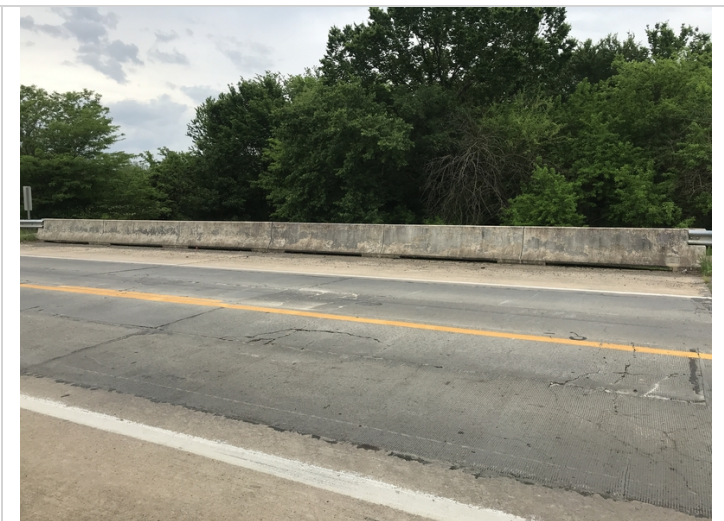
Right parapet. Typical.

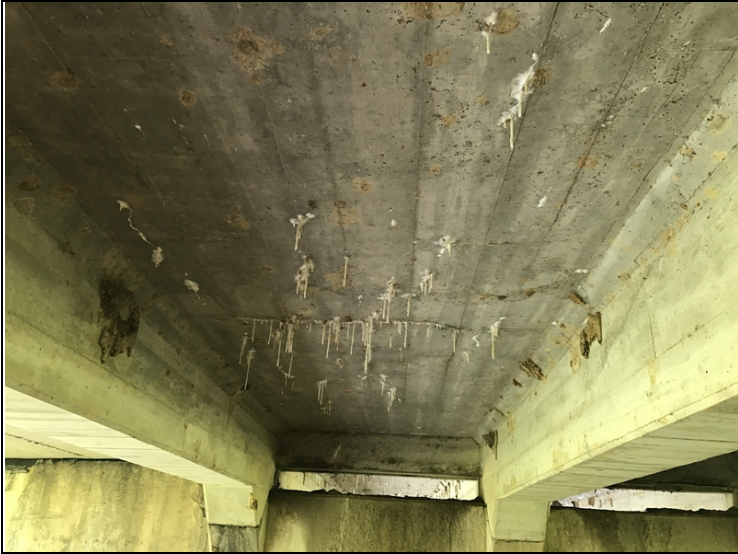
Span # 1 deck soffit.

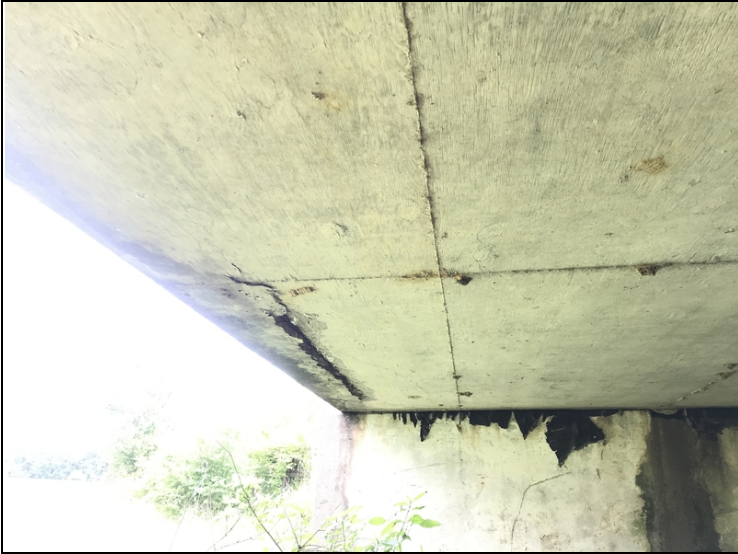
Span # 1 Left overhang. Slab span.

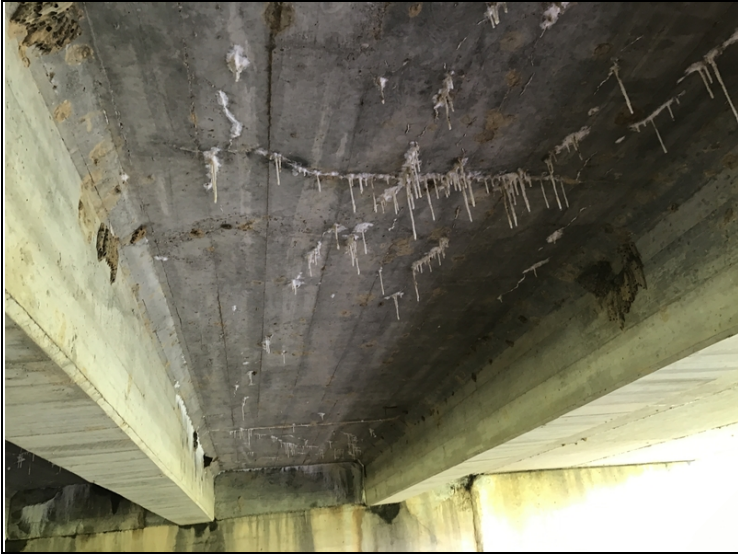
Deck soffit. Span # 1, Bay # 1.
