Asset #00320(Routine)

US Highway 71 over Old Freedom Cr- Scott Co

Location: 5.69 MI NO OF JCT SH 28

Team Lead: Jeff Jones, Inspection Date: 05/24/2021

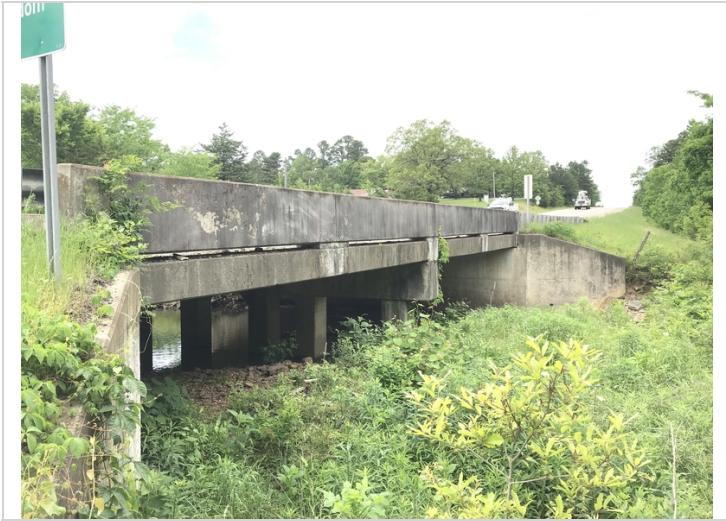
Elevation. East side of structure.

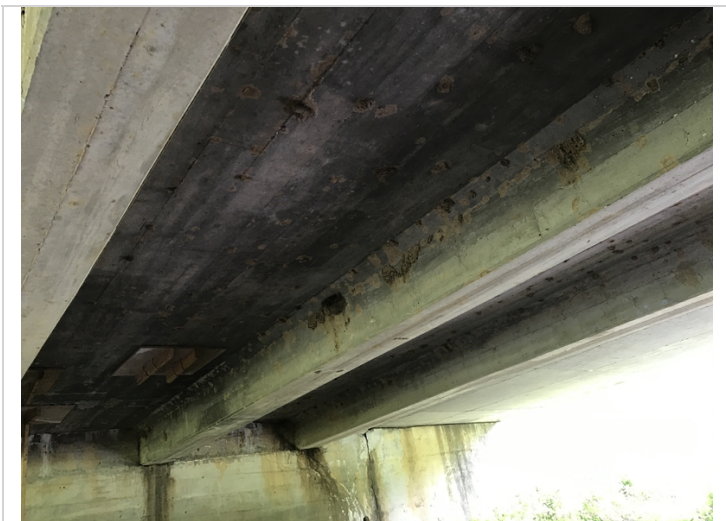
Undersurface of Span # 1. Typical.

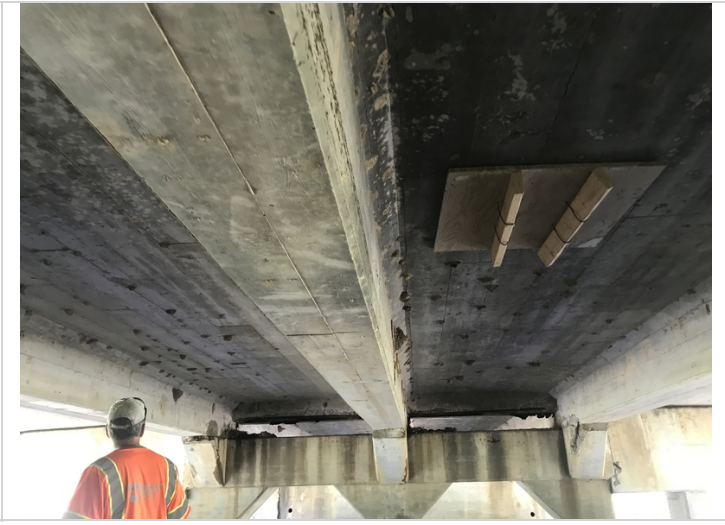
Span # 1 typical undersurface of the deck.

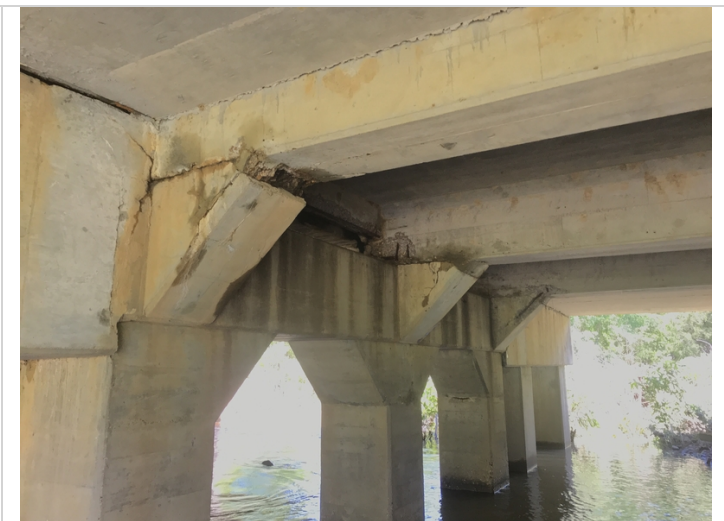
(234) -Span # 1 Rt of Column 5 has a small spall with exposed reinforcing steel adjacent to the original portions of the cap where Bt # 2 was widened. -Span # 1 Bent # 2 Girders # 1 & 3 cap haunch have spalling with exposed reinforcing steel. Girder # 2 has map cracking with efflorescence and a 12" delamination. -Span # 2, Girder # 1 one large spall with exposed reinforcing steel visible where bridge was widened. Initial section loss to the reinforcing steel.							
301	Pourable Joint Seal	LF	47	0	36	11	0
2310	Leakage	LF	25	0	25	0	0
2350	Debris Impaction	LF	11	0	0	11	0
2360	Adjacent Deck or Header	LF	11	0	11	0	0

Span # 1 cap haunches.

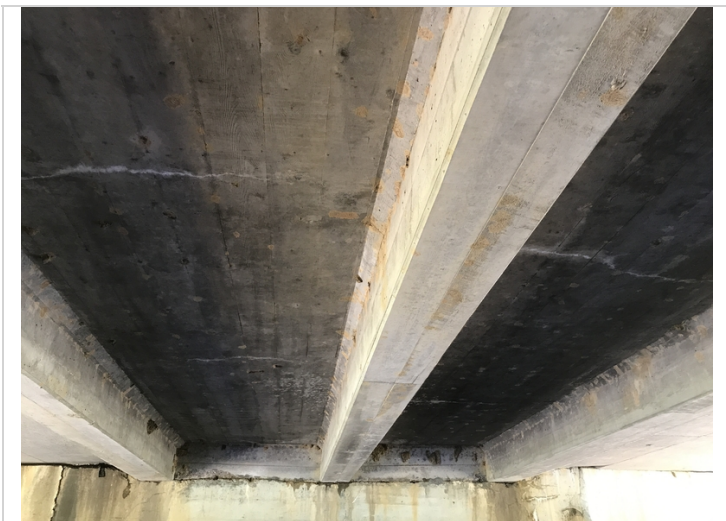
Span # 2 typical undersurface of the deck.

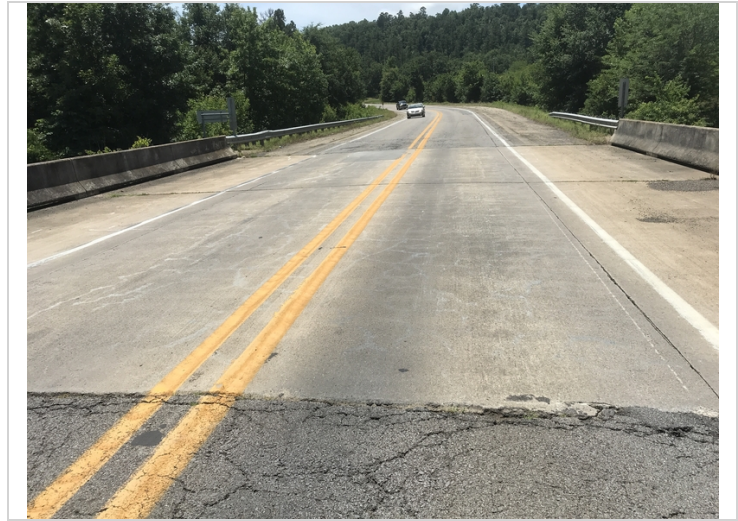
Typical driving surface of the deck.

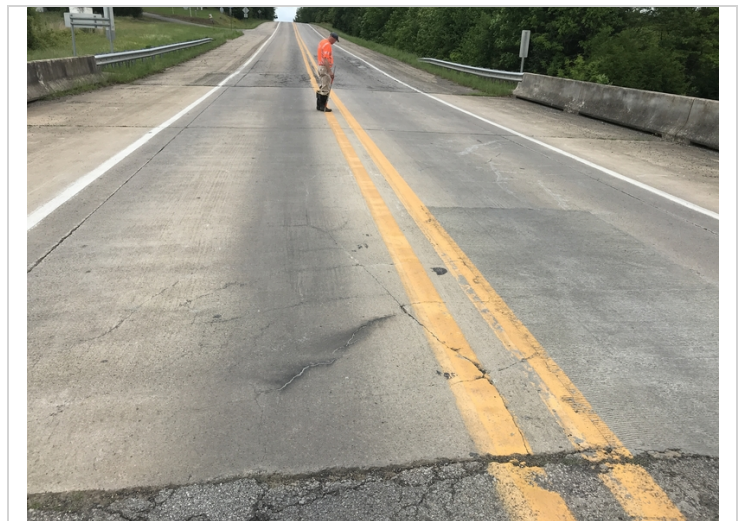
Wearing surface of the top flange. Typical.

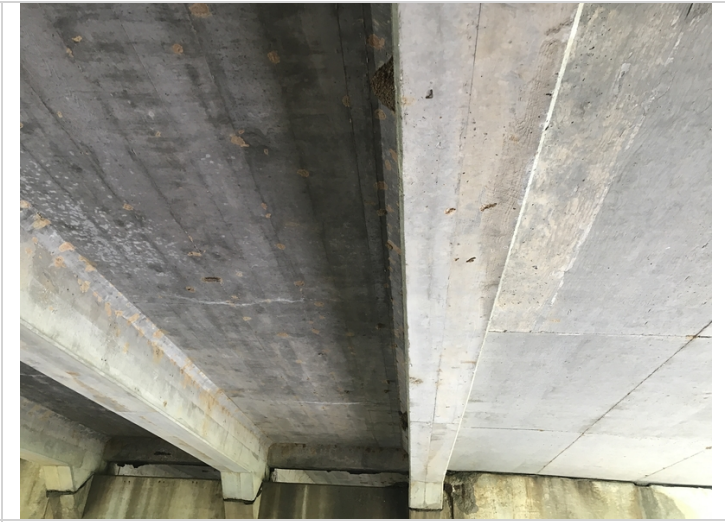
Undersurface of Span # 2. Typical.

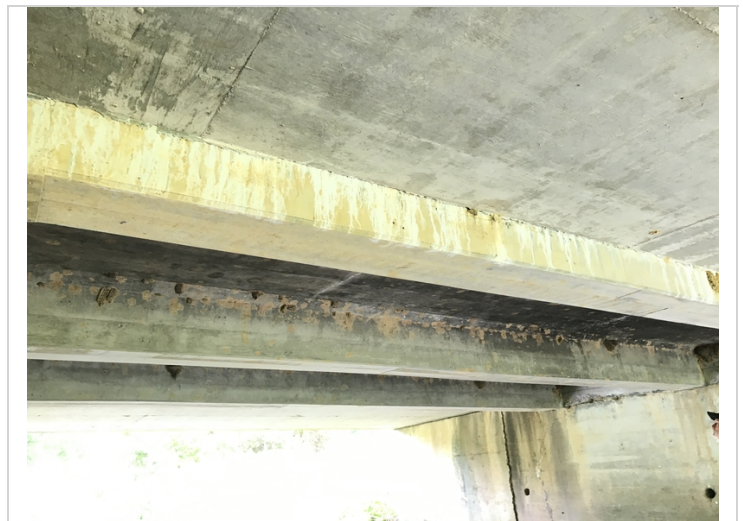
Superstructure. Typical. Span # 2.

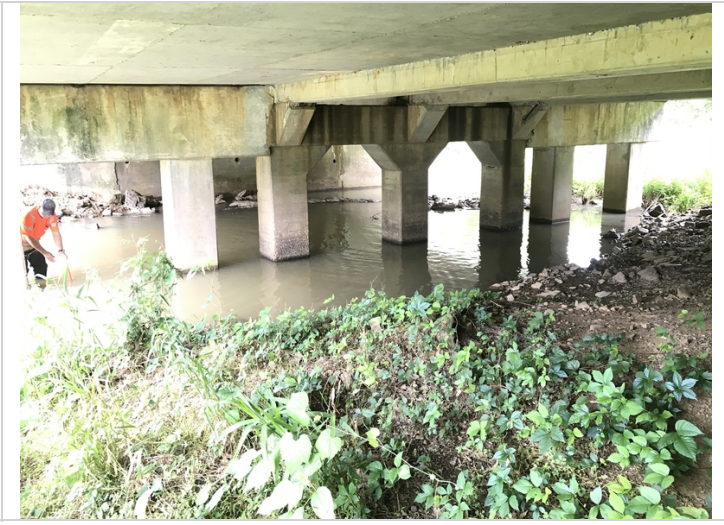
ELEMENTS	DESCRIPTION	UNITS	TOTAL	CS1	CS2	CS3	CS4
(205) -Concrete deterioration at the base of columns at Bent # 2 with up to 2" of concrete section loss at the base of columns that has been grouted in the past. -Light abrasion and concrete deterioration with repairs made by maintenance forces at the base of Bent # 2, Columns # 3, 4, and 5. -Bent # 2, Columns # 3 & 5 have shallow spalling with exposed reinforcing steel on the inside face.							
215	Reinforced Concrete Abutment	LF	152	115	32	5	0
1080	Delamination/Spall/Patched Area	LF	5	0	4	1	0
1090	Exposed Rebar	LF	4	0	0	4	0
1120	Efflorescence/Rust Staining	LF	20	0	20	0	0
1130	Cracking (RC and Other)	LF	8	0	8	0	0

Bent # 2. Columns. Typical.

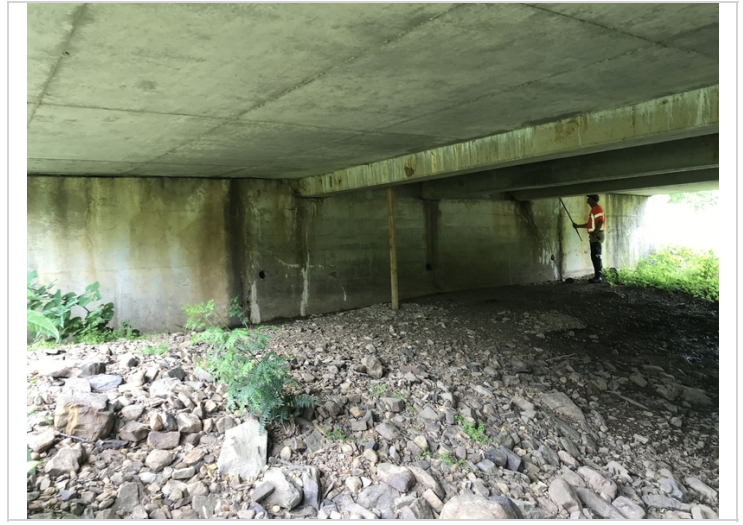
Bent # 1. Typical.

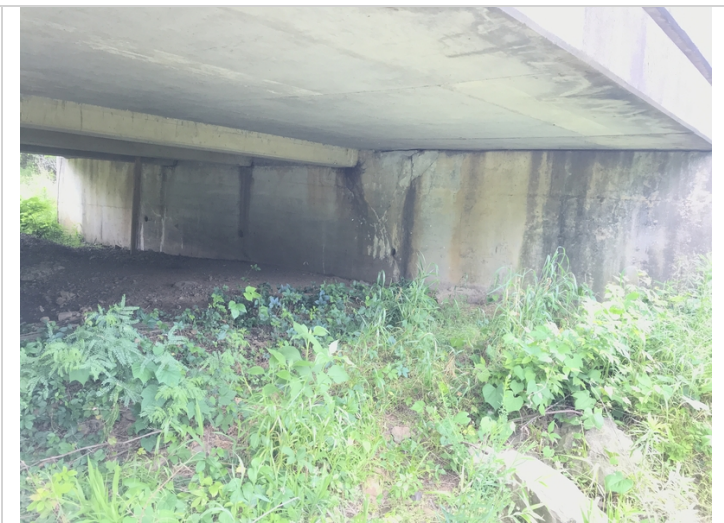
Bent # 1. Left. Typical.

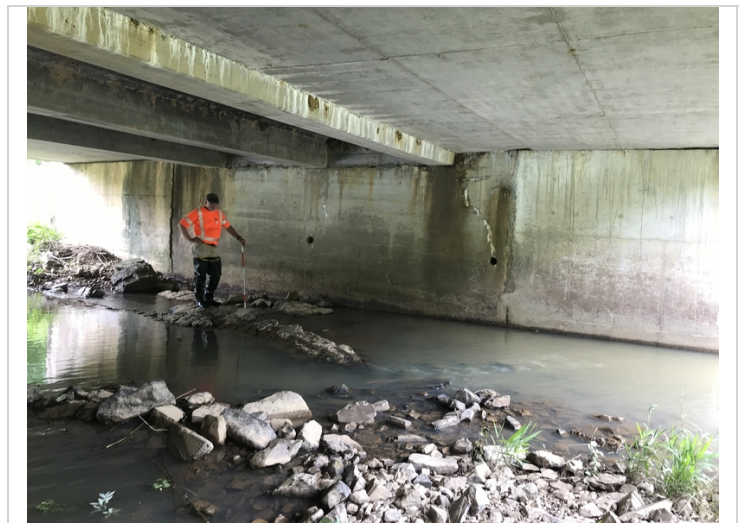
Bent # 3. Typical.

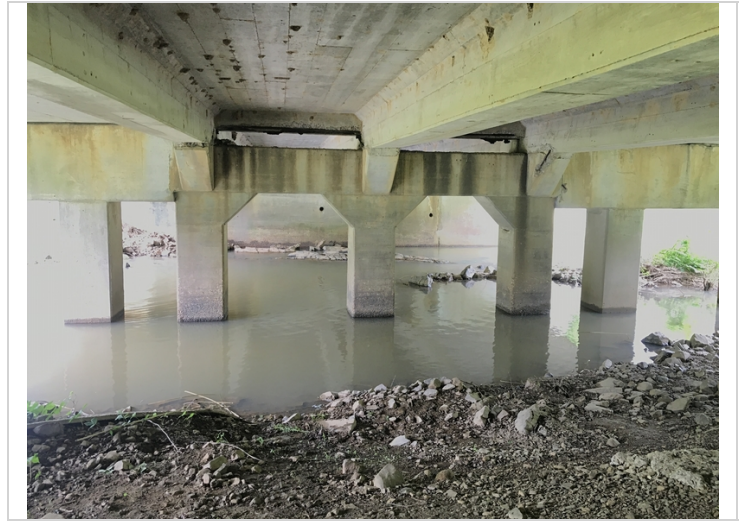
Bent # 2. Span # 1. Original portion of cap.

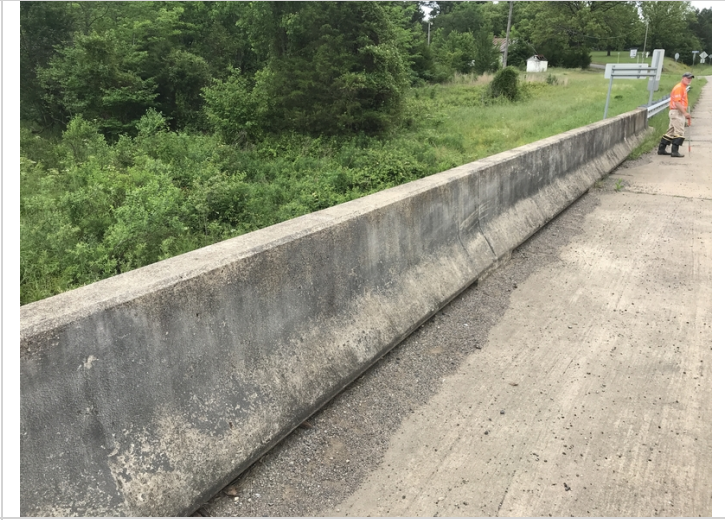
Parapet wall. Typical.
