Asset #00322(Routine)

US Highway 71 over Sq. Rock Cr. - Scott Co.

Location: 1.60 MI NO OF JCT SH 28

Team Lead: Jeff Jones, Inspection Date: 07/07/2021

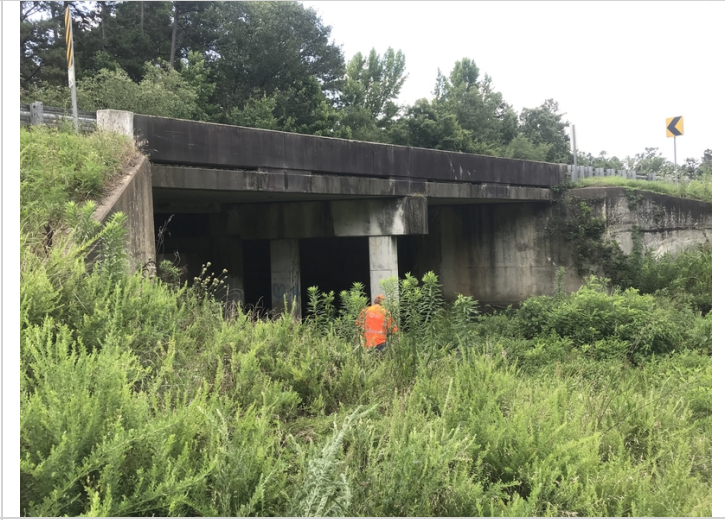
Elevation.

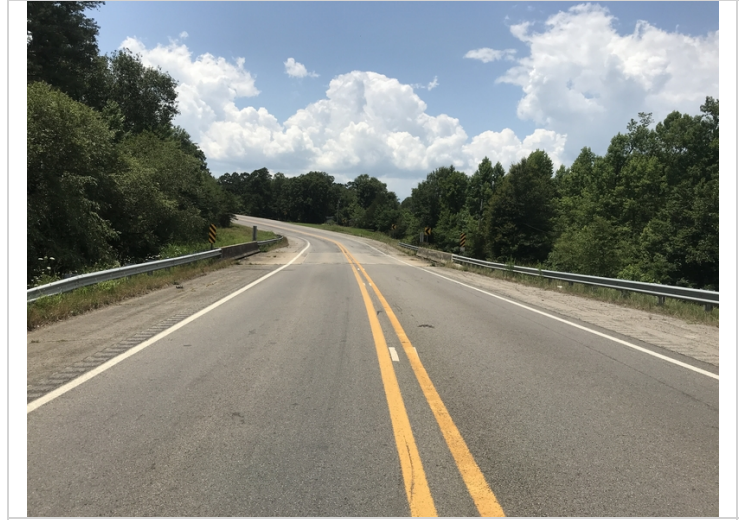
Approach roadway facing South.

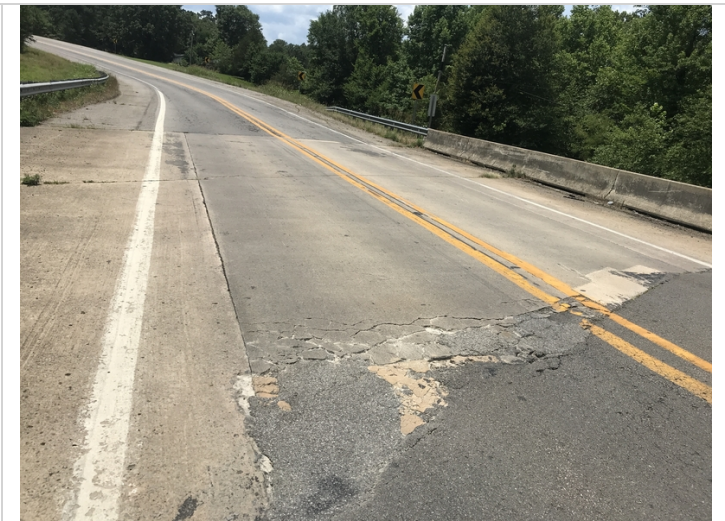
Deck. Typical.

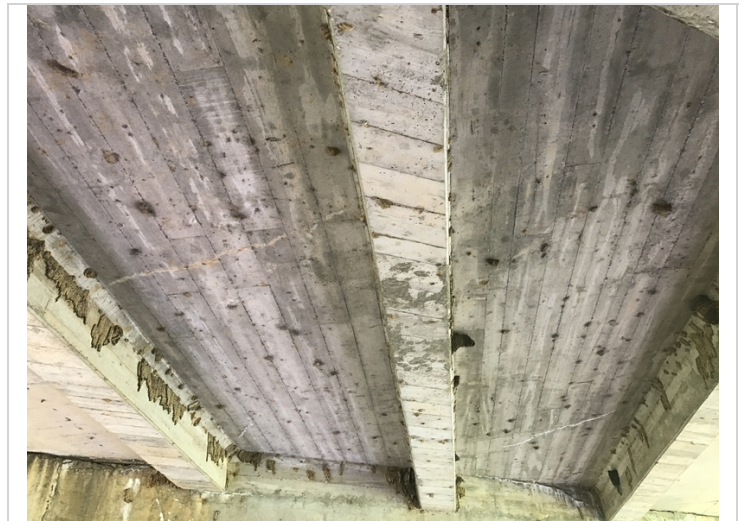
Span # 1 deck soffit. Typical.

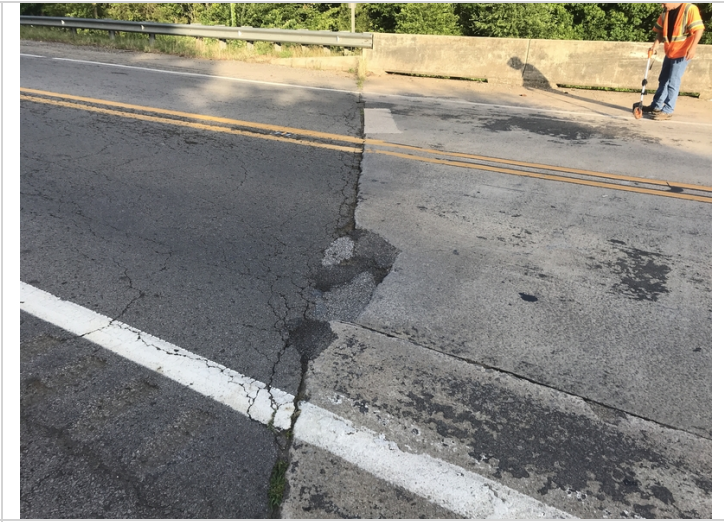
(16) Wearing surface- -The concrete driving surface is breaking apart over both abutments and over Bent # 2 in the northbound lane. -The concrete wearing surface is audible and abrades on the bridge deck under traffic. -The driving surface of the deck has map cracking that has been sealed with epoxy in the past. -Construction joint sealant on the driving surface of the deck is deteriorated. Deck soffit -There are areas with map cracking with efflorescence adjacent to Bent # 3 that are visible from the undersurface of the deck. -There are isolated transverse cracks with rust stains and efflorescence at variable spacing that are visible from the undersurface of the deck. -There are spalls with exposed reinforcing steel in the expansion dam of Span # 1 over Bent # 2 that are visible from the undersurface of the deck. -Span # 2 Deck soffit. Spall with exposed reinforcing steel in Bay # 2 adjacent to Bent # 3. (510-16) Wearing surface- -The concrete driving surface is breaking apart over both abutments and over Bent # 2 in the northbound lane. -The concrete wearing surface is audible and abrades on the bridge deck under traffic. -The driving surface of the deck has map cracking that has been sealed with epoxy in the past. -Construction joint sealant on the driving surface of the deck is deteriorated.

South abutment driving surface.

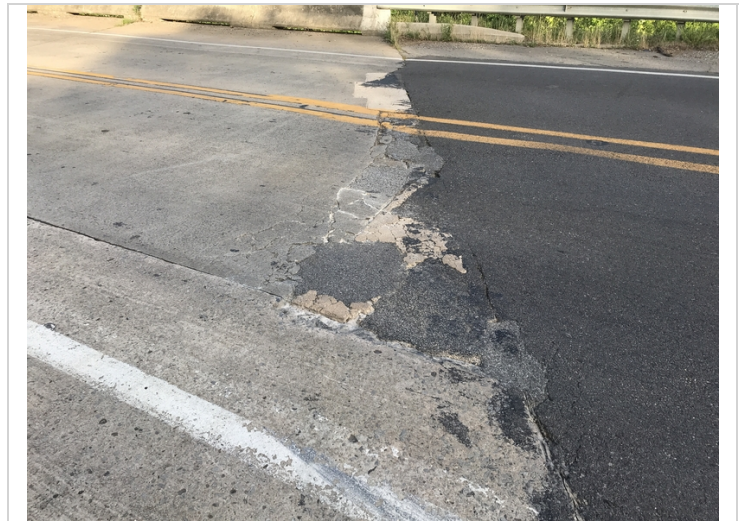
North bridge end.

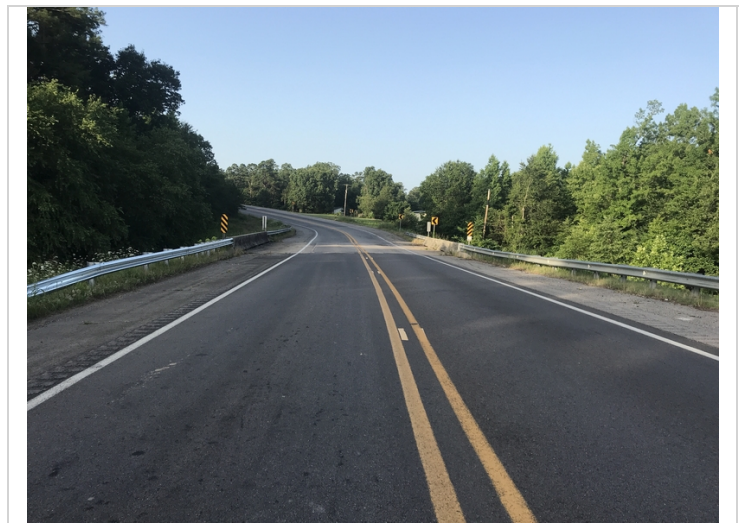
Roadway

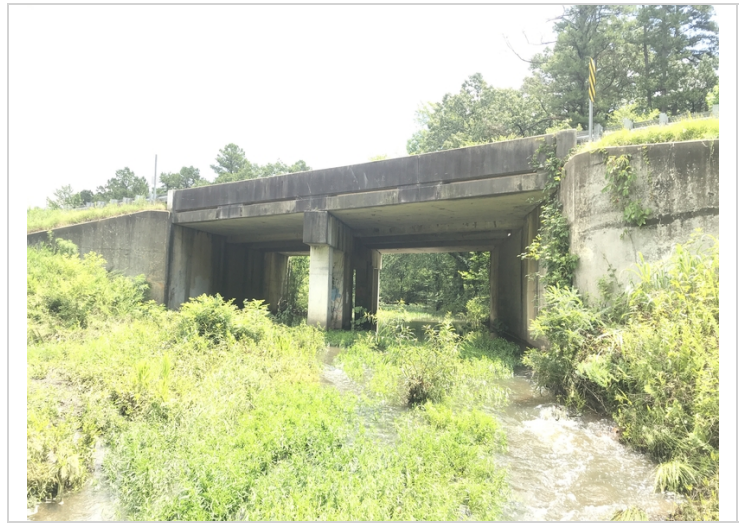
Elevation

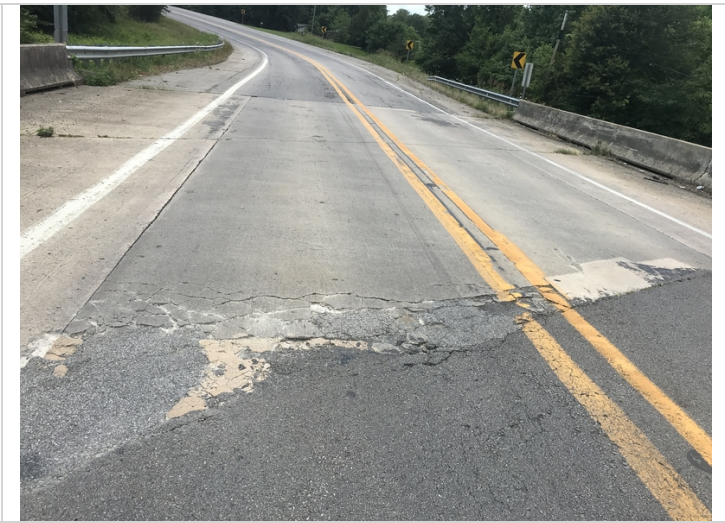
Span # 2 wearing surface. Typical.

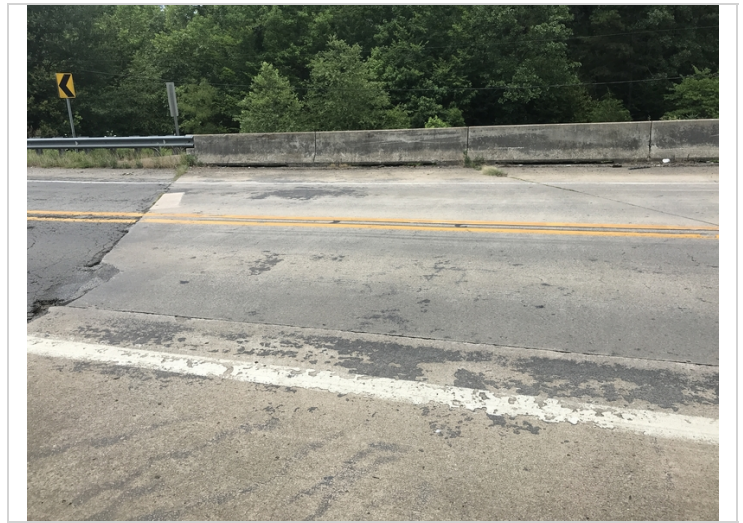
Span # 1 wearing surface.

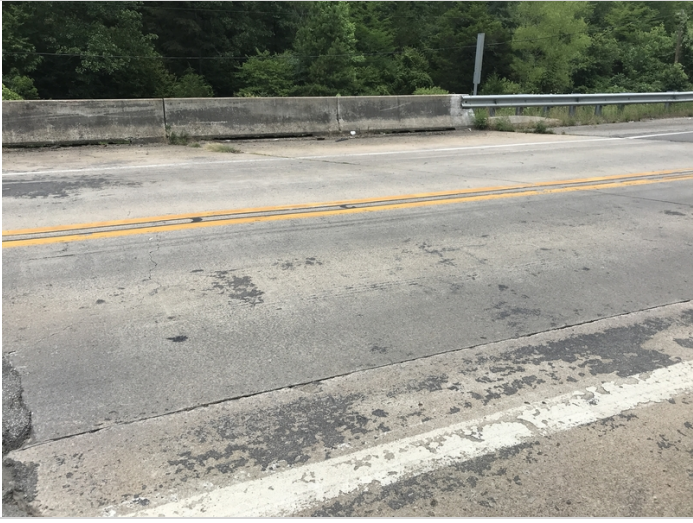
Span # 1 wearing surface.

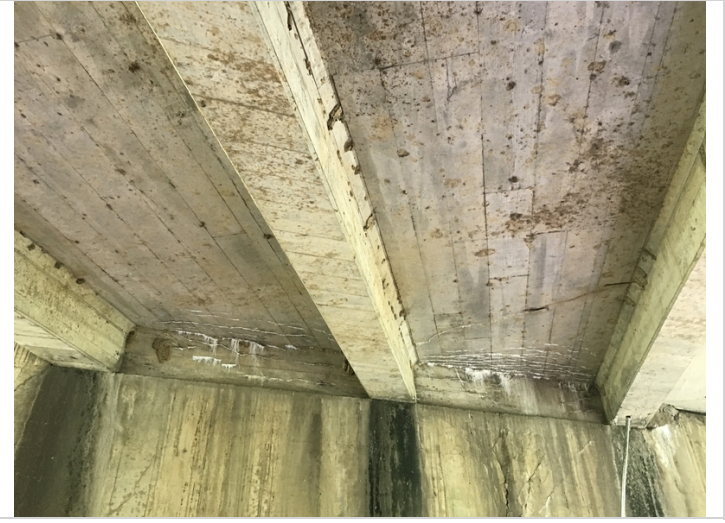
Span # 2 deck soffit adjacent to Bent # 3.

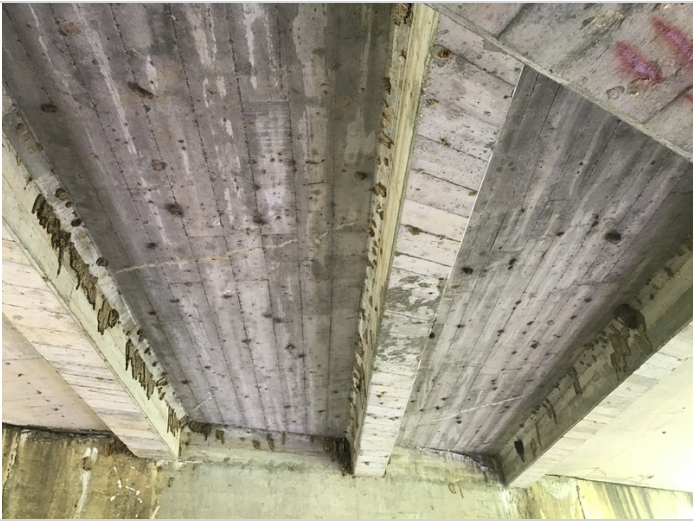
Span # 1 deck soffit. Typical.

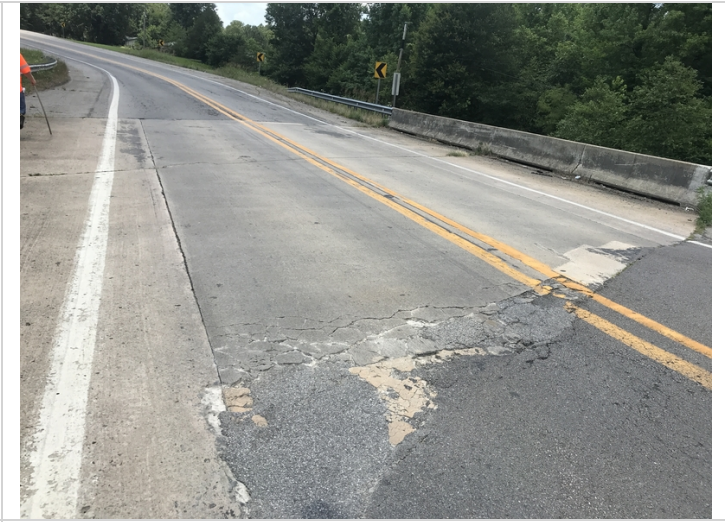
Wearing surface. North bridge end.

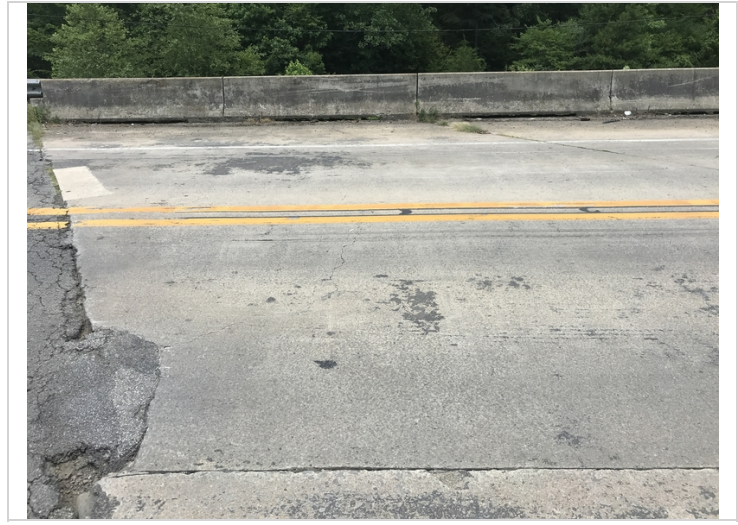
Span # 1 deck wearing surface. Typical.

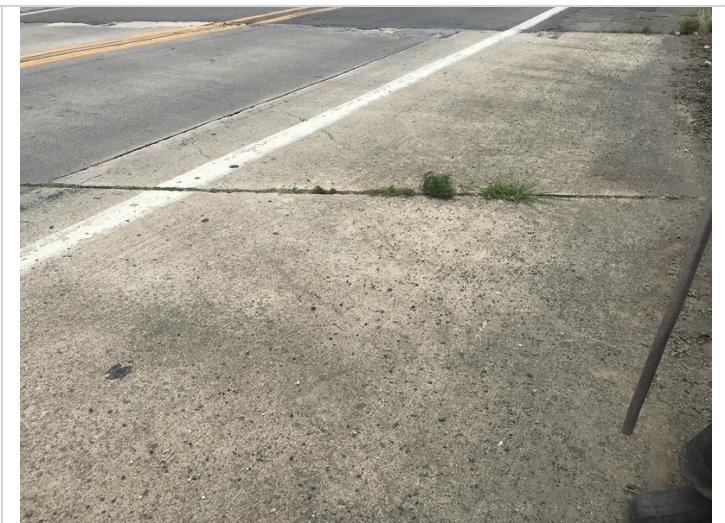
Slab. Typical.

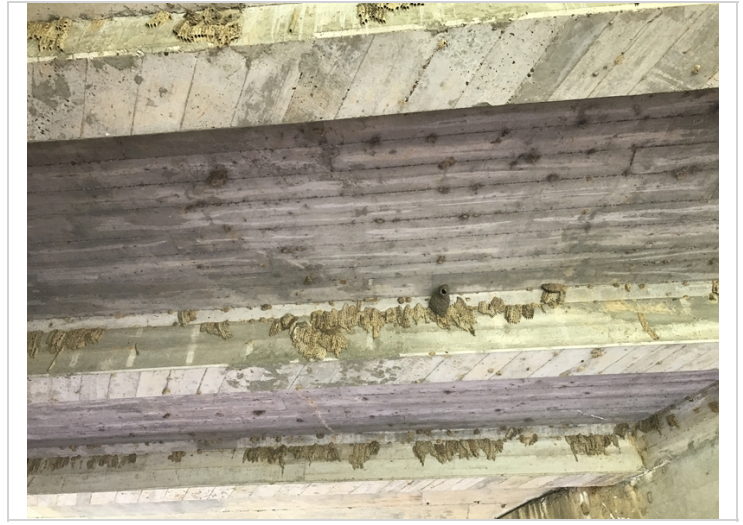
Span # 1 superstructure. Typical.

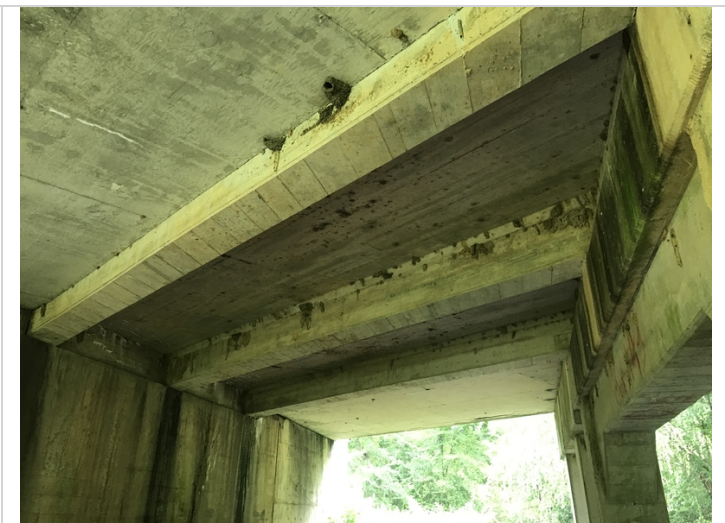
Span # 2 superstructure. Typical.

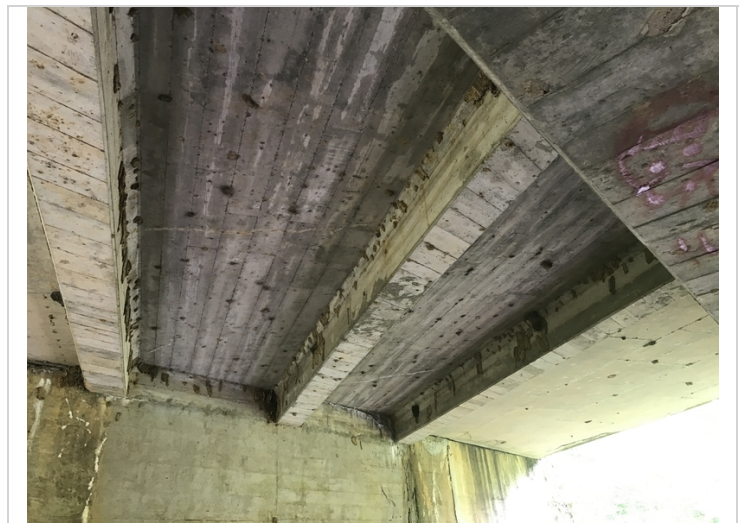
Span # 1 superstructure. Typical.

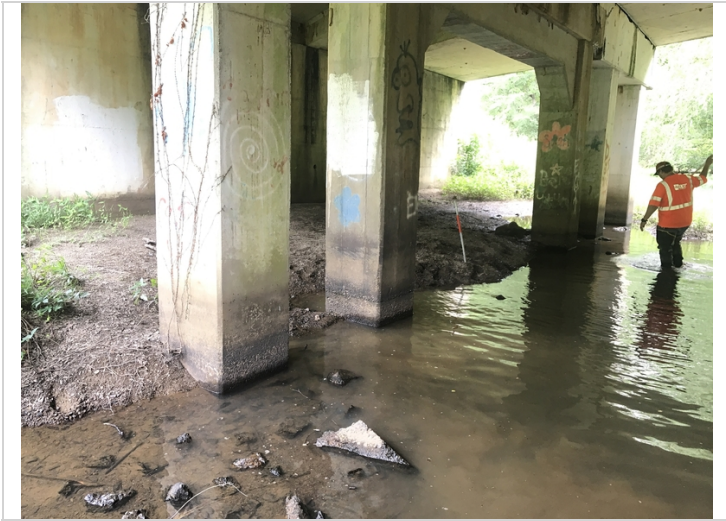
Bent # 2 columns. Typical.

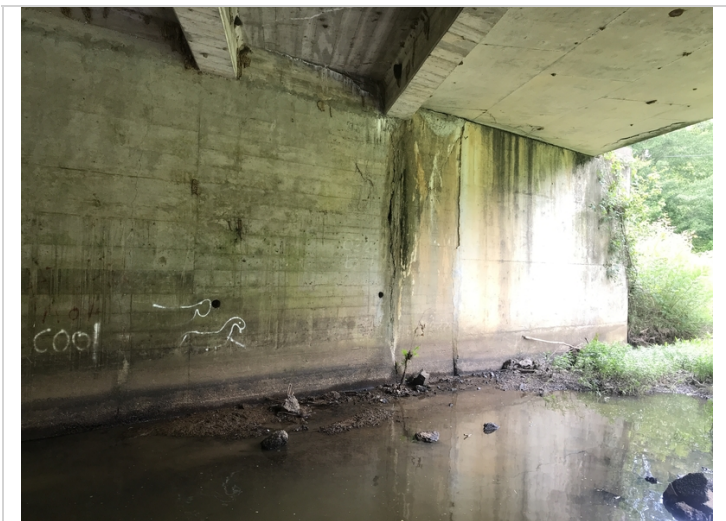
Left side of Bent # 1. Typical.

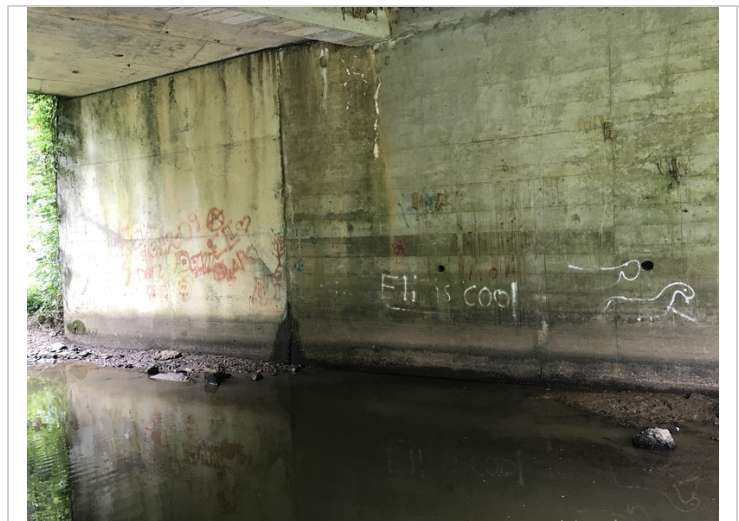
Right side of Bent # 1. Typical.

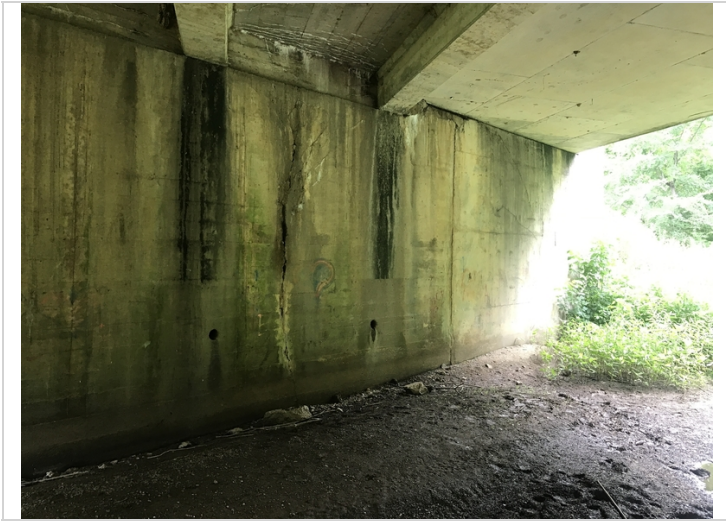
Right side of Bent # 3. Typical.

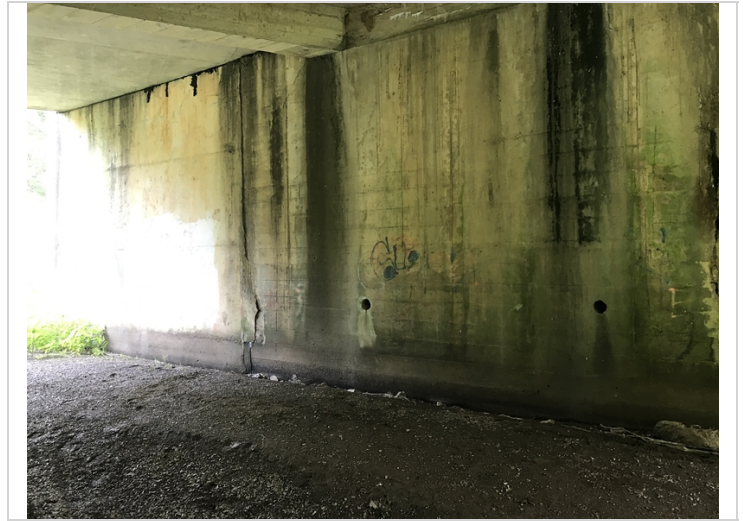
Left side of Bent # 3. Typical.

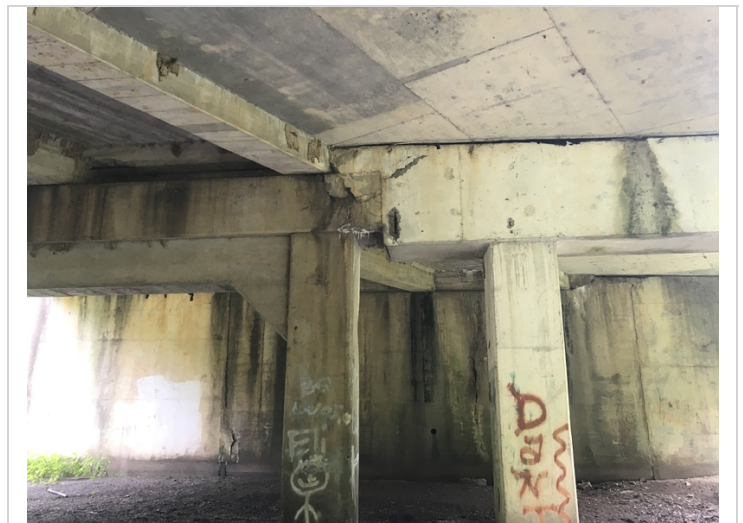
Right construction joint adjacent to Girder # 3.

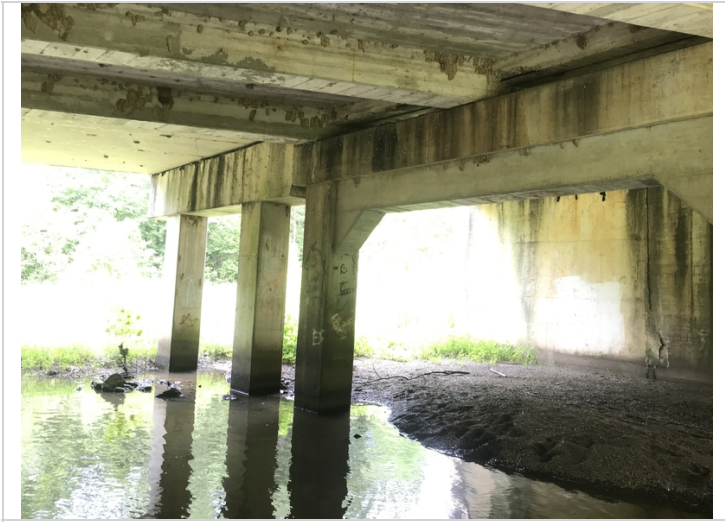
Left side of Bent # 2.

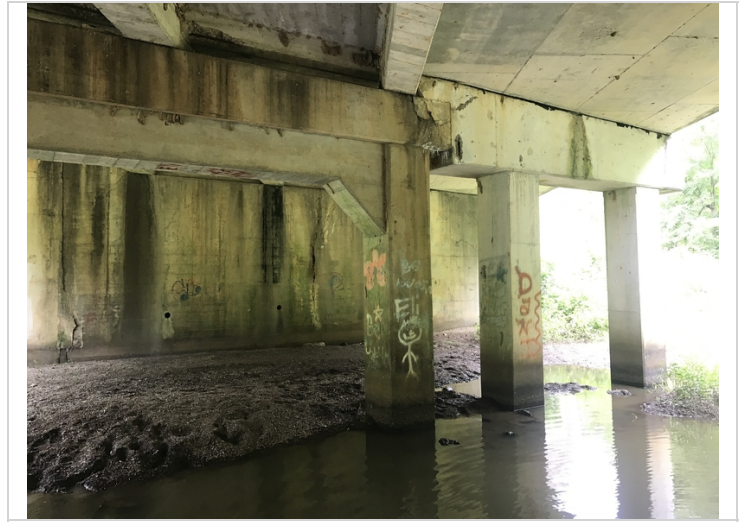
Right side of Bent # 2. Typical.

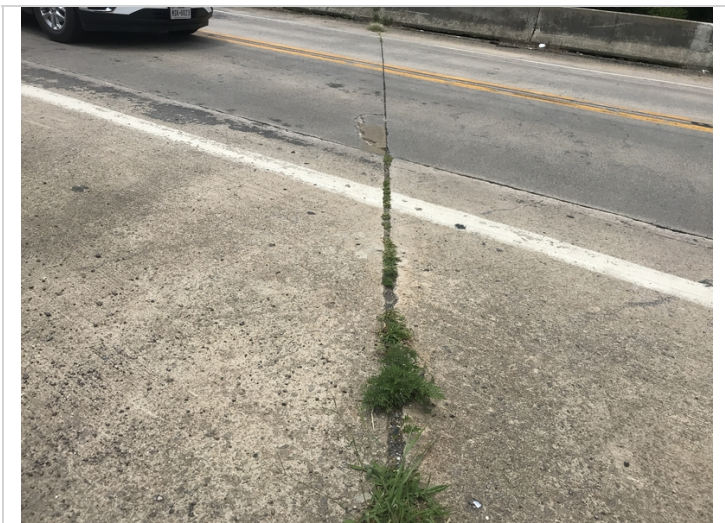
(301) -The joint seals are deteriorated and leak. -Debris accumulation in the joints typical in the gutters.							
331	Reinforced Concrete Bridge Railing	LF	100	53	27	20	0

Expansion joint sealant over Bent # 2.

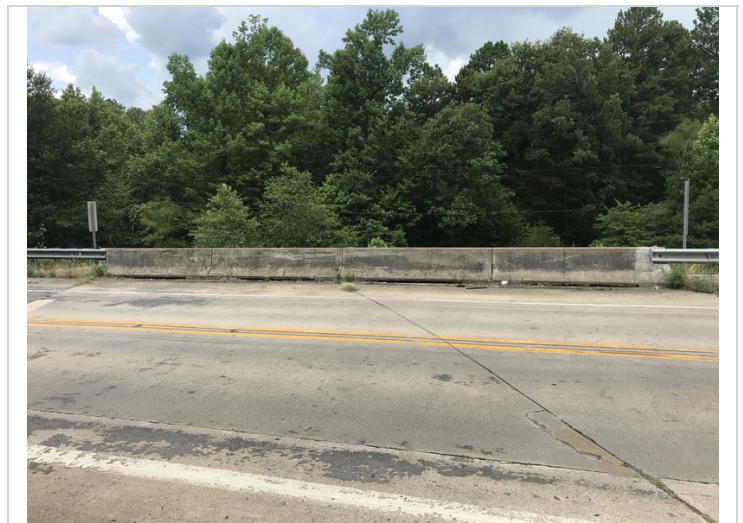
Left parapet. Typical.

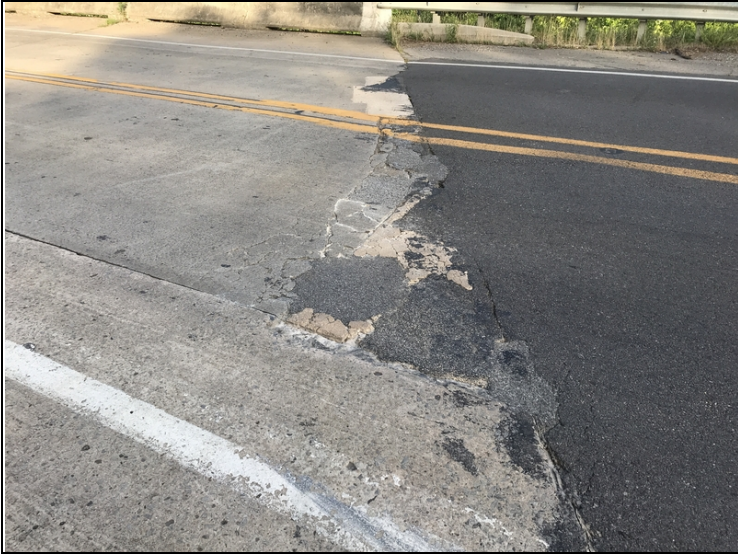
North bridge end.

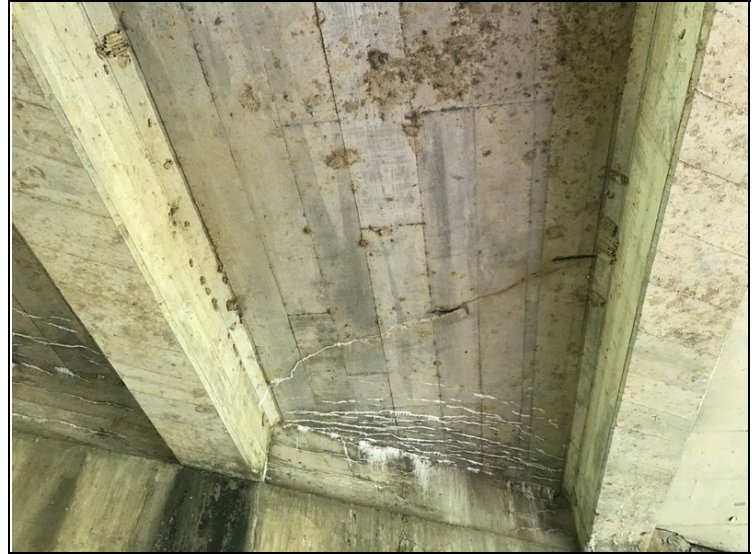
Span # 2 Bay # 2 deck soffit.

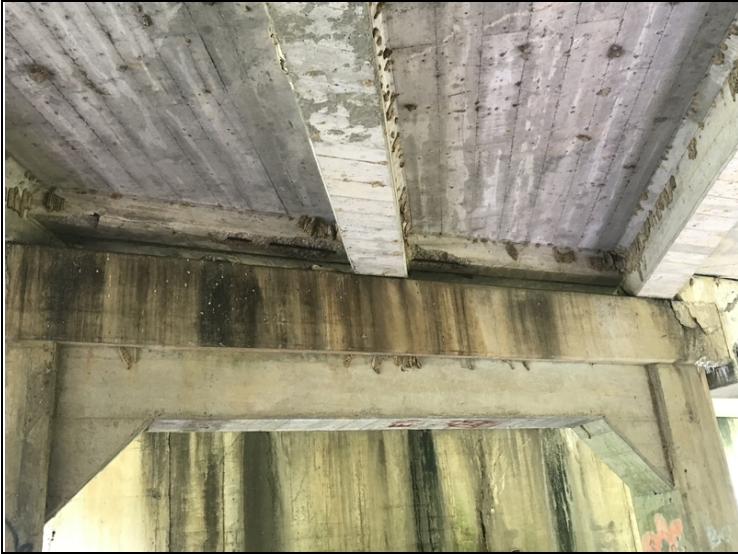
Span # 1 over Bent # 2 soffit of expansion dam.
