Asset #05864(Routine)

# US HWY 71-Logan Co over Little Petit Jean River

Location: 0.65 MI N. OF Scott, Co

Team Lead: Bob McEntyre, Inspection Date: 08/17/2022

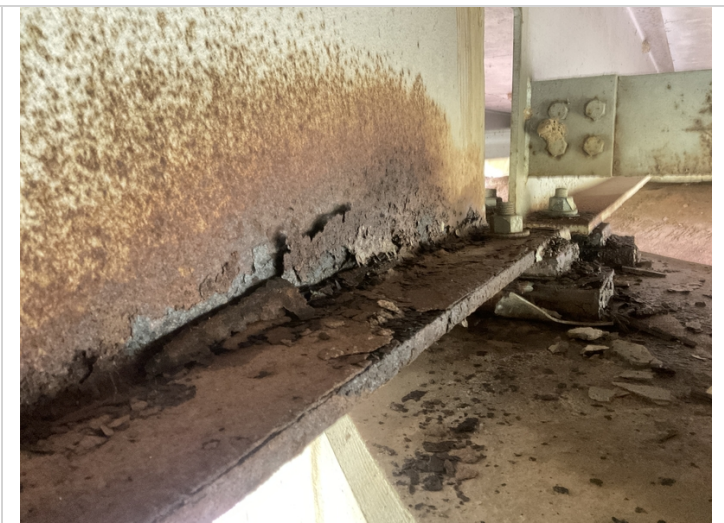
(107) -Superstructure has light freckled rust. -Beam ends have areas of active corrosion with flaking rust. Active corrosion and flaking rust was removed in numerous locations revealing section loss up to approximately 1/8" to base of webs and bottom flanges. The majority of the corrosion is limited to approximately 3' of the bearing area. -No visible cracks apparent during this inspection.							
205	Reinforced Concrete Column	EA	18	11	7	0	0
1080	Delamination/Spall/Patched Area	EA	1	0	1	0	0
1190	Abrasion/Wear (PSC/RC)	EA	6	0	6	0	0

Span 6, beam 4 at bent 7-Corrosion with flaking rust

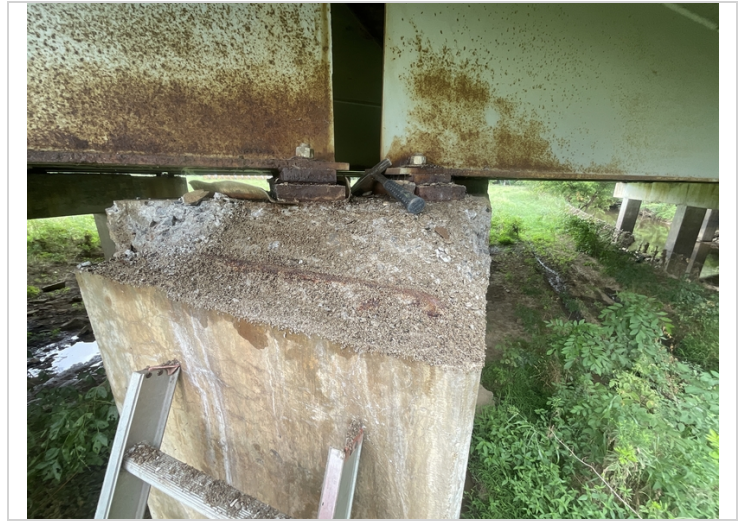
(234) -Substructure caps for the intermediate bents have full and partial width horizontal cracks located approximately 4" to 8" below the top of cap. -Cracks range in size from hairline up to 1/2" during this inspection indicating active corrosion in the primary longitudinal reinforcing steel. -Caps have vertical cracks over the center columns and over the exterior faces of the exterior columns. -Bent # 5 cap, left end has soft and deteriorated concrete with the top of the cap spalled off. The spalled area reaches the bearings but no loss of bearing area apparent at this inspection. -Bent # 6 cap backface between columns # 2 and # 3 has map cracking and delaminated areas. The left side of cap has a 9' long delaminated area in the top and face of cap. The delaminated area appears to extend under bearing # 1 of span # 5. -Several of the caps have delaminated areas and spalls with exposed reinforcing steel.

Bent # 5 cap, left end has soft and deteriorated concrete with spalling.

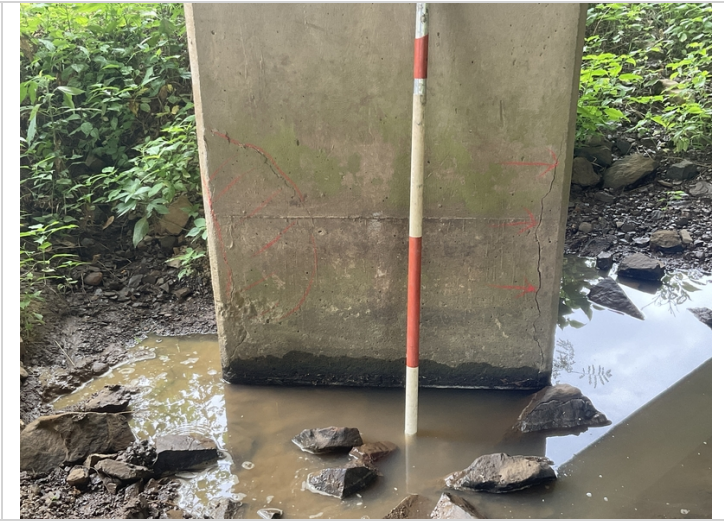
Bent # 6 column # 3

(205) -The columns in bents # 3 & 4 have light abrasion near the water elevation. -Bent # 6, base of column # 3 has vertical cracking along edge and a 16" x 10" delaminated area.							
215	Reinforced Concrete Abutment	LF	144	116	25	3	0
1090	Exposed Rebar	LF	1	0	0	1	0
1120	Efflorescence/Rust Staining	LF	5	0	5	0	0
1130	Cracking (RC and Other)	LF	22	0	20	2	0

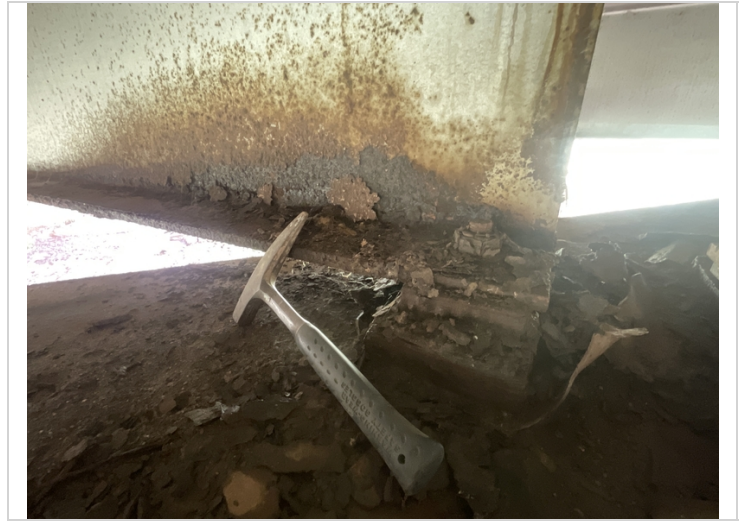
Span 6, beam 3 at bent 6-Corrosion/section loss

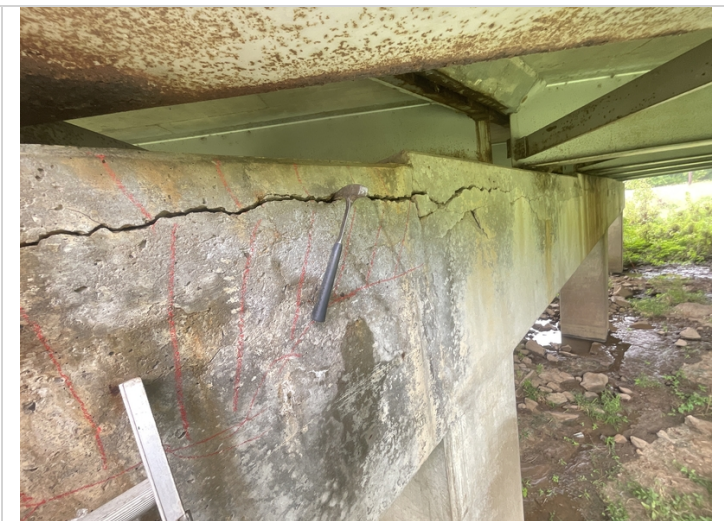
Bent # 6 cap backface, left side has 9' long delaminated area in the top and face of cap. The delaminated area appears to extend under bearing # 1 of span # 5

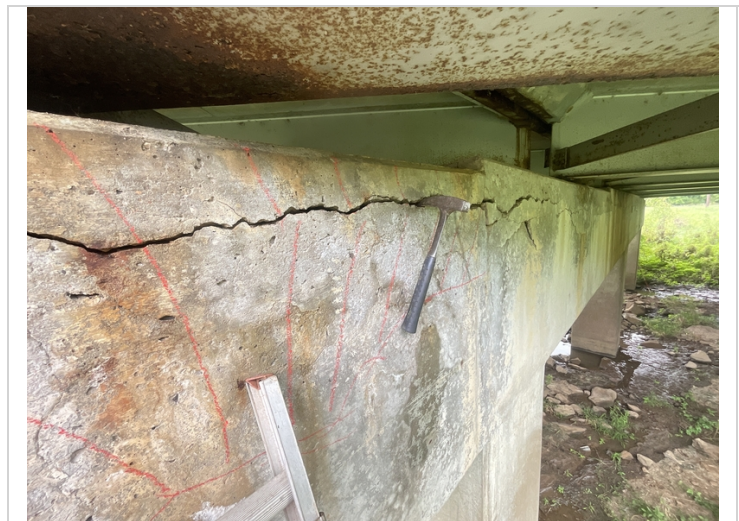
Bent # 6 cap backface, left side has 9' long delaminated area in the top and face of cap. The delaminated area appears to extend under bearing # 1 of span # 5

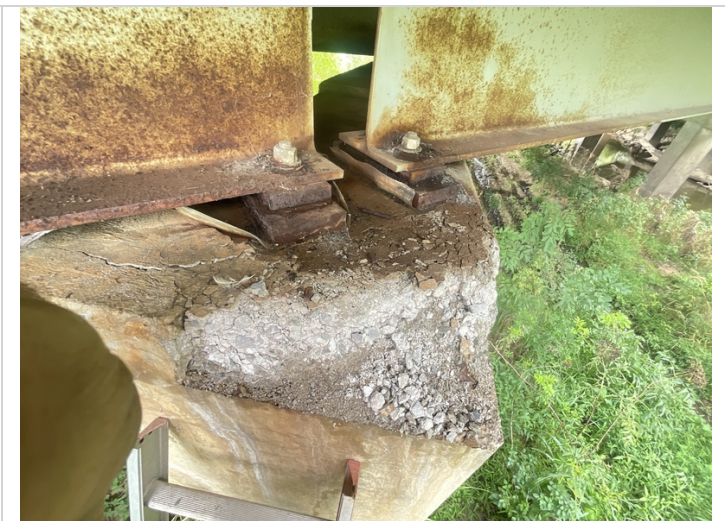
Bent # 5 cap, left end has soft and deteriorated concrete with spalling.

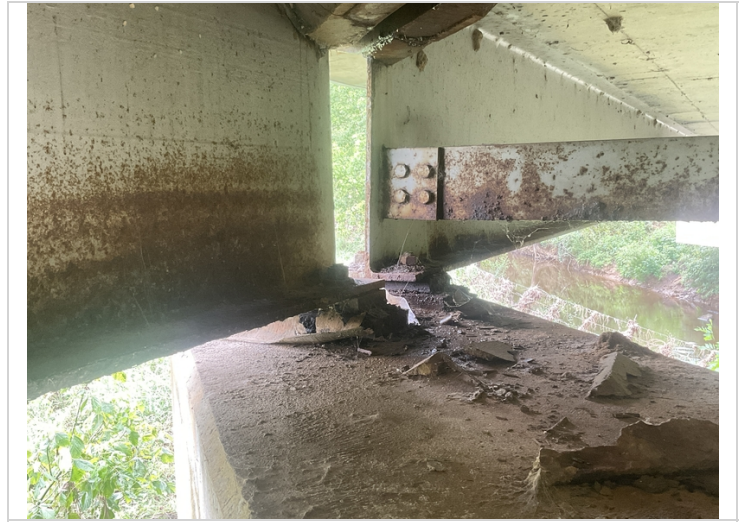
Beam 6 over bent 5-Corrosion

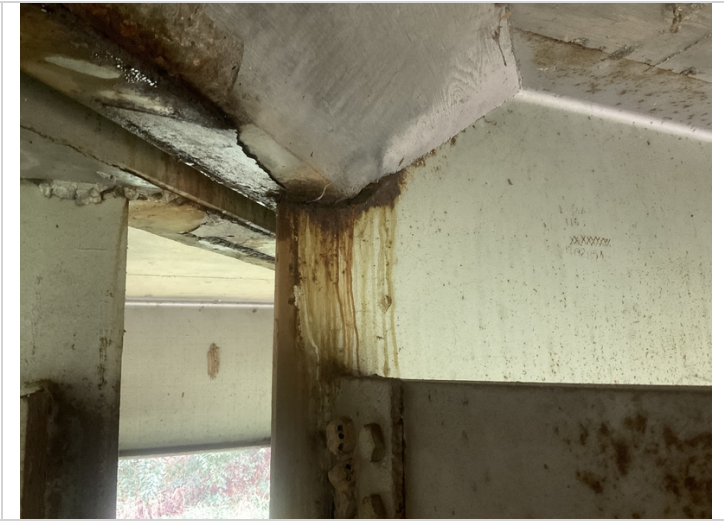
Span 5, beam 2 at bent 5-Corrosion to web at expansion dam

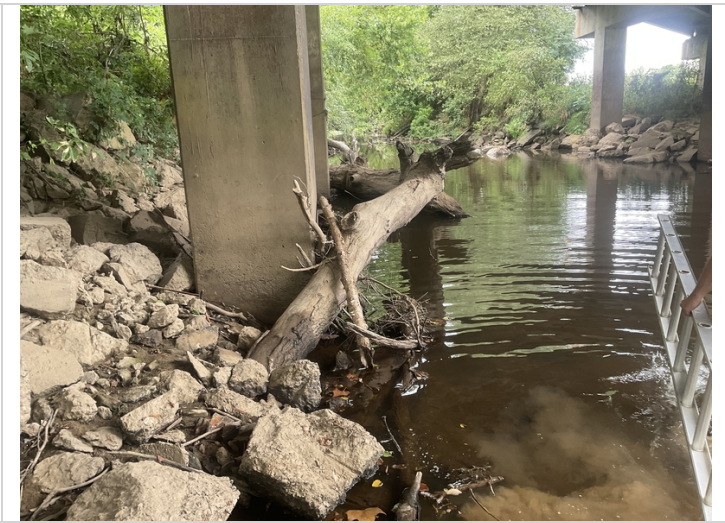
Drift at bent # 3

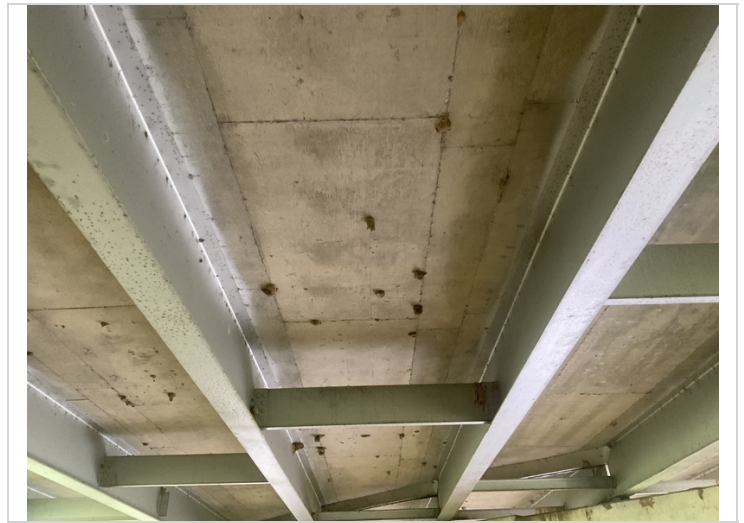
Typical undersurface

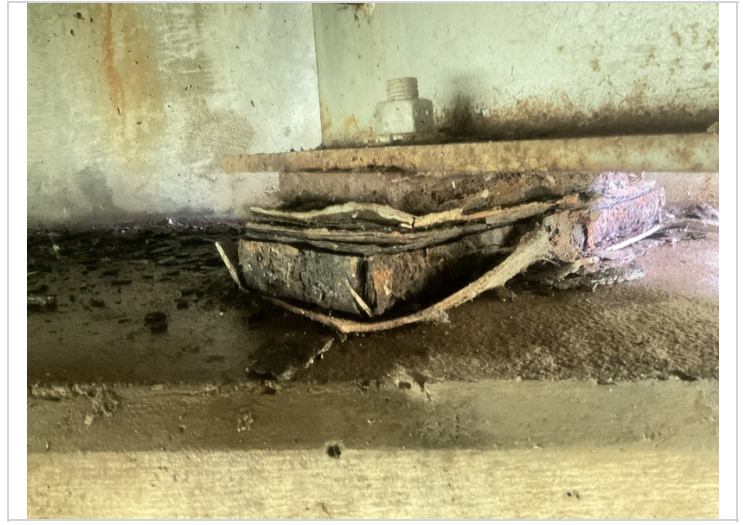
(311) -Bearings have active corrosion with flaking rust and heavy pack rust between the sole and masonry plates.							
313	Fixed Bearing	EA	42	0	0	42	0
1000	Corrosion	EA	42	0	0	42	0
515	Steel Protective Coating	SF	42	0	0	0	42
3440	Effectiveness (Steel Protective Coatings)	EA	42	0	0	0	42

Abutment 1, bearing 1-Corrosion

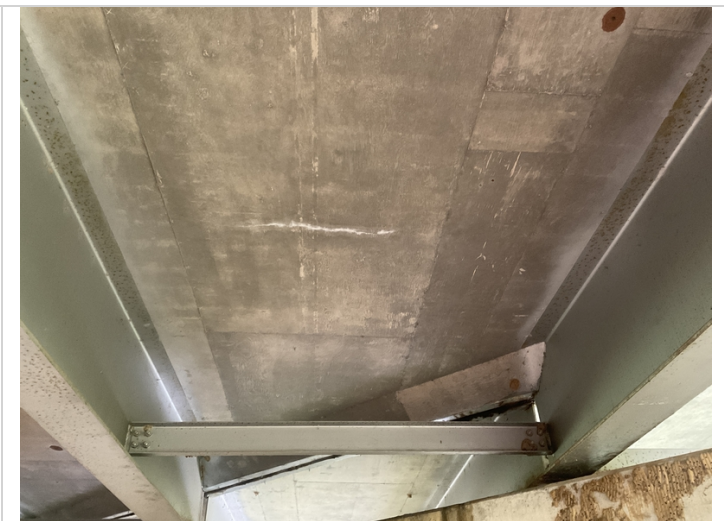
Span 1, bay 4-Transverse crack with efflorescence

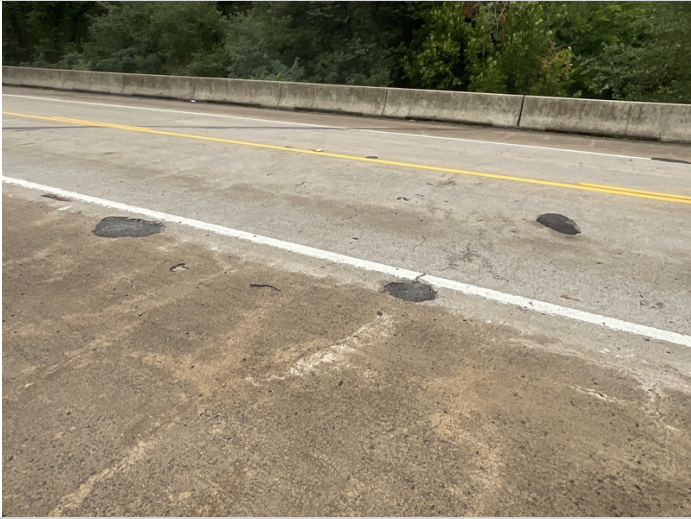
Span # 4 has several moderate sized spalls with temporary asphalt repairs.

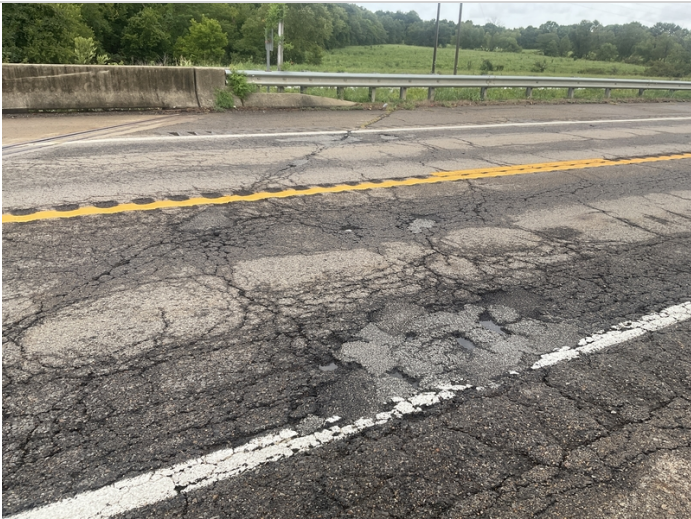
Asphalt driving surface of the North approach roadway is breaking apart with potholes forming.

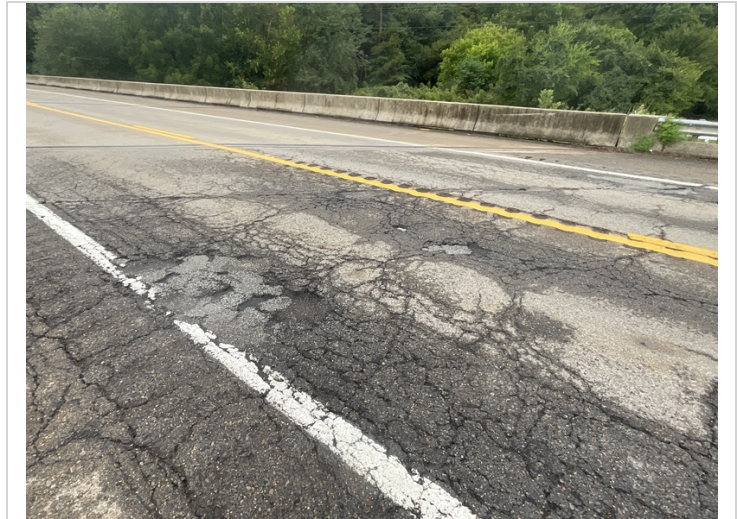
Asphalt driving surface of the North approach roadway is breaking apart with potholes forming.

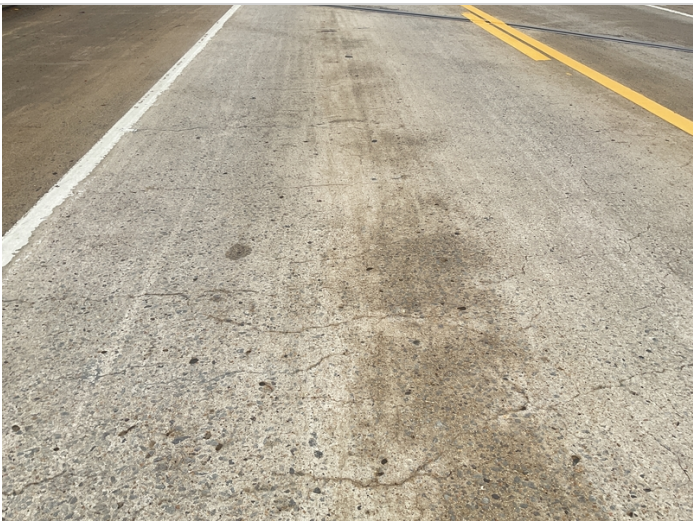
Span 3, left lane-Mapcracking

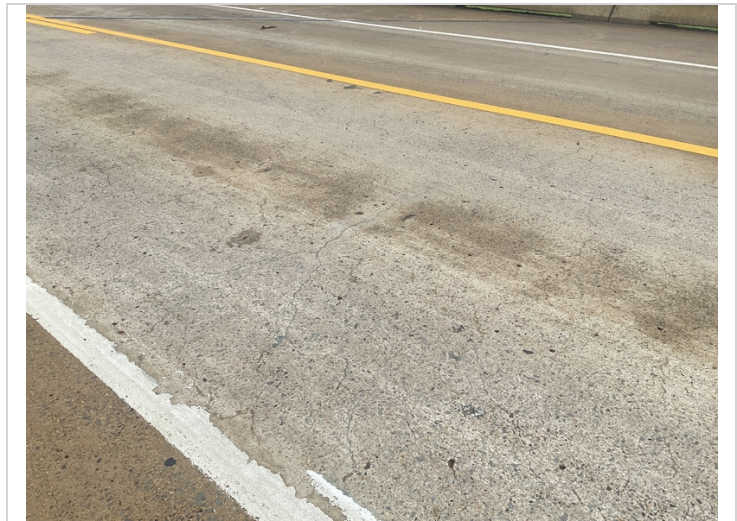
Span 3, left lane-Mapcracking

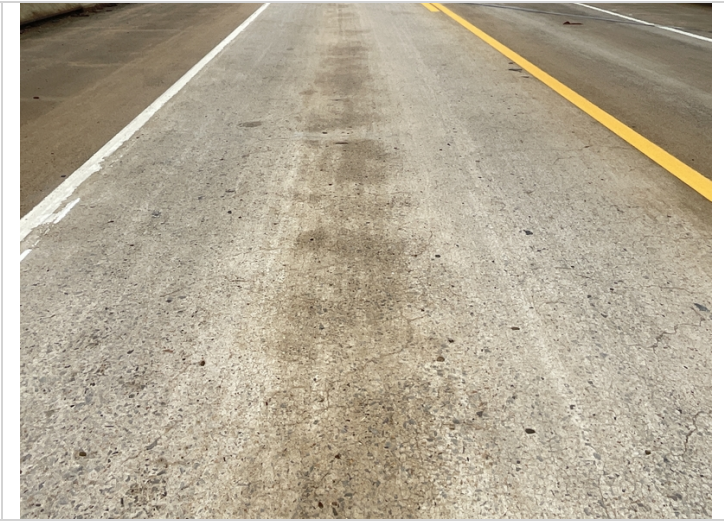
Span 3, left lane-Mapcracking

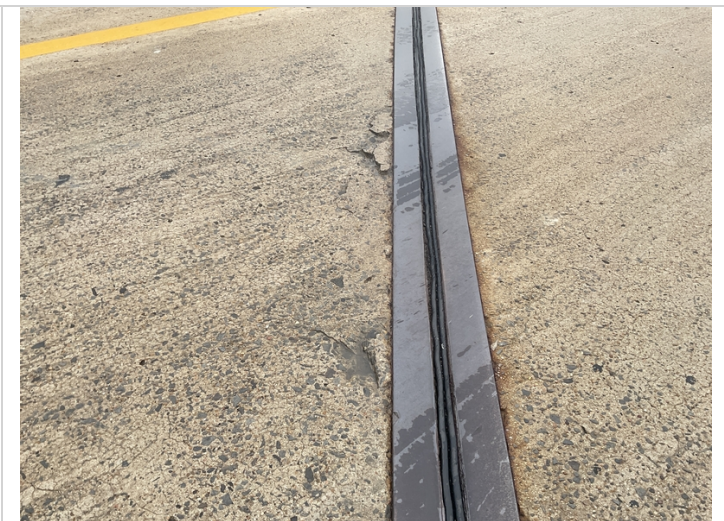
Span 2, right lane at bent 3-Delaminated/spalled area adjacent to expansion joint assembly

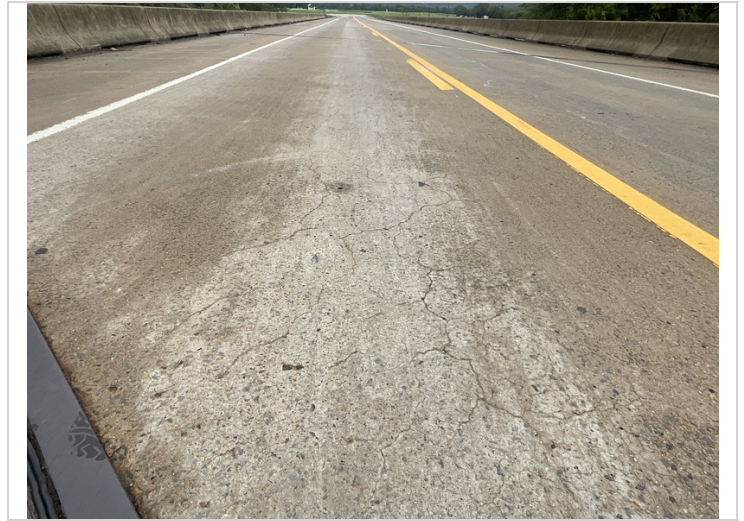
Span 1, left lane-Mapcracking

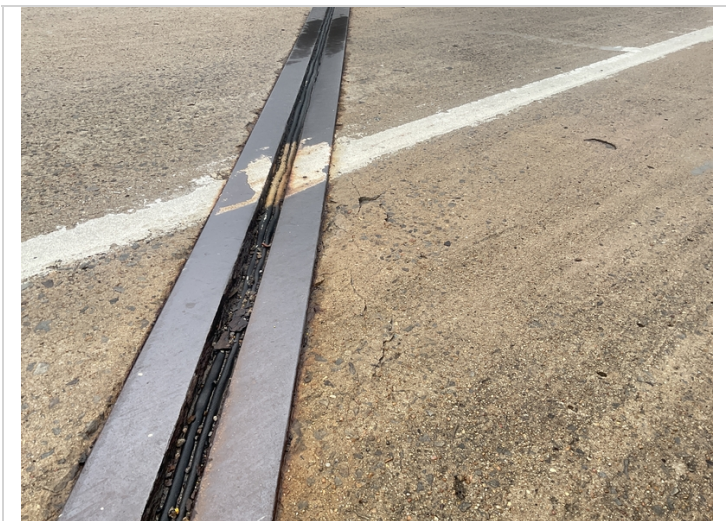
Span 2, left shoulder-Delaminated area adjacent to bent expansion joint assembly

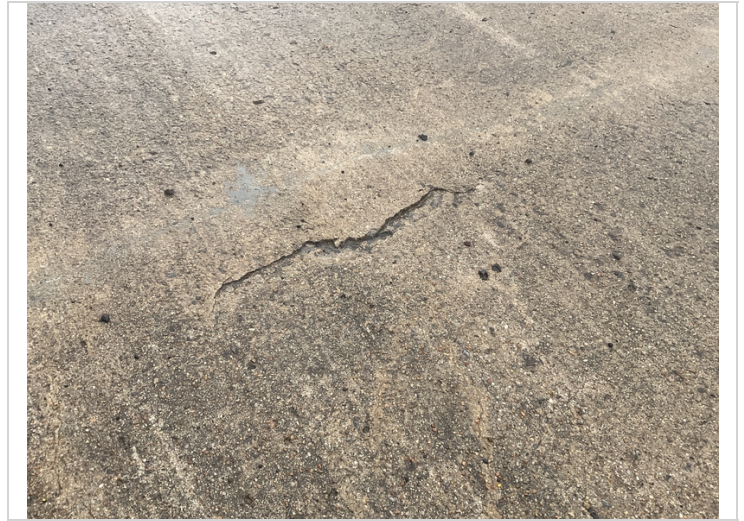
Span 1, left shoulder-Shallow delaminated area

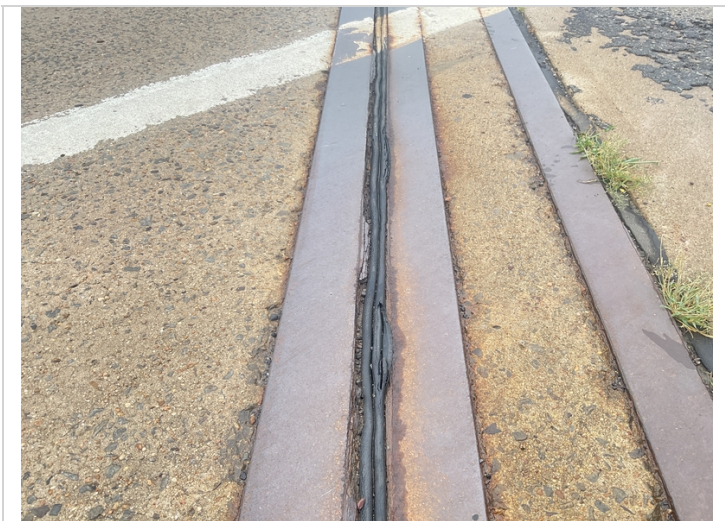
Abutment 1 expansion joint-Deterioration

Expansion joint assemblies have corrosion with pack rust causing seal adhesion failure. Abutment 1 expansion joint pictured

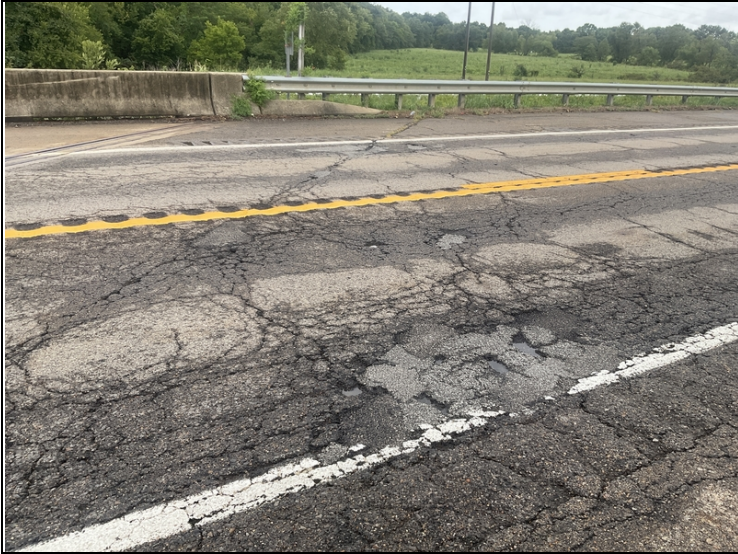
Asphalt driving surface of the North approach roadway is breaking apart with potholes forming.

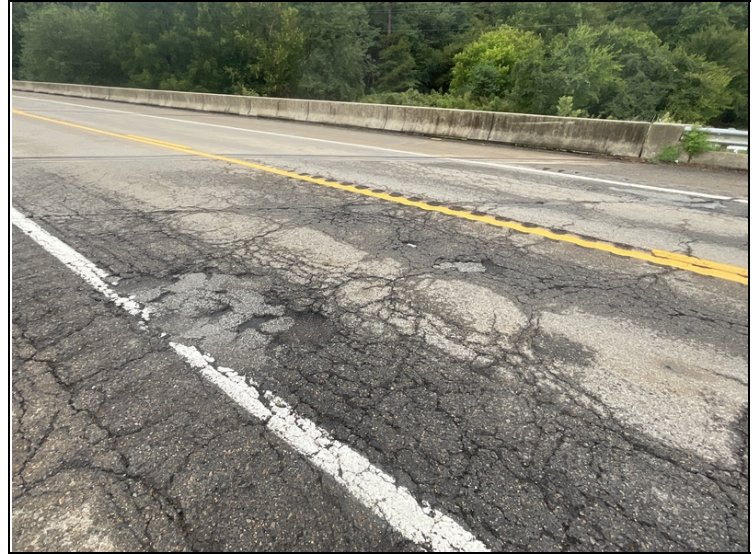
Asphalt driving surface of the North approach roadway is breaking apart with potholes forming.

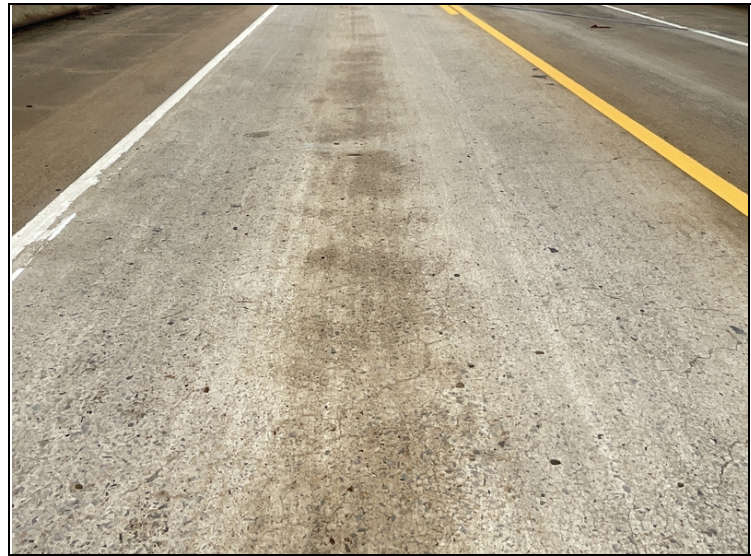
The driving surface of the deck has numerous areas of unsealed mapcracking in all spans.

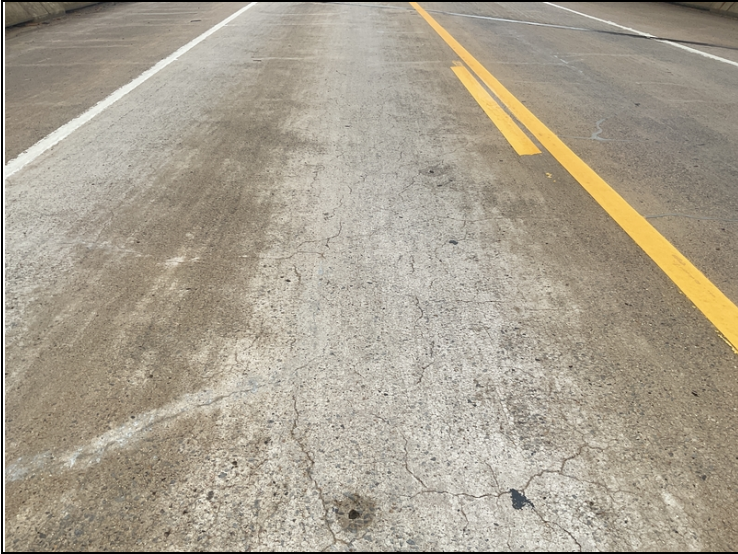
Span # 1, left lane-Mapcracking.

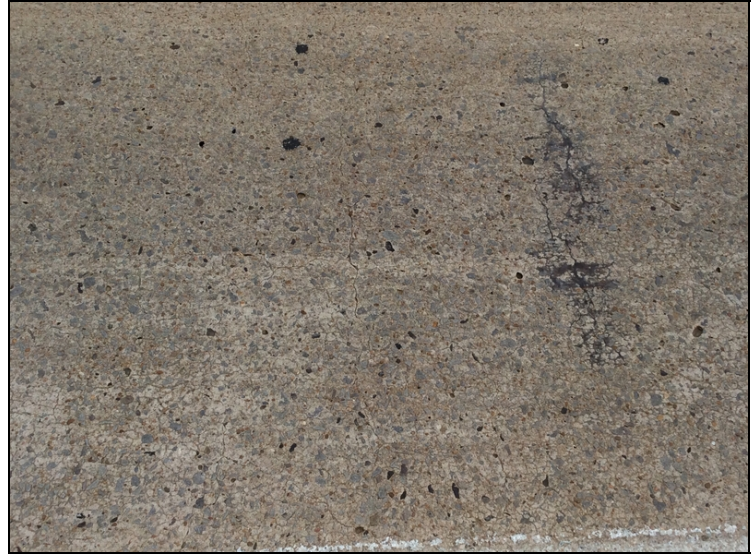
The driving surface of the deck has numerous areas of unsealed mapcracking in all spans.

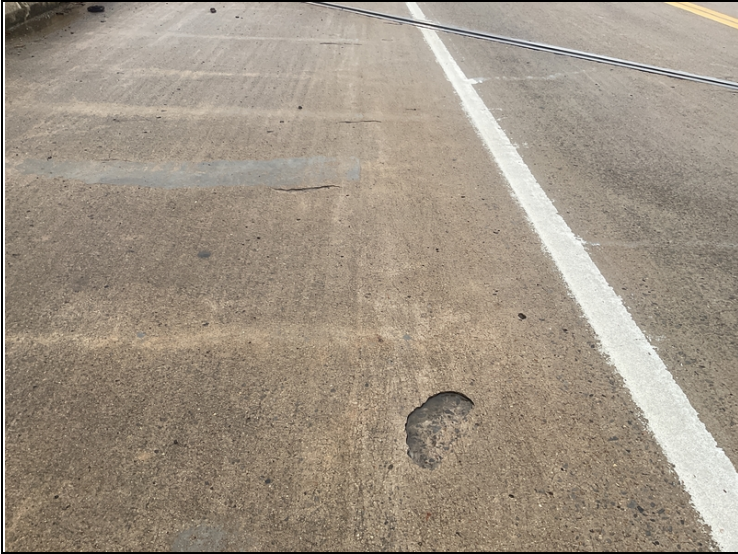
Span # 1, left shoulder-Shallow delaminated areas.
