Asset #00348(Routine, Underwater type 2)

State Highway 22 over Big Creek Seb. Co.

Location: 0.10 MI E OF BLOOMER, ARK

Team Lead: Jeff Jones, Inspection Date: 08/01/2022

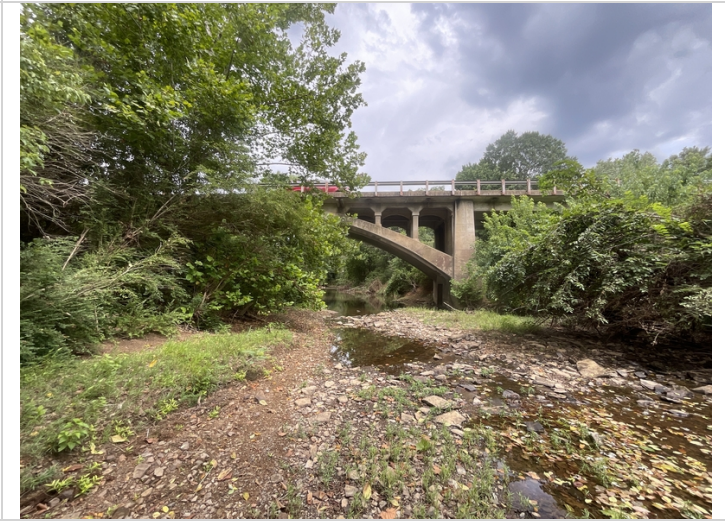
Elevation.

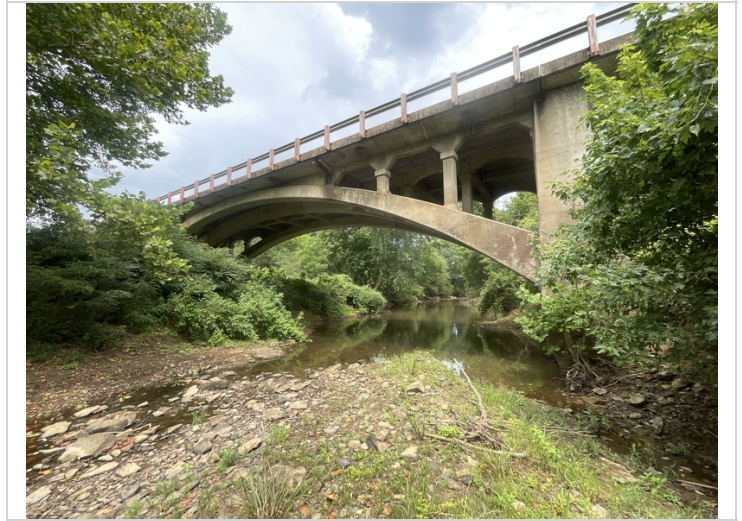
Elevation. Typical.

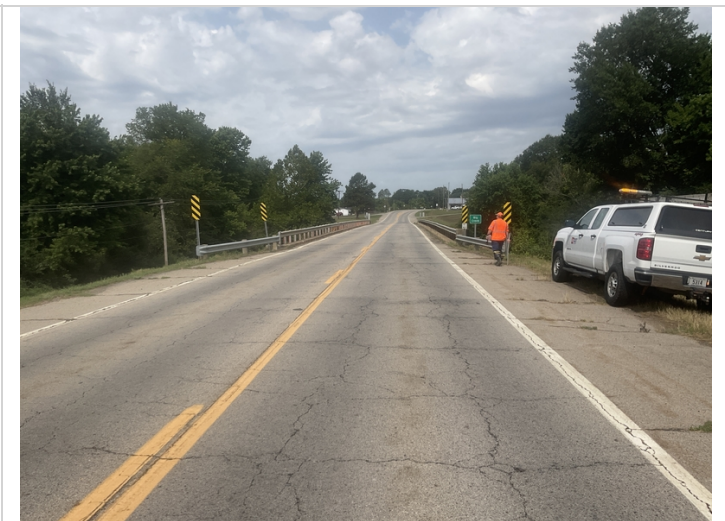
Approach roadway facing West.

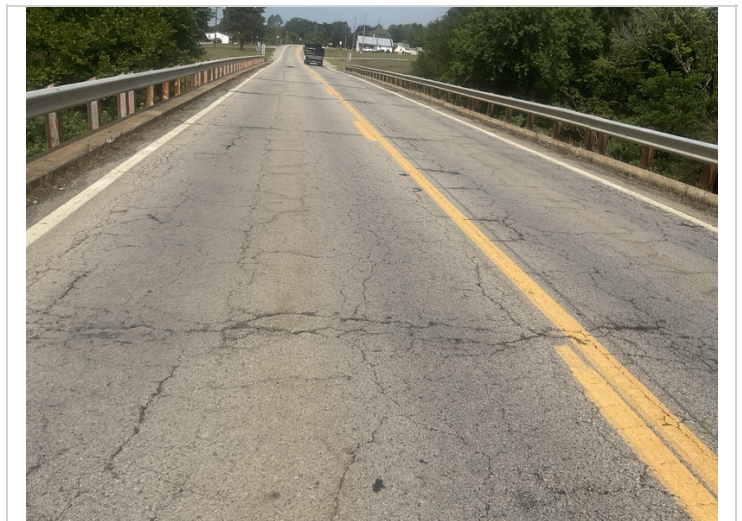
Deck. Typical.

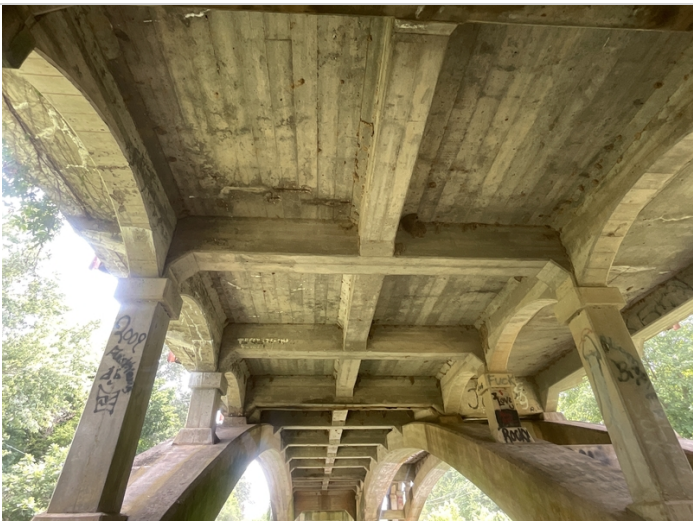
Span # 2 deck soffit. Typical.

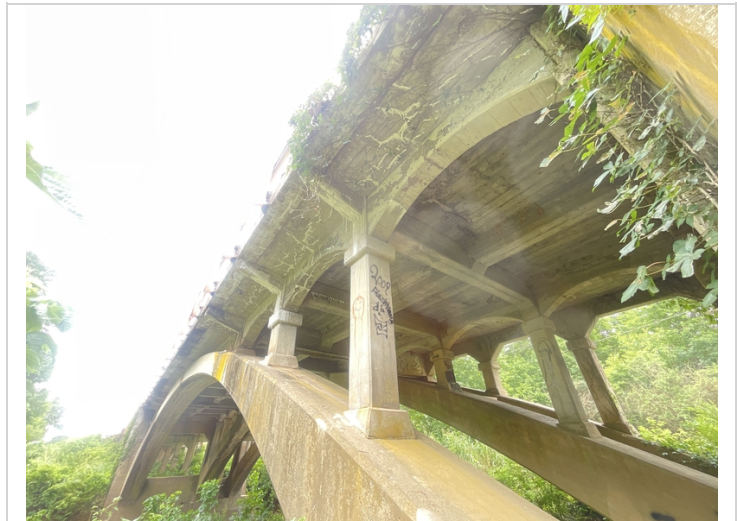
Left deck soffit and overhang. Span # 2.

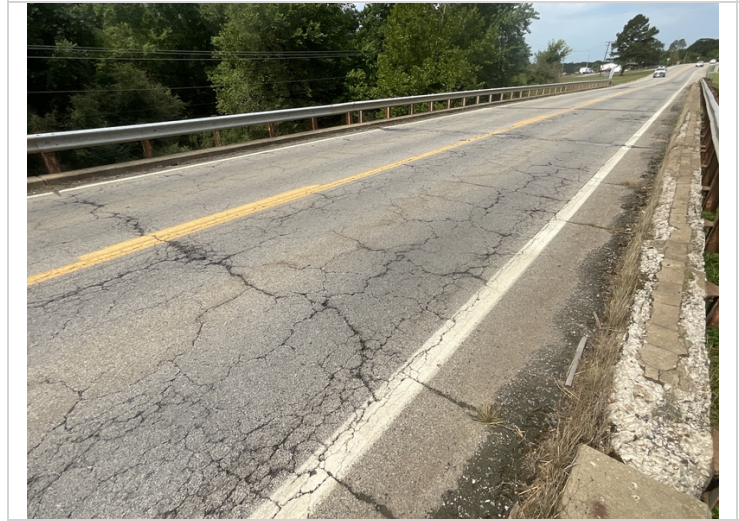
Deck. Typical.

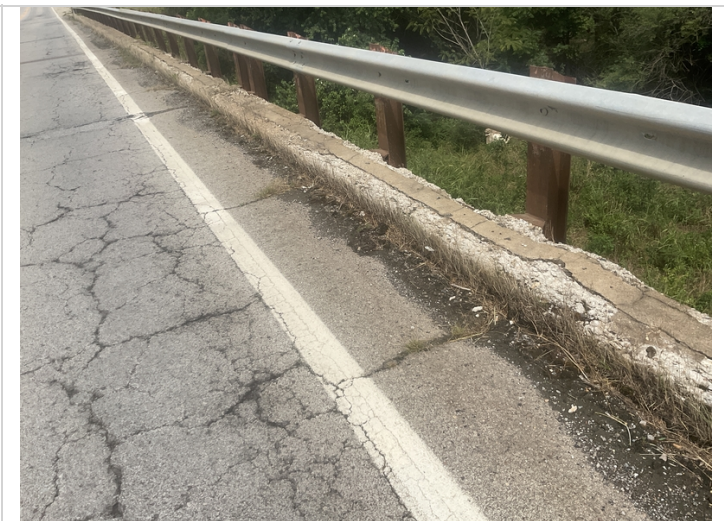
Debris in the Left gutter.

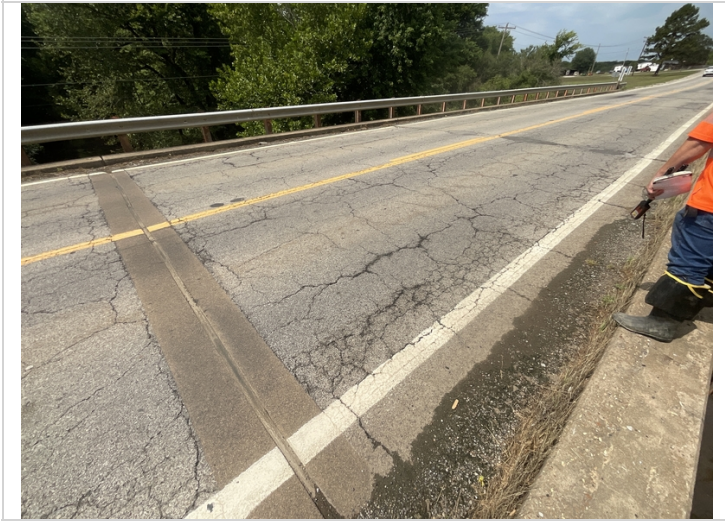
Deck over Span # 2. Typical.

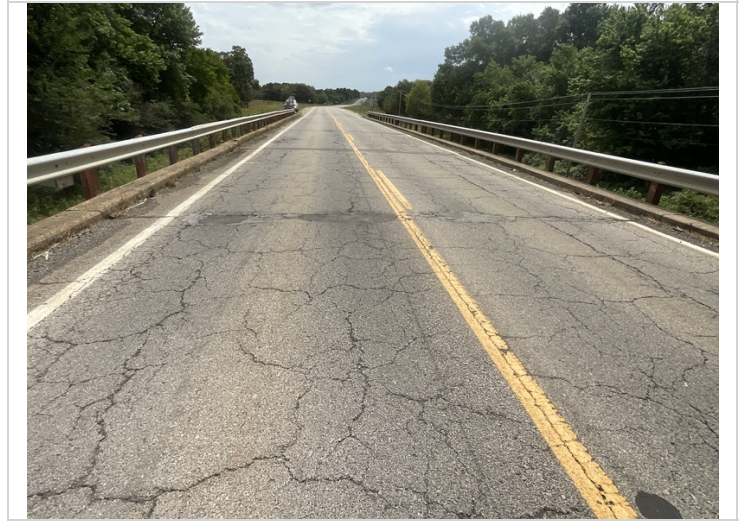
Deck. Typical.

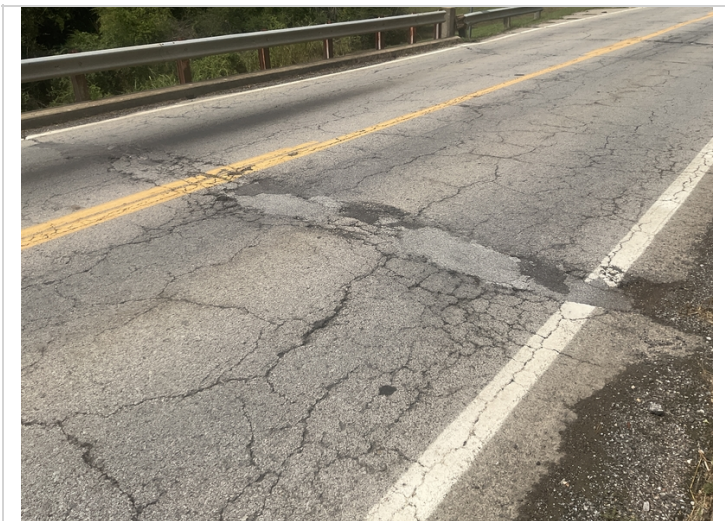
Expansion joint over Bent # 2. Typical.

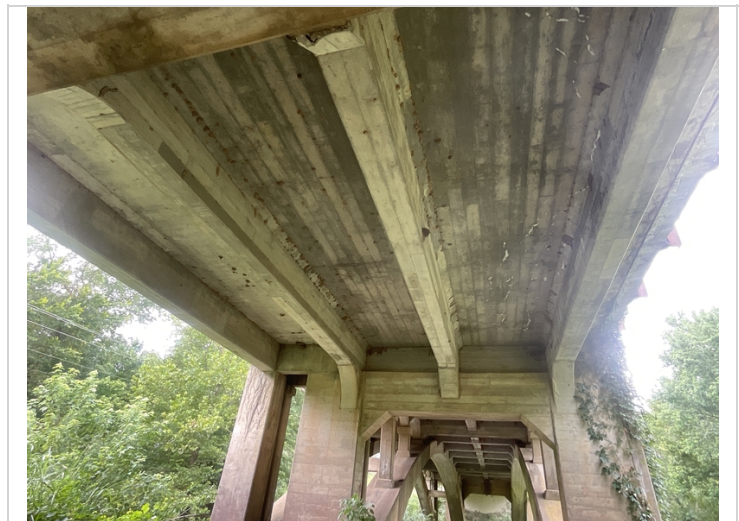
Span # 3. Typical.

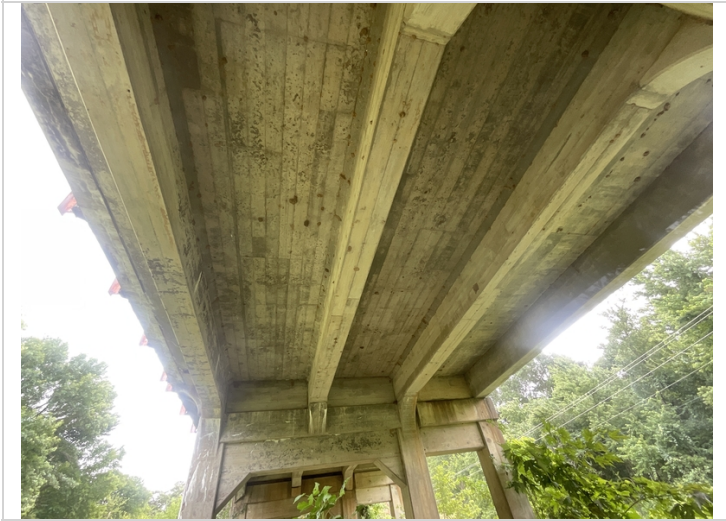
Span # 4 superstructure. Typical.

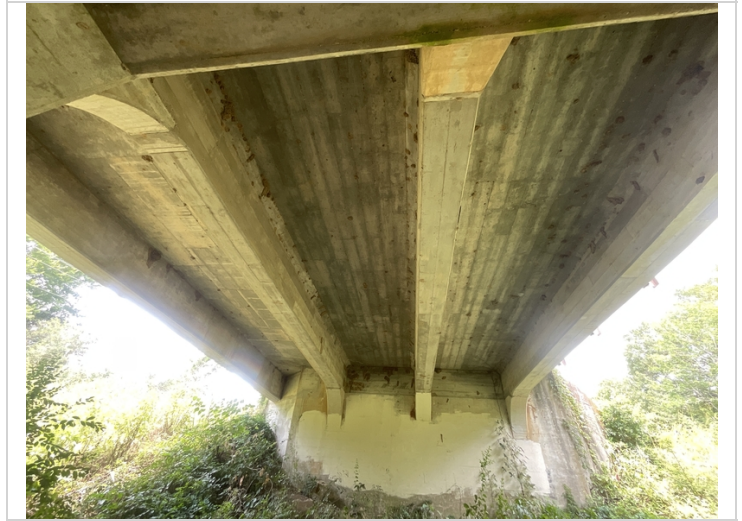
Span # 1 superstructure. Typical.

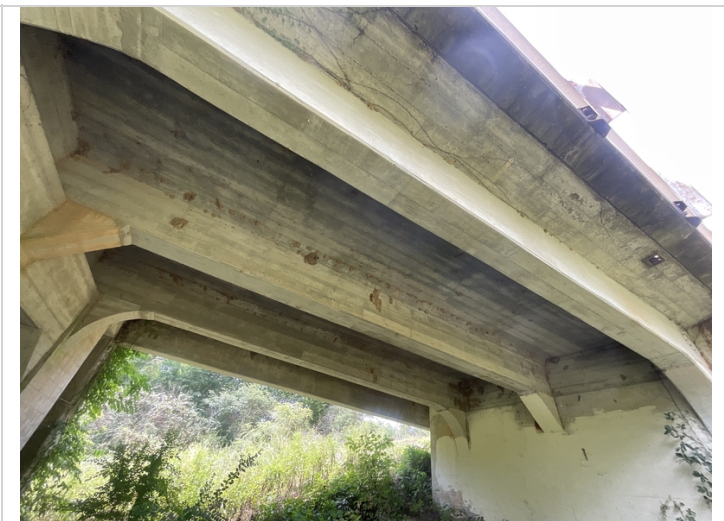
Span # 1 superstructure. Typical.

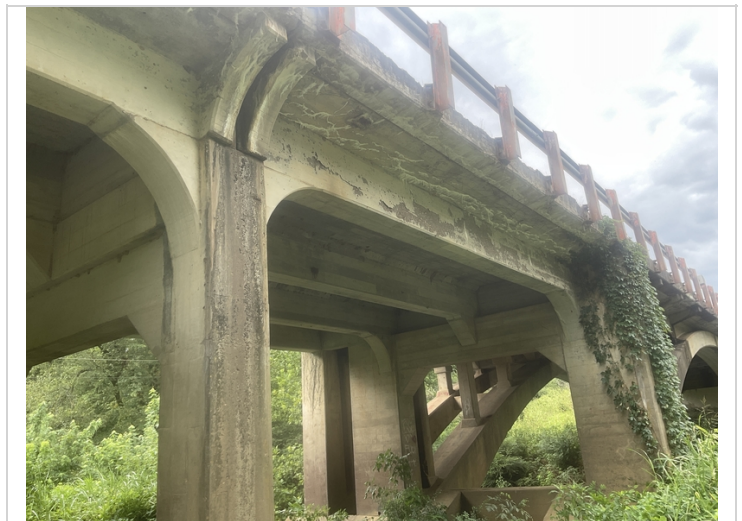
(110) -The exterior concrete girders have medium scale in the Left side of bridge. -Span # 5, Girders # 1 and 3 have concrete spalling at the haunches adjacent to Bent # 6. -Vertical hairline flexure cracks are typical in the concrete girders. -There are no apparent repairs since the last inspection.							
144	Reinforced Concrete Arch	LF	302	276	3	23	0
1080	Delamination/Spall/Patched Area	LF	3	0	1	2	0
1090	Exposed Rebar	LF	19	0	0	19	0
1130	Cracking (RC and Other)	LF	4	0	2	2	0

Span # 3. Girder # 1. Scale on the exterior face of the girder.

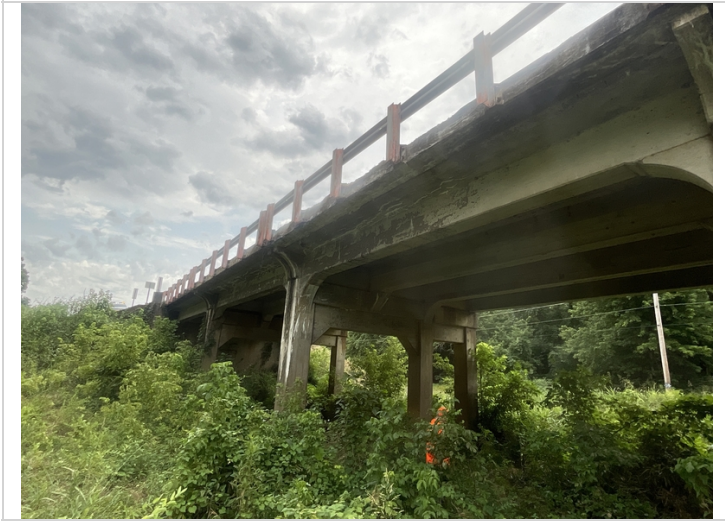
Scale. Girder # 1 Spans # 4 & 5.

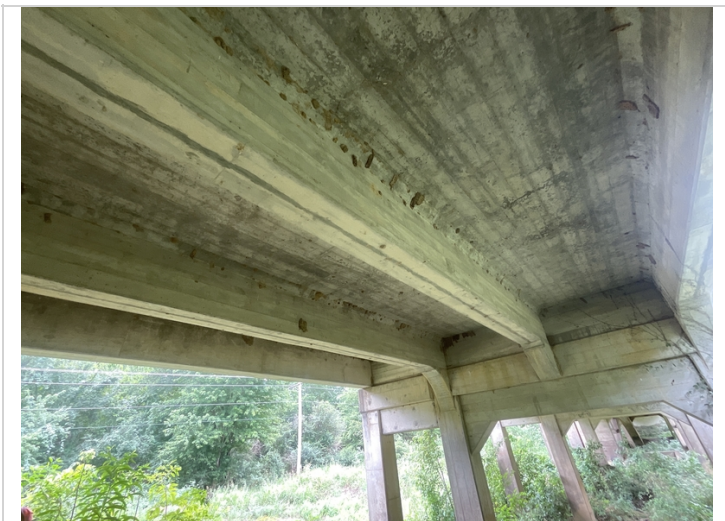
Span # 6. Typical.

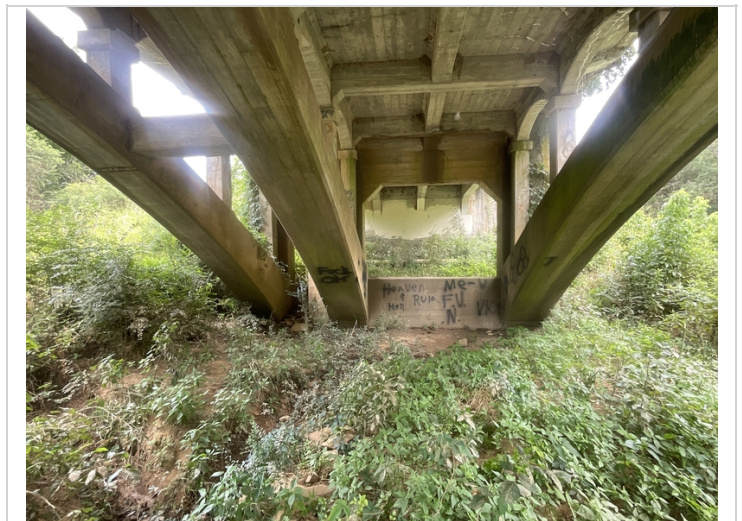
Skewback at Bent # 2. Typical.

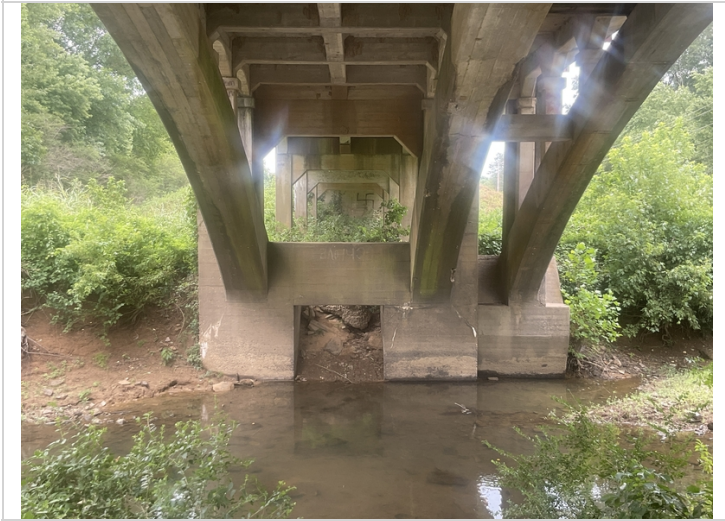
Skewback at Bent # 3. Typical.

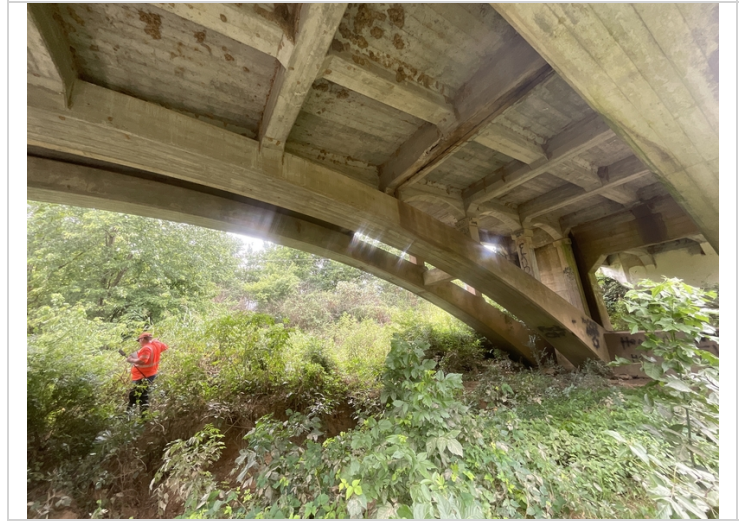
Arch Ribs # 2 & 3 adjacent to Bent # 2. Typical.

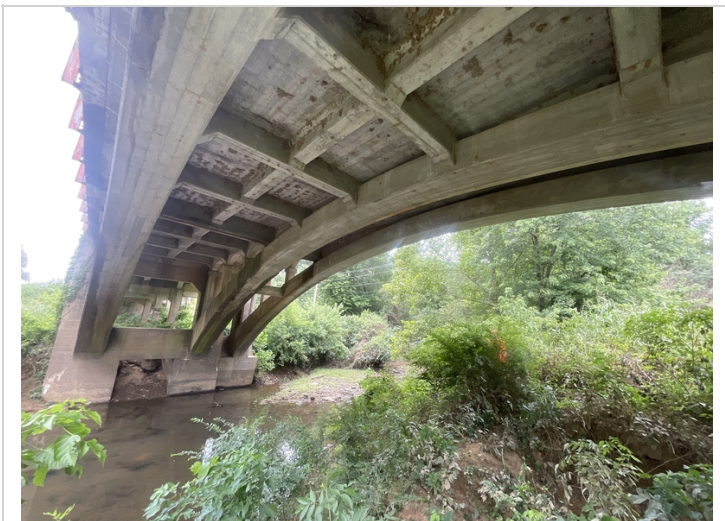
Arch Ribs # 2 & 3 adjacent to Bent # 3.

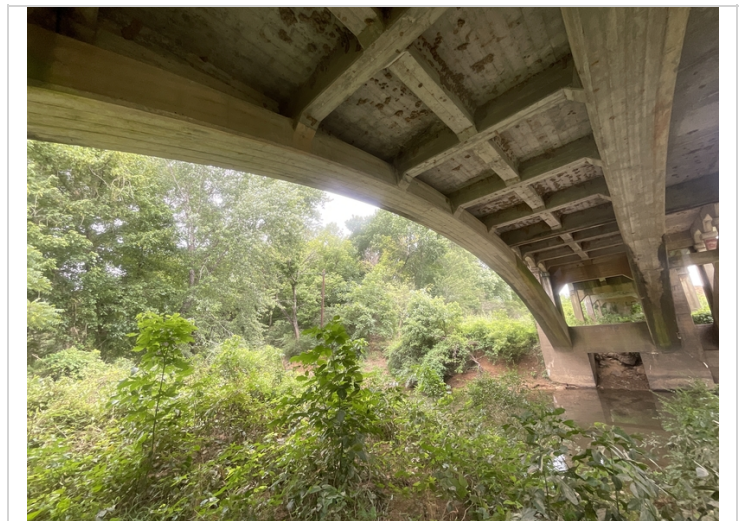
Arch Rib # 1 adjacent to Bent # 3. Typical.

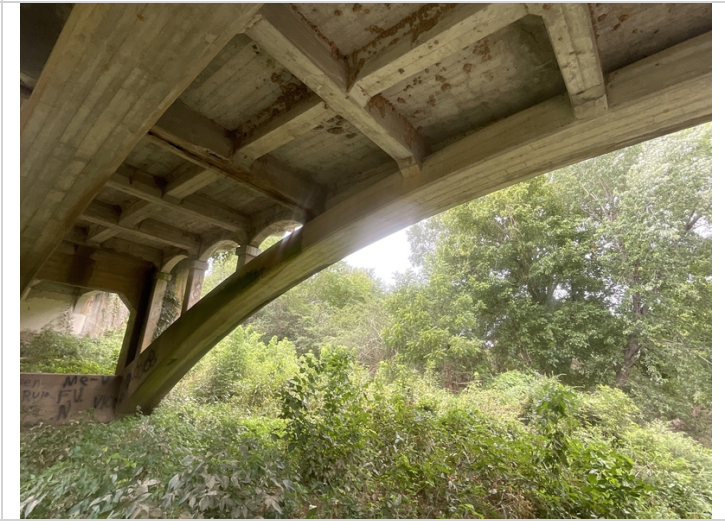
Arch Rib # 1 adjacent to Bent # 2.

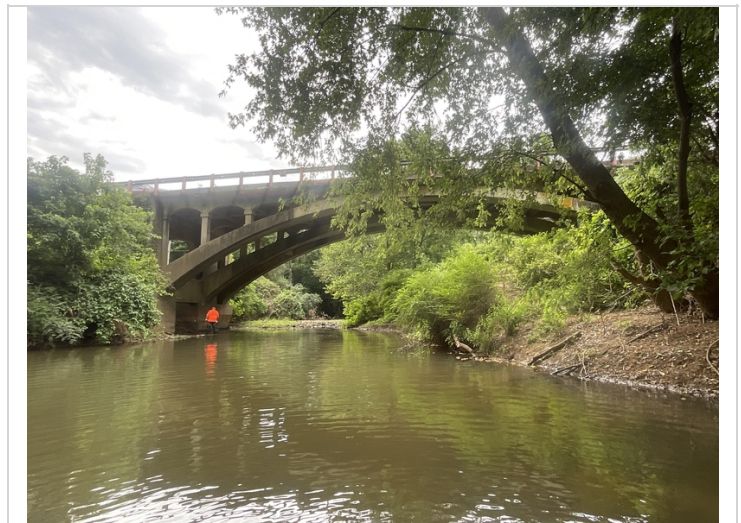
Arch. Typical.

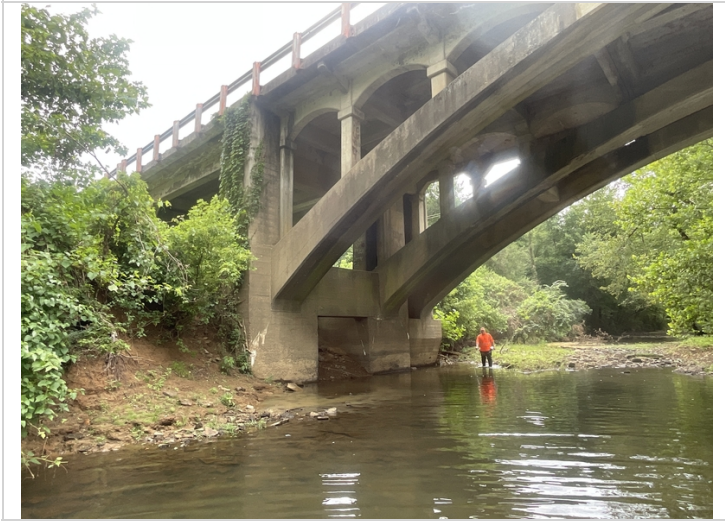
Bent # 3. Typical.

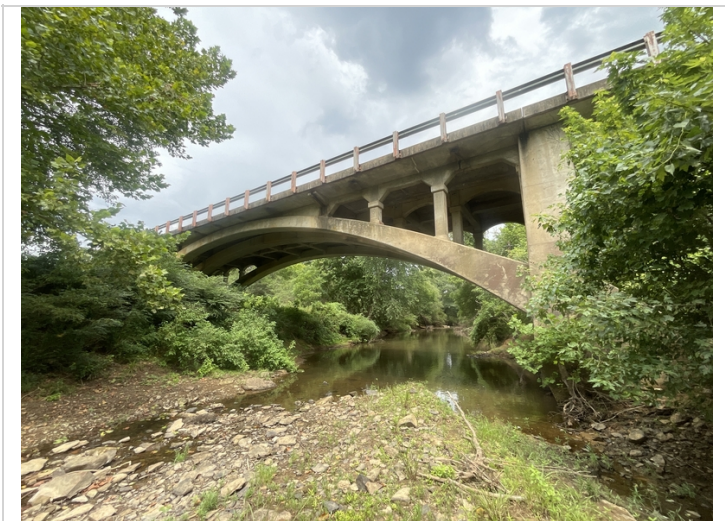
Arch. Typical.

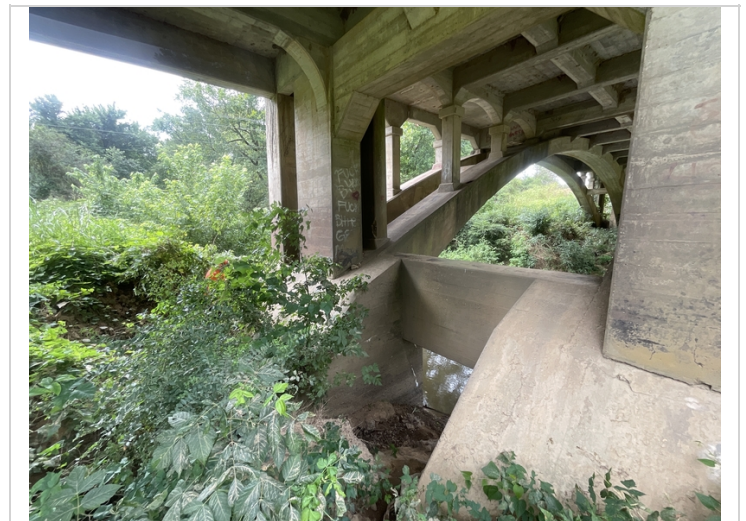
Bent # 3 Skewback arch Ribs # 2 & 3. Typical.

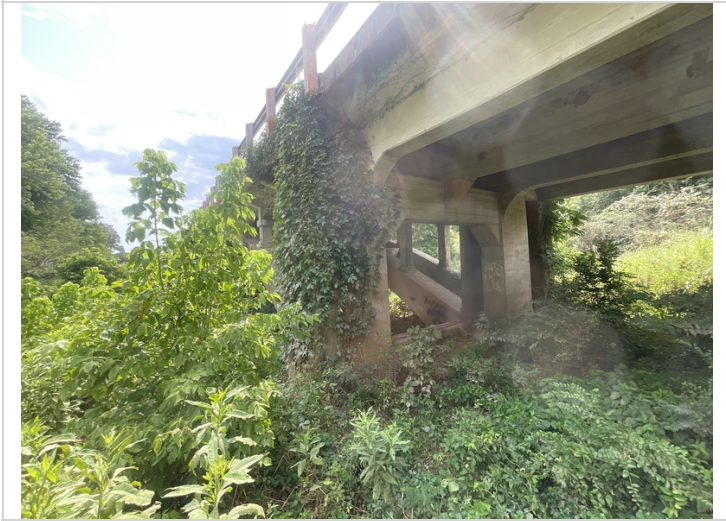
Portions of the structure are covered in vegetation during this inspection.
Photo taken of the Left column of Bent # 2.

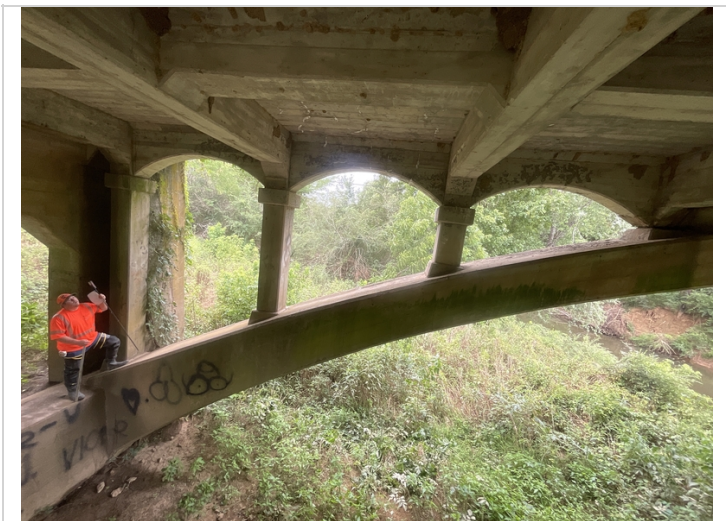
Columns of Span # 2 adjacent to Bent # 2.

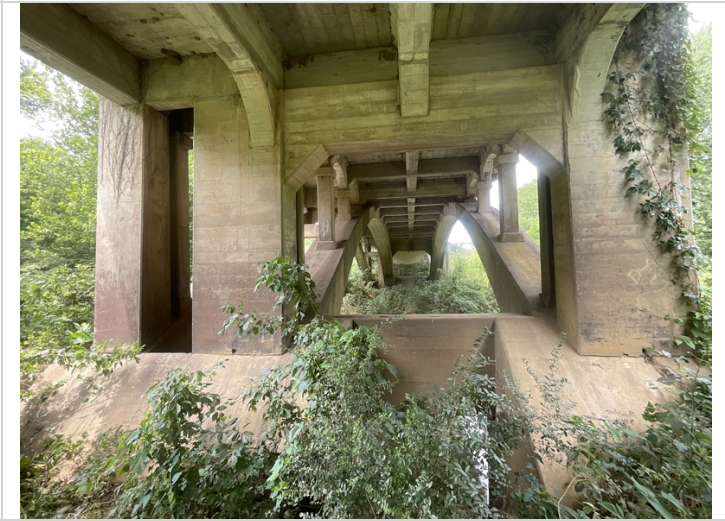
Superstructure. Span # 2 looking from Bent # 3 facing West.

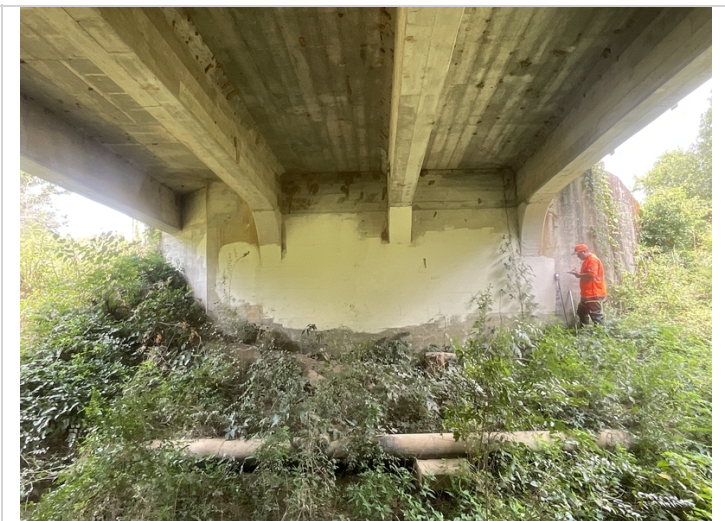
Bent # 1. West abutment. Abutment # 1. Typical.

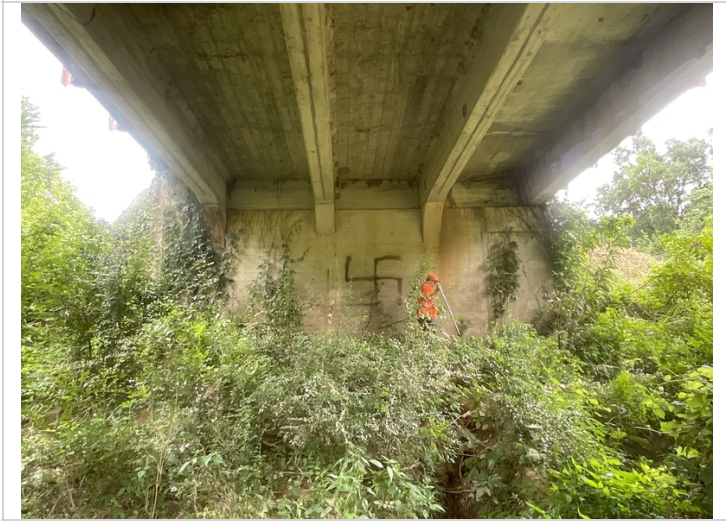
Bent # 7. East abutment. Abutment # 2. Typical.

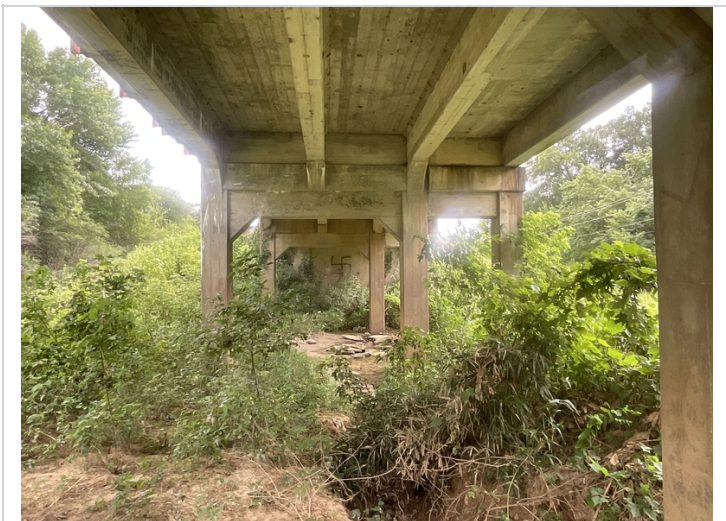
Bent # 5 back face. Typical.

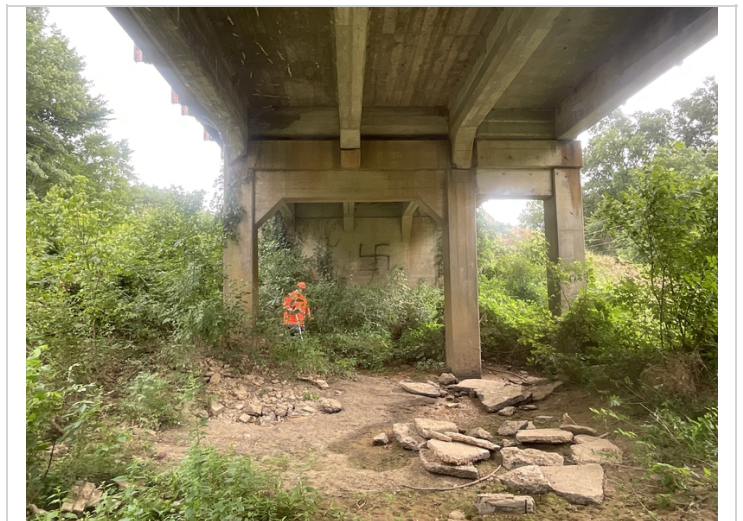
Bent # 6 back face. Typical.

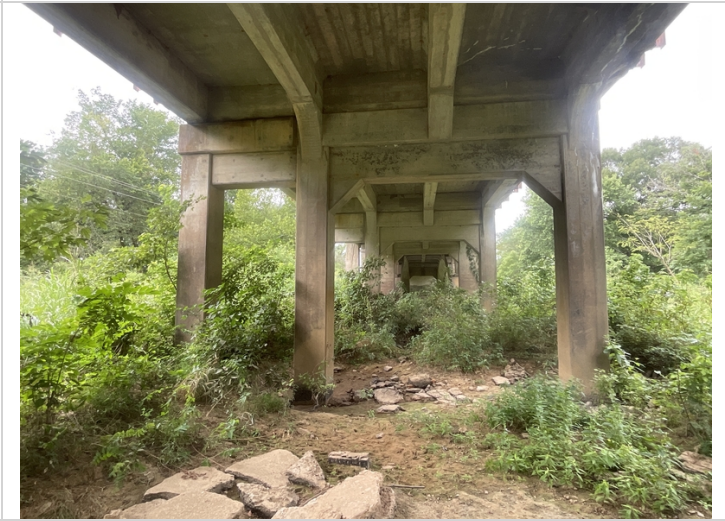
Bent # 5 ahead face. Typical.

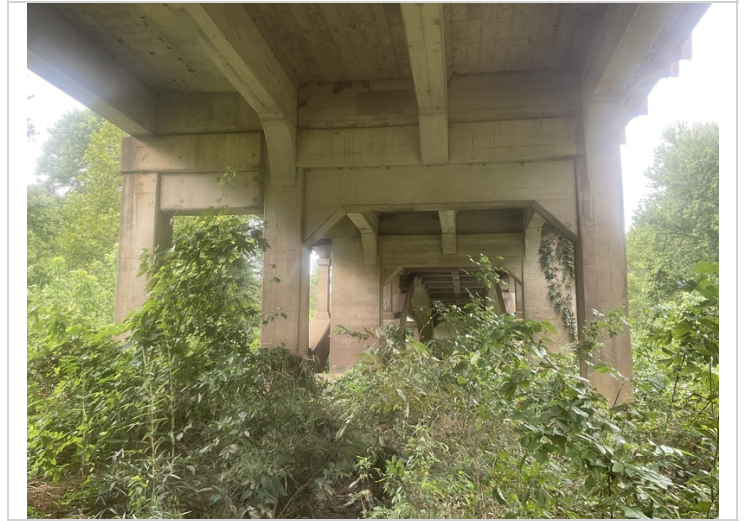
Bent # 4 ahead face. Typical.

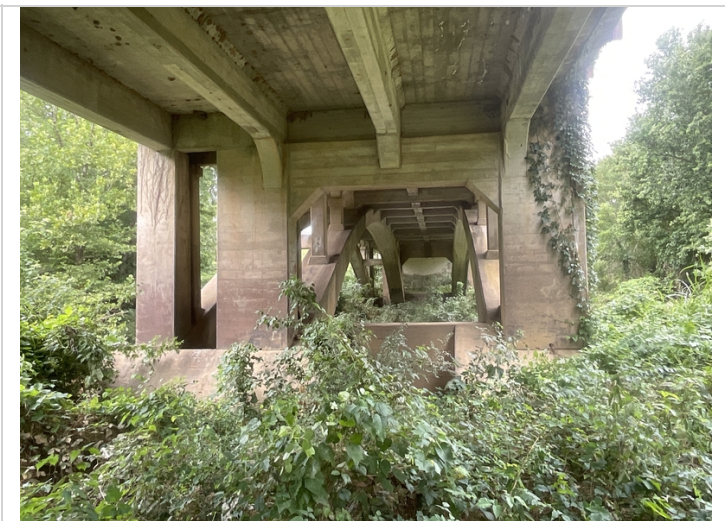
Bent # 3 ahead face. Typical.

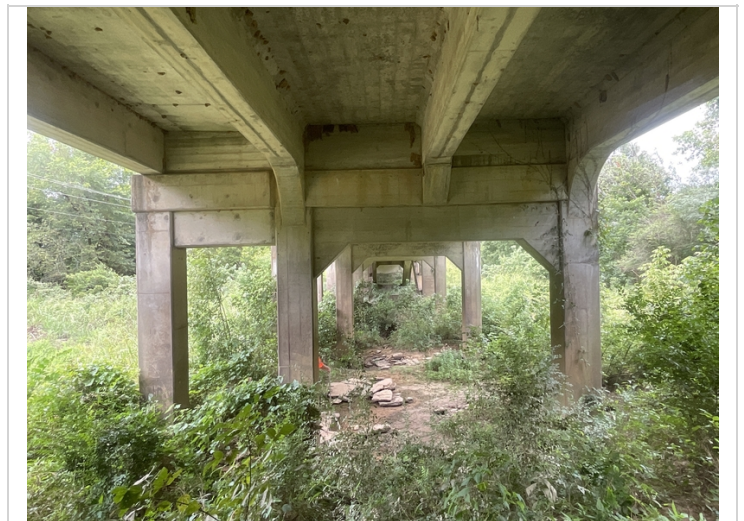
Bent # 6. Ahead face. Typical.

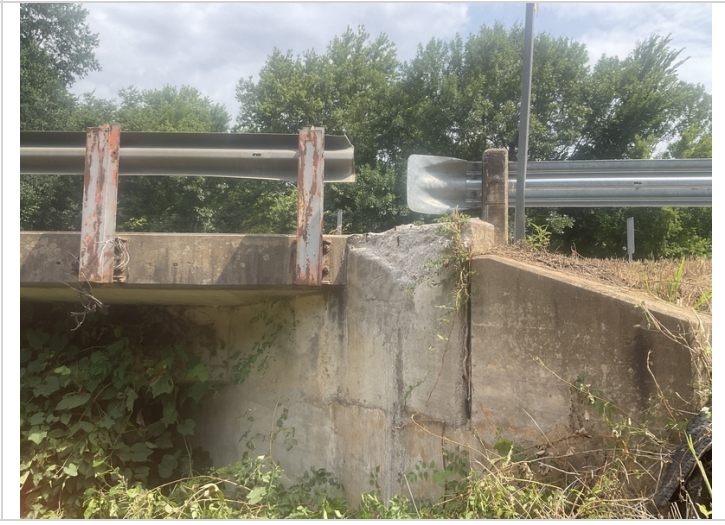
The Southeast end post has been knocked off the structure.

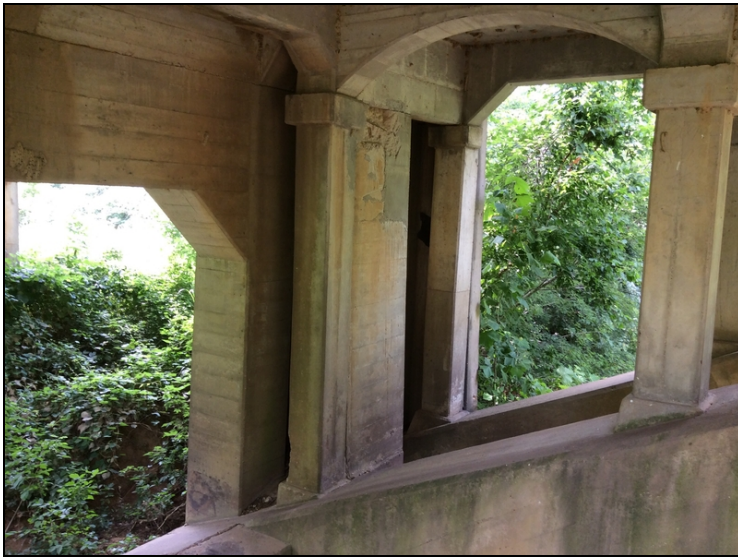
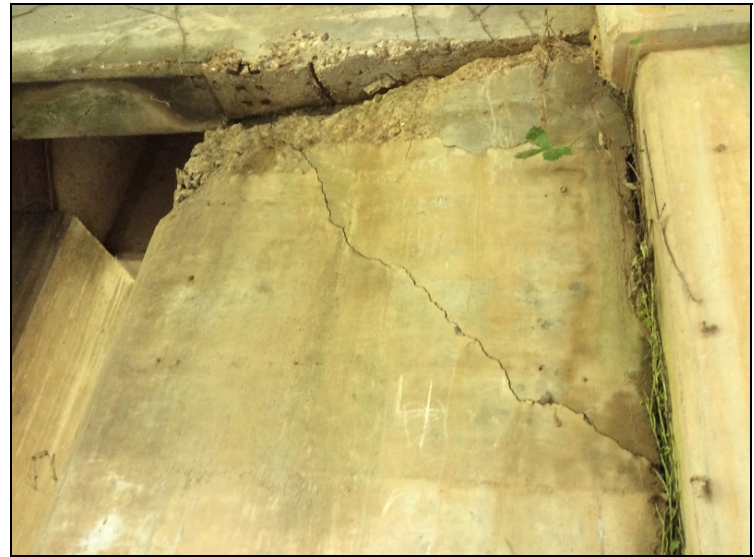
Bent # 2, column # 2-Spalling cracking on ahead face.

Column # 2. Bent # 2. Span # 2 ahead face.
Diagonal crack with spalling at the cap juncture
where the structure was widened.

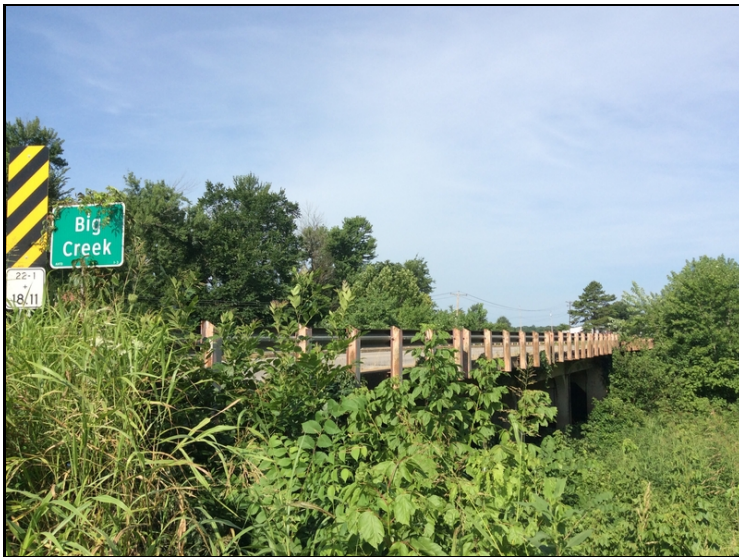
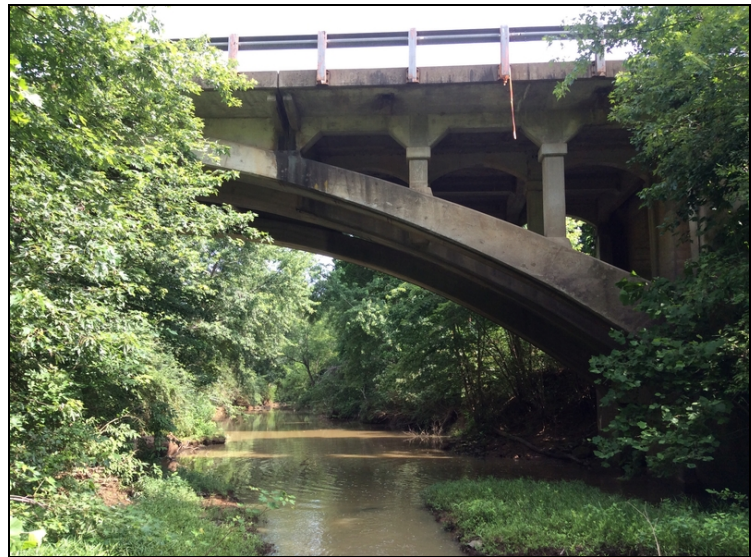
Channel - The channel has heavy vegetation that inhibits inspection efforts. Vegetation covers portions of the substructure.

Heavy vegetation inhibits inspection efforts.
