Asset #02147(Other Special Recurring)

US 71 - Polk Co over Six Mile Creek

Location: 1.5 MI S OF Hatfield

Team Lead: Jeff Jones, Inspection Date: 08/24/2022

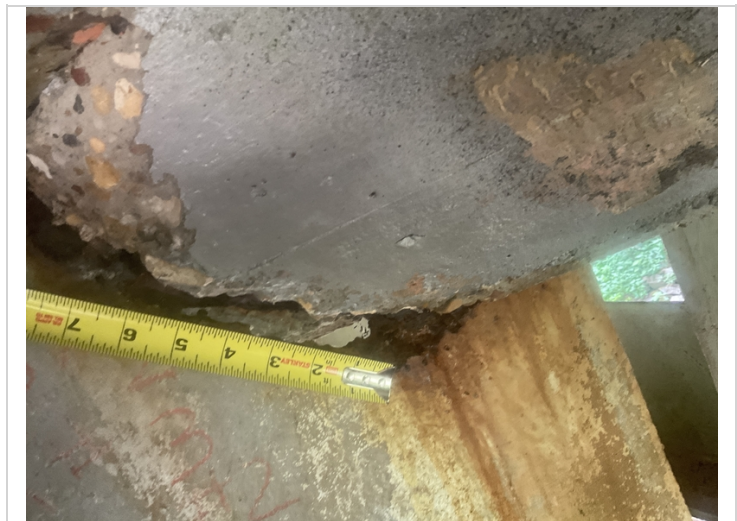
Span 2 over Bent 2. A 5" long hole in the web of beam at the expansion dam juncture.

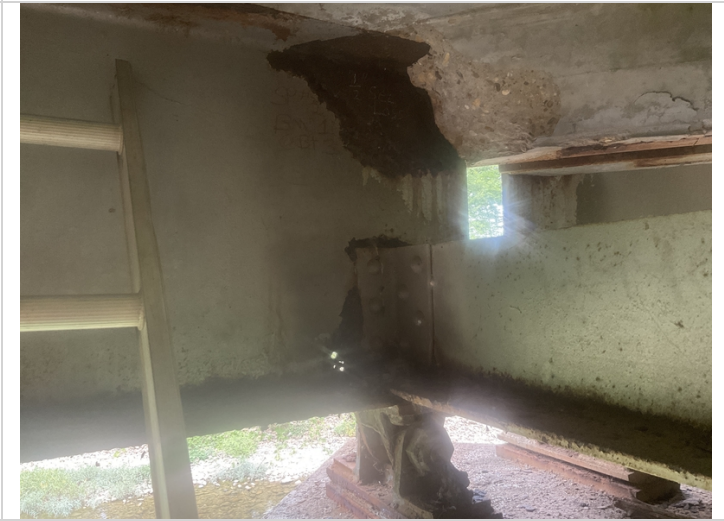
Span 2, Bent 3. Beam 1. Holes in the base of the web.

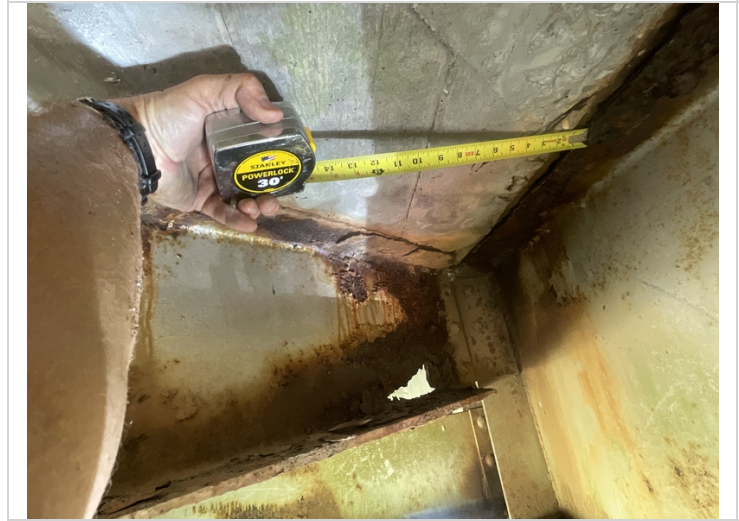
Span 3, Bent 4. Beam 5 - Top flange of Beam has knife edge section loss and reduced in width by 1".

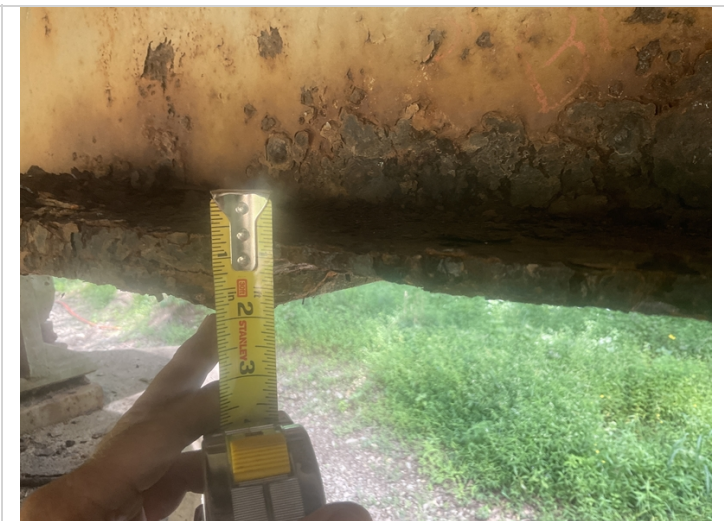
Span 3, Bent 4. Beam 5 - Bottom flange is reduced to 5/16" adjacent to the lower cover plate.

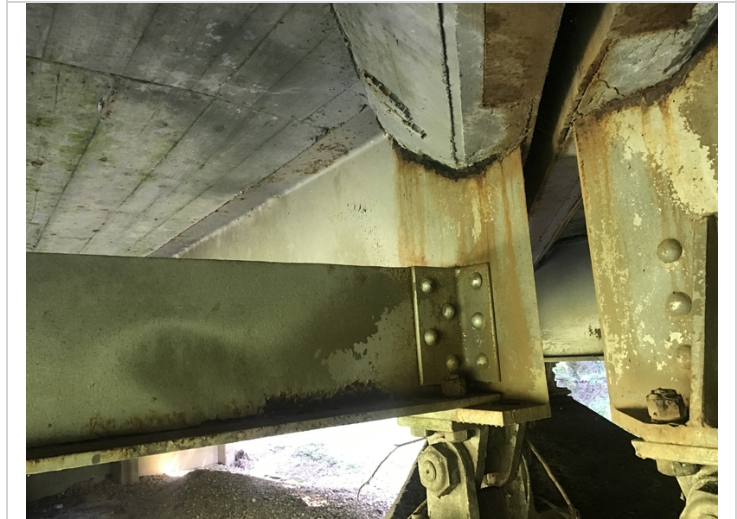
Span # 2, Bent # 2 beam # 1 with a 4" long x 1/2" wide hole through the web at the expansion dam.

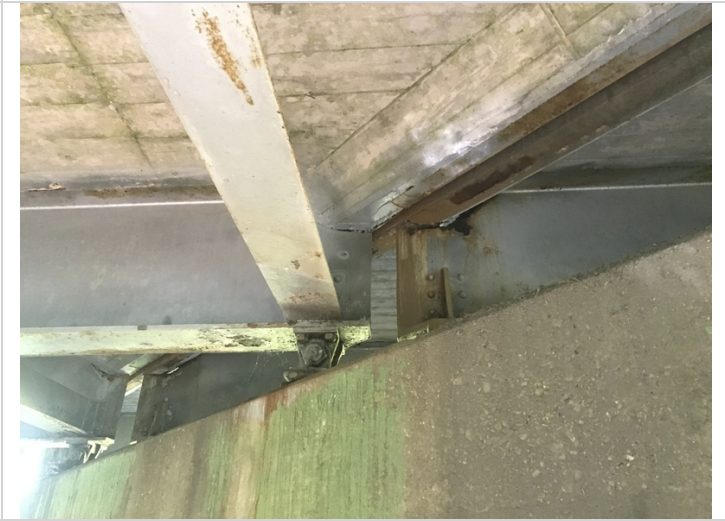
Span # 2, Bent # 2 beam # 2 & 3 with a 4" long hole through the web at the expansion dam.

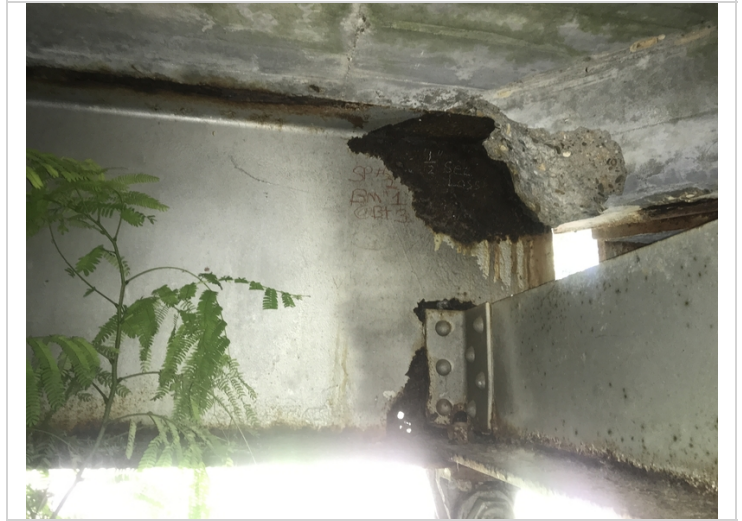
Span # 2, Bent # 3 beam # 1 with a 2" area of holes through the base of the web at the diaphragm connection.

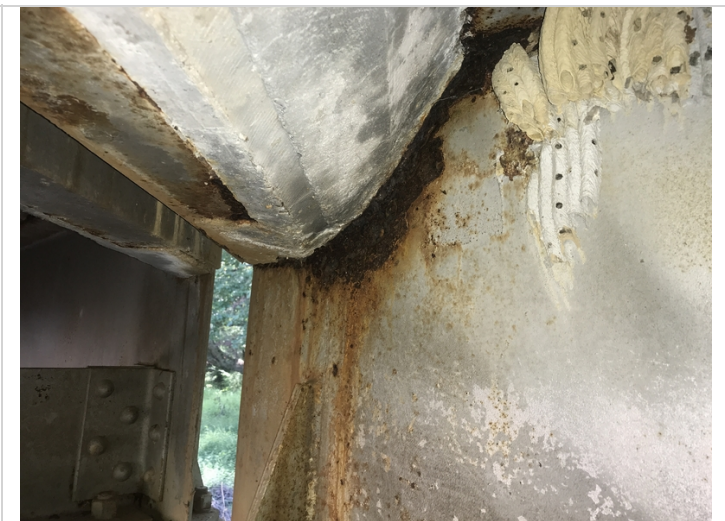
Span # 2, Bent # 3 beam # 5 with up to 7/16" section loss to the web at the expansion dam.

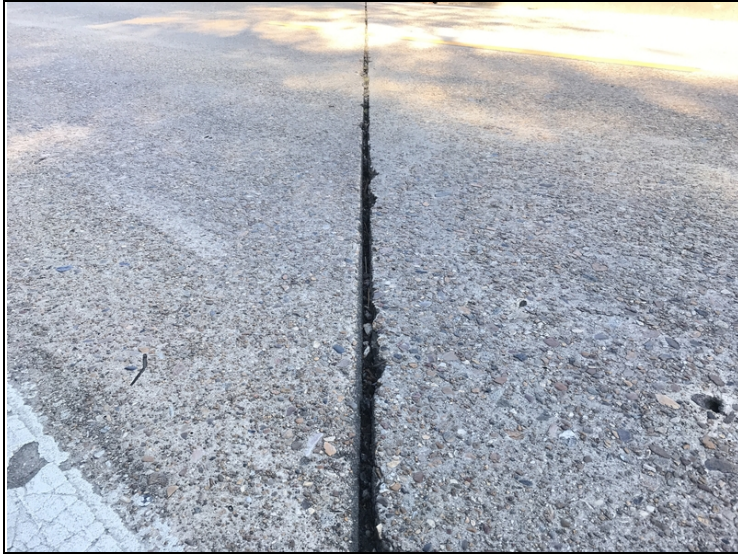
301	Pourable Joint Seal	LF	76	0	0	0	76
2330	Seal Damage	LF	76	0	0	0	76
(301) -The pourable joint seals are missing over Bents # 4 & 5.							
305	Assembly Joint without Seal	LF	180	92	88	0	0
2360	Adjacent Deck or Header	LF	88	0	88	0	0

Unsealed joint.

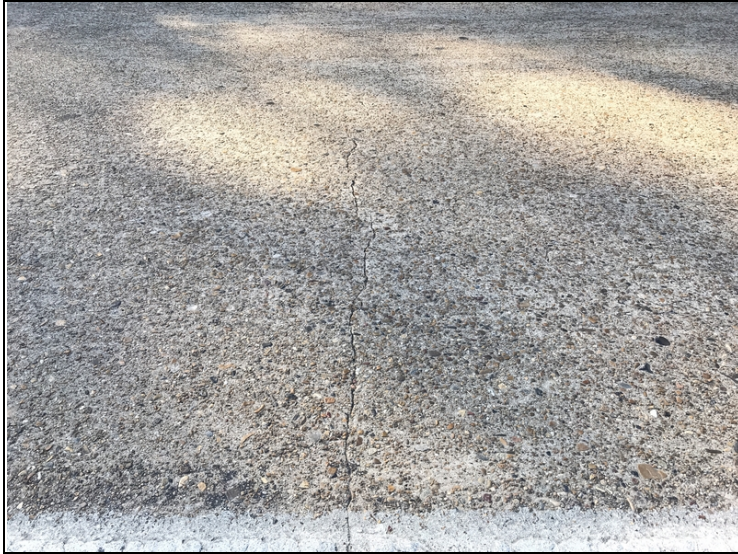
Transverse sealable cracks. Span # 4.

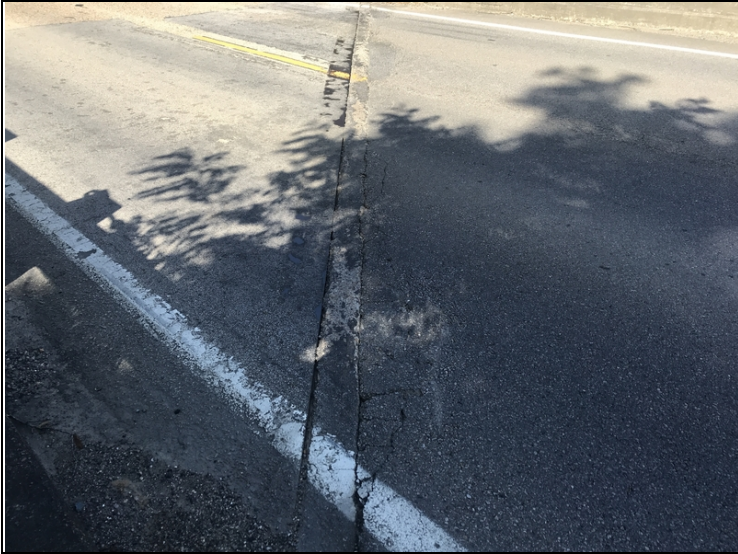
North approach roadway breaking apart at the abutment.
