Asset #A6686(Routine)

US 412 WB Lanes over Beaver Lake

Location: 7.2 Mi E Jct 71B & 412

Team Lead: Bob McEntyre, Inspection Date: 10/28/2021

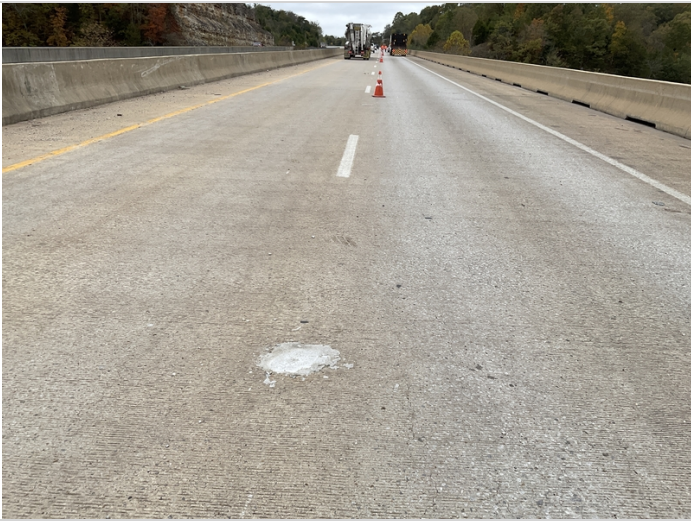
Plowable pavement markers removed.

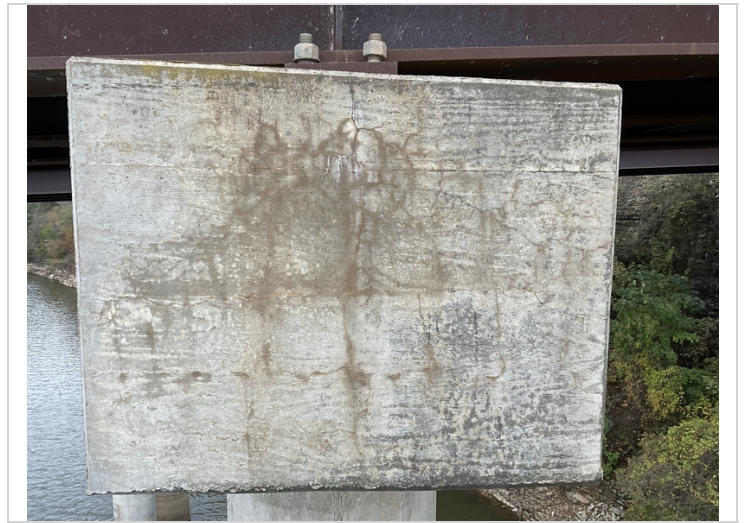
ELEMENTS	DESCRIPTION	UNITS	TOTAL	CS1	CS2	CS3	CS4
1090	Exposed Rebar	LF	1	0	1	0	0
1120	Efflorescence/Rust Staining	LF	0	0	0	0	0
1130	Cracking (RC and Other)	LF	125	0	118	7	0
<p>(234) -Bent # 2 has a horizontal crack near mid cap. -One shallow spall near centerline of bent # 2 cap that does not expose reinforcing steel. -Bent # 2 has map cracking on the left end of bent # 2 cap with cracking up to approximately 1/16" in a couple of locations.</p> <p>-Bent # 3 cap has map cracking up to approximately 1/8" wide on the ends of the cap. Hairline horizontal crack running approximately 3/4 of the length of bent # 3 cap. -Bent # 3 cap has several short duration vertical cracks propagating from the horizontal hairline crack.</p> <p>-Bent # 4 cap has a horizontal crack at mid cap. -Map cracking at both ends of bent # 4 cap. Cracks are up to 1/8" in width during this inspection. -Span # 3 side of bent # 4 cap has an area of efflorescence at the top of the cap. -Bent # 4 cap has a large amount of pigeon droppings on top of the cap.</p> <p>-Bent # 5 Right end of cap has map cracking. The left end of cap has a 3" spall in the undersurface with exposed reinforcing steel. -Bent # 5 cap has a horizontal hairline crack for the full width of the cap.</p>

Bent 2 cap, left end-Mapcracking.

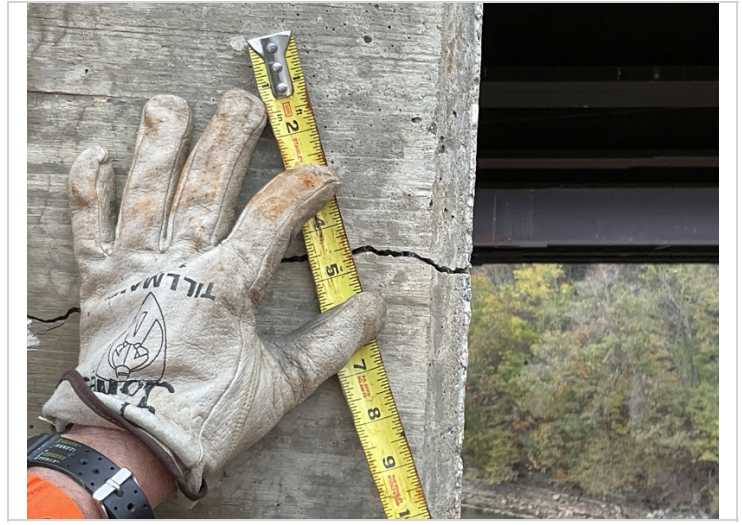
Bent 3 cap, Left end-1/8" wide mapcracking.

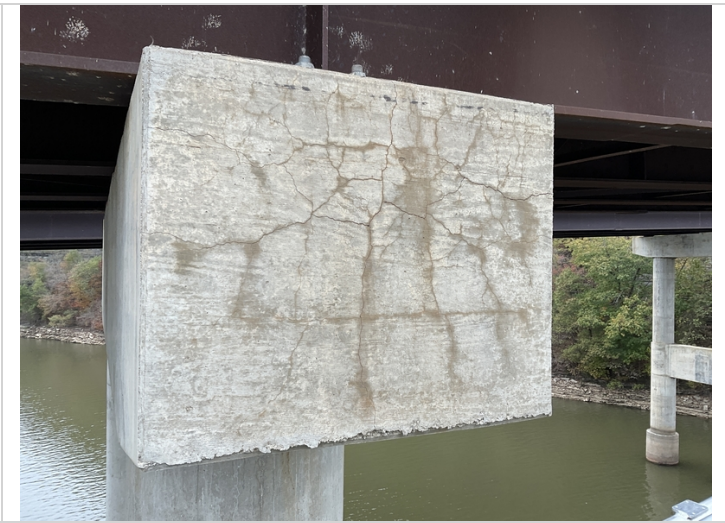
Bent 3 cap, left end-@Mapcracking.

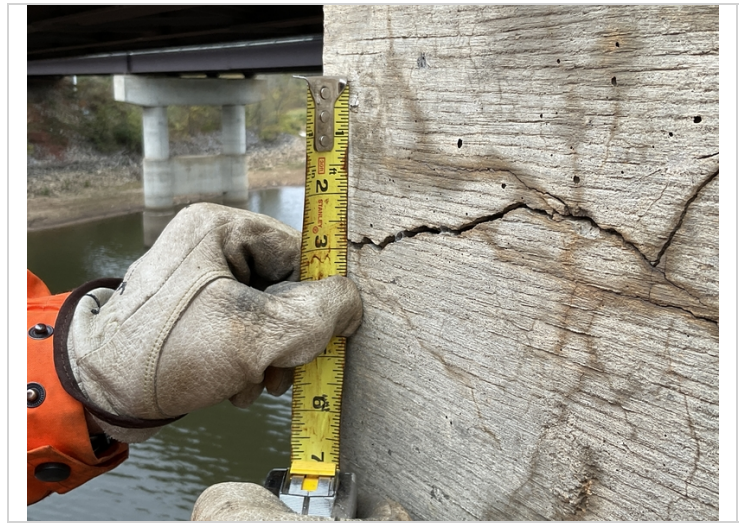
Bent 4 cap, left end-1/8" wide mapcracking.

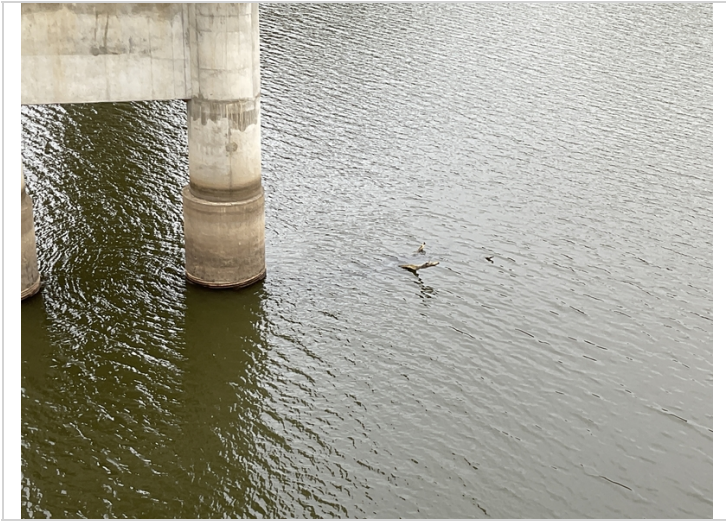
Submerged drift at bent 4.

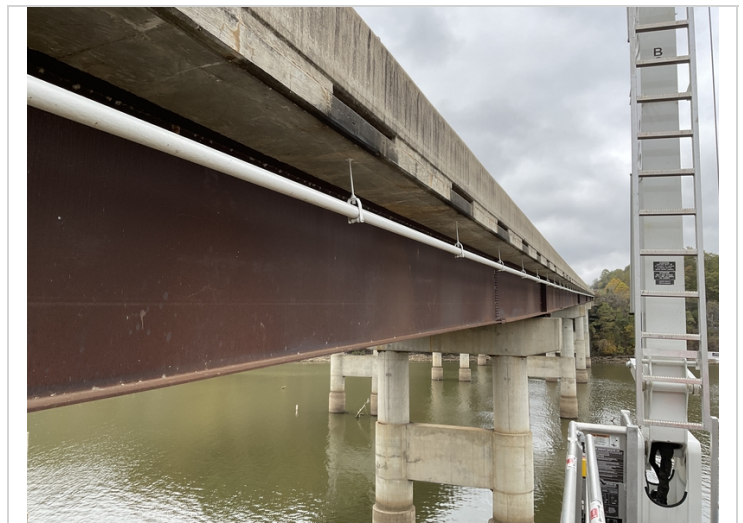
Utility attached to left side of deck.

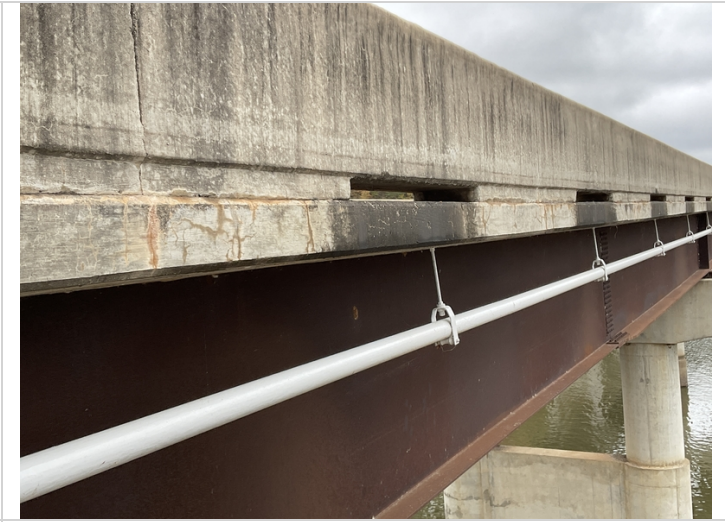
The exterior edges of the deck have mapcracking.

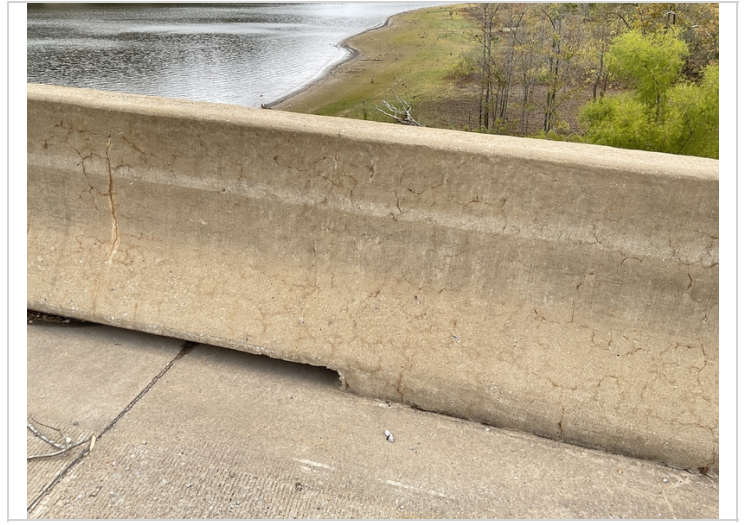
Mapcracking in parapets.

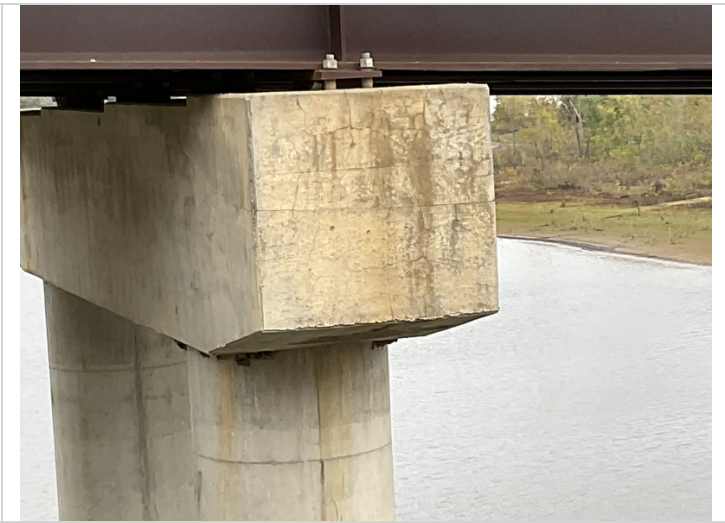
Bent 3, right end of cap has mapcracking.

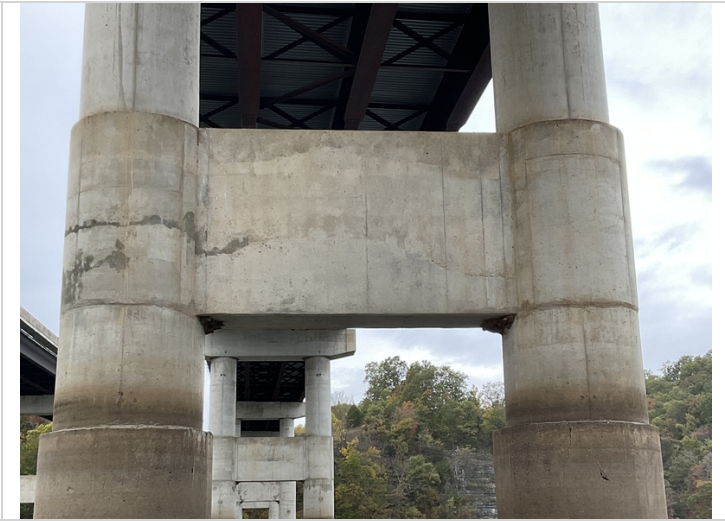
Bent 5 strut.

210	Reinforced Concrete Pier Wall	LF	64	58	6	0	0
1010	Cracking	LF	6	0	6	0	0
<p>(210) -This elements is being used in accordance with the latest ARDOT Bridge Inspection Manuel to monitor the horizontal struts.</p> <p>-Bent # 3 strut has an area of mapcracking in the top of the strut in an area approximately 6' in length.</p>							
215	Reinforced Concrete Abutment	LF	146	97	49	0	0
1080	Delamination/Spall/Patched Area	LF	11	0	11	0	0
1120	Efflorescence/Rust Staining	LF	4	0	4	0	0
1130	Cracking (RC and Other)	LF	31	0	31	0	0
1190	Abrasion/Wear (PSC/RC)	LF	3	0	3	0	0
<p>(215) -Minor vertical cracks in the back walls.</p> <p>-There are transverse cracks in the top of the back walls visible from the driving surface of the deck.</p> <p>-Minor dirt accumulation adjacent to the exterior beams on the abutments.</p> <p>-There are shallow spalls on the driving surface of the back wall adjacent to the asphalt.</p>

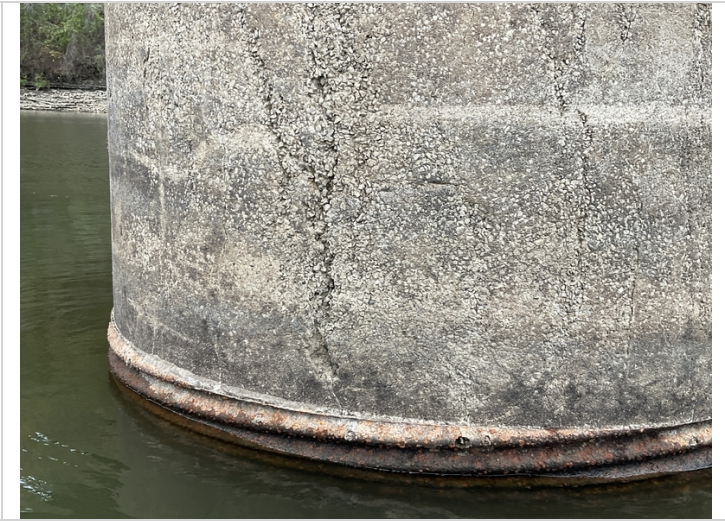
10/28, 11/01 & 11/2/2021 - RSM, JCJ, EJW, SPC, TJL & JPW: Routine inspection conducted these dates. NBIS Condition Rating for item "60" lowered from "6" to "5" due to wide excessive cracking in base of columns and ends of intermediate bent caps. Aspen 40 snooper truck was utilized for inspection access. A boat was used to inspect the lower portion of the substructure.

ELEMENTS	DESCRIPTION	UNITS	TOTAL	CS1	CS2	CS3	CS4
<p>(205) The section of columns / top of the drilled shafts in proximity of the average / normal lake elevation have wide vertical, transverse, and map cracking along with concrete deterioration that exposes the reinforcing steel in areas. Exposed reinforcing steel has very little concrete cover from the construction process.</p> <p>Some columns have vertical cracking that propagates from the top of the drilled shaft concrete into the base of the columns above the water elevation.</p> <p>Bent # 2 -</p> <p>Bent # 2 - Left column has three 8" pieces of vertical reinforcing steel visible in the North face of the column. Exposed reinforcing steel appears to be epoxy coated # 4 bar located approximately 4' below the top of the drilled shaft concrete.</p> <p>Bent # 2 - Right column has an 8" piece of vertical reinforcing steel visible in the West face of the column. Exposed reinforcing steel appears to be epoxy coated # 4 bar.</p> <p>There are areas with concrete deterioration up to 3/4" deep during this inspection. Located approximately 5' below the top of the drilled shaft concrete..</p> <p>Bent # 3 -</p> <p>-Bent # 3 right drilled shaft has light mapcracking at base with random areas of honeycombing and concrete deterioration with up to approximately 1-1/2 concrete section loss. The drilled shaft has several moderate width vertical cracks.</p> <p>Bent # 3 - Left column has concrete deterioration, numerous moderate width vertical cracks, areas of honeycombing.with up to approximately 1-1/2 concrete section loss in some locations.</p> <p>Bent # 4 -</p> <p>Most extreme case is Bent # 4, Column # 1 that has a vertical crack approximately 3/4" wide on the face and top of the drilled shaft concrete. The area surrounding the crack and the upper portion of the drilled shaft is delaminated. The column has a shallow 10" spall located at the top of the drilled shaft portion of column.</p> <p>Bent # 4 - Right column has numerous vertical cracks up to approximately 1/8" wide with concrete deterioration. The upper portion of the drilled shaft has wide horizontal cracking. The drilled shaft has one 4" long area of exposed reinforcing steel in the North face that appears to be from insufficient concrete coverage during the construction process.</p> <p>Bent # 5 -</p> <p>Bent # 5 - Column # 1 has vertical cracks approximately 1/4" wide on the face and top of the drilled shaft concrete.</p> <p>Bent # 5 - Column # 2 has vertical cracks up to approximately 1/16" wide at the water elevation in the top of the drilled shaft concrete. The top of the drilled shaft has a wide crack approximately 1/4" wide adjacent to the column.</p>

Bent 3, column 1-Honeycombing / concrete deterioration.

Added bridge to dive contract to get a better look at the cracks in the drilled shafts see the report in files- ADN 10/2018

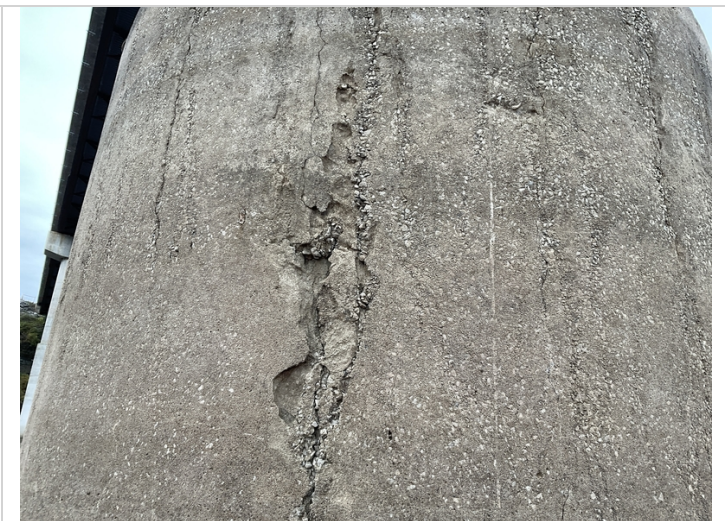
Bent 3, column 2-Honeycombing / concrete deterioration.

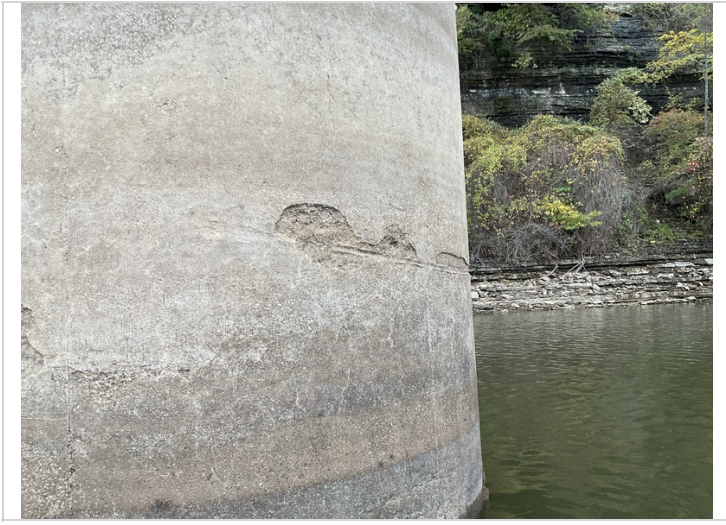
Bent 2, column 2-scaling

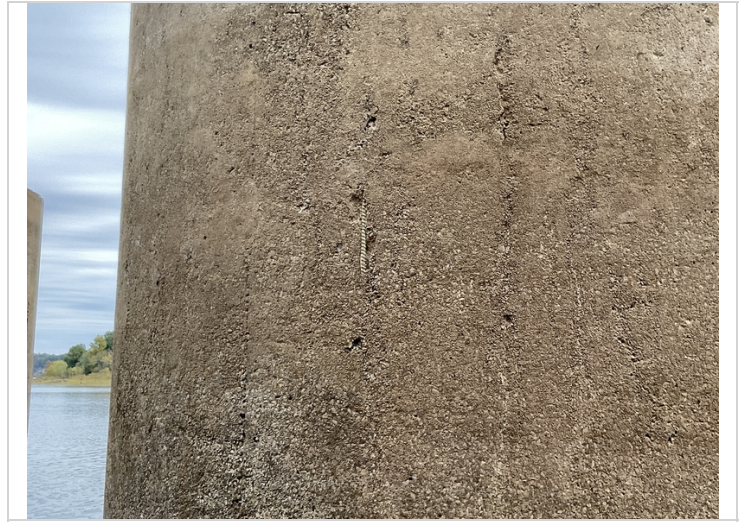
Bent 2, column 2-Exposed reinforcing steel.

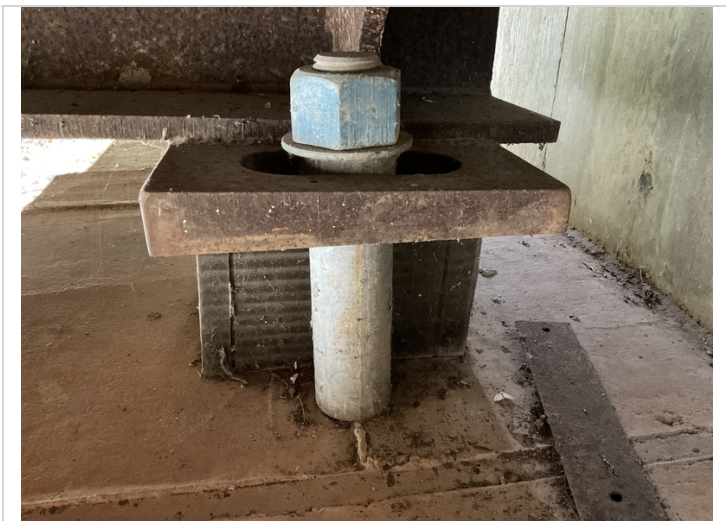
Abutment 2-Bearings at neutral position with ambient temperature approximately 55 Degrees Fahrenheit at time of inspection.

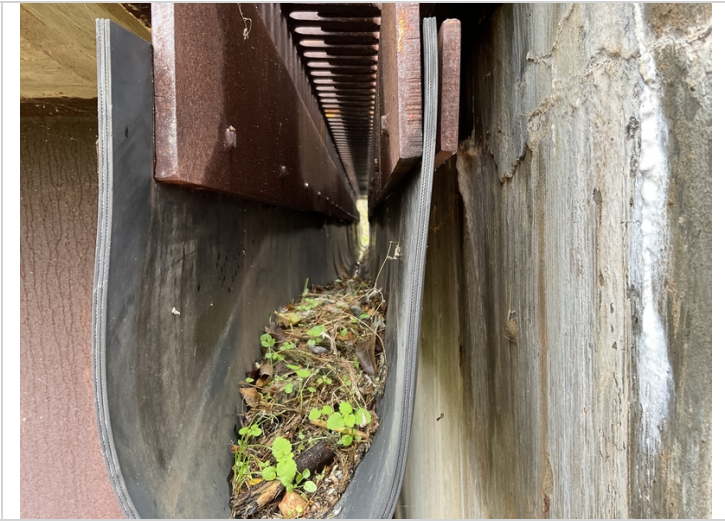
305	Assembly Joint without Seal	LF	80	80	0	0	0
<p>(305) -The assembly joint anchorage appears to be solid with no apparent noteworthy deficiencies during this inspection. -The right end of the expansion joint drainage trough at abutments # 1 and # 2 have debris accumulation that restricts drainage.</p>							
310	Elastomeric Bearing	EA	24	24	0	0	0
515	Steel Protective Coating	SF	48	48	0	0	0
<p>(310) -There are no apparent noteworthy deficiencies during this inspection. -Abutment # 1 has dirt and debris accumulated against exterior bearings.</p>							
331	Reinforced Concrete Bridge Railing	LF	1772	0	787	985	0
1120	Efflorescence/Rust Staining	LF	984	0	0	984	0
1130	Cracking (RC and Other)	LF	788	0	787	1	0
<p>(331) -The bridge rails have superficial map cracking and vertical cracks typical throughout. Some areas of cracking have efflorescence. -The right side of parapet in span # 1 at abutment # 1 has wide vertical and mapcracking on the exterior side.</p> <p>Approach Railing: -Collision damage to the Southwest approach railing has destroyed approximately 15' of the railing and two railing posts. The collision damage has created a "pocket" in the railing.</p>

The right end of the expansion joint drainage trough at abutment # 2 has debris accumulation that restricts drainage.

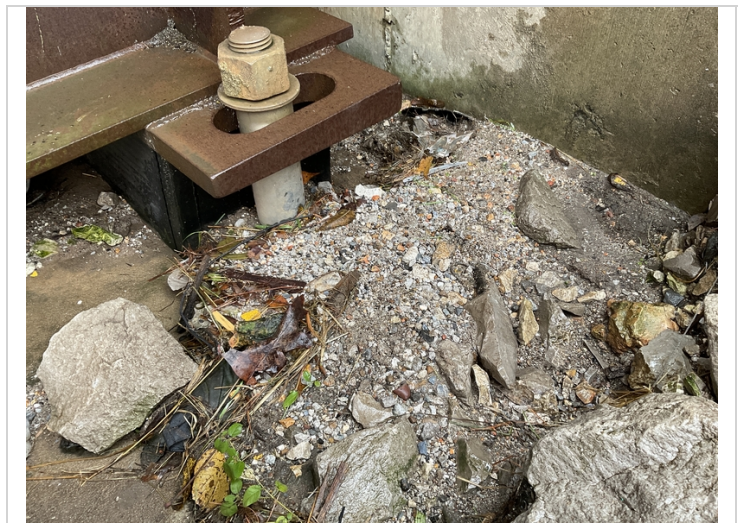
Abutment # 1 has dirt and debris accumulated against exterior bearings.

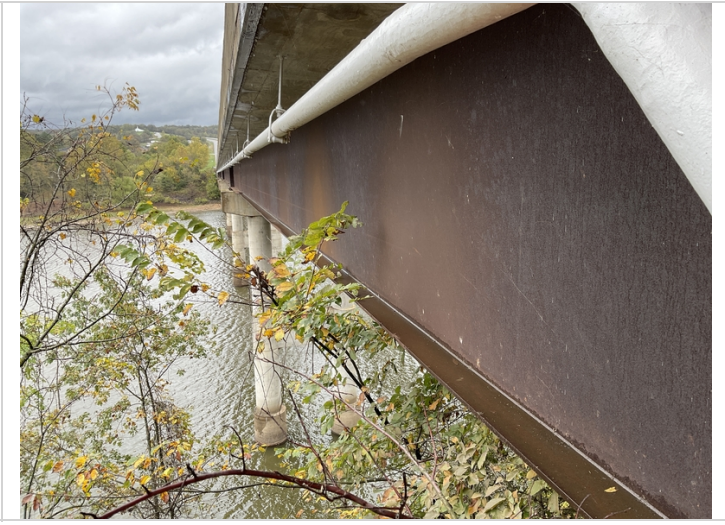
(107) -No visible cracks apparent in the beams during this inspection. -The undersurface of the bottom flanges of exterior girders have abnormal weathering with flaking rust to the weathering steel protective coating. -The beams have a light rust coating. -Span # 3, splice # 1, bay # 3, beam # 3 top flange has abnormal weathering with flaking rust due to leaking transverse saw joint. -Span # 4, girder # 4 @ splice # 1 has a 3/8" misalignment, (Constructed in this manner). -Span # 5, bay # 3, diaphragm # 2 from abutment # 2 has out of plane bending that appears to be the as-built condition.							
205	Reinforced Concrete Column	EA	8	0	2	5	1
1080	Delamination/Spall/Patched Area	EA	3	0	2	1	0
1130	Cracking (RC and Other)	EA	5	0	0	4	1

Exterior side of span # 1, girder # 1.

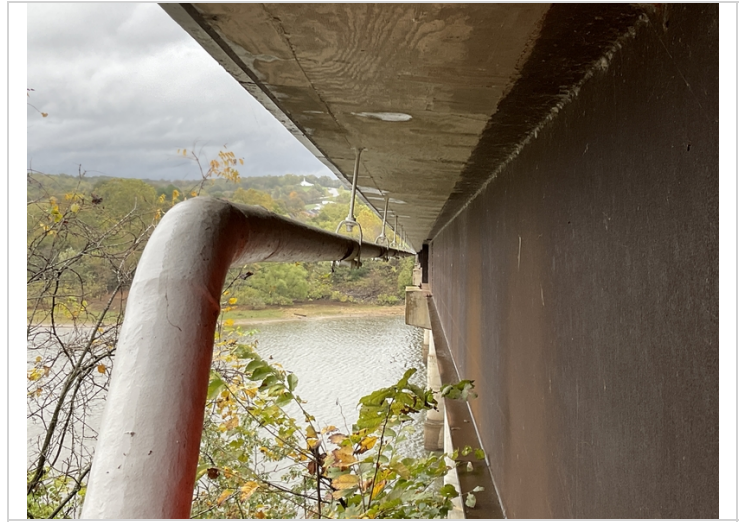
Utility on left side.

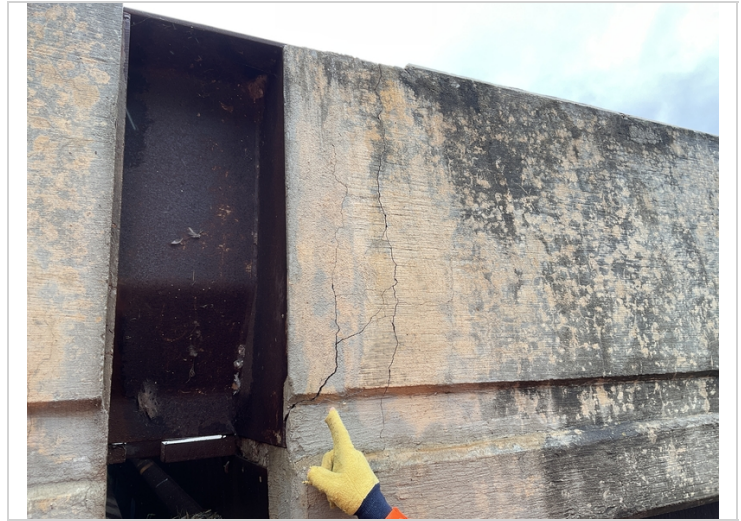
The right side of parapet in span # 1 at abutment # 1 has wide vertical and mapcracking on the exterior side.

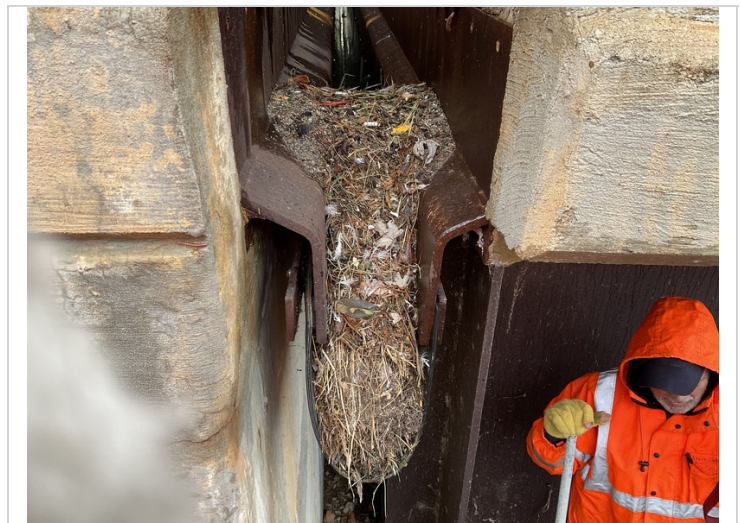
The expansion joint trough at abutment # 1 has debris accumulation on the right side.

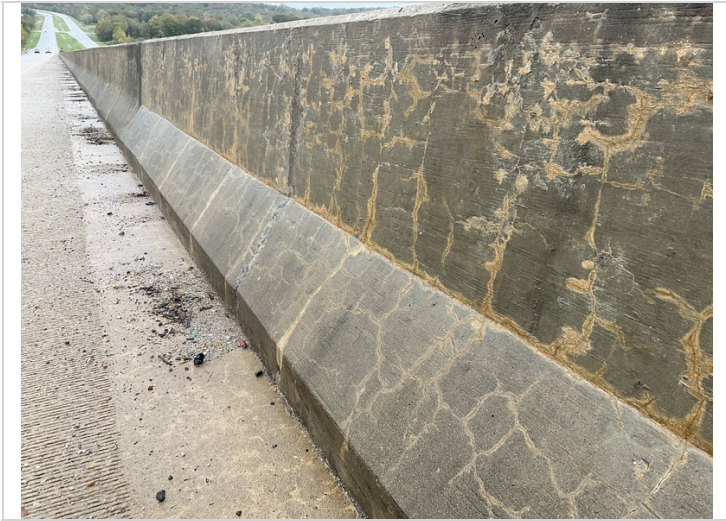
Span 1, right side-Mapcracking in right parapet.

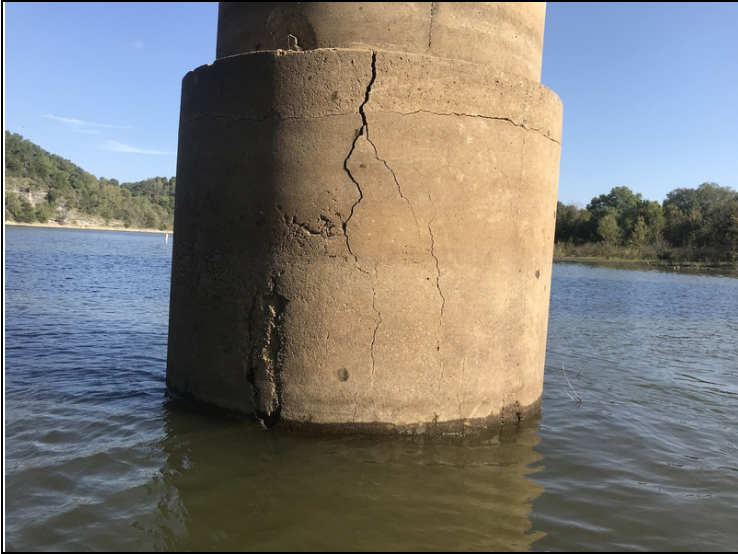
Left column of Bent # 4.

Most extreme case is Bent # 4, Column # 1 that has a vertical crack approximately 3/4" wide on the face and top of the drilled shaft concrete with the upper portion of the drilled shaft delaminated adjacent to the crack.

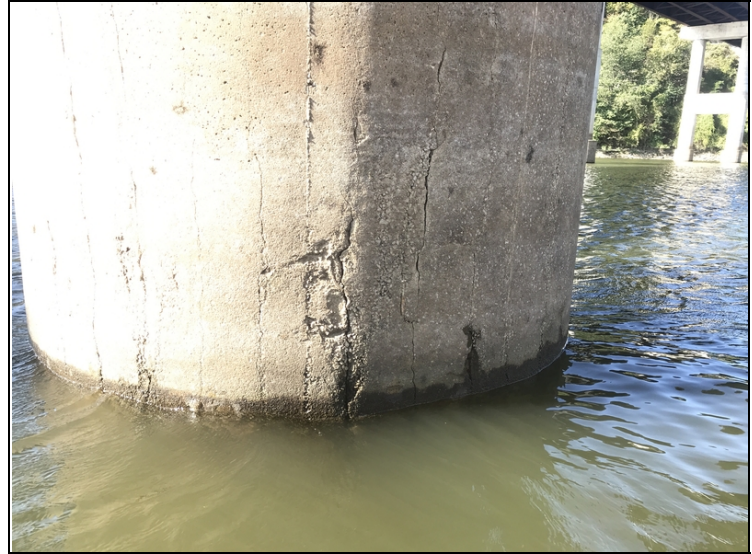
Bent # 4 - Right column has up to approximately 1/8" wide vertical cracks along with concrete deterioration that exposes reinforcing steel in the drilled shaft concrete.

Exposed reinforcing steel in the Right column of Bent # 4.

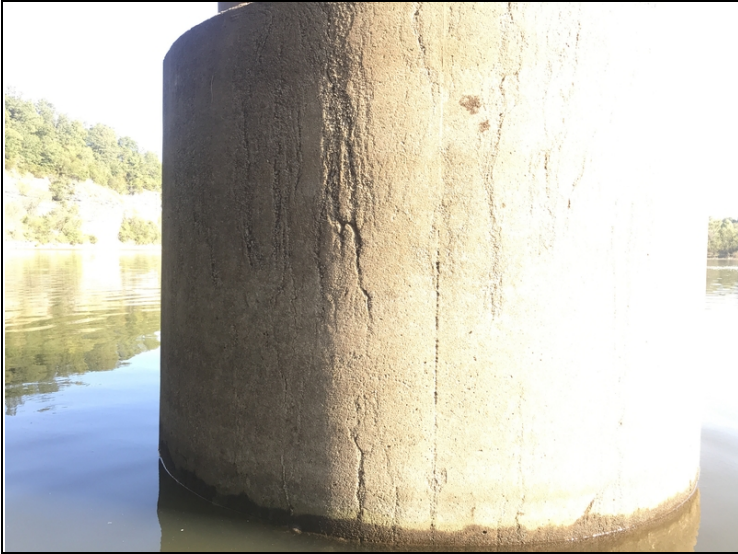
Bent # 2. Left column.

The section of columns / top of the drilled shafts in proximity of the average / normal lake elevation have vertical, transverse, and map cracking along with concrete deterioration that exposes the reinforcing steel in areas. Exposed reinforcing steel has very little concrete cover from the construction process.

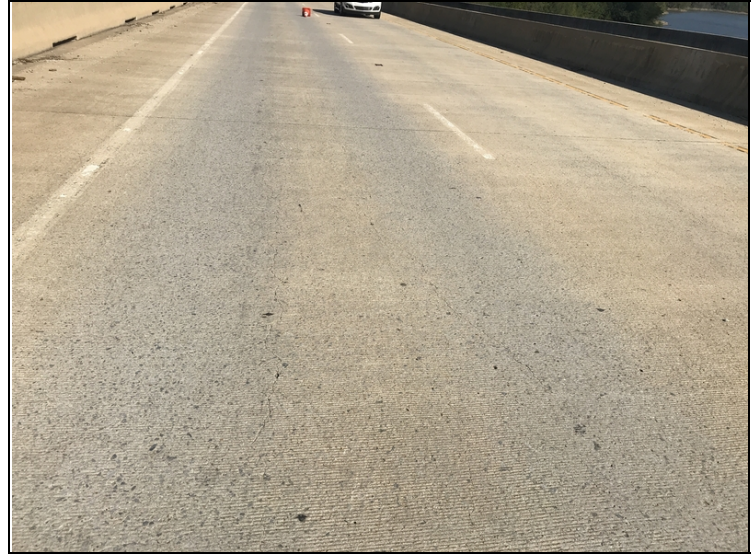
Deck -
The driving surface of the deck has sealable cracking in all spans.

Deck. Typical.

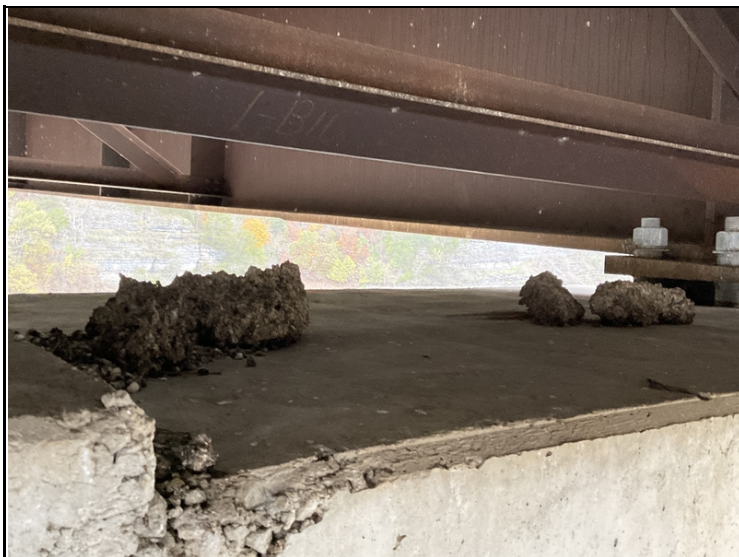
Bent caps -
Pigeon droppings have accumulated on the steel superstructure and bent caps. Bent # 4 is worst case.

Pigeon droppings-Bent # 4 cap.

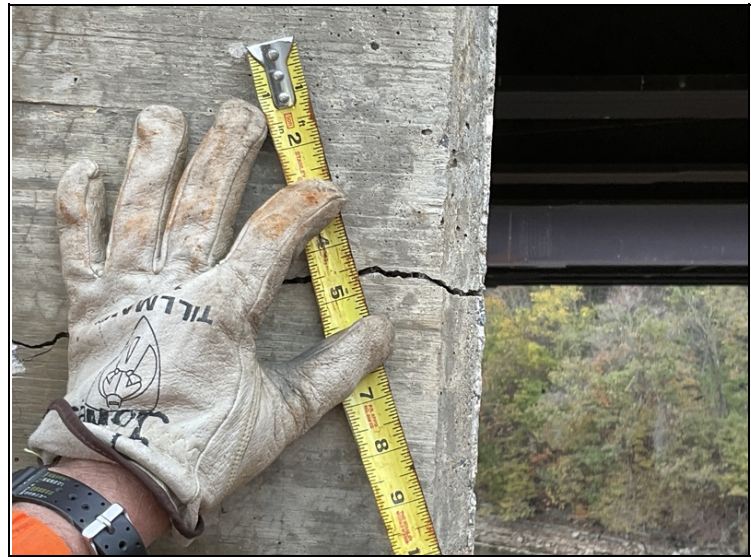
The ends of the intermediate bent caps have map cracking with cracks up to an 1/8" wide in some locations.

Bent # 3 cap-Left end-1/8" wide mapcracking.

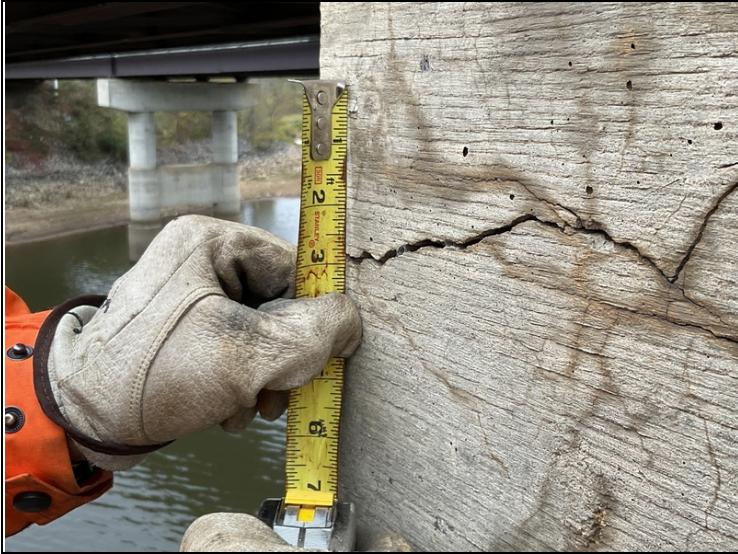
Bent # 4 cap, left end-1/8" wide mapcracking.

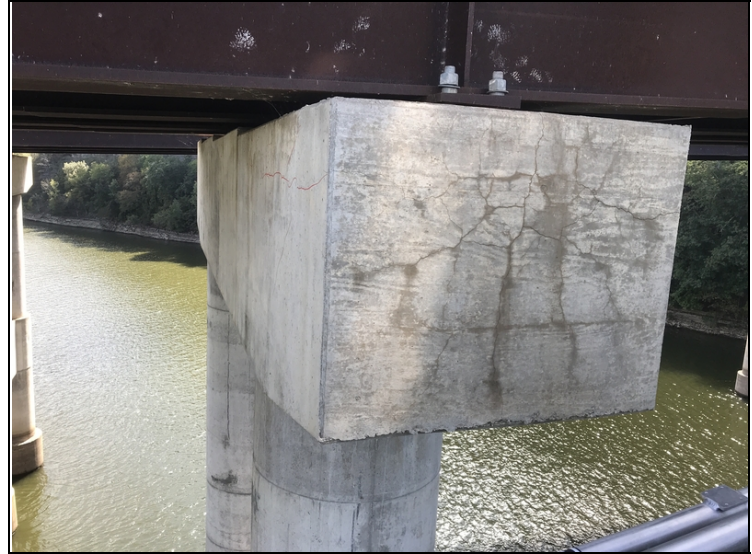
Left end of Bent # 3 cap. Typical.

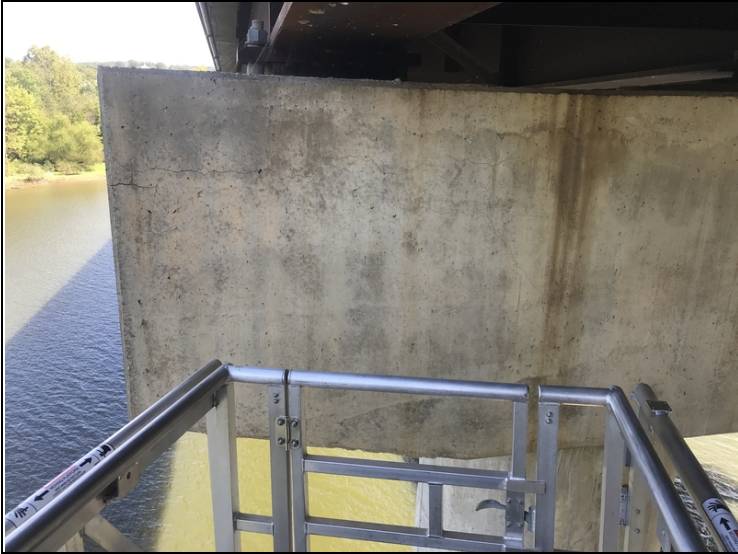
Span # 2 side. Left end of Bent # 3 cap.

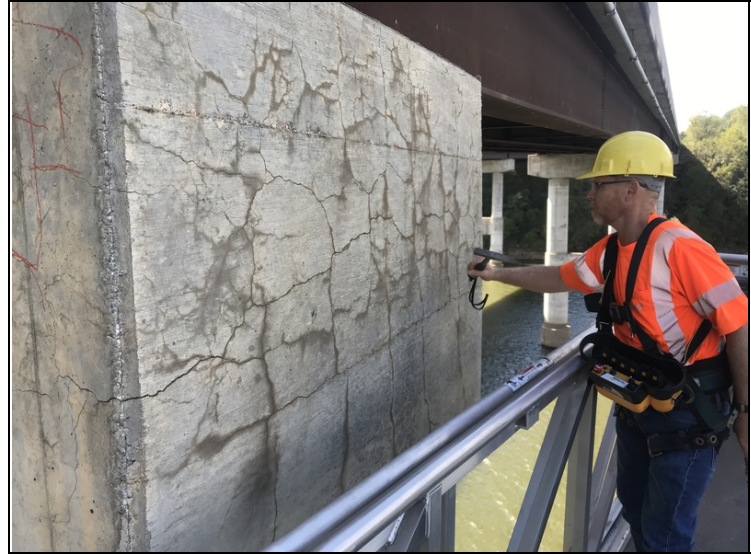
Left end of Bent # 4 cap sounds delaminated in areas.

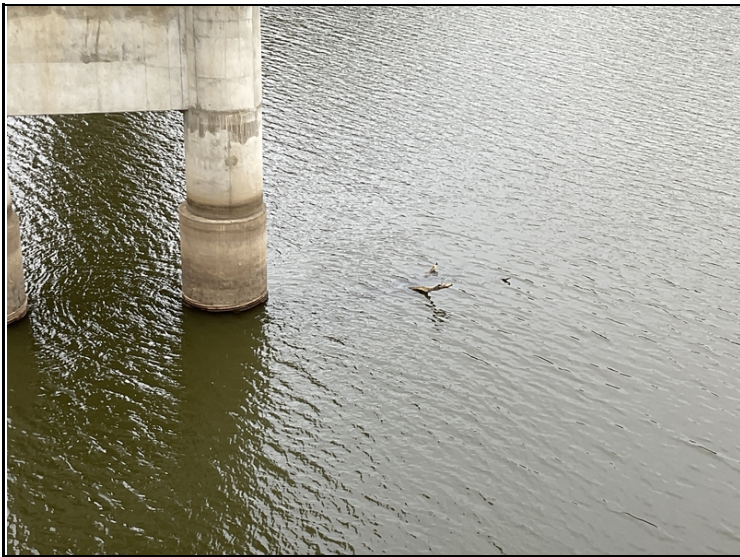
Channel -
The channel has an undetermined amount of submerged drift at the intermediate bents.

Submerged drift at bent # 4.

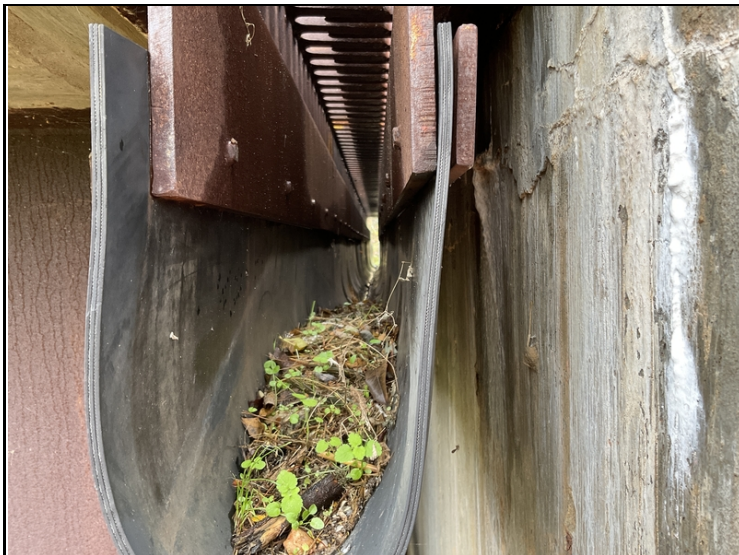
The right end of the expansion joint drainage troughs at abutments # 1 and # 2 have debris accumulation that restricts drainage. Abutment # 2 pictured.

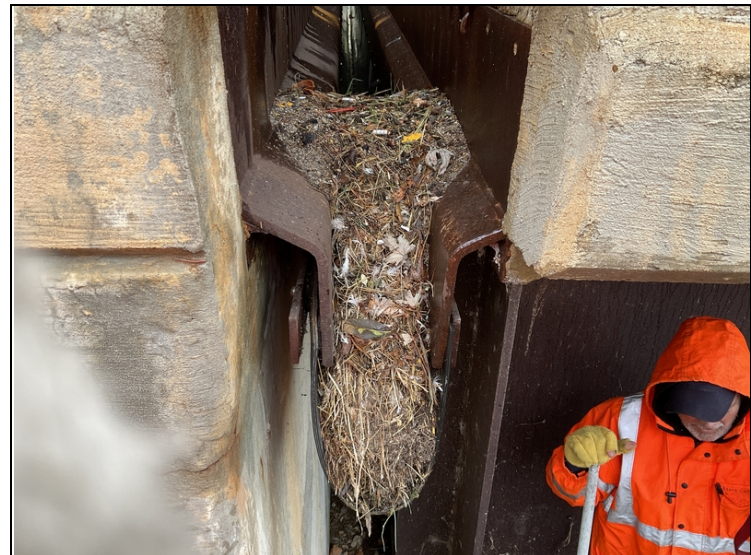
The right end of the expansion joint drainage troughs at abutments # 1 and # 2 have debris accumulation that restricts drainage. Abutment # 1 pictured.
