Asset #B6686(Routine)

US 412-East Bound over Beaver Lake

Location: 7.1 Mi E. Jct Hwy US 71B

Team Lead: Bob McEntyre, Inspection Date: 10/28/2021

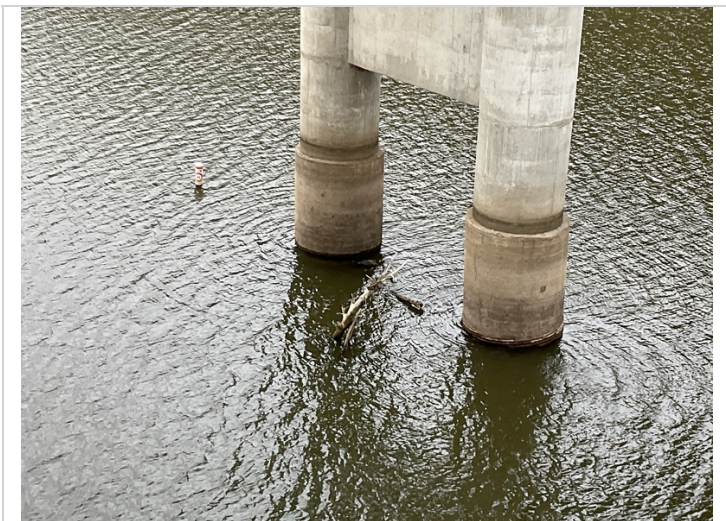
Submerged drift at bent 4.

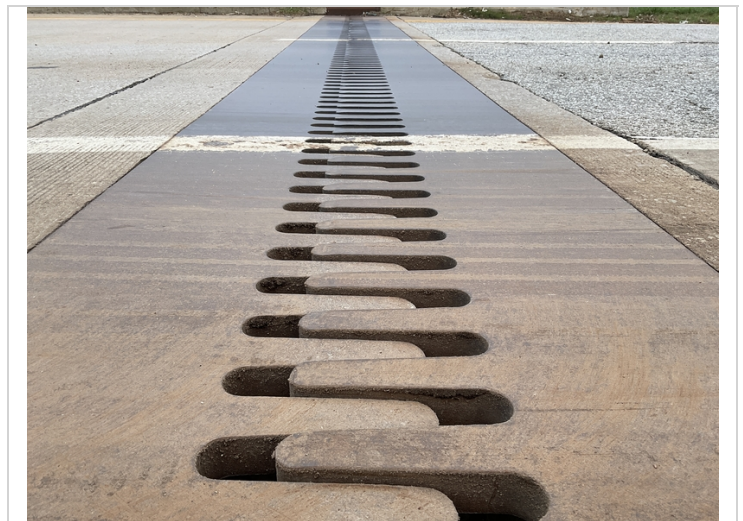
The finger joint over abutment # 2 has a height differential of approximately 3/8" from the portion of assembly at abutment # 2 side to the portion of assembly on the span # 5 side.

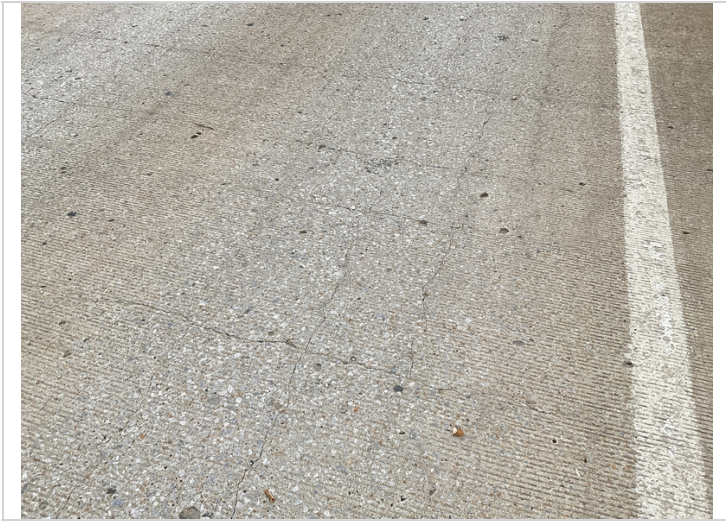
Span 3, right lane-Mapcracking.

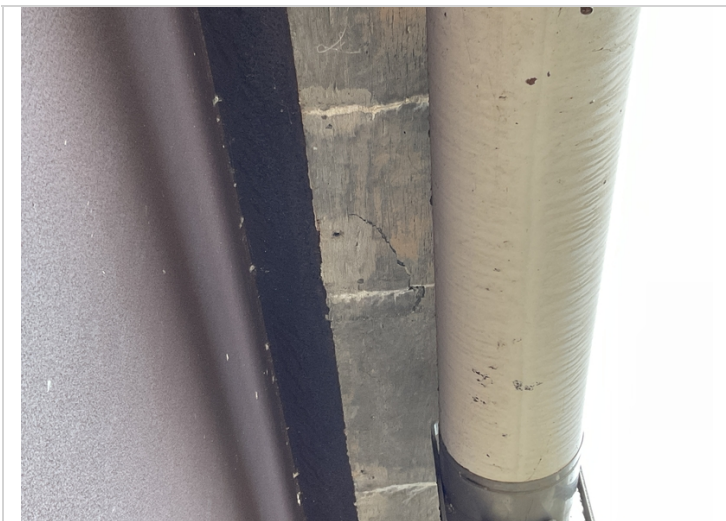
Span # 5, right side-Delaminated area in deck overhang adjacent to girder top flange.

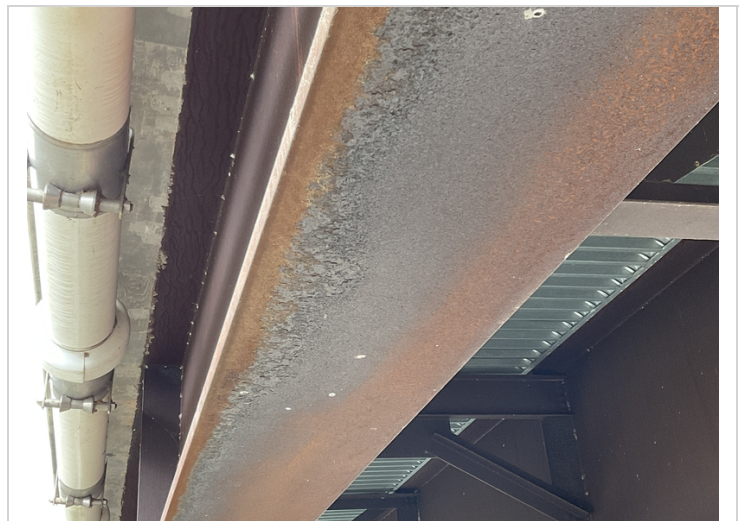
Span 5, girder 4-Abnormal weathering with large flakes.

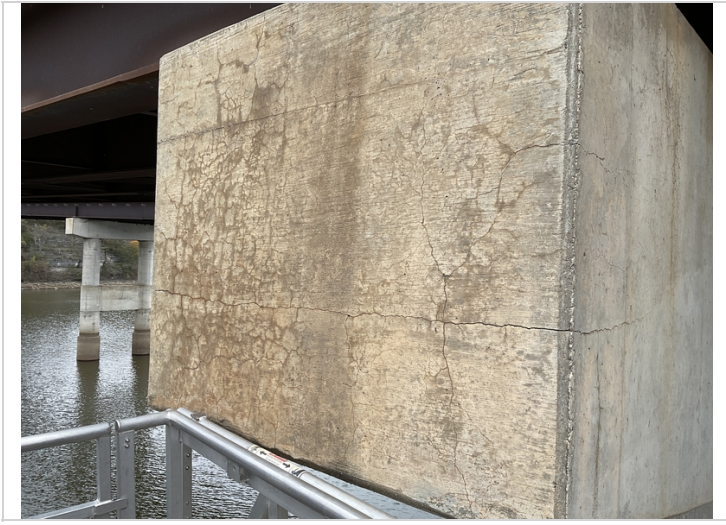
Bent 5 cap, right end-Mapcracking.

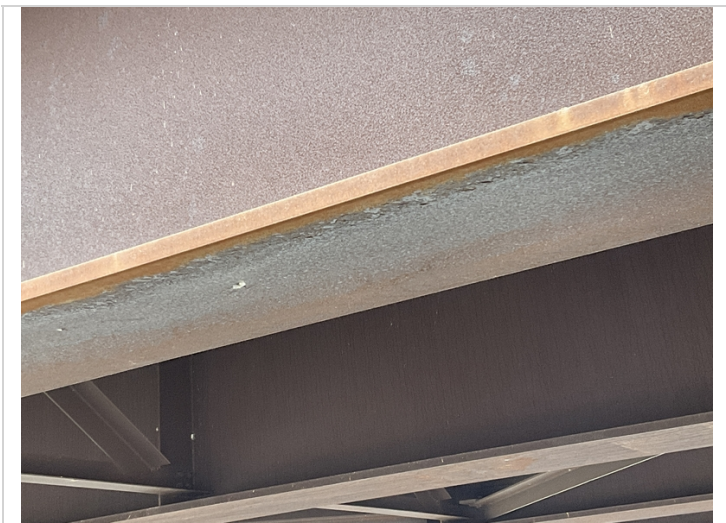
Span 4, beam 4-Abnormal weathering.

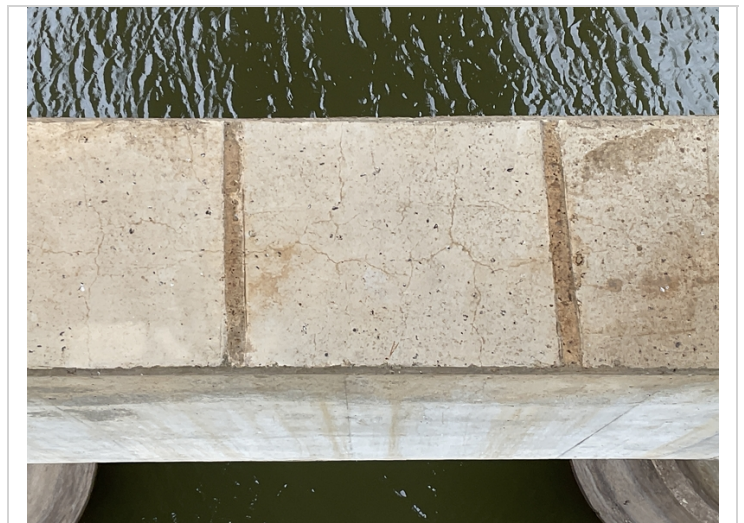
Bent 5 strut has mapcracking in the top surface.

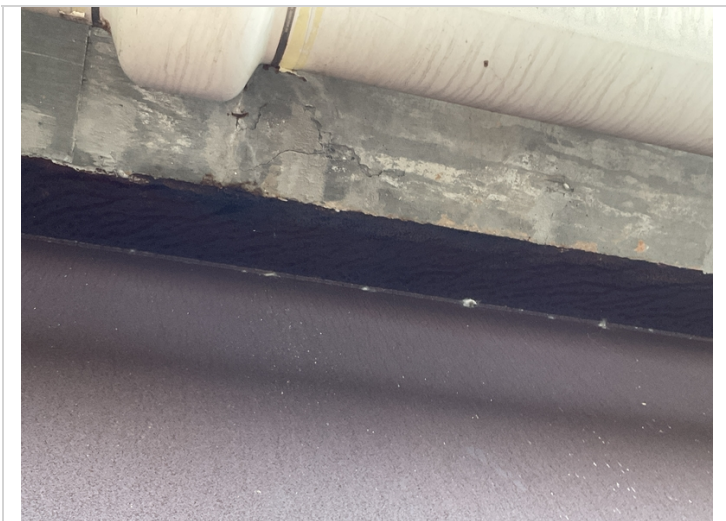
The undersurface of the deck overhang in span # 4 has a 12" delaminated area adjacent to girder # 4 top flange located adjacent to splice connection # 1.

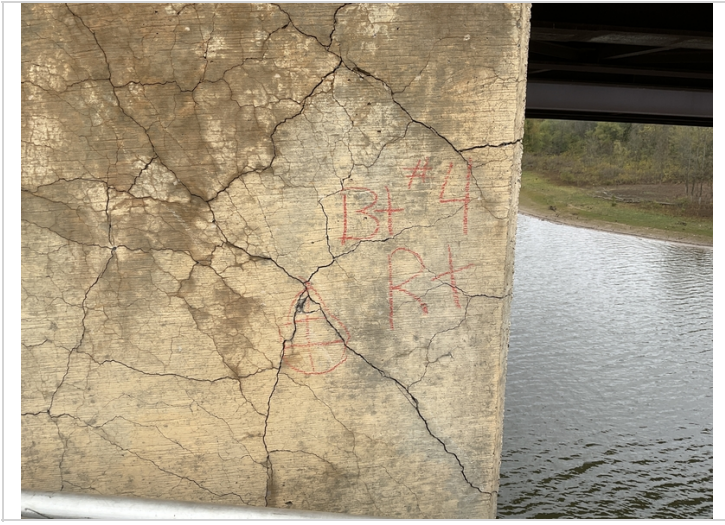
Bent 4 cap, right end-Delaminated area.

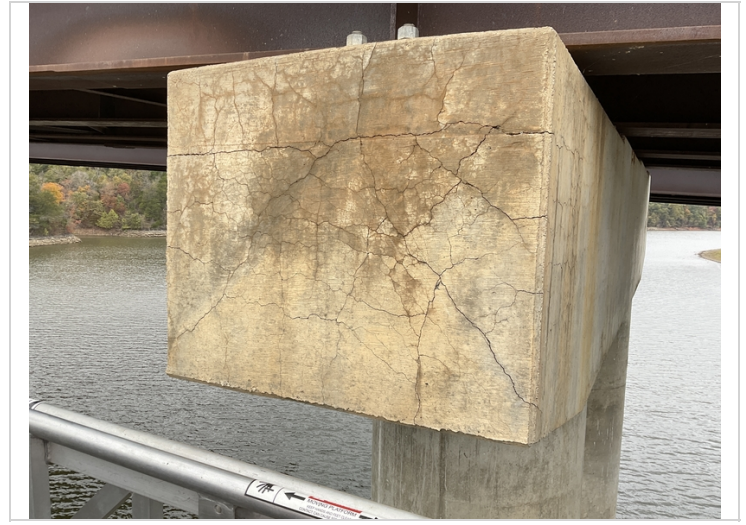
Bent 4 cap, right end-Mapcracking.

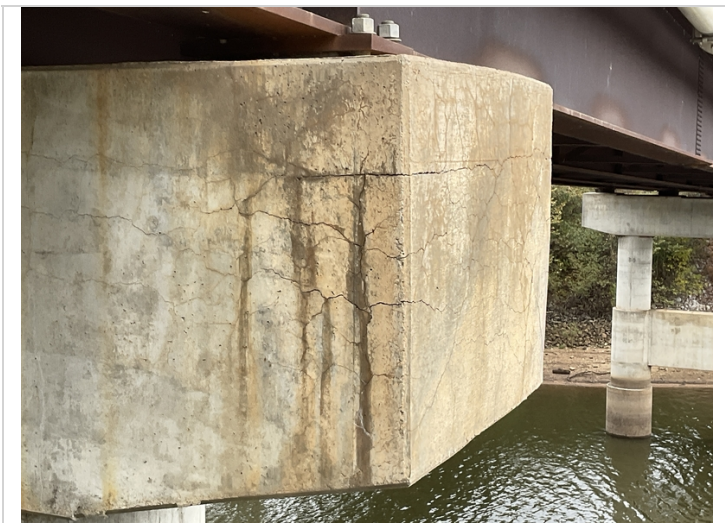
Bent 4 cap, right side-Wide mapcracking.

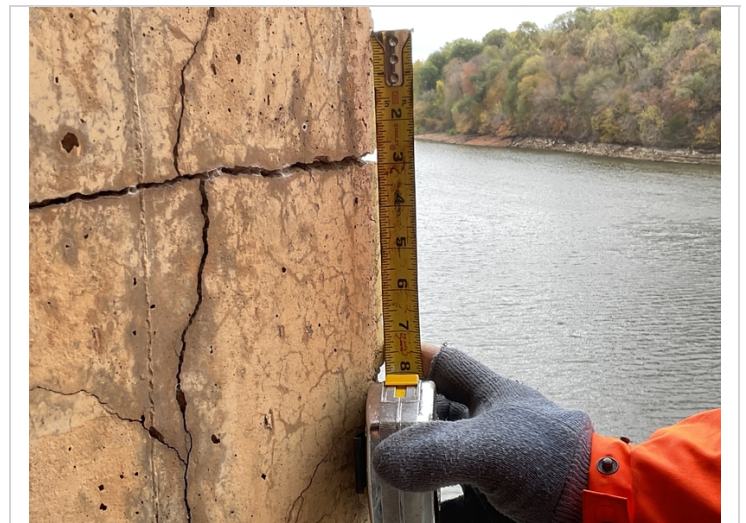
Bent 4 cap, right side-Wide mapcracking.

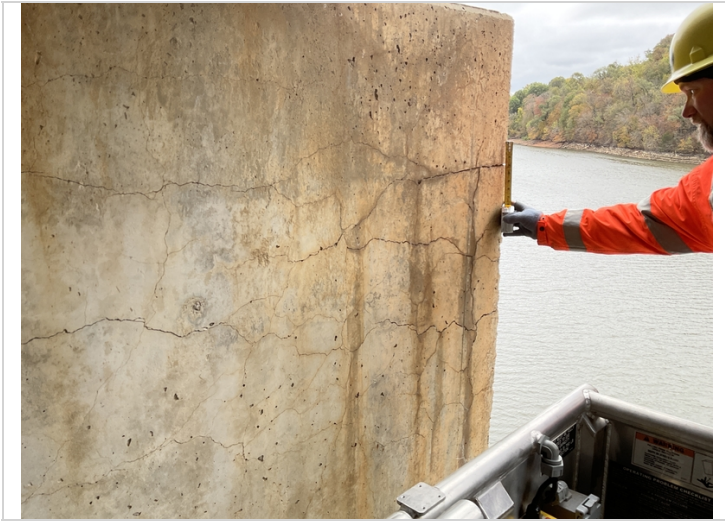
Bent 4 cap, right side-Wide mapcracking.

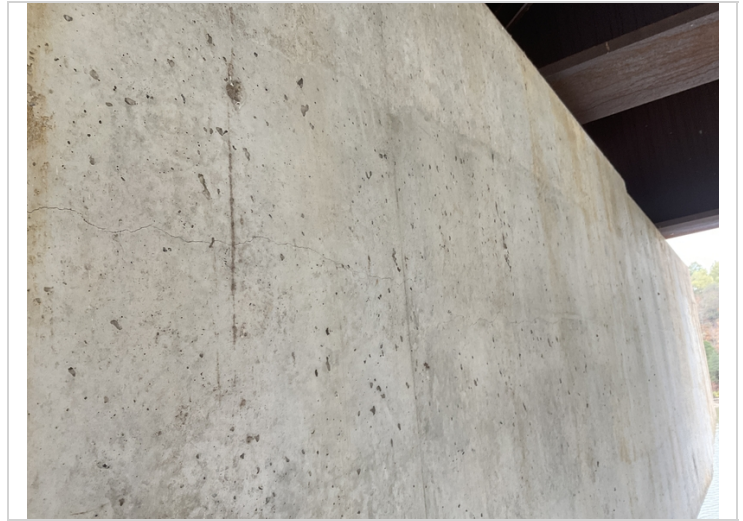
Bent 4 cap-Horizontal hairline crack.

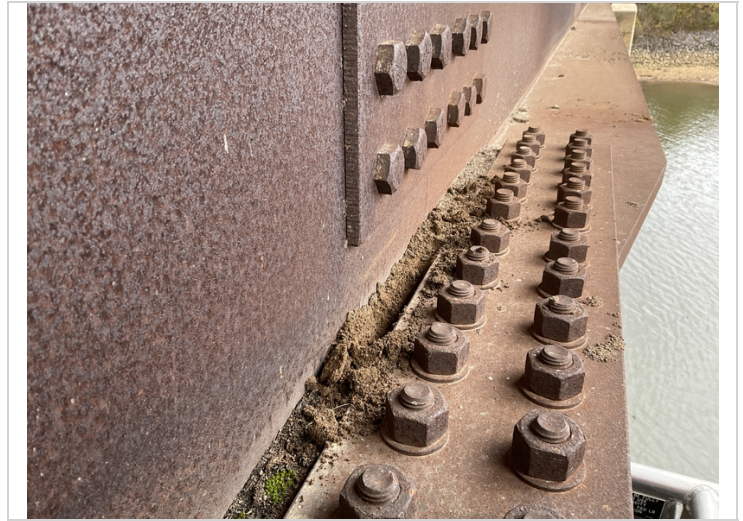
The exterior girders have dirt and debris accumulation behind the splice plate connections potentially causing corrosion / abnormal weathering to girders.

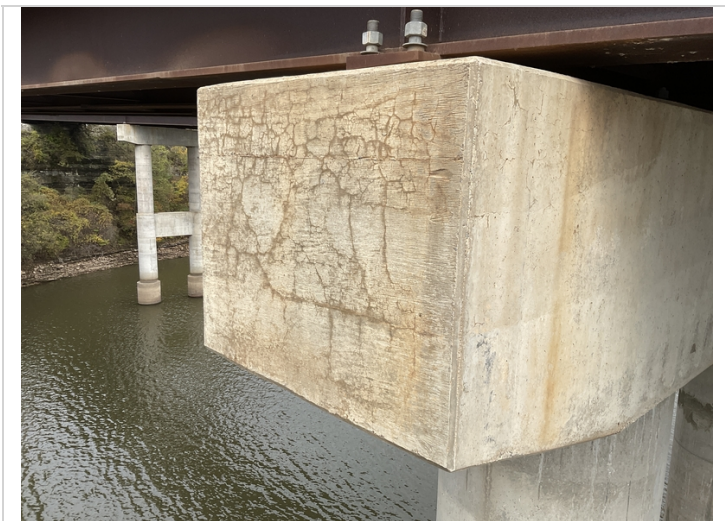
Bent 3 cap, right end-Mapcracking.

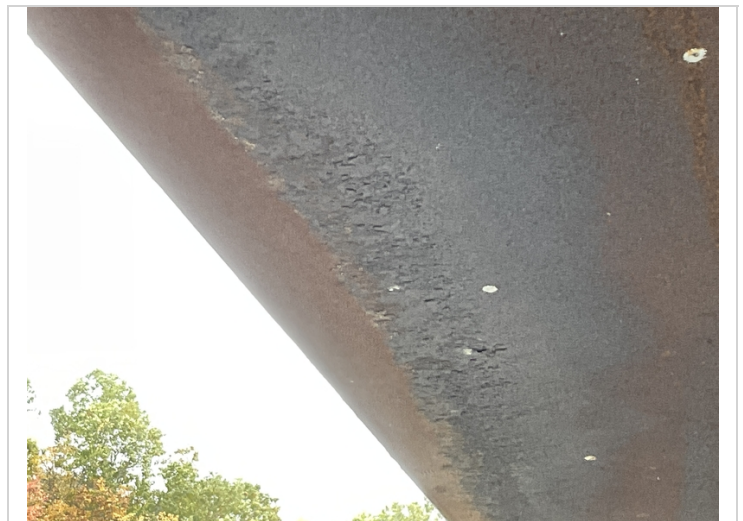
Span 2, girder 4-Abnormal weathering.

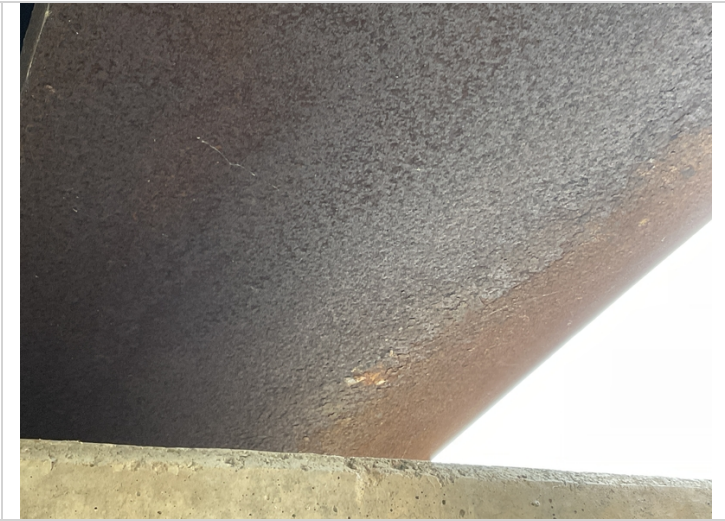
Span 2, girder 4-Abnormal weathering.

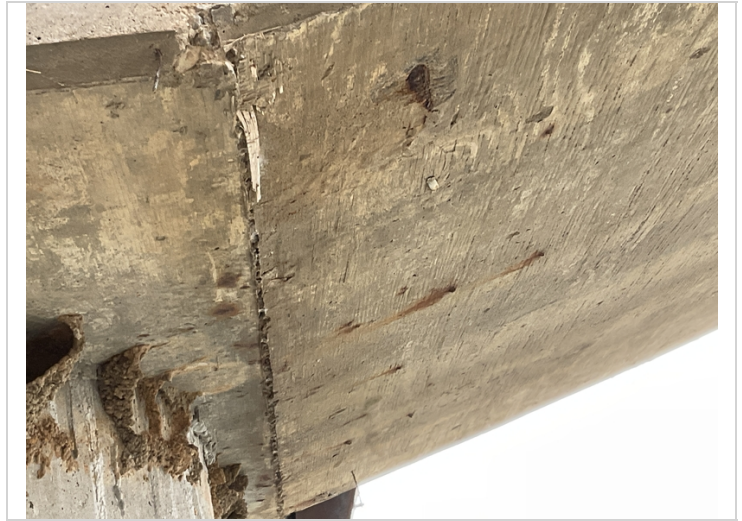
The undersurface of bent # 3 cap has two 3" shallow spalls with exposed reinforcing steel on the right side adjacent to column # 2.

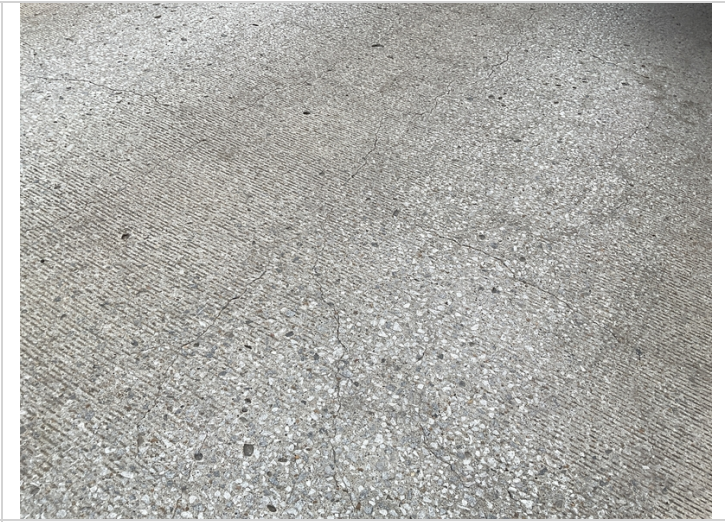
Span 1, right lane-Deck cracking.

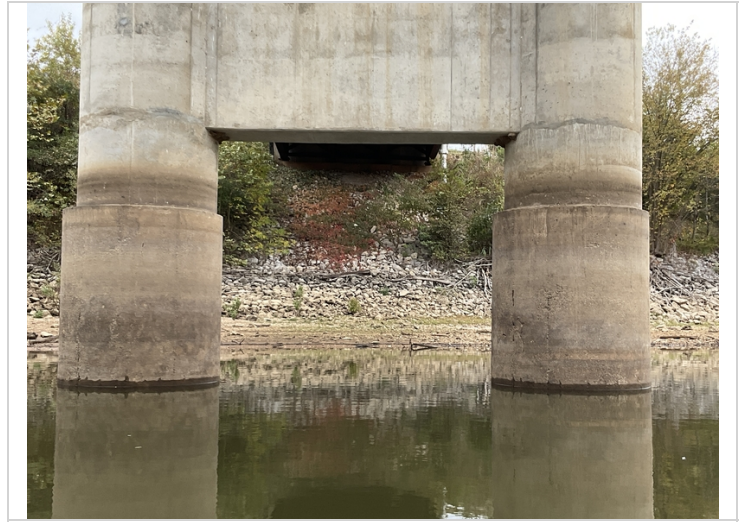
Bent 5 drilled shafts.

10/28, 11/01 & 11/2/2021 - RSM, JCJ, EJW, SPC, TJL & JPW: Routine inspection conducted these dates. NBIS Condition Rating for item "60" lowered from "6" to "5" due to wide excessive cracking in base of columns and ends of intermediate bent caps. Aspen 40 snooper truck was utilized for inspection access. A boat was used to inspect the lower portion of the substructure.

ELEMENTS	DESCRIPTION	UNITS	TOTAL	CS1	CS2	CS3	CS4
<p>(205) The section of columns / top of the drilled shafts in proximity of the average / normal lake elevation have wide vertical, transverse, and map cracking up to an 1/8" wide along with concrete deterioration that exposes the reinforcing steel in areas. Exposed reinforcing steel has very little concrete cover from the construction process. Some columns have vertical cracking that propagates from the top of the drilled shaft concrete into the base of the columns above the water elevation.</p> <p>-Bent # 2 has light scale at the top of the drilled shaft at the water elevation. -Both columns have vertical cracking. -Left column has map cracking with light efflorescence. -The lower portion of bent # 2 columns have 4" shallow delaminated areas in the ahead face.</p> <p>-Bent # 3, left column has wide vertical and map cracking with soft deteriorated concrete that has up to 4" of concrete section loss in areas. The column has exposed epoxy coated reinforcing steel at the top of the drilled shaft at the water elevation that appears to have insufficient concrete coverage from the construction process. -Bent # 3, right column has soft deteriorated concrete with light scale at the top of the drilled shaft at the water elevation. -Bent # 3, right column has vertical cracking. -Bent # 3, right column has soft deteriorated concrete with a 3' shallow spall with exposed reinforcing steel located 1' below the top of the drilled shaft.</p> <p>-Bent # 4, left column has wide vertical and map cracking with soft deteriorated concrete at the top of the drilled shaft. The cracks are up to approximately 3/8" wide at this inspection. -Bent # 4, left column has concrete deterioration with an exposed hoop. -Bent # 4, right column has light scale at the top of the drilled shaft at the water elevation.</p> <p>-Bent # 5, right column has one baseball sized spall with no exposed reinforcing steel on the South side of column located at the top of the horizontal strut. -Bent # 5 drilled shaft has honeycombing with numerous moderate width vertical cracks. -Bent # 5, left column has concrete deterioration with vertical rows of honeycombing at the top of the drilled shaft at the water elevation. -Bent # 5, left column has one isolated area of exposed steel in the left exterior face of the drilled shaft portion of column that appears to be from insufficient concrete coverage during the construction process.</p>

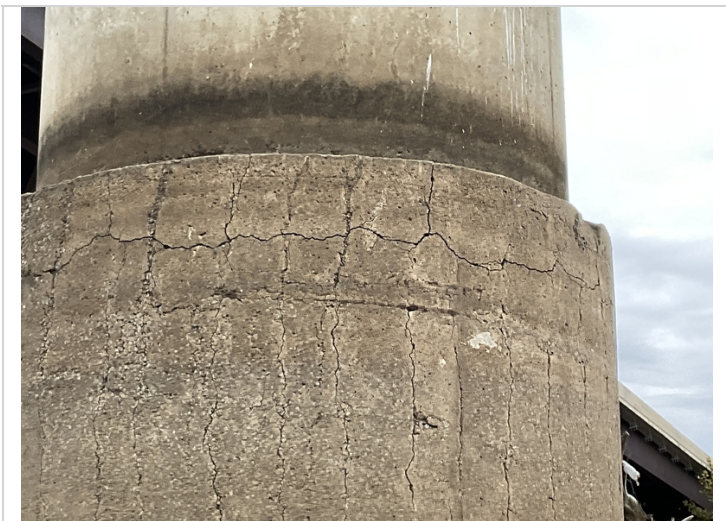
Bent 4, column 1-Wide horizontal cracking.

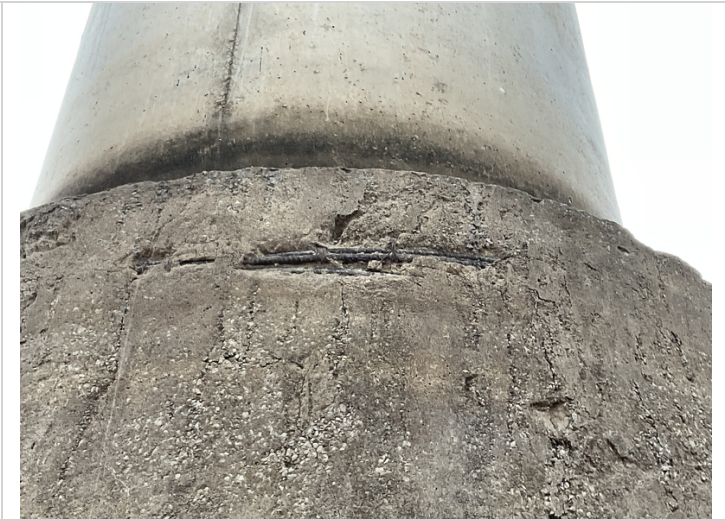
Bent 3, column 2-Exposed reinforcing steel.

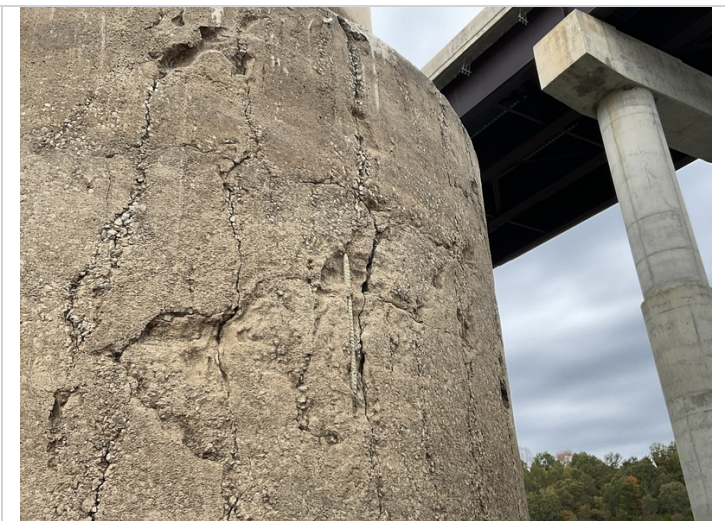
Bent # 3, column 1-Exposed reinforcing steel.

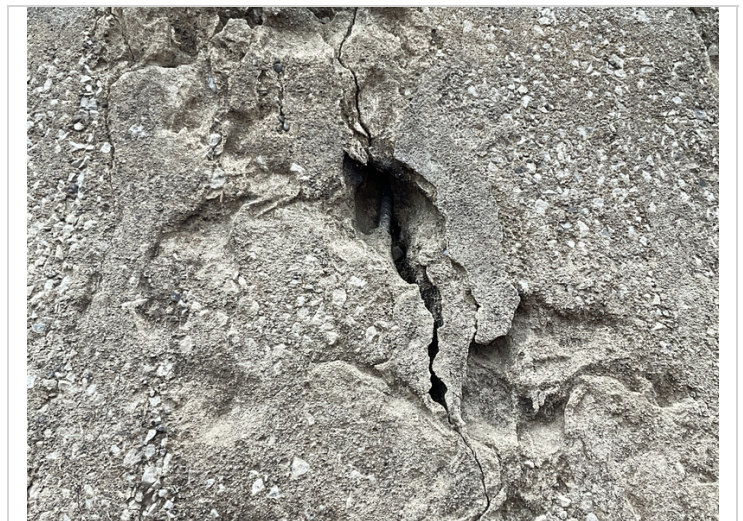
Bent # 3, column # 1-Honeycombing with exposed reinforcing steel.

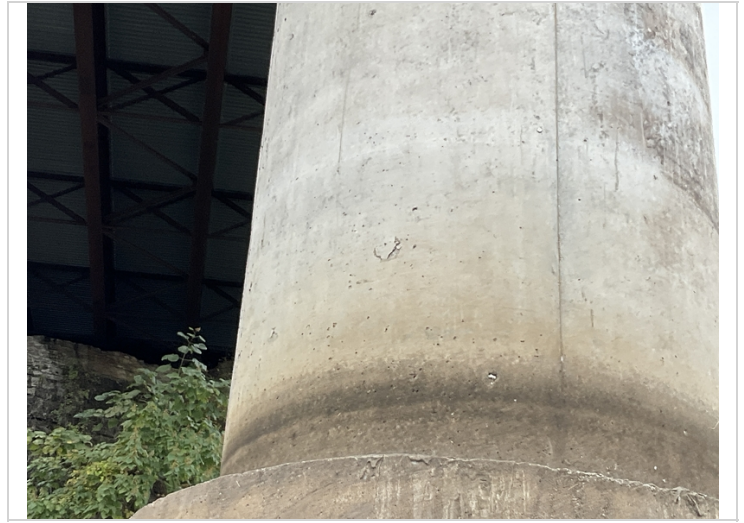
The lower portion of bent # 2 columns have 4" shallow delaminated areas in the ahead face.

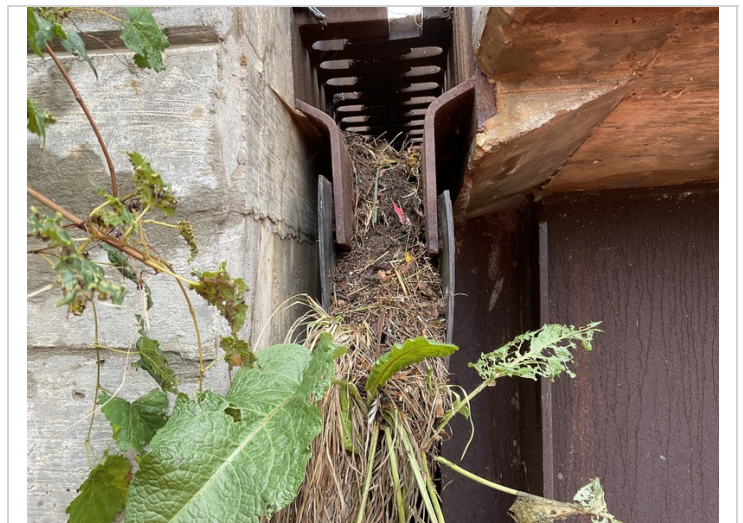
The expansion joint drainage trough on the left side of abutment # 2 has debris accumulation that restricts drainage.

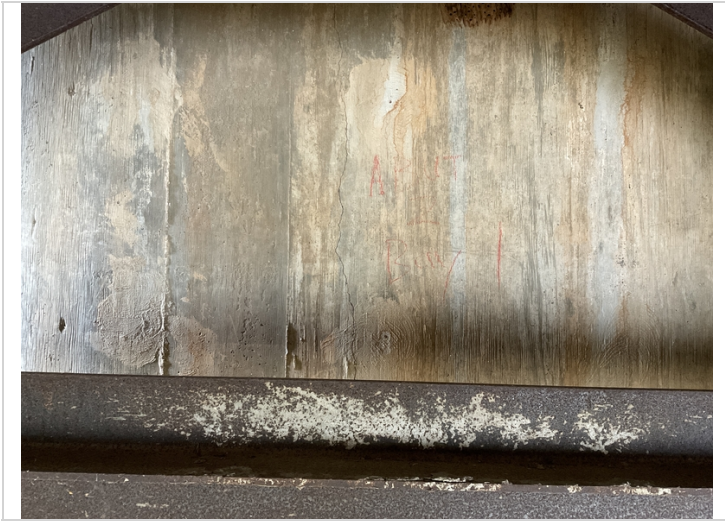
Abutment 2, bay 1-Vertical crack in backwall.

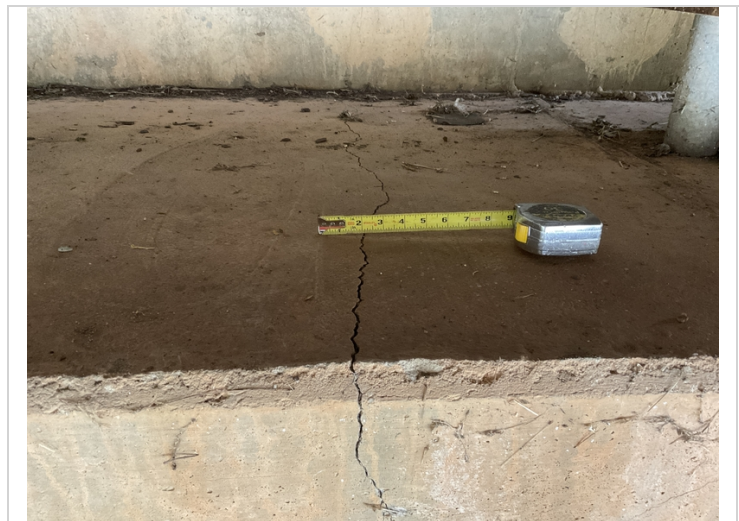
Abutment # 2 has a wide transverse crack that propagates across the bridge seat in bay # 2 located approximately 2' from girder # 3. The crack is 1/8" wide at this inspection.
Photo 2.

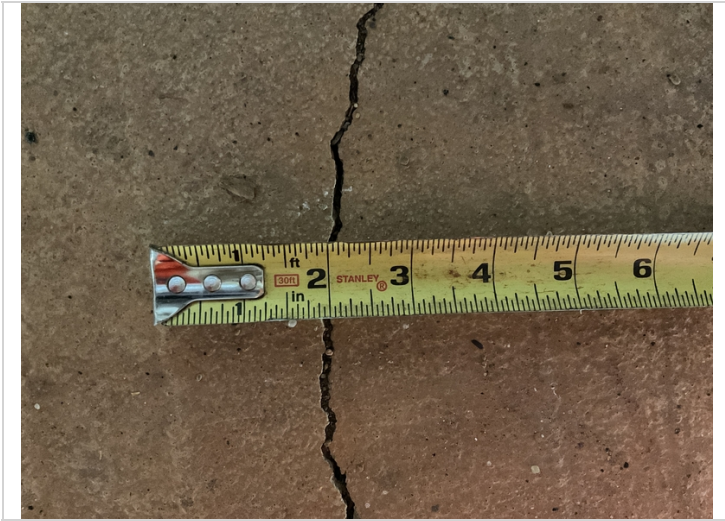
Abutment # 2 has a wide transverse crack that propagates across the bridge seat in bay # 2 located approximately 2' from girder # 3. The crack is 1/8" wide at this inspection.
Photo 1.

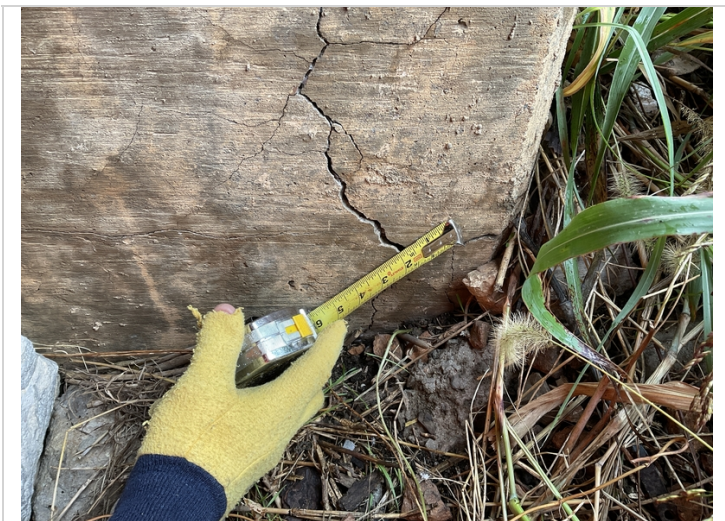
Wide mapcracking on right end of abutment # 2 bridge seat.
Photo 2.

The right side of abutment # 2 bridge seat has wide map cracking with cracks up to 1/4" wide.

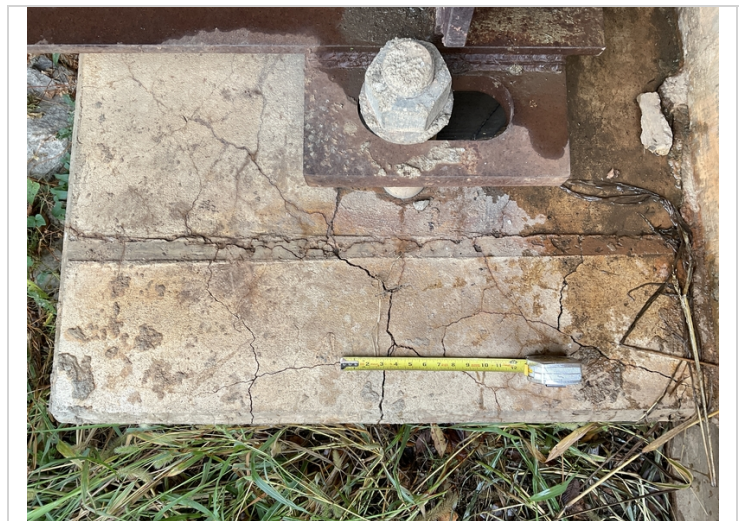
Wide mapcracking on right end of abutment # 2 bridge seat.

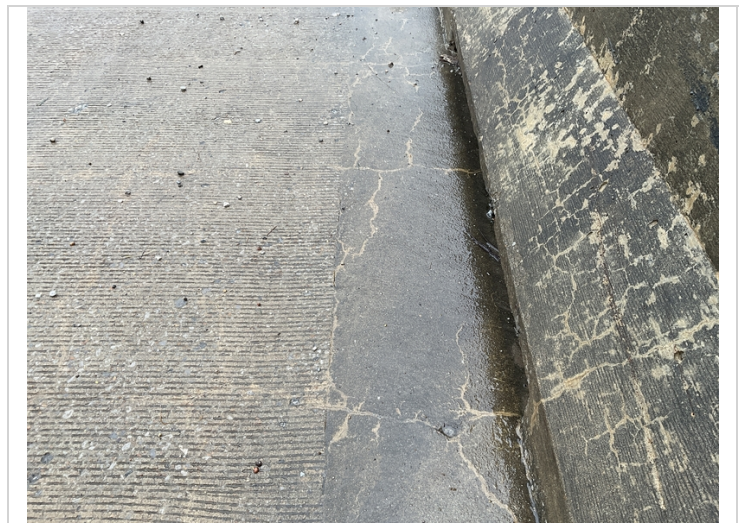
Span 1-Mapcracking in right gutter.

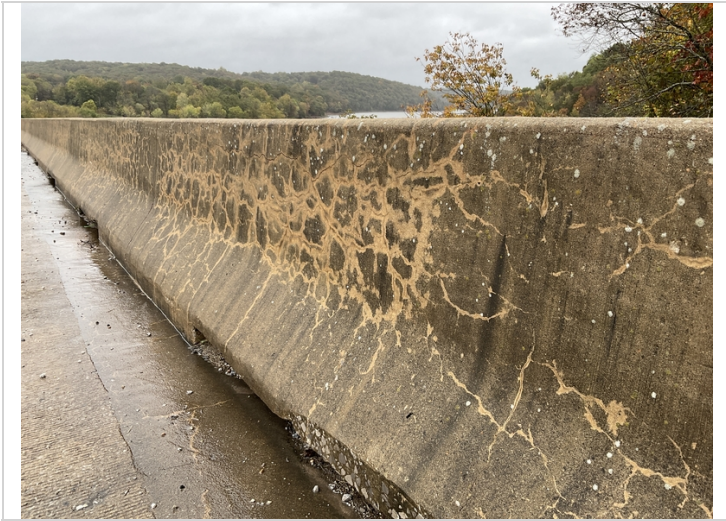
Span 1, right side-Mapcracking in parapet.

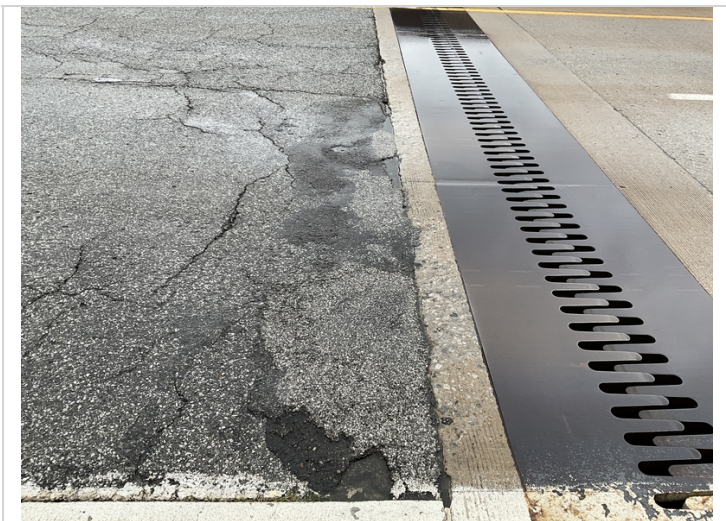
Asphalt mapcracking with repairs in West approach roadway.

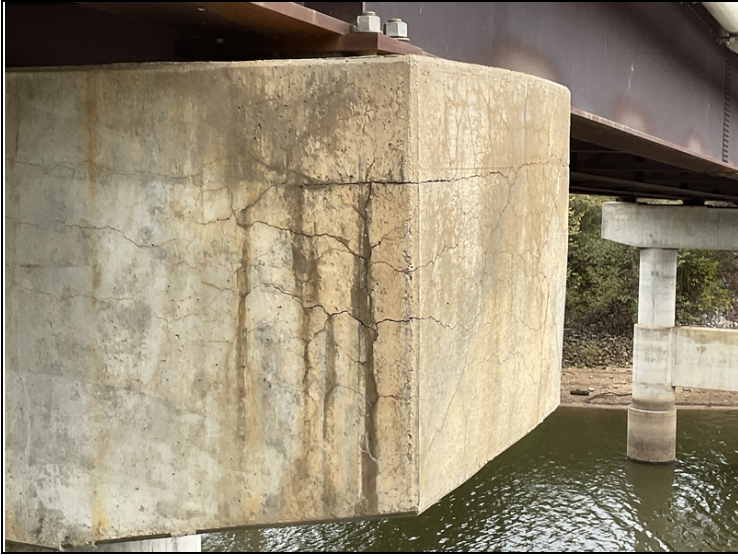
Bent # 4 cap, right side-Wide mapcracking.

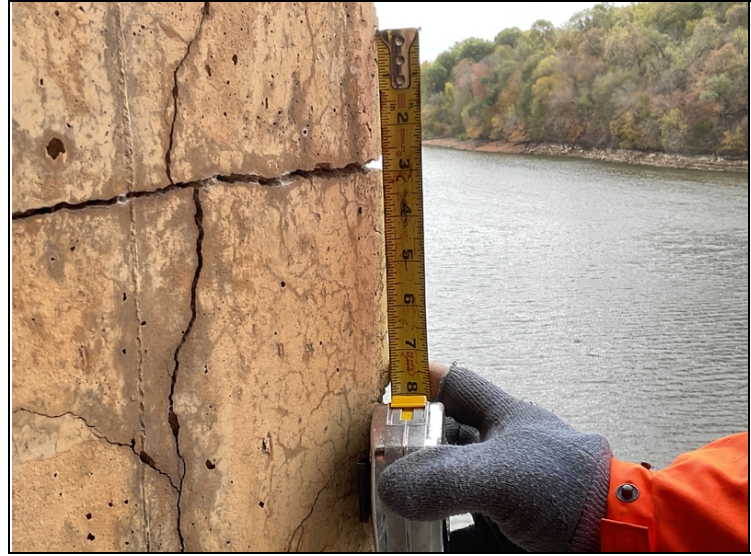
Bent # 4 cap, right side-Wide mapcracking.

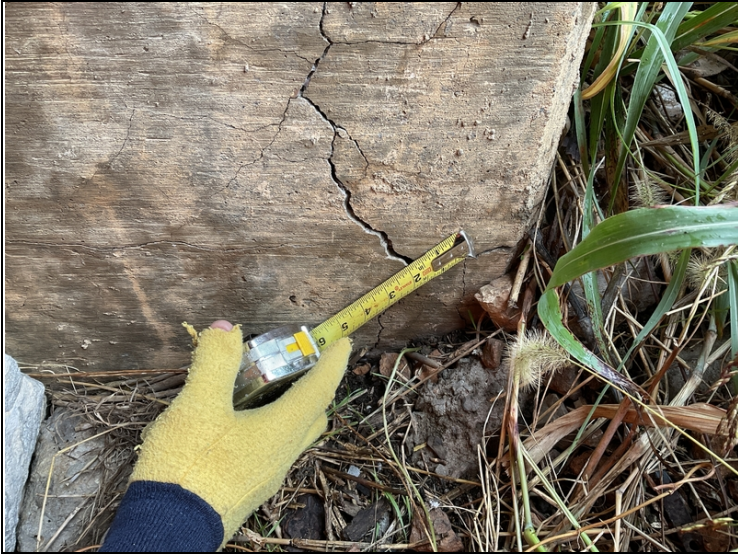
Wide mapcracking on right end of abutment # 2
bridge seat.

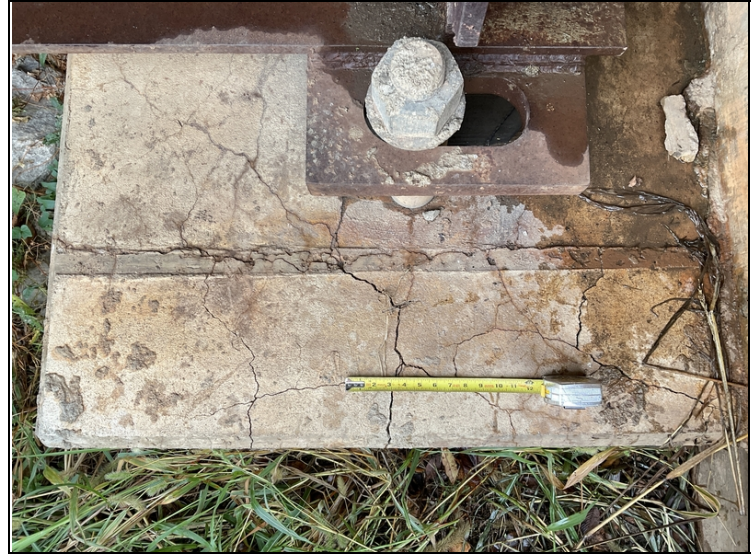
Wide mapcracking on right end of abutment # 2
bridge seat.

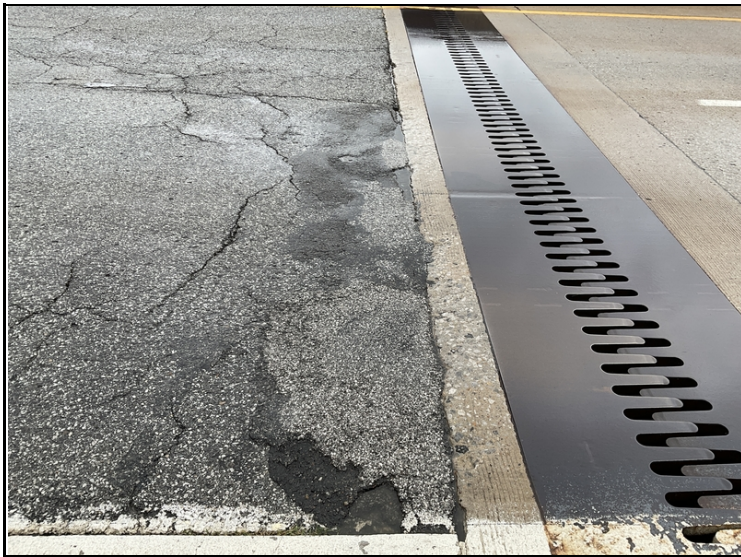
The asphalt of the approach roadways is beginning to settle at the bridge ends.

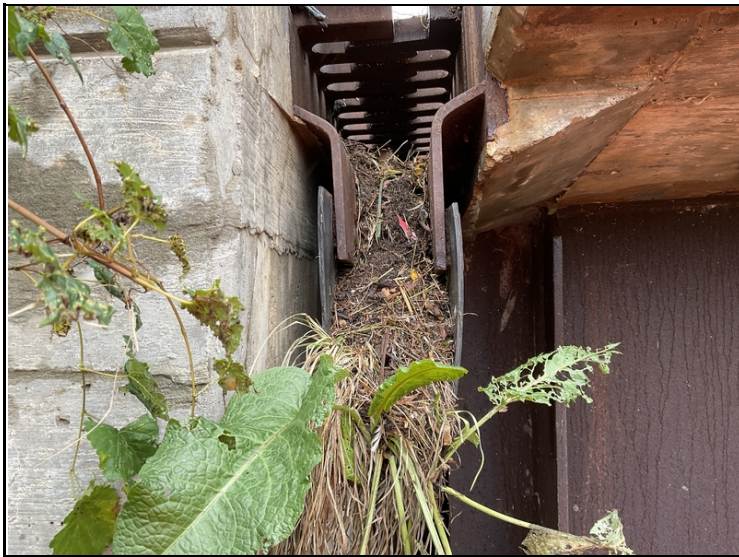
The expansion joint drainage trough at abutment # 2 has debris accumulation on the left side that restricts drainage.

The expansion joint drainage trough on the left side of abutment # 2 has debris accumulation that restricts drainage.

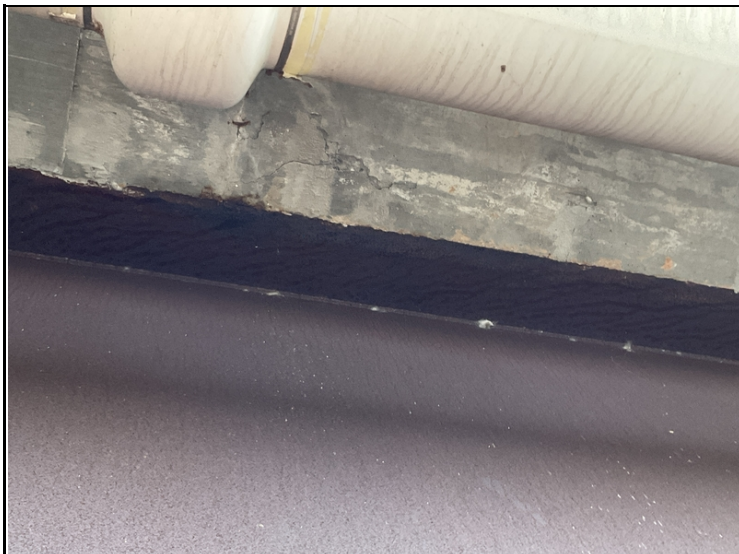
The undersurface of the deck overhang on the right side of span # 5 has two 12" Delaminated areas adjacent to the girder top flange.

The undersurface of the deck overhang in span # 4 has a 12" delaminated area adjacent to girder # 4 top flange located adjacent to splice connection # 1.

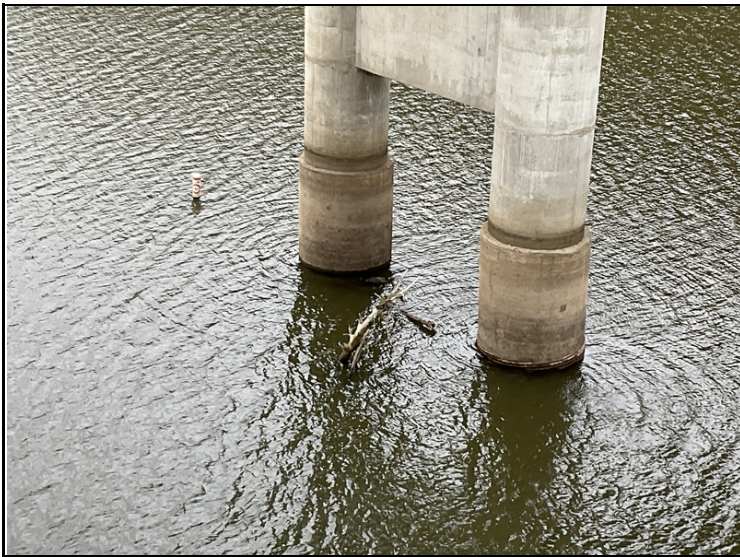
Channel -
The channel has an undetermined amount of submerged drift at the intermediate bents.

Submerged drift at bent # 4.
