Asset #05175(Routine)

US 64 Seb. Co. over Arkansas River Relief

Location: 0.5 MI S ARK. RIVER

Team Lead: Bob McEntyre Inspection Date: 08/19/2024

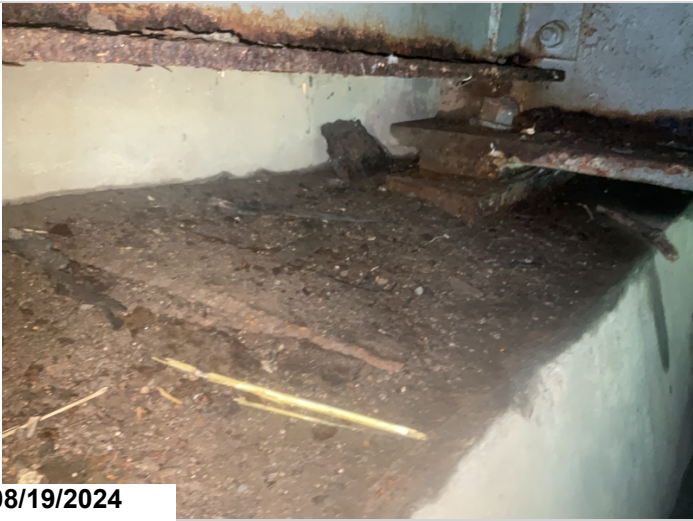
08/19/2024 - RSM & SPC: The bearing areas have heavy dirt and debris that has accumulated against the steel superstructure promoting corrosion. Abutment # 1 pictured.

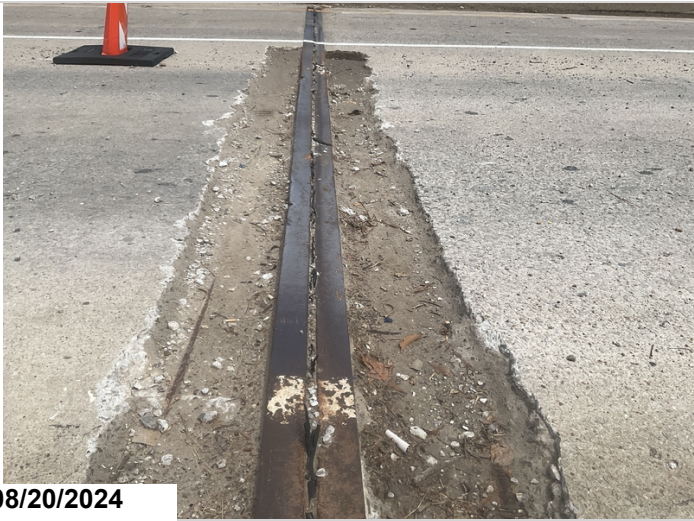
A 12" wide area of the deck has been removed in the outside lanes of the North and south travel lanes adjacent to the expansion joints in preparation for hydro-demolition project. Bent # 6 Northbound Expansion joint pictured.

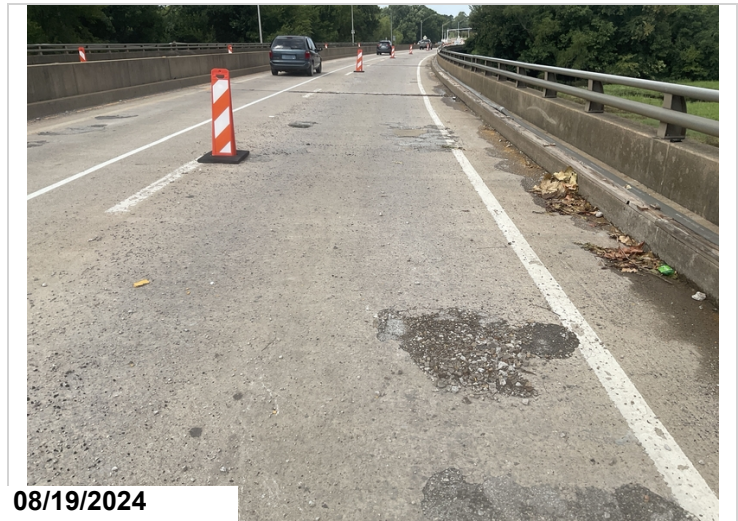
Span # 6, Westbound Outside Lane: Spalling with asphalt repairs.

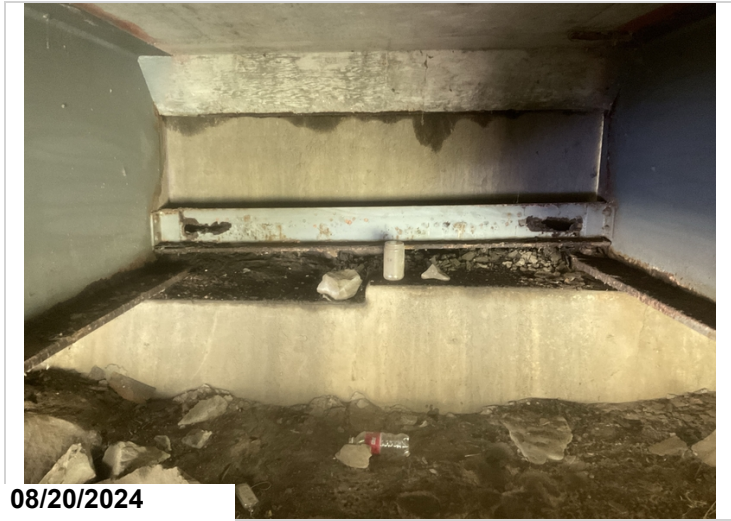
Abutment # 2, Bay # 8: Holes rusted through diaphragm.

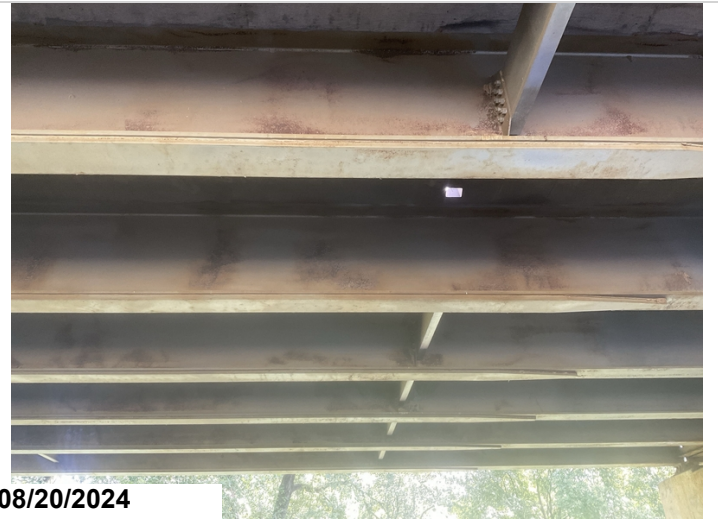
Paint system flaking/ peeling.

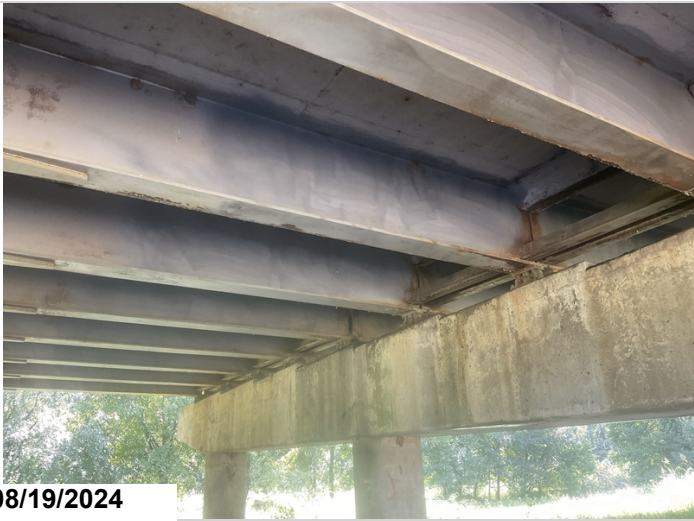
Spans # 4, 5 and 6: Ends of Girders have been painted in the past. Span # 5 girders pictured.

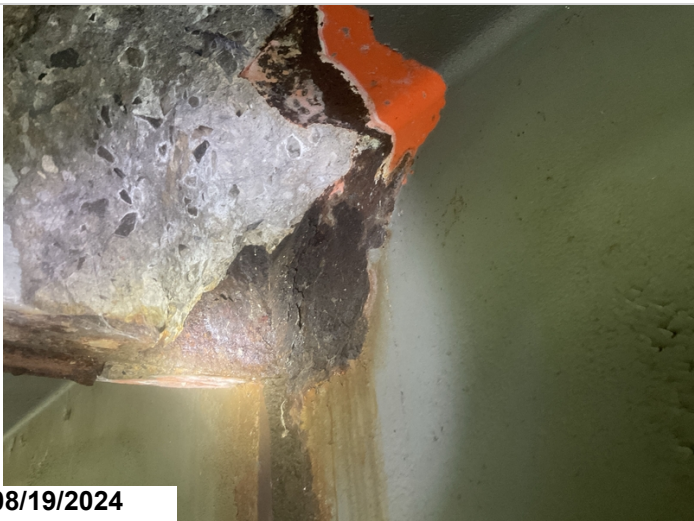
Span # 3, Bent # 3, Girder # 6: Corrosion to web and bottom flange in an area approximately 5' in length. Bottom flange has an estimated 1/16" section loss. Base of web and upper portion of web at expansion dam have an estimated 3/6" section loss. 5LF CS3.

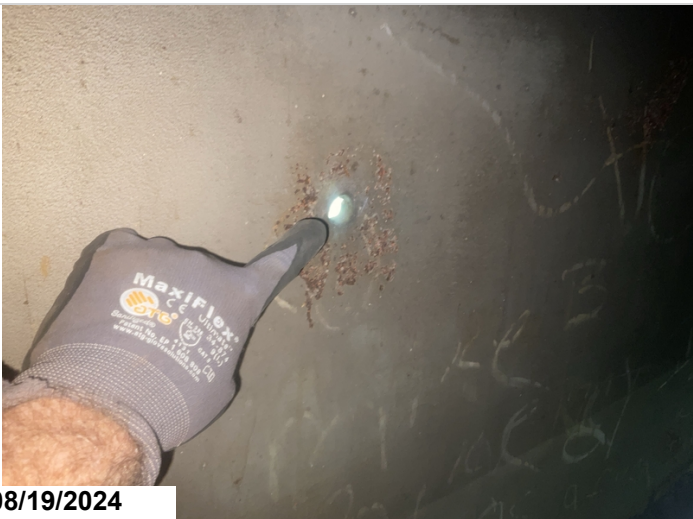
Span # 1, Girder # 1 Web, 10" Below Top Flange: 3/4" torch cut holes on approximately 9' spacing.

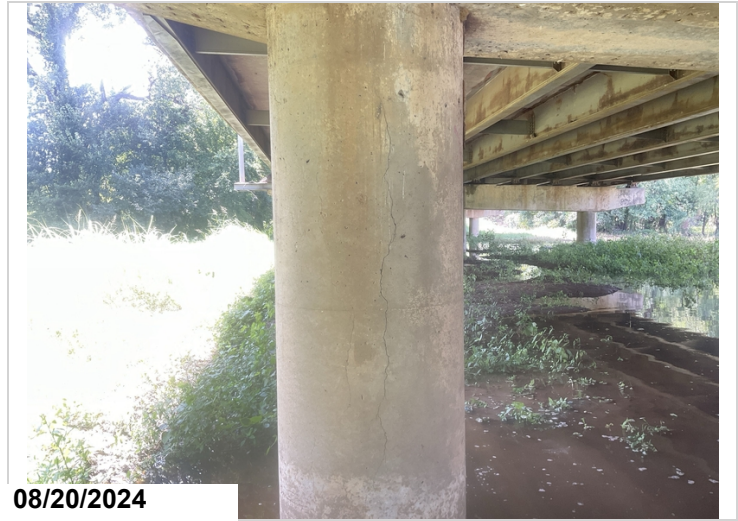
Moderate width vertical cracking in column.

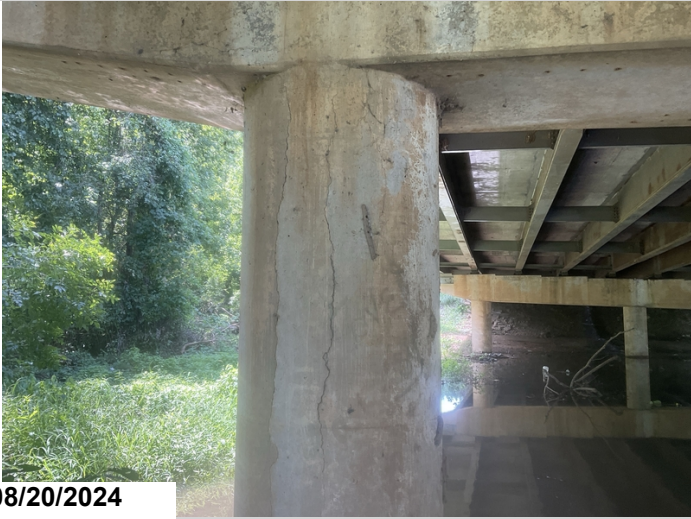
Bent # 3, Column # 3: 12" spall with exposed reinforcing steel in ahead side at the base of the column. Column has delaminated areas and vertical cracking in ahead side and back side. 1EA CS3.

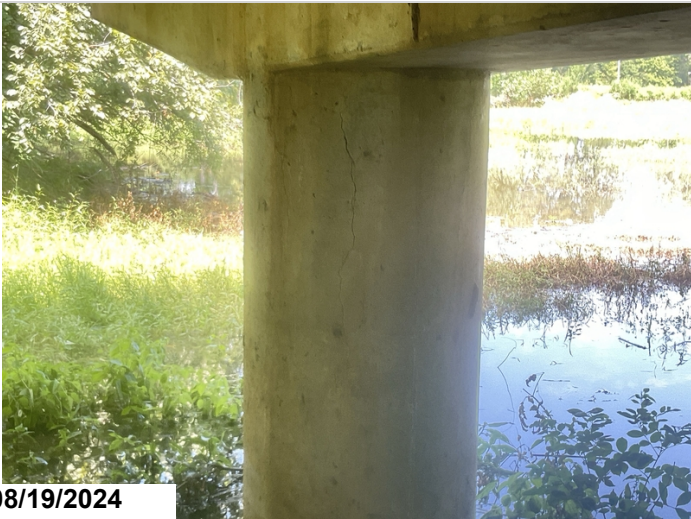
Bent # 3, Column # 1: Wide vertical cracking. 1EA CS3.

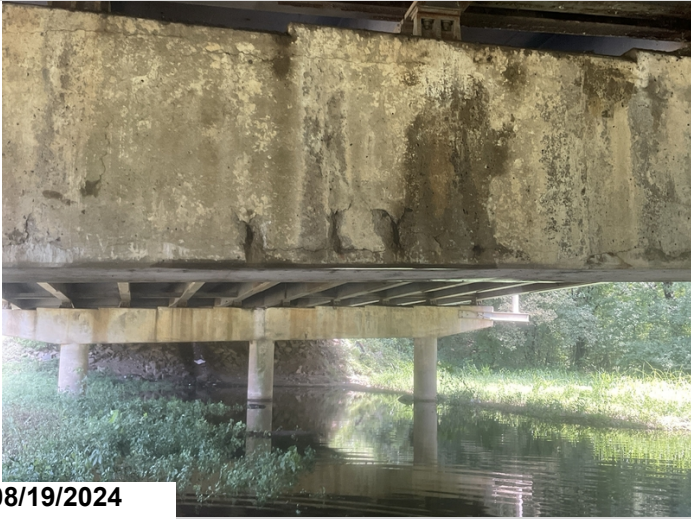
Bent # 5 Cap: Vertical 24" long delaminated area / spall with exposed reinforcing steel and numerous small delaminated areas with three 8" spalls with exposed reinforcing steel on the left side of the back face of cap. 4LF CS3.

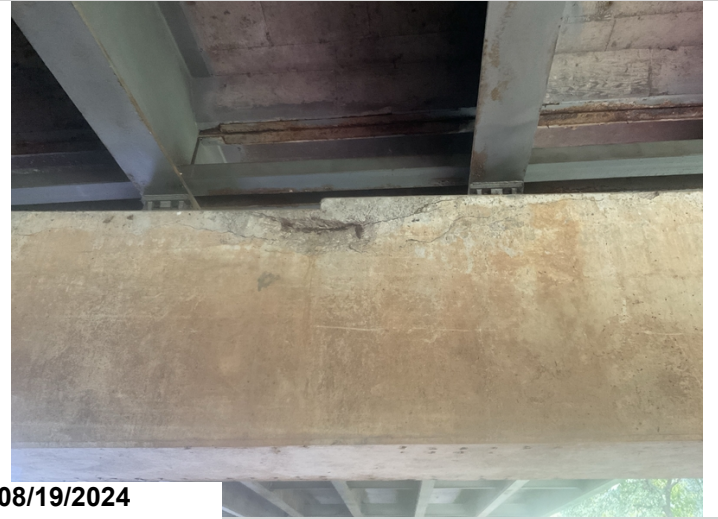
Bent # 2 Cap, Back Right Side: 2 12" spalls with exposed reinforcing steel. Spall, 1LF CS3, Exposed Steel, 1LF CS3.

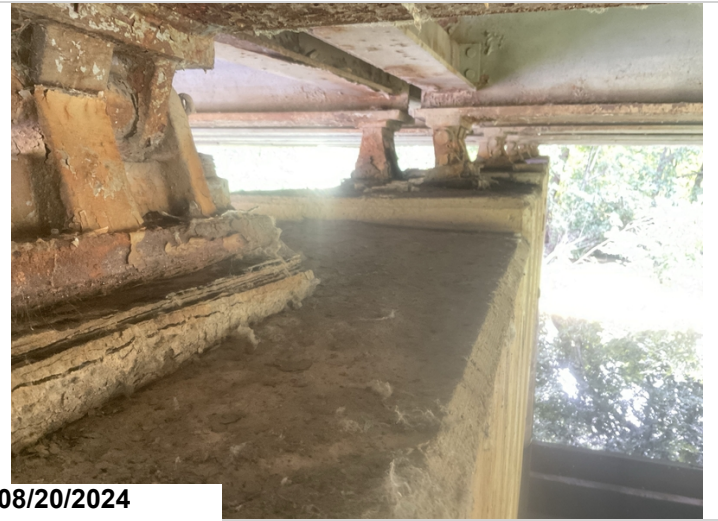
Bent # 3 Bearings: Failing paint system with pack rust between bearing plates.

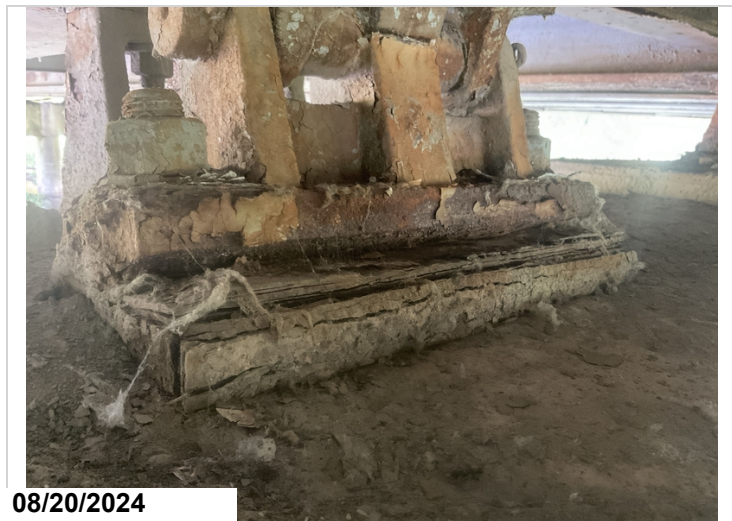
Span # 2, Bent # 3, Bearing # 2: Heavy pack rust between rocker and masonry plate. 1EA CS3.

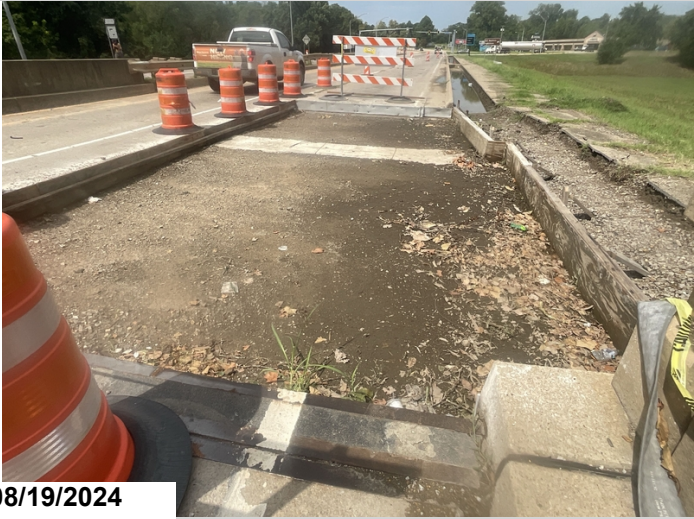
Approach Slabs: The outside Northbound lane of both approach slabs is in the process of being replaced.
Approach Slab # 2 pictured.

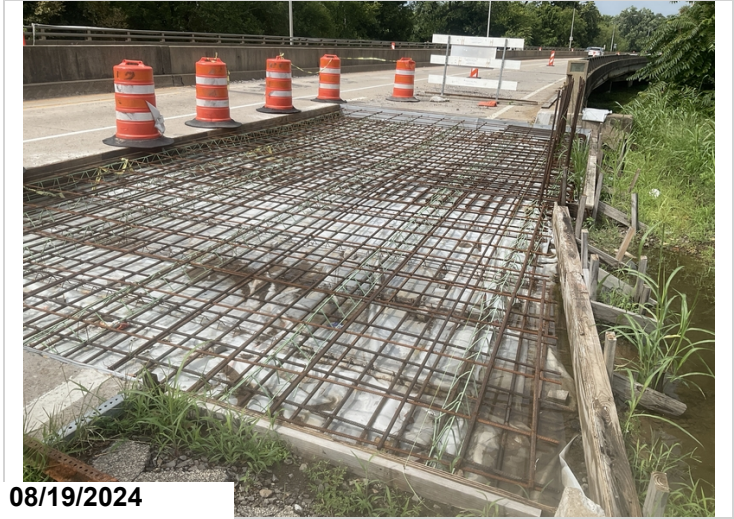
Approach Slab # 2: The outside Eastbound lane is in the process of being replaced.

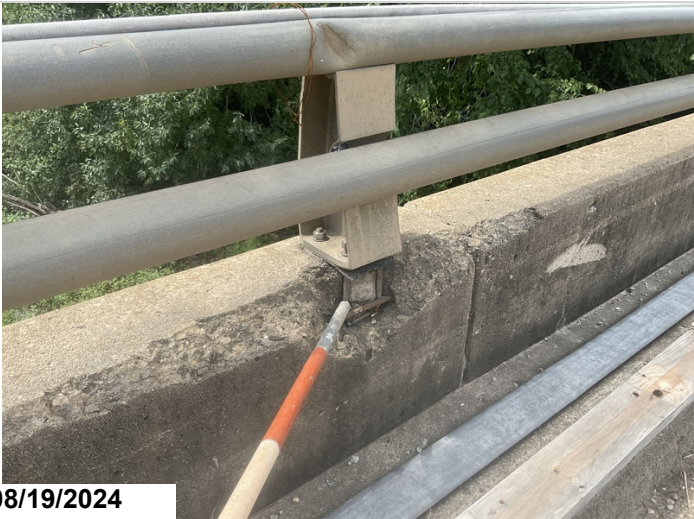
Span # 3, Right Railing, Eastbound Lane: Collision damage with a spall with exposed reinforcing steel at the base of the metal bridge rail post where the post is anchored to the concrete portion of the rail. 1EA CS3.

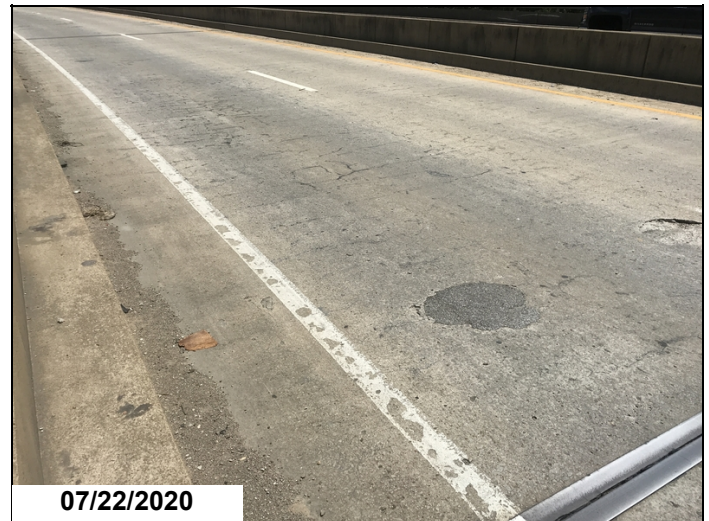
Span #3 SB cracking and spalling with exposed reinforcing steel.

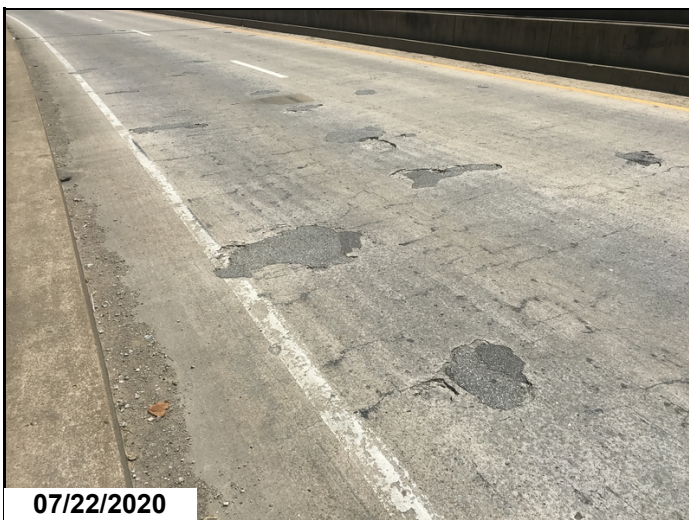
Span #2 SB concrete deterioration, delaminations and spalling.

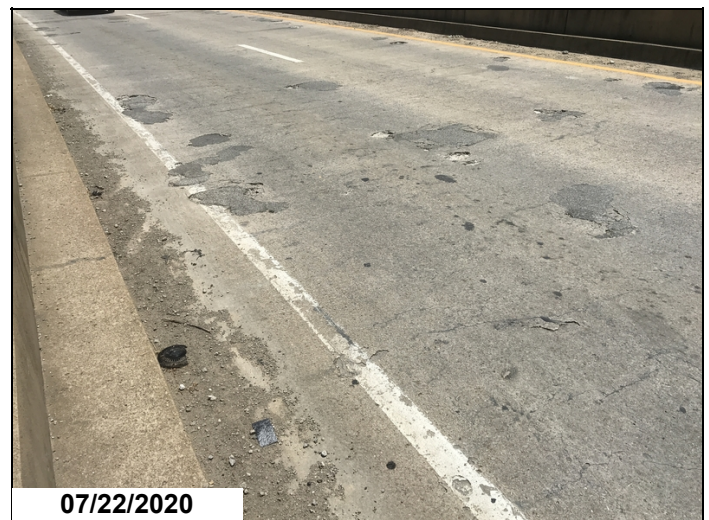
Span #1 SB concrete deterioration, delaminations and spalling.

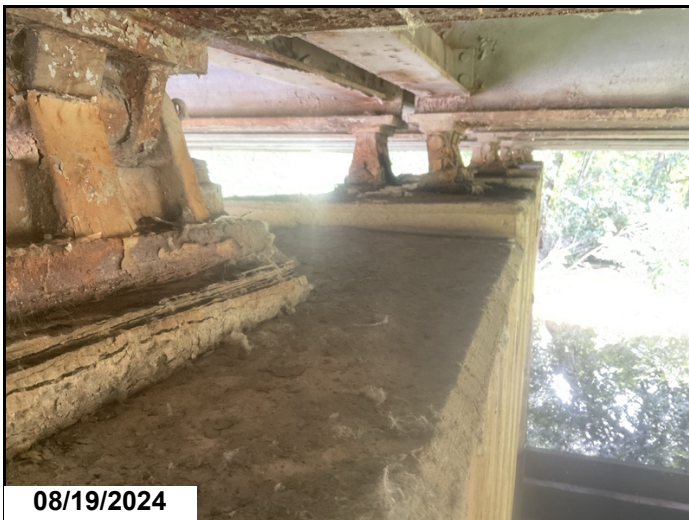
Bent # 3 Bearings: Pack rust between rockers and masonry plates.

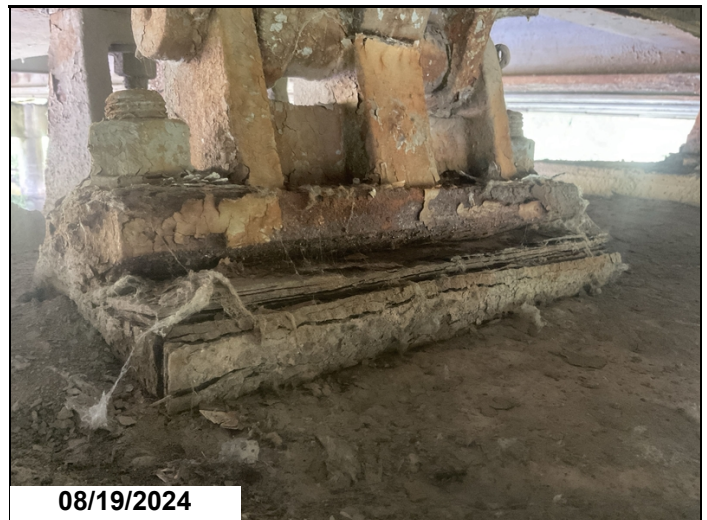
Span # 2, Bent # 3, Bearing # 2: Heavy pack rust between rocker and masonry plate. 1EA CS3.

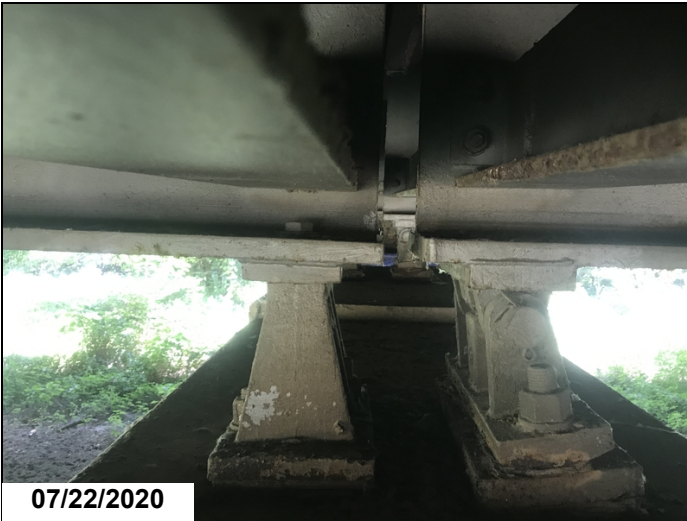
The bearings have pack rust between the masonry plates and the bent caps and between the masonry plates and the rockers in several locations. The pack rust appears to be causing the bearings to have a height differential between adjacent fixed and moveable bearings. This height difference is beginning to be noticeable on the driving surface of the deck with one side of the joint being higher than the other side. Bent # 2 pictured.

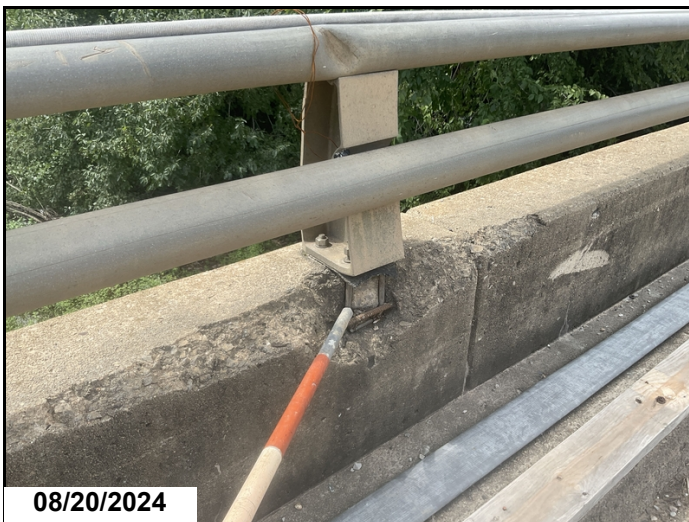
Span # 3, Right Railing, Eastbound Lane: Collision damage with a spall with exposed reinforcing steel at the base of the metal bridge rail post where the post is anchored to the concrete portion of the rail. 1EA CS4.

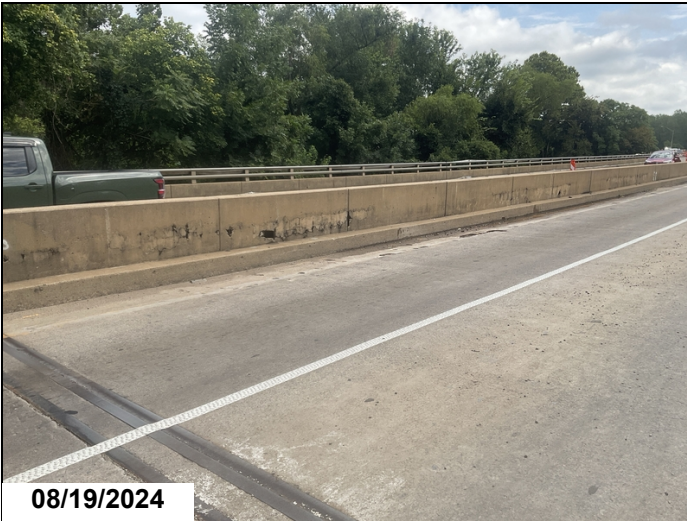
Span # 1: Median Barrier Wall: Concrete deterioration with spalling that exposes reinforcing steel and voids in the wall.

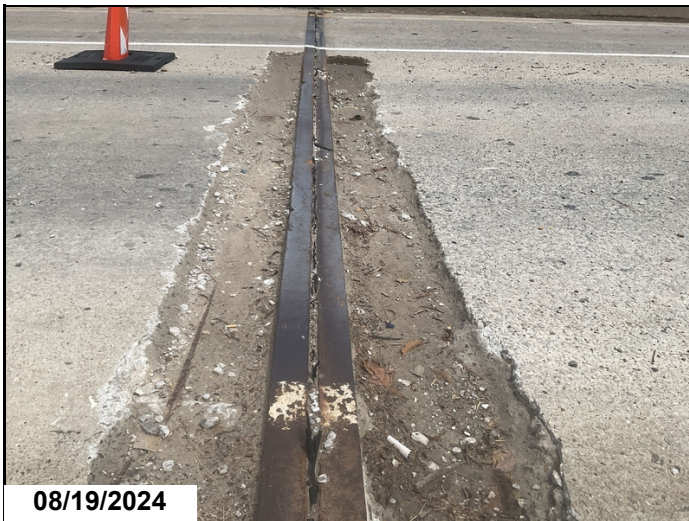
The expansion joint compression seals are deteriorated and missing in locations allowing water, dirt, and debris to leak onto the substructure. The expansion joint assemblies are jammed together in some locations.

08/19/2024 - The expansion joints are in the process of being rehabilitated / replaced as part of the Hydro-demolition project.

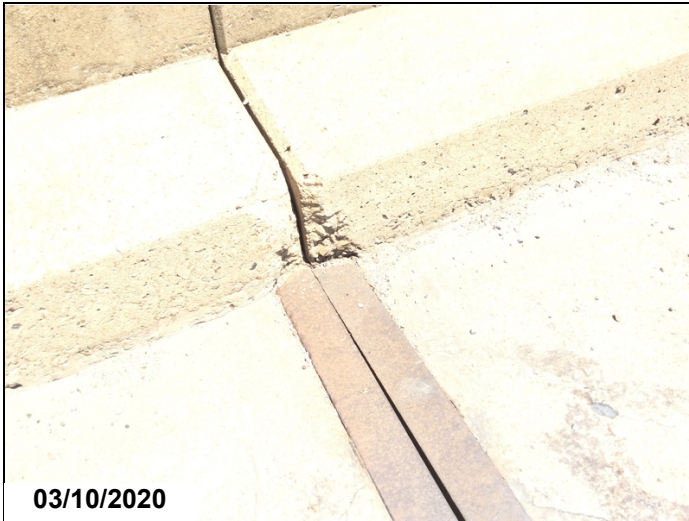
Bent #4, West bound side-Expansion joint assemblies jammed together.

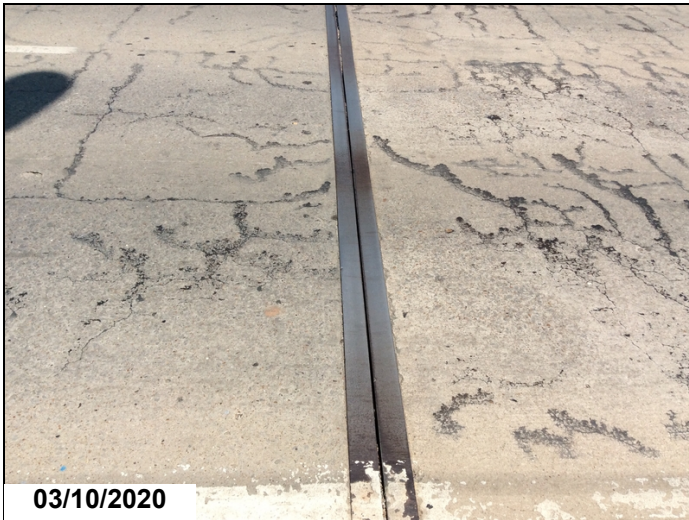
Bent 6. Deck joint seal

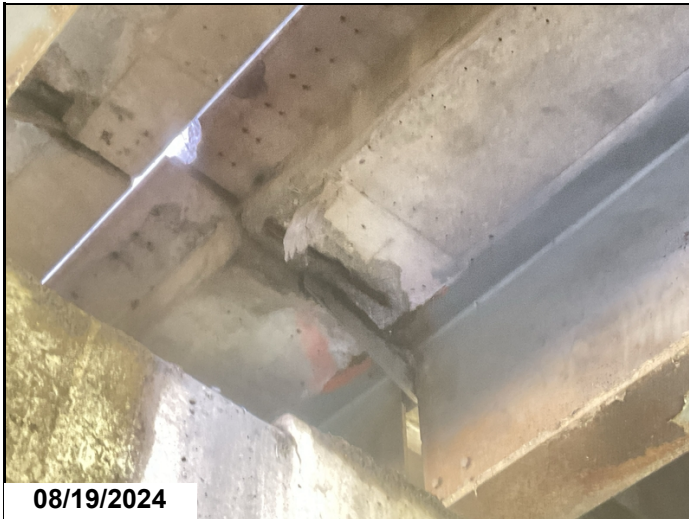
The undersurface of the deck has shallow spalling that exposes reinforcing steel under the median barrier wall and on the left side of the structure over Bents # 4 & 5.
2SF CS3.

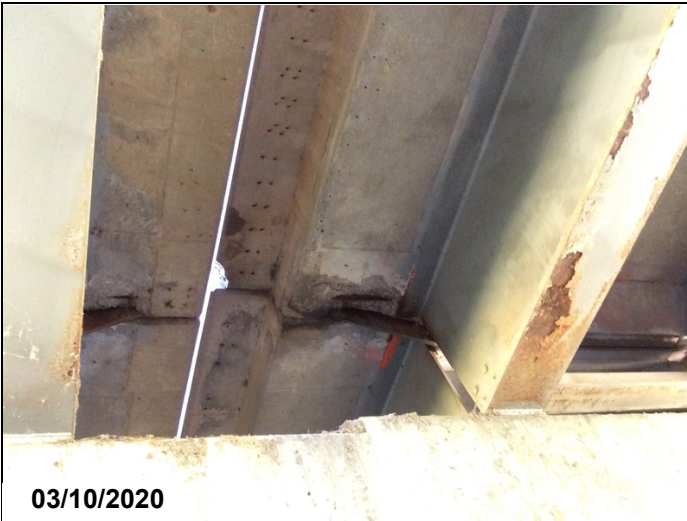
Undersurface of Span 3 at Bent 4. Centerline median.

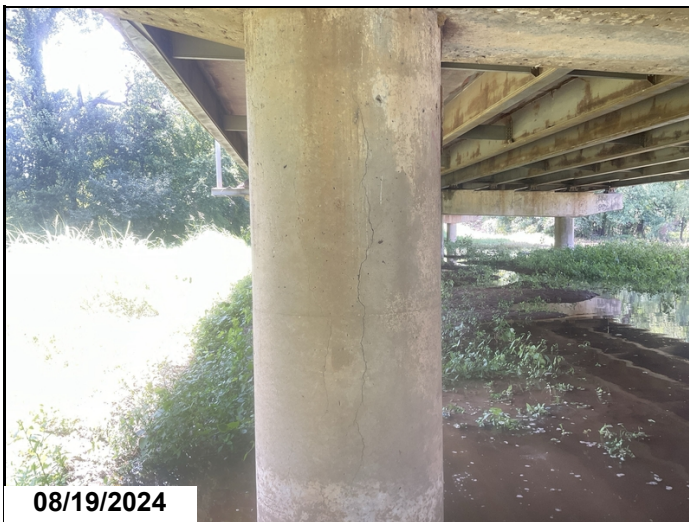
Moderate width vertical cracking in column.

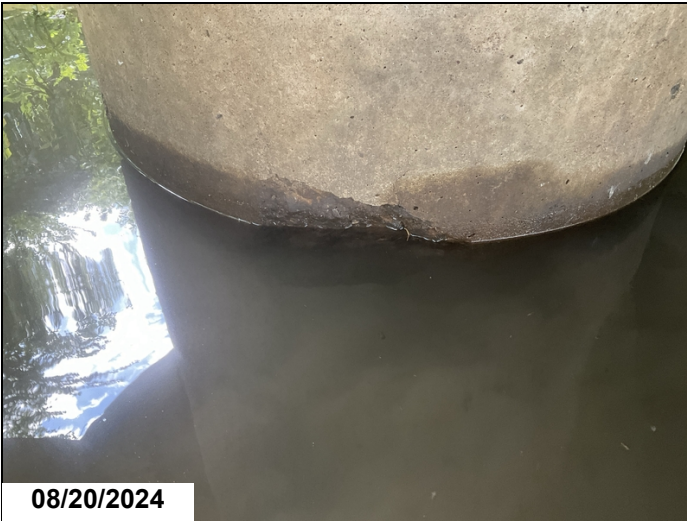
Bent # 3, Column # 3: 12" spall with exposed reinforcing steel in ahead side at the base of the column. Column has delaminated areas and vertical cracking in ahead side and back side. 1EA CS3.

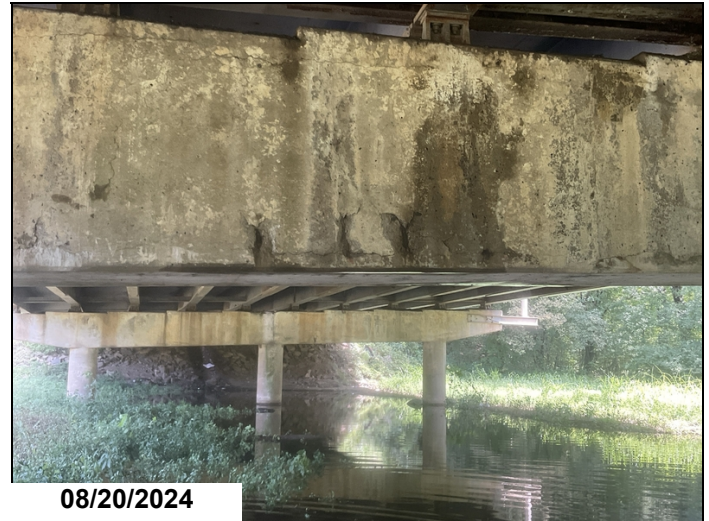
Bent # 5 Cap: Vertical 24" long delaminated area / spall with exposed reinforcing steel and numerous small delaminated areas with three 8" spalls with exposed reinforcing steel on the left side of the back face of cap. 4LF CS3.

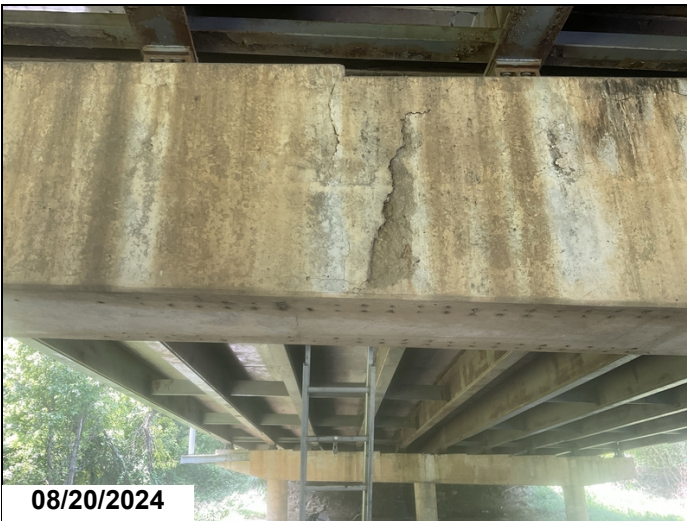
Bent # 3 Cap, Ahead Side, Between Columns # 2 and 3: Delaminated / spalled area. 1LF CS2. 1LF CS3.

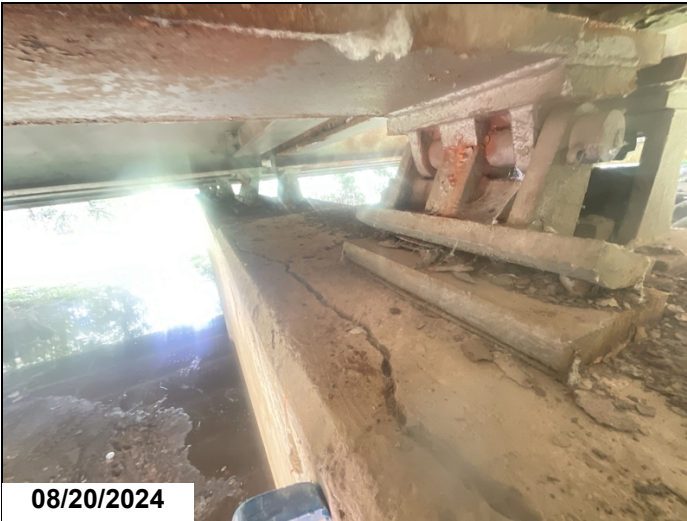
Bent # 2 Cap: Delaminated area.

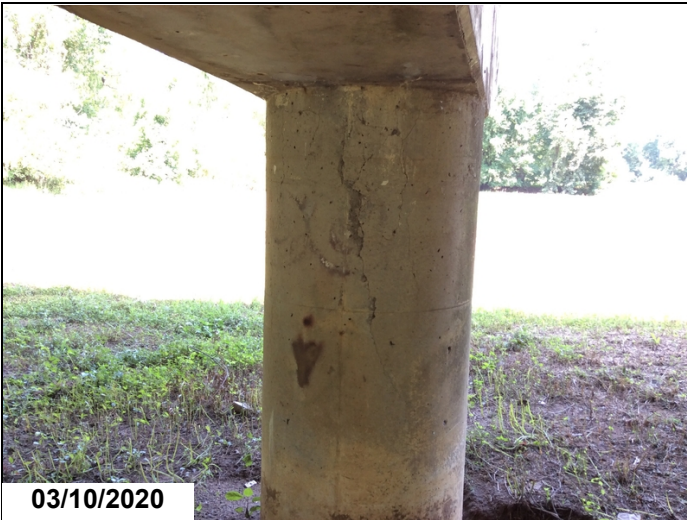
Cracking / delaminated area in column.

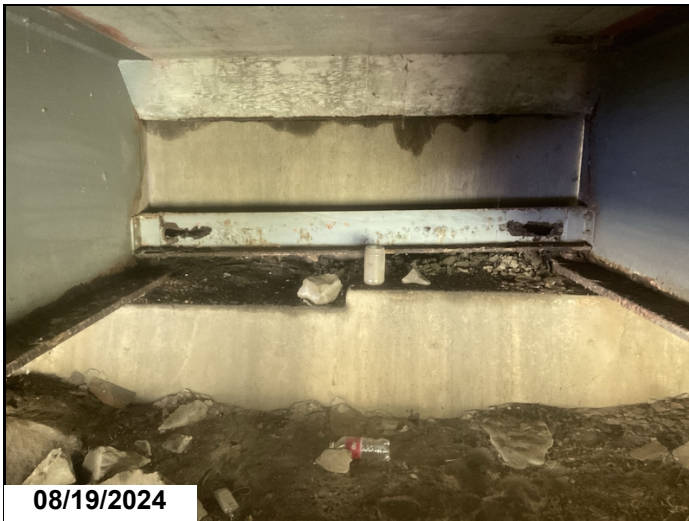
Abutment # 2, Bay # 8: Holes rusted through diaphragm.

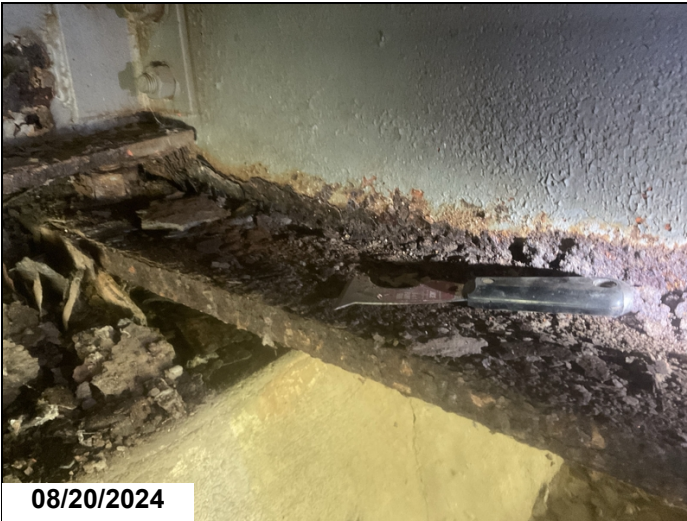
Span # 6, Abutment # 2, Girder # 9: Corrosion / section loss. 3LF CS3.

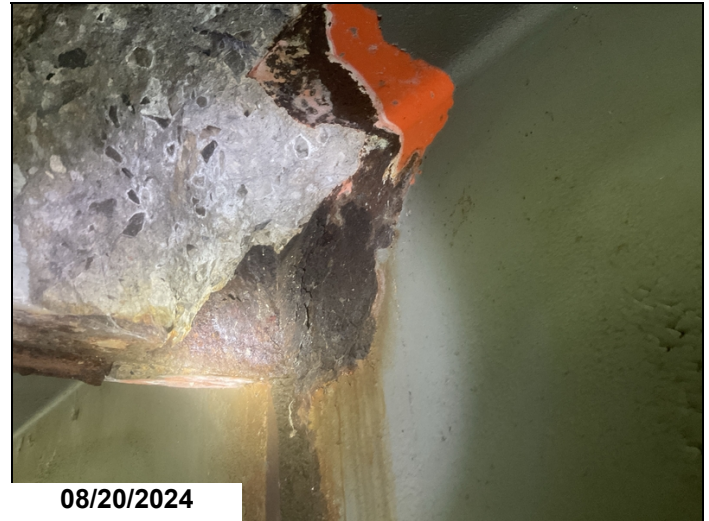
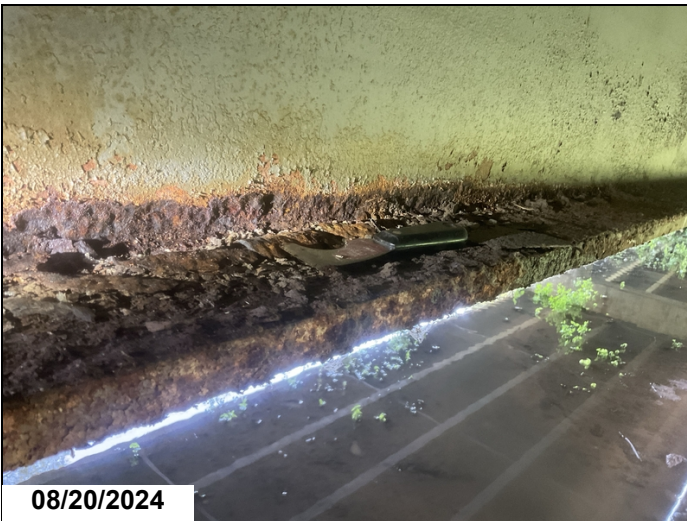
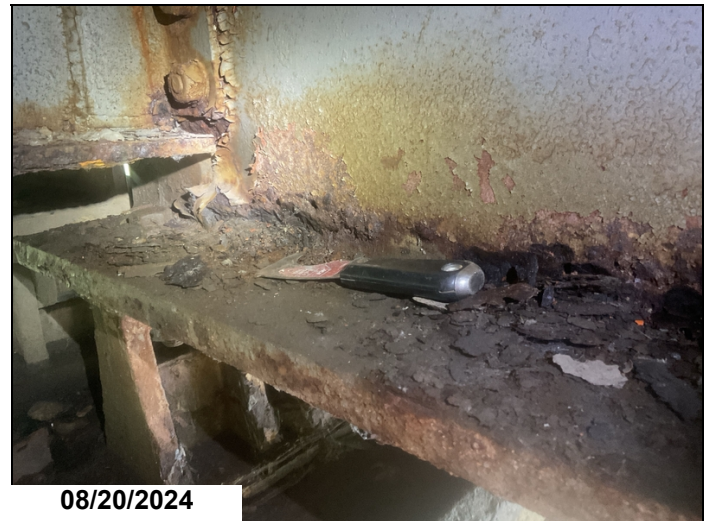
Span # 3, Bent # 3, Girder # 6: Corrosion to web and bottom flange in an area approximately 5' in length. Bottom flange has an estimated 1/16" section loss. Base of web and upper portion of web at expansion dam have an estimated 3/6" section loss. 5LF CS3.

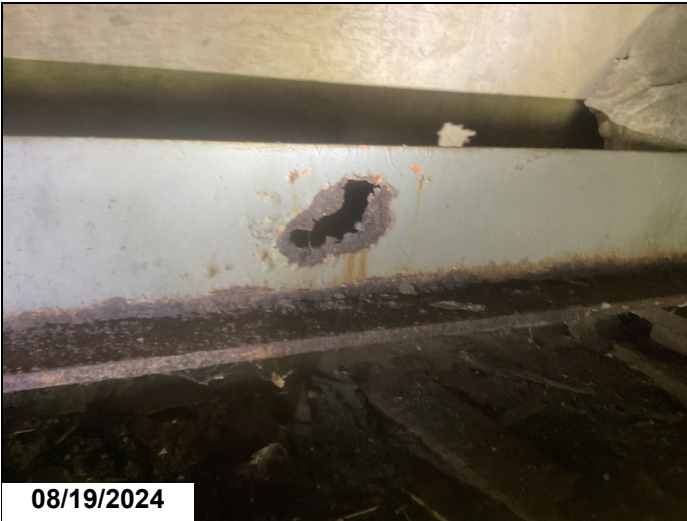
Diaphragms, Over Abutments: Holes rusted through several of the diaphragms at the abutments. Abutment # 1, Bay # 9 diaphragm pictured.

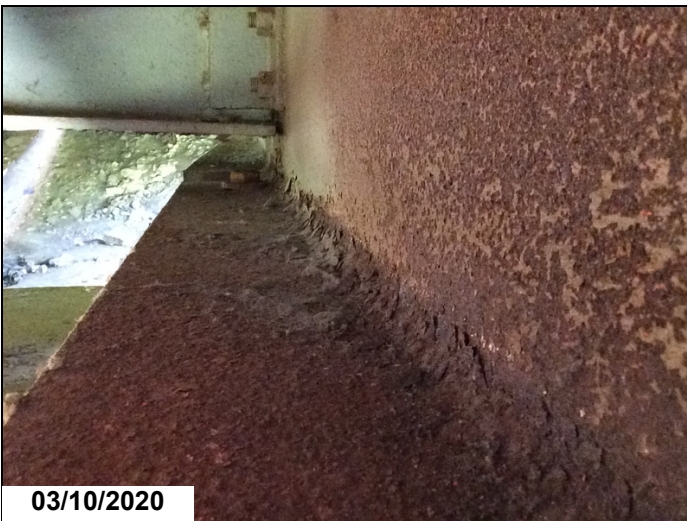
Span # 2, girder #2 at bent # 2-Corrosion with flaking rust.

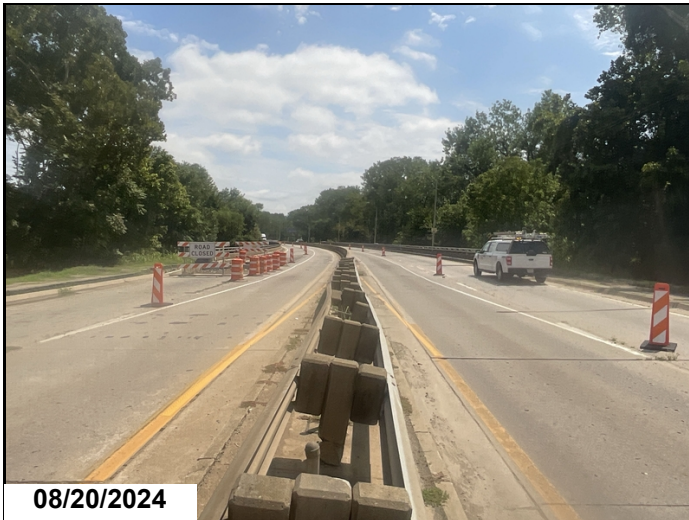
Median Approach Guardrailing of the West approach has several posts that are fractured at the base.

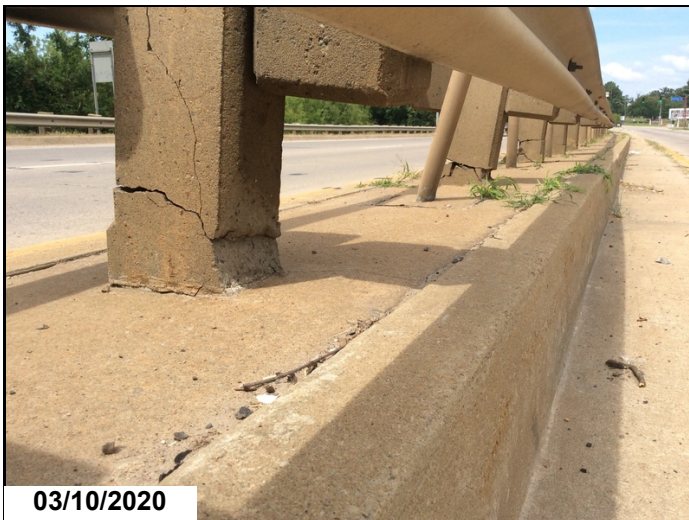
West approach-Median approach railing posts are fractured at base.

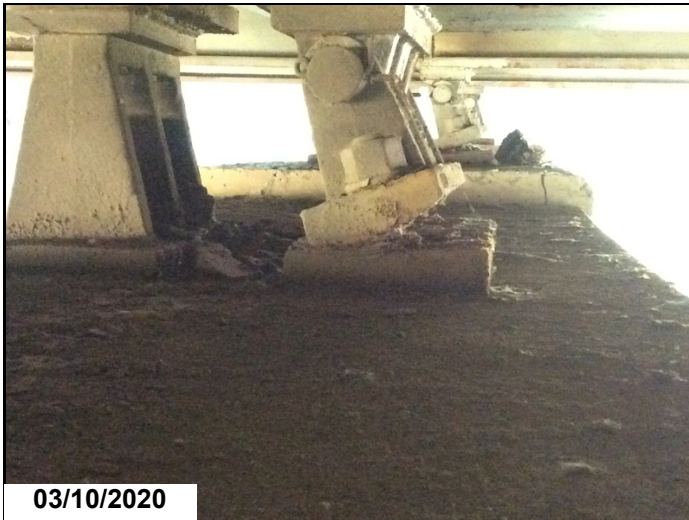
Bent # 2 bearings-Full expanded.

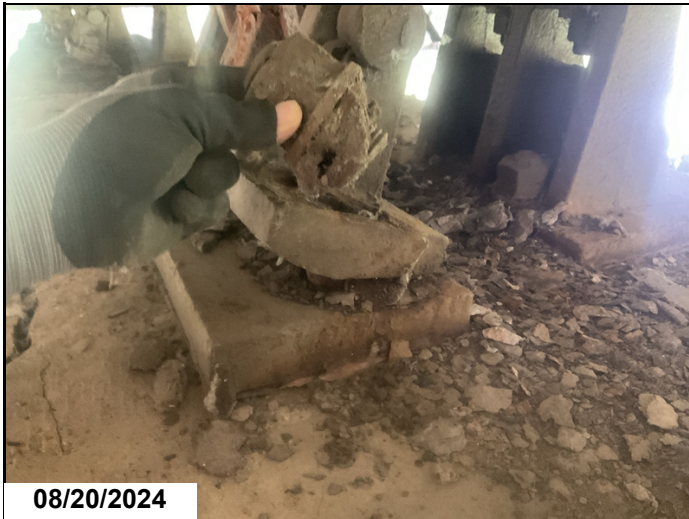
Span # 1, Bent # 2, Bearing # 9: Right anchor bolt sheared off. 1EA CS3.

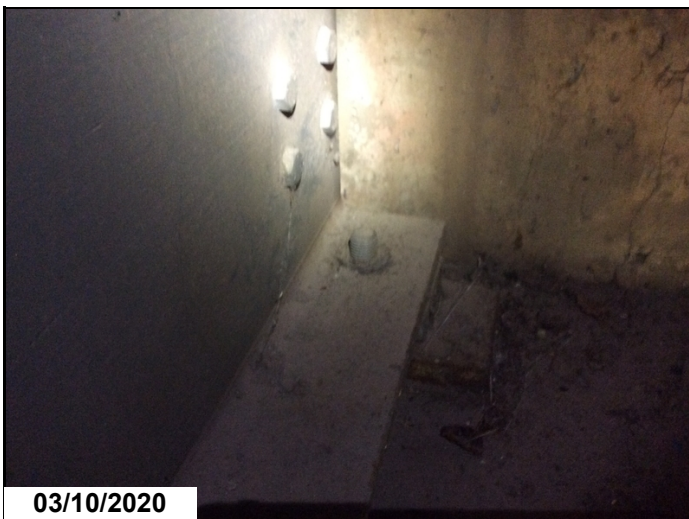
Span # 1, bearing # 6 has a missing anchor bolt nut at abutment # 1.

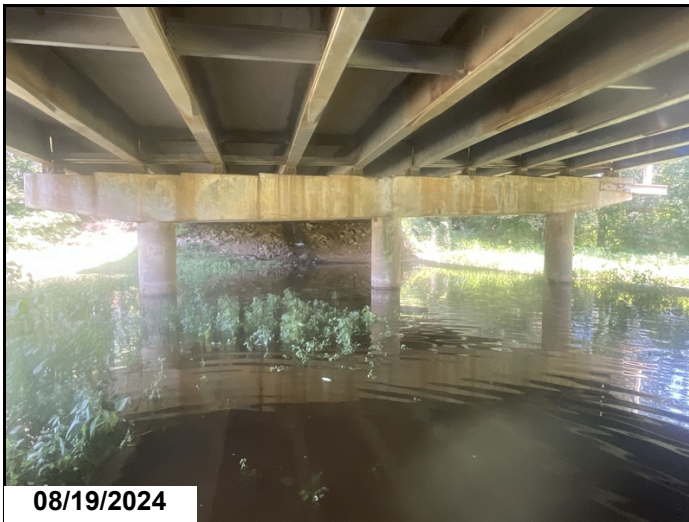
Visual observations during dry conditions indicate that there are minor scour holes around several of the columns from the historic flood of the Arkansas River circa May 29, 2019.

Past high water events has caused areas of minor localized scour around the bent columns.

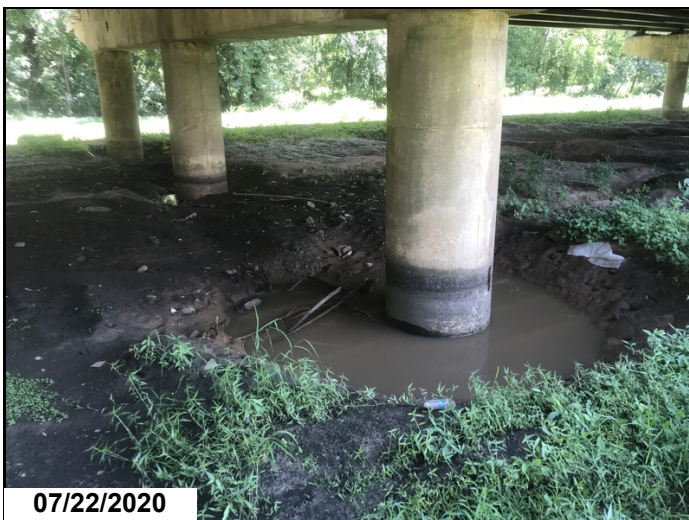
Bent # 6 localized scour.

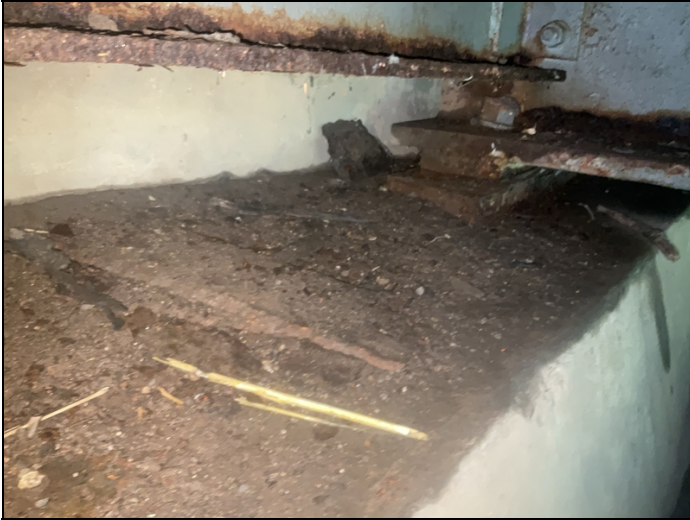
08/19/2024 - RSM & SPC: The bearing areas have heavy dirt and debris that has accumulated against the steel superstructure promoting corrosion. Abutment # 1 pictured.

A-58 - Cap Cleaning/Flushing Needed (Yes)

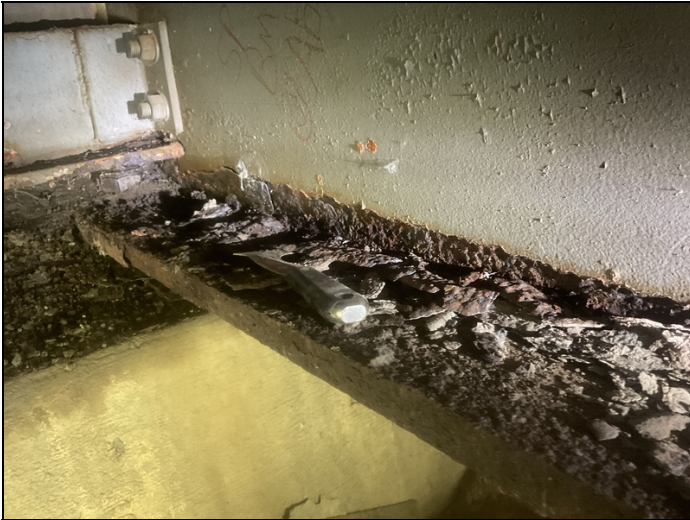
Span # 6, Abutment # 2, Girder # 8: Corrosion / section loss. 4LF CS3.

A-60 - Full Girder Painting Needed (Yes)

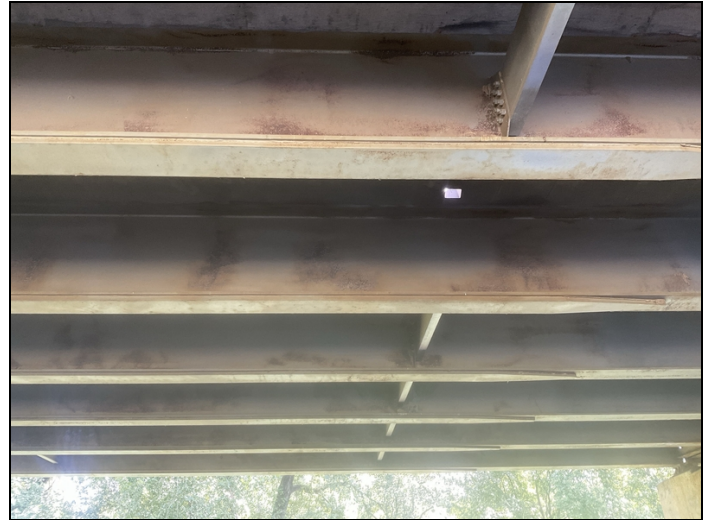
Paint system flaking / peeling.
