Asset #01672(Routine, NSTM)

SH 59-Wash Co. over Baron Fork Creek

Location: 0.05 Mi. S Jct Hwy 45

Team Lead: Eric West, Inspection Date: 06/23/2022

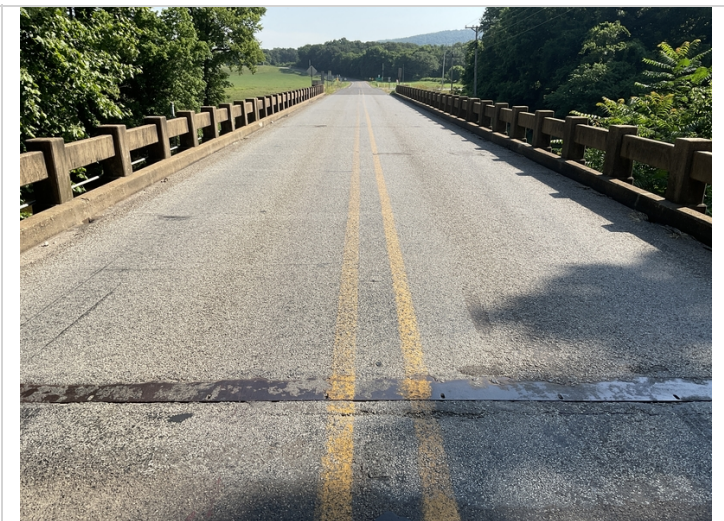
Typical driving surface of the deck.

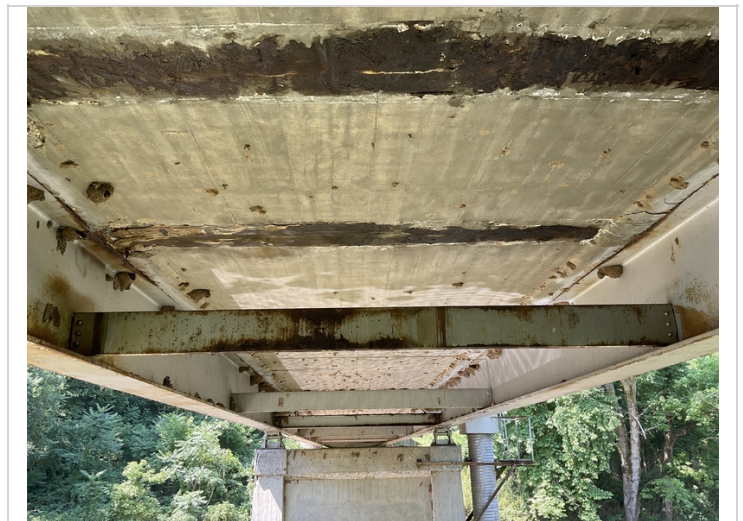
Span #1 typical undersurface of the deck.

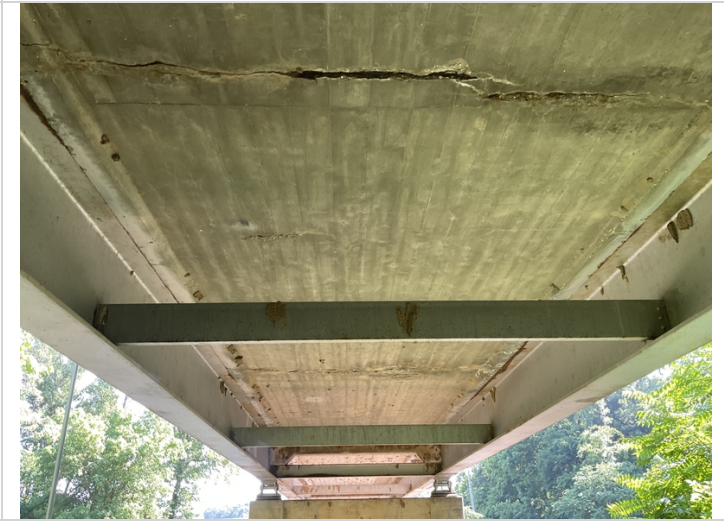
Span #3 typical undersurface of the deck.

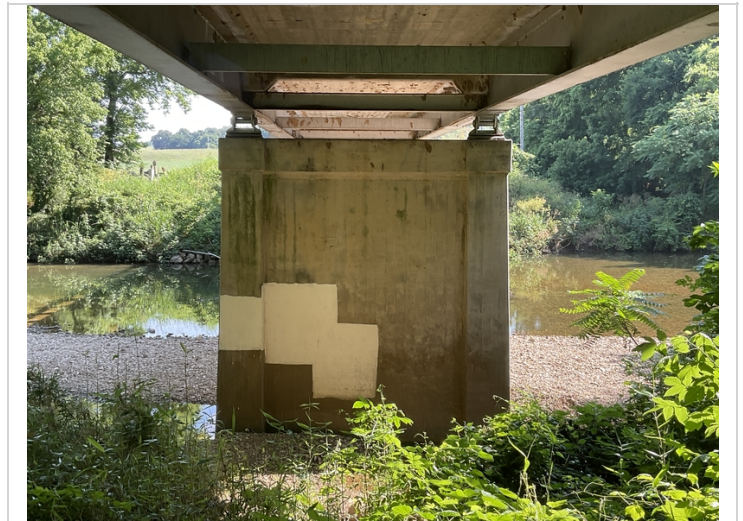
Bent #3 typical.

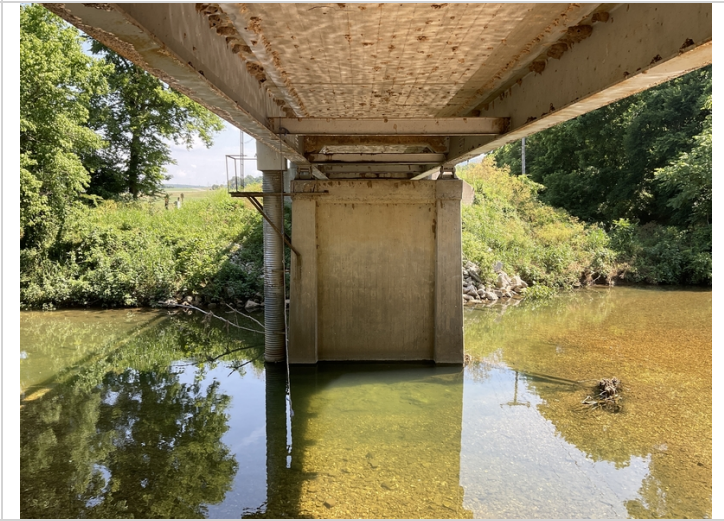
Bent #2 typical.

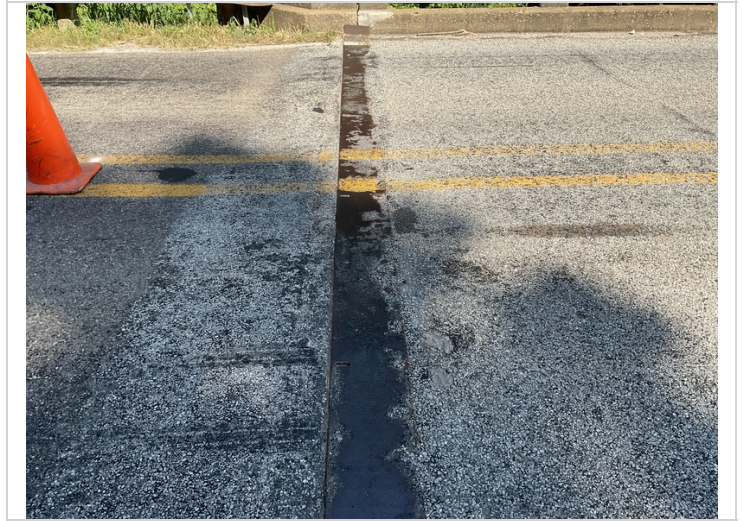
Abutment #2 assembly joint.

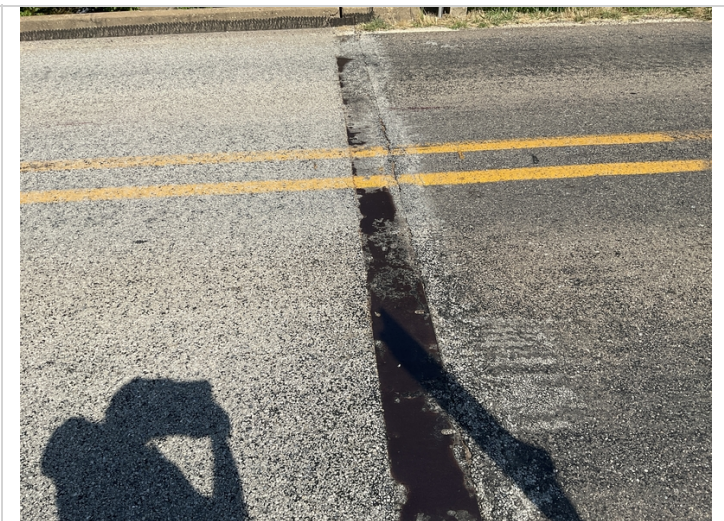
Abutment #1 assembly joint .

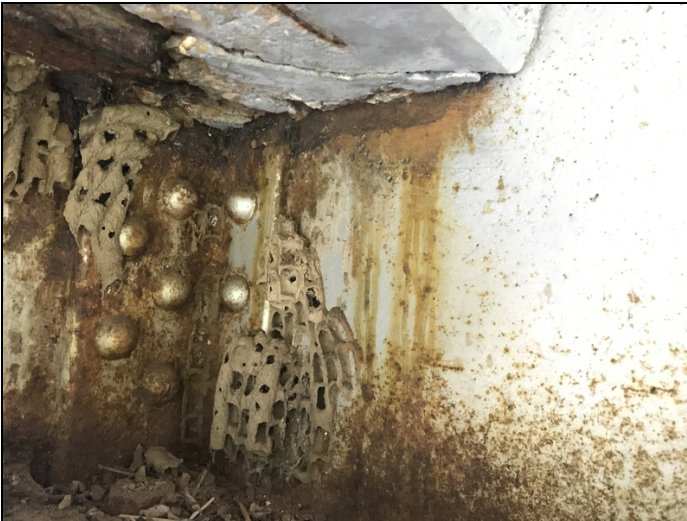
Girder 1 over bent 2-Approximately 1/16" section loss to web.

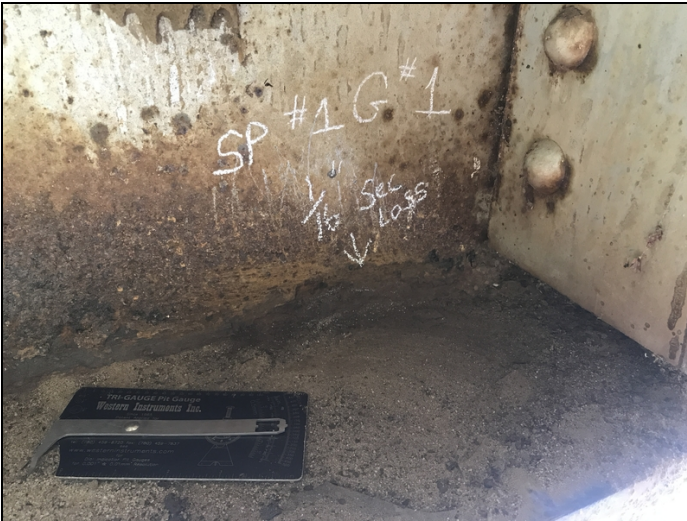
Girder # 1 of span # 1 has approximately 1/16" section loss to base of web located adjacent to diaphragm # 2 connection.

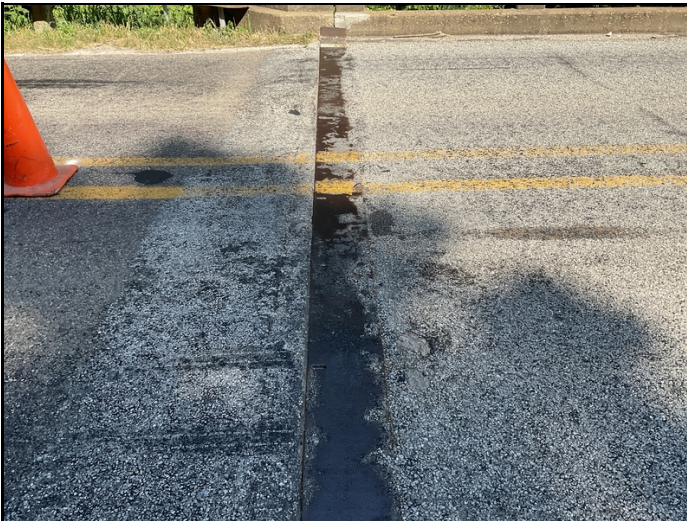
Abutment #2 assembly joint.

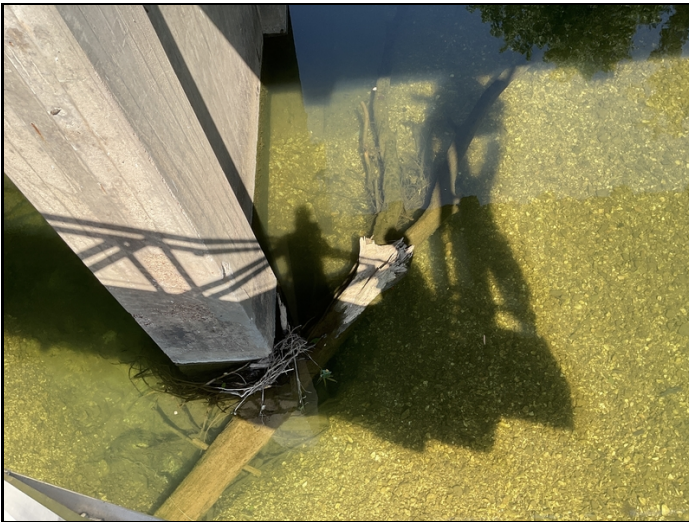
Comment: 05/24/2021 - RSM & SPC: Visual observation along with probing from a snooper truck revealed that the channel has drift accumulation at bents # 2 and # 3. The top and up to approximately 8' of the vertical face of footings at bents # 2 and # 3 are partially exposed at this inspection. The footings appear to be cast in a solid rock channel with no apparent undermining or scour problems at this inspection.

Bent #2 drift accumulation.
