Asset #03488(Routine)

US 71-Wash Co. over West Fork White River

Location: 0.10 Mi. So. of Greenland

Team Lead: Eric West, Inspection Date: 07/31/2023

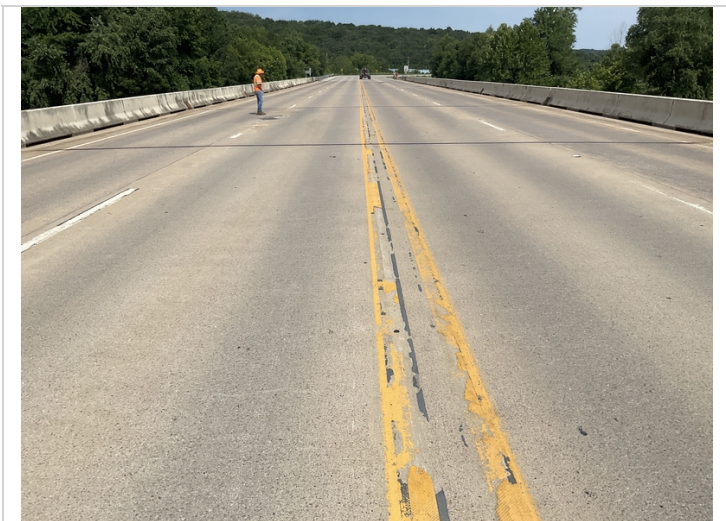
Typical driving surface.

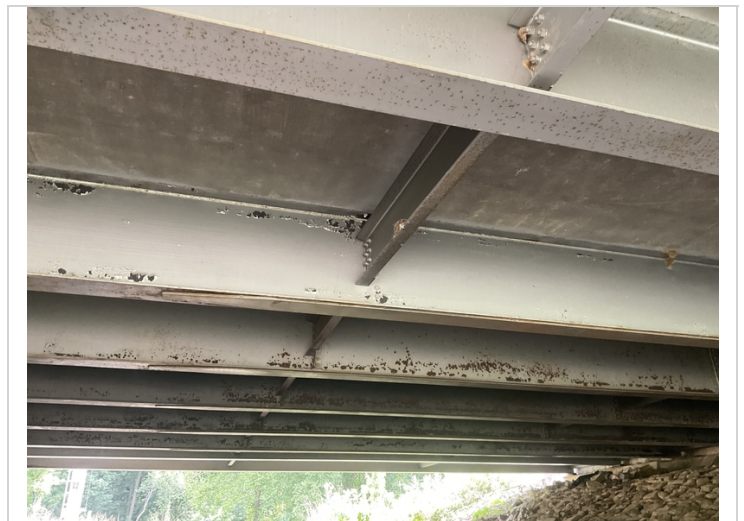
Span # 1 typical undersurface.

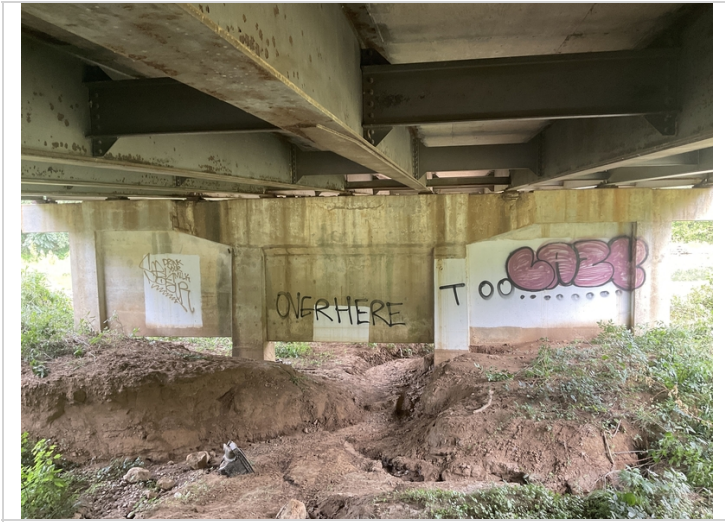
Bent # 3 typical.

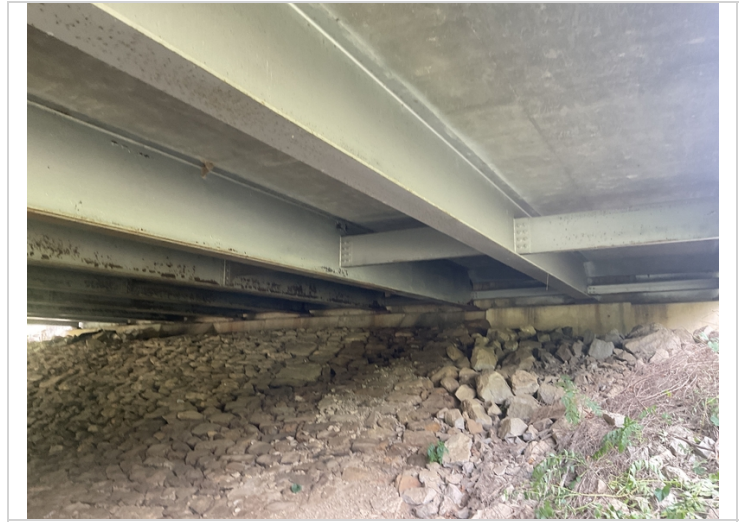
Abutment # 1 typical.

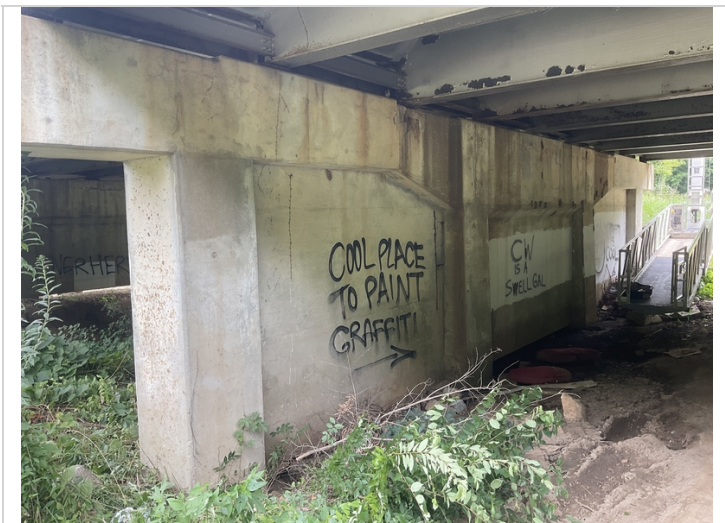
Bent # 2 typical.

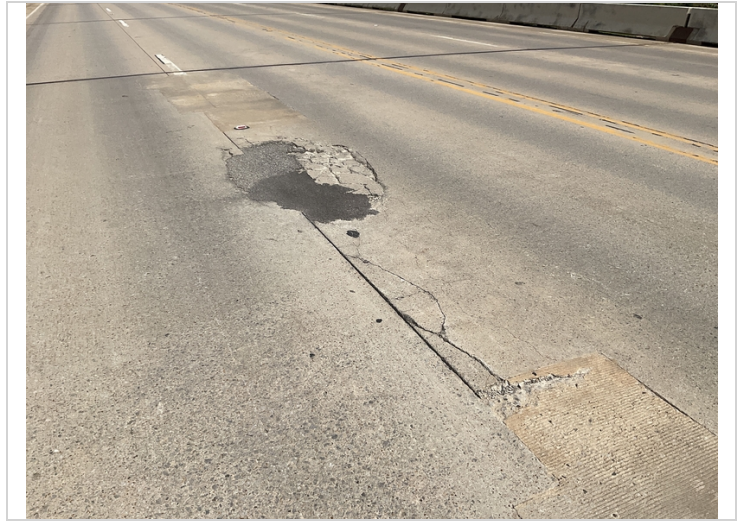
Span # 2 has a 2' wide x 16' long area of delaminated concrete that is breaking apart in the South bound lanes that is raised up approximately 1.5" higher than the surrounding deck area.

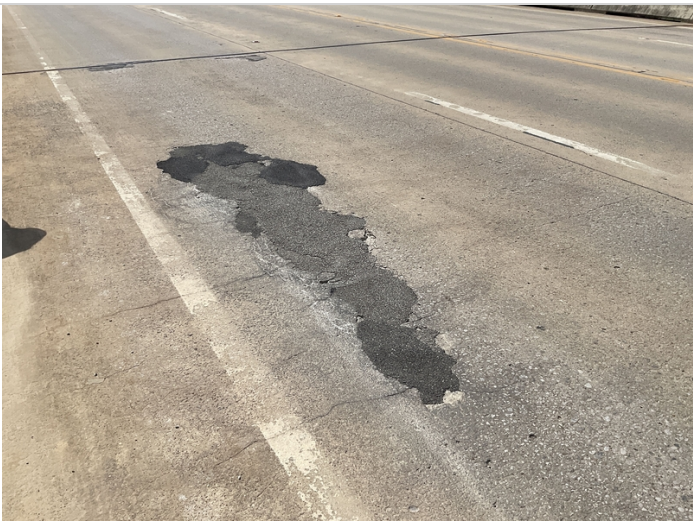
Span # 4 northbound outside lane has a 12' long X 30" wide area of temporary asphalt patches.

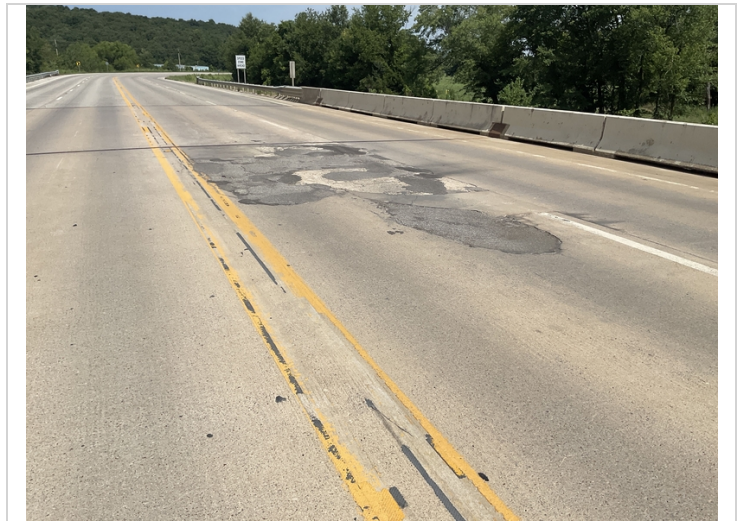
Span # 6 northbound lane with numerous temporary asphalt patches.

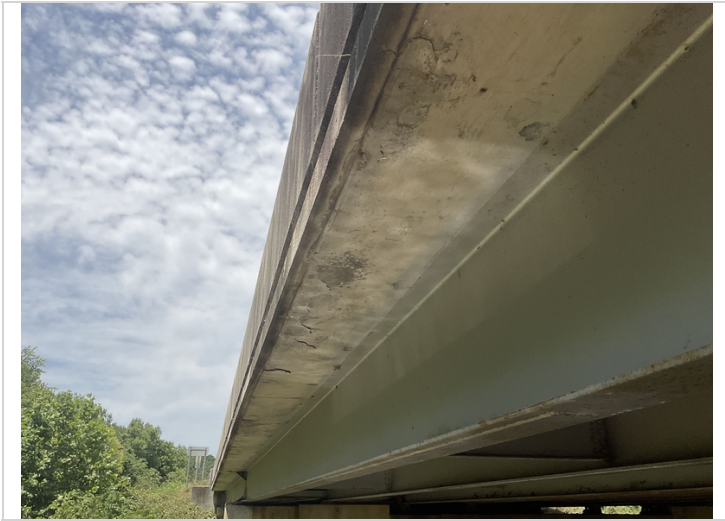
Span # 6 Lt overhang of the deck with numerous concrete delaminations.

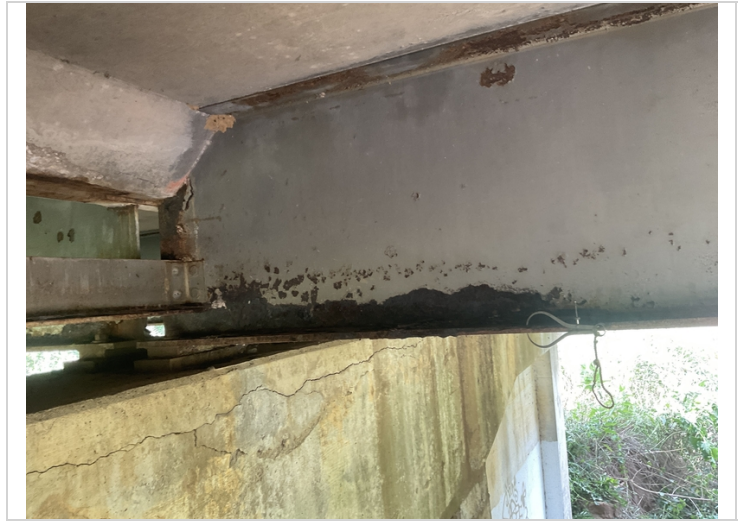
Span # 3, Beam # 5 with up to 2' long area of the bottom flange that has been reduced to approximately 5/8" remaining section.

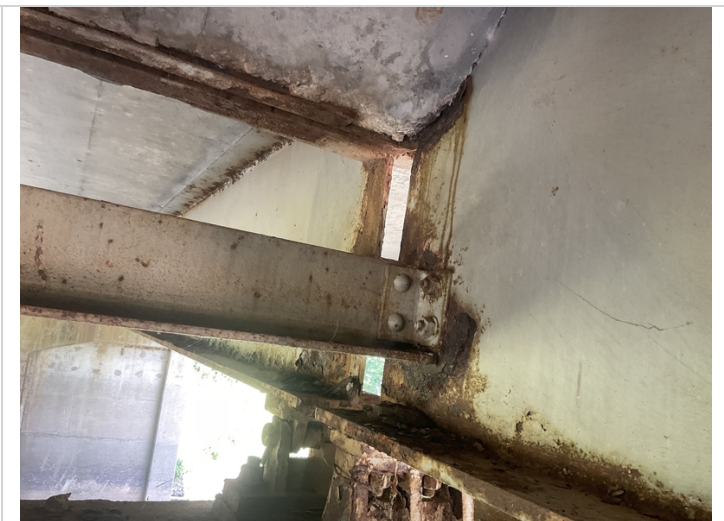
-Span # 4, beam # 5 at bent # 5 has a 3" X 1" hole rusted through top of web at the expansion dam juncture.							
-Span # 4, beam # 7 at Bent # 5 has up to 5/16" section loss at the base of the expansion dam juncture and up to 3/16" section loss at the diaphragm connection.							
-Span # 5, beam # 6 at Bent # 6 has approximately 3/16" section loss at the diaphragm connection.							
-There are no visible cracks apparent during this inspection.

Span # 4, Beam # 7 at Bent # 5 has up to 5/16" section loss at the base of the expansion dam juncture and up to 3/16" section loss at the diaphragm connection.

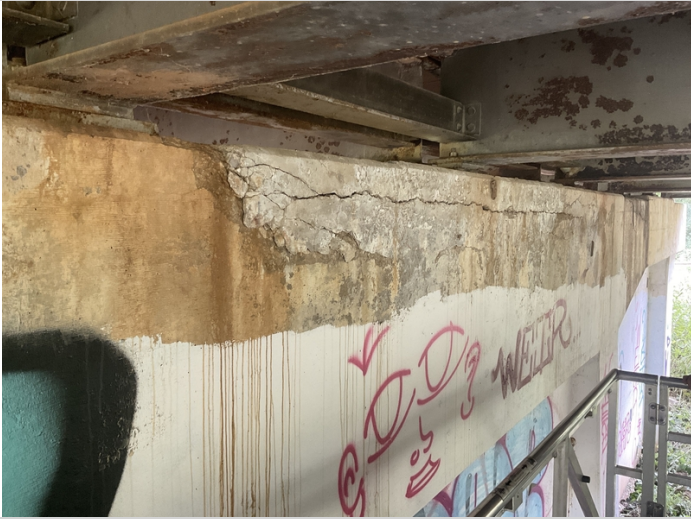
Bent # 2 aheadface under beams 4 - 6 has a 12' long X 13" tall delaminated area with a 5/16" wide horizontal crack, the crack extends approximately 1" under beam # 5 bearing device.

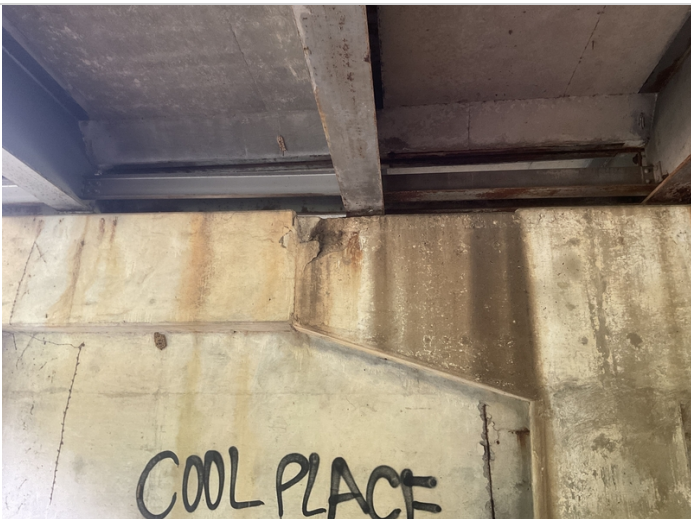
Bent # 2 cap backface has a 1' spall with exposed reinforcing steel in the bearing area of beam # 3.

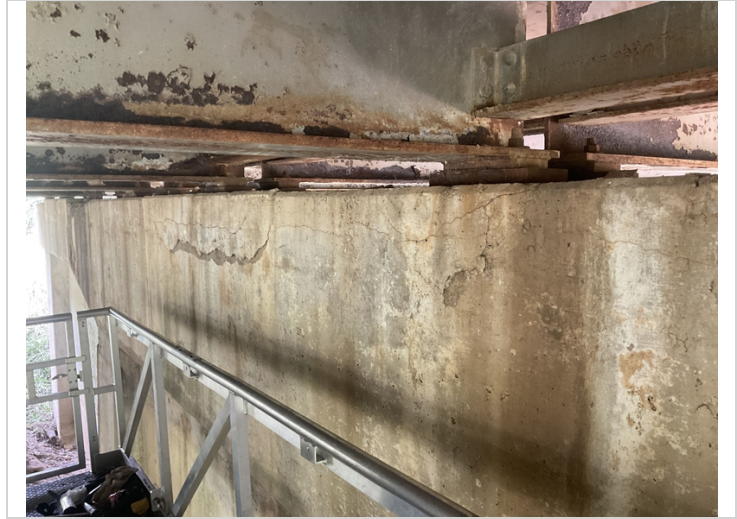
Bent # 3 backface under beams # 4 - 6 has an approximately 9' long X 12" wide concrete delamination in the vertical face of the cap.

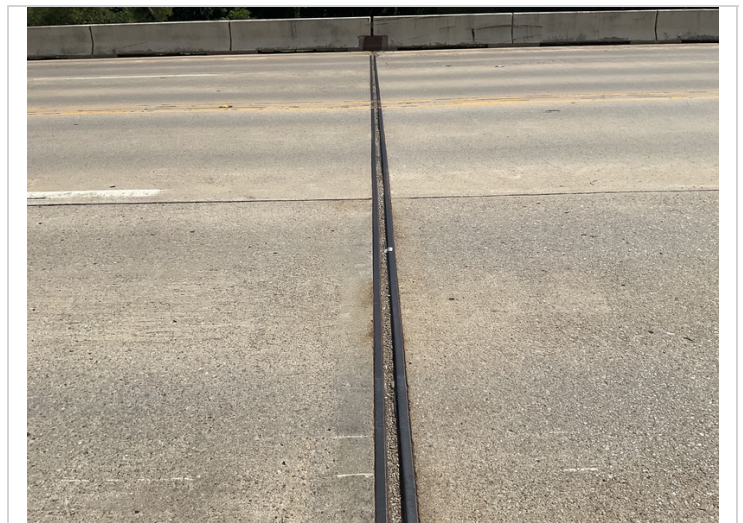
Bent # 2 strip seal typical.

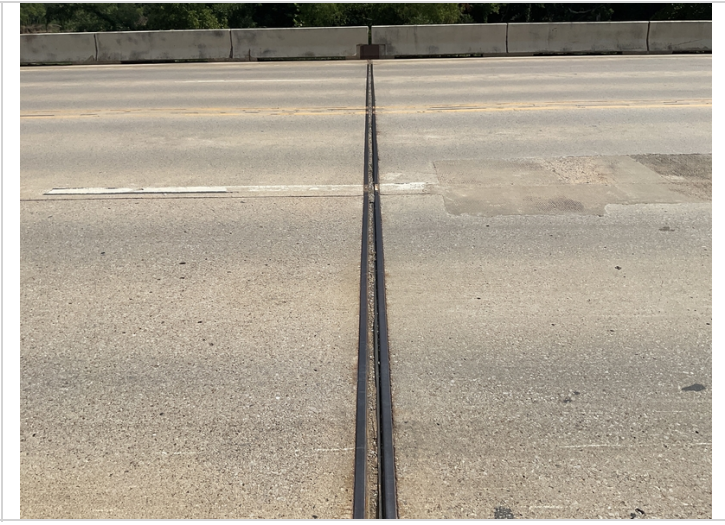
Bent # 3 strip seal typical.

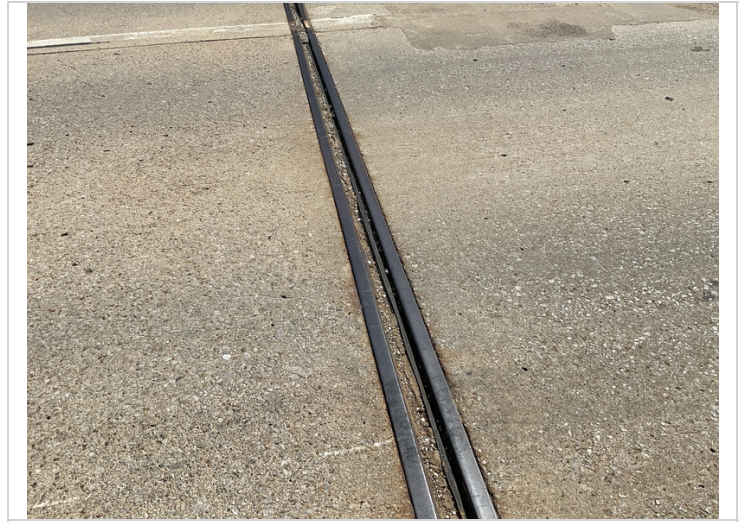
-All expansion joint assemblies have heavy dirt and debris accumulation at this inspection.
-The strip seals appear to be pulling out of the extrusions in numerous locations at all bents.
-Abutment # 1 road iron joint assembly has a cracked weld in the Northbound and Southbound lanes where the structure was widened in the past.
-Bent # 4 has portions of the seal that has fallen out of position and is no longer in the assembly.
-Stains on the substructure caps indicate that the seals leak.

Bent # 3 strip seal working out of the anchorage extrusion.

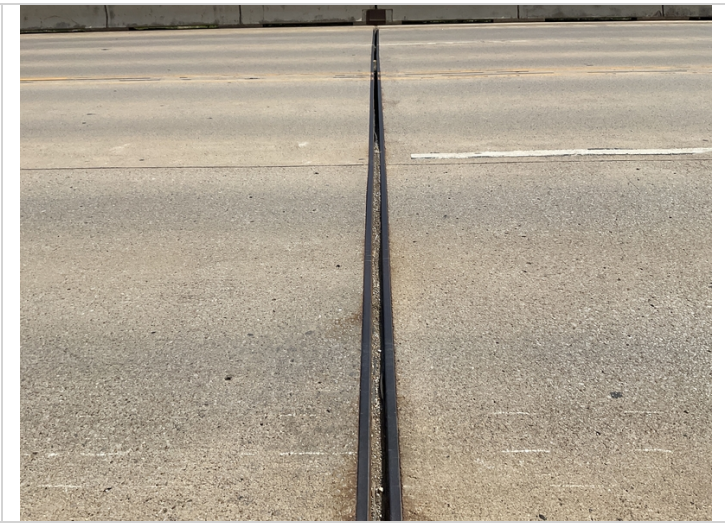
Bent # 4 strip seal typical.

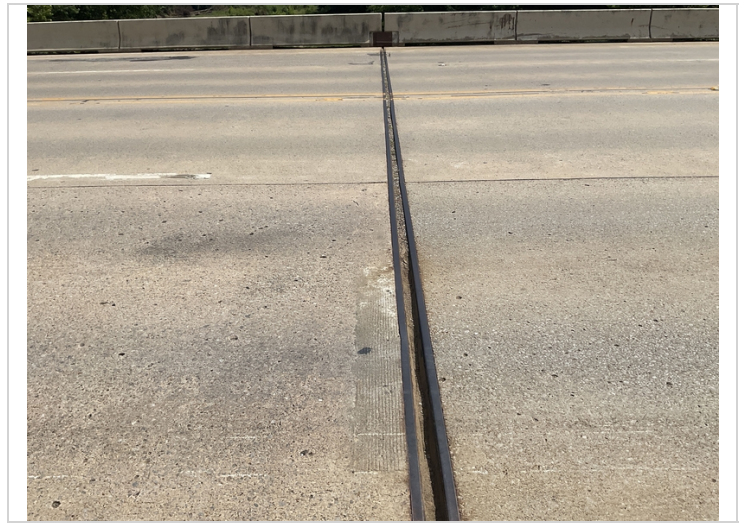
Bent # 5 strip seal typical.

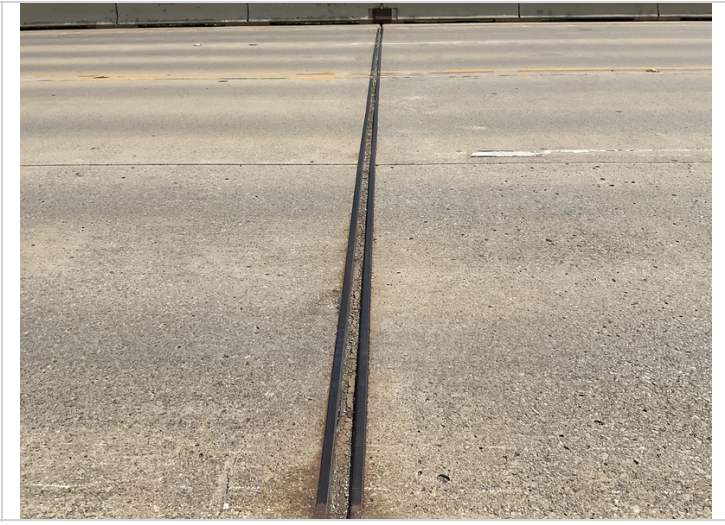
Bent # 6 strip seal typical.

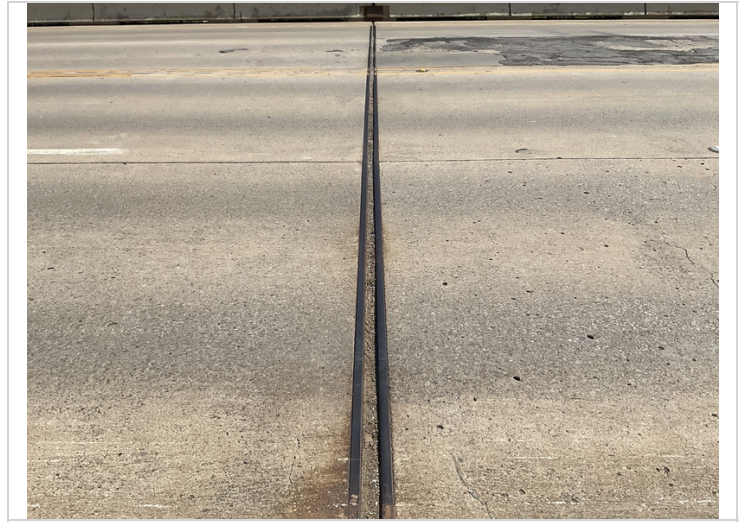
Bent # 7 typical.

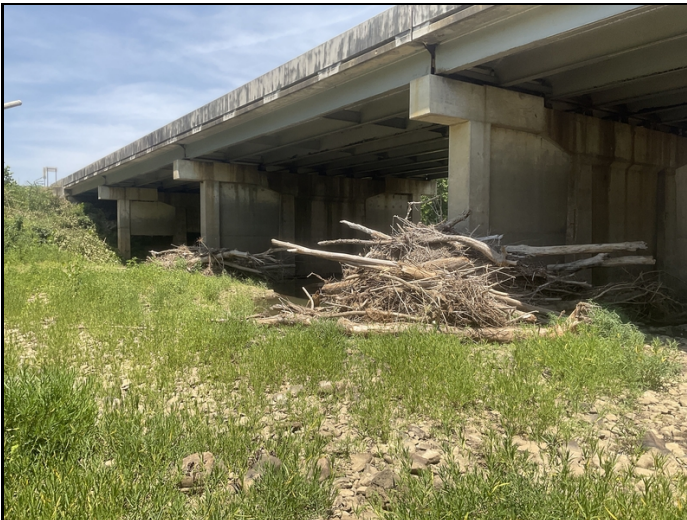
Channel-
Drift accumulation at Bents # 5 & 6.

Bents # 5 & 6 drift accumulation.

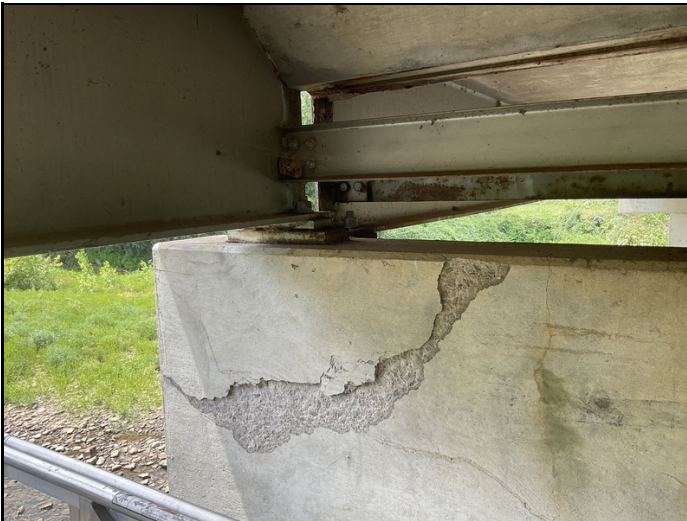
Bent # 4 Lt cap backface with an approximately 4' long X 30" tall concrete delamination that extends from the Lt end of the cap under beam # 1 and appears to extend approximately 2" under the bearing.

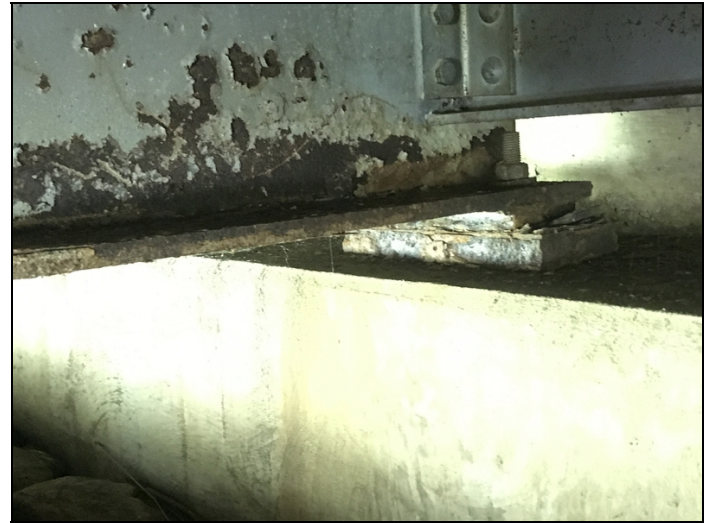
Bent # 1. Bearing at Beam # 4.

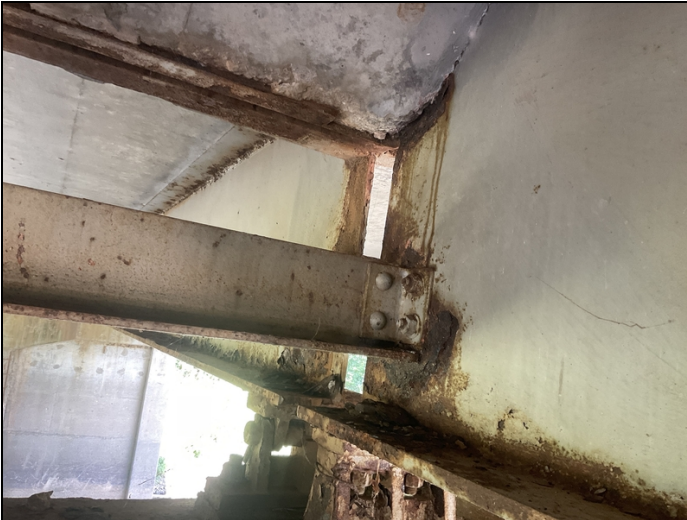
Span # 4, Beam # 7 at Bent # 5 has up to 5/16" section loss at the base of the expansion dam juncture and up to 3/16" section loss at the diaphragm connection.

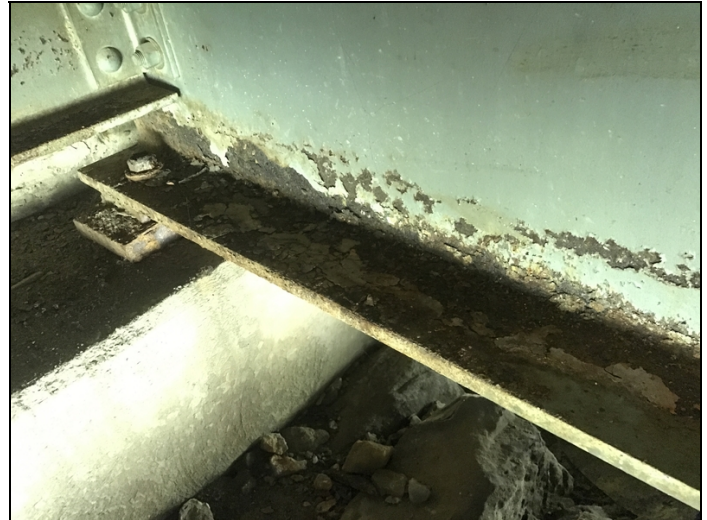
Bent # 1. Beam # 3. Corrosion.

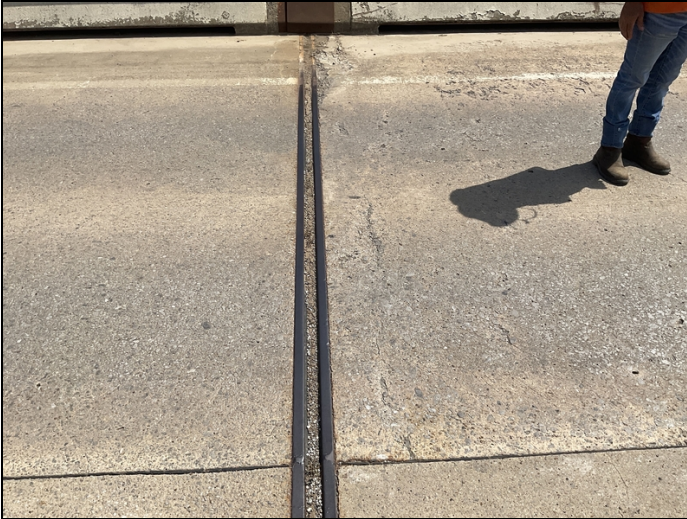
Span # 1 outside lane and shoulder has delaminated concrete and a 5" long area that is breaking apart and extend above the driving surface approximately 1" adjacent to bent # 2.

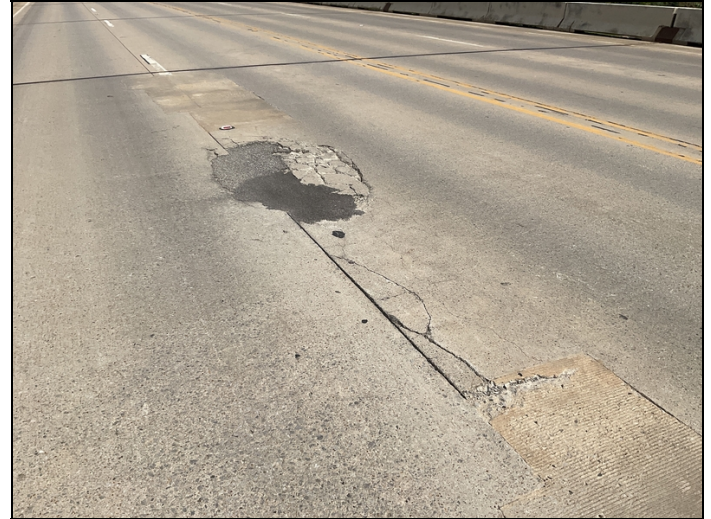
Span # 2 has a 2' wide x 16' long area of delaminated concrete that is breaking apart in the South bound lanes that is raised up approximately 1.5" higher than the surrounding deck area.

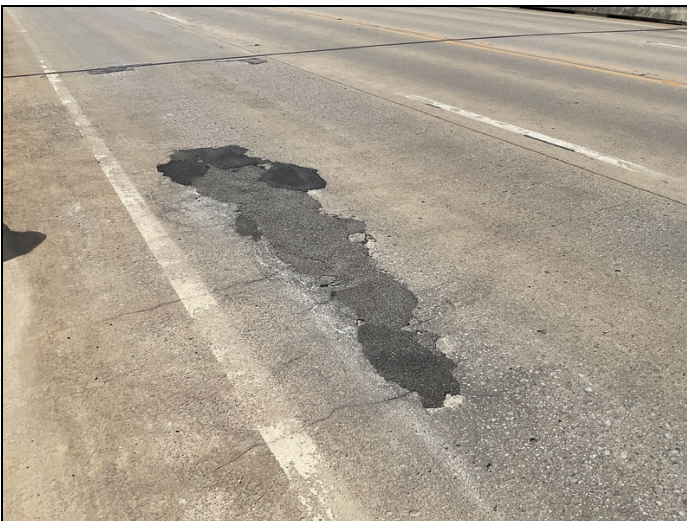
Span # 4 northbound outside lane has a 12' long X 30" wide area of temporary asphalt patches.

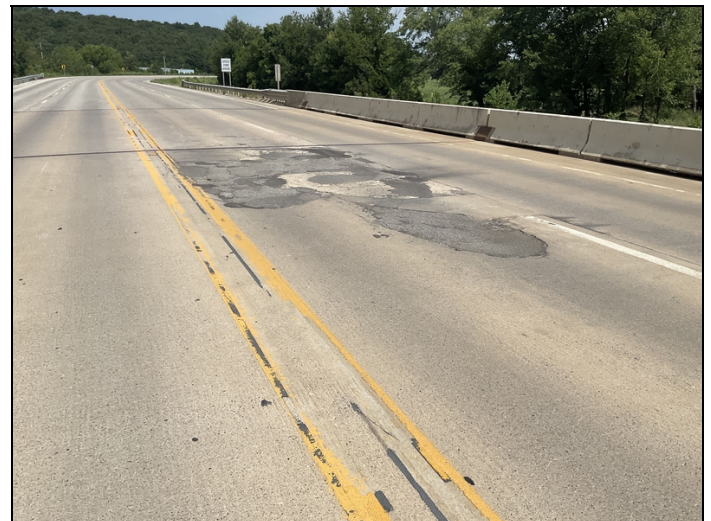
Span # 6 northbound lane with numerous temporary asphalt patches.

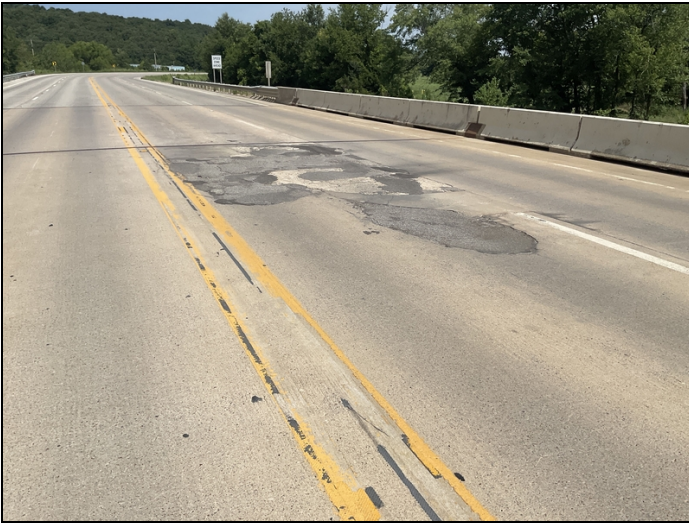
Span # 6 northbound lane with numerous temporary asphalt patches.

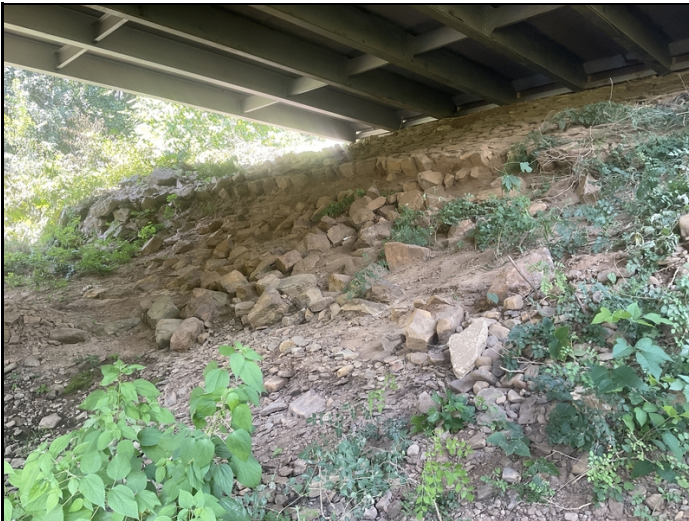
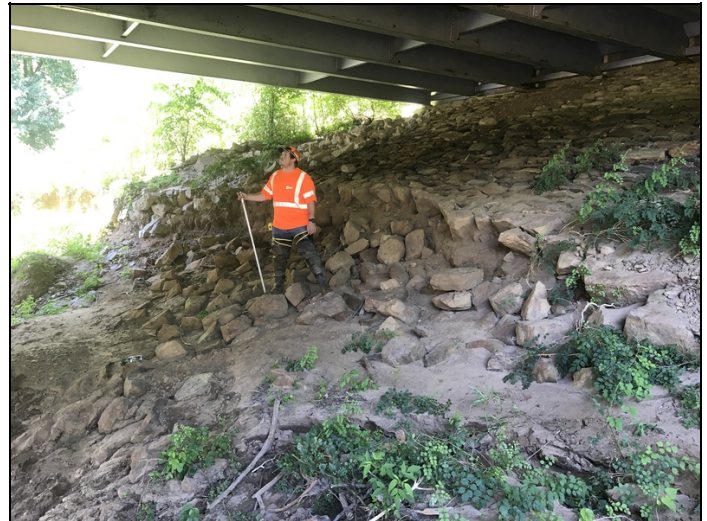
A large portion of the hand placed rip rap at the North abutment has been scoured out and displaced during past high water events. The scour at the base of the North abutment slope has exposed the footings of Bent # 7.

North abutment. Erosion and displacement of hand placed rip rap.

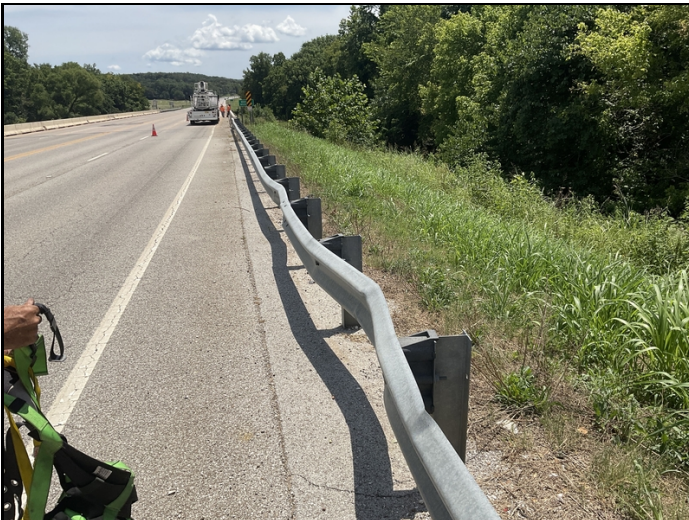
Approach Guardrail-
The Northwest approach guardrail has collision damage.

Northwest approach guardrail. Approximately 22' of damaged rail.

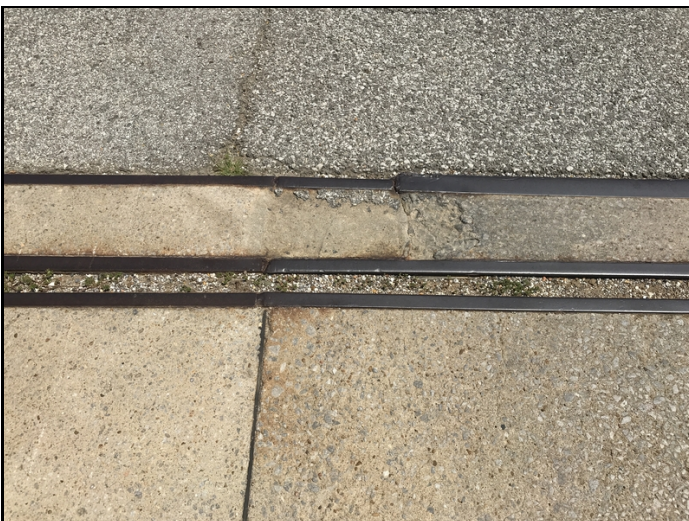
The South abutment road iron and expansion joint assembly has fractures and broken welds in the Northbound and Southbound lanes with a portion of the road iron assembly missing in the Northbound lane.

Bent # 1, top of backwall, cracked weld in the angle.

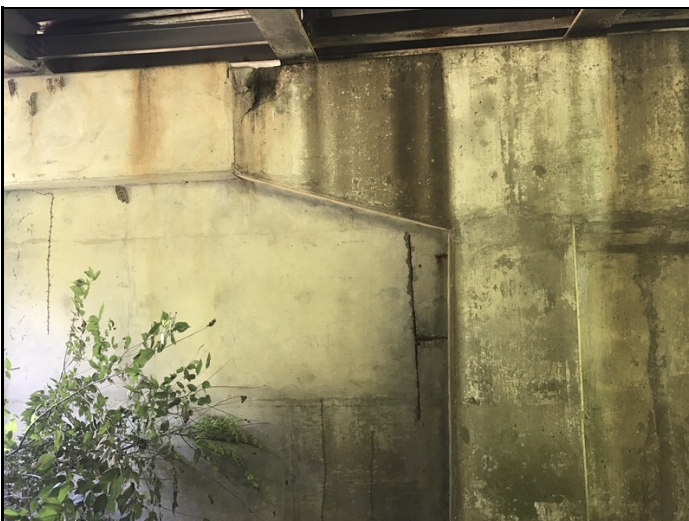
Numerous areas of spalling with exposed reinforcing steel in the abutments and intermediate bents.

Span # 1 side of abutment # 1. Left.

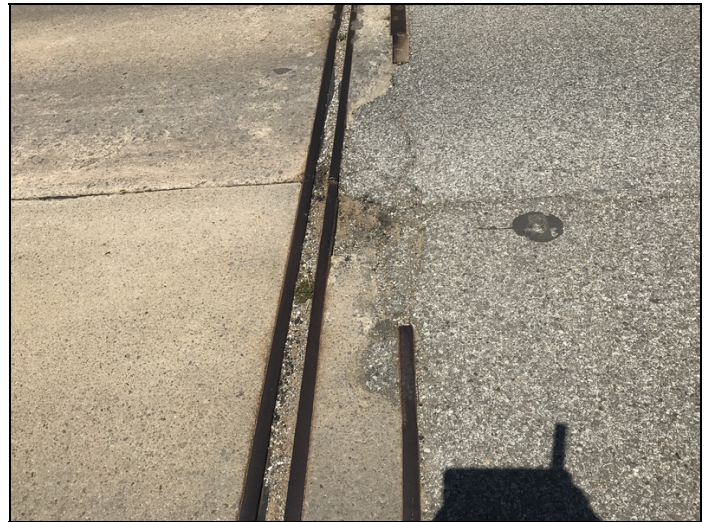
Bent # 1. Northbound Lanes.

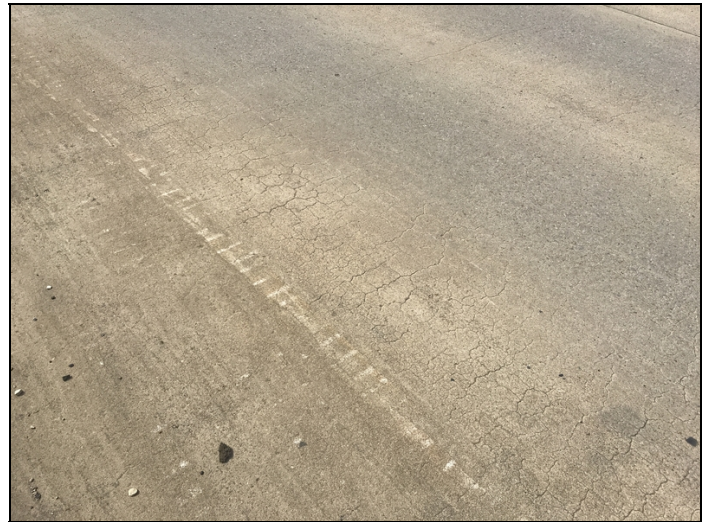
The shoulders and driving surface of the deck has sealable cracking with numerous delaminated areas in all spans.

Span 4, right lane-Mapcracking.

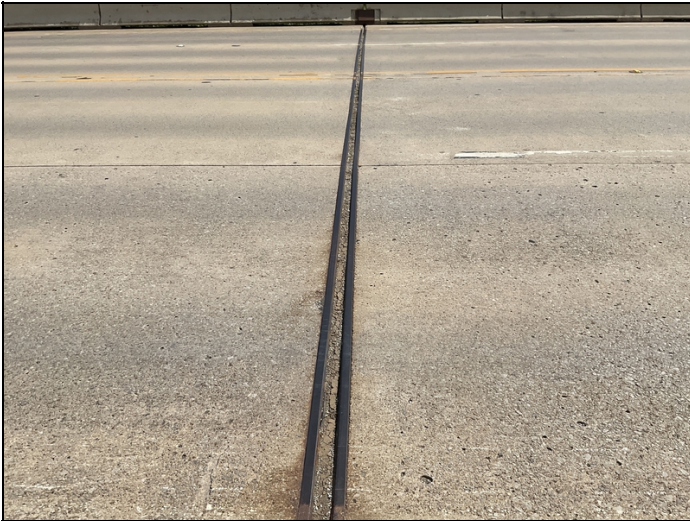
-All expansion joint assemblies have heavy dirt and debris accumulation at this inspection.

Bent # 6 strip seal typical.

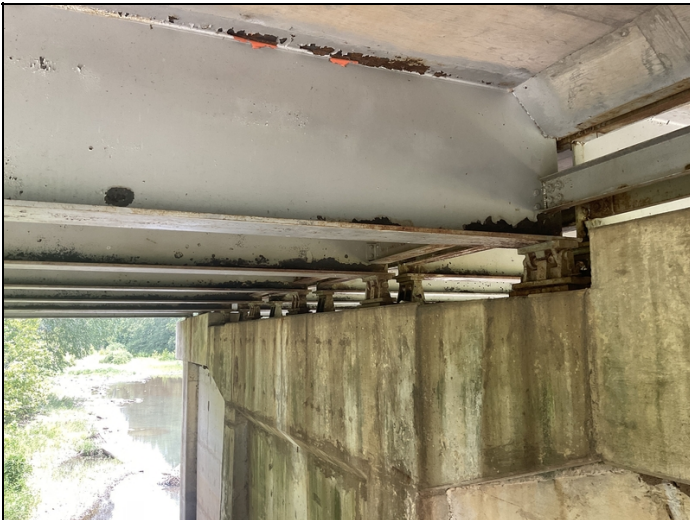
- The steel beams have a failing paint system.

Span # 6 Bent # 6 active corrosion, pack rust and section loss.
