Asset #A3959(Routine)

US 64-SEC 2, WB LN over I 540-SEC 2-Crawford Co.

Location: JCT. HWY 64,71 & 540

Team Lead: Bob McEntyre Inspection Date: 09/13/2023

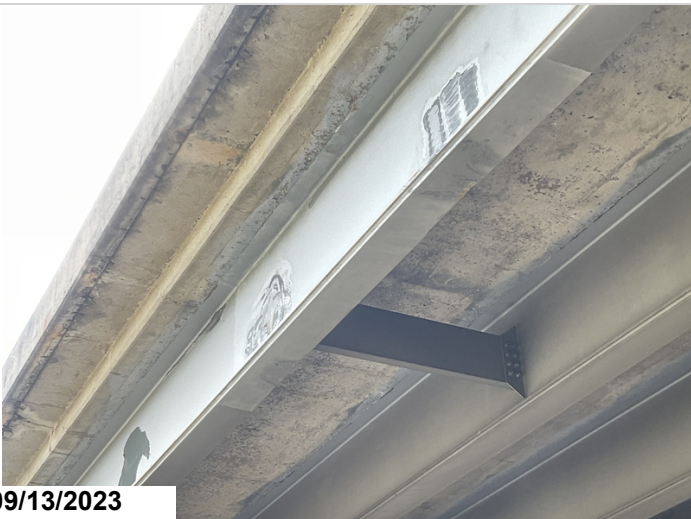
Span # 4, beams # 1 & 2 have old impact scars

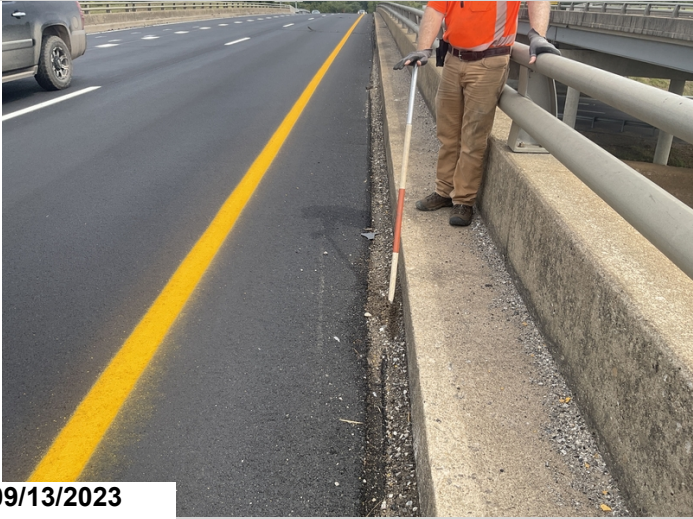
Dirt and debris in gutters

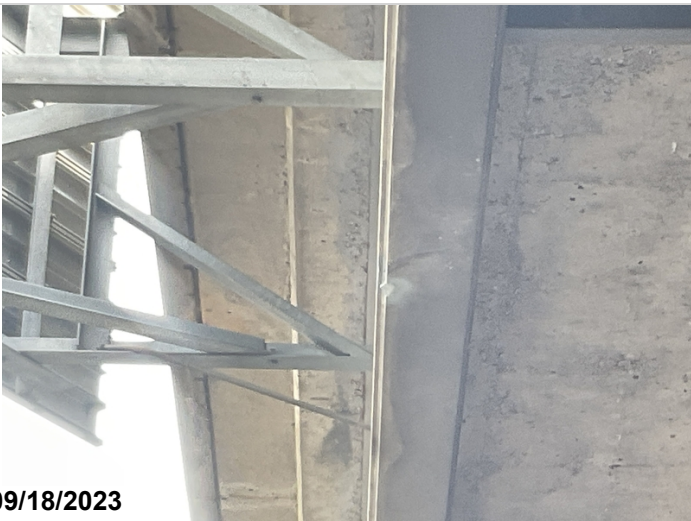
Span # 2, beam # 1 over right lane has a 2" x 2" x 1/2" notch in the bottom cover plate due to traffic impact.

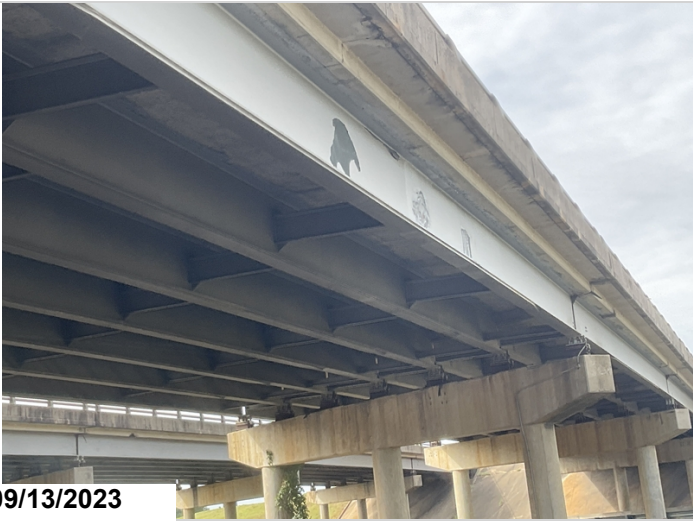
Beam # 1 of span # 4.

ELEMENTS	DESCRIPTION	UNITS	TOTAL	CS1	CS2	CS3	CS4
-Span # 4, beam # 1 has areas of paint peeling. -No visible cracks apparent in the superstructure during this inspection.							
205	Reinforced Concrete Column	EA	12	9	3	0	0
1090	Exposed Rebar	EA	1	0	1	0	0
1130	Cracking (RC and Other)	EA	2	0	2	0	0

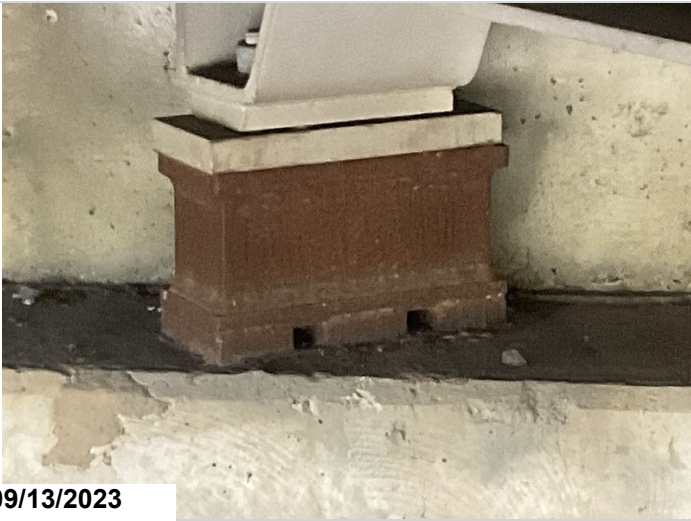
Abutment 2 typical bearing.

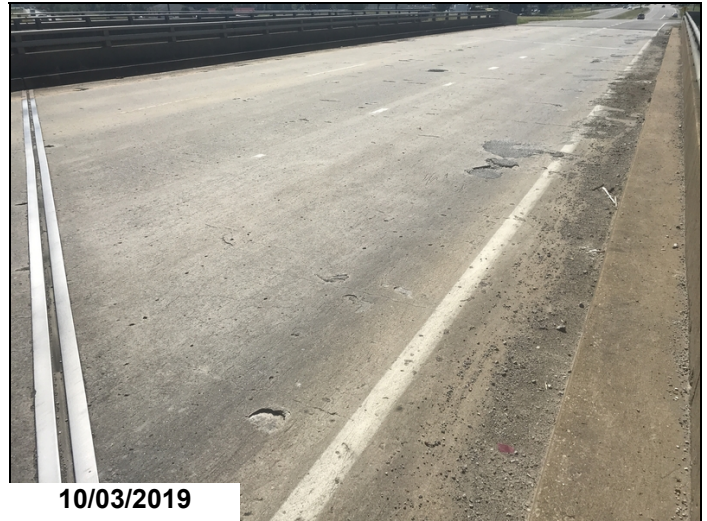
Span # 2 typical driving surface of the deck.

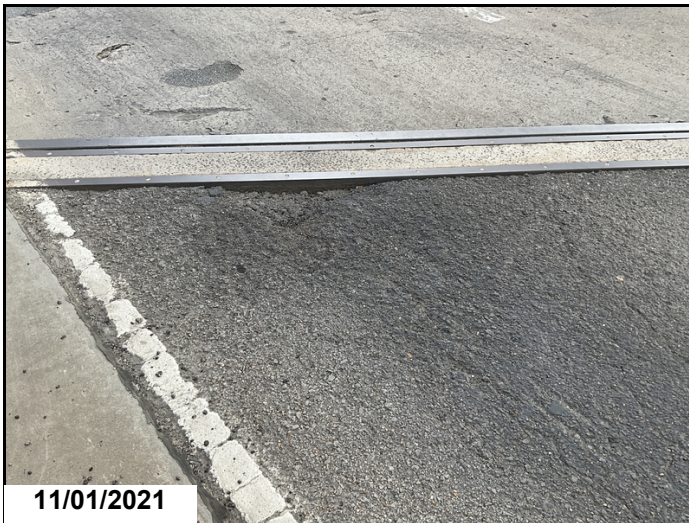
11/01/2021

09/13/2023 - RSM - No apparent pothole in the West approach roadway at this inspection.

There is a minor pot hole in the approach roadway adjacent to the West bridge end.
