Bridge 05464 Inspection Report

Route:16 Section:02 Log:3.929

INSPECTIONS *			
(90) Inspection Date			07/16/2024
(91) Frequency			24
(92) Critical Feature Inspection	Done	Freq. (Mon)	Date
A: Fracture Critical Detail	No		
B: Underwater Inspection	No		
C: Other Special Inspection	No		
* The inspection date and frequency information in this box contains the current NBI date and frequency information. Please refer to the report header for the date this inspection was conducted.

Team Lead: Jeff Jones, Inspection Date: 07/16/2024

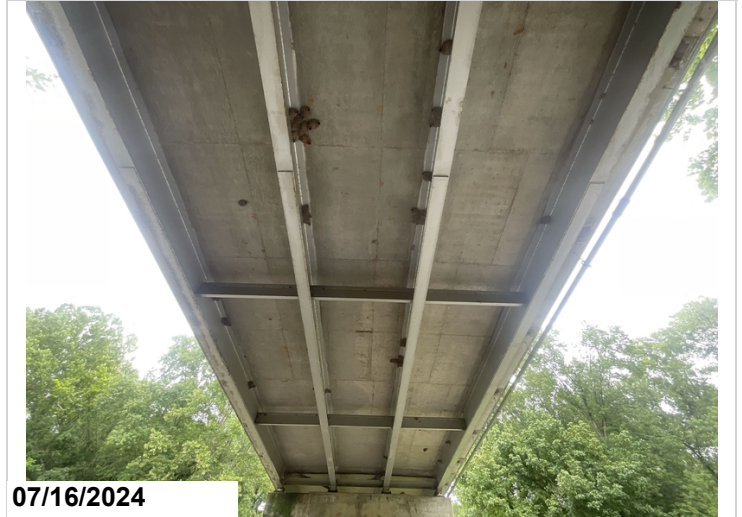
Undersurface of Span 2. Typical.

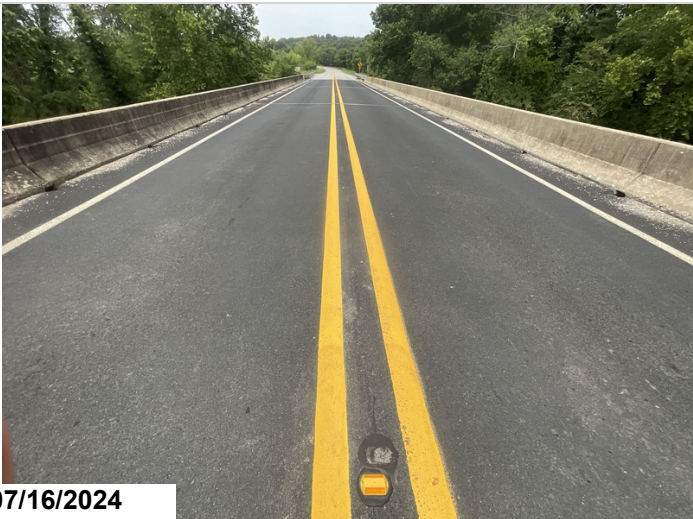
Deck. Typical.

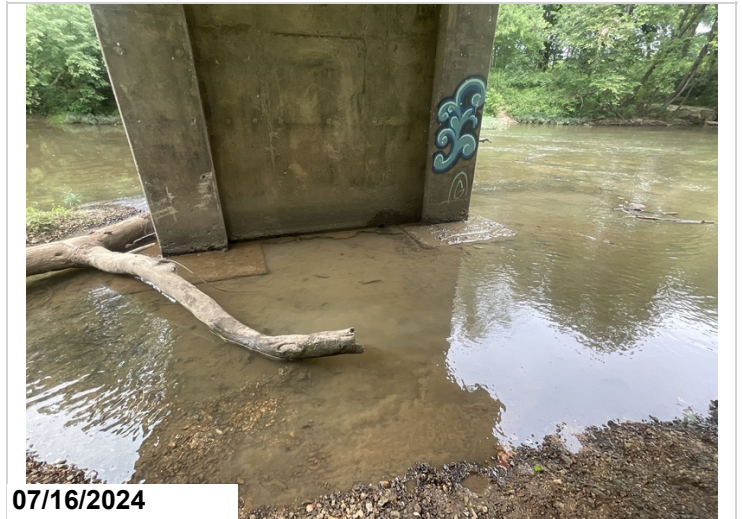
Wading and probing along with visual observations during low and clear water conditions indicate that the top of Bent 2 & 3 footings are exposed. Top of footings appear to be well keyed into the solid rock channel. Top of footings appear to be reasonably close to the same elevation as the adjacent channel floor with no apparent scour problems during this inspection.

Bent 3 footing exposed.

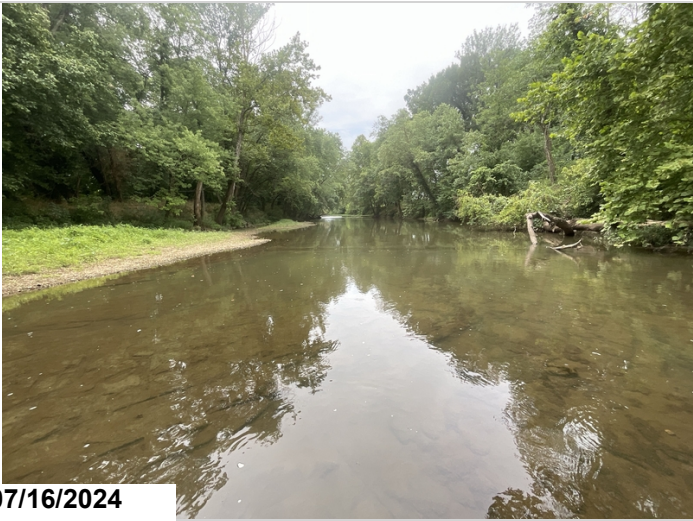
Channel. Right side of structure.

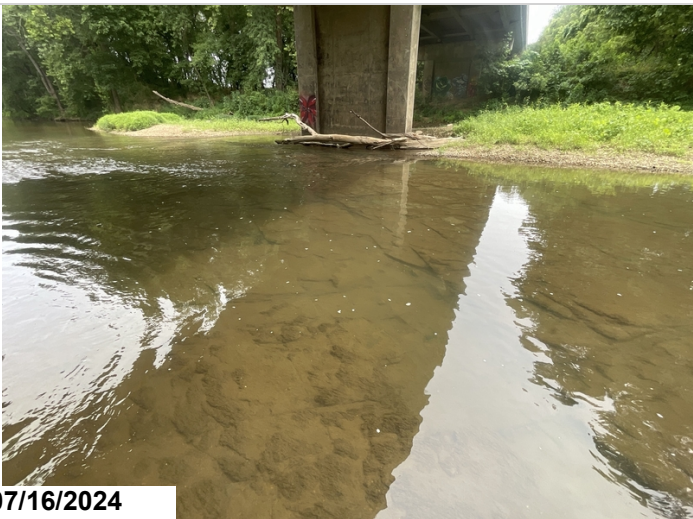
Solid rock Channel exposed under Span 2.

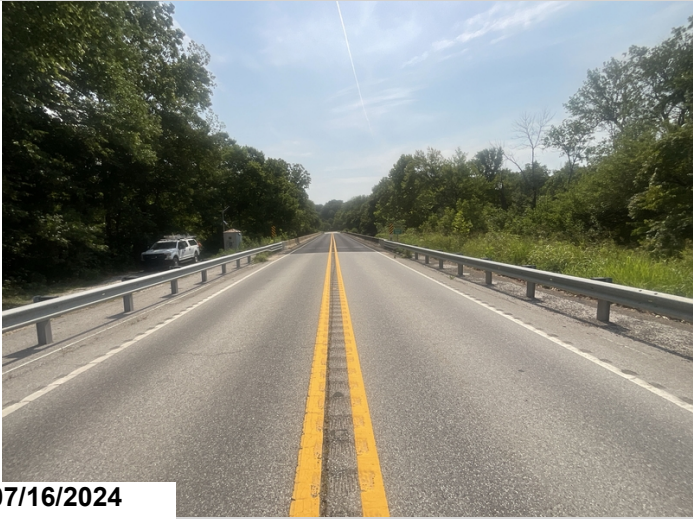
Approach roadway facing East.

A-66 - Approach minor pothole/leveling needed

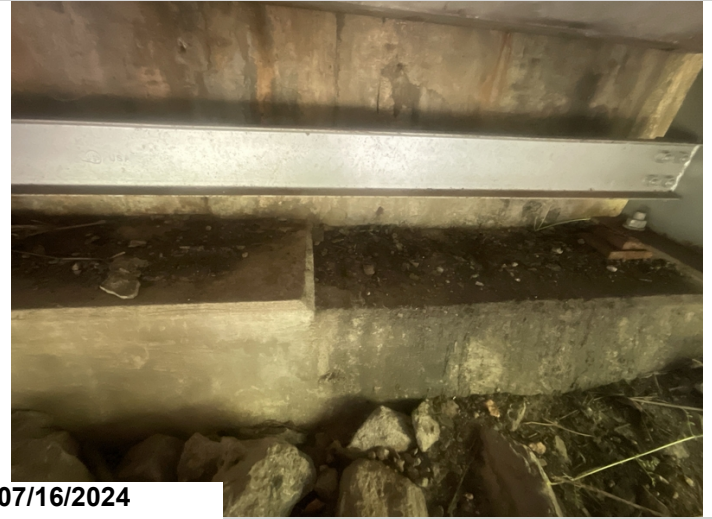
Abutment 1. Debris on cap.

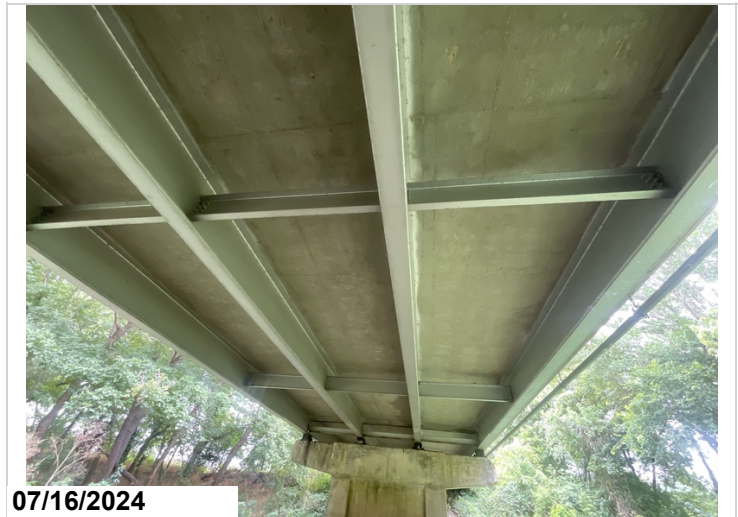
Span 4 , Undersurface of the deck. Typical.

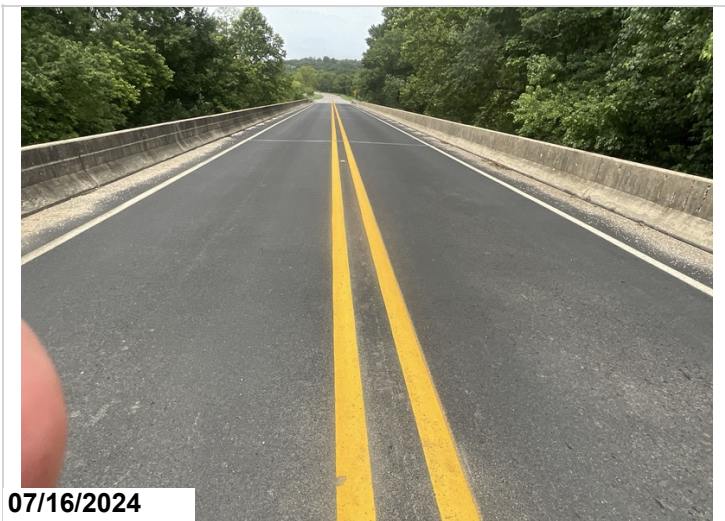
Deck. Looking West. Typical.

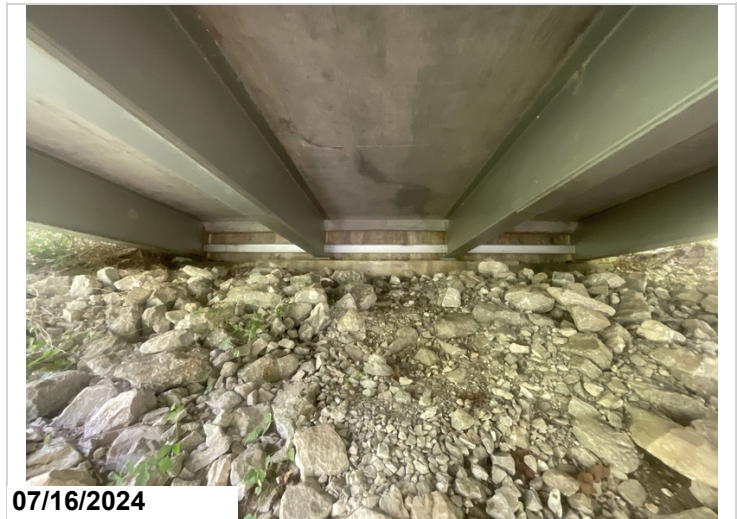
Abutment 1. Typical.

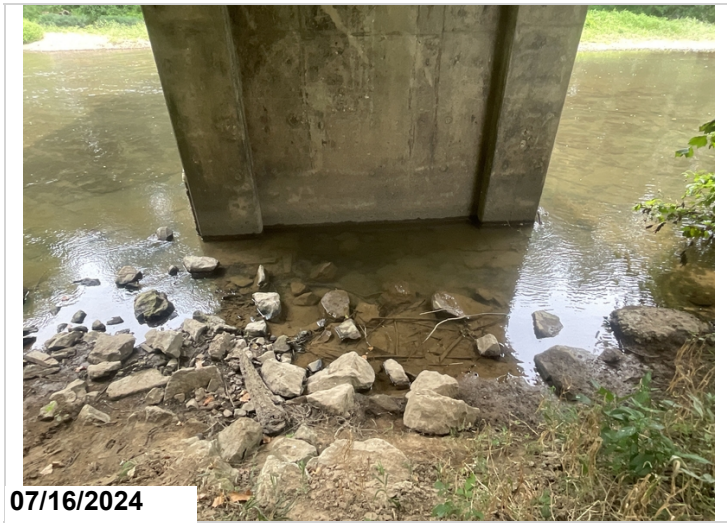
Bent 2 footings exposed.

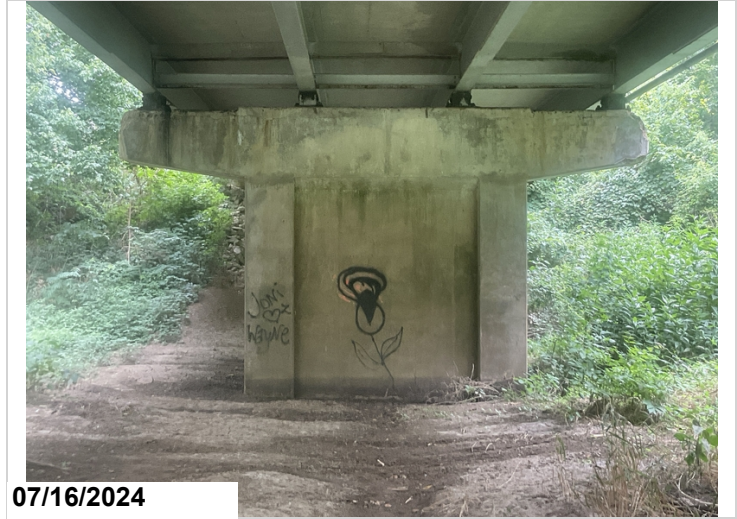
Bent 5 back face.

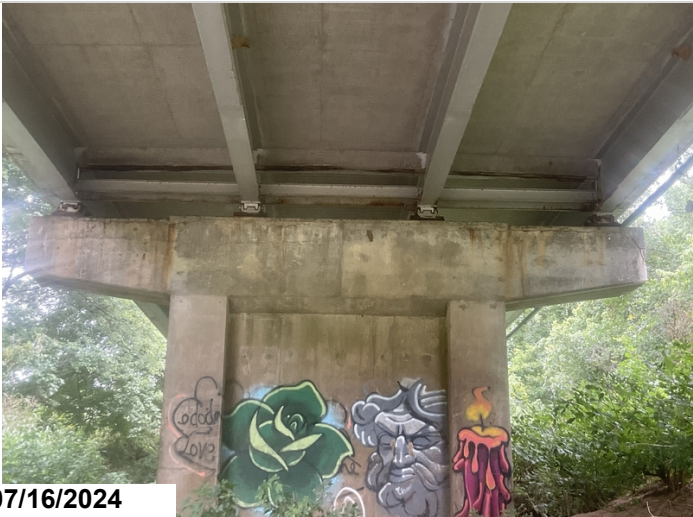
Bent 4 cap. Back face.

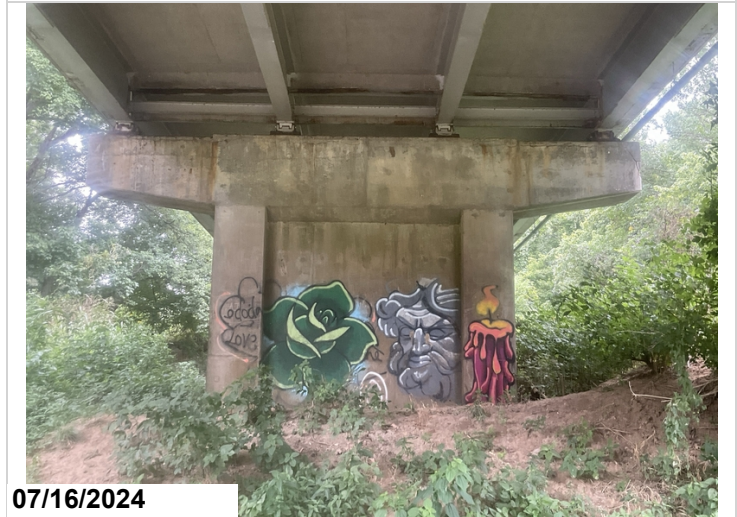
Bent 4 back face. Typical.

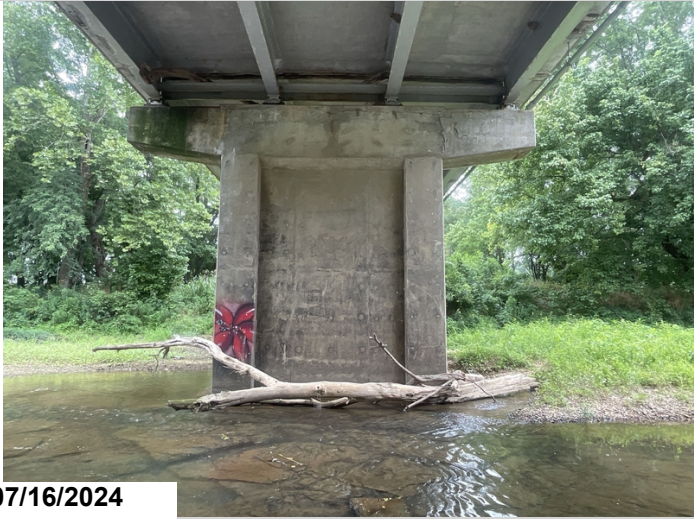
Bent 3. Back face. Typical.

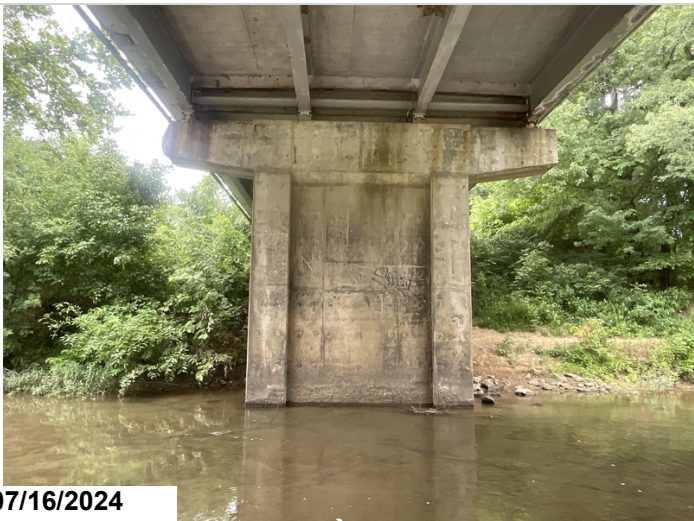
Bent 2. Ahead face typical.

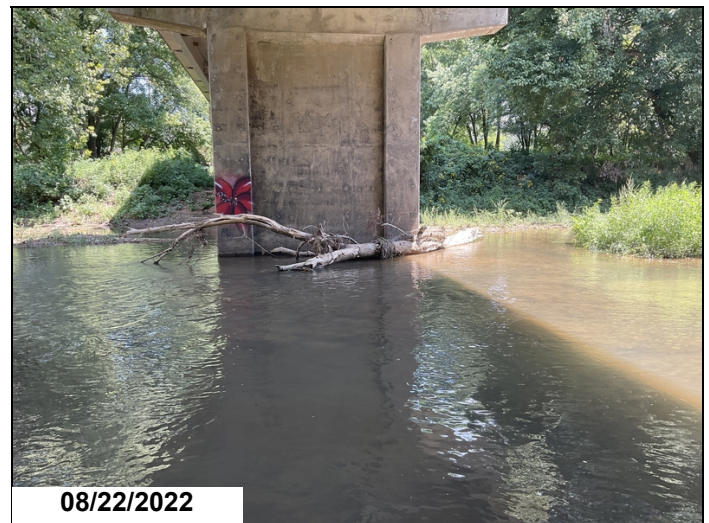
Bent 3 drift accumulation.

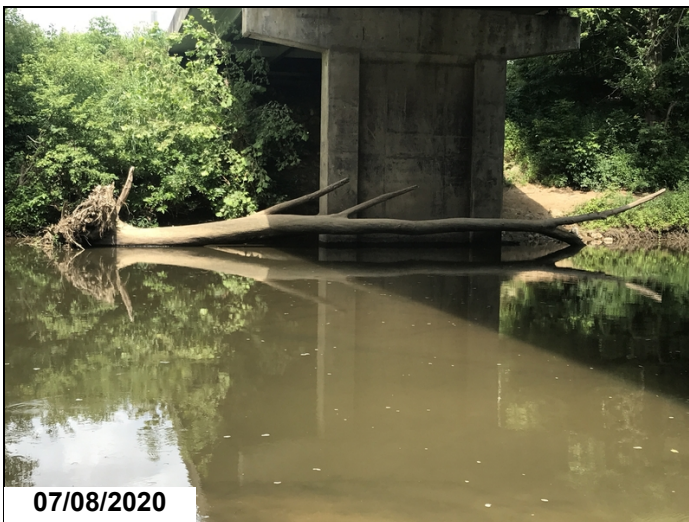
The channel has a tree wedged against bent 2.
