Bridge 00412 Inspection Report

Route:64 Section:02 Log:19.65

(4) Place Code	48200
(6) Features Intersected	Millers Branch
(7) Facility Carried	US Highway 64
(9) Location	11.5 E JCT US 71
(11) Mile Point	19.65 mi
(12) Base Highway Network	No

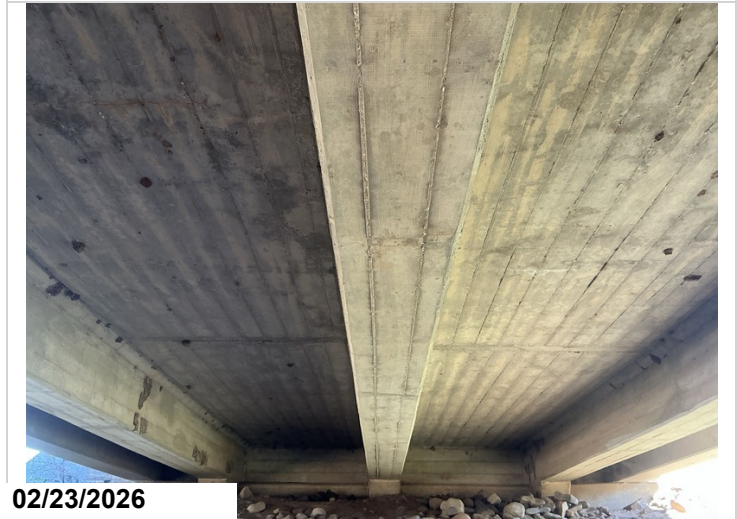
Undersurface, Span # 11: typical.

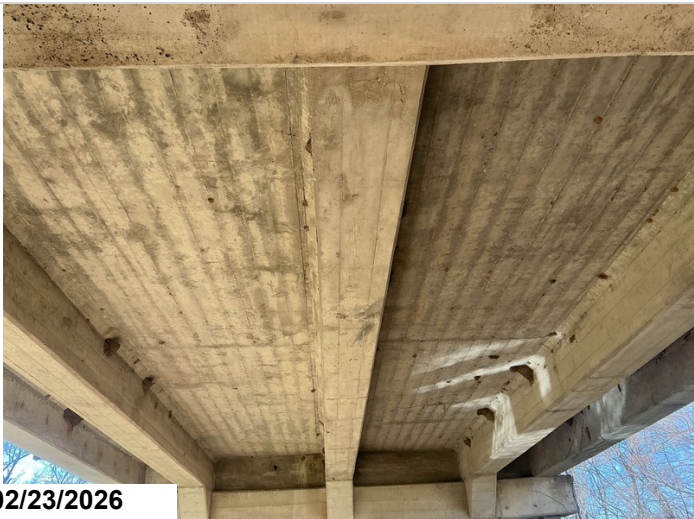
Undersurface, Span # 9: typical.

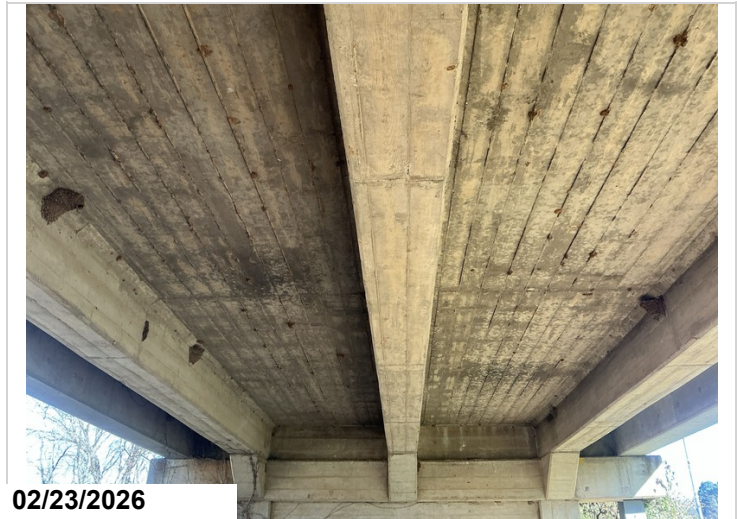
Undersurface, Span # 10: typical.

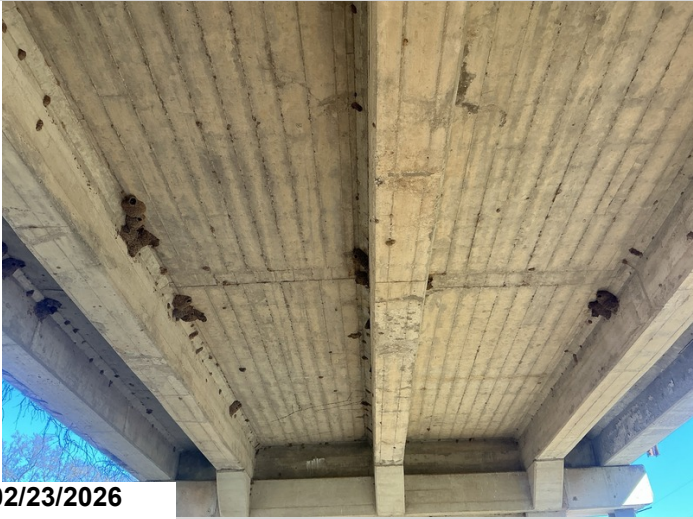
Undersurface, Span # 8: typical.

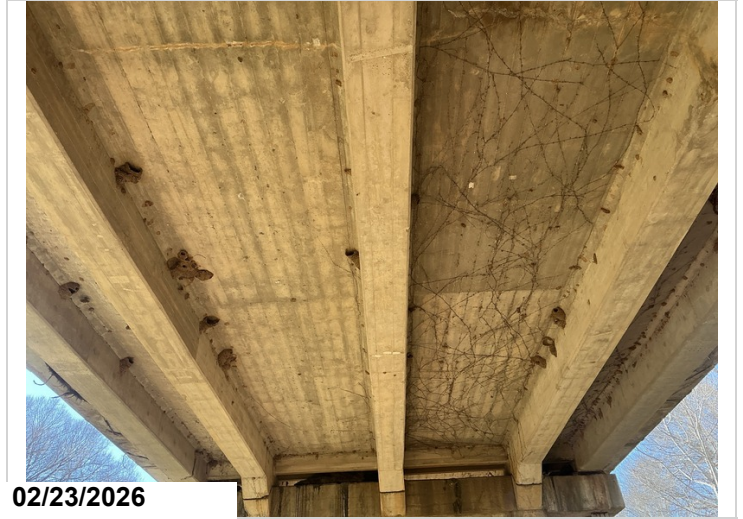
Undersurface, Span # 6: typical.

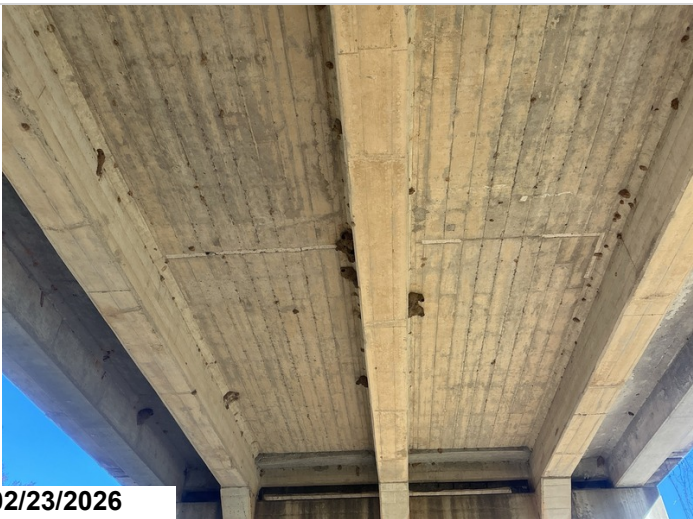
Undersurface, Span # 7: typical.

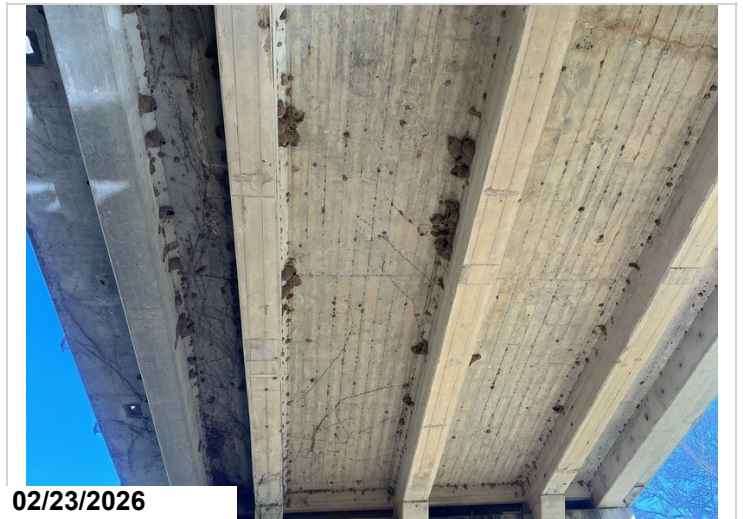
Undersurface, Span # 5: typical.

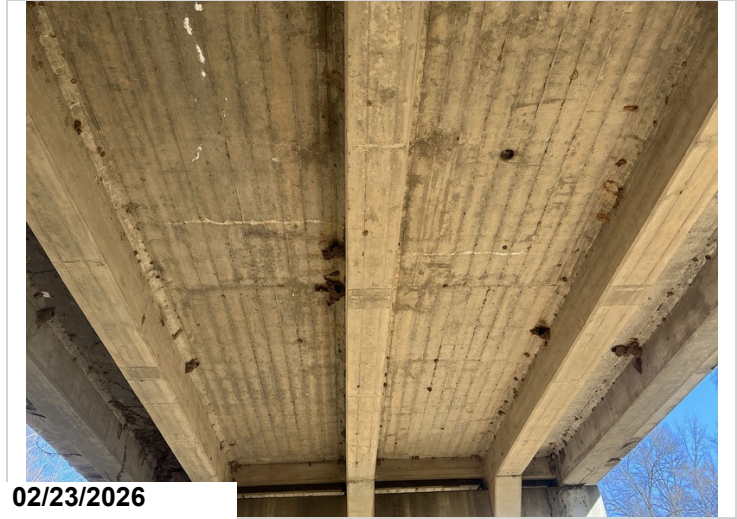
Undersurface, Span # 3: typical.

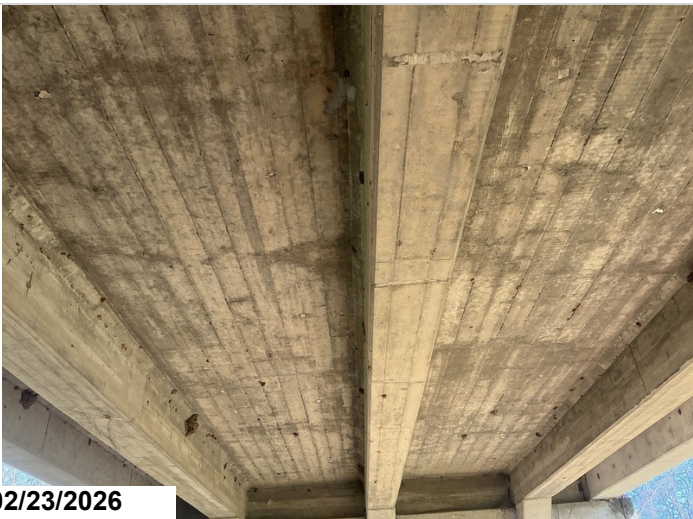
Undersurface, Span # 2: typical.

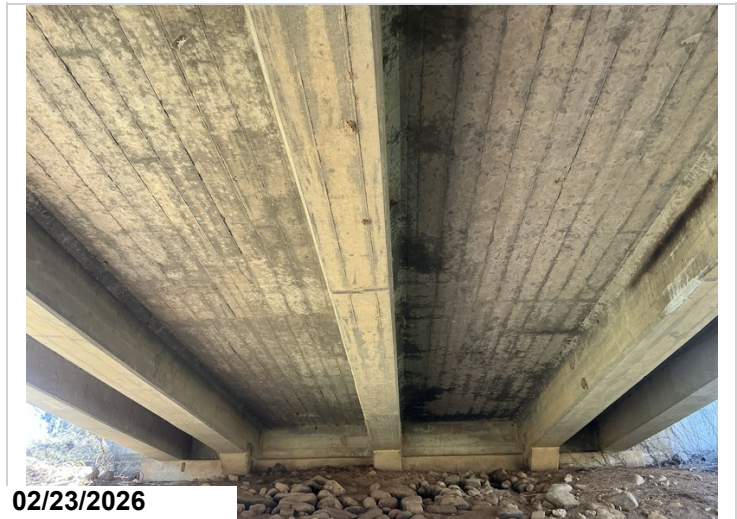
Undersurface, Span # 1: typical.

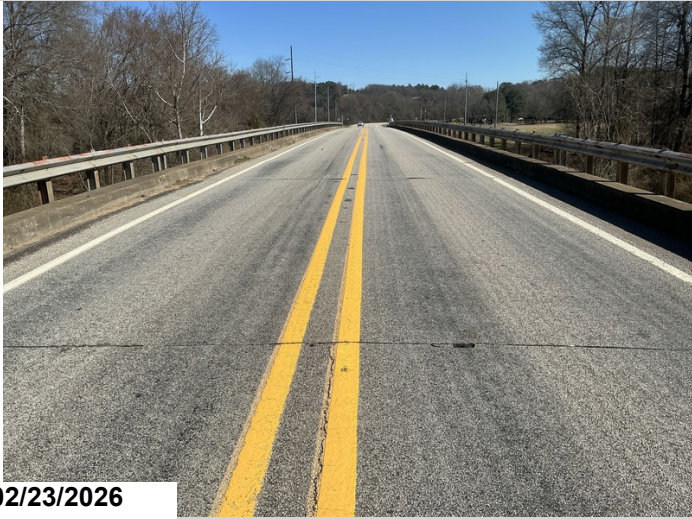
Driving Surface: typical.

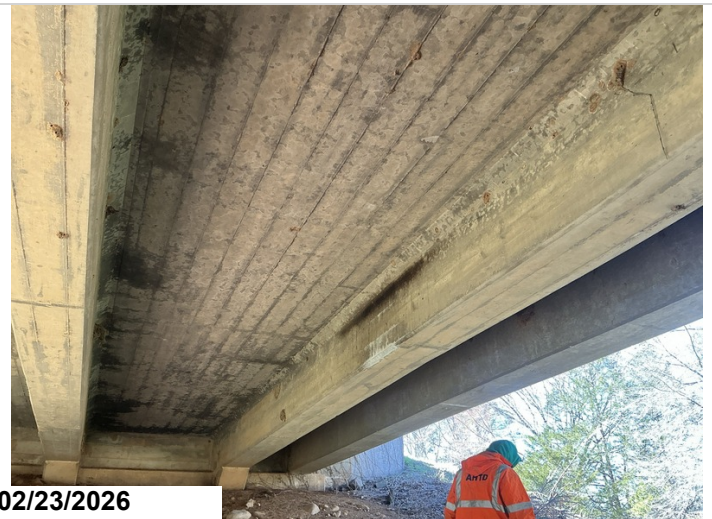
Span # 1, evidence of bats on girder # 4 near mid span.

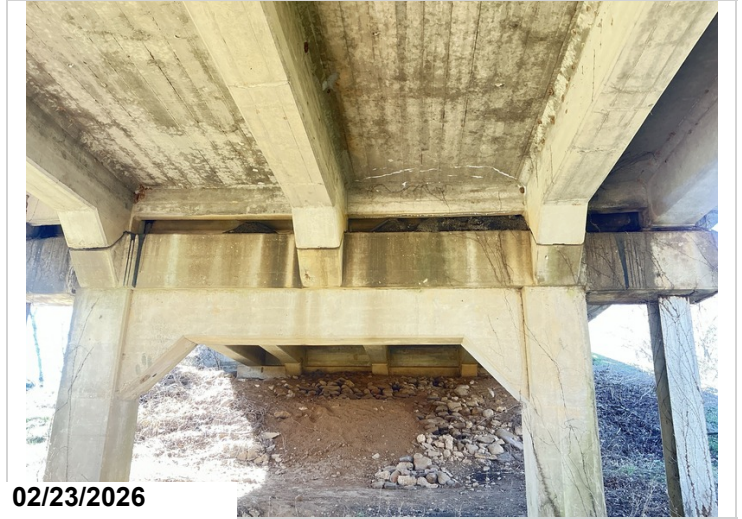
Bent # 2 asphalt on the bent cap.

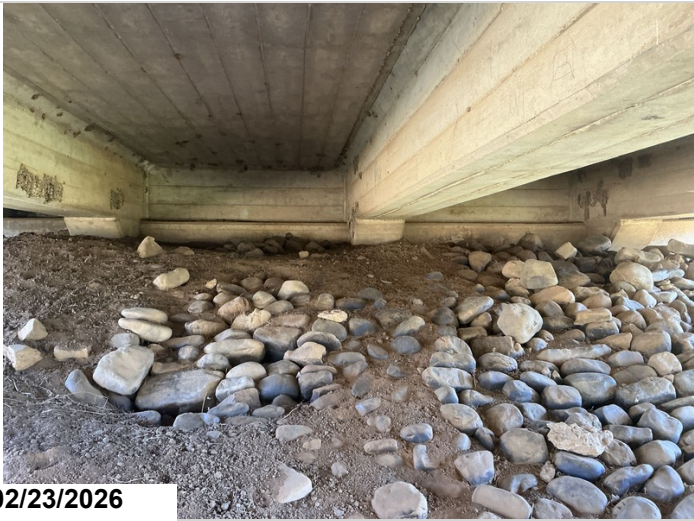
Abutment # 2: typical.

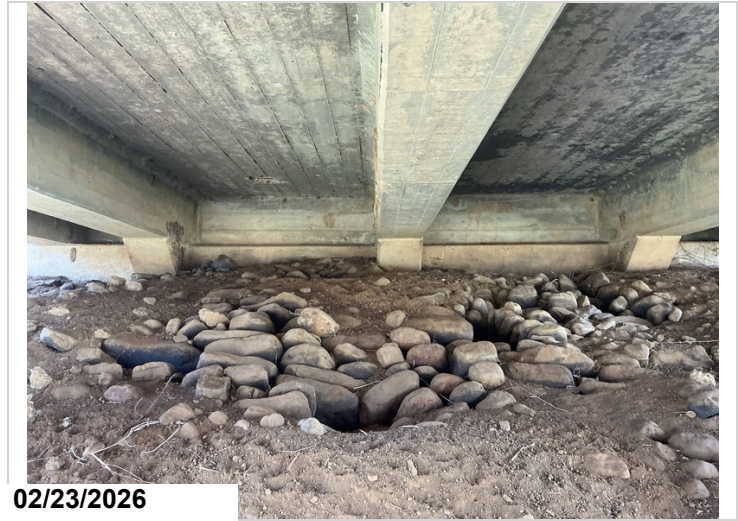
Abutment # 1: typical.

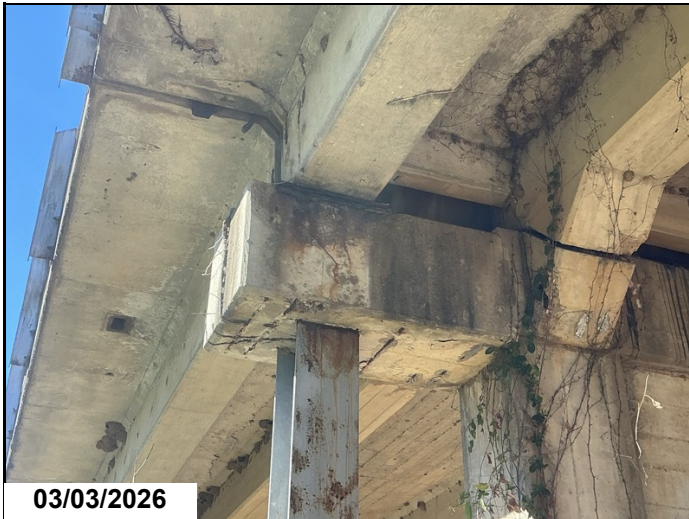
Span # 6, bearing # 5, bent # 6: bearing has heavy corrosion with layers of flaking rust/ section loss. The bearing has approximately 1" bearing area loss in a 5" long area due to spall in bent cap.

Span # 6, bearing # 5 at bent # 6 has heavy corrosion with layers of flaking rust/ section loss. The bearing has approximately 1" bearing area loss in a 5" long area due to spall in bent cap.

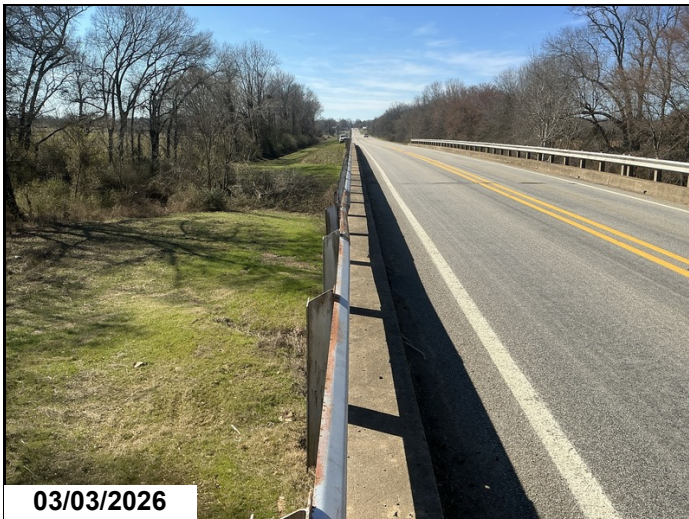
(330) Metal Bridge Railing: The bridge railing has areas of light collision damage with minor collision damage that has caused scrapes and out of plane bending to the railing. Span # 9, right: the bridge railing has minor collision damage in an area approximately 12' long that has caused out of plane bending to the railing and bent one post out of plumb. The paint system is failing with areas of light rust throughout. (515-330) Steel Protective Coating: the paint system is failing in areas along the bridge rails.

Span # 9 right bridge railing has minor collision damage in an area approximately 12' long that has caused out of plane bending to the railing and bent one post out of plumb.

Span # 9 right bridge railing has minor collision damage in an area approximately 12' long that has caused out of plane bending to the railing and bent one post out of plumb

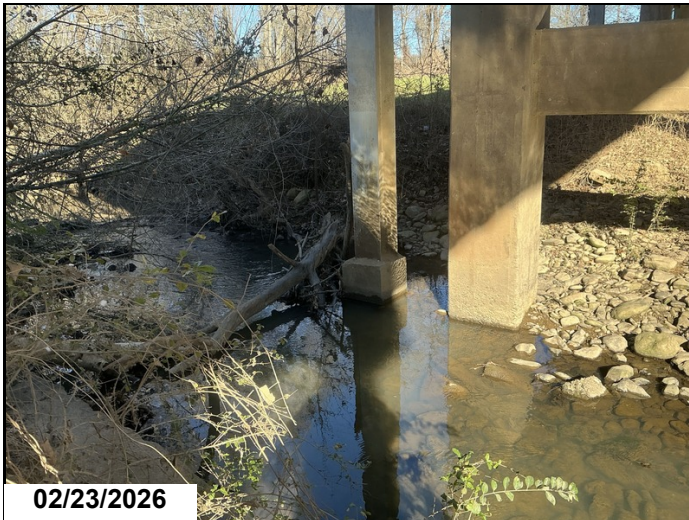
Channel -
The channel has light drift accumulation at bent # 5.

The channel has light drift accumulation at bent # 5.

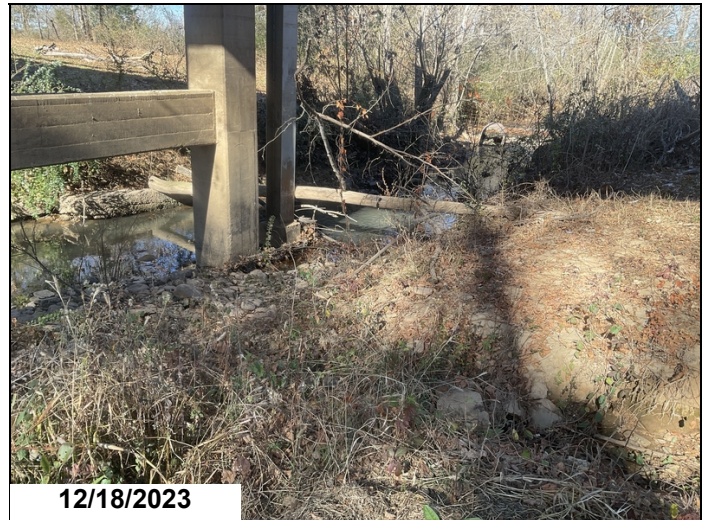
Light drift accumulation at bent # 5
