Bridge 00413 Inspection Report

IDENTIFICATION	
(1) State Names	5 - Arkansas
(8) Structure Number	00413
(5) Inventory Route	1
(2) Highway Agency District	04 - District 04
(3) County Code	33 - Crawford County

(4) Place Code	0
(6) Features Intersected	Big Mulberry River
(7) Facility Carried	US Highway 64
(9) Location	1 MI E JCT 215 IN MULBERRY
(11) Mile Point	19.9 mi

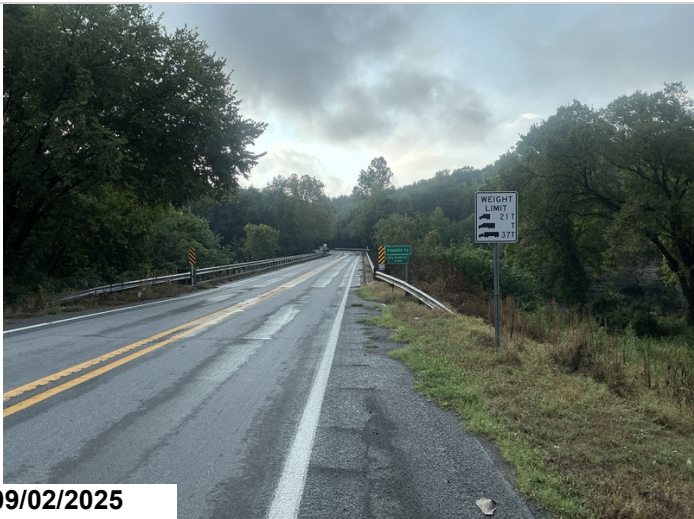
West approach load posting sign.

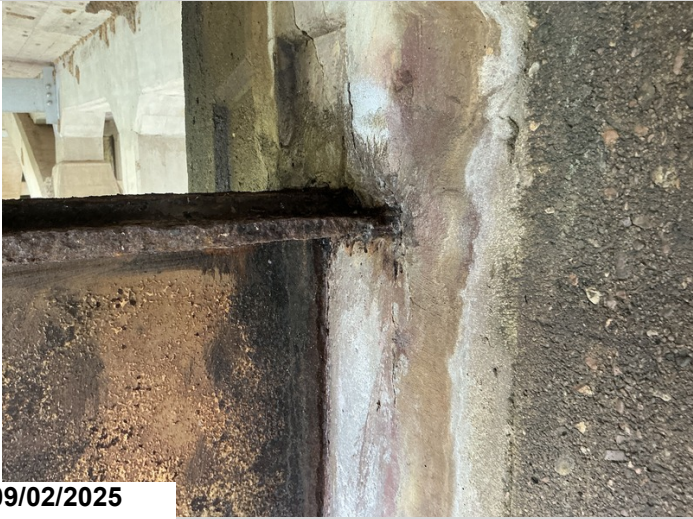
Bent # 5, Span # 4 , left: the top flange has been reduced to 5/16" thickness.

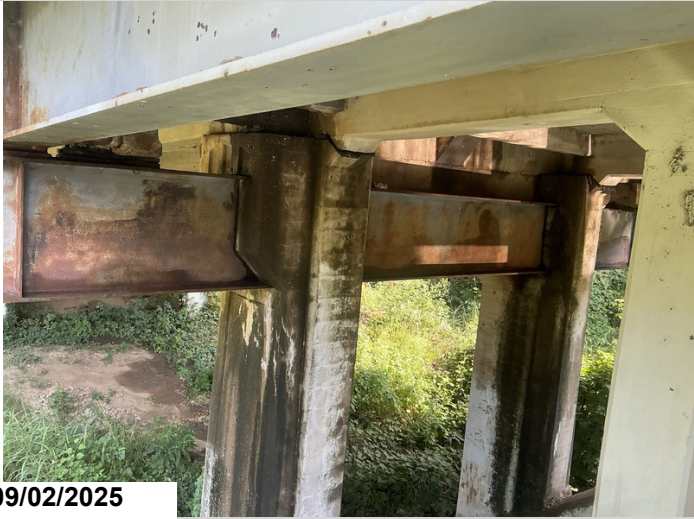
Cap, Bent # 3: typical.

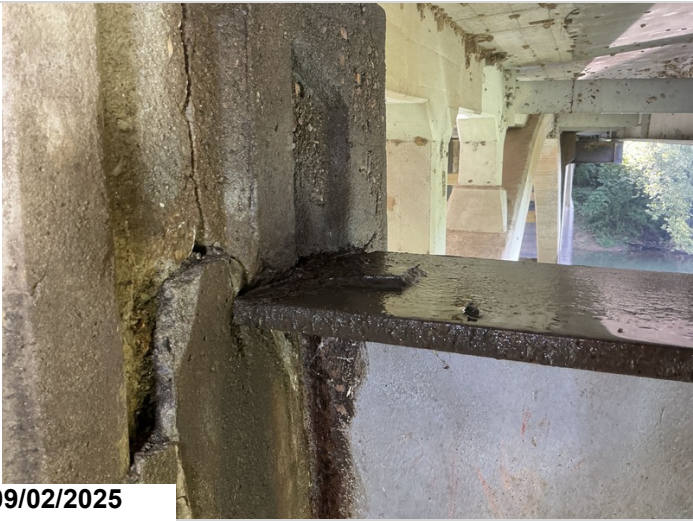
Bent # 3 Steel Cap, Right:

There is active corrosion in the steel cap on the top and bottom flanges at the juncture where the w-beam passes through the (original) reinforced concrete cap. Section loss measures up to 3/16" on the cover plate. Top flange original thickness is 7/8" and has been reduced down to 9/16" at the bent cap juncture.

No visible cracks apparent in the NSTM steel cap during this inspection.

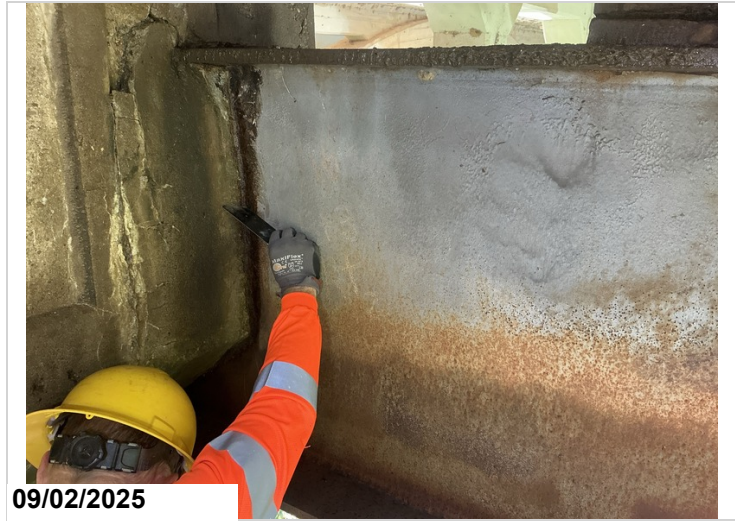
Bent # 3 Steel Cap, Right:

The Span # 2 side of cap has 5/16" section loss to the steel cap at the juncture where the w-beam passes through the (original) reinforced concrete cap.

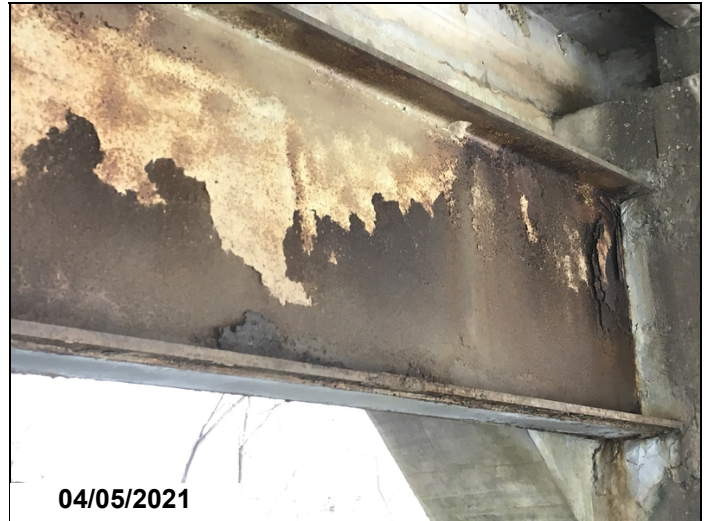
Bent # 6 cap. Interior between the columns.

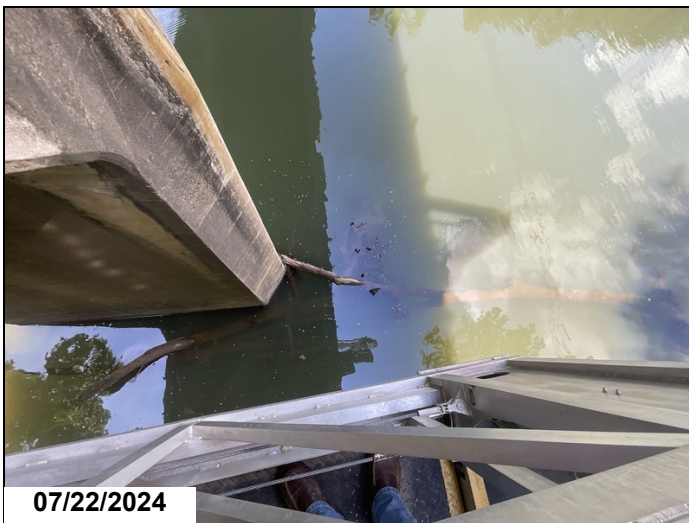
Channel -
The channel has drift accumulation at the base of the substructure.

Submerged drift accumulation at bent # 5.

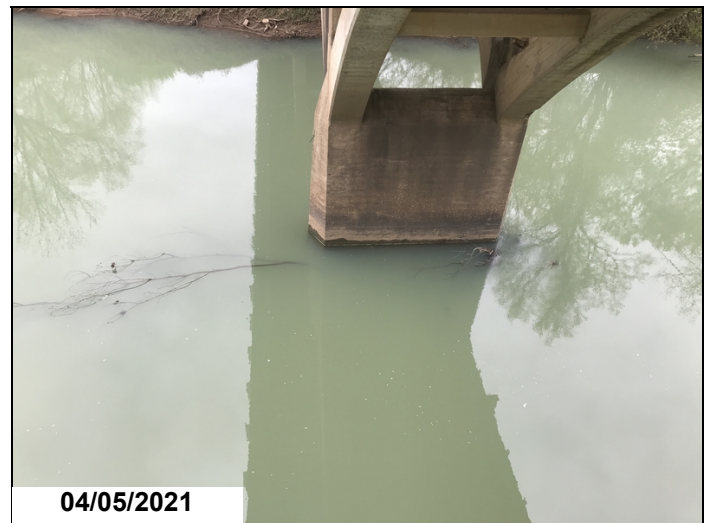
Submerged drift accumulation at bent # 5.
