## Bridge 01899 Inspection Report

Route:5 Section:16 Log:24.61

District 05, 137 - Stone County

Asset #01899(Routine, NSTM)  
SH 5/Stone County over SYLAMORE CREEK  
Location: .3 MI N JCT SH 14 W  
Team Lead: Seth Foreman Inspection Date: 09/17/2025

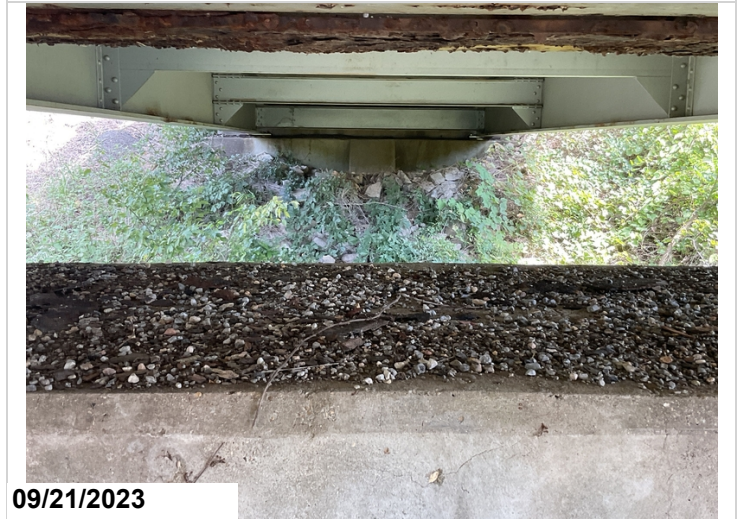
Debris on cap @ Bent 6 & Abutment 2.

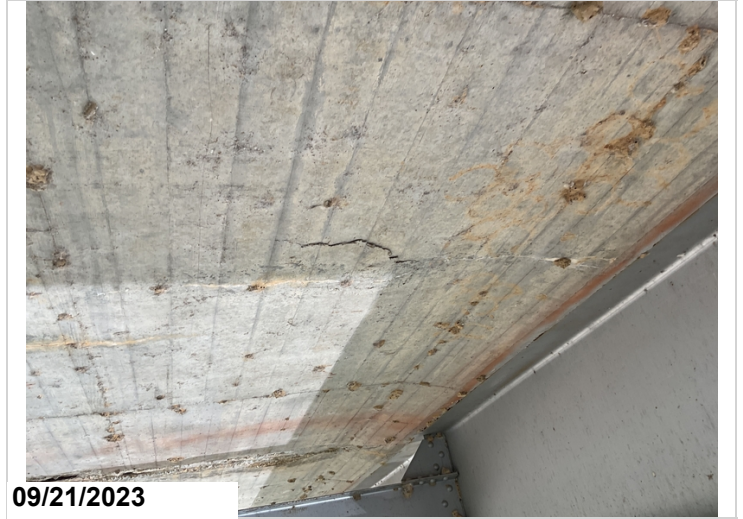
Delaminated area to soffit @ Span 4.

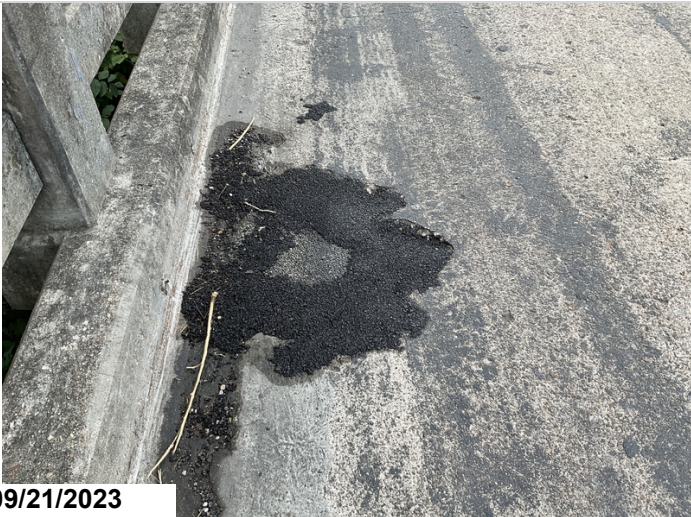
Patched area to deck @ Span 1.(#2)

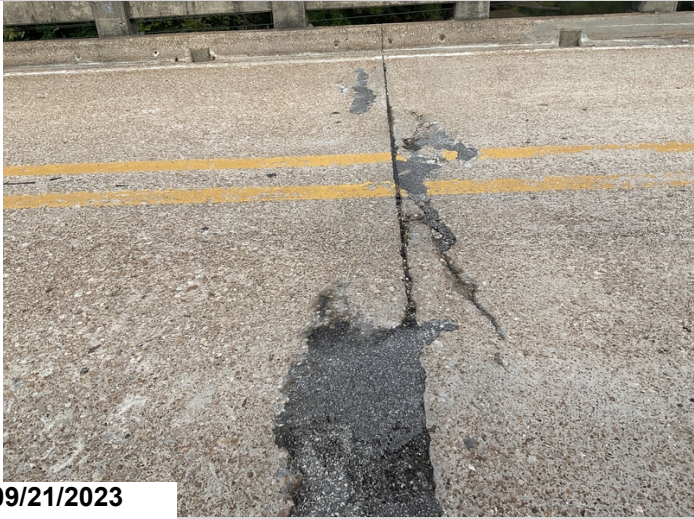
Spalls/patched areas to deck @ end of Span 4.(#3)

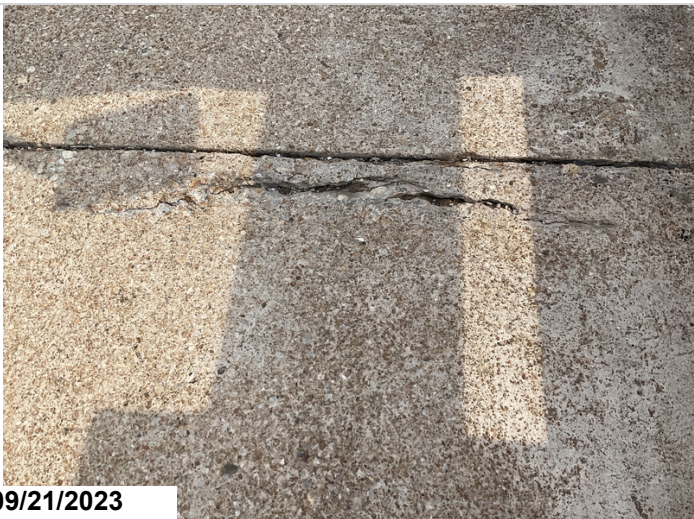
Spalls to deck @ Span 5.(#3)

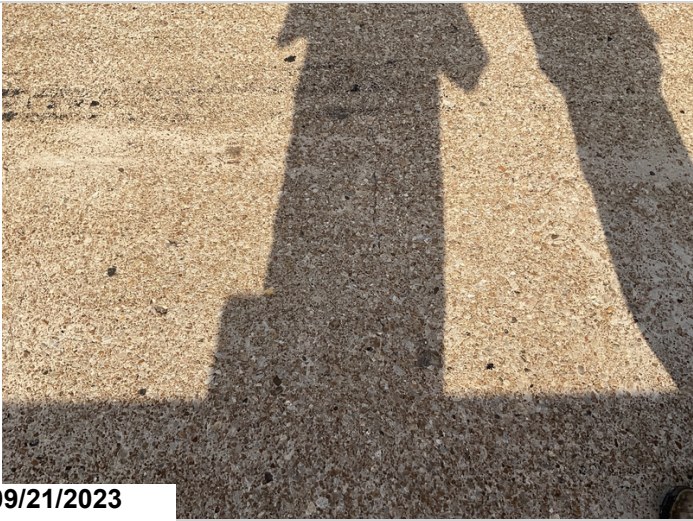
Typical cracking to deck.(#2)

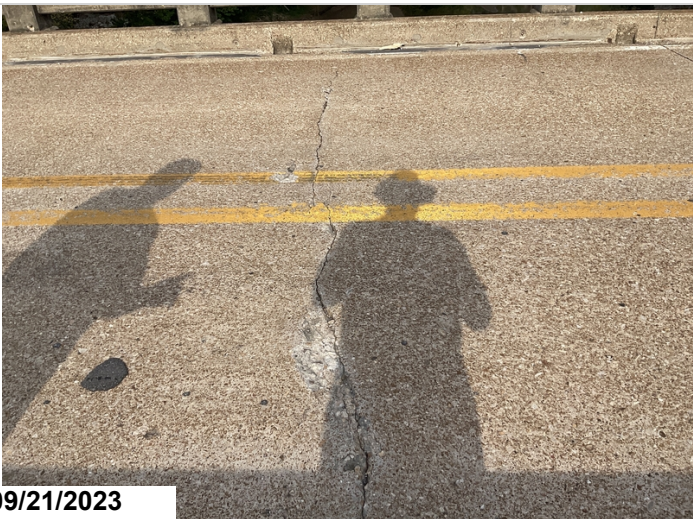
Typical transverse cracking & spalling to deck.(#3)(typical)

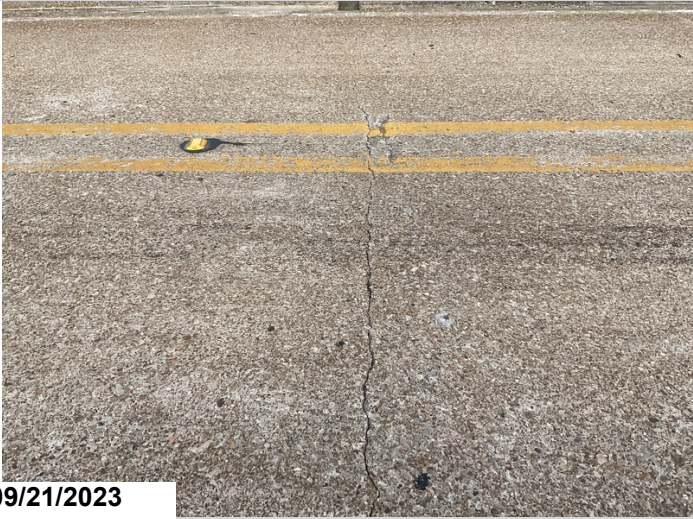
Typical transverse cracking to deck.(#3)

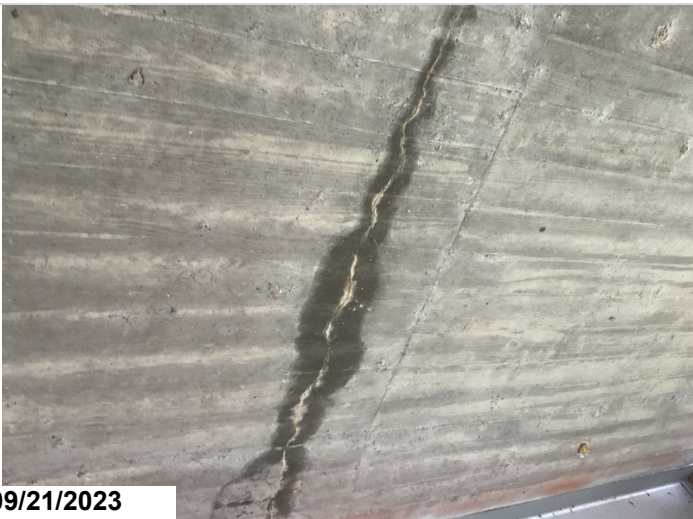
Efflorescent cracking to soffit @ Span 2.(#2)(typical)

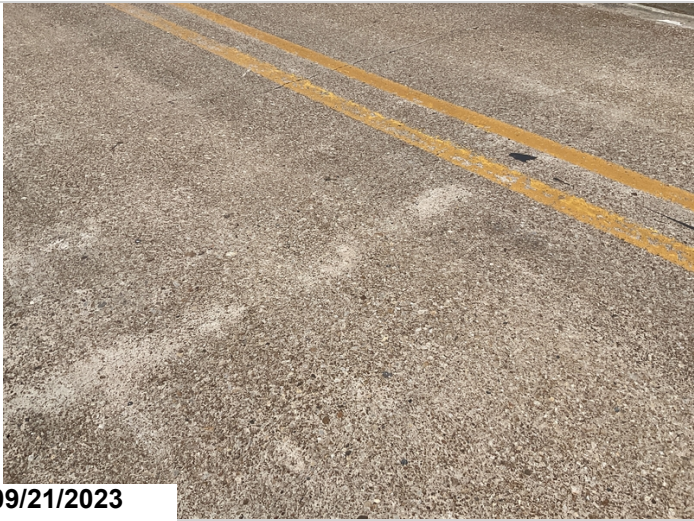
Typical abrasion to deck.(#2)

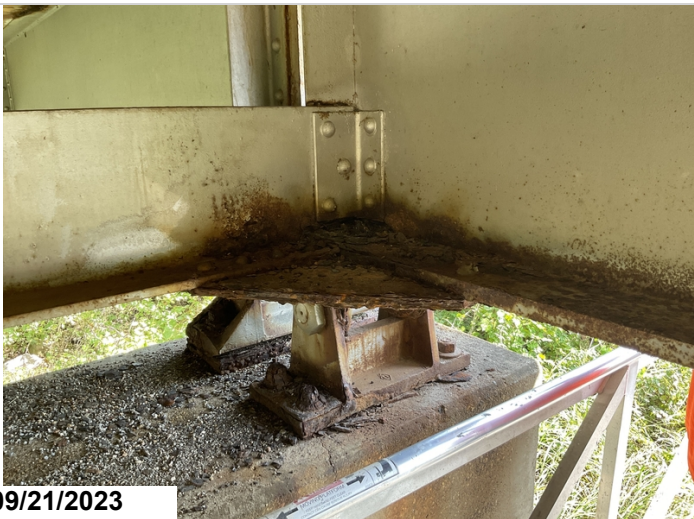
Rust with pack rust & s/l to diaphragm, bottom flange & connecting plate @ Girder 2 @ end of Span 6.(#3)

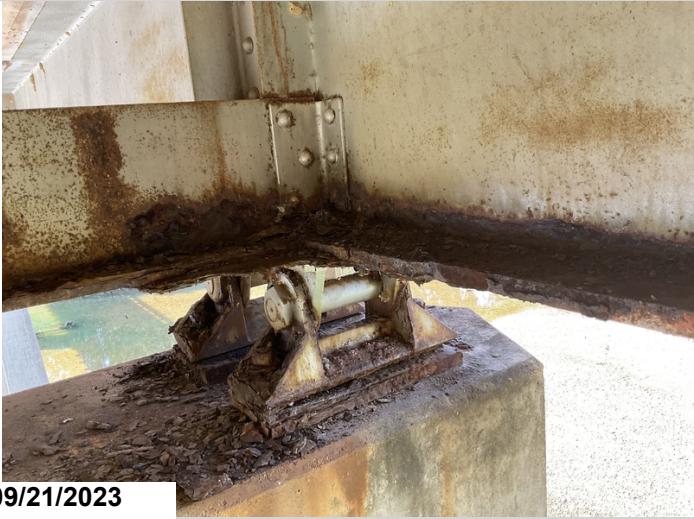
Rust with 100% s/l to diaphragm connection plate & heavy s/l to bottom of web & bottom flange @ Girder 1 @ beginning of Span 6.(#3)

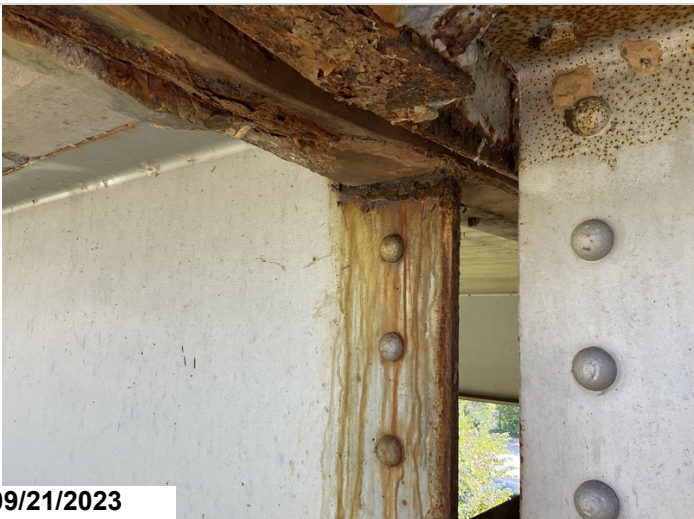
Rust with 3/16" s/l to web below haunch @ Girder 1 @ beginning of Span 6.(#3)

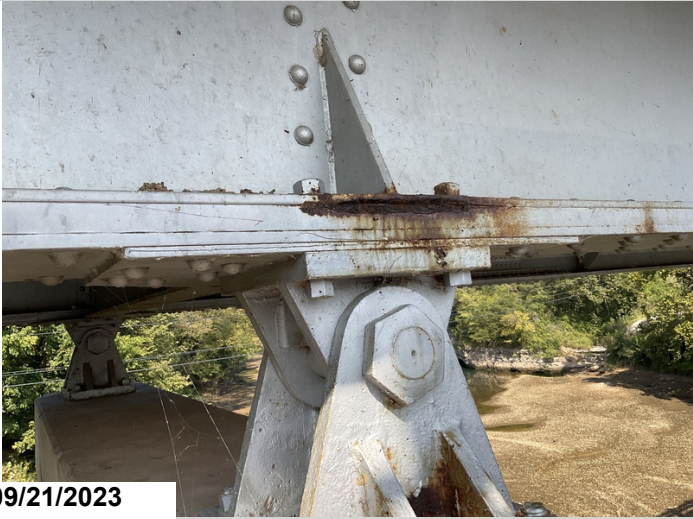
Rust with pack rust between cover plate & bottom flange @ Girder 2 @ end of Span 3.(#3)

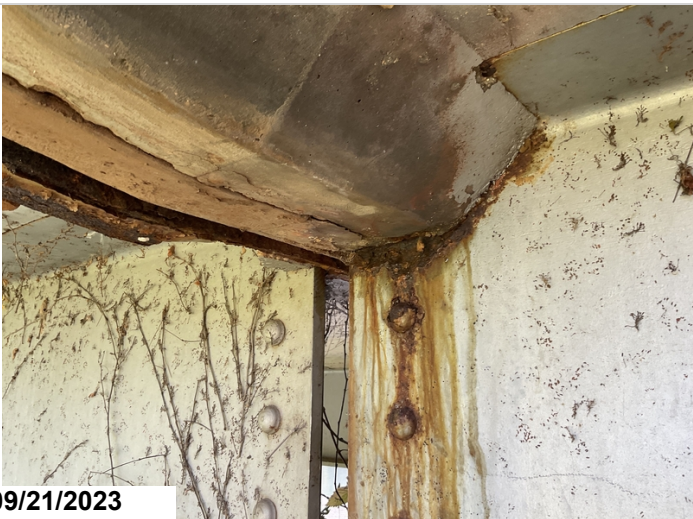
Rust with 5/16" s/l to web below haunch @ Girder 1 @ end of Span 2.(#3)

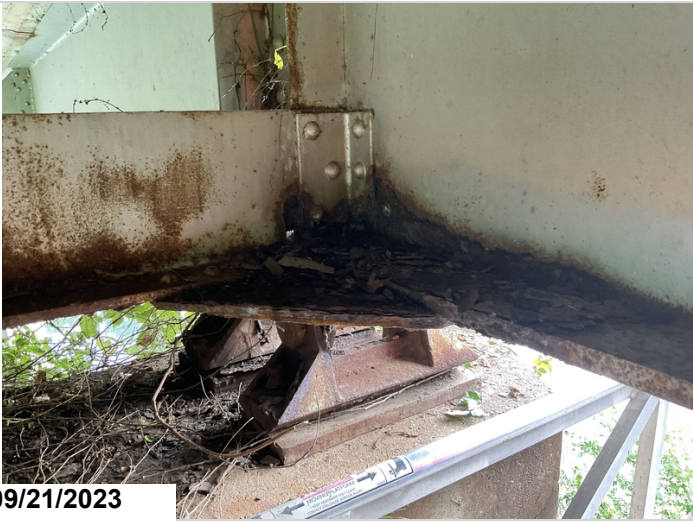
Rust with pack rust & s/l to diaphragm, bottom flange & connecting plate @ Girder 2 @ end of Span 2.(#3)

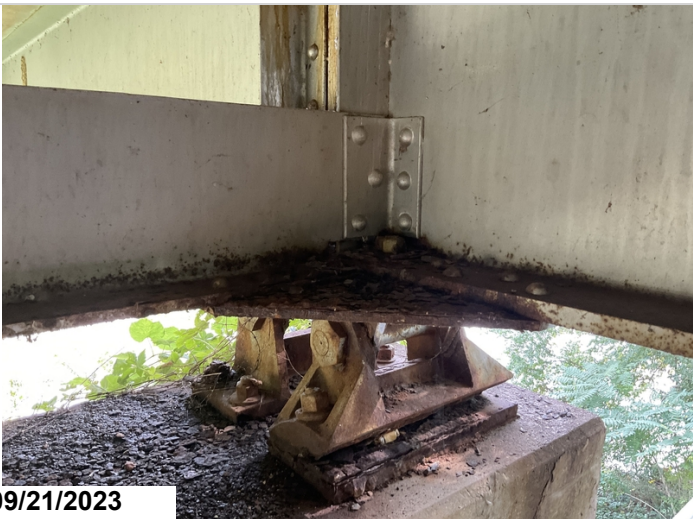
Rust with pack rust & s/l to diaphragm, bottom flange & connecting plate @ Girder 2 @ end of Span 1.(#3)

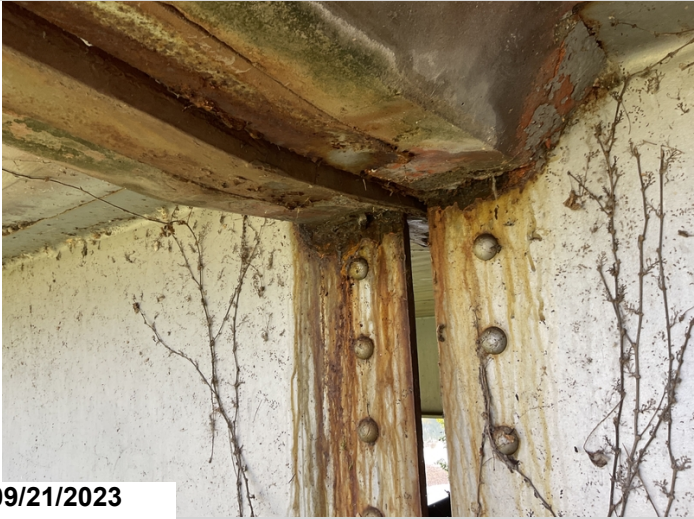
Rust with 3/16"s/l to web below haunch @ Girder 1 @ end of Span 1 & 5/16" @ beginning of Span 2.(#3)

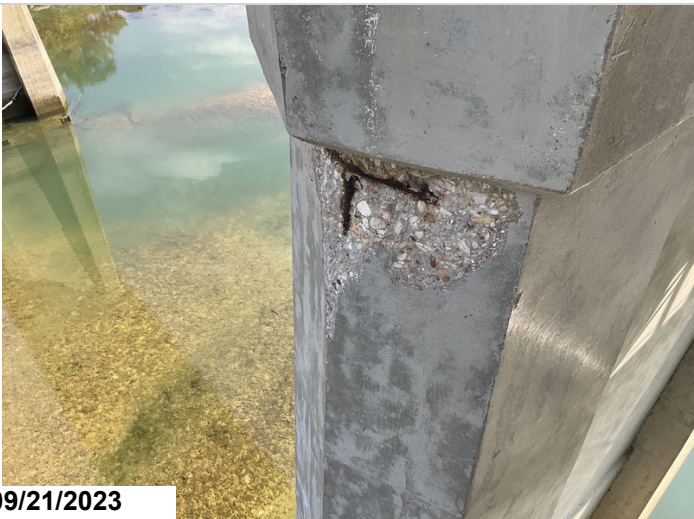
Spall with rebar exposed with s/l to Left side of Column 1 @ Bent 3.(#3)

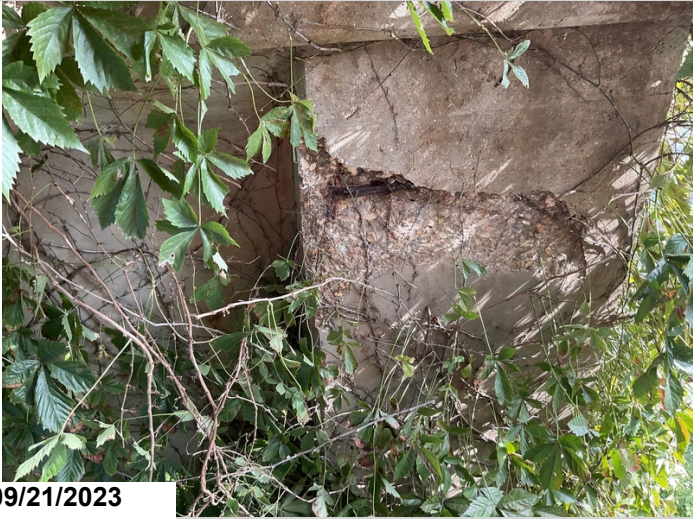
Spalls with rebar exposed with s/l to backside of Column 2  
@ Bent 2.(#3)

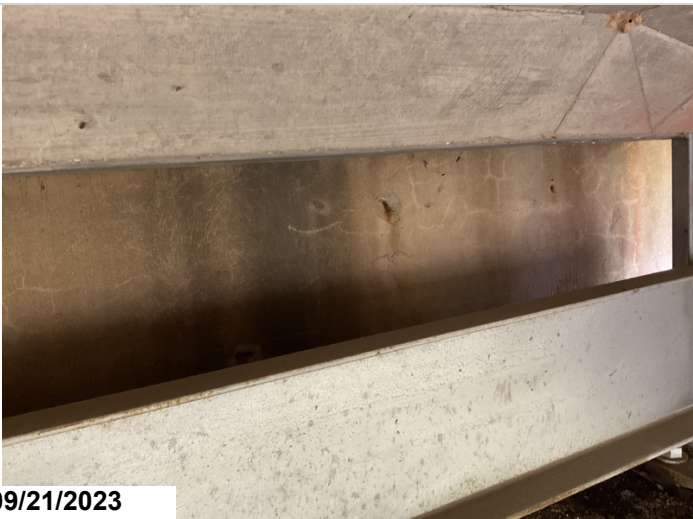
Area of map cracking to Abutment 2.(#2)

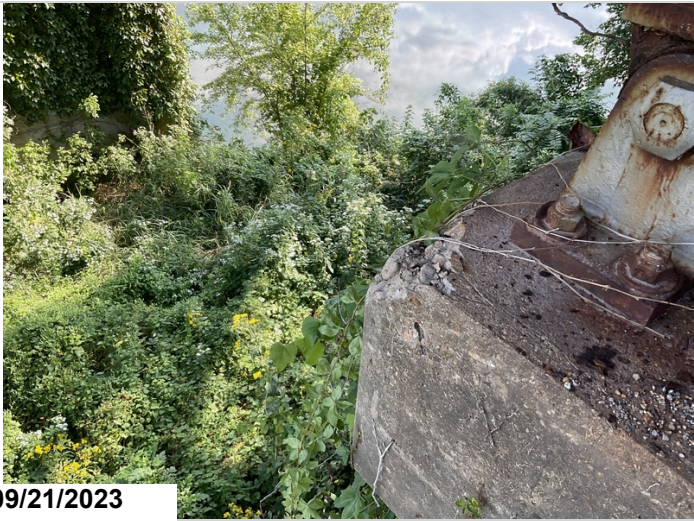
Spall to Left end of cap @ Bent 1.(#3)

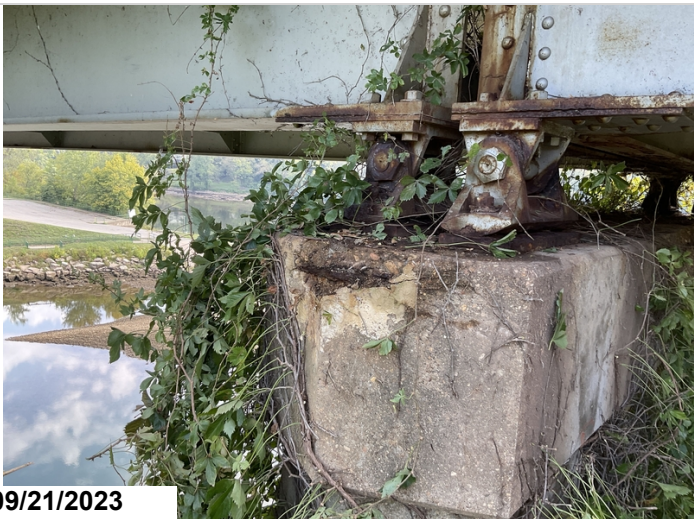
Spall with rebar exposed with s/l to Left end of cap @ Bent 2.(#3)

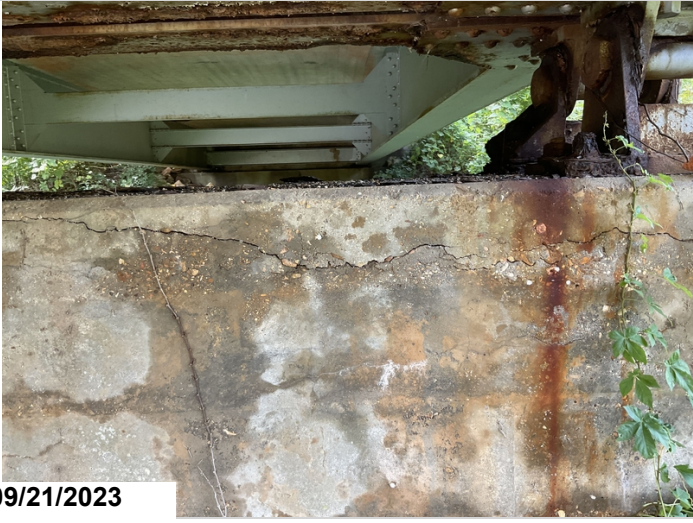
Horizontal cracking to ahead of cap @ Bent 1.(#3)

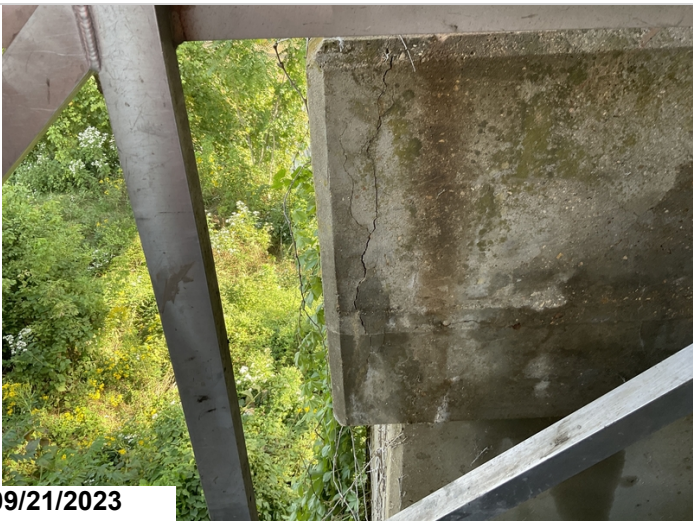
Vertical cracking to Left end of cap a Bent 1.(#3)

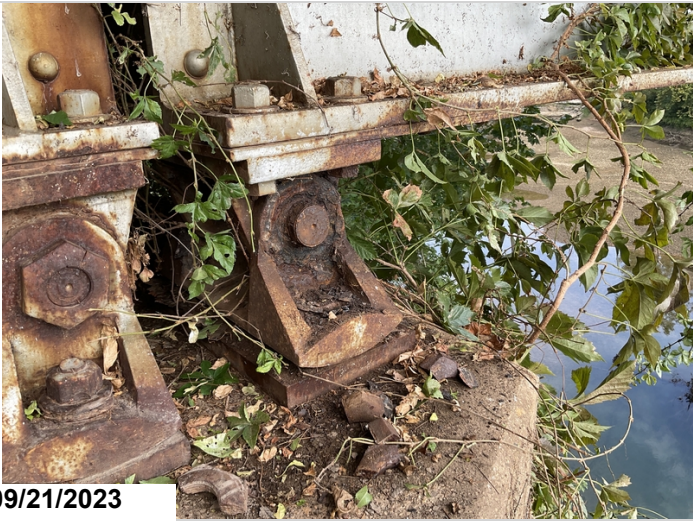
Exterior nut on rocker pin @ Moveable Bearing 2 on ahead side of Bent 2 is missing & Anchor bolt is also missing due to heavy corrosion.(#4)

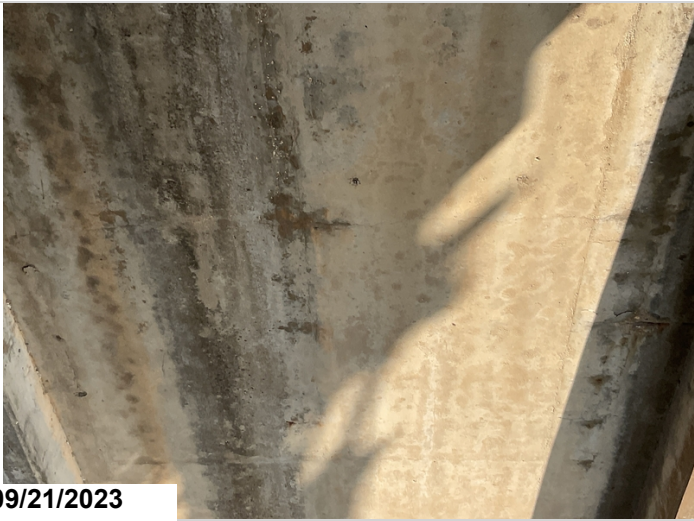
Horizontal cracking to Concrete Pier Wall @ Bent 5.(#2)

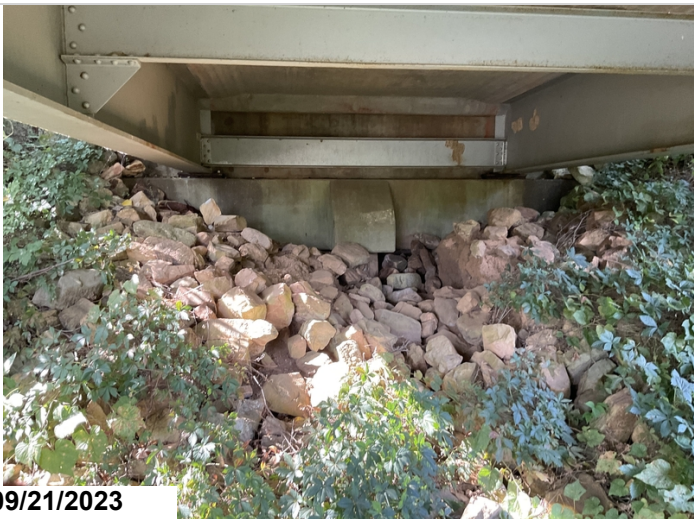
Erosion to slope exposing 1 pile @ Abutment 1.(#3)

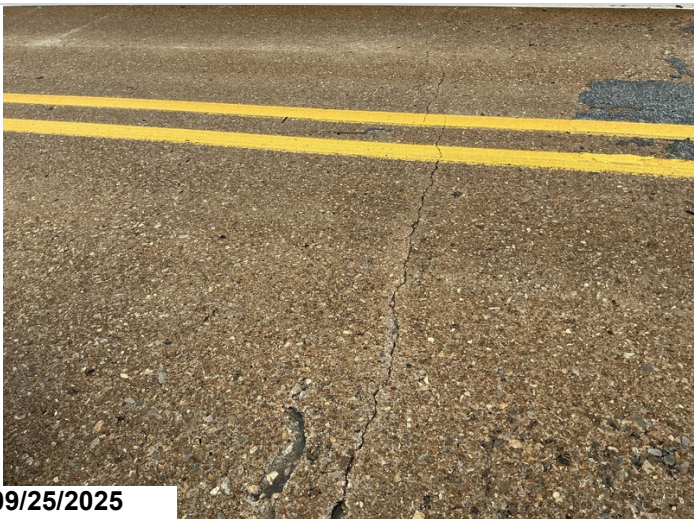
Transverse cracks to deck at all spans.

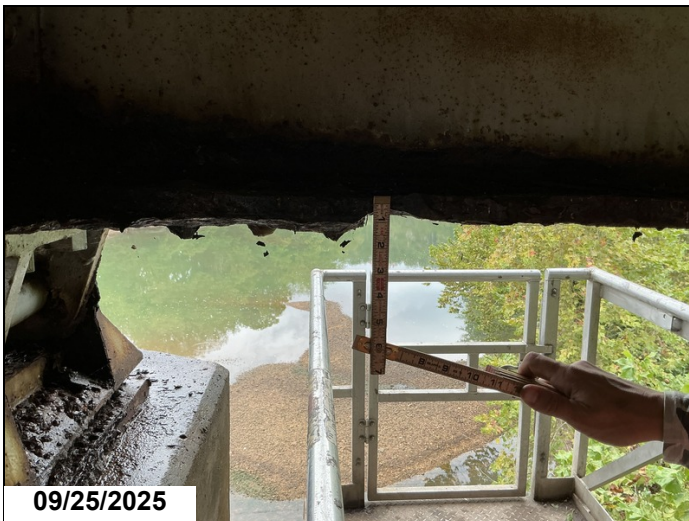
Rust with section loss to girder 1 beginning of span 6.

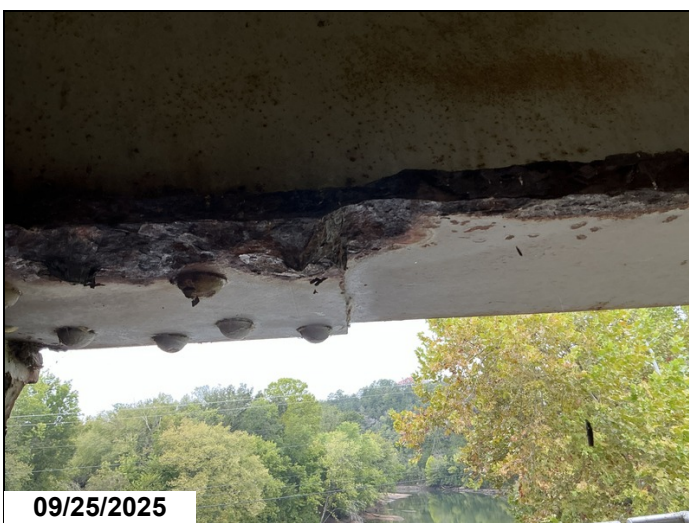
Rust with section loss to girder 1 beginning of span 6.

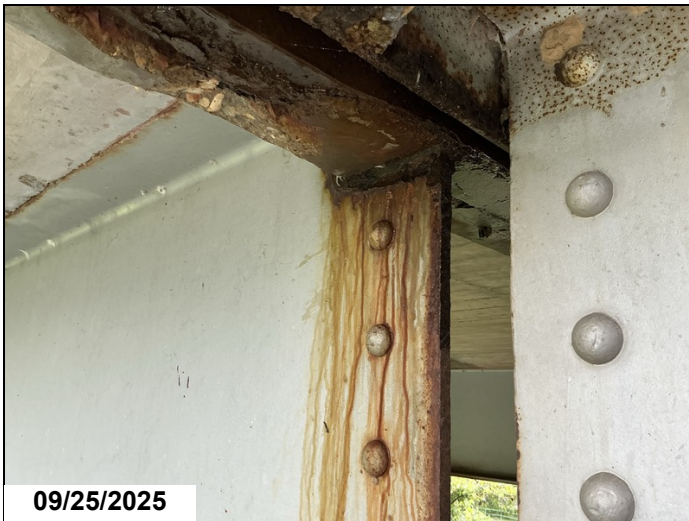
Rust with section loss to girder 1 beginning of span 6.

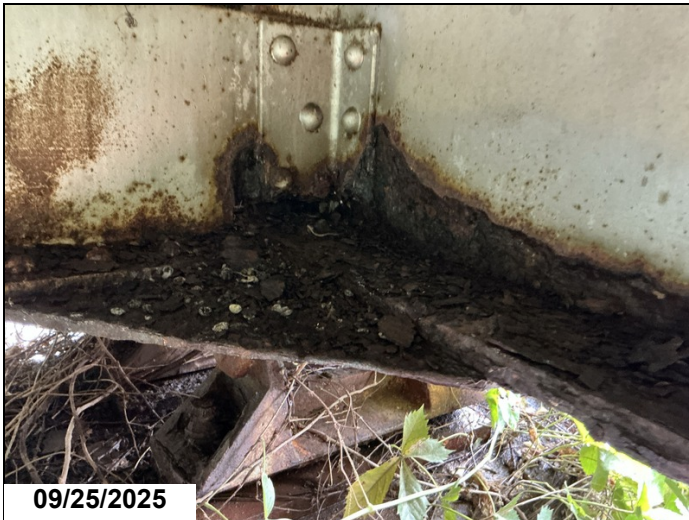
Rust with section loss to girder 2 end of span 2.

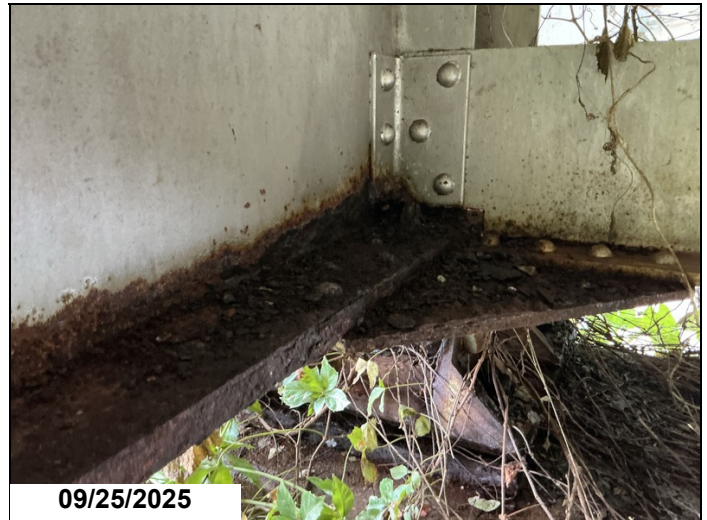
Rust with section loss to girder 1 end of span 2.

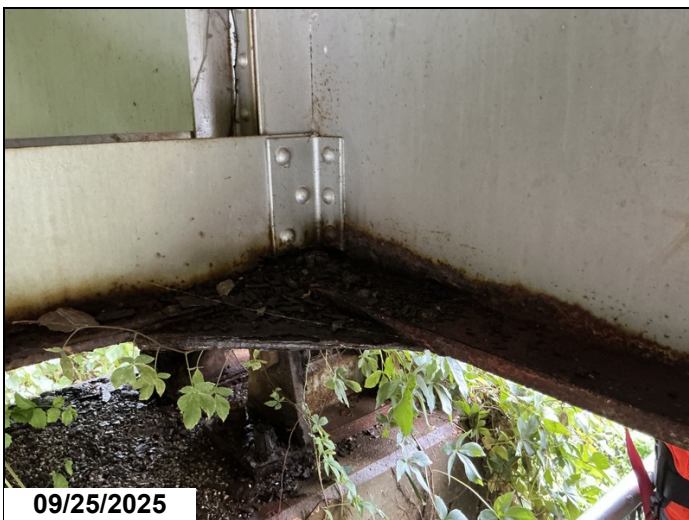
Rust with section loss to girder 1 beginning of span 2.

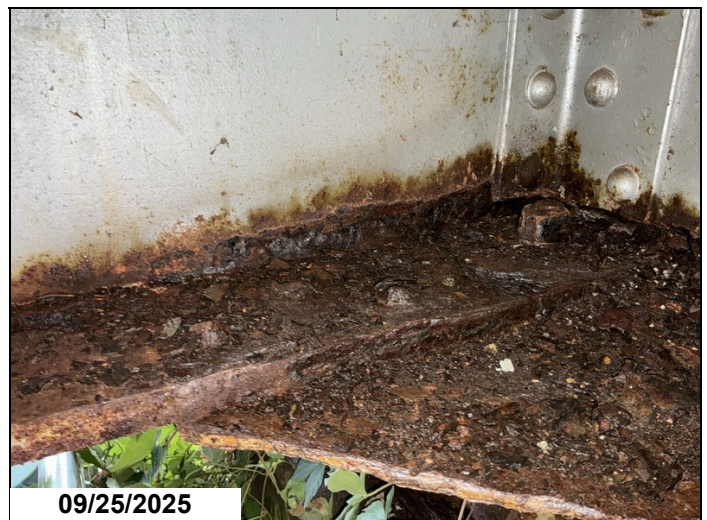
Section loss to bottom of web @ Girder 1 @ end of Span 1.

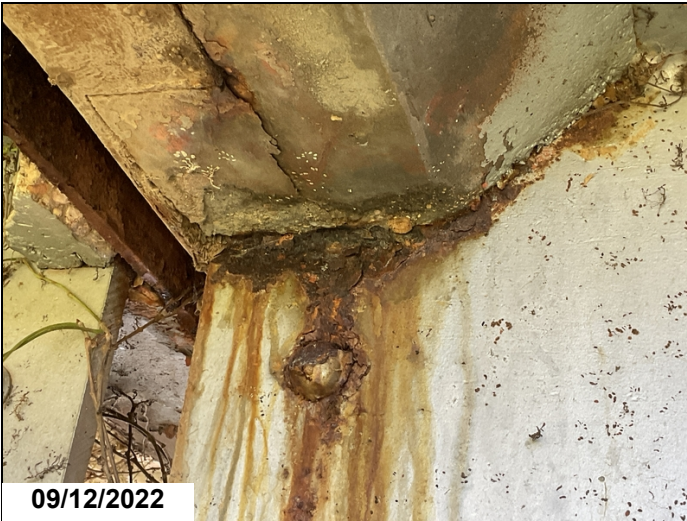
Girders 1 & 2 above Bents 1, 2, 5 have rust with section loss to Girders, diaphragms, and connection plates.

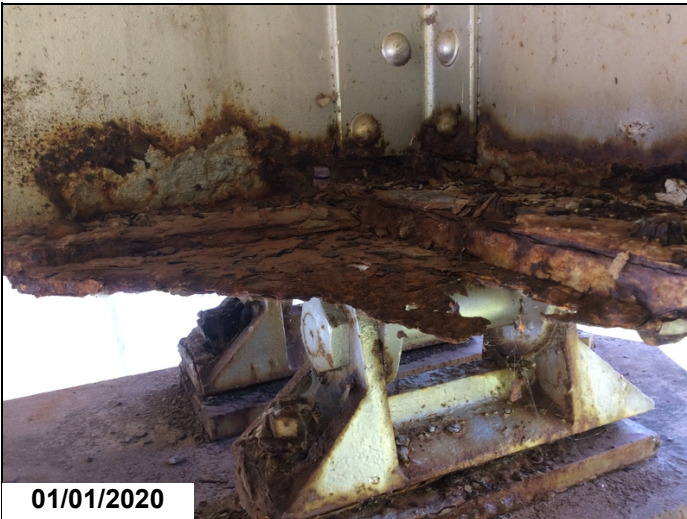
Diaphragm connection plate at Girder 1, Bent 5 ahead side.

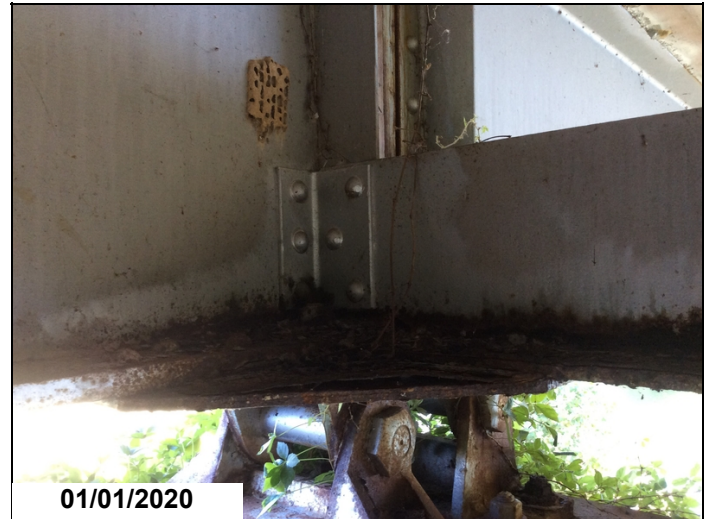
Diaphragm connection at Girder 1 at Bent 1.

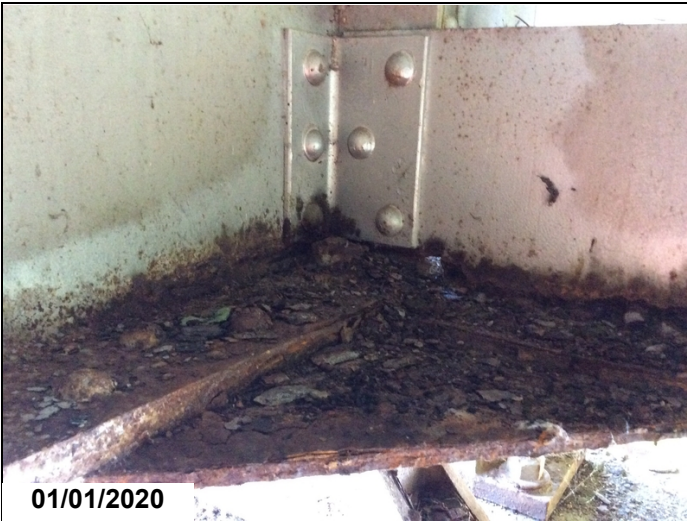
Section loss to bottom of web @ Girder 1 @ end of Span 1.

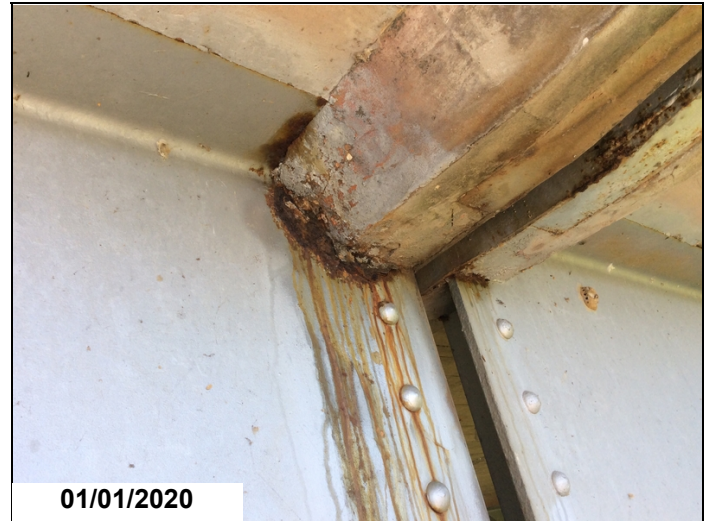
Haunch area at Girder 2 over Bent 6.

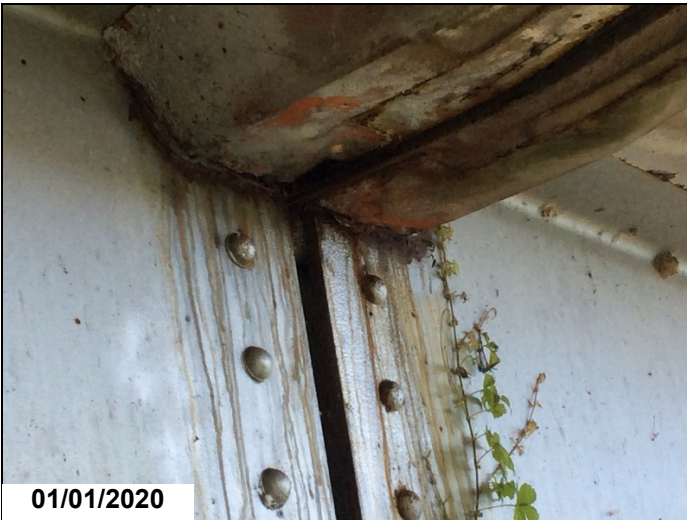
Rust to haunch area of Girder 2 at Bent 1.

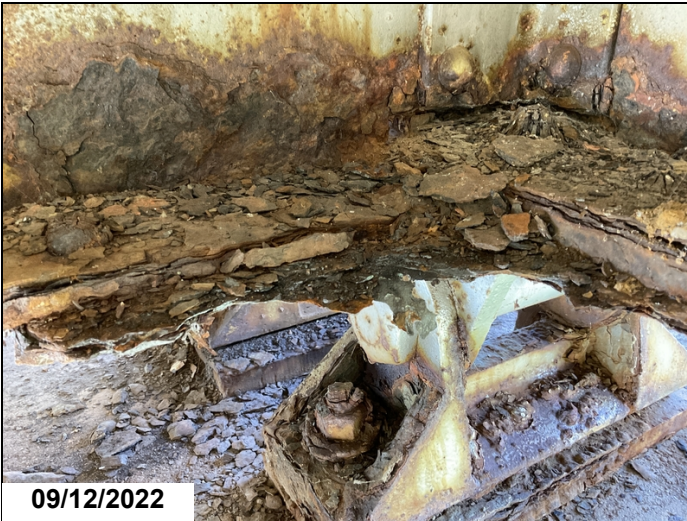
Span 6 - Girder 1 has heavy section loss with part of the gusset plate at bottom flange missing at beginning of span.

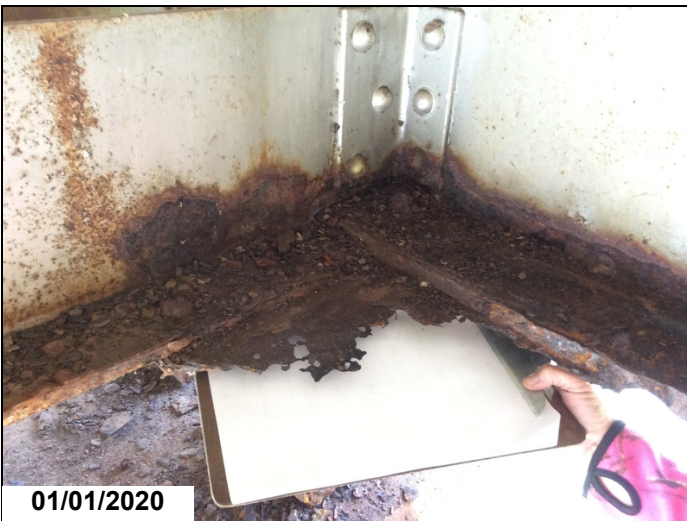
Span 6 - Girder 1 has heavy section loss with part of the gusset plate at bottom flange missing at beginning of span.

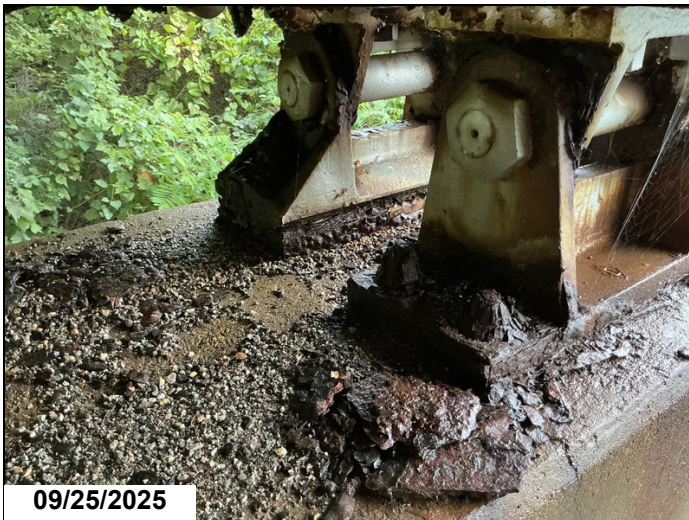
Rust with heavy section loss to anchor bolt nuts to bearing 2 on back and ahead side of bent 6.

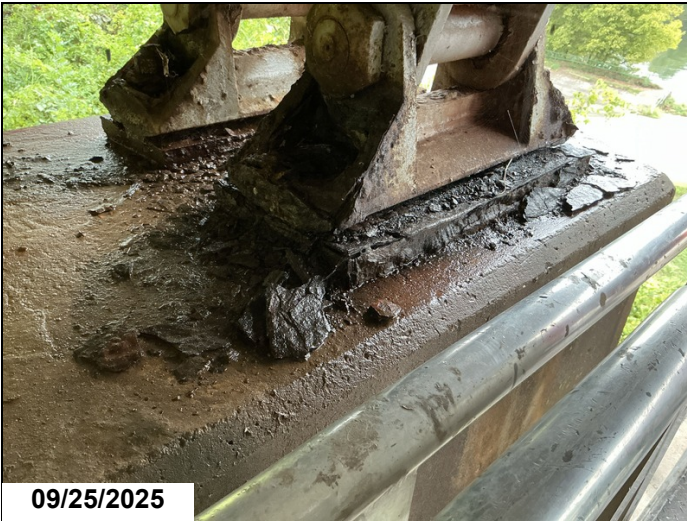
Rust with pack rust and anchor bolt missing to bearing 2 back side of bent 5.

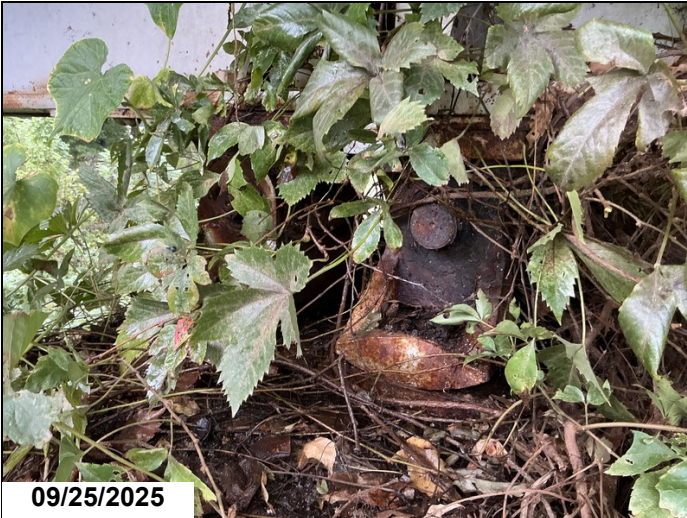
Anchor bolts missing from bearing 2 ahead side of bent 2.

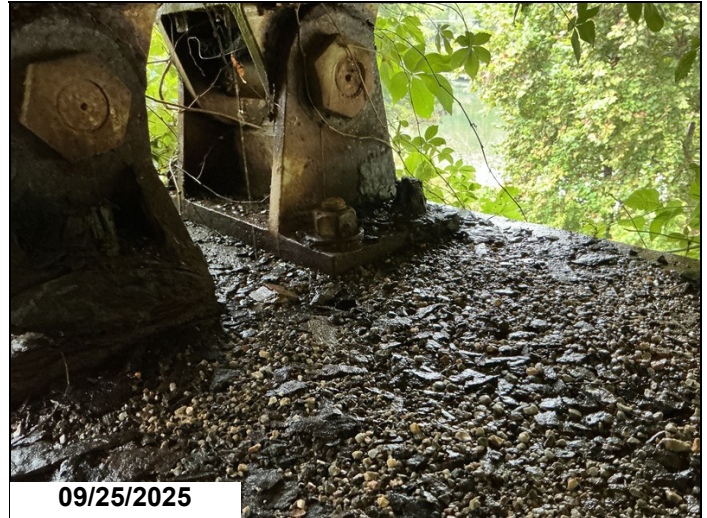
Rust with heavy section loss to nut Bearing 1 on ahead side of bent 1.

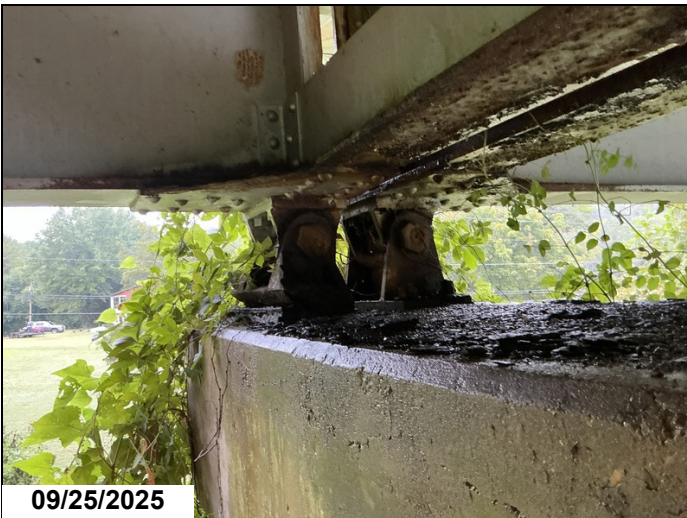
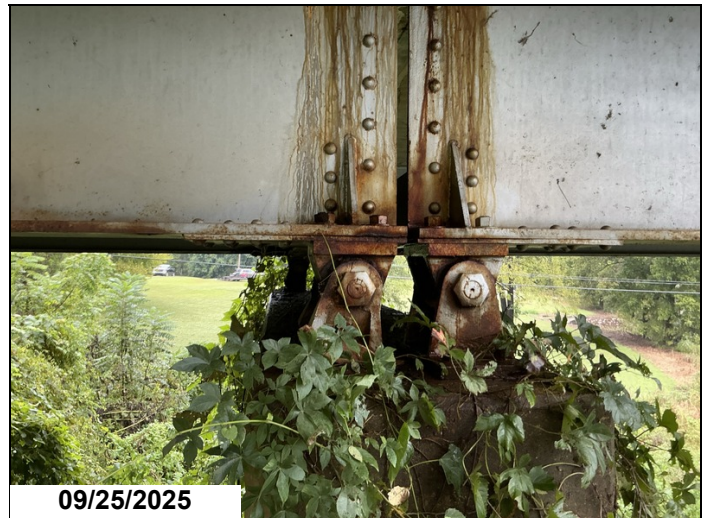
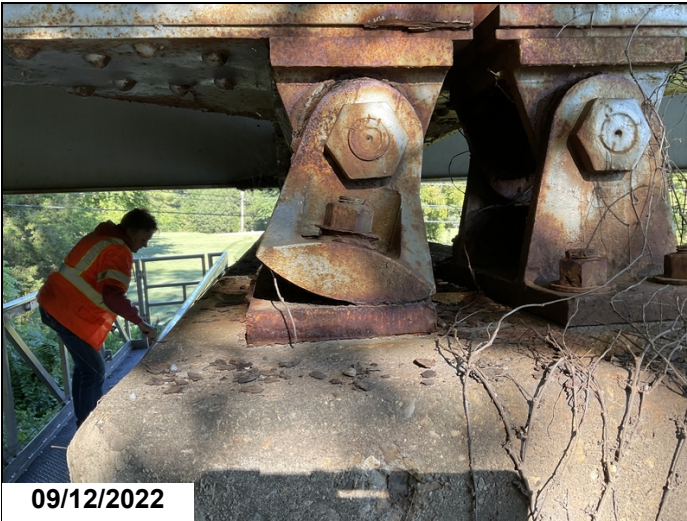
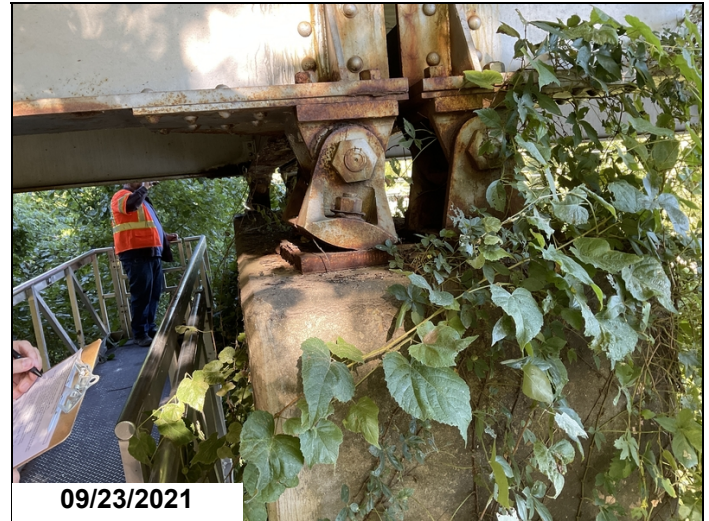
Rocker bearings at Bent 1 have rotated ahead closing deck joint.

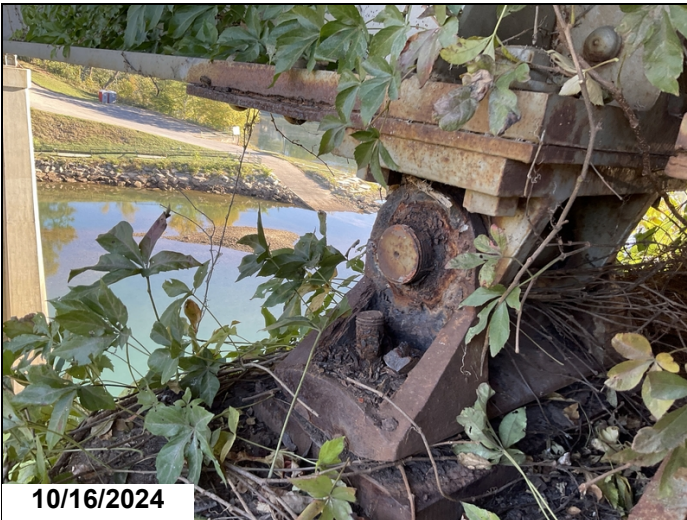
Bent 2, ahead, bearing 1: is missing the exterior nut.

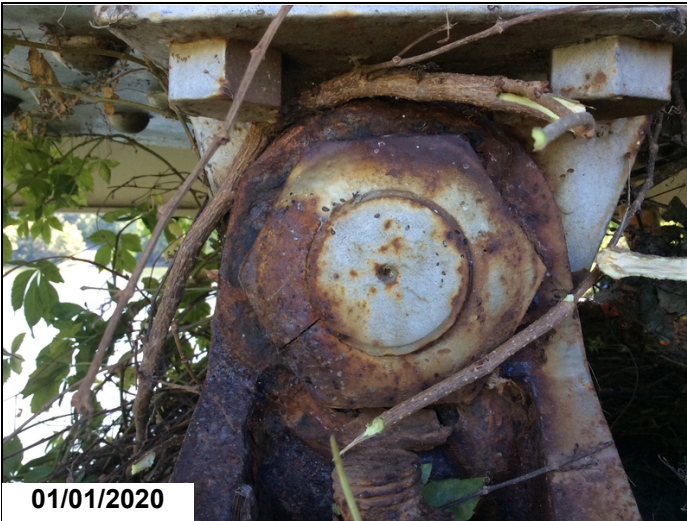
Exterior anchor bolt nut is cracked @ Girder 1 Bent 2 ahead.

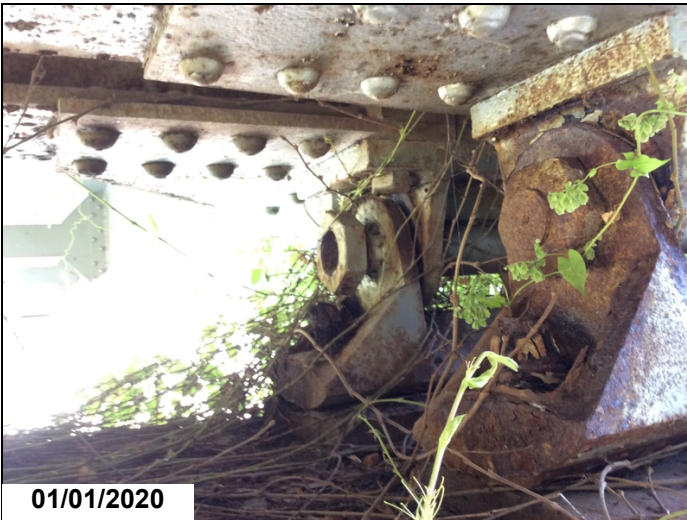
Interior nut has backed off of pin at the ahead side Bearing 2 at Bent 2.

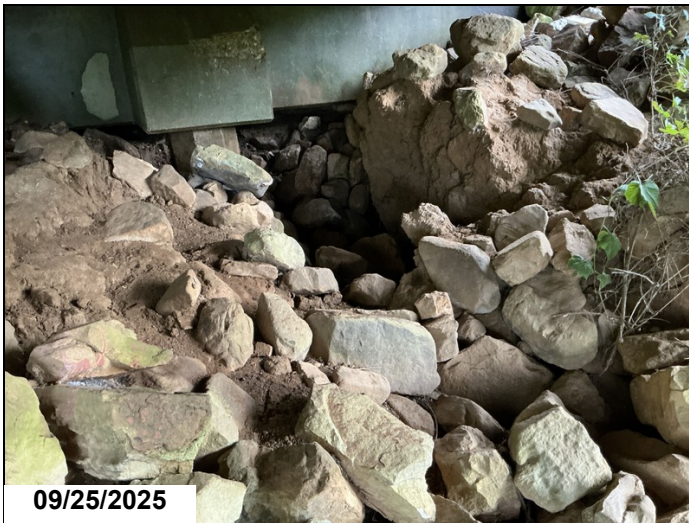
Scour at abutment 1 exposing concrete pile.

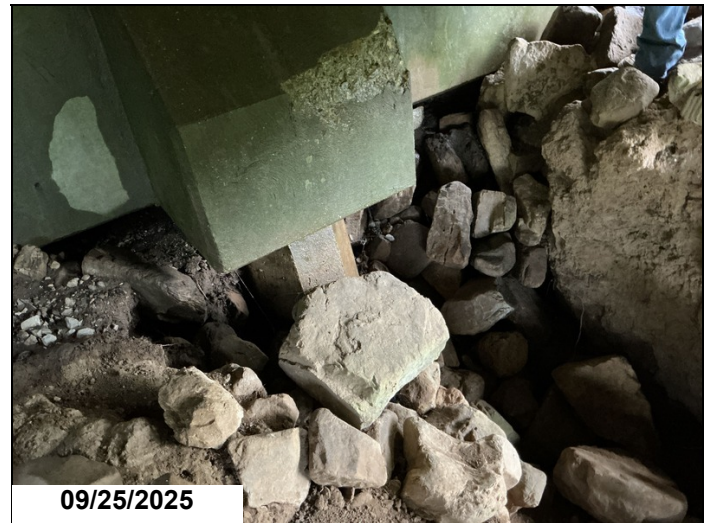
Scour at abutment 1 exposing concrete pile.

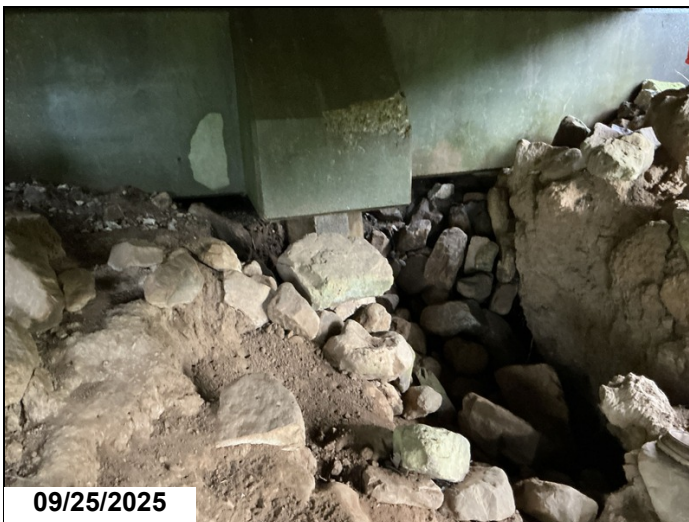
Scour at abutment 1 exposing concrete pile.

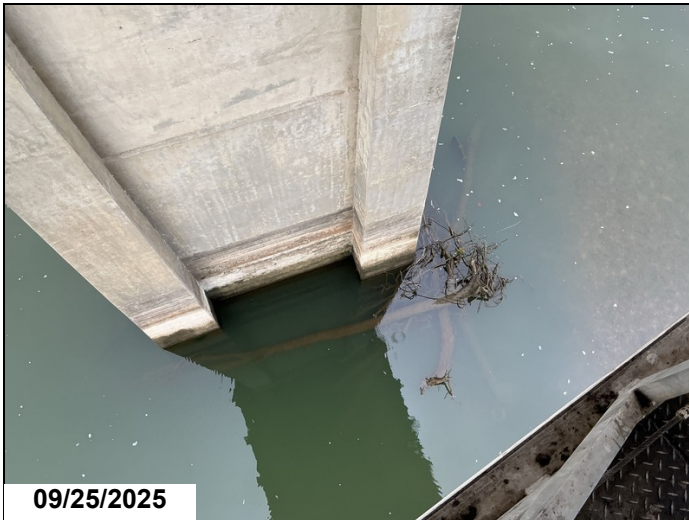
Drift @ Bents 3 & 4.

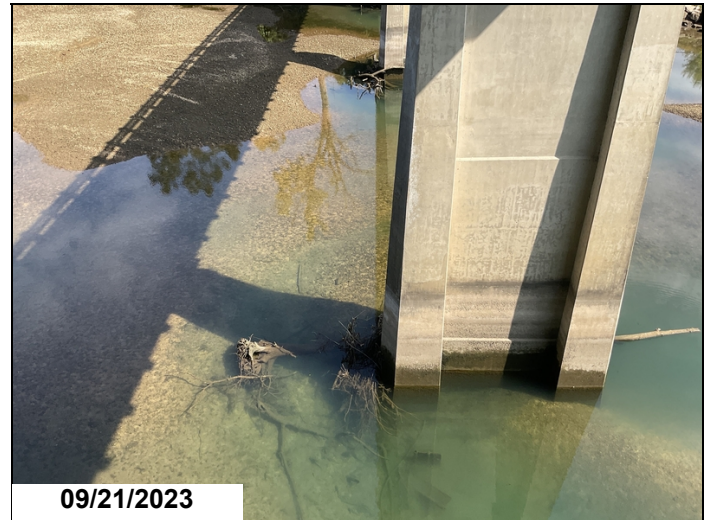
Drift @ Bents 3 & 4.

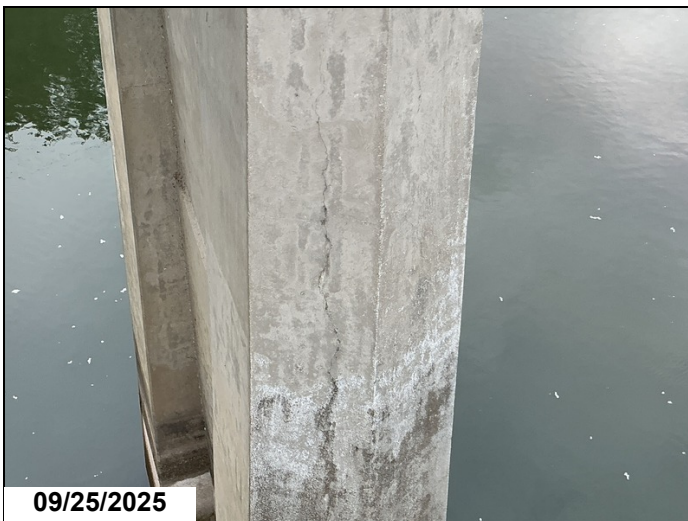
Vertical crack to column 2 at bent 3.
