## Bridge 01899 Inspection Report

Route:5 Section:16 Log:24.61

District 05, 137 - Stone County

Asset #01899(Routine, NSTM)  
SH 5/Stone County over SYLAMORE CREEK  
Location: .3 MI N JCT SH 14 W  
Team Lead: Seth Foreman Inspection Date: 09/17/2025

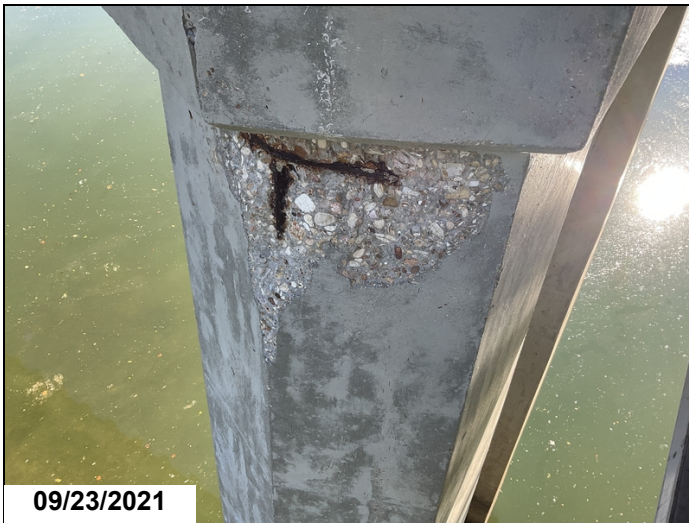
Caps and columns at Bents 1 thru 5.  
Spalls with rebar exposed and delaminated areas.  
Column 1 @ bent 3.

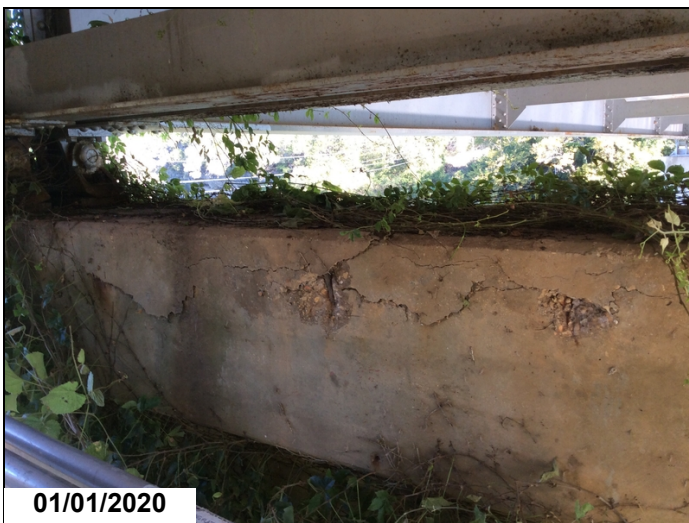
Large delaminated area, Spalls with exposed rebar at  
Bent 2 back side of cap.

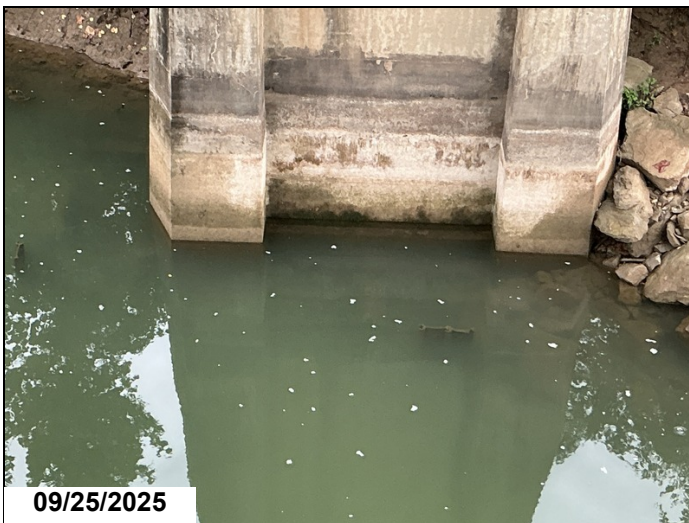
Channel  
has minor scour with tops of footings exposed at Bents 3  
thru 5.

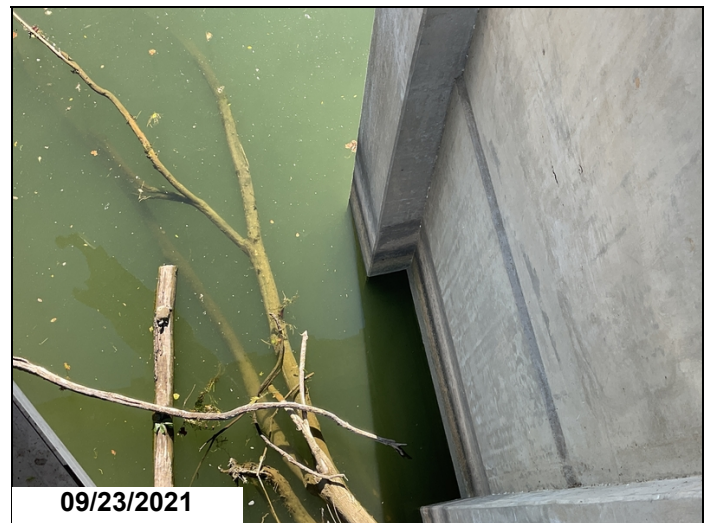
Channel  
has minor scour with tops of footings exposed at Bents 3  
thru 5.

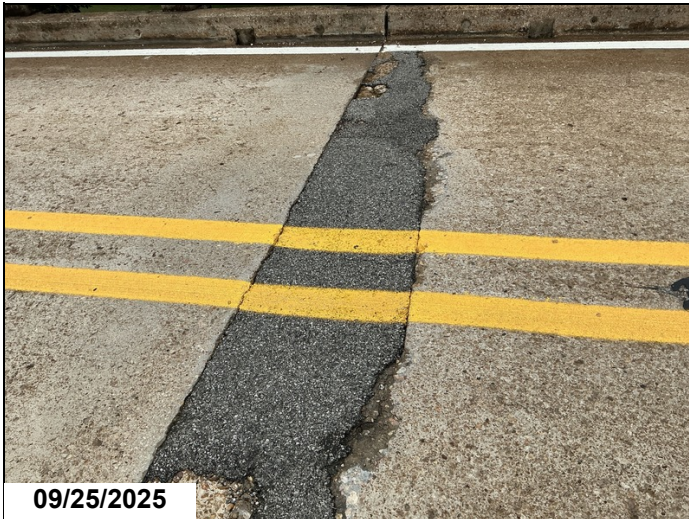
Deep spalls and delaminated areas to deck with some exposed rebar.(covered with asphalt).

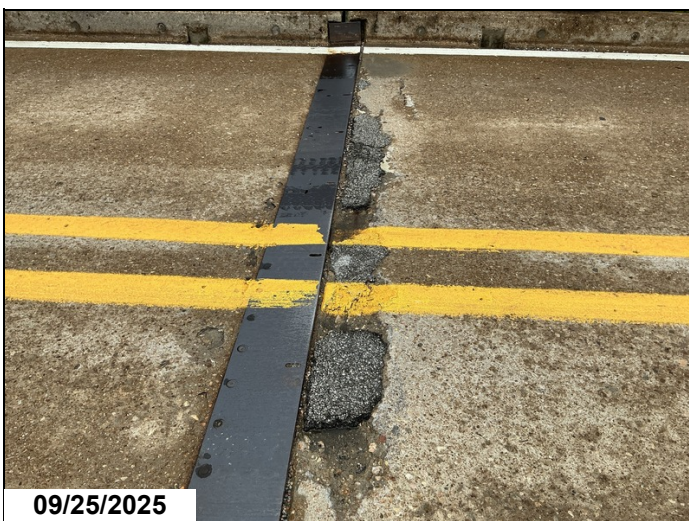
Deep spalls and delaminated areas to deck with some exposed rebar.(covered with asphalt).

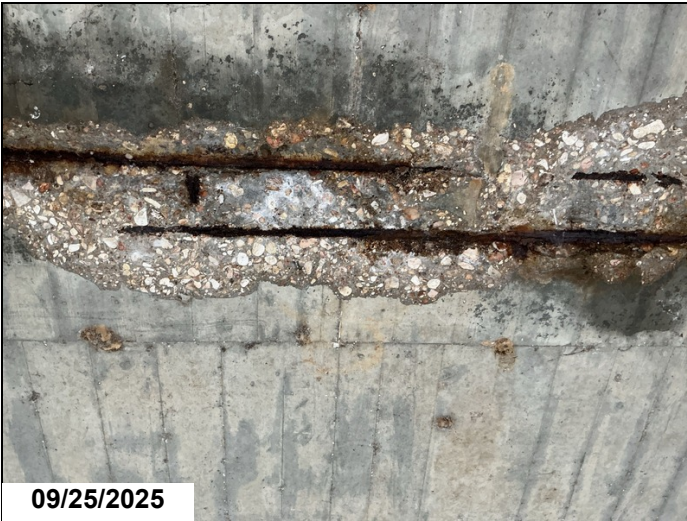
Spall with exposed rebar to undersurface of span 5.

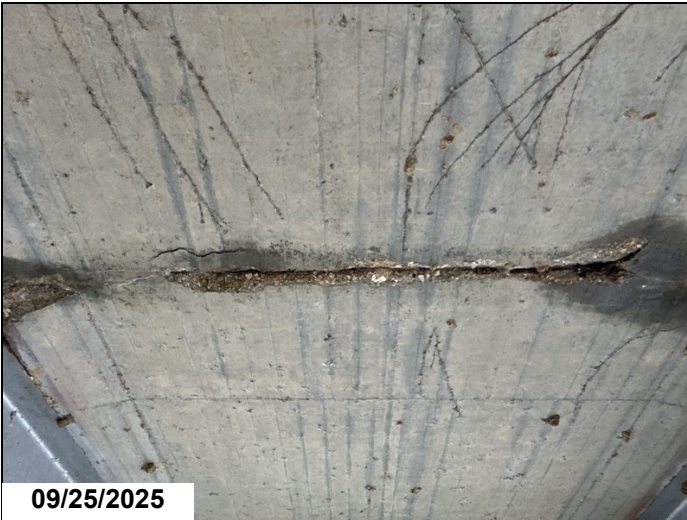
Spall with exposed rebar to undersurface of span 3.

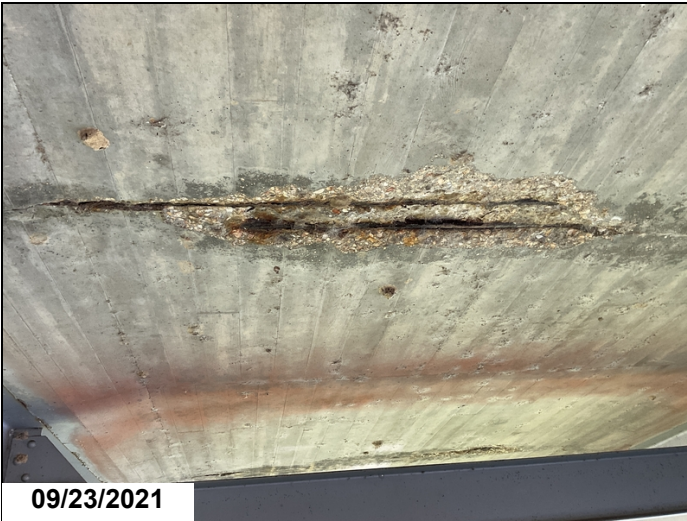
Spalls with rebar exposed to deck below. (Some exposed rebar has been painted) at Spans 2 thru 7.  
Span 2.

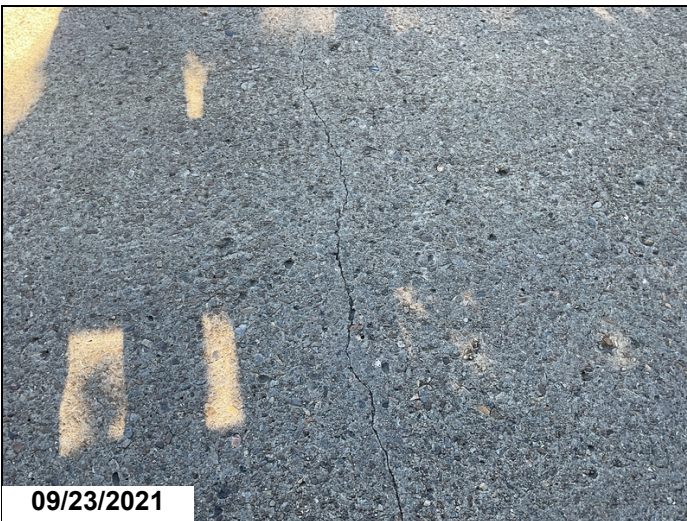
Unsealed transverse cracks to deck at all Spans.

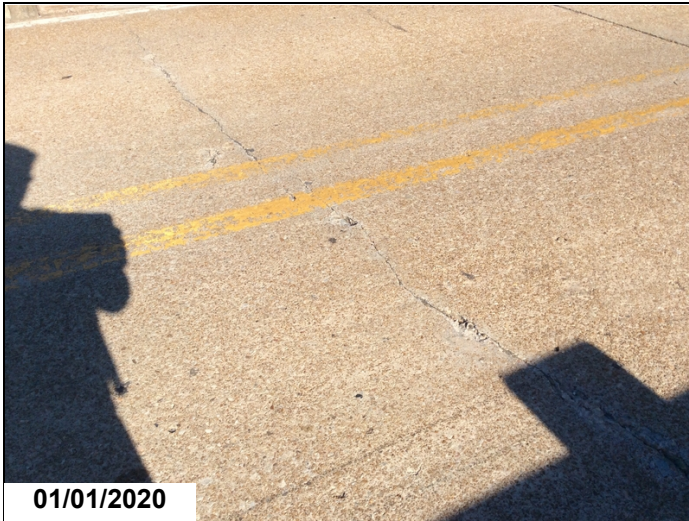
Span 5 Deck cracks and spalls.

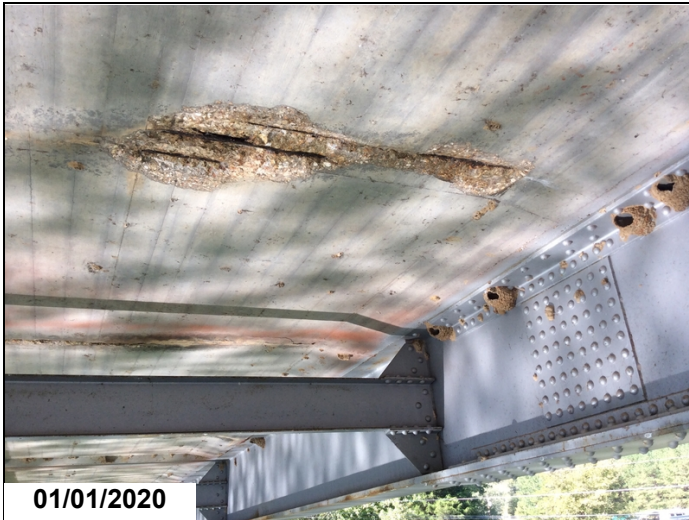
Span 3, Typical spall with exposed rebar to soffit.

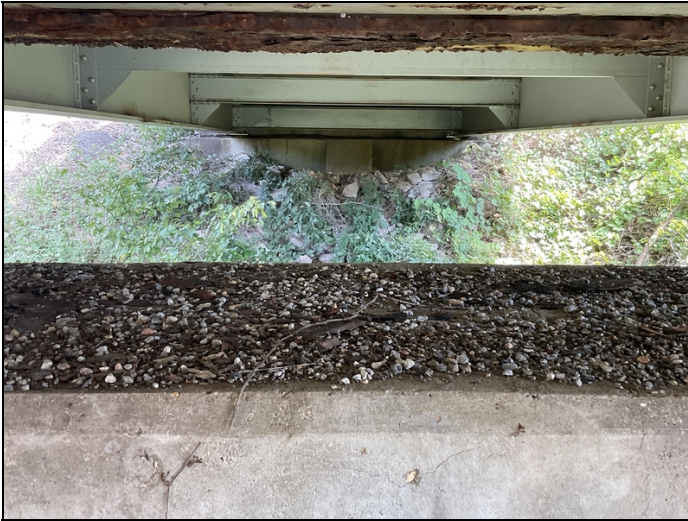
Debris on cap @ Bent 6 & Abutment 2.

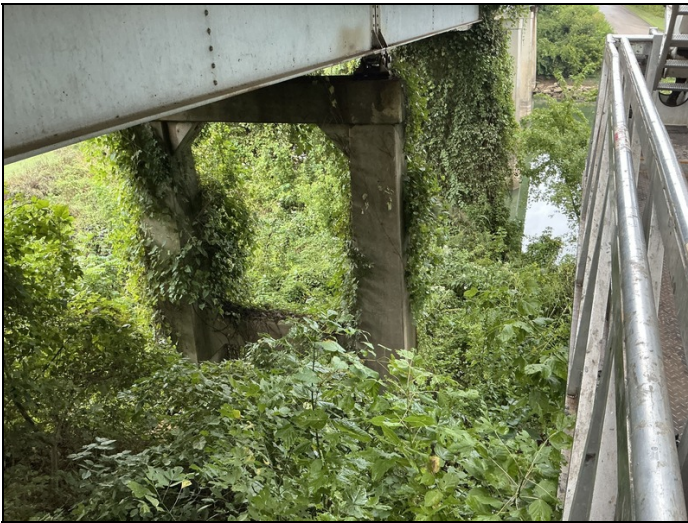
Vegetation @ Spans 1, 2, 6 & 7.

Vegetation under bridge.
